## Brine Stabilities on Hot SNF Storage Canister Surfaces

**Charles Bryan and Eric Schindelholz**  
**Sandia National Laboratories**

*SFWST Annual Working Group Meeting*  
*University of Las Vegas*  
**May 23, 2018**

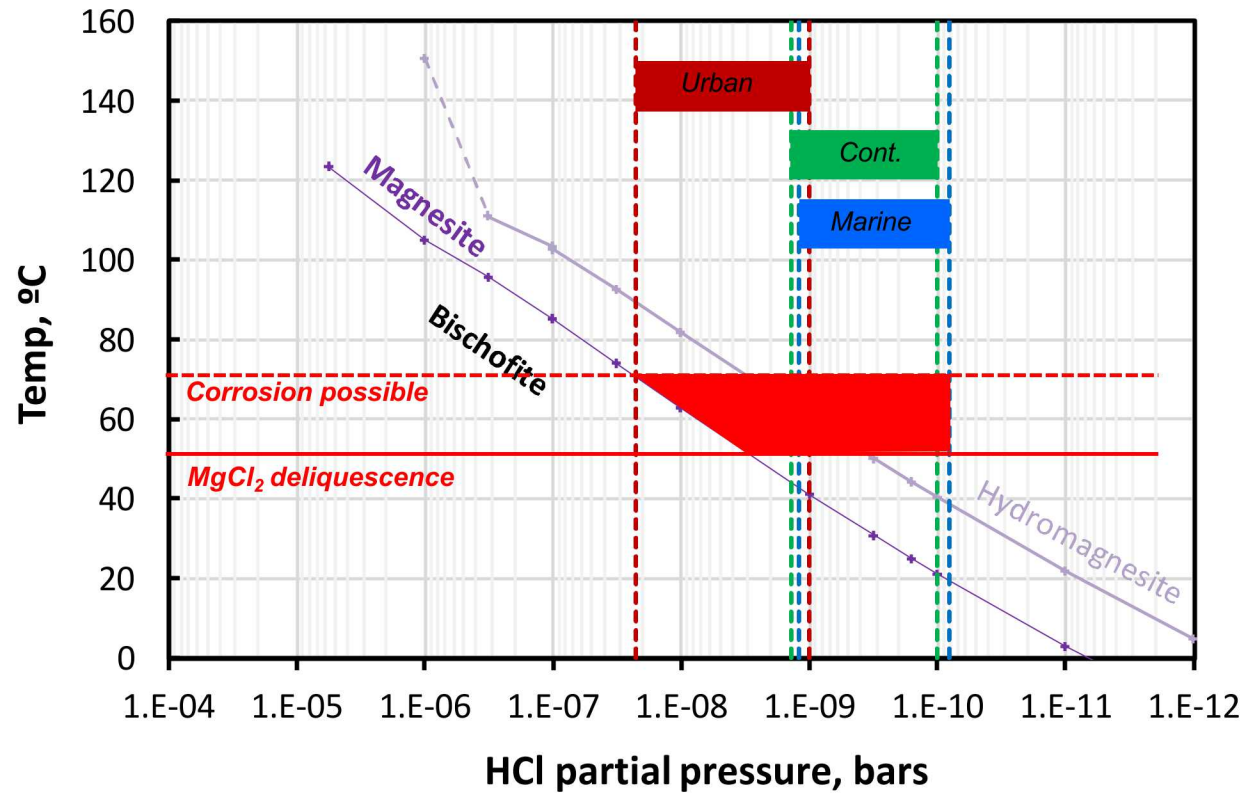
- *MgCl<sub>2</sub> brine, , deposited on silicon wafers*
- *Experimental conditions 48°C, 40% RH, 2 L/min air flow.*
- *Experiment run for 6 weeks*

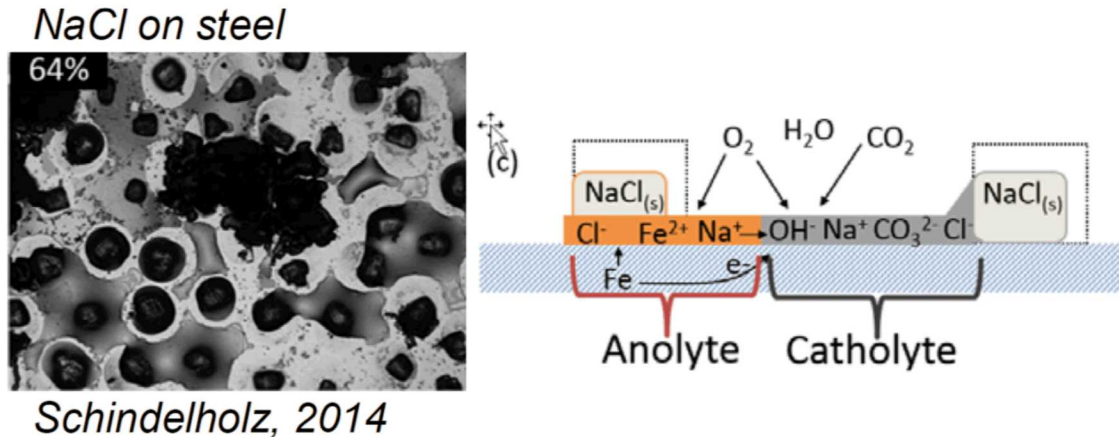
## Corrosion reaction

- Metal oxidation at the anode (pit or SCC crack)
  - Oxygen reduction at the cathodic region surrounding the anode produces hydroxide.
- $$\frac{1}{2}\text{O}_2 + \text{H}_2\text{O} \rightarrow 2(\text{OH}^-)$$
- OH<sup>-</sup> generated at the cathode (pH increases); in the atmosphere, carbonation occurs.
  - Cathodic brine chemistry can result in brine dryout, changes in brine properties (thickness, composition)

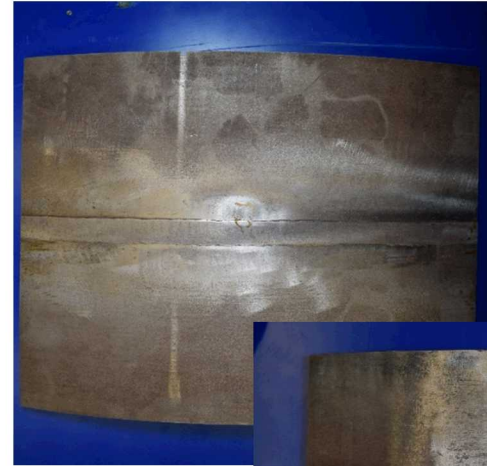
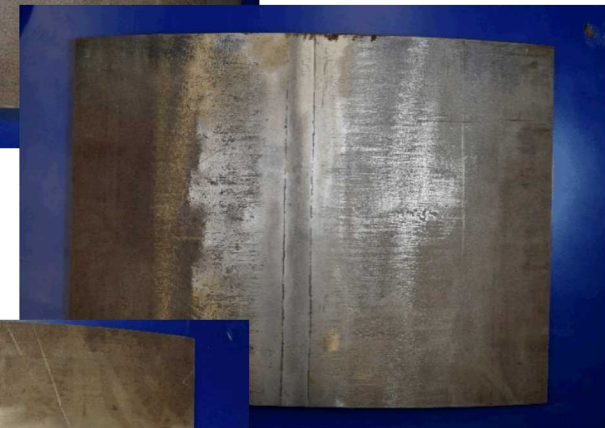
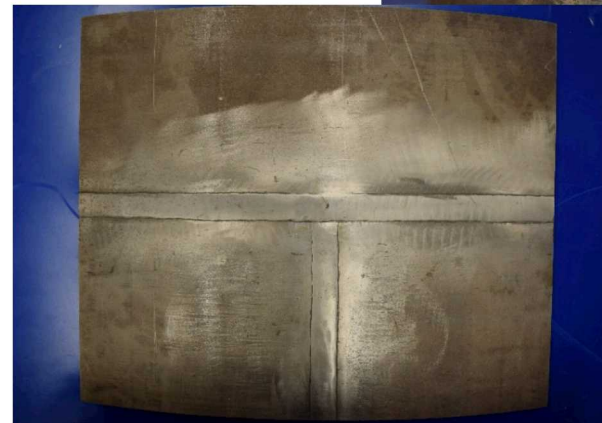
- **Test conditions: 80 °C, 35% RH**
- **Large mockup plates (18" x 20") to maintain most weld residual stresses near the center of the plates**
  - Circumferential weld
  - Longitudinal weld
  - Weld intersection
- **Heavy salt load (nominally 3 g/m<sup>2</sup> MgCl<sub>2</sub>)**
- **Goal: Accelerated test to determine location and orientation of canister SCC cracks**

- *After 2 months, pitting observed on all samples, both in weld and HAZ*
- *Vibro-thermography of plates indicated no SCC formation*
- *However, deposits observed on the metal plates... Contaminant pulled into the RH chamber? Salts? Mg-carbonate or other phase?*

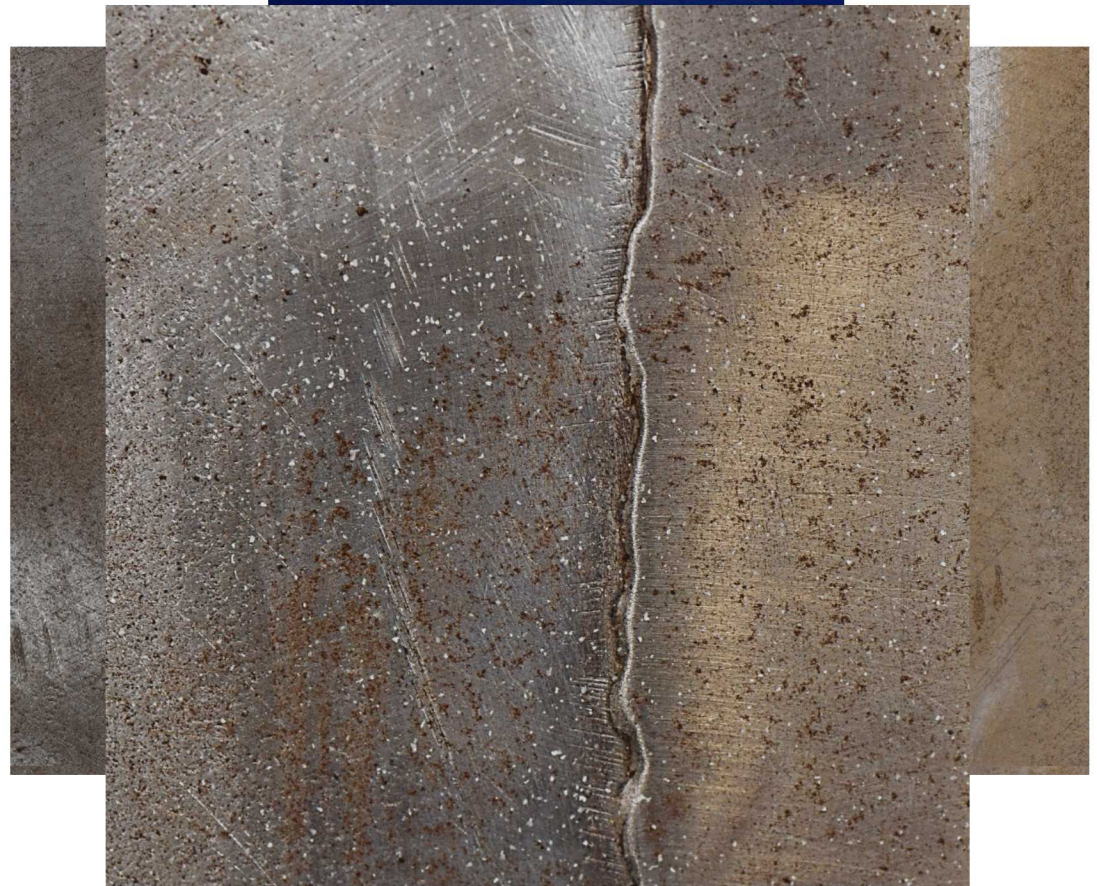
- *Particles are plates, thin and delicate, with one smooth surface and one textured surface (scale?)*
- *Higher magnification: textured surface consists of intergrown hexagonal or pseudo-hexagonal crystals*
- *Flakes are aluminum oxide/hydroxide!*

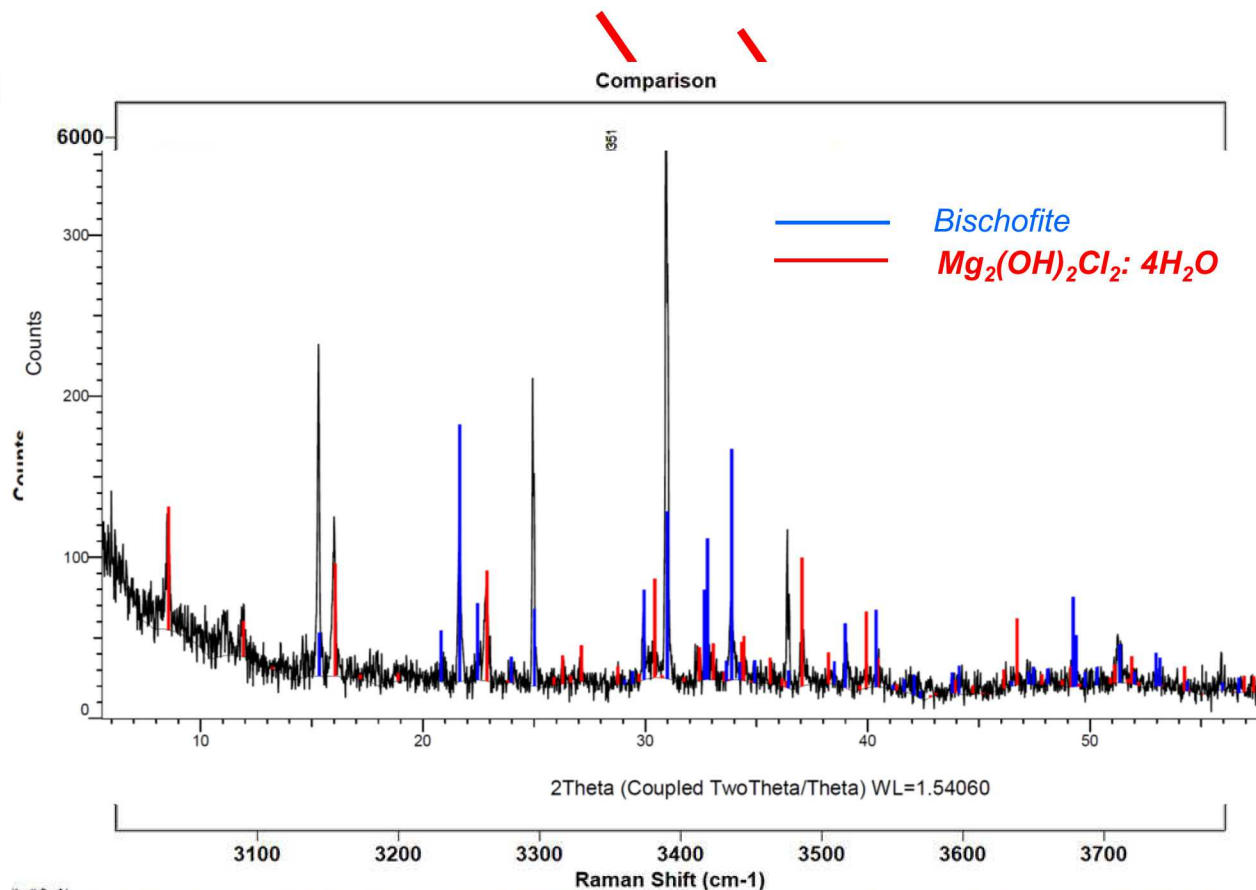
### Formation of Magnesium hydroxychloride hydrate

- Formed in RH chamber at test conditions—less deliquescent than bischofite.
  - Brine volume reduced—reduced cathode region and smaller maximum pit size.
  - If goes to completion, no cathode, pitting stifles (Caveat—continued salt deposition will occur under natural conditions)

- Why did magnesium hydroxychloride form?
  - Oxygen reduction raises pH in cathode — likely
  - Degassing of HCl — possibly. Chemical analysis suggests degassing occurred...
