SAND2018-3116

Development and Evaluation of a Drone- Deployed Wind Turbine Blade Nondestructive Inspection System

Sandia National Laboratories

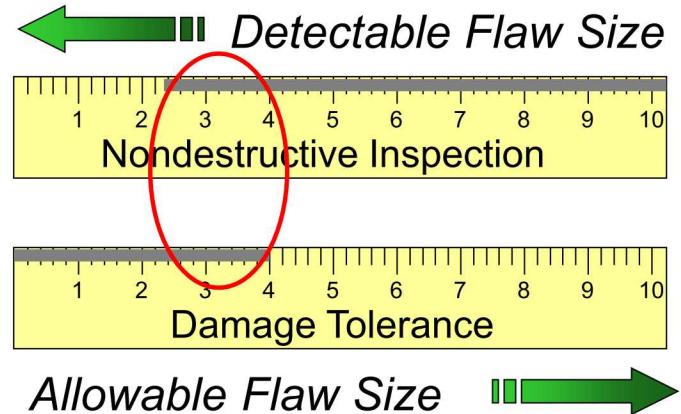
Figure 1-9: Required Relationship Between Structural Integrity and Inspection Sensitivity

Figure 1-9 depicts the approach used to arrive at the desired NDI performance levels. Structural analysis and testing, which include a damage tolerance assessment, are used to determine the level of damage that can be sustained by the blade such that it can still achieve its desired function and lifetime. Inspection methods must then be developed and validated to ensure that all flaws can be detected prior to reaching a critical size. Damage tolerance assessments (DTA) are difficult to complete in composite materials, especially those produced with the VARTM process, and are exceptionally challenging in structures as large as wind turbine blades. Wide variations in operational environments and sources of damage onset also exacerbate a damage tolerance assessment. As a result, this NDI effort uses a conservative approach and includes flaw sizes that are expected to be below the DTA levels. This ensures that the results from the NDI evolution work will produce NDI methods that perform at or above the desired performance levels. DTA analysis and testing

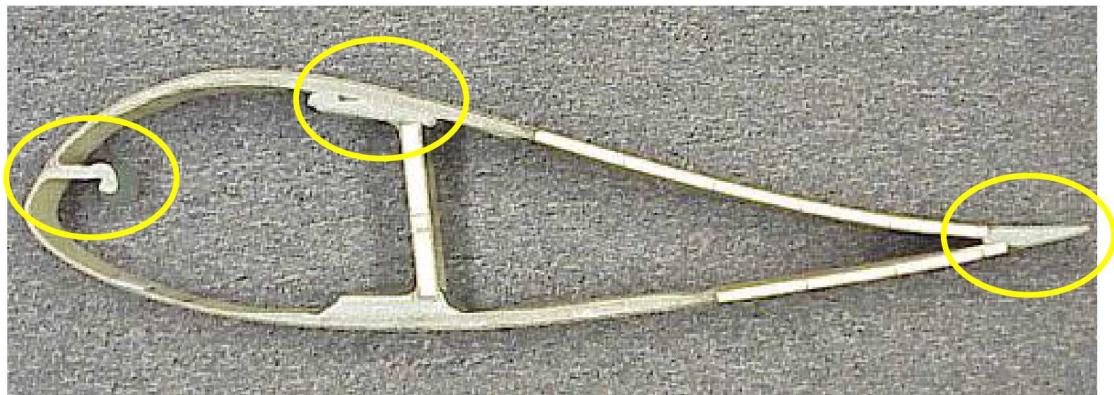
Figure 2-1: Inspection Areas of Interest – 1) Leading Edge Bond, 2) Spar Cap, 3) Spar Cap-to-Shear Web Flange Bond Line and 4) Trailing Edge

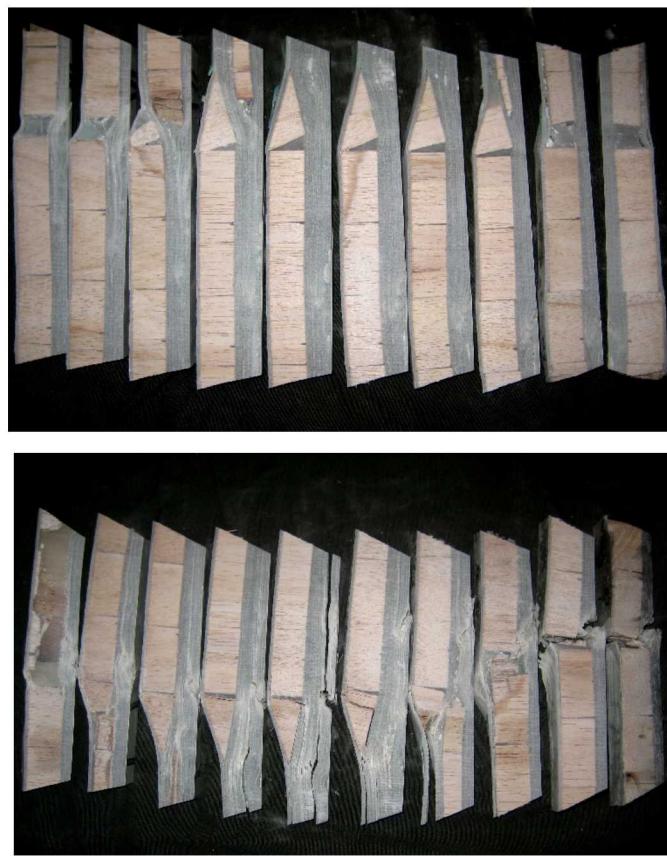
Figure 2-4: Figure Comparing Pristine Blades with Cracks, Delaminations and Other Laminate Fractures that Can Occur in Wind Blades

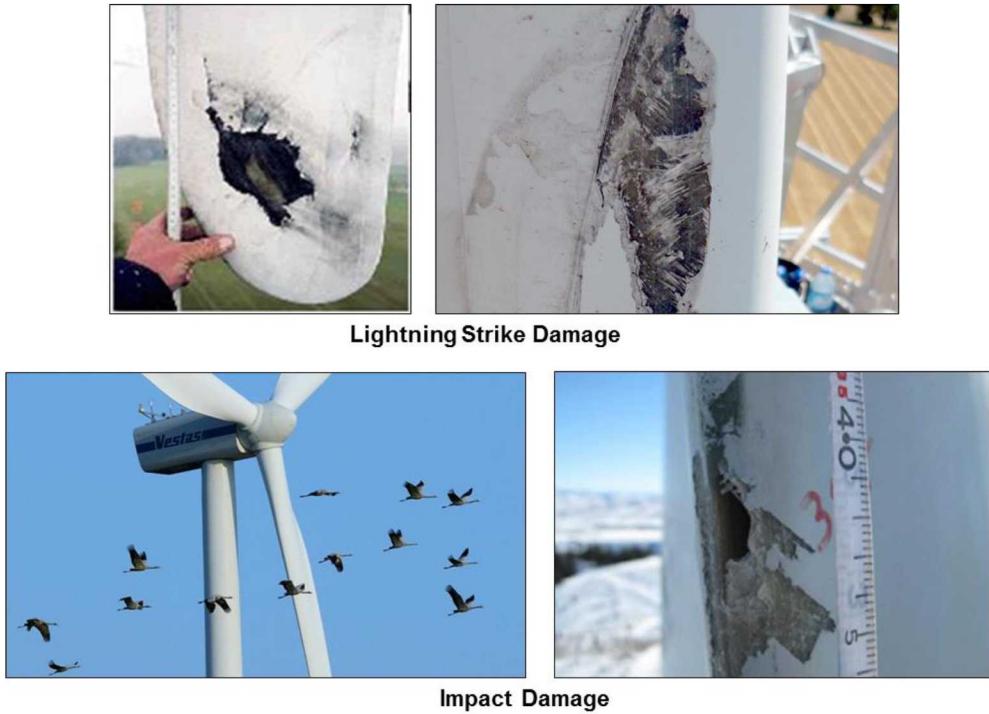
Figure 2-6: Types of Damage to Wind Blades Experienced During Operation (1)

The most common operational damage is from surface impact and rain/dust erosion. Other damage stems from bird strikes, lightning strikes, other object strikes, the propagation of manufacturing anomalies and the origination of new damage stemming from normal fatigue stress loads, off-design overloads or other environmental conditions. Figure 2-6 to Figure 2-8 show various types of wind blade damage. Note that all photos feature damage that is extreme or that has propagated to the point of blade failure. The goal of this effort to conduct nondestructive inspections before minor damage can grow to levels of concern. Figure 2-9 shows several images of subsurface damage that can be detected via NDI methods.

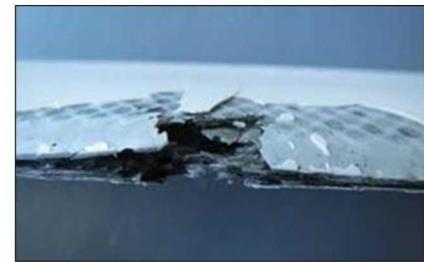
Trailing Edge Disbond and Fracture Damage

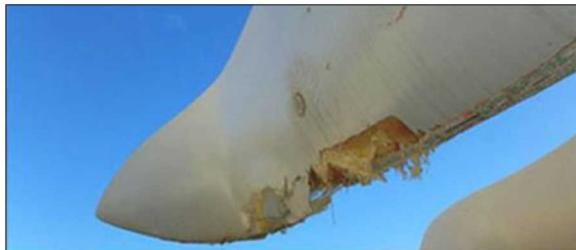
Erosion and Impact Damage

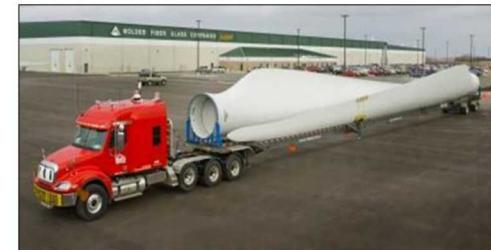
Damage from Shipping and Installation Handling

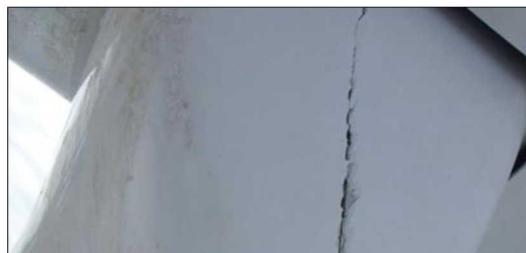
Severe Growth of Fiber Fracture

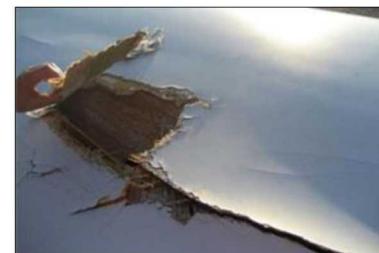
Delamination and Subsequent Laminate Fracture

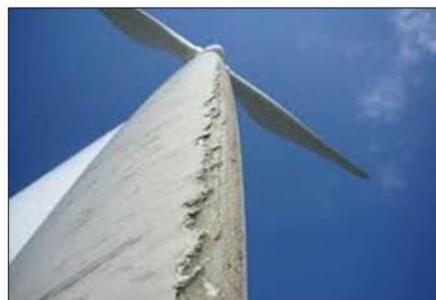
Erosion Damage

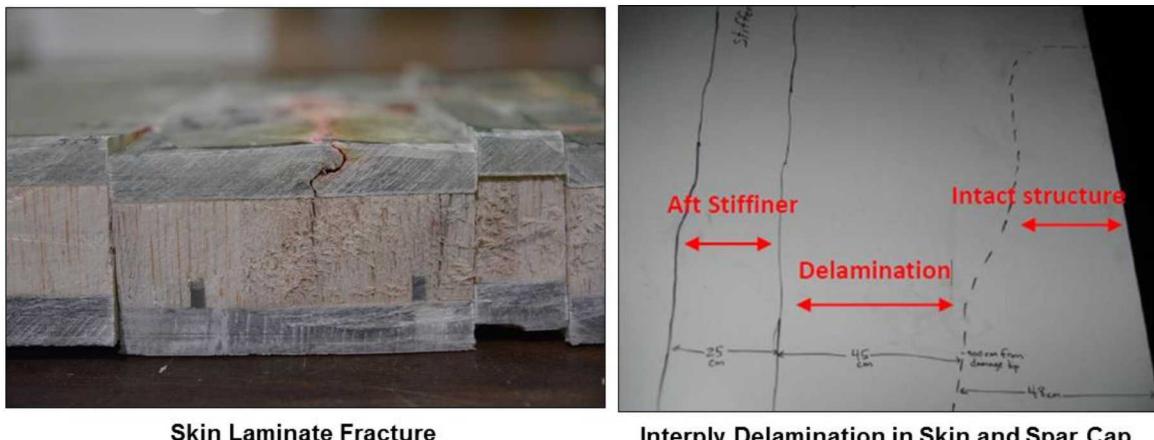
Figure 2-9: Subsurface Wind Blade Damage Detectable Using NDI Methods in the Field

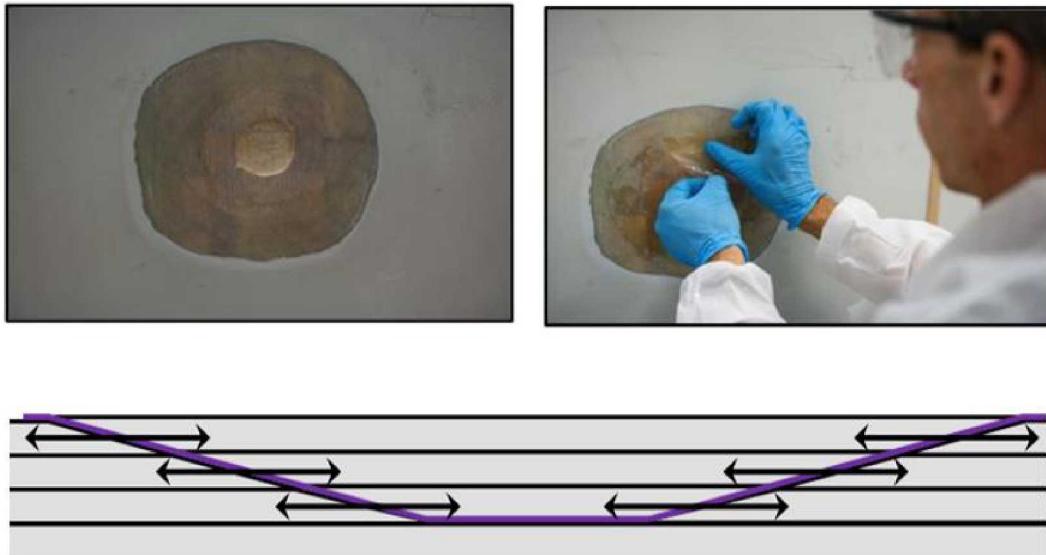
Figure 2-11: Tapered Scarf Angle, Replacement of Plies and Resulting Shear Stress Distribution in the Scarfed Repair Joint

A typical repair process is shown in Figure 2-11 where a tapered sanding process is used to remove the damaged region. Then, replacement plies of similar material and orientation are placed into the repair region and cured using in-situ vacuum and heating equipment (if elevated cure temperatures are needed). An example of a blade tip repair is shown in Figure 2-12. The success of a repair can be affected by numerous factors including: surface preparation, the ambient temperature and humidity conditions during curing, proper mixing and uniform application of the resin, improper curing profiles and improper placement/orientation of the plies. Most of the problems associated with improper repairs will result in damage within the repair that can be detected by NDI methods. Normally, the damage could be detectable during a post-installation inspection or within 6-12 months of operation.

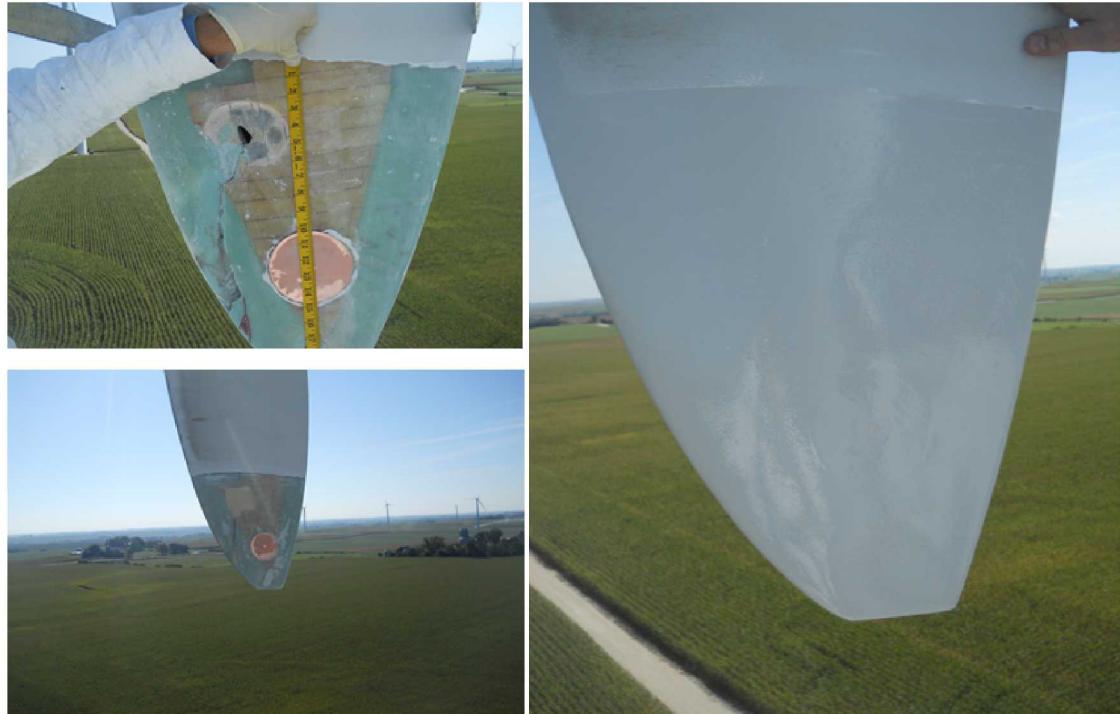
Figure 2-12: Picture of a Lightning Strike Tip Repair

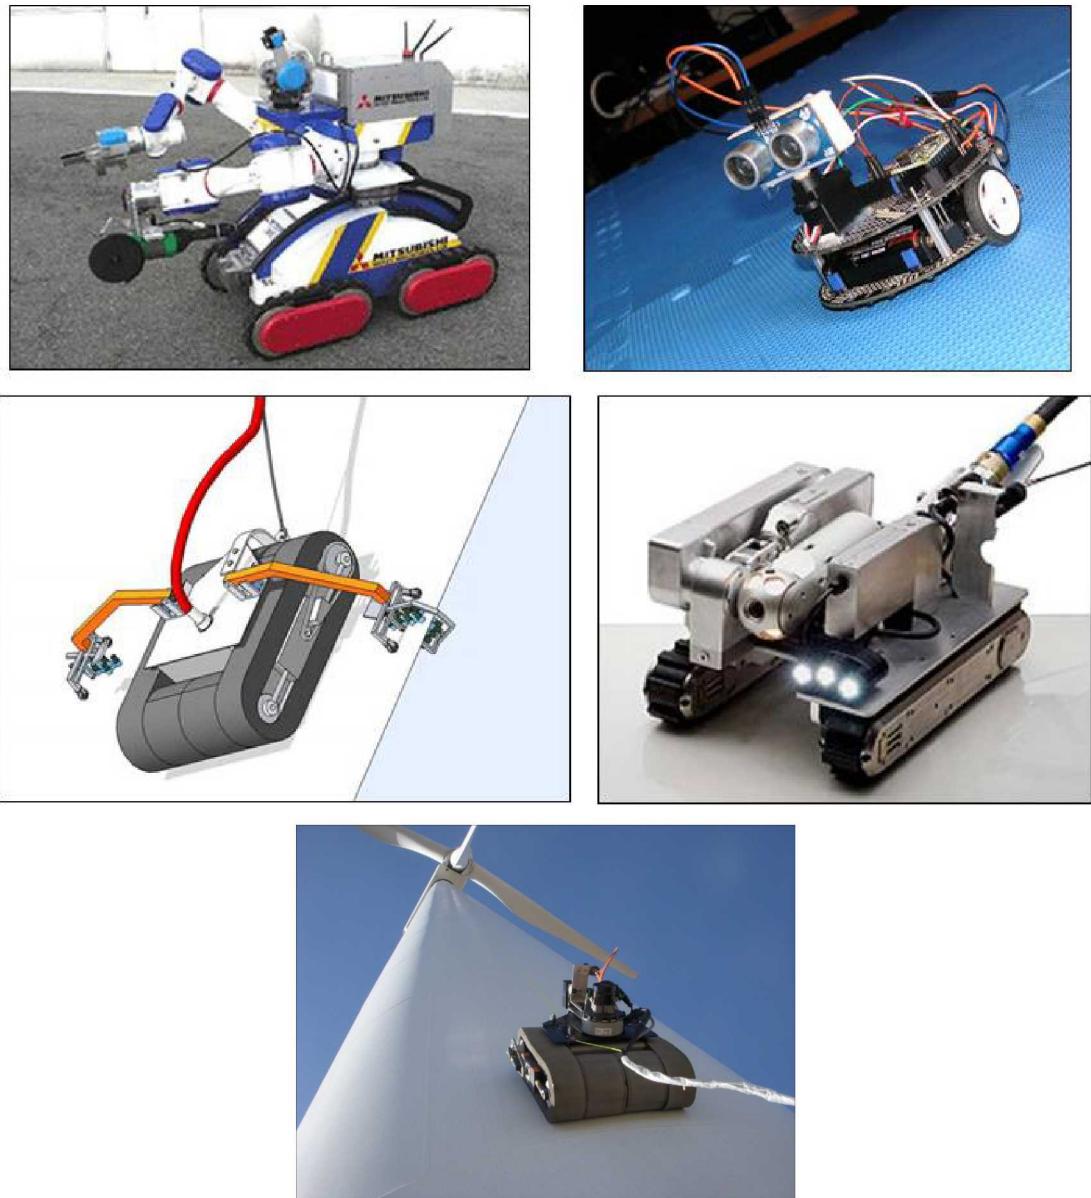
Figure 2-17: Remotely Controlled Auto Crawler Devices for Possible Deployment of NDI Equipment

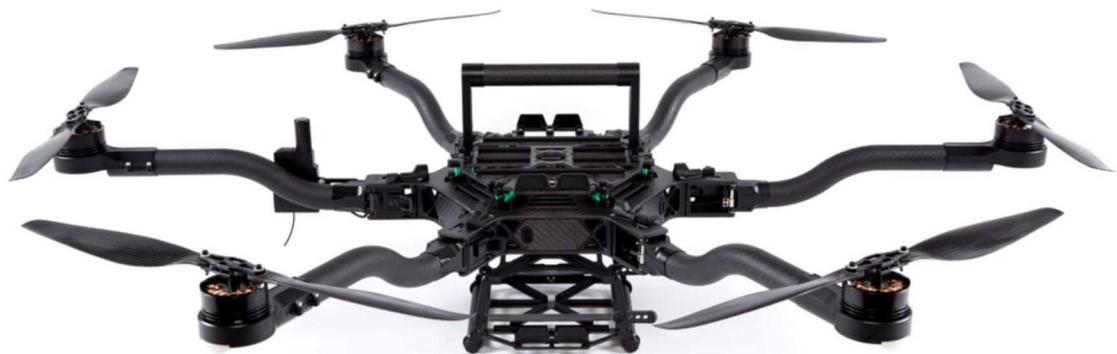
Figure 3-2: Alta Freefly 6 in COTS Configuration

Figure 3-1 shows an overview of the key features of the drone platform. The SkySpecs inspection platform employs two primary systems: (1) a commercial-off-the-shelf (COTS) Freefly Alta 6 drone (Figure 3-2) and (2) a custom-built rig with a variety of integrated sensors, software, and systems that is mounted to the top of the airframe (Figure 3-3). The sensor rig's computer, outfitted with SkySpecs' proprietary automation software, interfaces with the drone's embedded flight control system to achieve autonomous aerial inspections of wind turbine blades. The Alta 6 drone is largely unmodified from its COTS configuration, whereas the sensor rig is custom-fabricated from a combination of carbon fiber plates and tubes, aluminum standoffs, custom hardware mounts and interface parts, and other COTS sensors. The advanced positioning capabilities of the sensor rig are performed using a combination of these COTS sensors, including an inertial measurement unit (IMU), global navigation satellite system (GNSS) receivers, Velodyne VLP-16 light detection and ranging (LiDAR) puck, and data transmitting radio, combined with a CPU and motherboard.

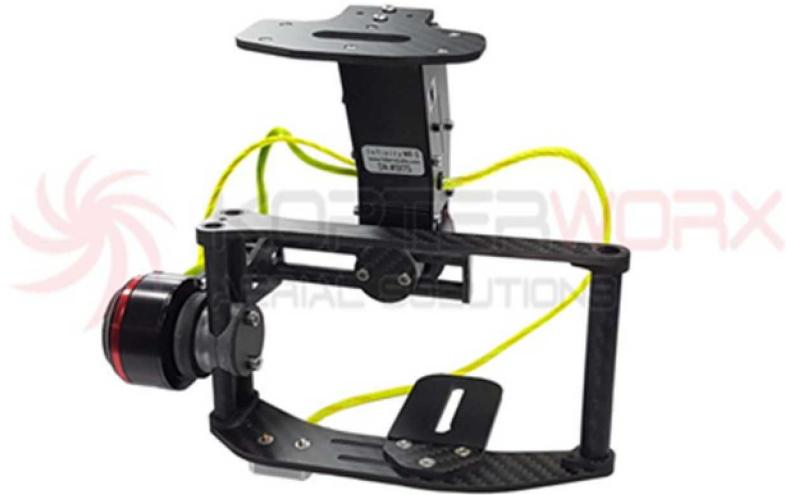
Figure 3-5: HD AirStudio Infinity MR-S Very Lite Gimbal

The current visual inspection equipment consists of a Sony UMC-R10C 20 megapixel lens-style camera (Figure 3-4) mounted on a HD AirStudio Infinity MR-S Very Lite two-axis gimbal (Figure 3-5). This setup allows the drone to orient the camera, as needed, to take high resolution photos of the wind blade surface. The most efficient way to add subsurface damage detection capabilities to the drone is to integrate a sensor or inspection transducer with similar form factor, power, and weight specifications as the Sony UMC-R10C onto this existing gimbal, either alongside the camera or adding the ability to swap out the camera. Additionally, SkySpecs' engineering personnel should be able to rapidly model and 3D print any interface mounts required to fit a new sensor onto the integrated, 2-axis gimbal.

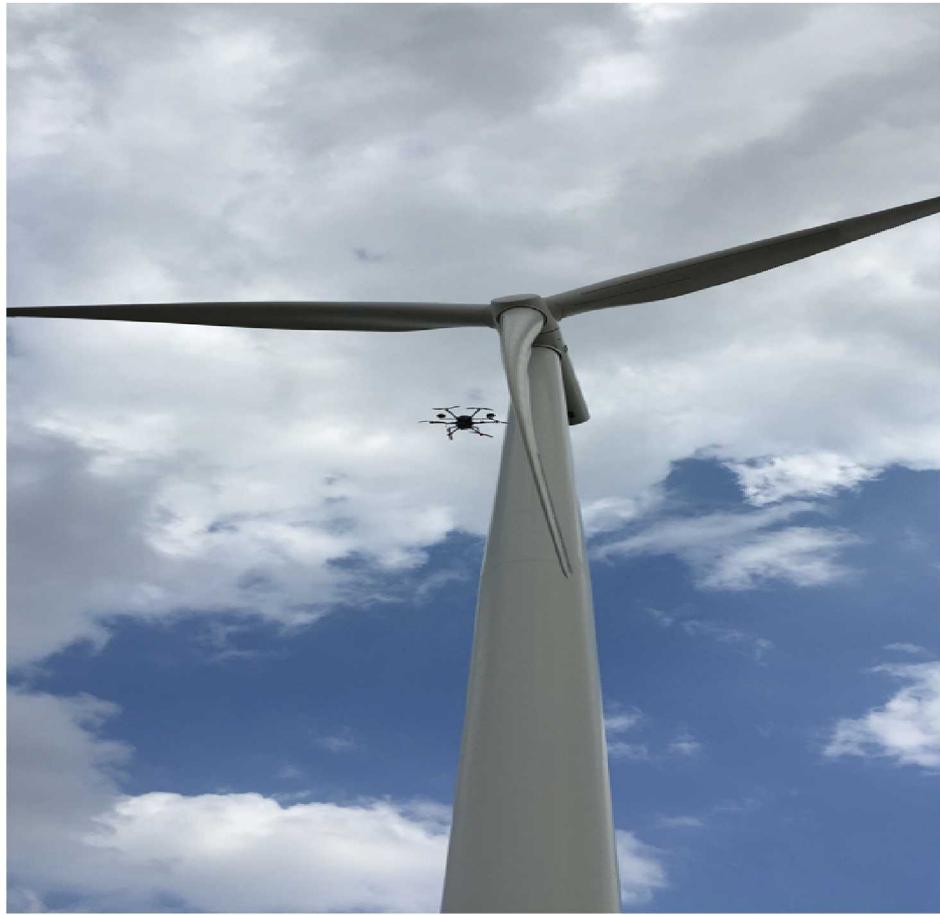
Figure 3-6: SkySpecs Drone Inspecting a Wind Blade

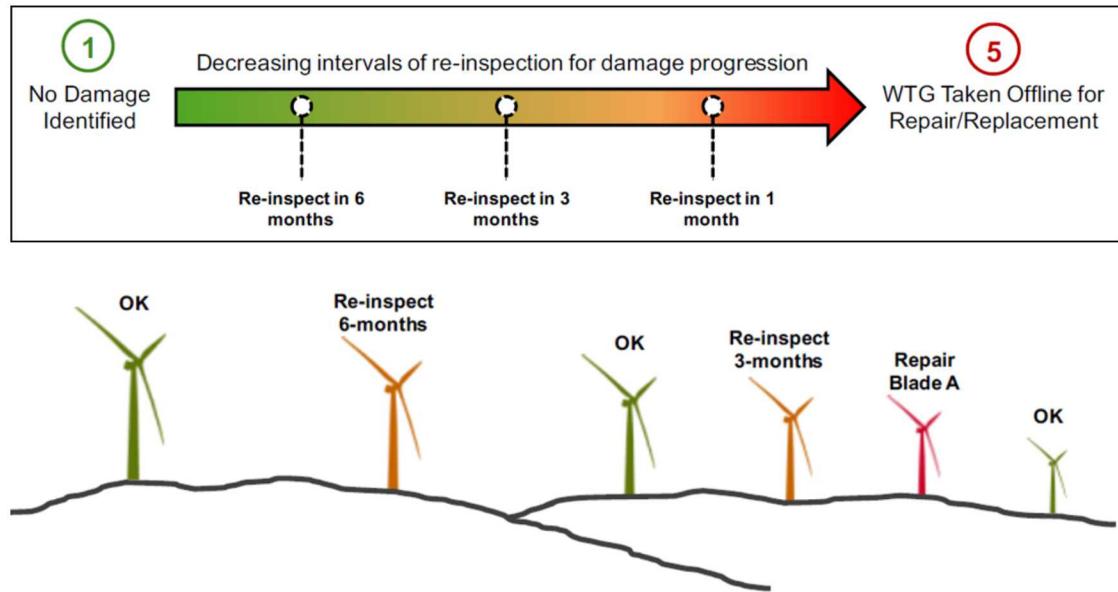
Figure 3-8: Damage Severity Affects Maintenance Interval

In addition to classifying the damage type, damage categorization is important in standardizing and executing reinspection and repair work scheduling. Figure 3-8 shows an example of how these damage categories can affect the maintenance interval on a set of turbines. Figure 3-9 summarizes the criteria for each of the categories on a scale of 1 – 5, with 5 being the most severe. These categories provide the wind farm operators with the necessary quasi-quantitative information to make informed decisions on repairs and inspection intervals. The following sections provide examples of the damage categories for a sample of damage types.

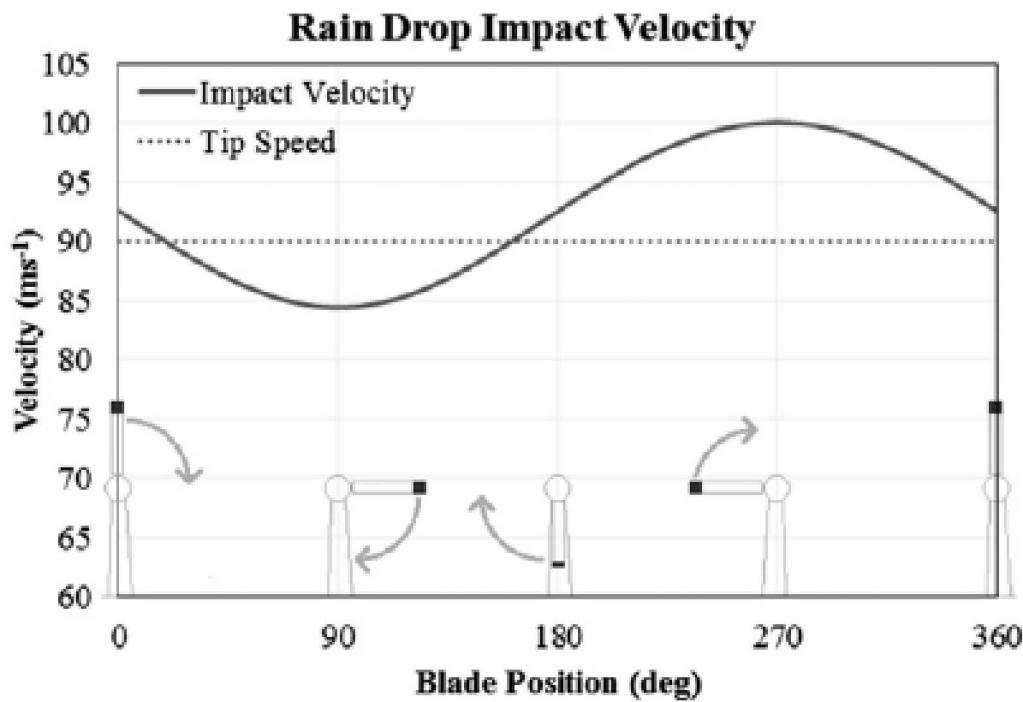
Figure 3-10: Rain Drop Impact Velocity vs. Blade Position

Erosion is predominantly found on the leading edge and is typically a result of environmental conditions, such as dust/sand, rain, and ice. Due to the high speed of the wind blade tips, these environmental conditions can cause significant erosion over time. As shown in Figure 3-10, the downward velocity of rain also causes a non-negligible change in rain drop impact velocity with respect to blade position [3.2]. Based on Sandia aerodynamics models, Figure 3-11 shows that the surface roughness caused by erosion can decrease the AEP by approximately 2.5% at a moderate wind speed site and 5% at a low wind speed site [3.2].

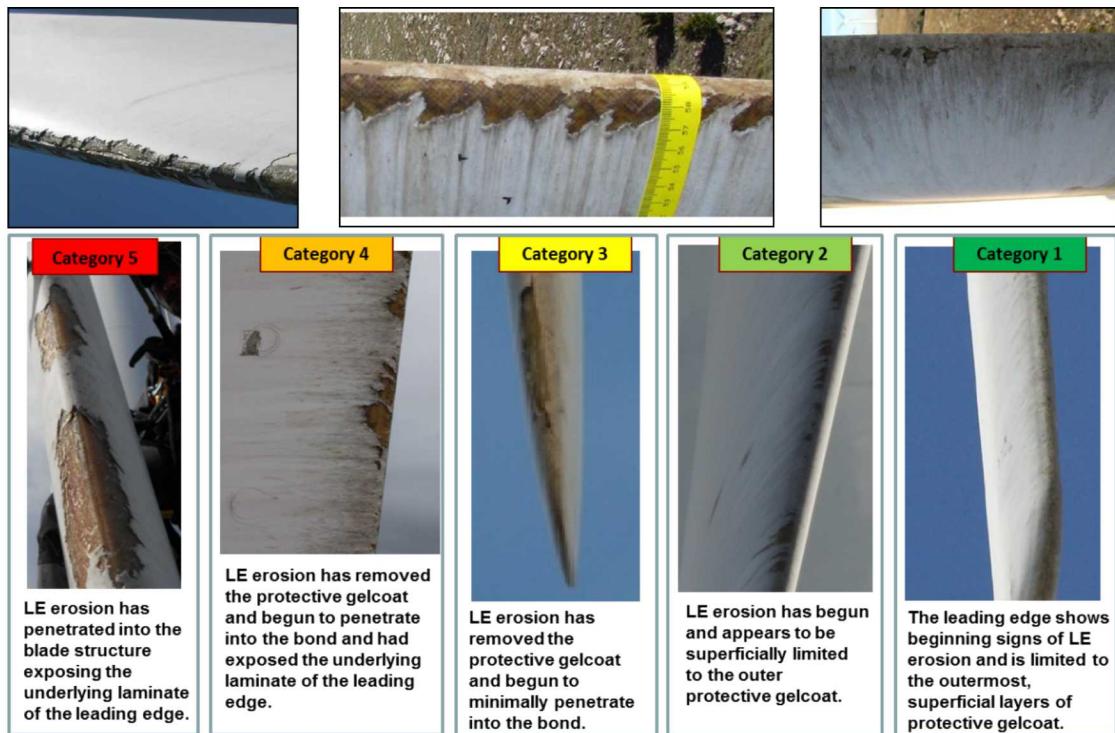
Figure 3-12: Leading Edge Erosion – Damage Severity Examples

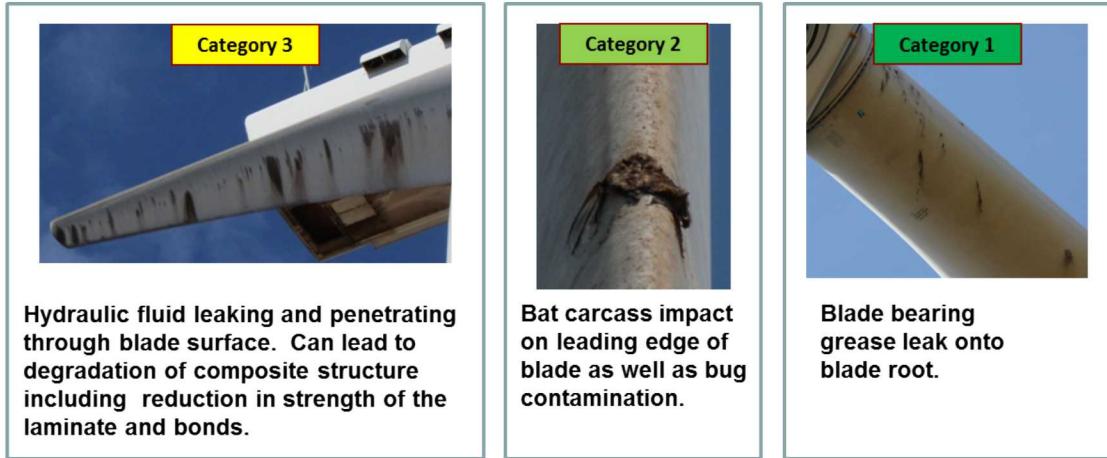
Figure 3-13: Shell Contamination – Damage Severity Examples

Shell Contamination includes contaminants such as bugs, dirt, hydraulic oil or blade bearing grease that may negatively impact blade structure and/or turbine performance. Figure 3-13 provides examples of Category 1-3 damage. Note, a Category 4 or 5 rating for contamination is not likely to occur since there will generally be more severe issues that lead to taking a turbine offline ahead of contamination (e.g., hydraulic pump burst).

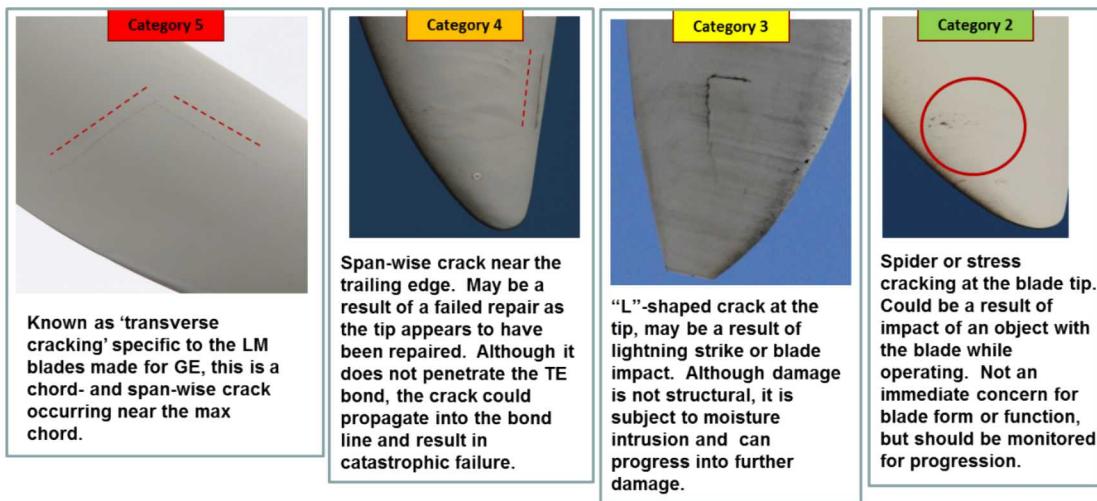
Figure 3-14: Cracks – Damage Severity Examples

Cracks may penetrate through the blade gel coat or even the primary blade structure. Cracks can possibly occur during manufacturing, object impact, or blade loads that exceed the design intent and cause the blade to bend and shell to crack. A coating crack is typically narrow and does not appear to have much depth. Whereas, a crack penetrating the coating into the structure may appear wider with greater depth. Figure 3-14 shows examples of cracks with varying severity.

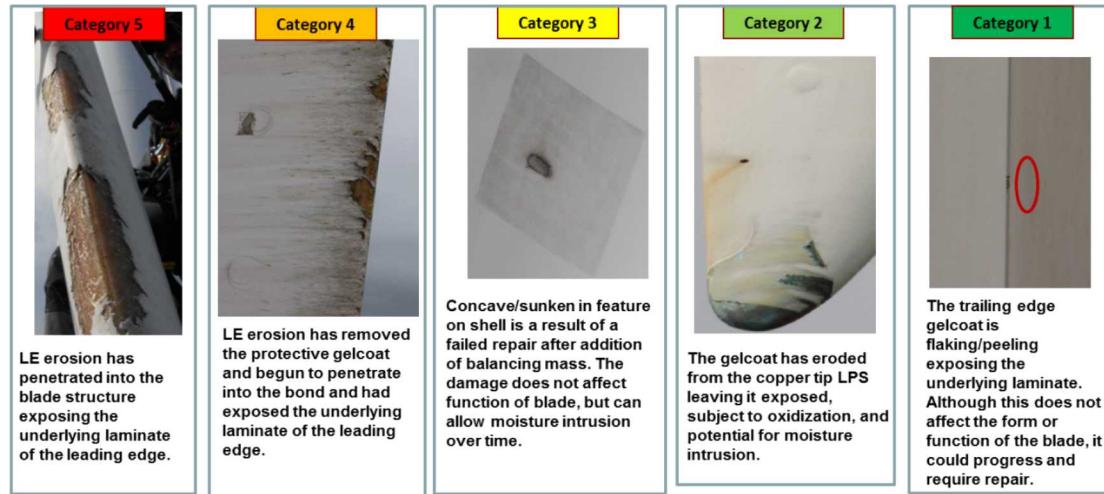
Figure 3-15: Gel Coat/Top Coat – Damage Severity Examples

blade to bend and shell to buckle. Figure 3-15 illustrates varying severity levels of gel coat/top coat damage.

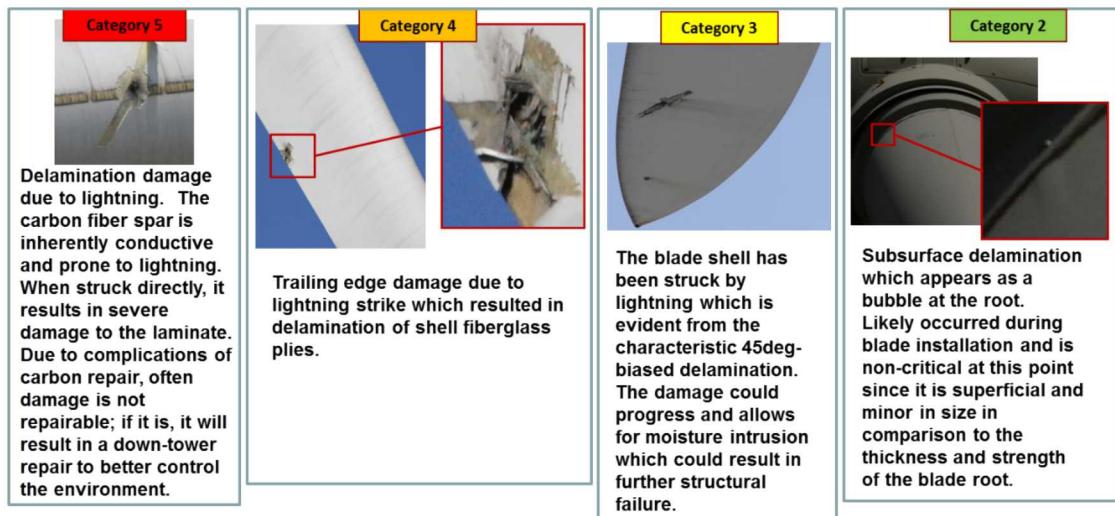
Figure 3-16: Laminate Damage – Damage Severity Examples

Fiberglass delamination is the separation of fiberglass ply layers of the blade laminate that can greatly lower blade strength depending on location and severity. Possible causes can be poor manufacturing, structural impact, blade loads which exceed design intent and cause the blade to bend and shell to buckle, temperature fluctuations, or water/fluid intrusion which expands either when struck by lightning or as it freezes causing ply delamination. Examples of laminate damage are shown in Figure 3-16.

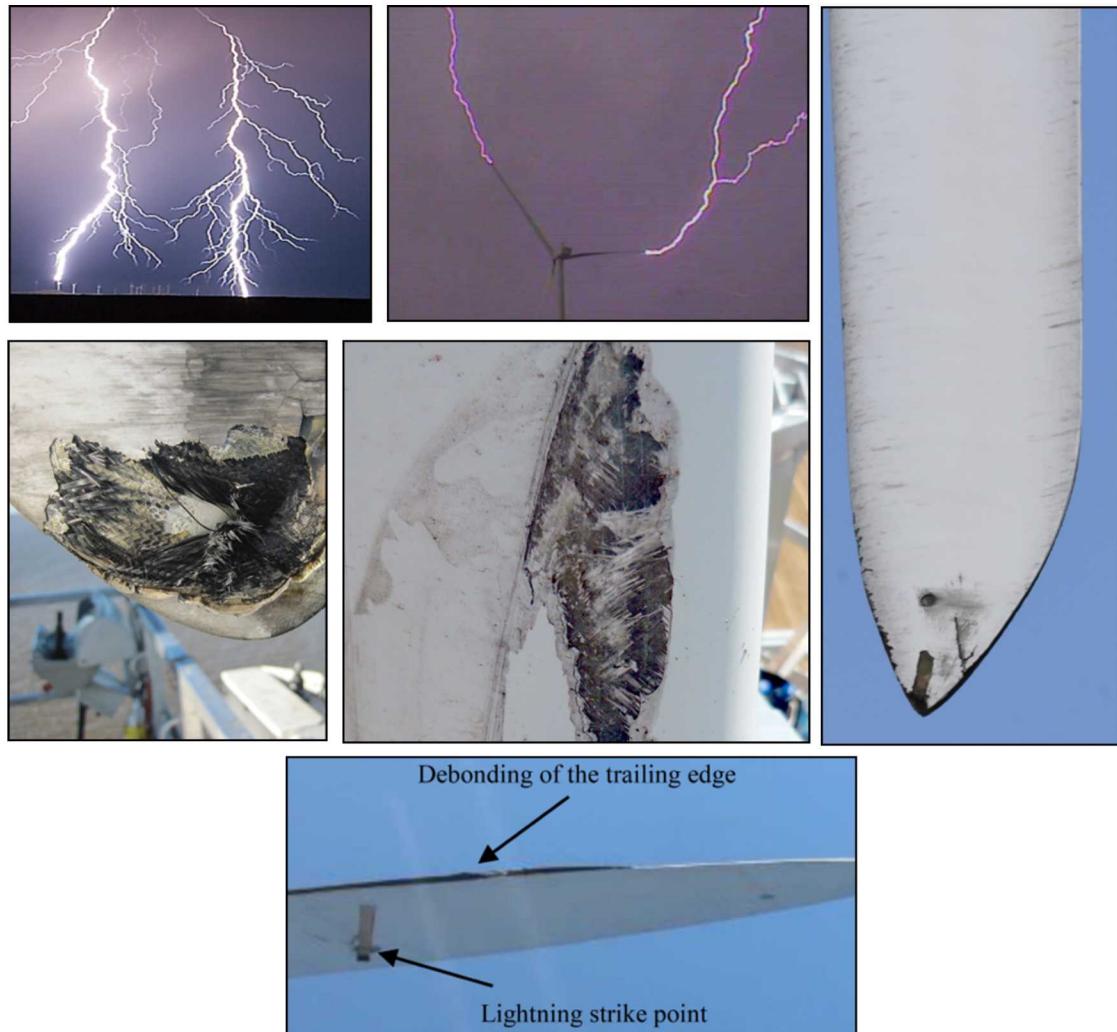
Figure 3-17: Lightning – Damage Severity Examples

warranty, the owner is placed in the position of monitoring for damage at an early stage before it moves from a lower cost repair situation, to a full replacement requirement. Damage types include, but are not limited to, gel coat damage, cracks, delamination, disbonding, and trailing edge separation. For example, a lightning strike to the lightning cable through the blade shell can result in trailing edge delamination due to high pressure inside the blade. Typical locations of lightning damage are at the tip of the blade near the lightning receptor. Scorching is also likely and may include holes or delaminations where lightning entered or exited the blade at a location other than receptor. Figure 3-17 and Figure 3-18 show various categories of lightning damage.

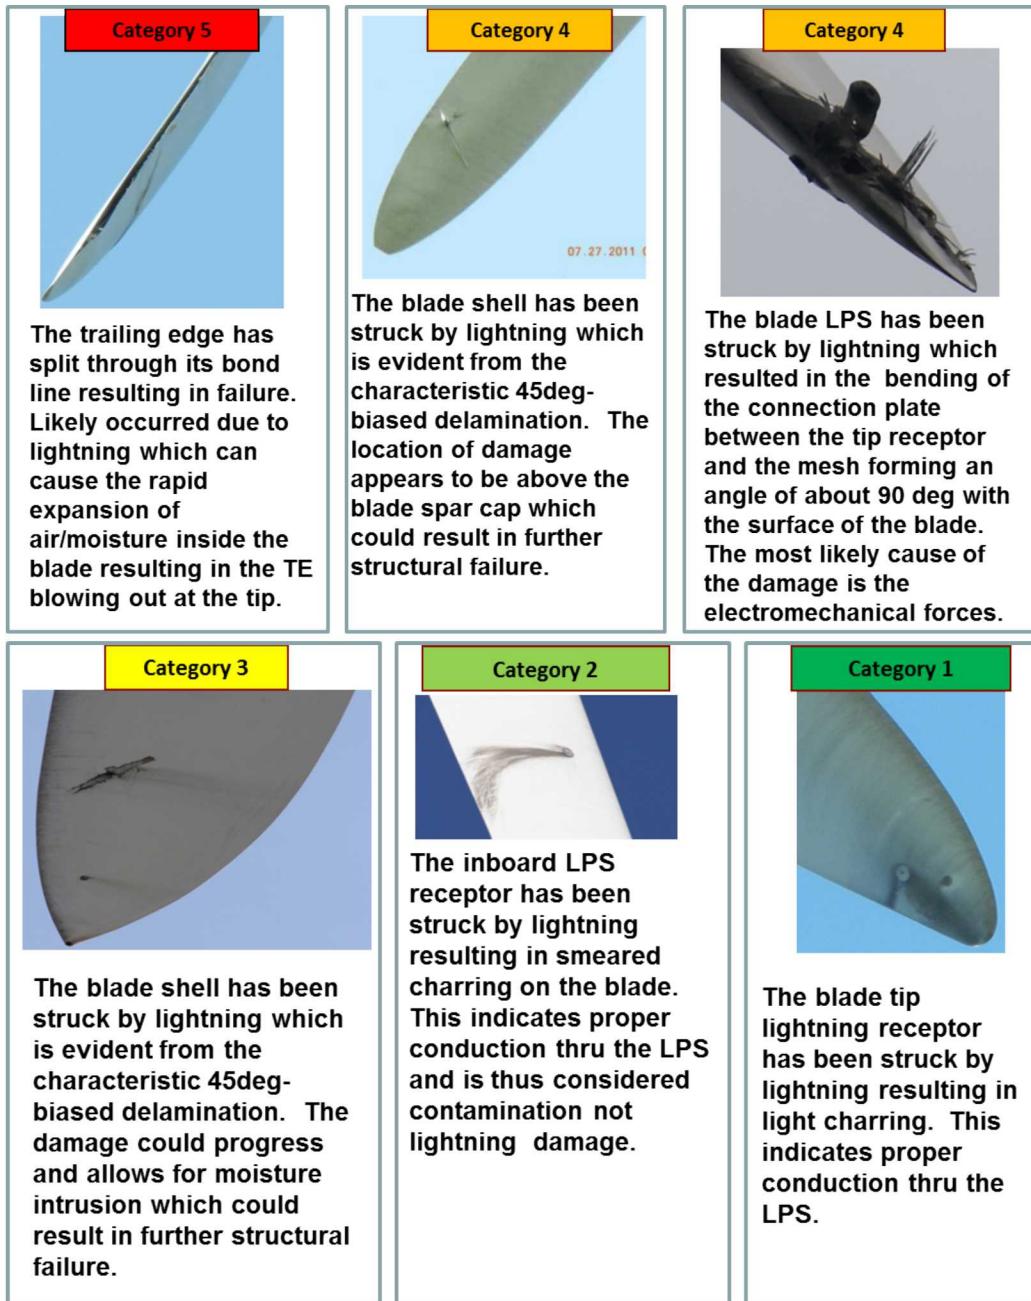
Figure 3-18: Lightning – Damage Severity Examples

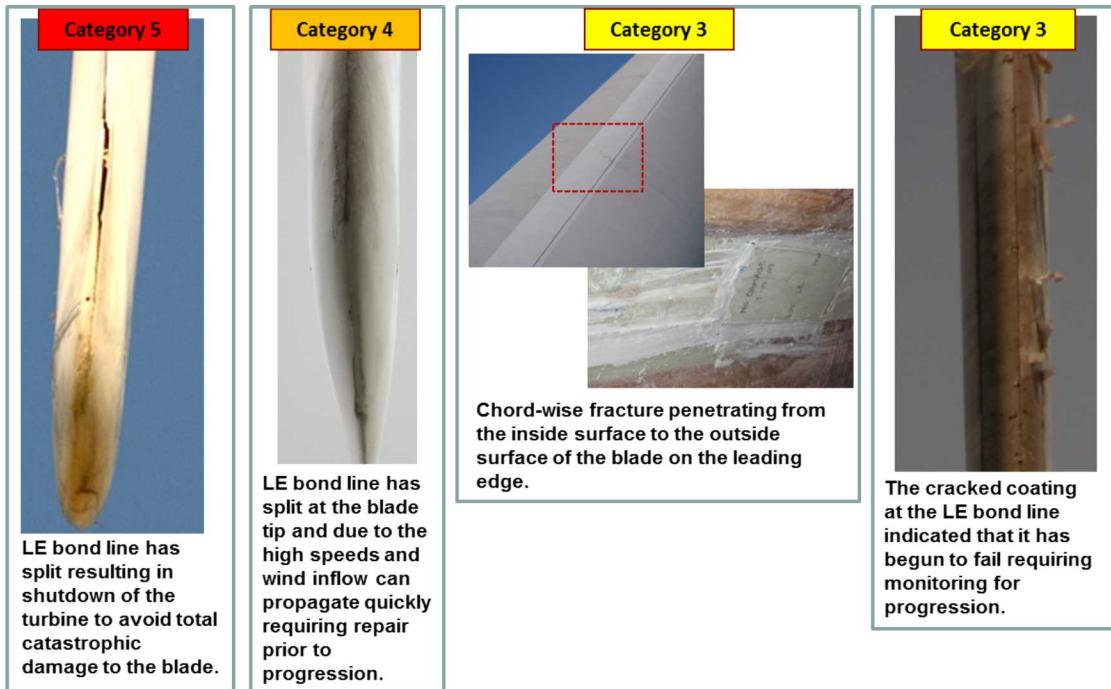
Figure 3-19: Leading Edge – Damage Severity Examples

Leading edge damage includes but is not limited to erosion, cracks, and de-bonding of the leading edge bonded joint. Damage on the leading edge can progress quickly due to the high speed wind inflow experienced and because it is most susceptible to impact (e.g., rain, dirt, bugs). Figure 3-19 summarizes different types of leading edge damage.

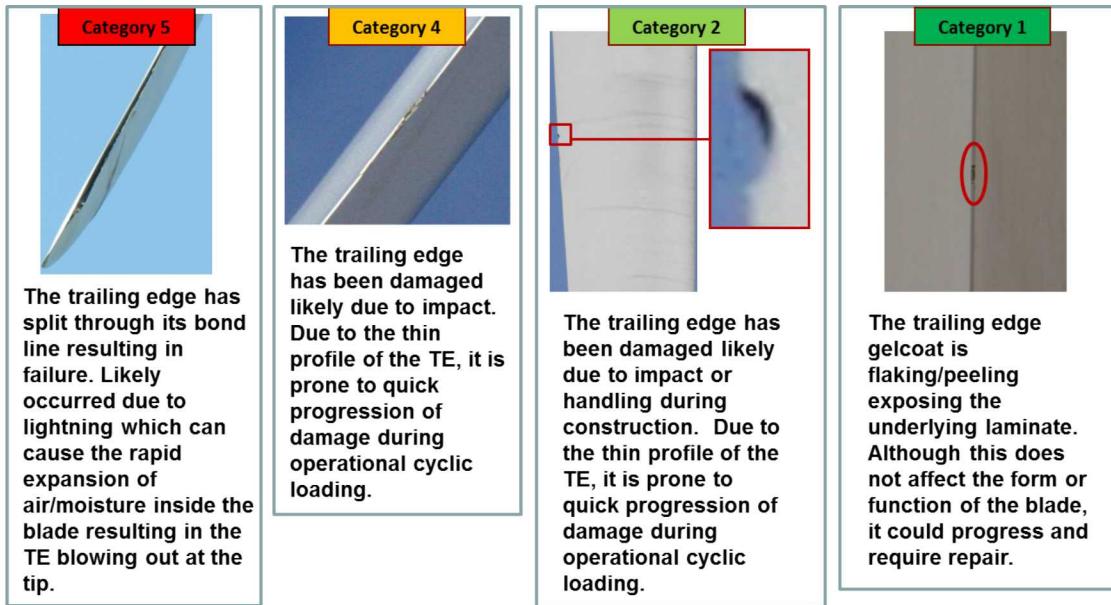
Figure 3-20: Trailing Edge Disbond and Fracture – Damage Severity Examples

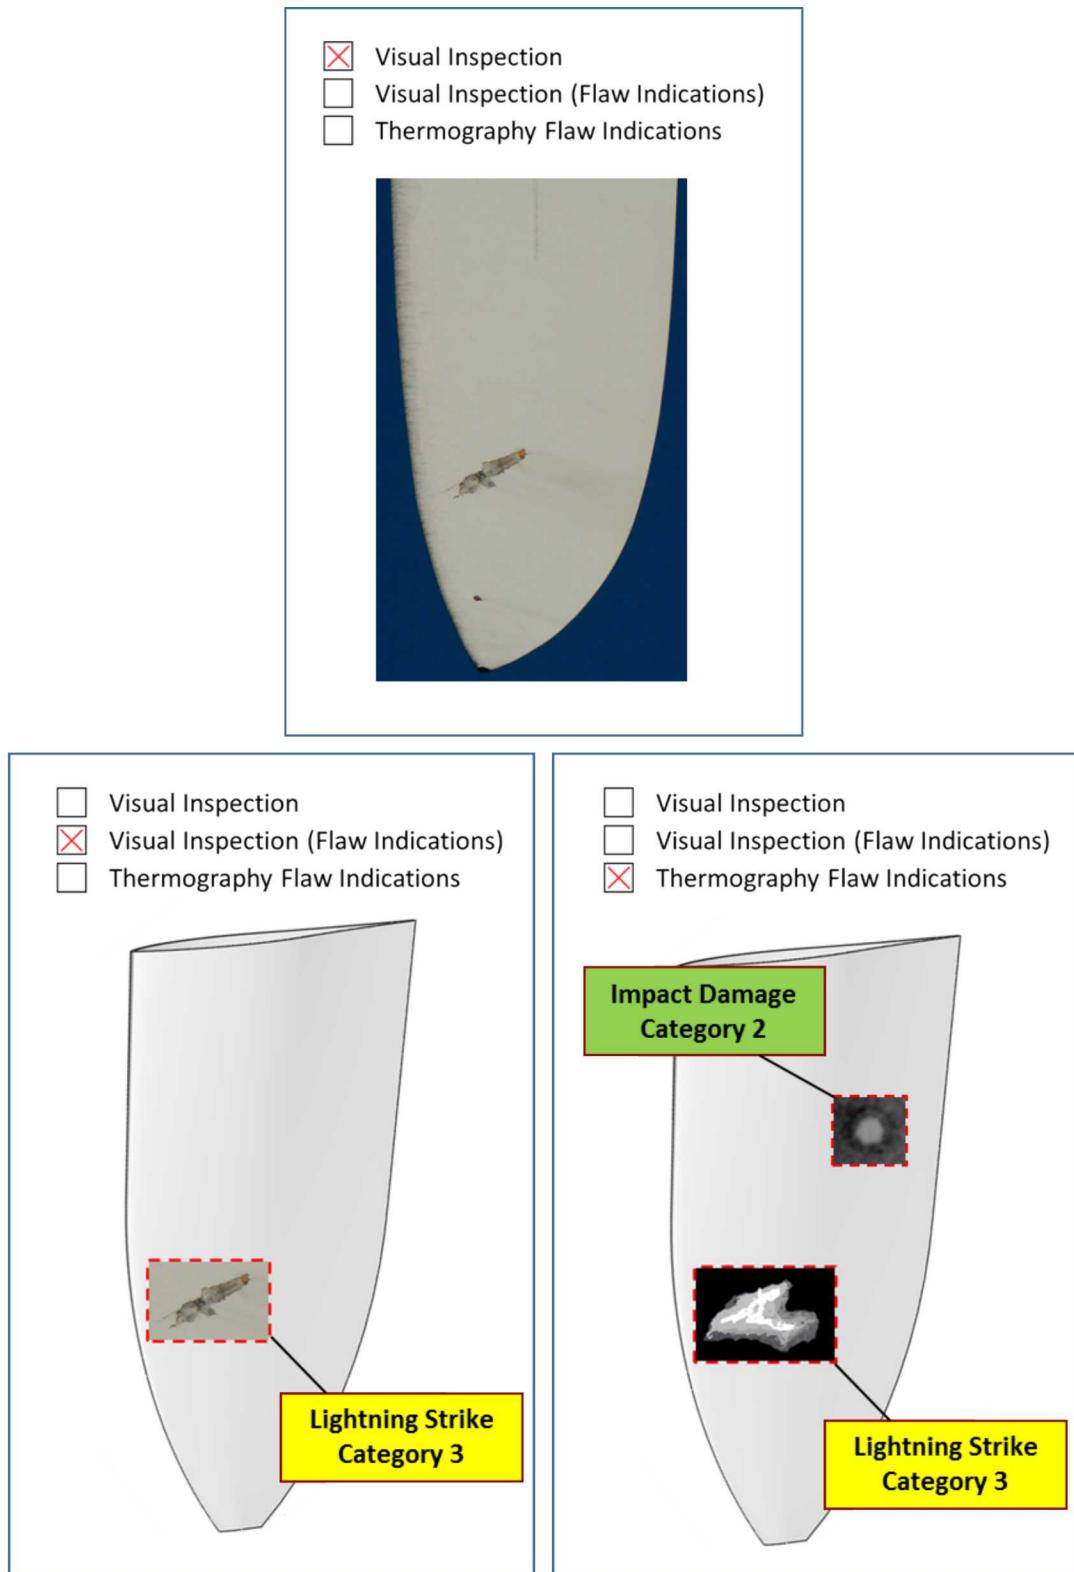
Figure 3-21: Example Automated Data Classification of a Lightning Strike

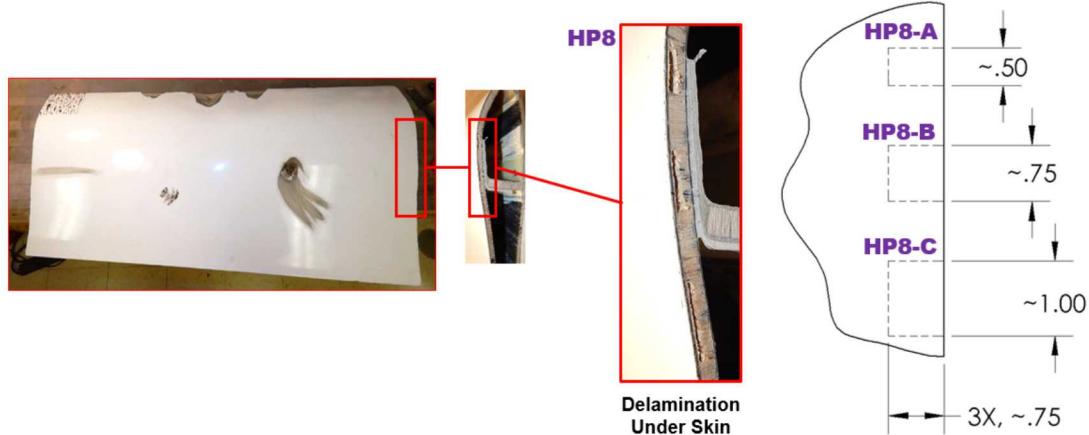
**Figure 3-24: Wind Blade Visual Test Specimen CB-V1
HP8 Flaws Used to Assess the Subsurface Damage Detection of
IR Inspections**

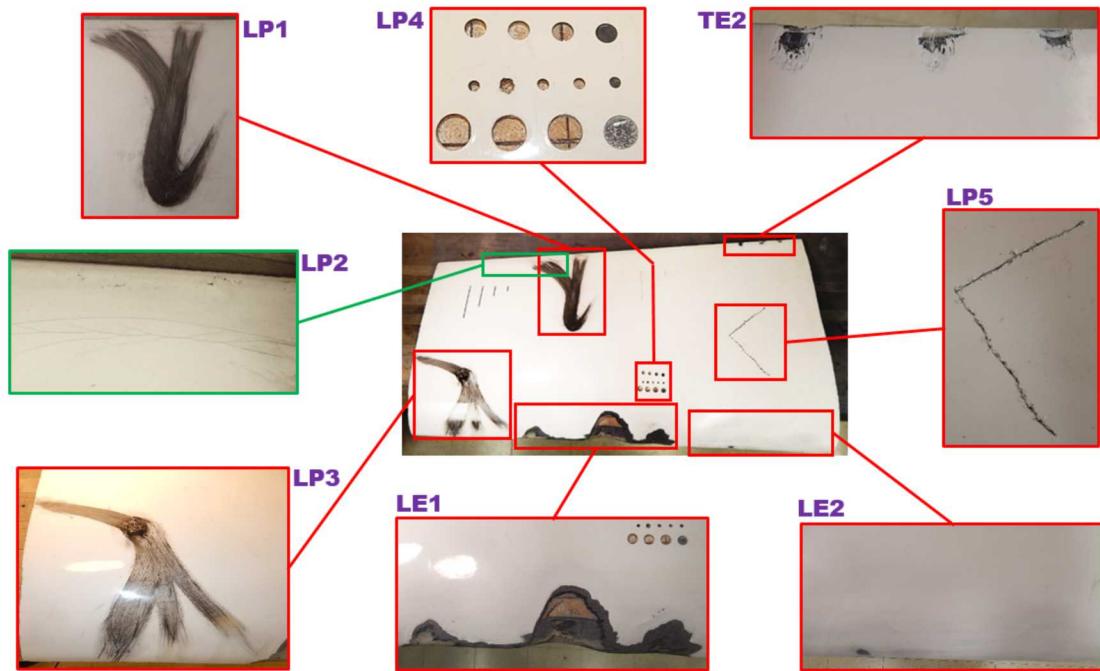
**Figure 3-25: Wind Blade Visual Test Specimen CB-V1
Low Pressure Side Flaws**

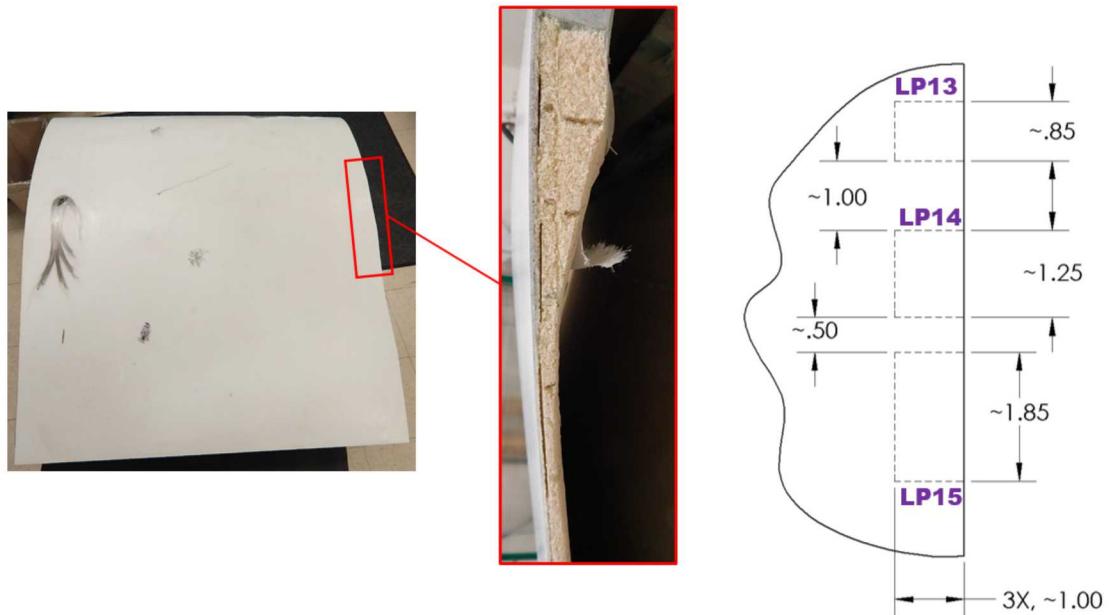
**Figure 3-34: Wind Blade Visual Test Specimen FF-V2
Low Pressure Side Flaws Used to Assess the Subsurface Damage
Detection of IR Inspections**
