SAND2018-3116

Development and Evaluation of a Drone- Deployed Wind Turbine Blade Nondestructive Inspection System

Sandia National Laboratories

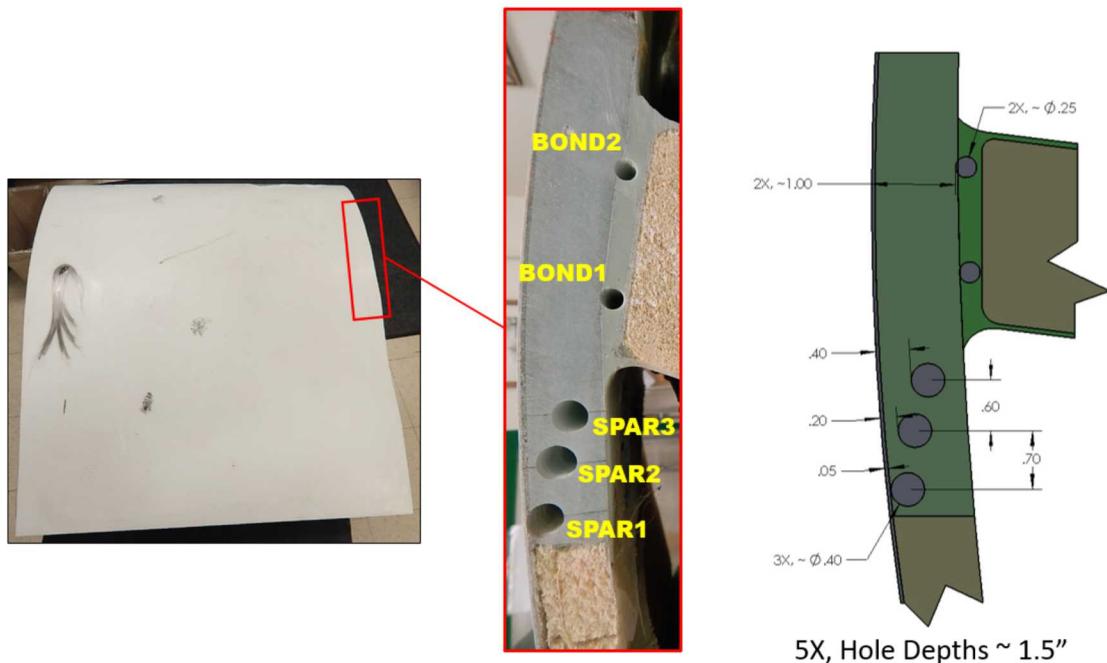
**Figure 3-35: Wind Blade Visual Test Specimen FF-V2
Low Pressure Side UT & IR Flaws**

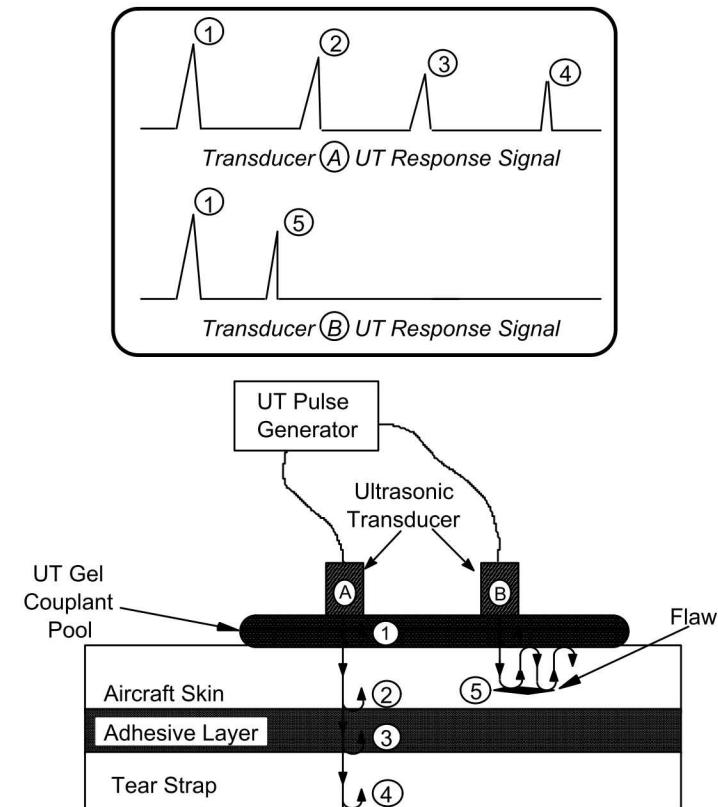
Figure 4-1: Schematic of Pulse-Echo Ultrasonic Inspection and A-Scan Signal Showing Reflection of UT Waves at Assorted Interfaces

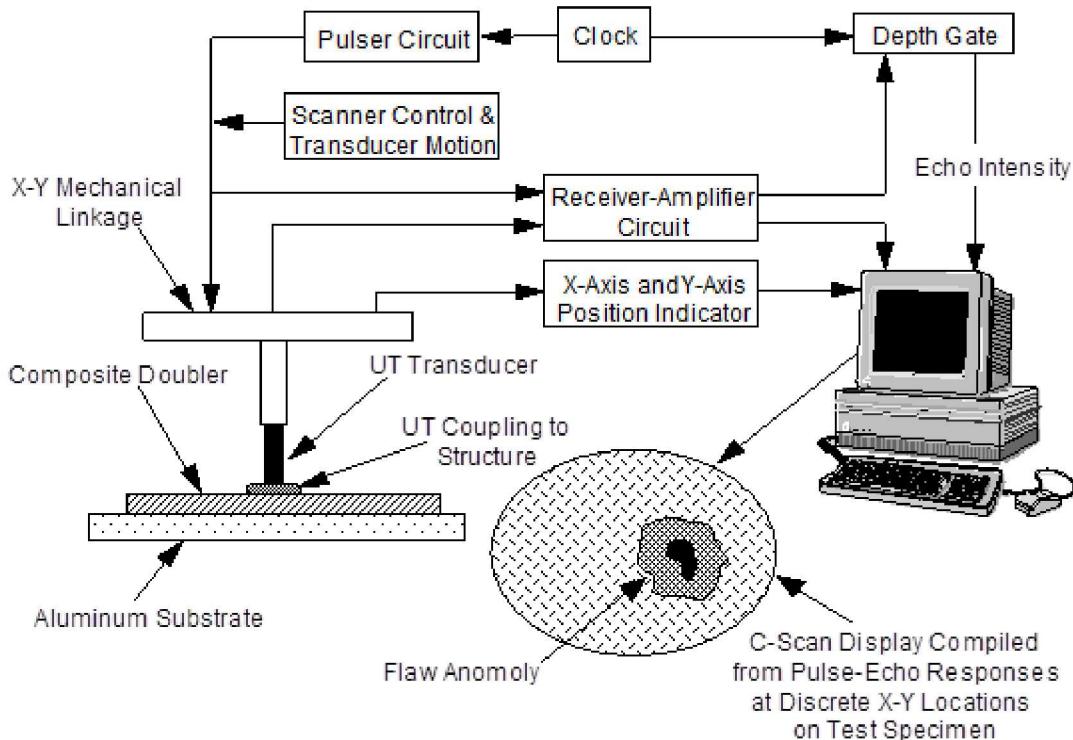
Figure 4-2: Schematic of C-Scan Setup for Pulse-Echo Ultrasonic Inspection

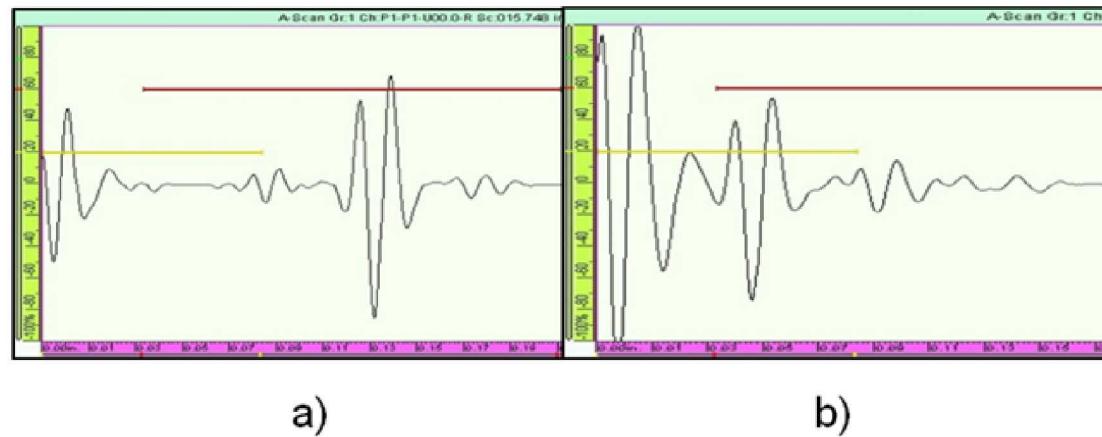
Figure 4-4: Sample Ultrasonic Signals Generated from: a) Structure Without Damage and b) Structure With Damage

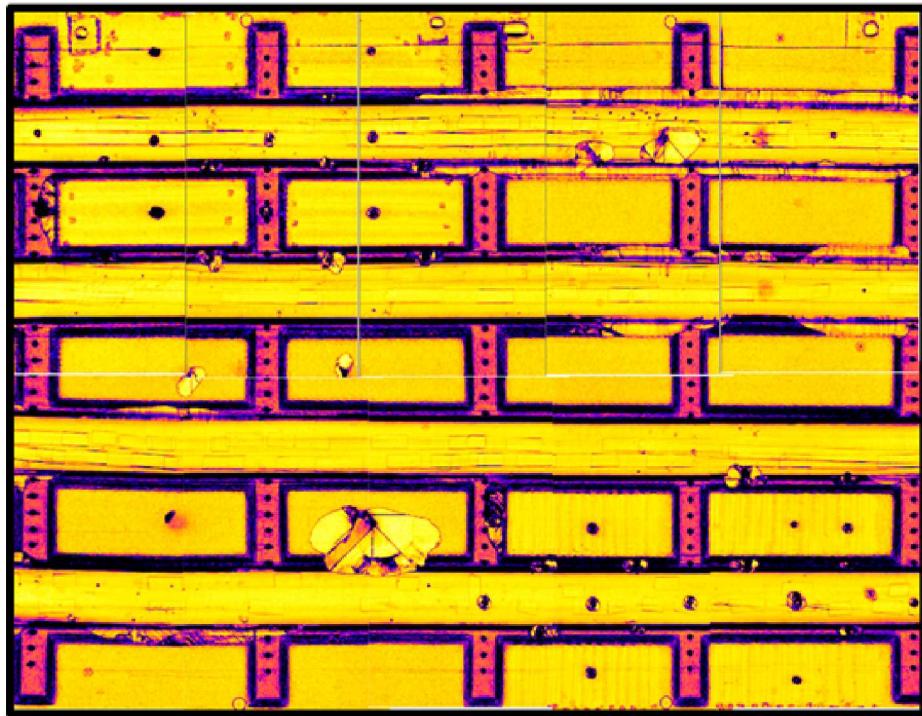
Figure 4-5: Sample C-Scan produced by an Automated Ultrasonic Scanning Device

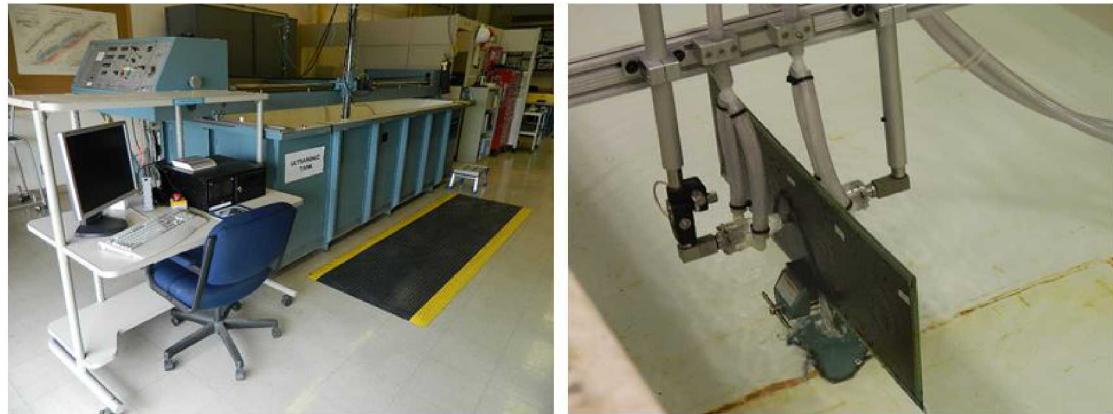
Figure 4-36: Automated Through-Transmission Ultrasonic Immersion Tank System

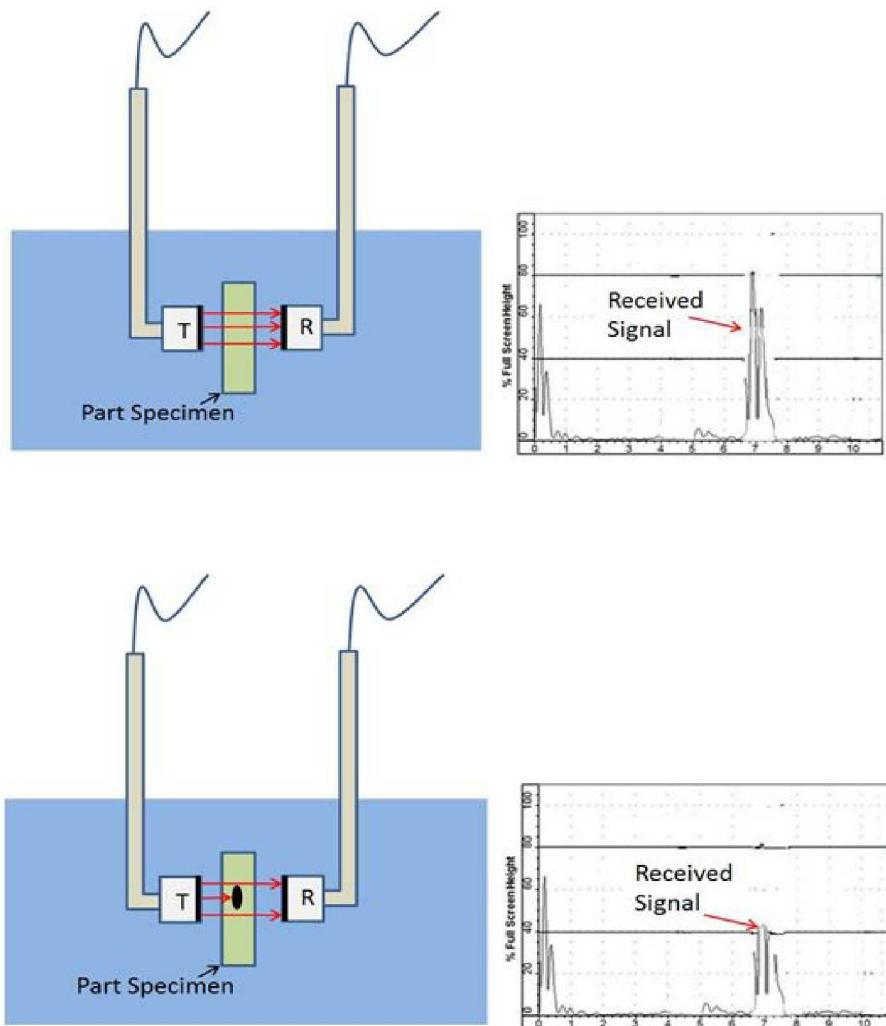
Figure 4-38: Through-Transmission UT in Immersion Tank Showing Good vs. Bad Areas – Damage Creates a 40% Reduction in Amplitude of the Received Signal

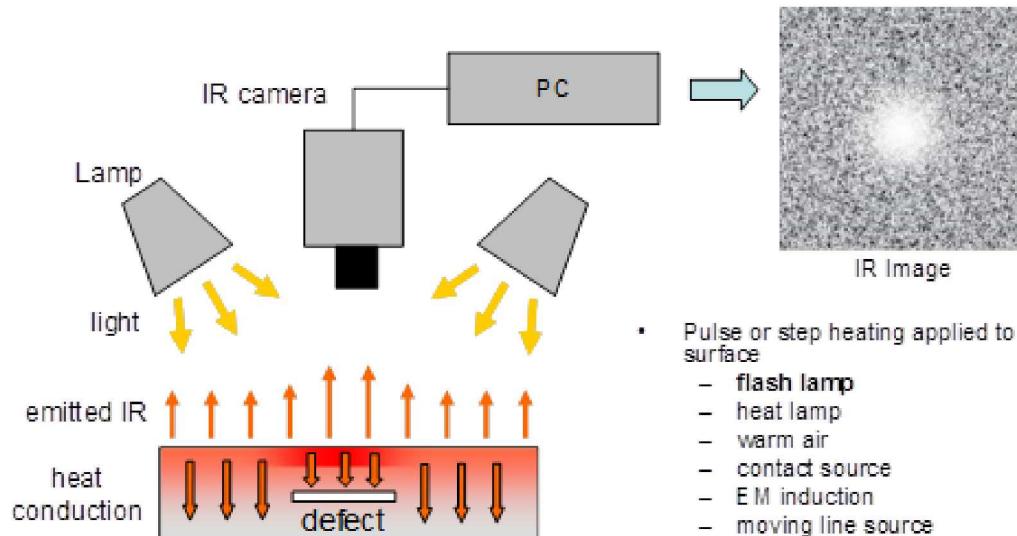
Figure 4-39: Principle of Active Pulsed Thermography

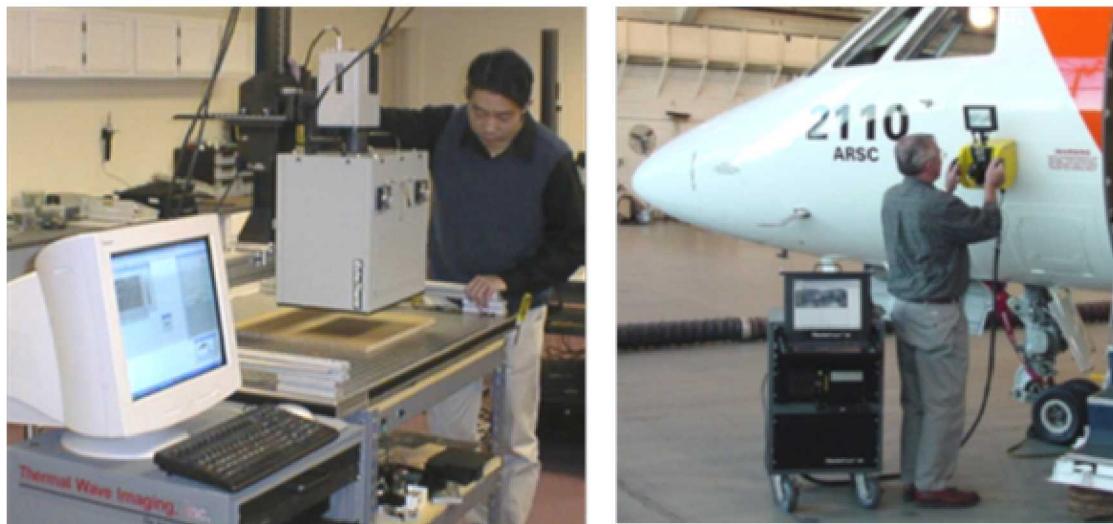
Figure 4-41: Laboratory Thermal Wave Imaging System Inspecting Composite Flaw Detection Panels and Portable Field System Inspecting an Aircraft Fuselage

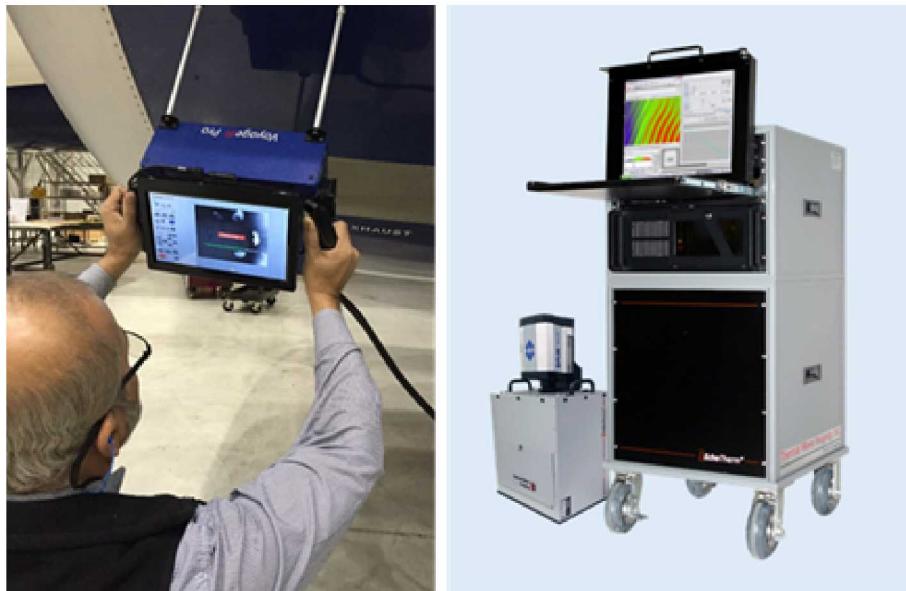
Figure 4-45: Hand-Held Flash Thermography Systems with Roll-Around Data Acquisition Cart
(images courtesy of Thermal Wave Imaging, Inc.)

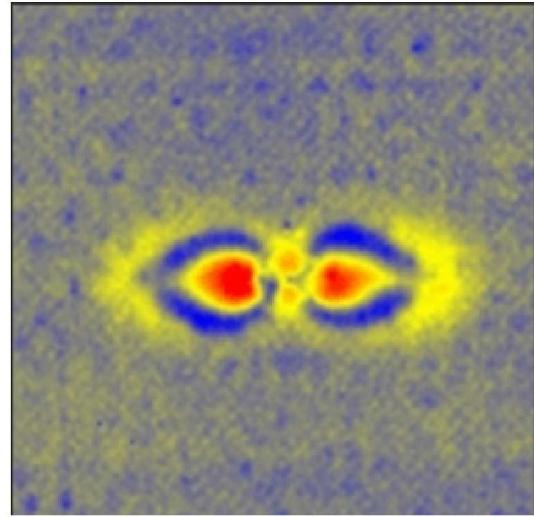
Impact Damage in a Solid Laminate Composite Structure

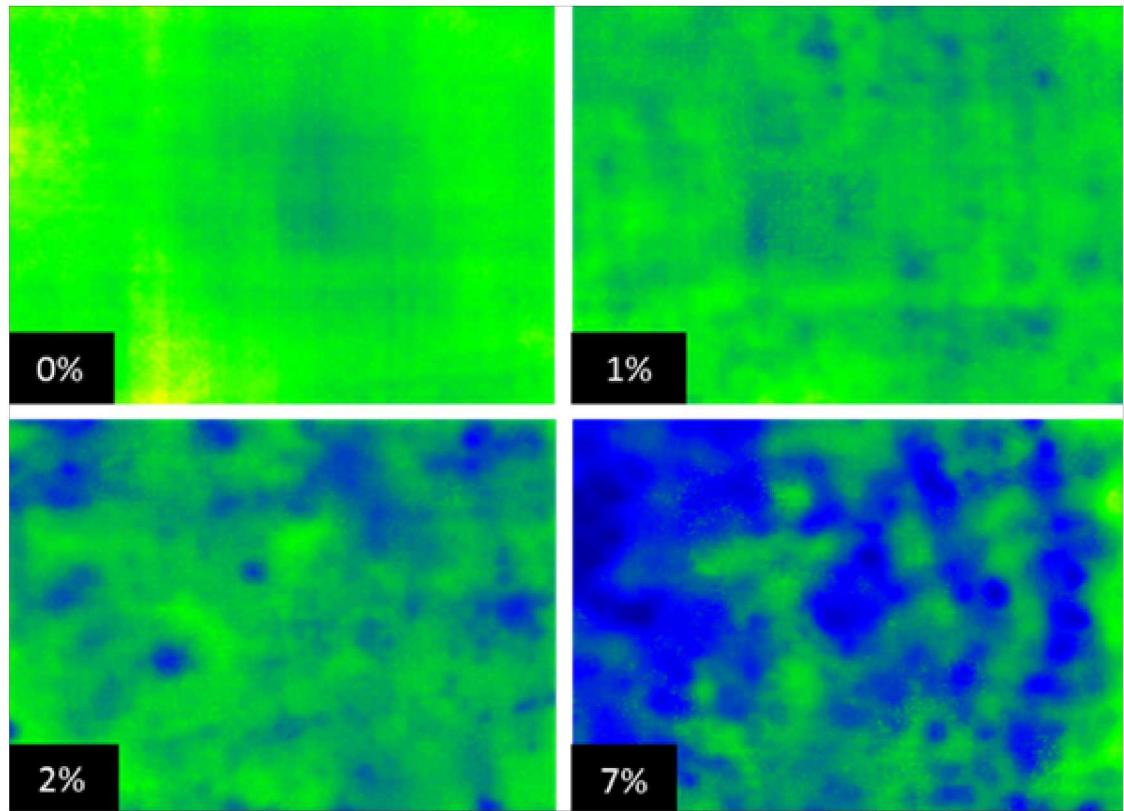
Figure 4-51: Use of TNDI to Measure Porosity Levels in a Composite Lamine
(images courtesy of Thermal Wave Imaging, Inc.)

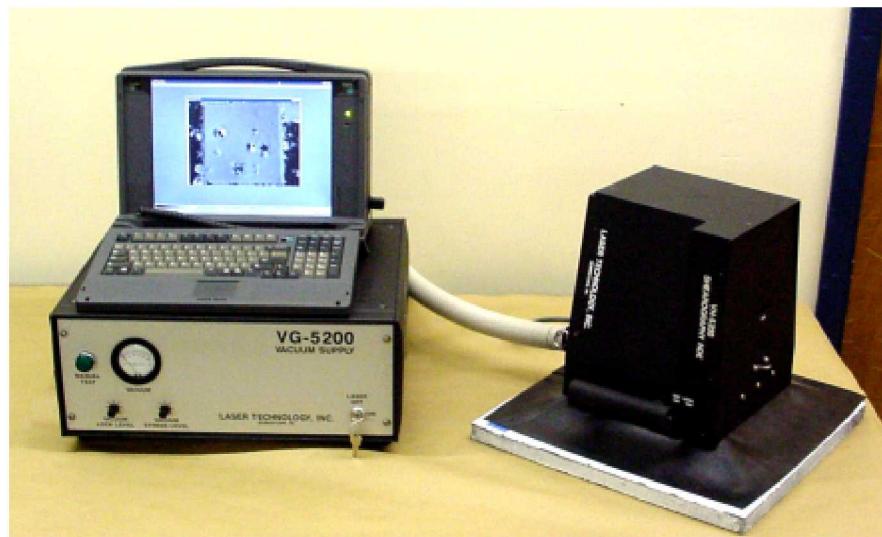
Figure 4-57: LTI-5200 Portable Shearography System with Camera on Test Specimen

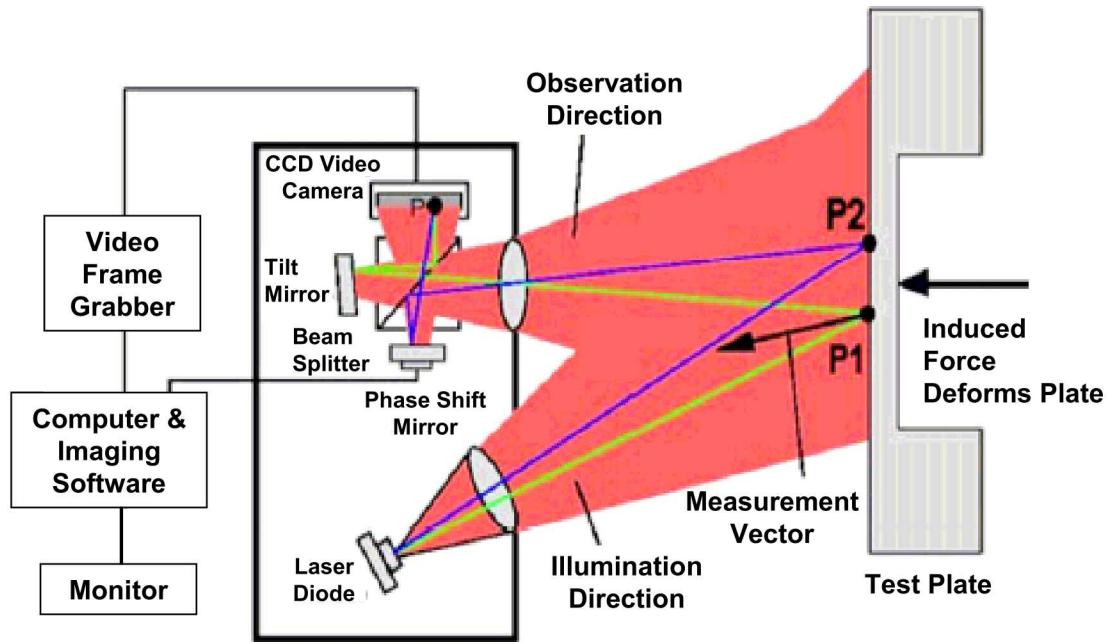
Figure 4-58: Basic Principle of Shearography

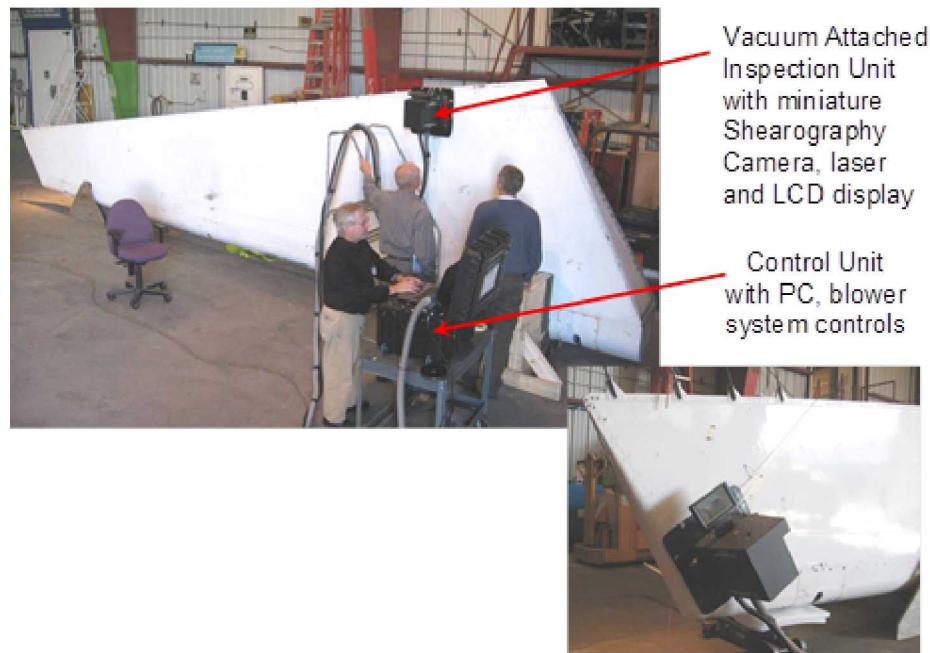
Figure 4-59: Composite Rudder Inspection Using LTI-5200 Portable Vacuum Shearography System

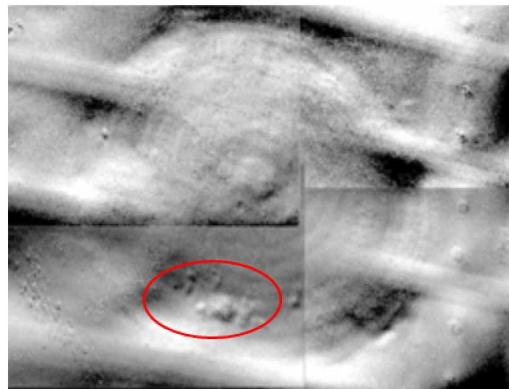
Figure 4-63: Shearographic Inspection Image of a Scarfed Repair to a Honeycomb Structure with Anomaly Indications in the Repair Plies

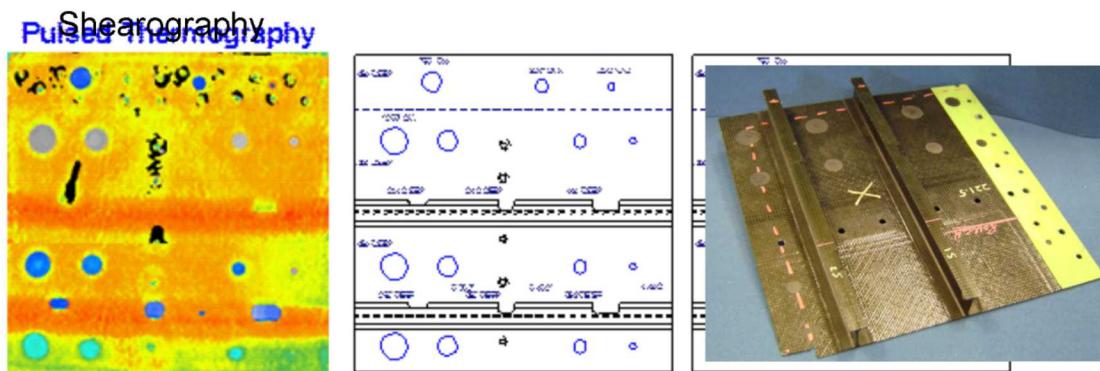
Figure 4-64: Shearography Image Produced from Inspection of Composite Laminate Panel (0.11" th. skin) with Flaw Profile as Shown in Drawing on the Right

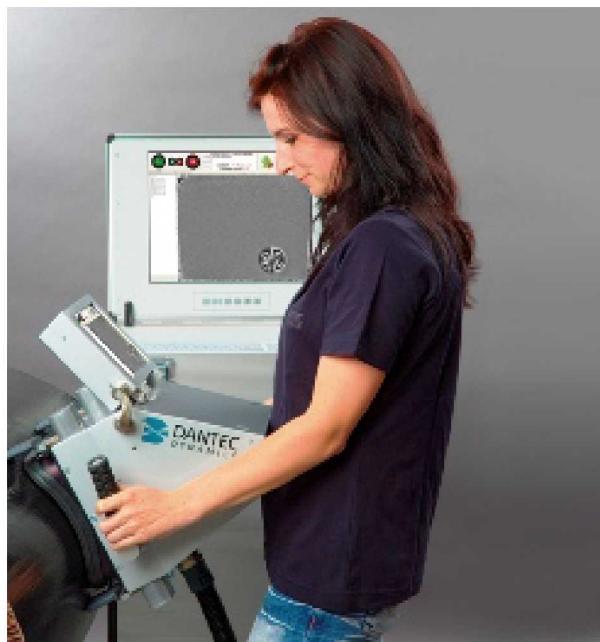
Figure 4-65: Q-810 Laser Shearography System

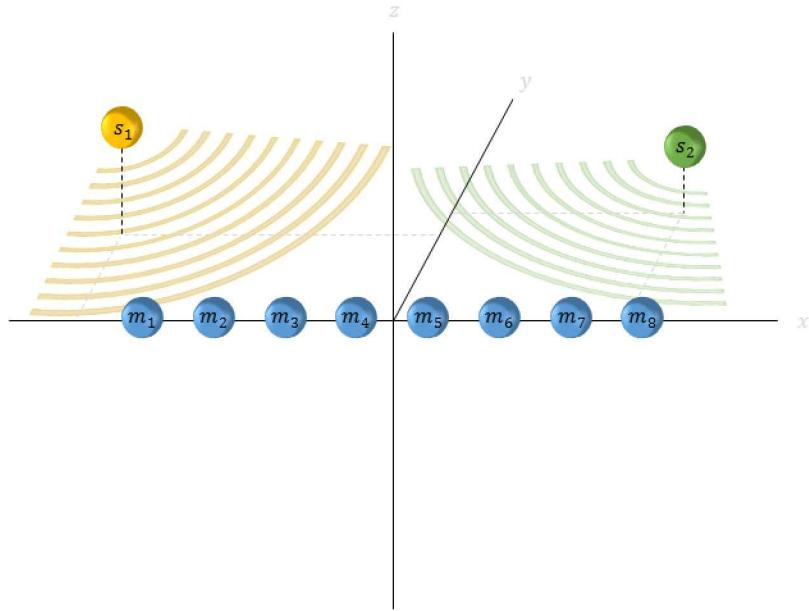
Figure 4-74: Schematic of 1-D Linear Microphone Array with Two Monopole Acoustic Sources in 3-D Field

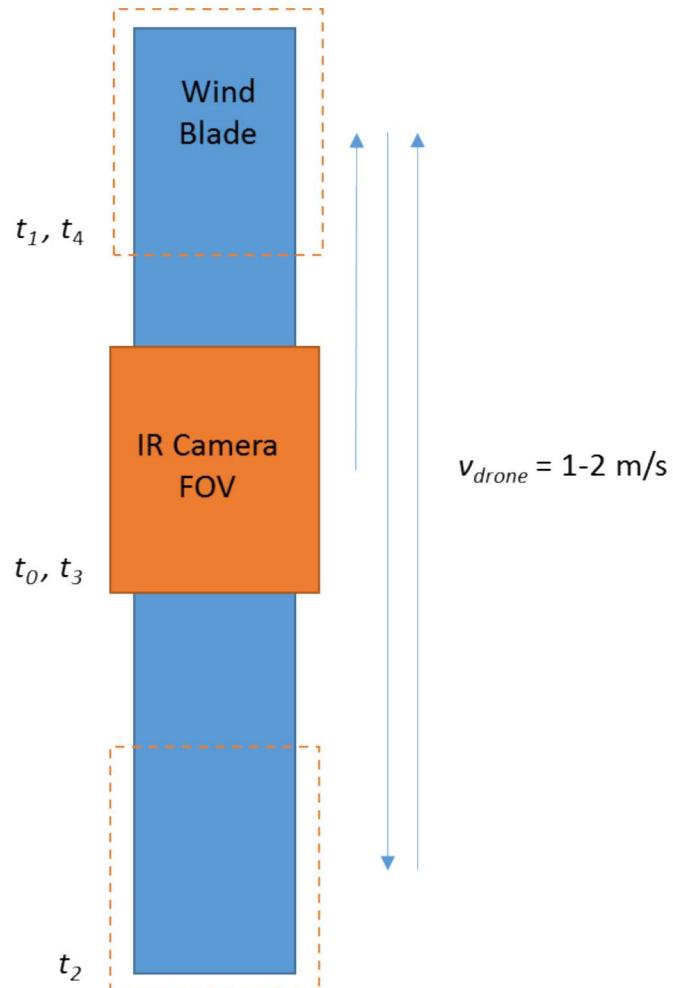
Figure 5-1: Notional Example of an Augmented Flight Pattern Showing Back and Forth Drone Movement

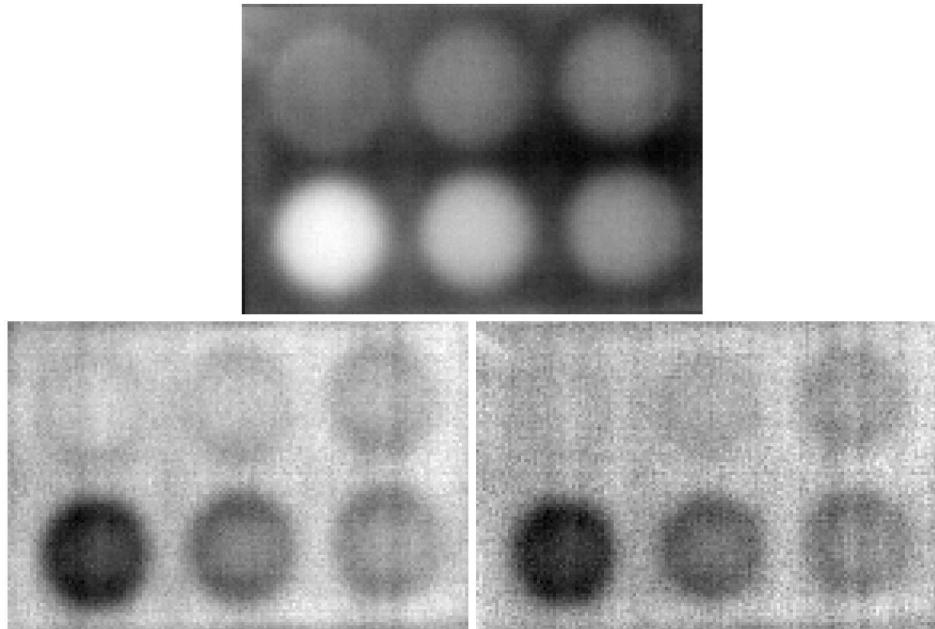
Figure 5-4: Example Results for TSR, 1D, and 2D Analyses

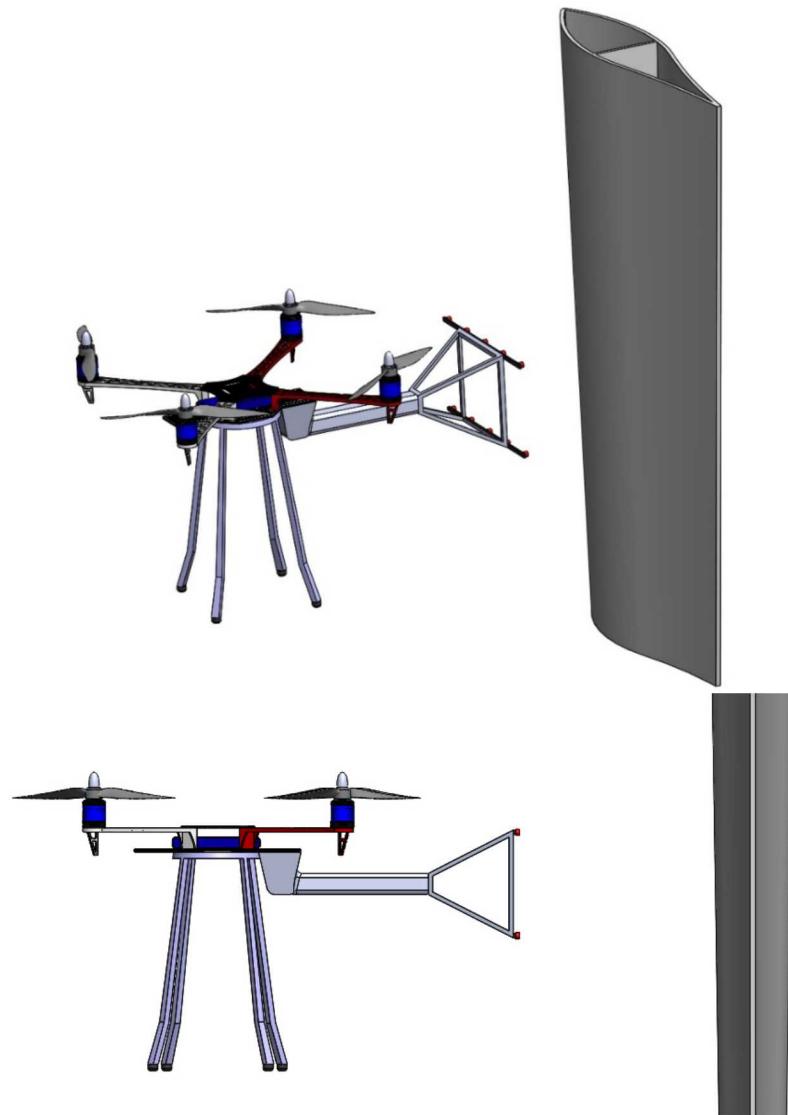
Figure 5-8: Acoustic Beamforming Drone Integration Concept

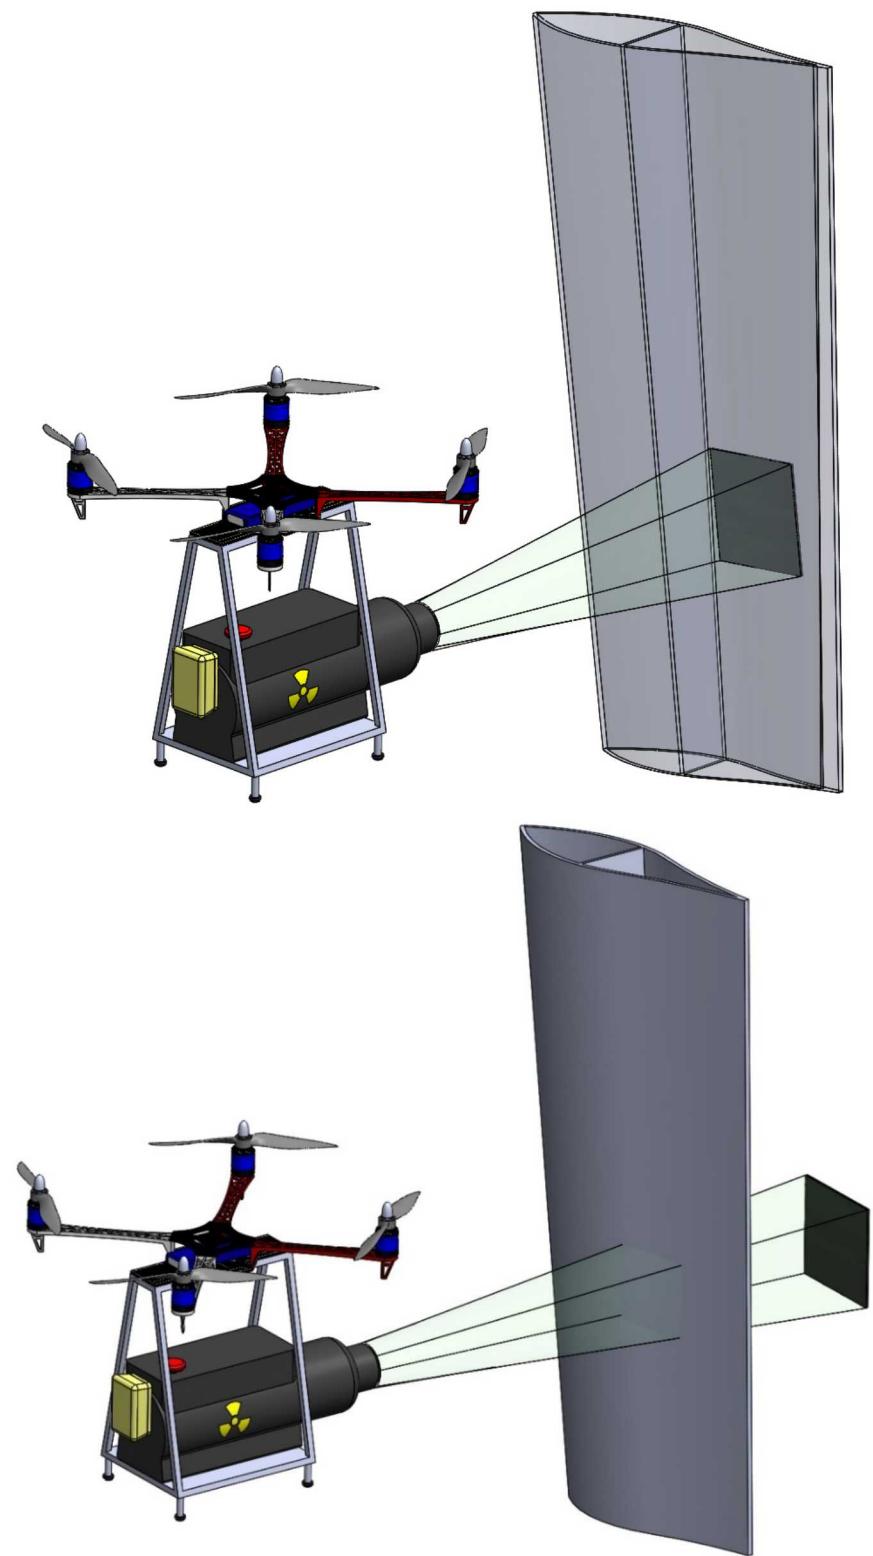
Figure 5-9: X-Ray Drone Integration Concept

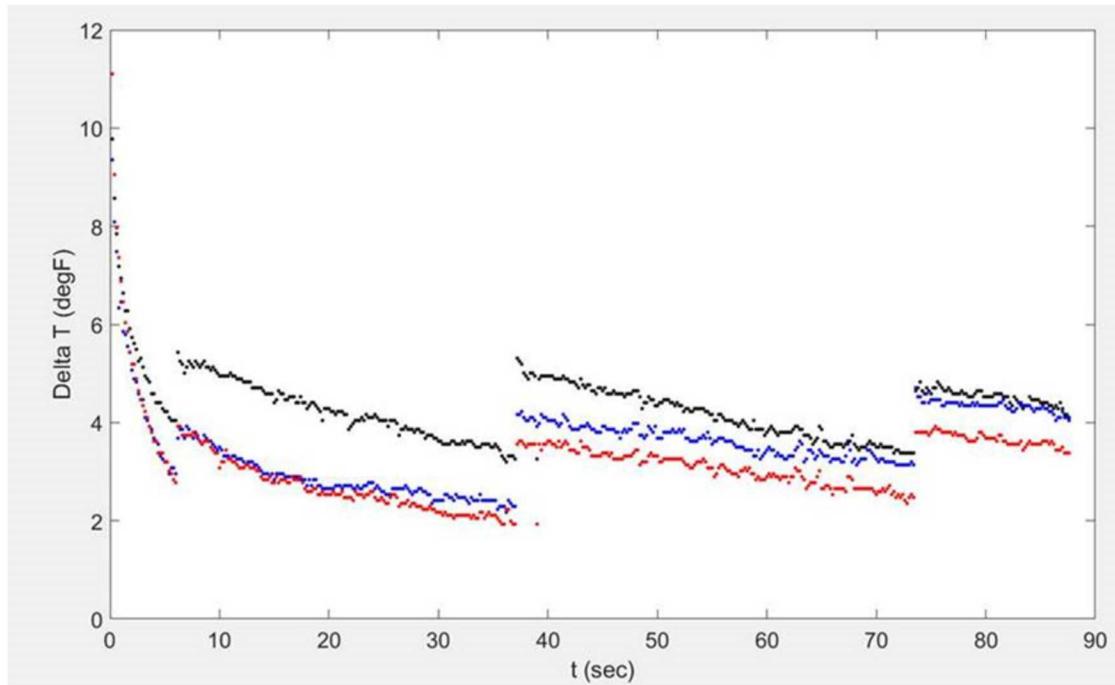
Figure 6-1: Example of Inadequate Temperature vs. Time History on the FLIR Vue Pro R

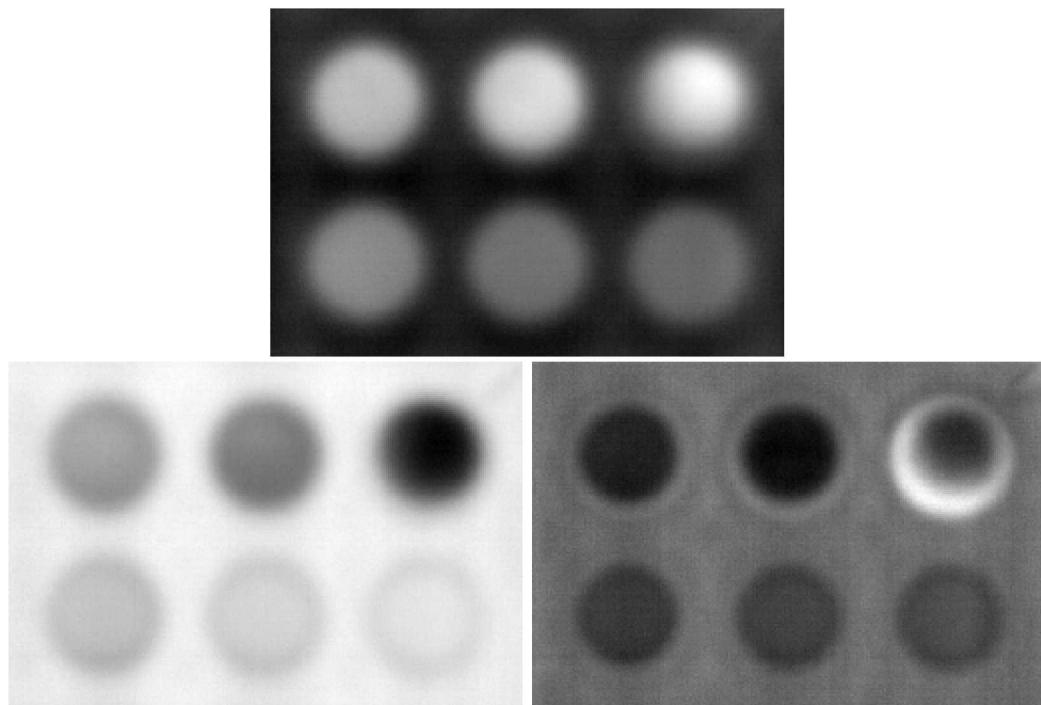
Figure 6-16: G11-STD-1 Flash Tubes Test 1 Results for TSR (at 180 frames), 1D (at 189 frames), and 2D (at 180 frames)

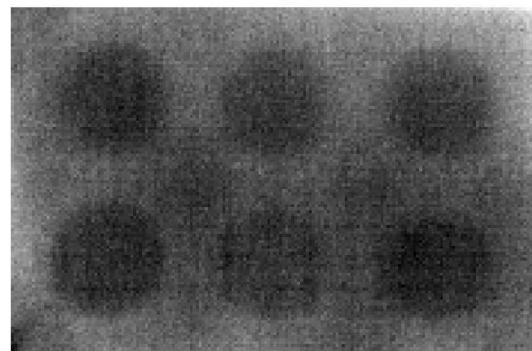
Figure 6-41: G11-STD-1 Internal Forced Air Test Results for Test 2 (15s of Heating)

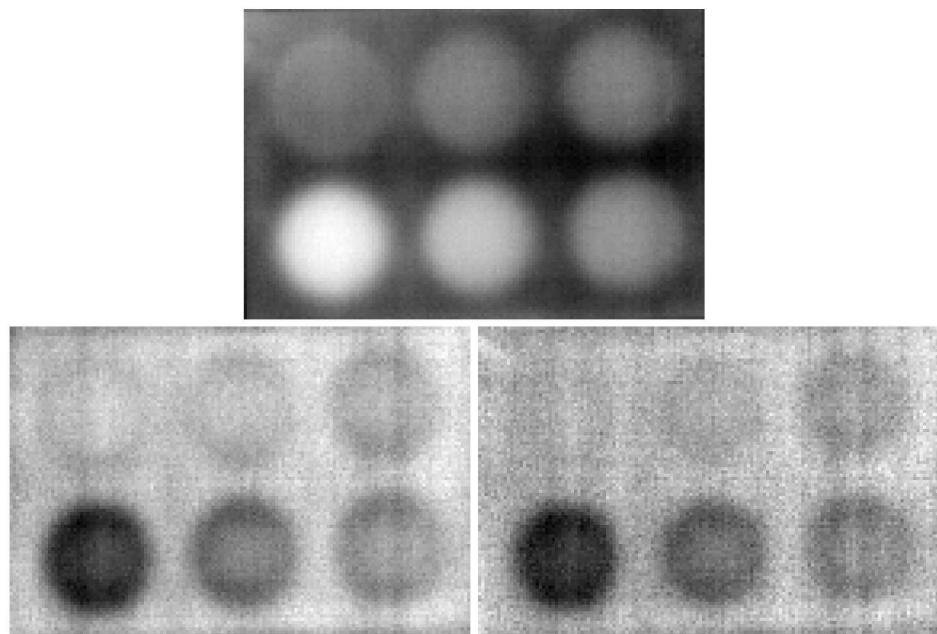
Figure 6-48: G11-STD-2 Solar Radiation Test 1 Results for TSR (at 1 frames), 1D (at 188 frames), and 2D (at 168 frames)

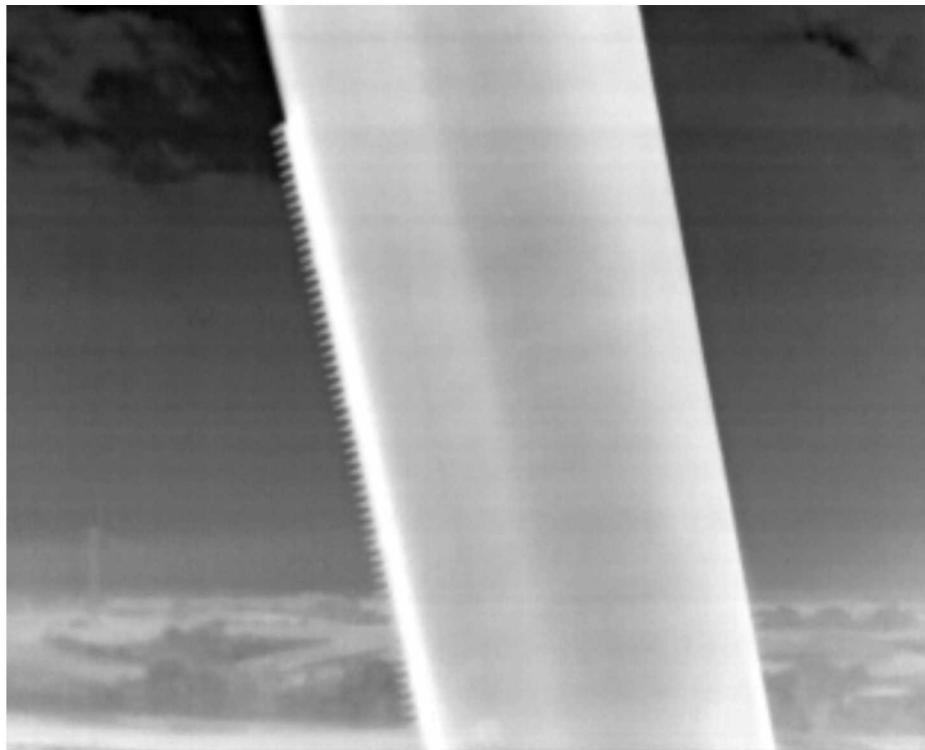
Figure 7-8: Screenshot of First Drone-Deployed IR Video

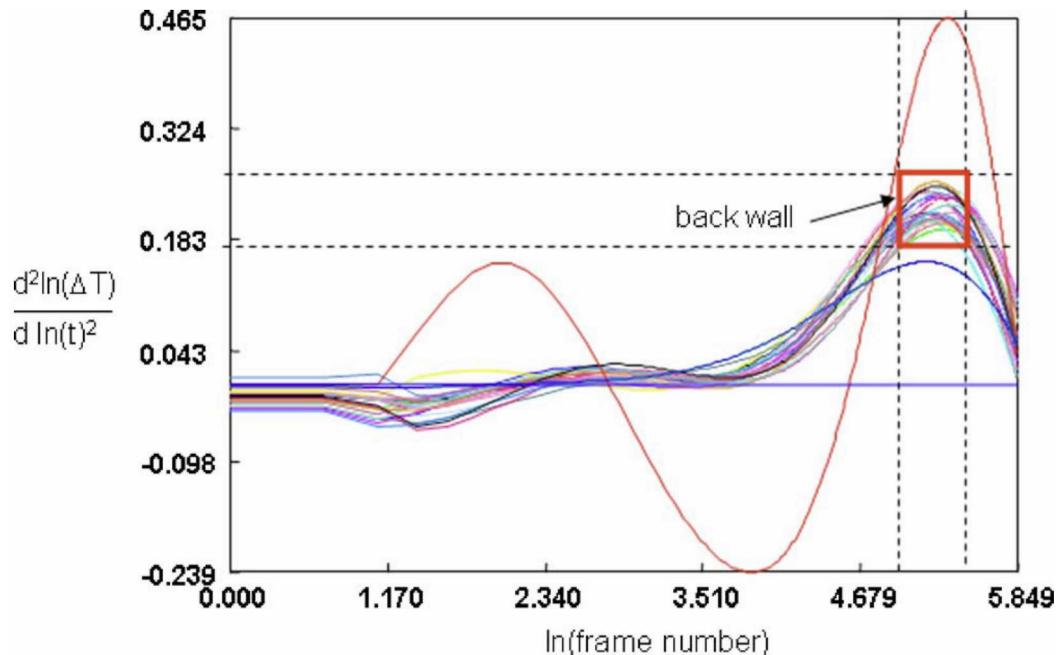
Figure 8-1: Plot of TSR 2nd Derivative Showing Bounds (in Red) on Time and Amplitude Shifts [8.1]
