# REPLACING METAL-BASED LIGHTNING STRIKE PROTECTION LAYER OF CFRPS BY 3D PRINTED ELECTRICALLY CONDUCTIVE POLYMER LAYER

## ABSTRACT

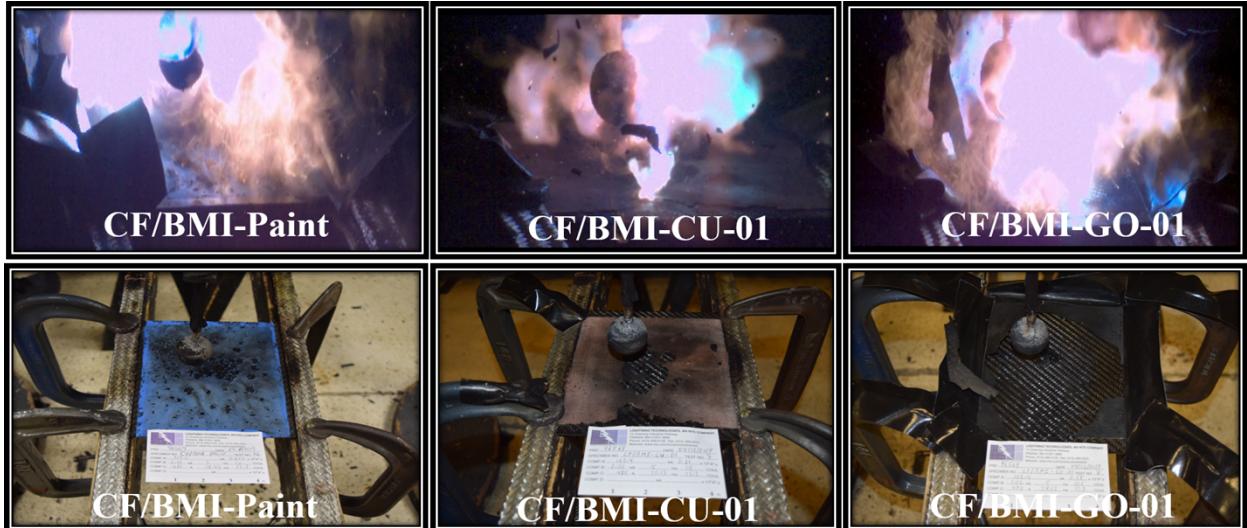
Figure 4. Lightning strike on composite panels with (a) Paint (b) CU-PLA layer (C) GO-PLA layer.

The event of the lightning strike was captured using a high-speed camera at a frame rate of 5100 fps. Although this frame rate is not adequate to capture the highly transient lightning strike event lasting only for a few microseconds in case of component A and a few milliseconds in case of component C as shown in table 2. The damaging behavior of CFRP due to lightning strike was captured successfully using the employed video camera. Figure 4. shows the lightning event on (a) unprotected CFRP (b) CU-PLA protected CFRP (c) GO-PLA protected CFRP. The unprotected CFRP suffered fiber puncture and resin evaporation at multiple places.

It should be noted that the unprotected CFRP was a painted panel without any electrically conductive layer protection on top of it. Paint behaved as the dielectric material and reduced the fast dissipation of the lightning current. Resistance to the current flow created heat, known as “Joule's heat”, on the surface of the CFRP structure. Low thermal diffusion due to paint application led to thermal damage of the CFRP panel [13]. On the other hand, the CU-PLA based layer had much higher surface electrical conductivity than the painted CFRP panel. The high electrical conductivity of CU-PLA dissipated the lightning current faster without damaging the CFRP panel significantly. However, as the PLA has a low thermal degradation point, during the event of a lightning strike, some part of CU-PLA layer melted and stripped away from the

surface of the panel. This allowed for contact of lightning current to the exposed area resulting in significant damage in that area. Damage to the CU-PLA protected CFRP was found to be lower than the unprotected CFRP. On the other hand, the electrical conductivity of GO-PLA was not as high as the CU-PLA layer, hence the lightning strike damaged the GO-PLA layer on the CFRP surface. GO-PLA may not have provided enough protection to the panel, but it was successful in constraining the damage to a limited area.
