# Corrosion of the 304L stainless steel produced by the laser engineered net shape (LENS) technique

Michael A. Melia, Rebecca F. Schaller, Hai-Duy A. Nguyen, Jason M. Taylor, Jeffrey Rodelas, and Eric J. Schindelholz

## Abstract

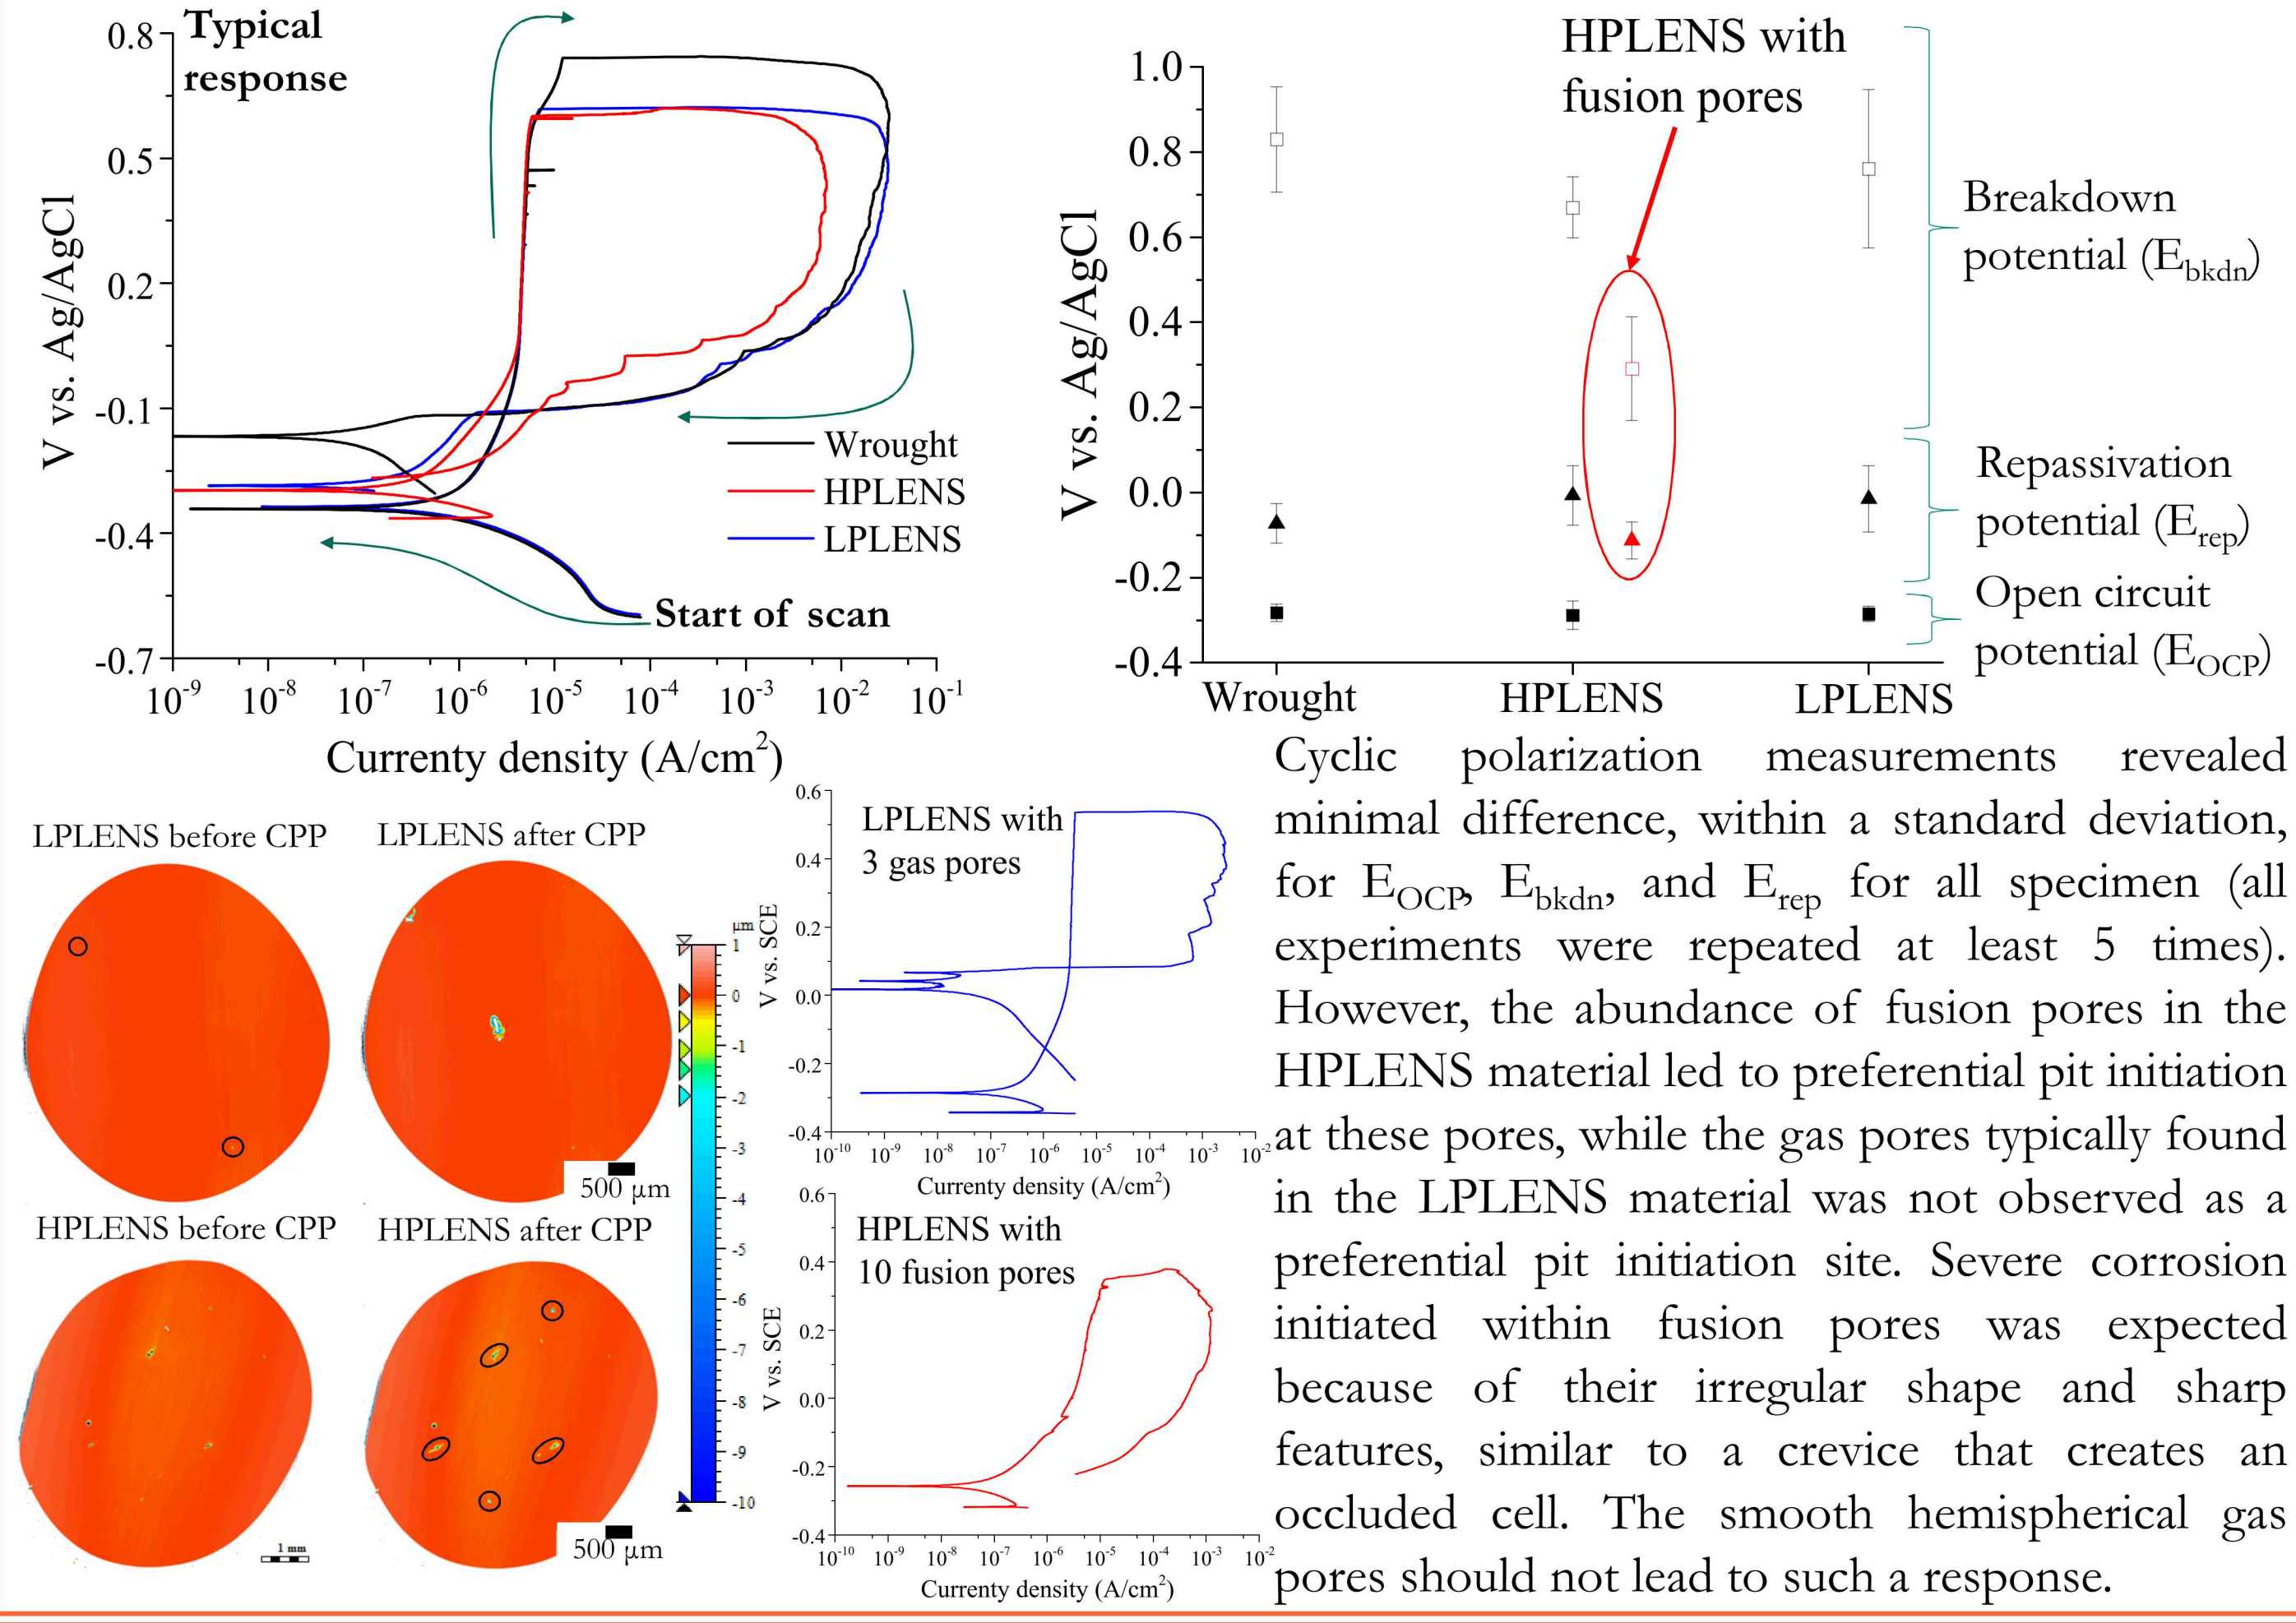
## Cyclic potentiodynamic polarization (CPP) measurements in quiescent 0.6 M NaCl solution – scan rate = 1 mV/sec.

Cyclic polarization measurements revealed minimal difference, within a standard deviation, for  $E_{OCp}$ ,  $E_{bkdn}$ , and  $E_{rep}$  for all specimen (all experiments were repeated at least 5 times). However, the abundance of fusion pores in the HPLENS material led to preferential pit initiation at these pores, while the gas pores typically found in the LPLENS material was not observed as a preferential pit initiation site. Severe corrosion initiated within fusion pores was expected because of their irregular shape and sharp features, similar to a crevice that creates an occluded cell. The smooth hemispherical gas pores should not lead to such a response.

The microstructure and corrosion response of 304L stainless steel manufactured using two LENS processes was investigated. The cyclic potentiodynamic polarization measurements revealed the breakdown and repassivation potentials for LP and HP LENS were comparable to wrought 304L. The abundance of fusion pores present in the HPLENS material often led to premature breakdown while the gas pores in the LPLENS had much less impact on pit initiation. The DLEPR experiments verified the presence of  $\delta$ -ferrite can lead to local dissolution of the austenite phase, however this effect did not appear to correlate to an increased susceptibility to pit initiation or metastable pitting. Fusion pores were evidently observed to be the controlling factor in pit initiation for these materials, with their mechanism for increased corrosion activity similar to that for crevice corrosion.
