In-situ TEM High Cycle Fatigue Response of Nanocrystalline Pt

Christopher M. Barr, Nathan Heckman, Brad L. Boyce, and Khalid Hattar
Material, Chemical, and Physical Sciences, Sandia National Laboratories

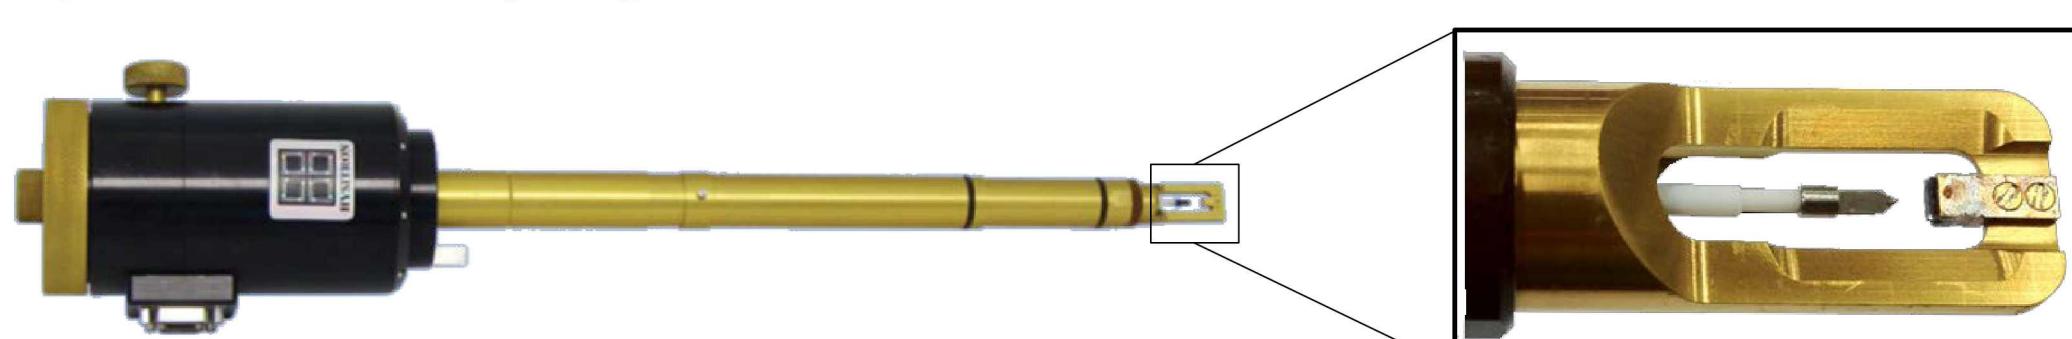
- In-situ TEM mechanical testing provides unique platform to explore underlying deformation mechanisms
- Quantitative mechanical testing with cyclic loading capabilities available via Bruker/Hysitron PI-95 stage at Sandia's I³TEM CINT facility

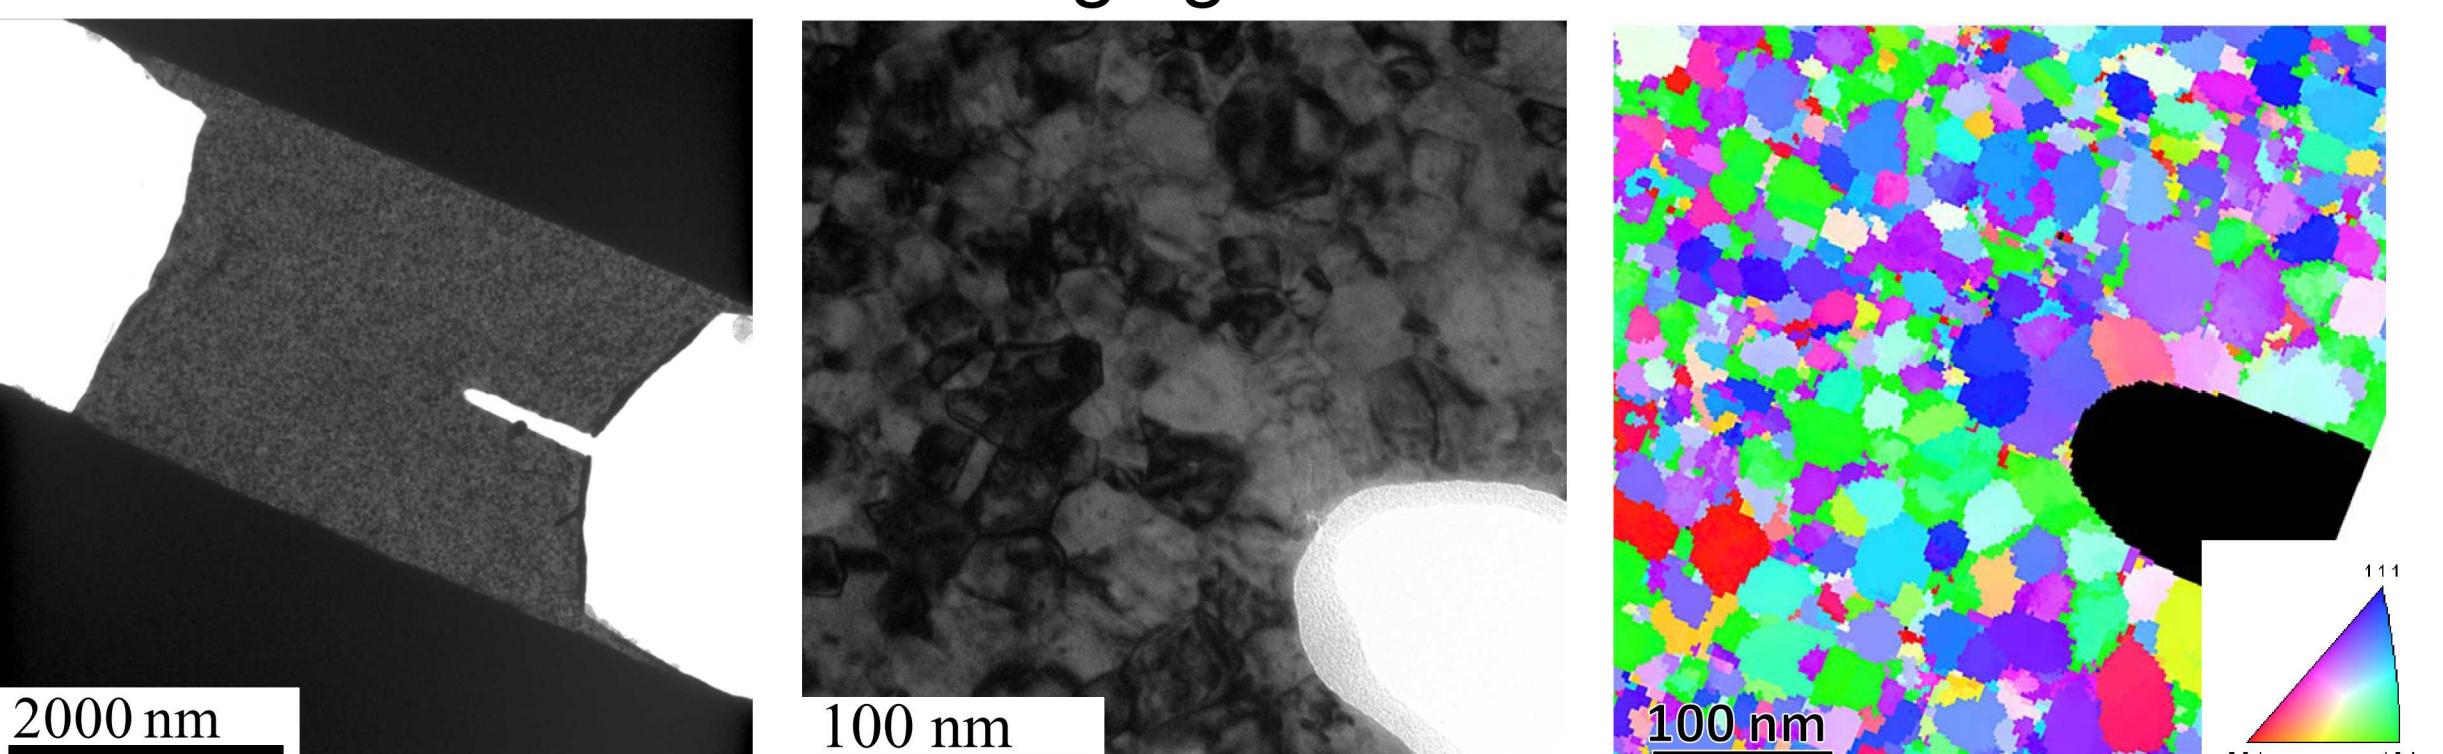
- FIB notch creates localized deformation and allows for higher resolution in-situ TEM imaging

- Precession electron diffraction (PED) provides ability to examine grain rotation and grain boundary misorientation evolution during fatigue propagation

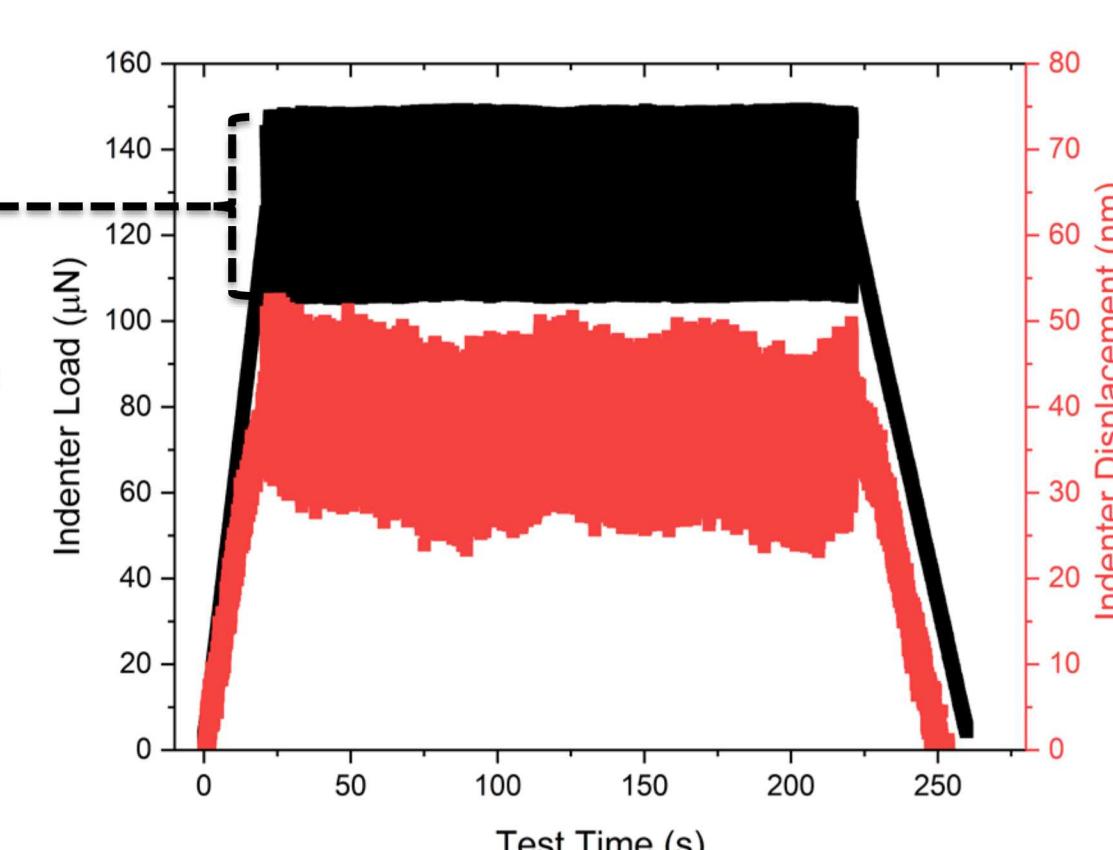
- Mean load (P_{mean}) = 135 uN
- Amplitude load (P_{amp}) = 35 uN
- 200 Hz dynamic loading → image motion blur with standard 15 frames/s camera
- 13 cycles per individual frame

- PED orientation maps taken prior to test and during intermediate loading condition (120,000 total cycles)

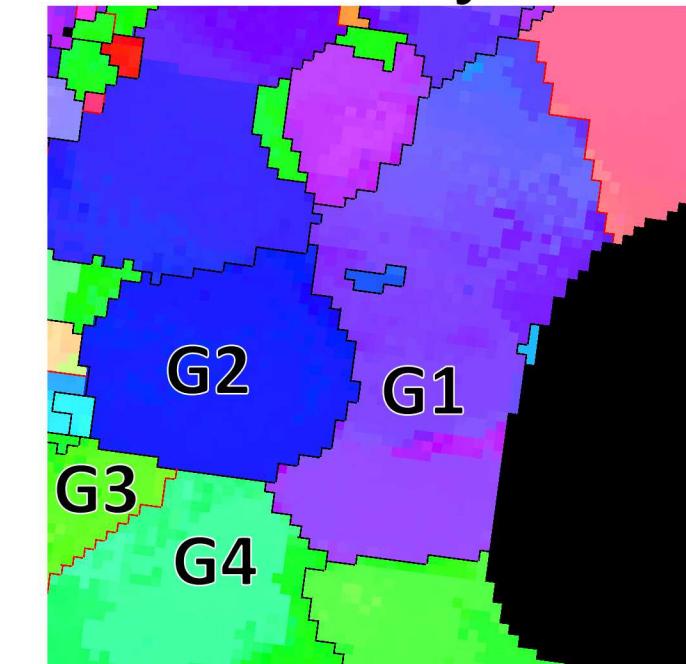
- Intermediate PED map (120,000 total cycles) indicates significant and quantifiable grain and grain boundary rotation

GB 3-4 (Twin Boundary Σ3)	Misorientation	Deviation from Ideal Σ3
Prior to Cyclic Loading	59.9° [1 1 1]	0.8 °
Crack Impinges GB at GB ₁₋₂	56.9 [7 7 6]	4.9 °

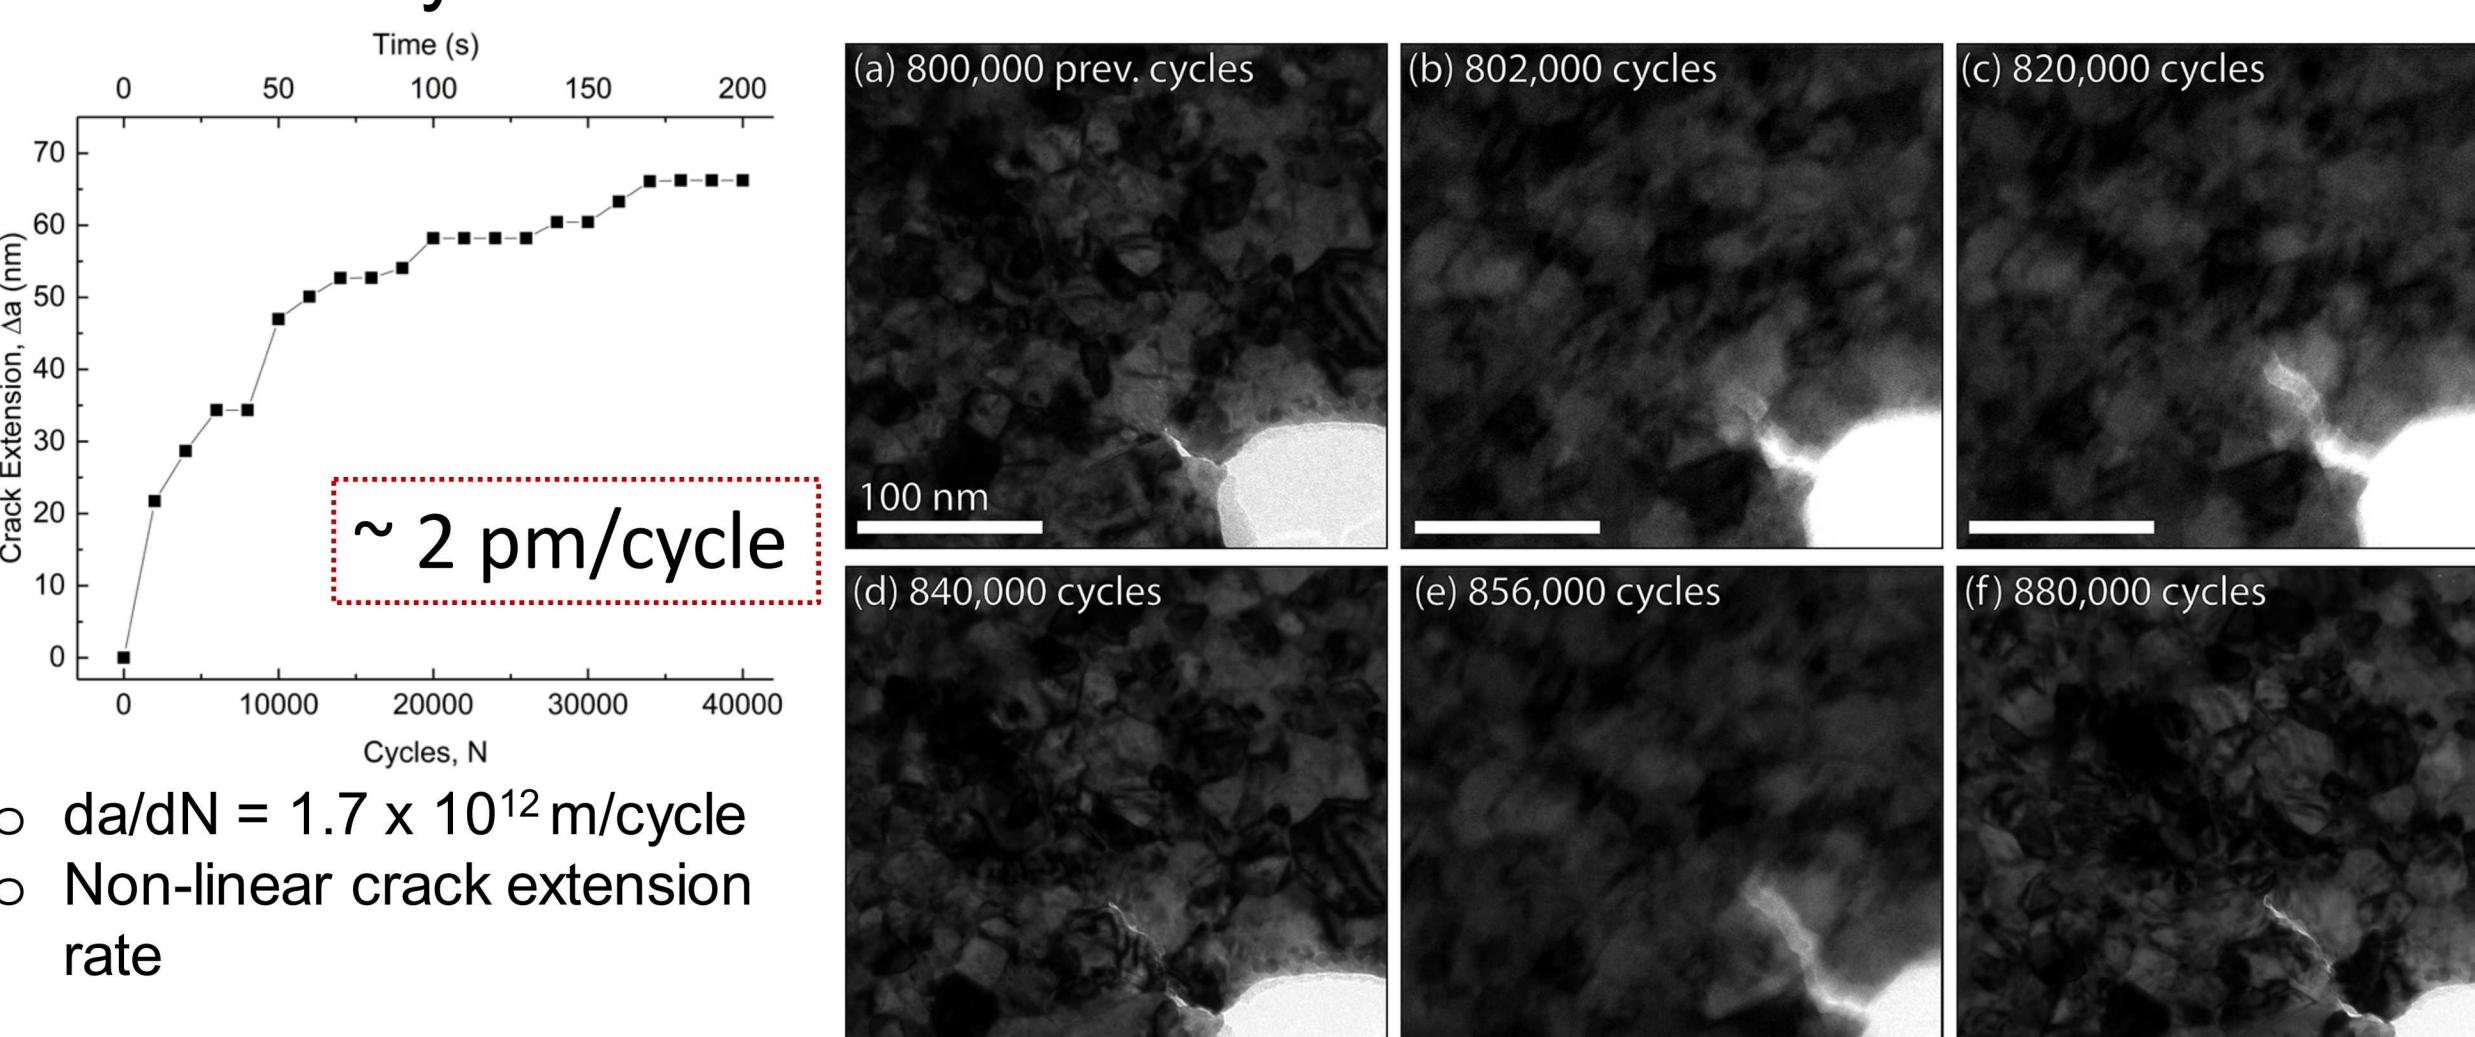
- Rapid propagation – transgranular between 800,000 to 854,000 total cycles

- After 854K cycles, cyclic loading crack impinges grain boundary

- No indications of previous deflected crack path – propagation continues closer to a mode I (normal to loading) direction
- Transgranular crack propagation has characteristics of "classic" zig-zag crack deflection

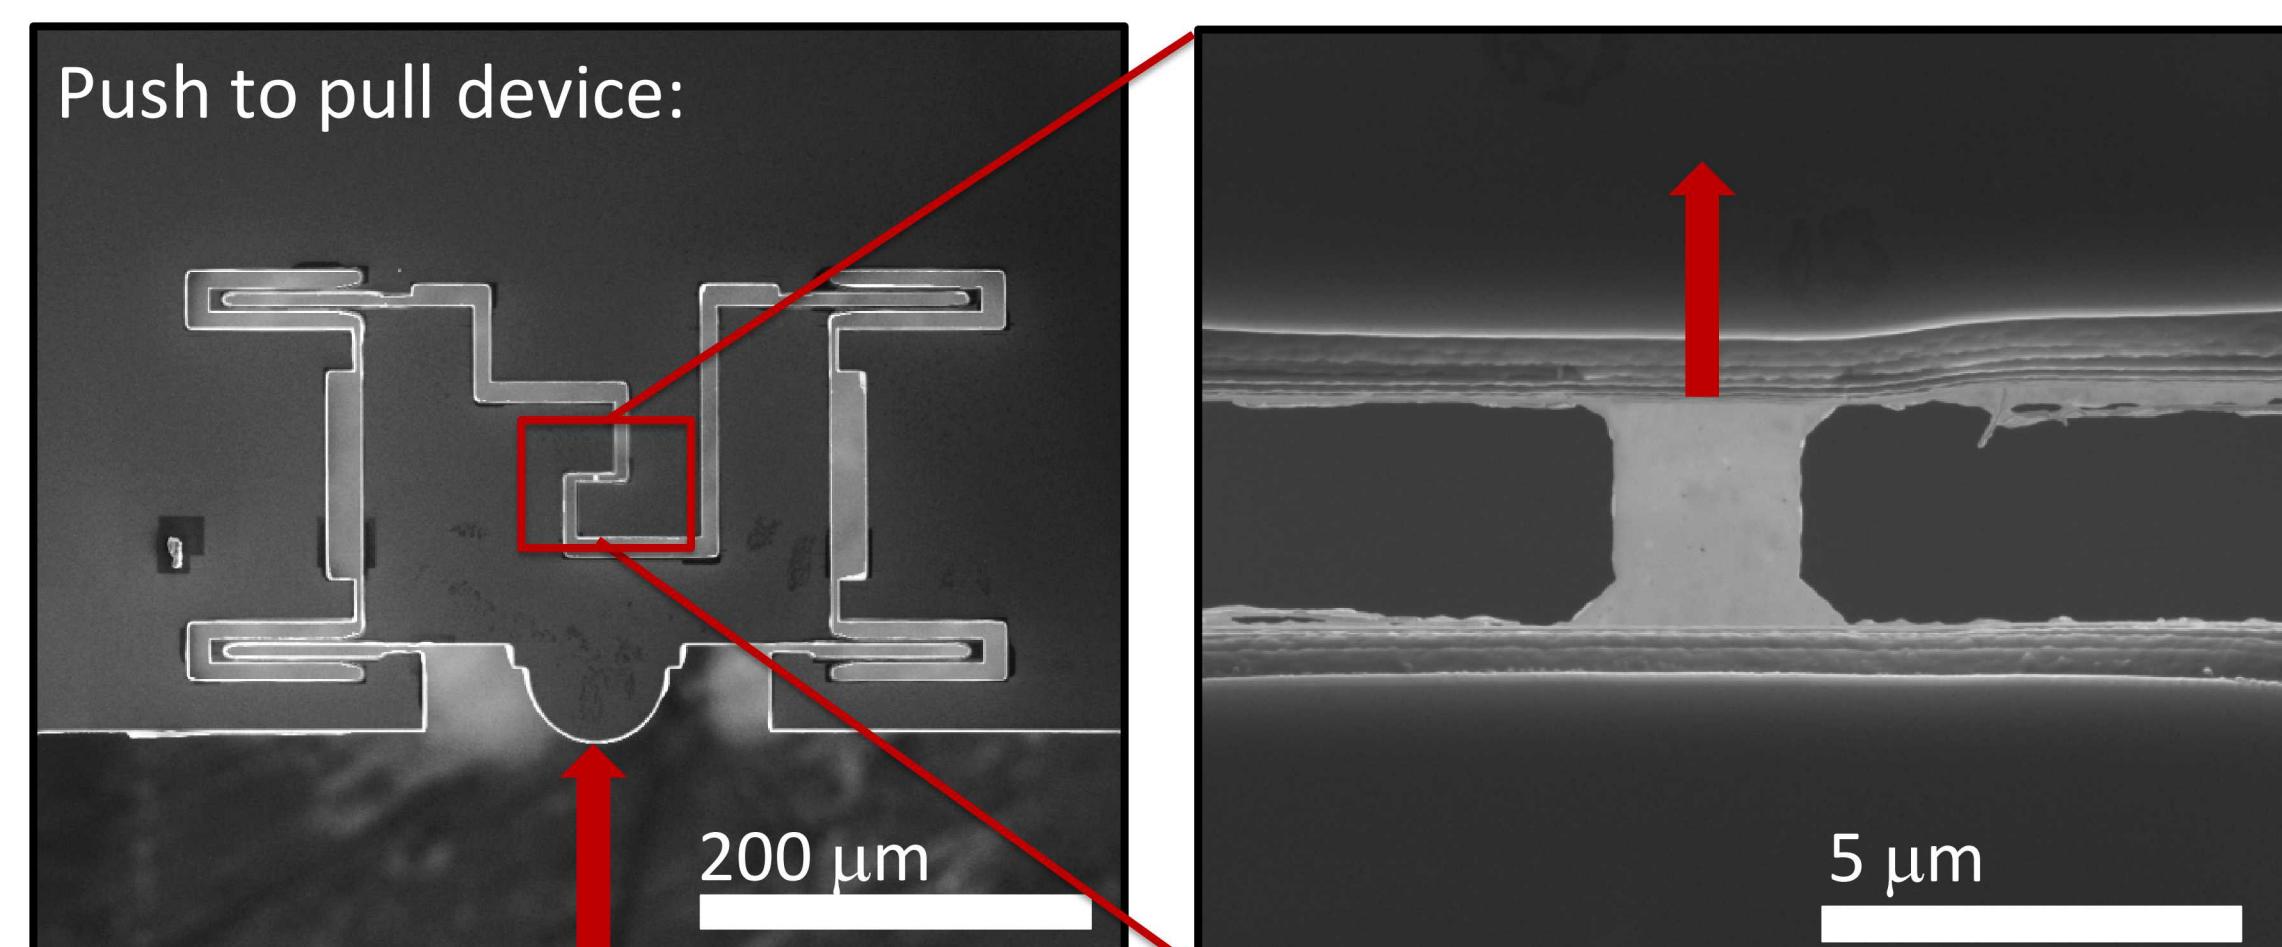
- Push-to-Pull devices – microfabricated Si test frames
- $F_{\text{applied}} = F_{\text{measured}} - F_{\text{spring}}$
- Pt film (40 nm) sputter deposited on NaCl → floated onto devices
- FIB utilized for nanoscale machining → create small geometry for tension-tension fatigue → critical to minimize Ga imaging
- Indenter compression creates region of tension on sample

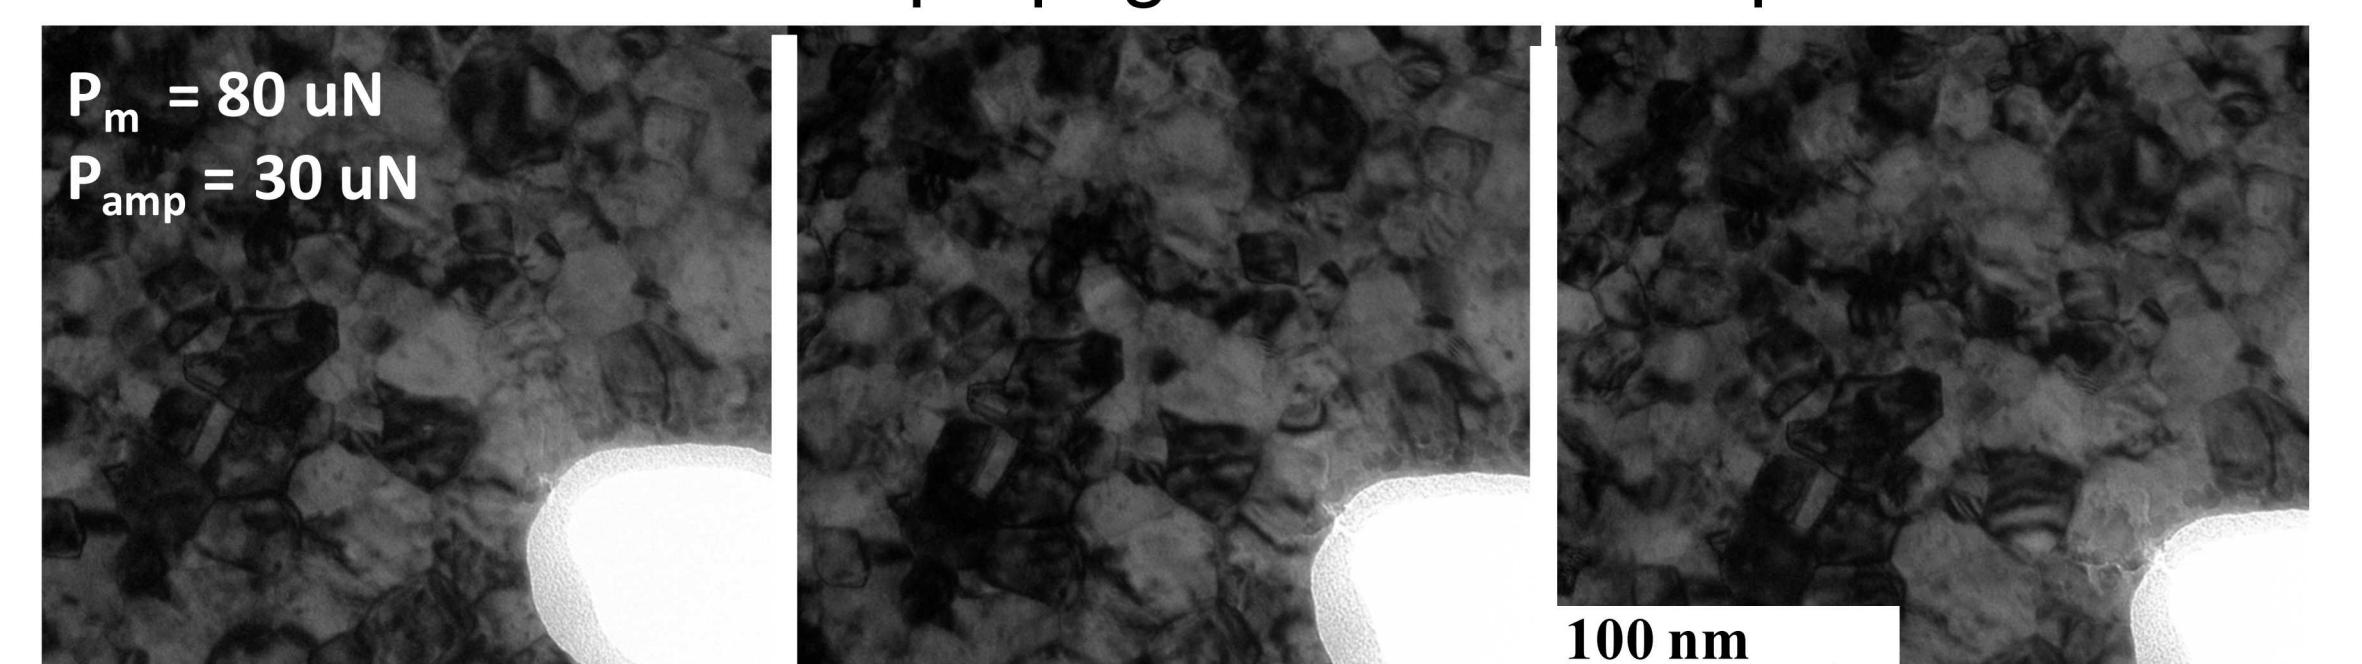
- Cracks initiation and propagation at notch tip

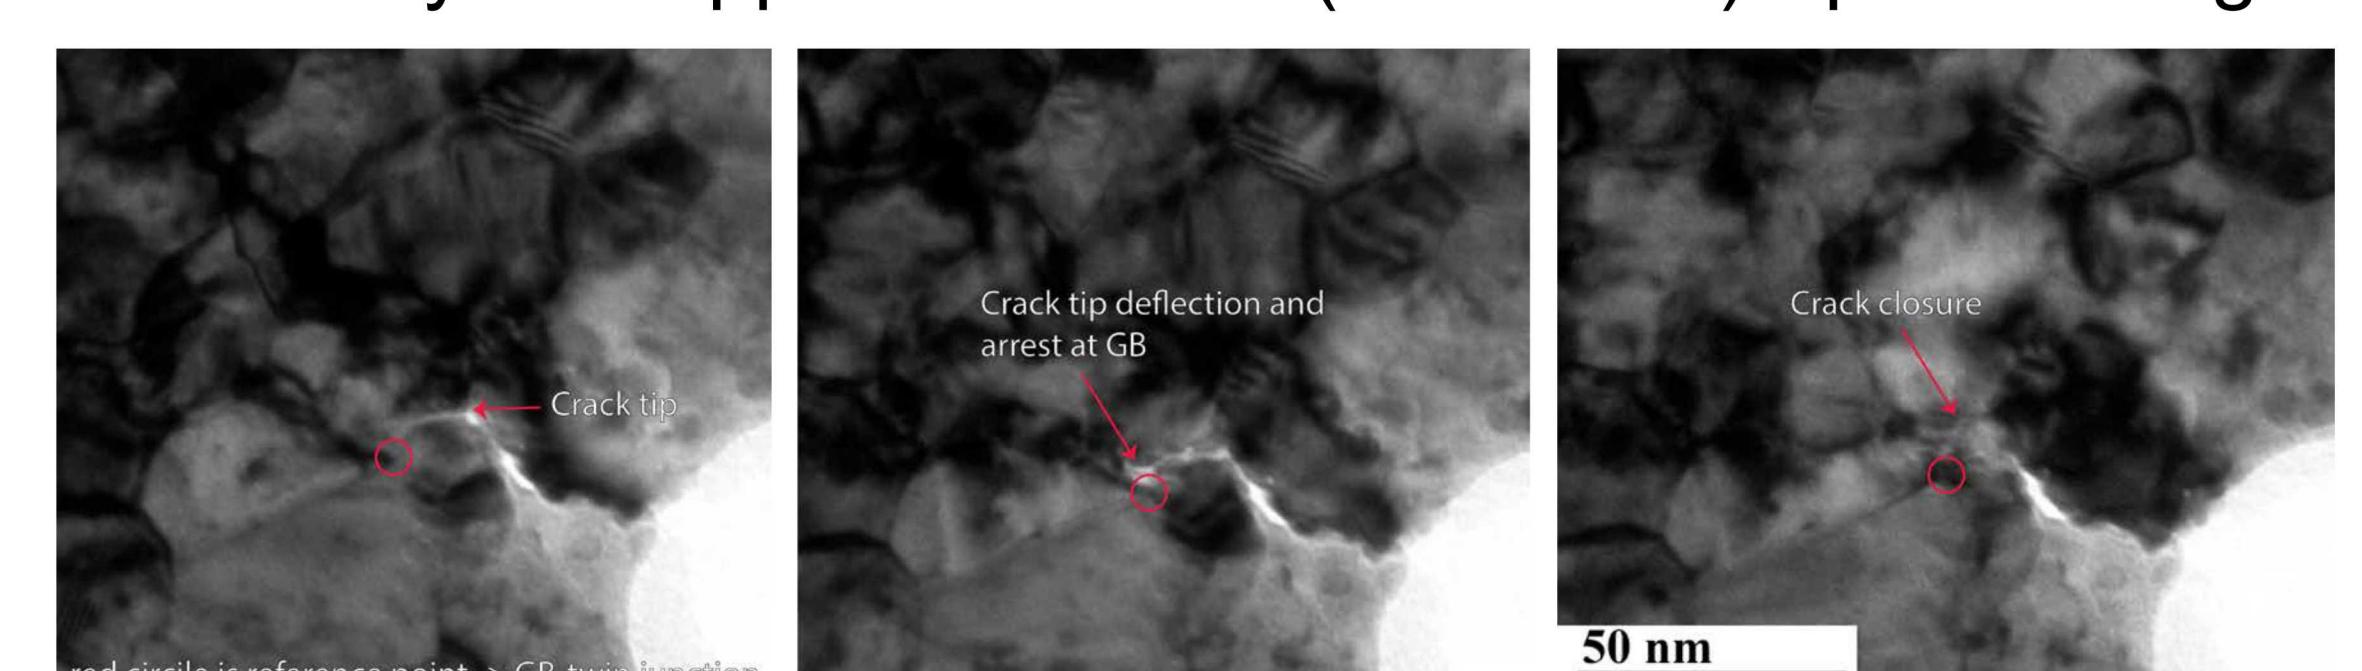
- Crack propagation transgranular
- Significant crack deflection away from mode I direction
- Deflected crack with mix-mode condition impinges grain boundary and appears to close (crack heal) upon loading

- Unique crack healing event observed during crack deflection away from mode I conditions
- Localized deformation (grain rotation and grain boundary misorientation change) quantified via PED orientation analysis
