SANDIA REPORT

SAND2020-1577

V28 Test Report

Jerome H. Stofleth, Megan K. Tribble, Robert W. Crocker

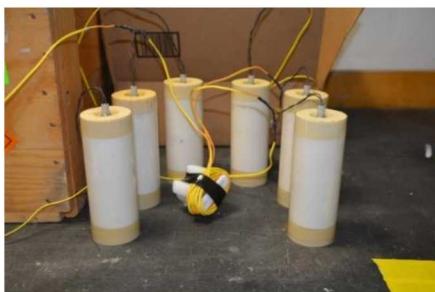
Figure 2: Individual charges packed into plastic bottles—detonator adapter shown at center.

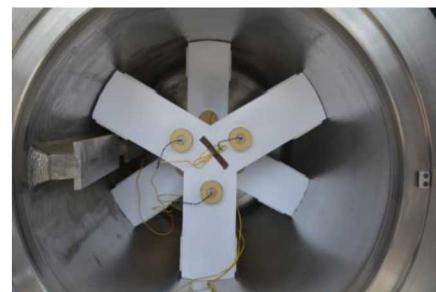
Figure 3: Six 1.5 lb C-4 charges (11.25 lb TNT equivalency) arranged in the V28 vessel.

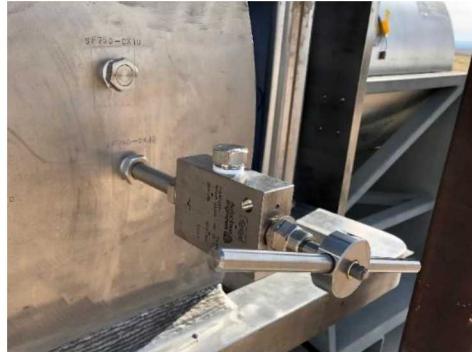
Figure 14: Large three-way sample valve installed on the drain port.

A large $\frac{3}{4}$ ” three-way sample valve (Parker/Autoclave Engineers 20SM12074) was fitted for Tests 1 and 4. This valve was installed in one of the two large drain ports on the door, as shown in Figure 14. The sample port of the valve was connected to the door and the common flow ports were plugged. The smaller $\frac{3}{8}$ ”-size is used for drawing liquid and gas samples in the existing EDS

systems. The goal was to determine if this larger valve could survive the explosive event while remaining functional and sealed to qualify it for future system designs.

After Test 1, it was determined that the valve had failed. It was loose after the shot and the high-speed video showed gas release during the event. Hence, the valve was left off for Tests 2 and 3. However, upon inspection while setting up for Test 4, it became obvious that the valve was still fully functional and that the leak was most likely due to improper installation (improperly torqued fitting). The valve was re-installed and successfully survived Test 4.

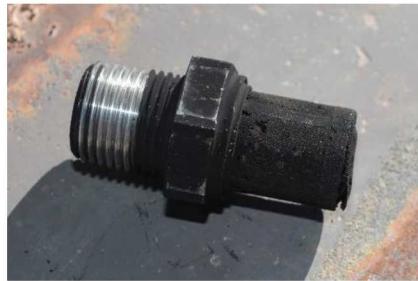
Figure 16: Small filter

Two styles and sizes of sample port filters were tested in this campaign. One design was smaller and used a thin wire mesh supported by a perforated ‘thimble’, while the other design was a straight version of the existing liquid sample dip tube screen with a larger tube and more substantial mesh. The port filters were covered by a more restrictive small blast cover, a model of which is shown in Figure 15. The smaller design was used on Tests 1, 2, and 3, while the larger design was used on Test 4. The small filter was repeatedly damaged, while the large filter did not exhibit any damage. As shown in Figure 16, Figure 18, and Figure 19, the small filter had multiple holes after only one test. Post-mortem analysis showed that the mesh was damaged at several of the 0.090” thimble openings.

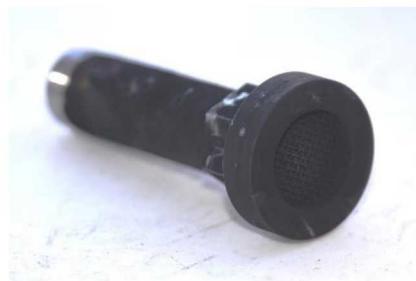
Figure 17: Large filter

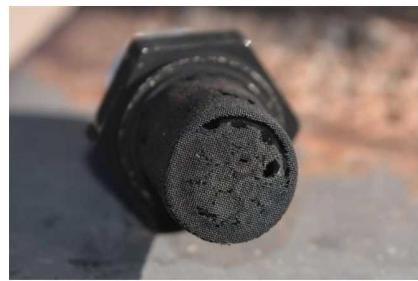
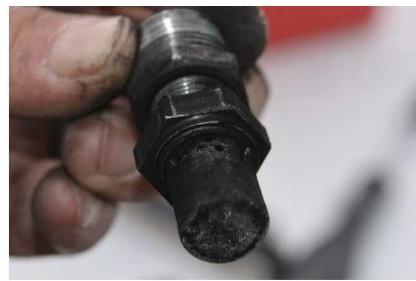
Figure 18: Holes in small filter mesh

Figure 19: Holes in small filter mesh

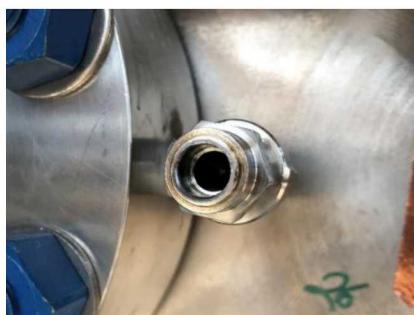
Figure 20: Failed fitting as found on feedthrough flange post-shot

On Test 3, the feedthrough flange was installed with its leak check fitting closest to the center of the door. Normally, the flange is installed with the fitting at the bottom or on the side opposite the center of the door. The fitting, a Kwik-flange-to-pipe adapter (MDC 731024), failed during this test. The failure is attributed to two causes. First, the fitting was closer to the center of the door than normal, an area which clearly experiences the most movement. Second, the charges were located closer to the ends of the vessel in this test, thereby increasing the coupled energy to the door. The fitting failed at the neck of the leak check flange and was later welded back together for future testing use (not in operations). Later leak checks with the fixed fitting indicate that the weld does not allow any leaks.

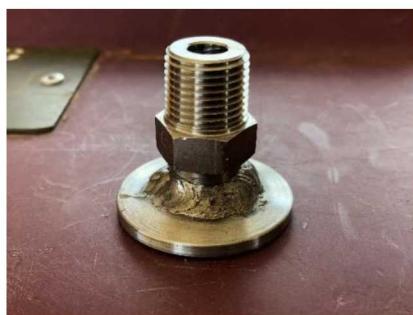
Figure 21: Fixed fitting

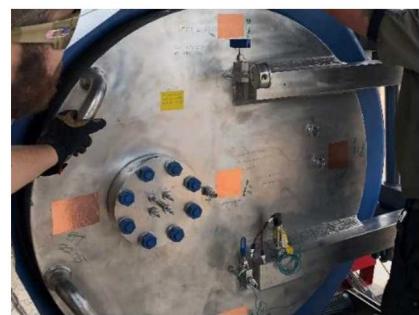
Figure 22: Close-up picture of door, showing the positioning of the fitting on Test 3.
