Evaluating the Influence of Size Effects on Load-Displacement Behavior and Failure in Threaded Fasteners, Part I: Experimental Testing

Thomas R. Bosiljevac, Yuriy B. Veytskin¹, John P. Mersch², Jeffrey A. Smith², Peter W. Grimmer²

R&D S&E Mechanical Engineering, Experimental Environment Simulation,
Sandia National Laboratories, Albuquerque, NM, 87185

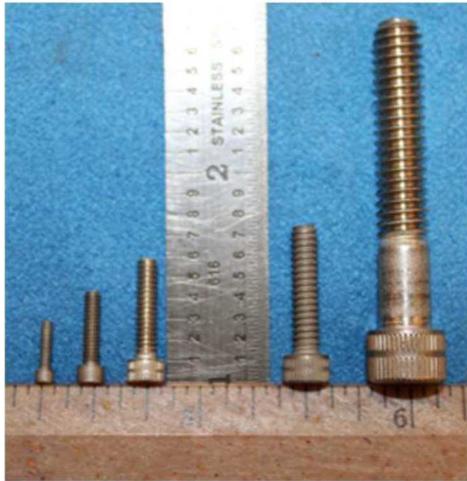
Figure 1: A286 Threaded Fasteners

The new test fixture and bushing design focused on allowing a lighter test fixture to be used while minimizing compliance issues in the load train. Additionally, the new fixture design would allow localized displacement measurements to be obtained closer to the region around the threaded fastener for the first time. The concept was to allow quasistatic tensile tests to be performed on small threaded fasteners ranging in size from #00 to #4. The specific bushings fabricated for use in the threaded fastener test series were designed for A286 stainless steel fasteners #00, #02, #04, #06 and #4, respectively. Refer to the NAS1351 and NAS1352 datasheets [1], [2]. The A286 threaded fasteners are shown below in Figure 1. The new fixturing utilized a redesigned test fixture and bushing combination made of 4340 steel heat treated to 42-46 Rockwell hardness (Rc) as referenced from the NASM1312-2 datasheet [3].

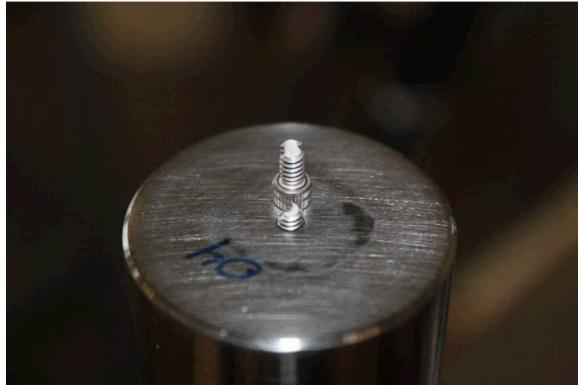
Figure 11: #04 threaded fastener failure

One other noticeable effect relates to the difference in LVDT and DVRT strain at failure. In almost all the fasteners tests, a difference of 0.01 mm/mm is seen between the LVDTs and DVRTs strains. Other observational results are shown in the figures below of tested threaded fastener specimens. Figure 11 shows a #04 fastener failure of the specimen still threaded into the lower bushing with the cap head half standing up behind for comparison. Figure 12 shows the typical modes of failure, with the most common type of fracture being a step fracture occurring over two threads. The largest size, #4, in Figure 12(b) shows a 90° failure of the bulk bolt, suggesting brittle failure which occurs at a normal plane of 90° from the loading axis. The smaller sizes suggest closer to a 45° fracture to the loading axis, as expected for more ductile materials. However, note that because of the helical geometry of the threads, traditional interpretations of specific angles associated with ductile or brittle fracture have less clarity in these complex geometries. Additionally, the #4 fastener has a larger non-threaded region than the other sizes, further complicating direct comparisons.

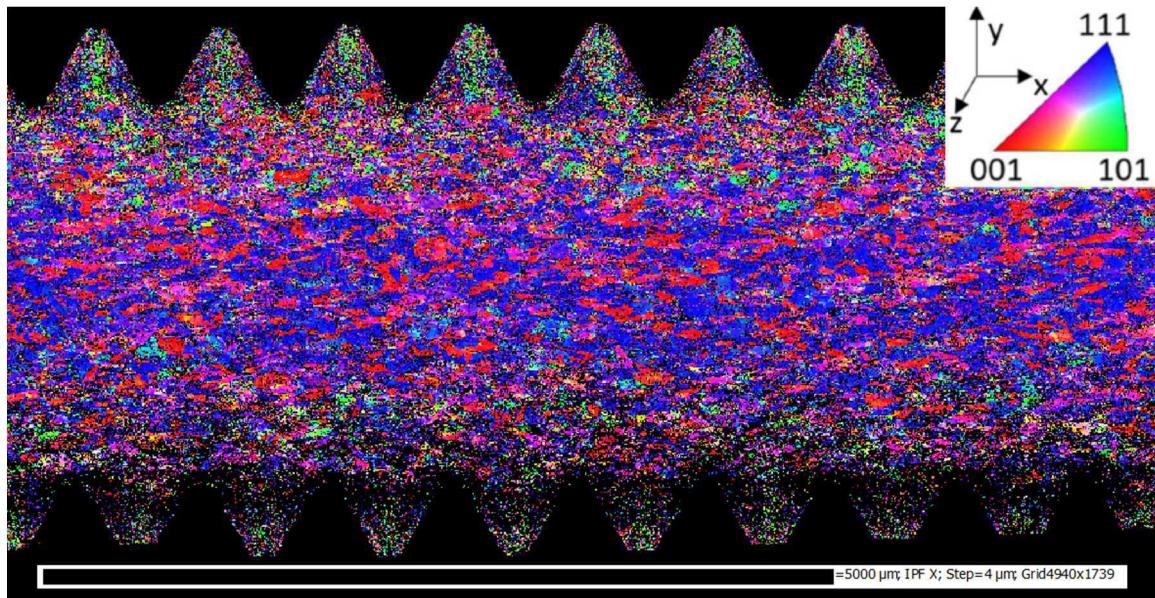
Figure 14: EBSD map of untested #06 fastener

A failure analysis can be conducted based on electron backscatter diffraction (EBSD) images collected of the same fractured specimens for microstructure-property relationships. The stark differences between the strength and ductility of the #00 and #02 fasteners and the #04, #06, and #4 fasteners motivated a microstructural investigation. EBSD maps, captured from a scanning electron microscope, of an untested #02 and #06 fastener are shown in Figures 13 and 14, respectively. Note Figures 13 and 14 show the Inverse Pole Figures with respect to the “x direction” (IPF X), which is along the axis of the fastener. The #02 fastener map is morphologically (structurally) representative of the #00 and #02 group, and the #06 fastener map is morphologically representative of the #04 and #06. No EBSD has been performed on the $\frac{1}{4}$ ” specimens. The grain structure is very different in the two fasteners, as the grains in the #06 tend to be elongated with a columnar pattern, and have evidence of cold work through the preferential axis orientation in the #06 fastener whereas the grains in the #02 fastener are equiaxed, indicating an annealed structure (as opposed to cold-worked), with more clearly defined grain boundaries in the EBSD map. Note that, while the grain structure indicates a cold-worked vs. annealed structure, all of the fasteners have been subsequently precipitation strengthened (age hardened) to a high-strength condition. In both Figures 13 and 14, the distributions of the colors of the inverse pole figures are similar, suggesting that the crystallographic grain orientations are preferred to similar extents in both fasteners, however Figure 13 shows more affinity for the $\langle 1 1 1 \rangle$ Euler-based axis (blue) and $\langle 0 0 1 \rangle$ (red) along the axis of the cold-worked fastener while $\langle 1 0 1 \rangle$ (green) is less prevalent, especially in the central region of the fastener. It is known that cold working deforms metal grain structures, as observed in Figure 14, and creates a “locking effect” from the entanglement of generated dislocations, which causes increased yield and ultimate tensile strengths and reduced deformation, all of which are represented in Figure 10 when comparing the #00 and #02 “annealed” fastener group to the #04 and #06 “cold worked” fastener group. It is known that annealing increases ductility by reducing the number of dislocations and increasing the number of slip conditions at grain boundaries, and this increased ductility is represented by an increased strain to failure for the #00 and #02 fastener group in Figure 10. The correlation between the microstructure and
