# Shear Behavior of Bedded Salt Interfaces and Clay Seams

Sobolik, S.R. <sup>1\*</sup>, S.A. Buchholz <sup>2</sup>, E. Keffeler<sup>2</sup>, S. Borglum<sup>2</sup>, B. Reedlunn <sup>1</sup>

<sup>1</sup> Sandia National Laboratories, Albuquerque, New Mexico, USA; <sup>2</sup> RESPEC, Rapid City, South Dakota, USA

This paper was prepared for presentation at the 53rd US Rock Mechanics / Geomechanics Symposium held in New York, New York, USA, 23-26 June 2019. This paper was selected for presentation at the symposium by an ARMA Technical Program Committee based on a technical and critical review of the paper by a minimum of two technical reviewers. The material, as presented, does not necessarily reflect any position of ARMA, its officers, or members. Electronic reproduction, distribution, or storage of any part of this paper for commercial purposes without the written consent of ARMA is prohibited. Permission to reproduce in print is restricted to an abstract of not more than 200 words; illustrations may not be copied. The abstract must contain conspicuous acknowledgement of where and by whom the paper was presented.

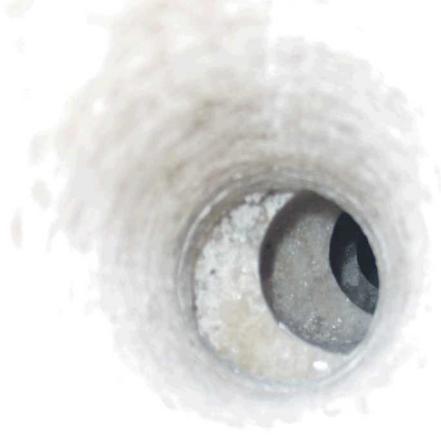
Fig. 2. Example of interface sliding in a borehole at WIPP.

An idealized WIPP stratigraphy used for rock mechanics calculations with many interfaces is illustrated in Figure 1. The effects of shear along these interfaces have long been thought to have significant impacts on the mechanical behavior of disposal rooms built for the long-term disposal of radioactive waste, particularly as they pertain to the evolution of room closure, roof falls, and changes in strength and permeability at these interfaces. Figure 2 shows a photograph looking into a vertical borehole at WIPP, where three interfaces have clearly slid since the borehole was originally drilled.

The interface between the halite layer and the clay section is well-defined. The fractured interface revealed a significant intrusion of salt crystals through the interface, giving it a higher stiffness and greater fracture stress than was expected. This condition has been observed at other interfaces at the WIPP site (Holt and Powers, 2011), which is different than other less stiff clay interfaces there (Figure 2).

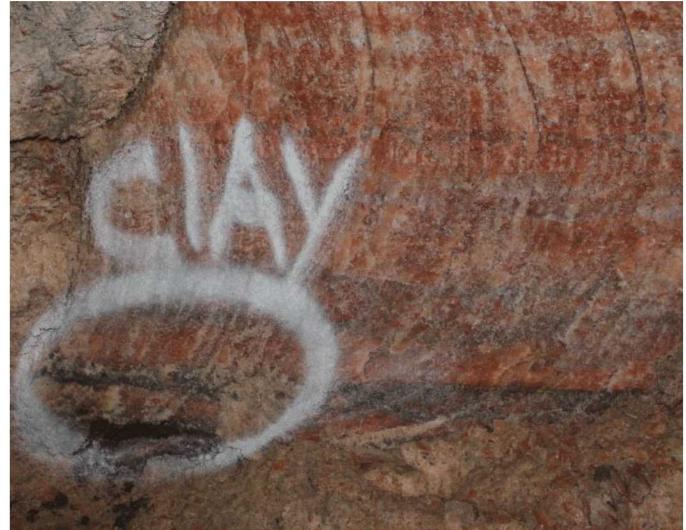
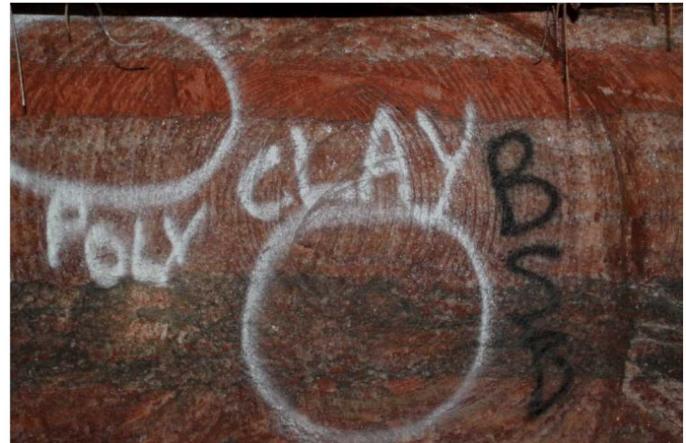
Fig. 4. Exposed Clay Seam (Top) and Halite/Polyhalite Contact (Bottom) for Test Core Collection (regions in photos are approximately 6 feet wide).

Sample collection was conducted in a salt-potash mine located near the WIPP facility. According to the original plan, as many samples as possible were to be drilled from the floor of an inclined drift at the mine. An exposed seam in the rib (side wall) of the drift would be followed until it went into the inclined floor. Core was to be extracted from a location where the interface was estimated to be approximately 24 inches (60 cm) below the floor. Several sites along the drift of the mine were scouted for well-defined clay seams, or well-defined interfaces between halite and another material (anhydrite or polyhalite). Two such locations are shown in Figure 4.

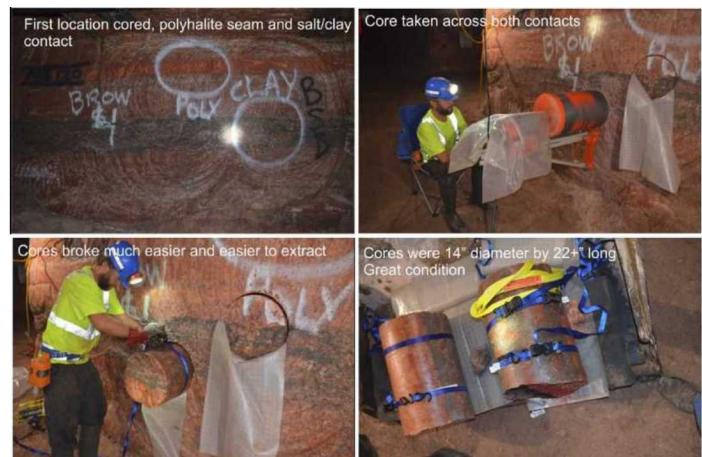
Fig. 5. Core extraction from side wall of drift.

The cores were drilled using a concrete coring rig with a diamond bit core barrel having dimensions of 12 inches (300 mm) in diameter and 22 inches (560 mm) long. Several cores were drilled from the floor as planned, but nearly all exhibited damaged seams or interfaces, which made them unsuitable for testing. As a result, a determination was made to extract cores horizontally from the rib. This procedure was much more successful; several intact cores were extracted for all the desired interface types. The extraction of two such cores are illustrated in Figure 5. These cores were wrapped in
