2019 Photovoltaic Reliability Workshop, Denver CO 26-28 February 2019

# Electroluminescent Imaging of Modules Exposed to Snow and Ice Loading: a Preliminary Analysis

Laurie Burnham<sup>1</sup>, Bevan Walker<sup>2</sup>, Daniel Riley<sup>1</sup><sup>1</sup>Sandia National Laboratories and <sup>2</sup>evolve|re

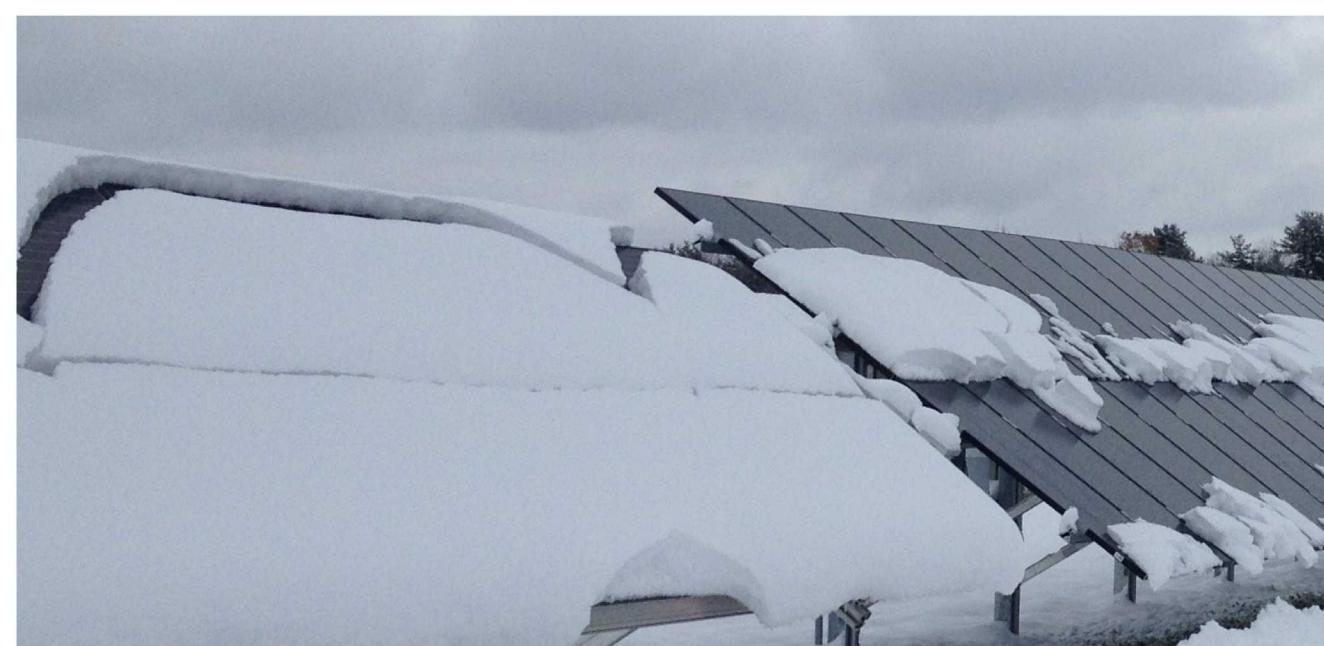
Figure 5. Differential snow shedding across modules creates mechanical stress

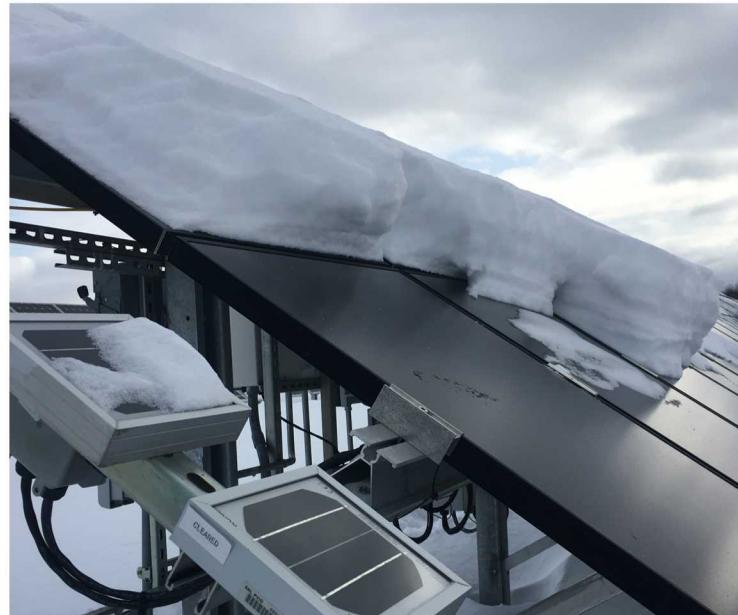
Figure 4. Differential snow shedding across monolithic CIGS modules creates electrical stress
