SANDIA REPORT

SAND2020-2933

Evaluation of Commercially Available Precursors for Obscuring Wet Industrial Irradiator Facility Pools to Delay Adversarial Source Removal. Part 2

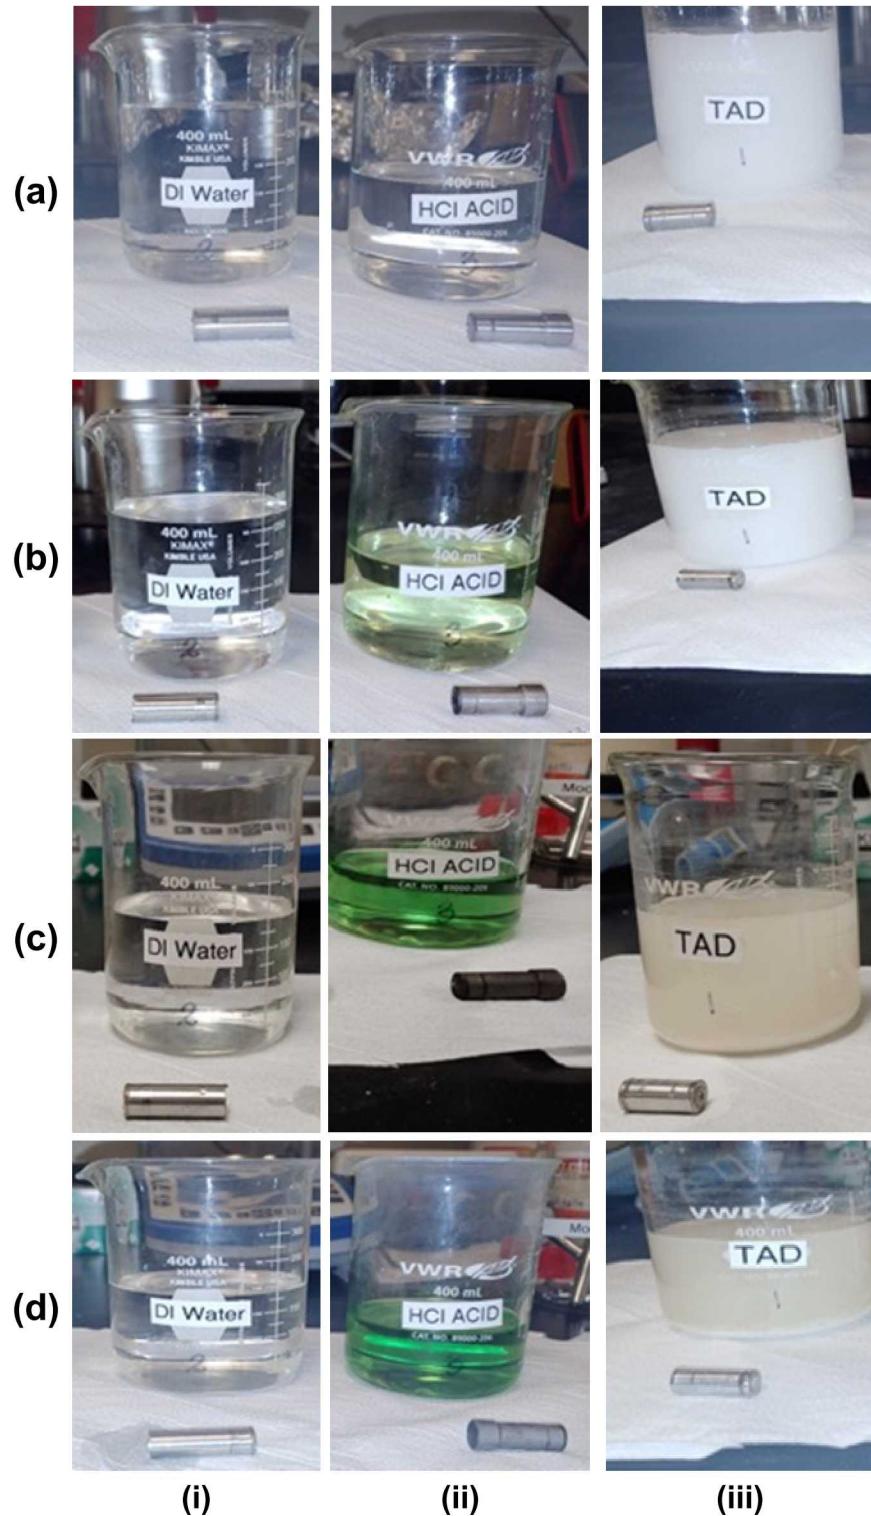
Figure 2. Picture of the various solutions (i) H_2O , (ii) HCl, and (iii) TAD and the slugs used for corrosion study at time = (a) 0 h, (b) 46 h, (c) 178 h, (d) 196 h.

Corrosion Results and Discussion. Three solutions were initially investigated: (i) DI water, (ii) (conc) HCl, and (iii) TAD; and the original slugs are shown in Figure 2, (a). Aged samples are shown in Figure 2, (b) through (d).

Due the surprising changes noted, additional aging studies were undertaken allowing the above solutions to age for 178 and 196 hours. As can be noted in Figure 2, for the 178 h samples, the water solution stays clear, the HCl solution gets darker green, and the TAD starts to settle with a larger precipitate noted and the solution turning a light pale yellow. Figure 6 shows the areas of the slug samples most impacted by the soaks. The water continues to rust with much more oxidation noted in the water image, Figure 6, (i)(A).

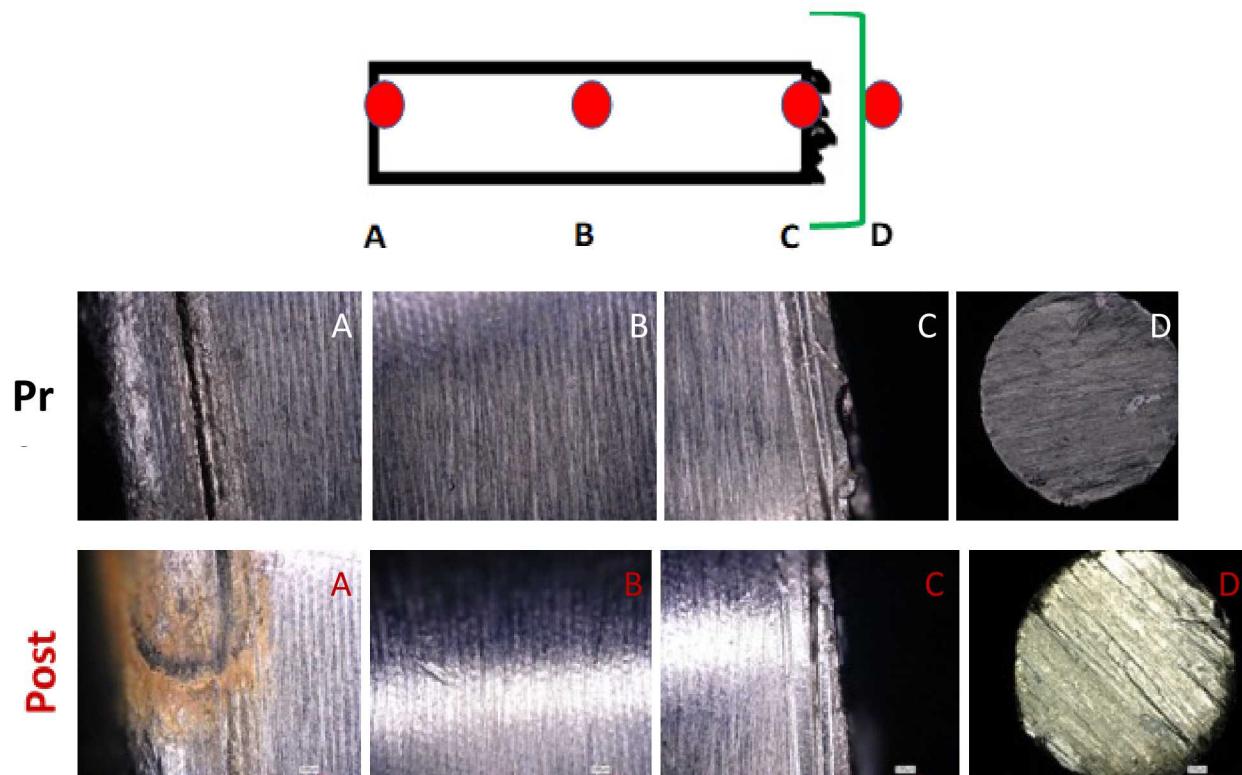
Figure 3. Schematic and resultant optical images at (i) pre (0 h) and (ii) post (46 h) in H_2O .

Water. It was expected that there would be no impact on the slug upon soaking in water, as this is the surrogate used in the IRF setup. However, as can be clearly observed in the Figure 3, A Post photo, there is considerable rust present after the relatively short soak of 46 hours. Corrosion was seen in the areas that had been cut or scratched by the steel tube cutter. It is common for stainless steels to develop this corrosion in areas that may have contaminants from the cutting process. The pristine areas of the slug did not show signs of corrosion.

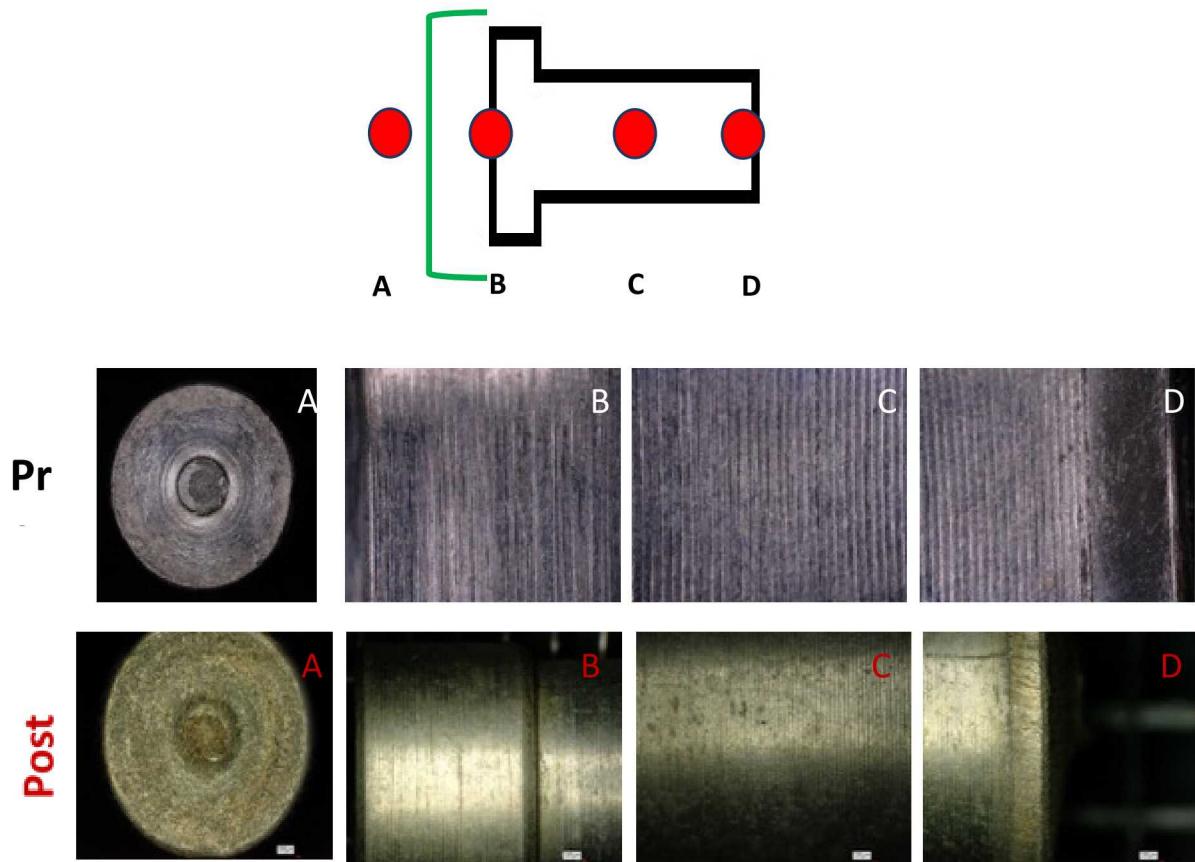
Figure 4. Schematic and resultant optical images at (i) pre (0 h) and (ii) post (46 h) in (conc) HCl.

HCl Solution. The next solution investigated was concentrated HCl. This solution was investigated to have chemically induced corrosion in order to characterize this behavior. Not surprising, after soaking for 46 hours (Figure 4) there is significant pitting, etching, and loss of materials for the post. This occurred throughout the sample and not only where the slug had been sawed. In particular, the terminus (Figure 4, D Post) shows the removal of material associated with the soak. As can be observed in Figure 2, the solution turned green indicative of iron, molybdenum and nickel being dissolved from the stainless steel, which was confirmed by X-ray fluorescence (see Appendix A).

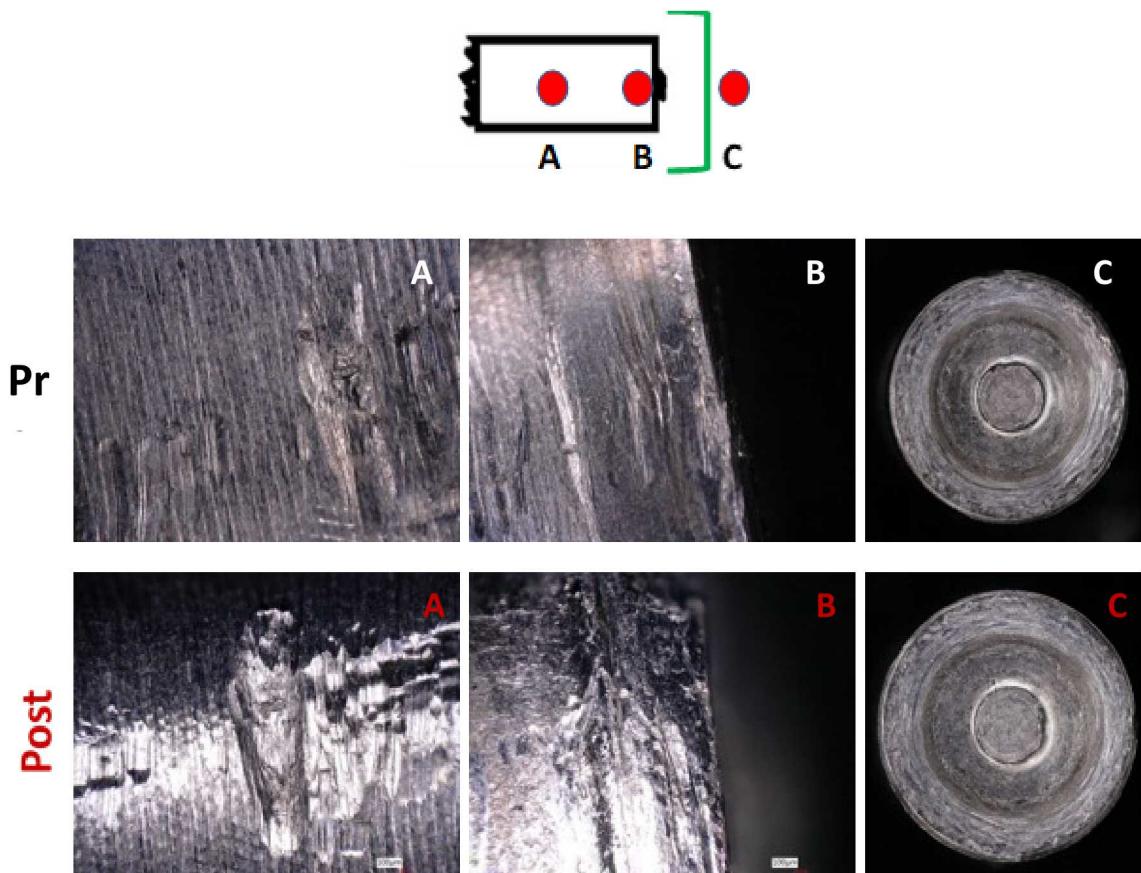
Figure 5. Schematic and resultant optical images at (i) pre (0 h) and (ii) post (46 h) in TAD

TAD Solution. Finally, the effects of the first obscurant investigated, TAD, were explored. The results are shown in Figure 5. After 46 hours, the sample showed no decomposition (or rust). This was surprising, as the water-only sample showed rust had formed on the surface of the slugs. The surface looks clean with a possible coating of the TAD on the surface notable in Figure 5, C Post. The TAD remained suspended in solution at 46 hours, staying a bright white and providing significant obscuration without agitation (Figure 2).

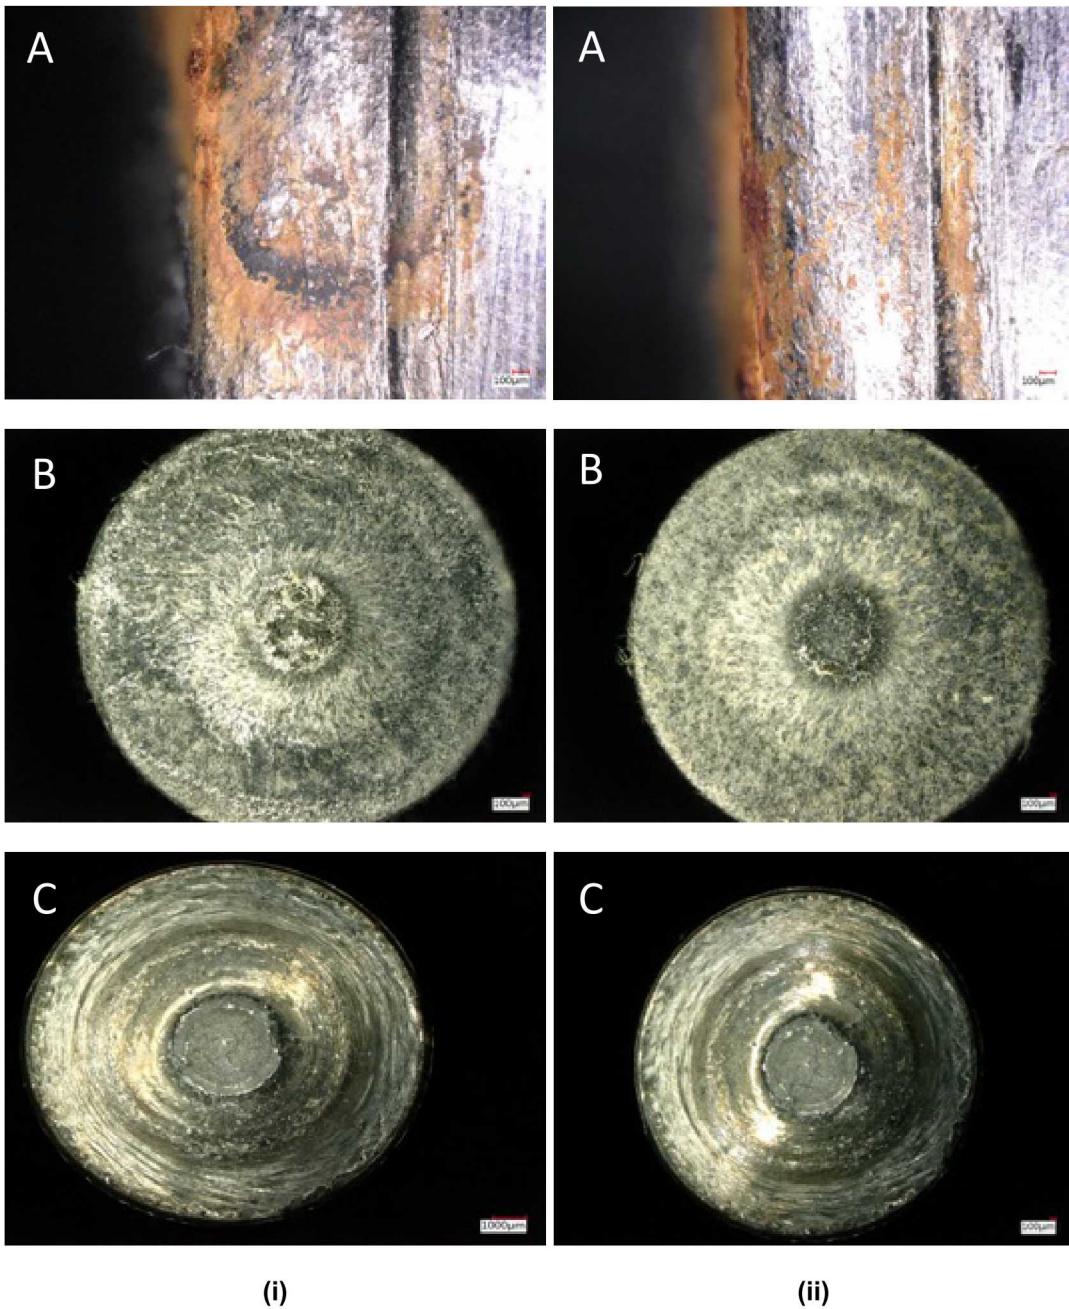
Figure 6. Select optical images of impacted areas at: (i) 178 and (ii) 196 h for (A) H_2O , (B) HCl , and (C) TAD.

For B, the distinguishing area on the point of the slug continues to increase with loss of metal to the HCl , and changes continue as the samples are further aged (196 hours, see Figure 6, (ii)). The continued pitting by simple water is surprising; whereas, the loss of metal in the HCl was fully expected. There appears to be no impact by the TAD solution, which may be due to the smaller titanium dioxide (TiO_2) particle filling in any damaged areas.

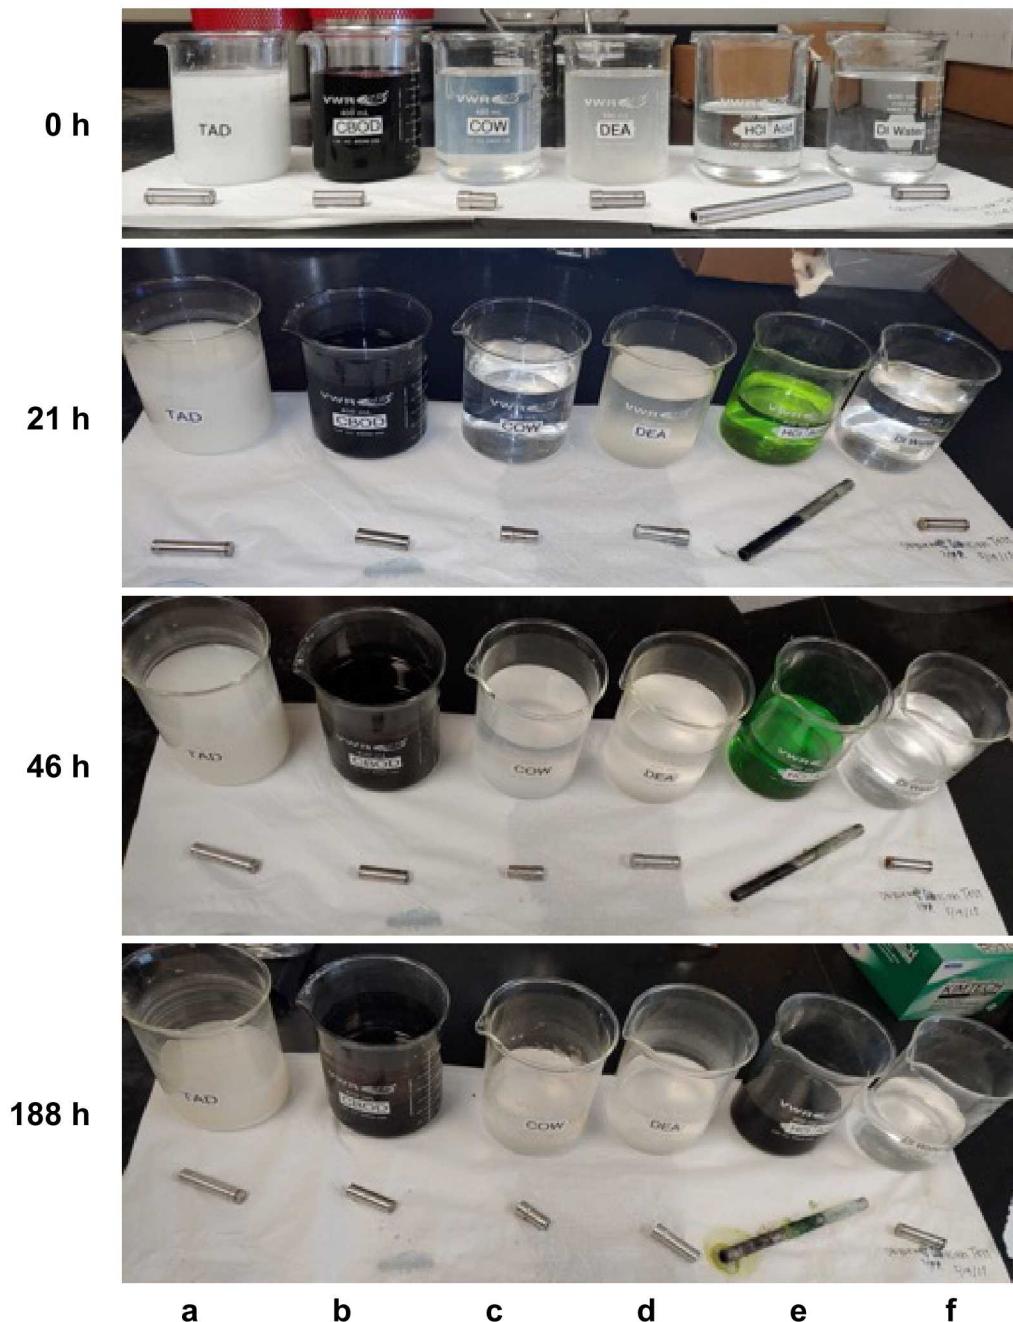
Figure 7. Select optical images of pencil slugs for: (a) TAD, (b) CBOD, (c) COW, (d) DEA, (e) HCl, and (f) DI water at hours listed.

Based on the surprising rust prevention by TAD, the other obscurants were similarly studied. In addition, TAD, water, and HCl were repeated. Initial slug images and solutions are shown in Figure 7. Additionally, Figure 7 reveals the change noted over time for the slugs and solutions.

For all of the obscurants (TAD, CBOD, COW, and DEA), similar behavior of the solution to that noted for the BRUCE tests were observed. That is, TAD and CBOD maintained their dispersion, while COW and DEA slowly settled to the bottom of the beaker. Inspection of the slugs for these were made at regular intervals through the test. For the HCl and water samples, similar decompositions as was previously noted was observed. The HCl reaction continued to decompose and color the rod (see Figure 7). Optical images were not recorded due to the lack of noted changes.

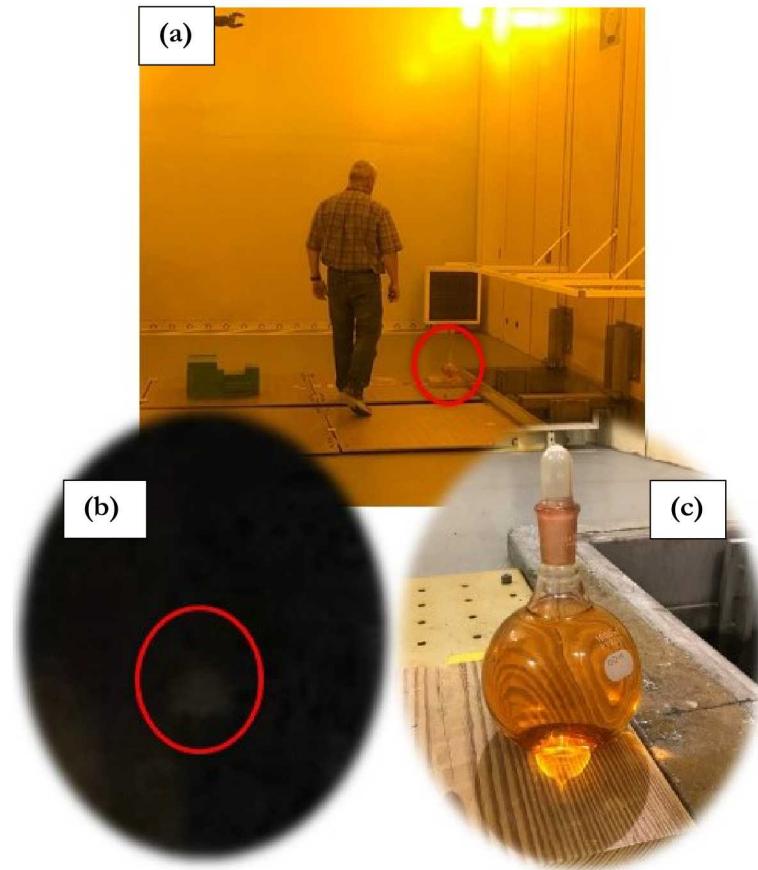
Figure 8. Images of the *R6G* sample (a) near edge of pool, (b) during irradiation, and (c) after irradiation (5 min).

Figure 8 (a) and (b) images are taken through the thick, mineral-oil filled glass of the irradiation chamber. The lights of the chamber were turned off during this sample irradiation so that any fluorescence could be seen. As seen in Figure 8 (b), the *R6G* sample glowing slightly as it is exposed to the radiation. The 0.023 mM solution continued to glow weakly for approximately 3 minutes. The concentration can be increased if a scintillation approach is of interest for a brighter response; however, the samples do decompose rather quickly, and higher concentrations would impact the water quality negatively. The same sample (*R6G* #1) was kept in the irradiation chamber for subsequent tests to evaluate the extent to which it would degrade. (see Figure 9, C). As can be observed, the sample has decomposed.

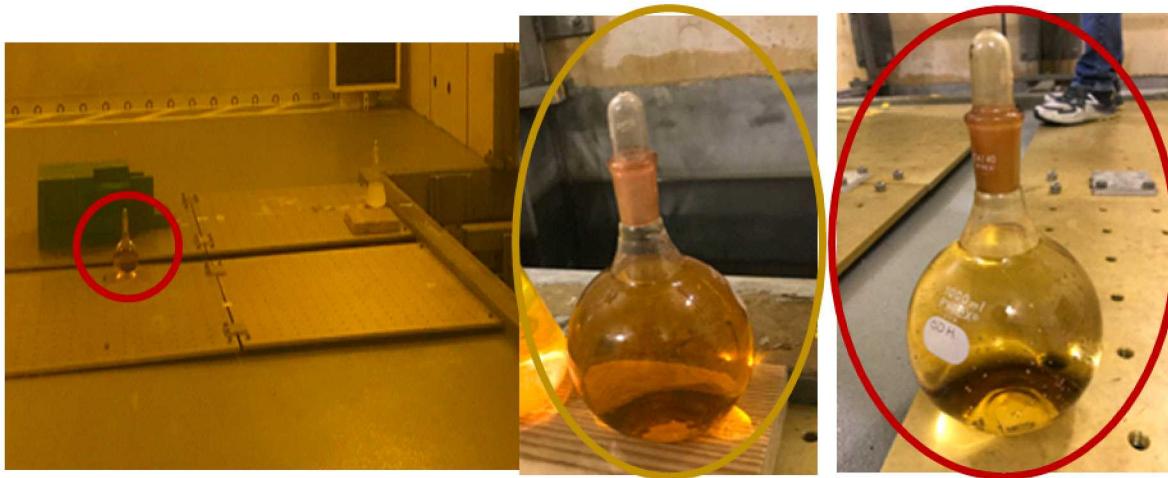
Figure 9. Images of the R6G sample #1 during testing (A), after 5 min irradiation (B), and after 360 min irradiation (C).

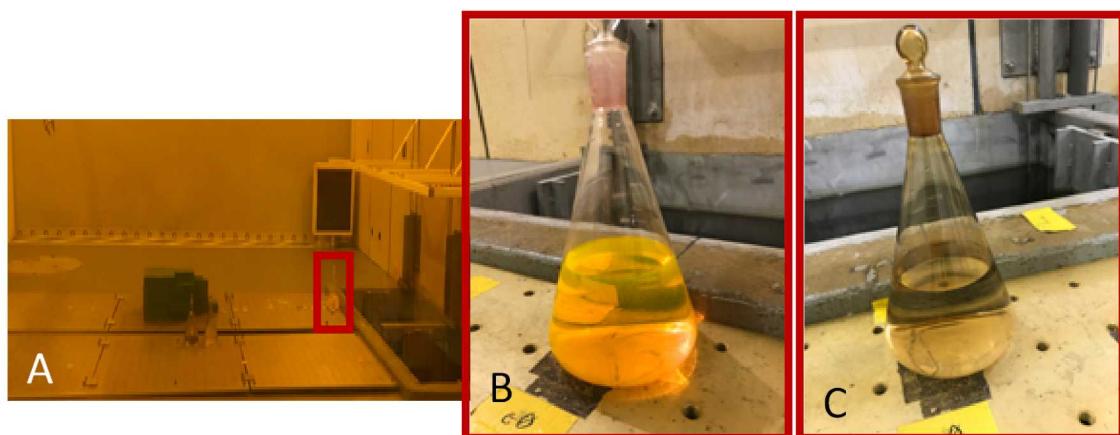
Figure 10. Images of R6G sample #2 during testing (A), before irradiation (B), and after 10 min irradiation (C).

A repeat R6G sample, #2, (see Figure 10) was also irradiated, and similar scintillation and decomposition was observed.

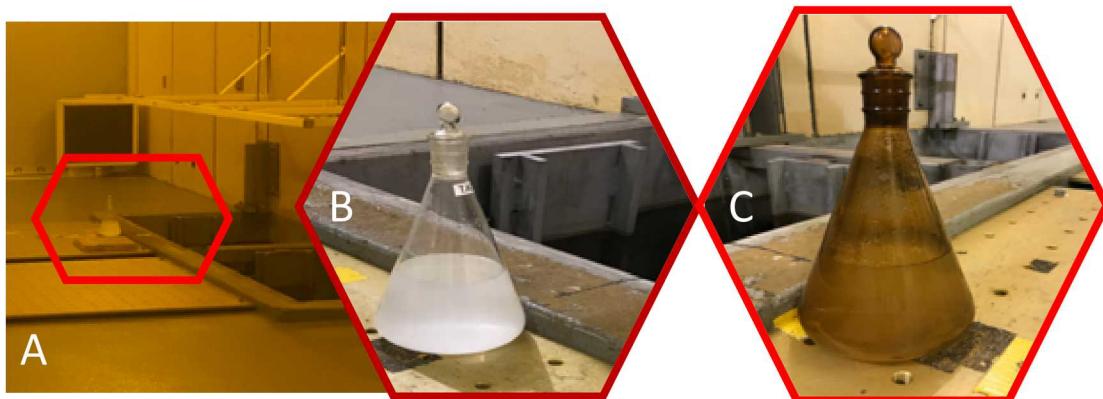
Figure 11. Images of the TAD sample (A) during testing, (B) before irradiation, and (C) after 360 min irradiation.

(b) *TAD*. Again, a TAD solution was made at the concentration levels of the previous BRUCE testing and placed in the GIF irradiation chamber (Figure 11). Prior to irradiation, the sample was white and easily dispersed as shown in Figure 11, B. The sample was then exposed for 6 hours to the ^{60}Co sources, and result is shown in Figure 11, C. Several observations were made during the process. First, the glassware turned a dark color during this exposure, which is thought to be due to the changes in the metals co-located in the glass. However, the TAD solution did not show any color changes or additional precipitation during the exposure. Further, the solution's properties were only slightly altered. The pre-irradiation properties were: pH: 6.51, conductivity: 3.3 $\mu\text{S}/\text{cm}$, turbidity: 164 NTU. Post-irradiation properties were: pH: 6.00, conductivity: 4.3 $\mu\text{S}/\text{cm}$, turbidity: 181 NTU. The variations are all believed to be within experimental measurement error and fall within the parameters set out in the original report. In fact, the turbidity increased, which would be a useful property for the obscurant objective.

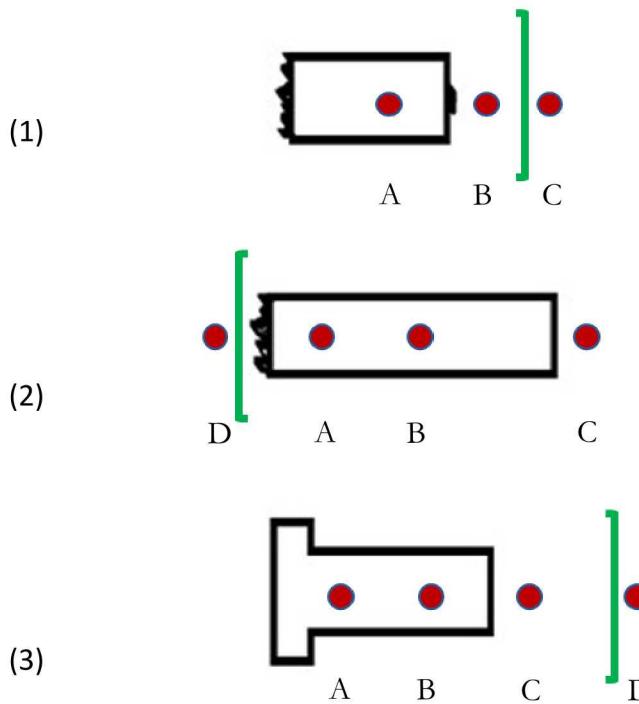
Figure A-10. Schematic of slugs (1 – 3) and locations (●) of where pictures were obtained. Green bar indicates face (90°) picture taken.

To monitor any induced corrosion a microscope was used to take optical images at 100 times magnification. The microscope used was a Keyence VHZ 7000 optical microscope. Pictures were taken at various areas along the slugs. Figure A-9 shows the “before” pictures and the solutions. The areas photographed on the slugs each time are depicted in Figure A-10 by a red dot.

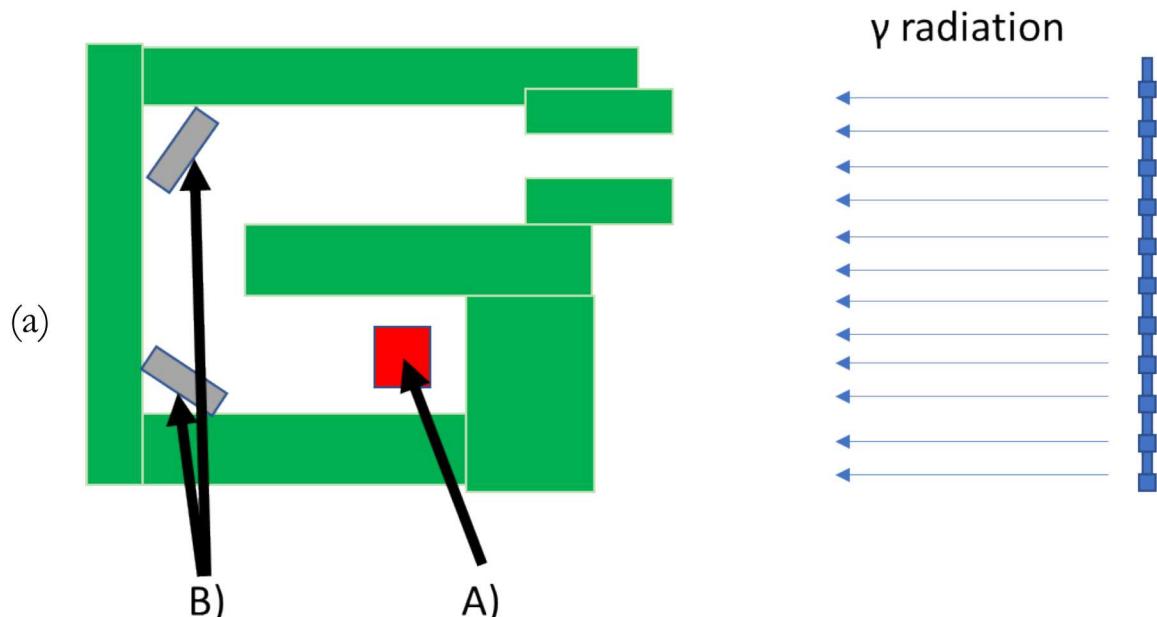
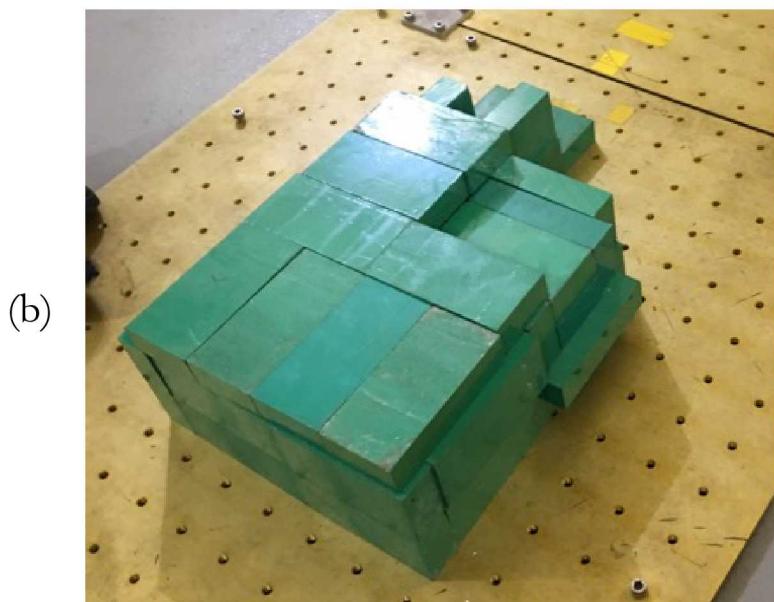
Figure B - 1. Design for protecting camera from source unitizing lead bricks (green): (a) schematic where A) GoPro™ and B) optical metallic mirror; and (b) testing apparatus.

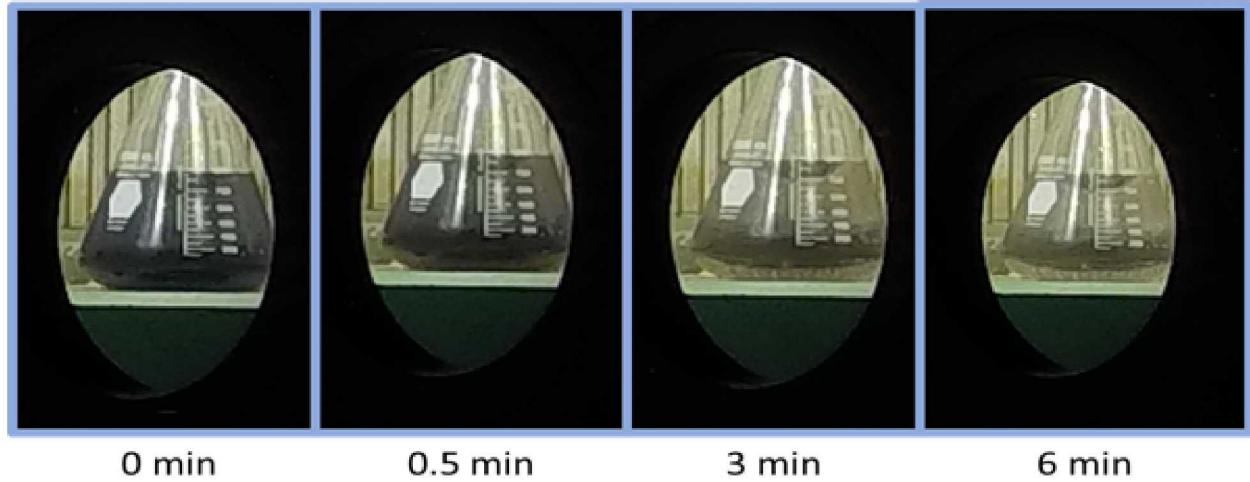
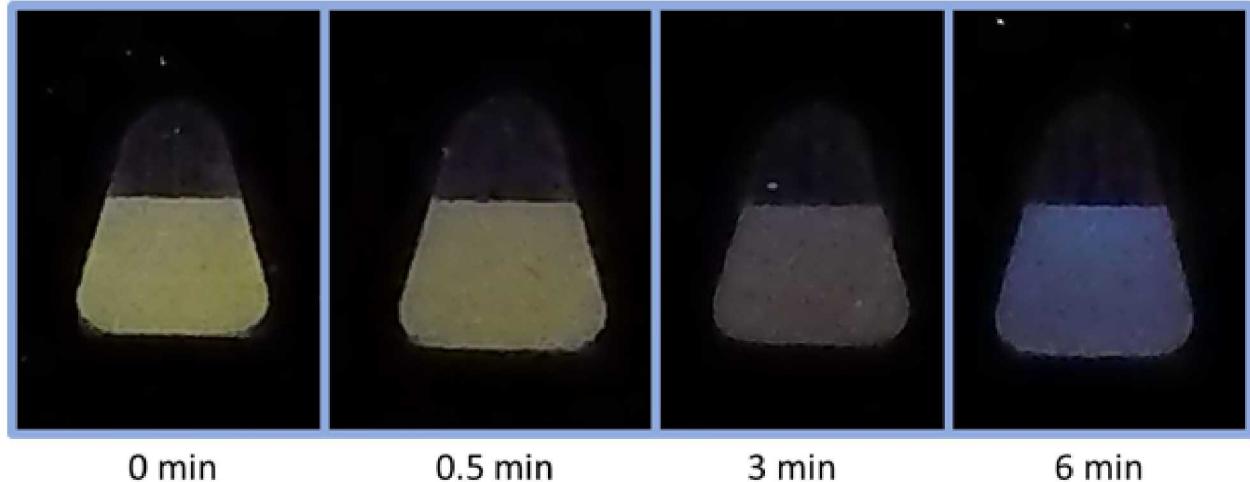
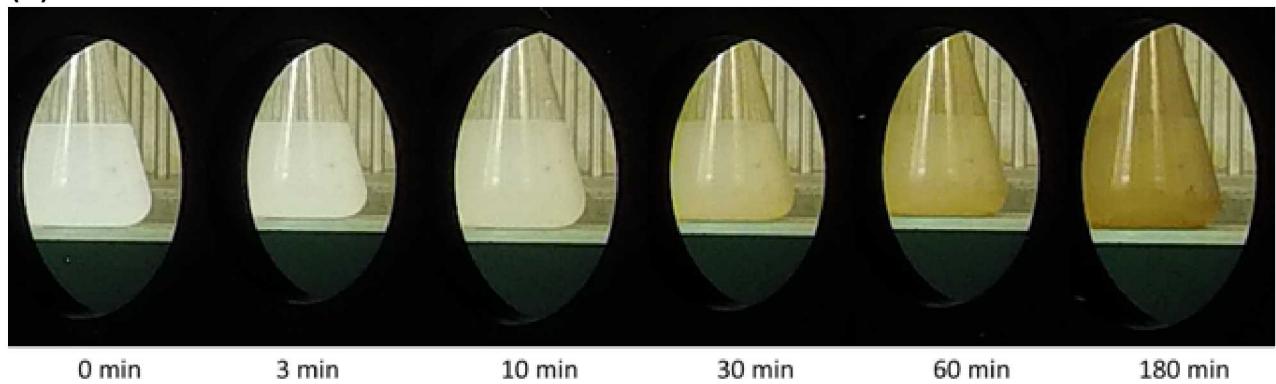
Figure B - 2. Optical Decay of Obscurants: (a) CBOD, (b) R6G, and (c) TAD
