**PVUSA EXPERIENCE WITH POWER CONVERSION FOR
GRID-CONNECTED PHOTOVOLTAIC SYSTEMS**

Walt Stolte, Bechtel Corporation
and PVUSA Project Team

Pacific Gas and Electric Company
Research and Development
San Ramon, CA 94583

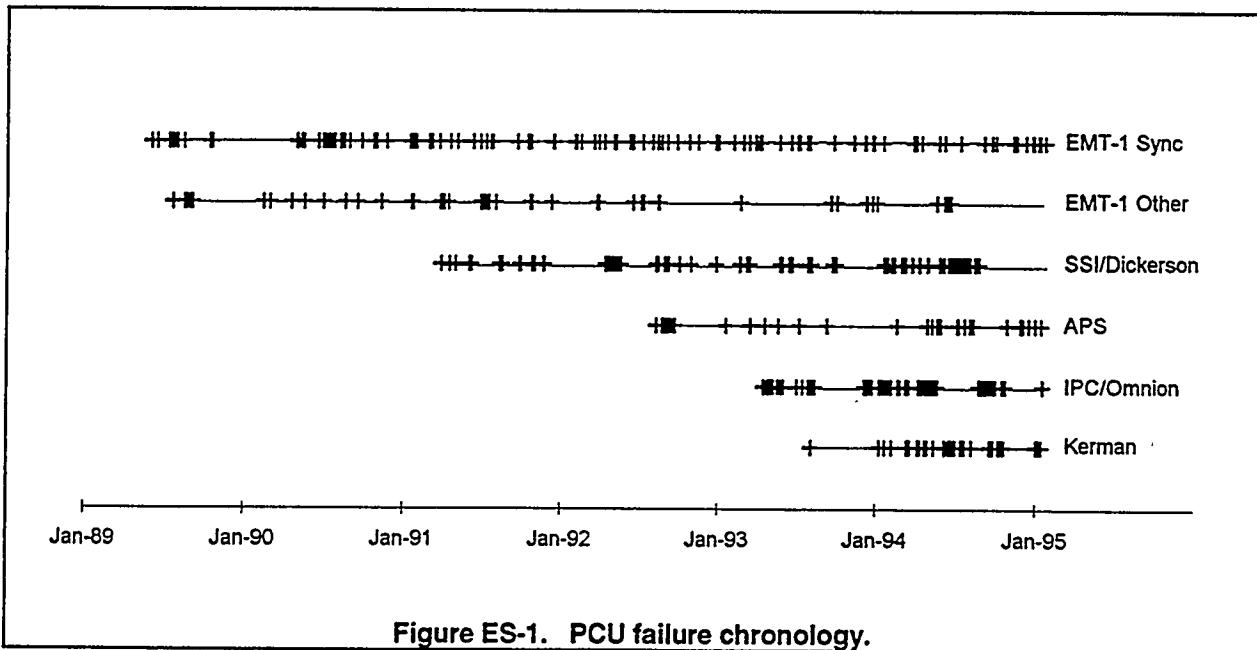
Figure ES-1. PCU failure chronology.

Entries in Figure ES-1 for EMT-1 are for five DECC units, which were brought on line at various times as the EMT-1 PV systems were installed. The synchronizing errors are related to the PCU's morning wakeup procedure and require a manual reset. This nuisance problem is ameliorated with biannual adjustments of the starting voltage to accommodate seasonal variations in array voltages. Early problems included trips, failures to start, and failures to power track accurately. Corrective actions over time included adding capacitors across the ac power transducer, adjusting transducer gains and delay times, and repairing loose or broken connections and faulty resistors.

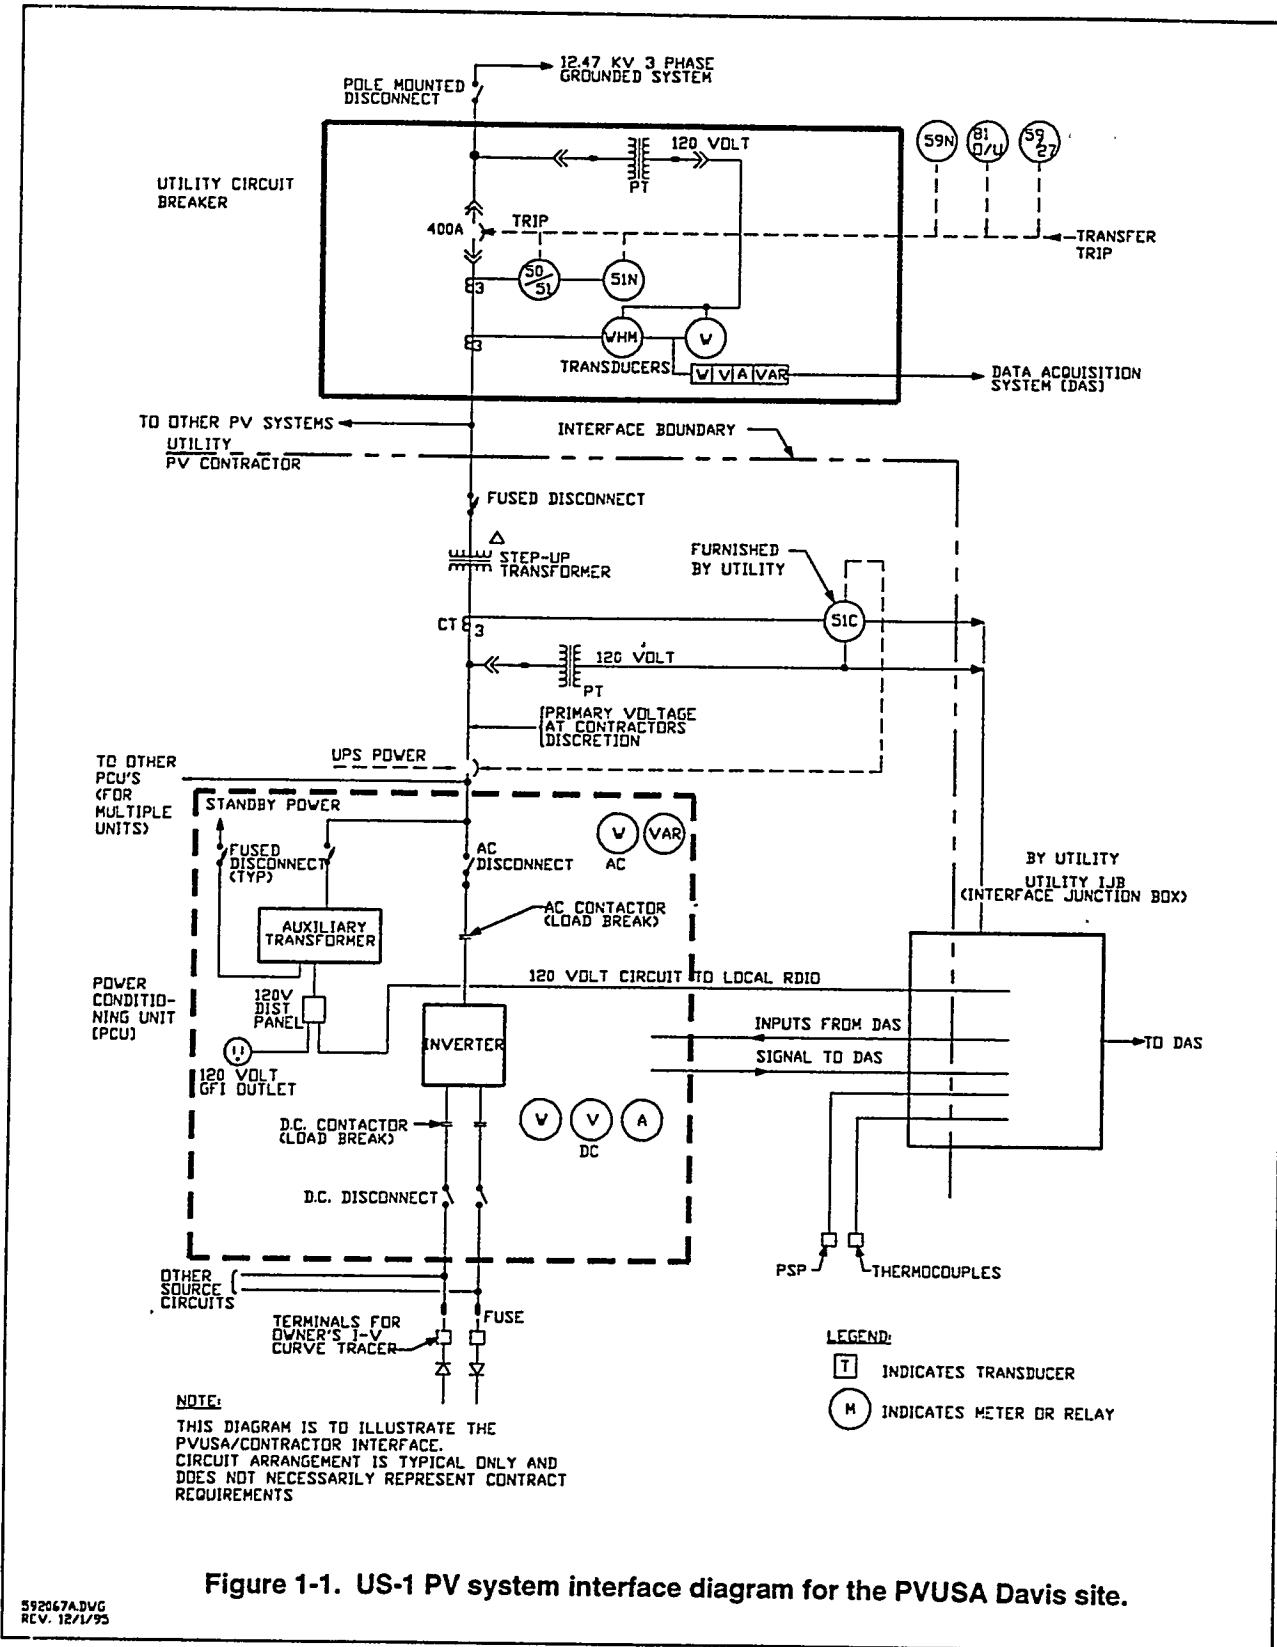
Figure 1-1. US-1 PV system interface diagram for the PVUSA Davis site.

The Integrated Power Corporation (IPC) US-1 PV system uses a PCU provided by Omnion Power Engineering Corporation in East Troy, Wisconsin. The PCU is an Omnion Series 3200 static power converter and is rated at 200 kW.

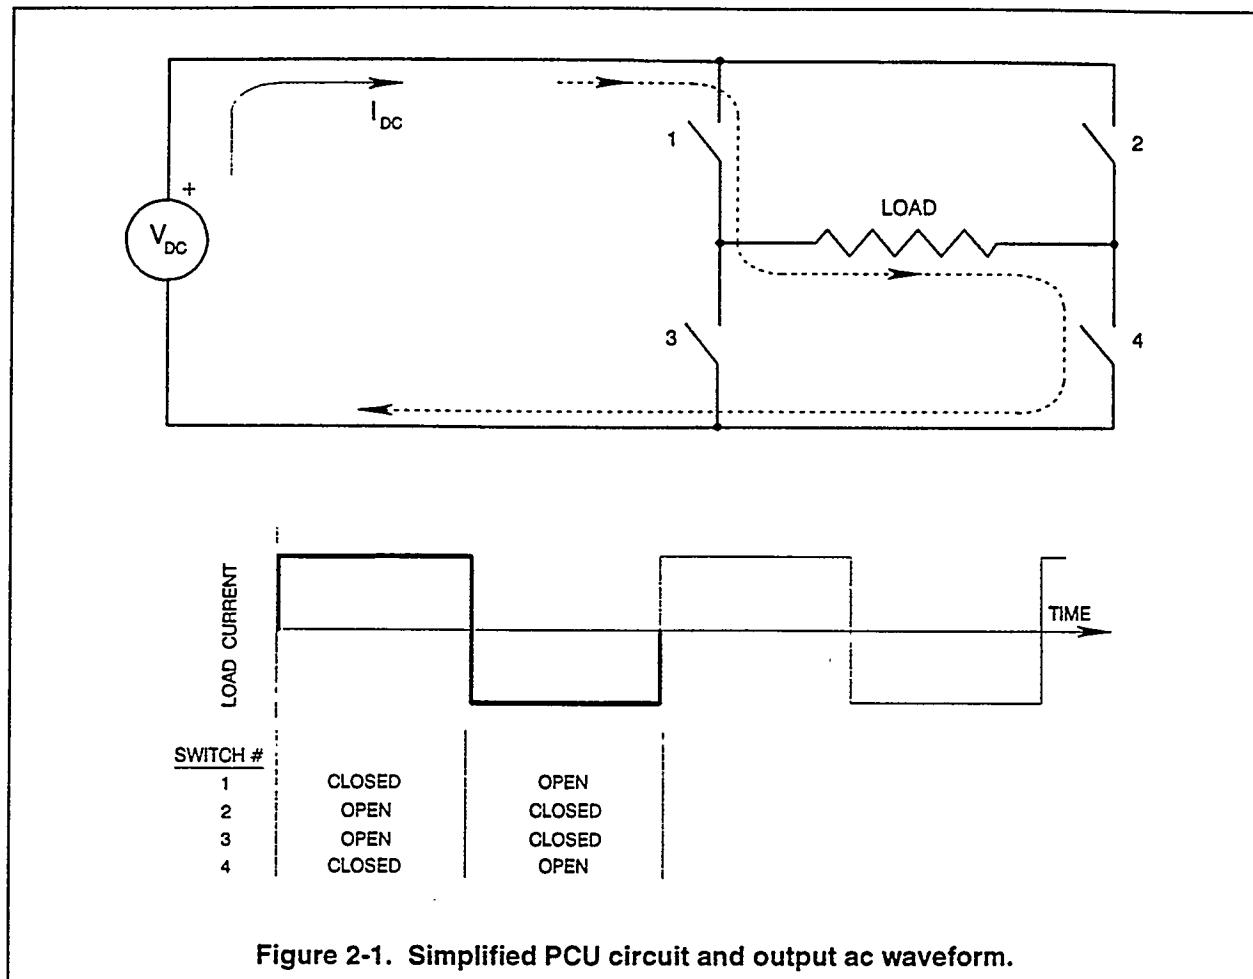
Figure 2-1. Simplified PCU circuit and output ac waveform.

Inversion from dc to ac is accomplished as follows. Closing switches 1 and 4 causes a current to flow through the load, as illustrated by the dashed line in Figure 2-1. After 8 milliseconds (for a 60-Hz, single-phase unit), switches 1 and 4 open, and switches 2 and 3 close. This causes the current to flow through switches 2 and 3, and in the opposite direction through the load (not illustrated). The current, of course,

continues to flow in the same direction in the dc portion of the system. After another 8 milliseconds, switches 2 and 3 open, and switches 1 and 4 close. This cycle is repeated 60 times per second, and an alternating current is produced in the load, as indicated by the waveform in the lower half of the figure. The table under the waveform shows the conditions of the four switches during the two 8-millisecond time periods discussed above. The waveform illustrated is for a resistive load; inductive or capacitive load components will alter the waveform. Additional features are incorporated into practical PCUs so that the ac output more closely resembles a sine wave. (The waveshapes produced by some of the earliest low-power inverters were not too much better than those illustrated in Figure 2-1.)

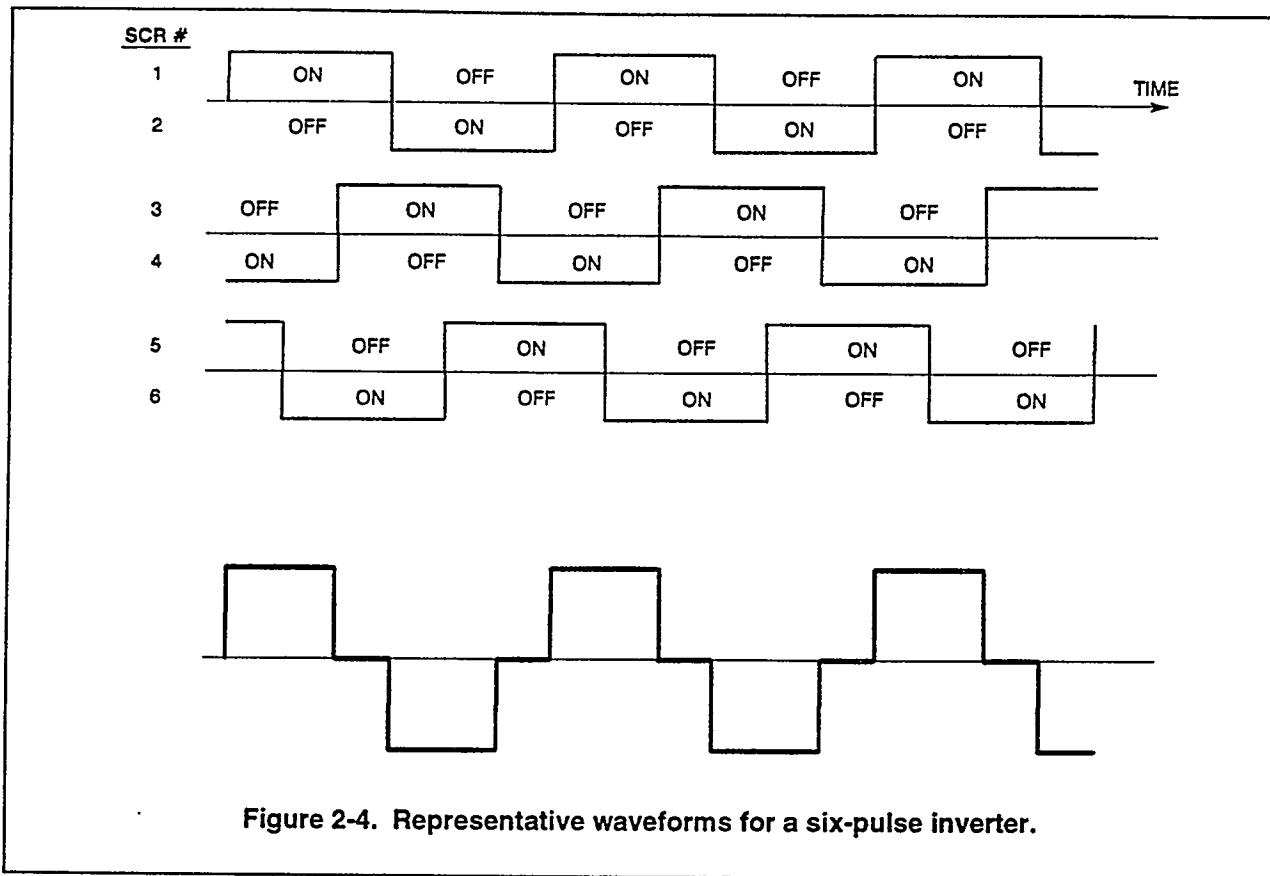
Figure 2-4 shows waveforms for a three-phase, line-commutated PCU. The upper three curves illustrate the gating and on/off states of the six SCRs as functions of time; the lower curve shows the resulting current for one phase. The SCR numbers refer to Figure 2-2. This configuration is known as a six-pulse

inverter (per the number of SCRs). Mathematically, the theoretical output waveshape is an odd function, i.e., $F(t) = -F(-t)$. As a result, there are no even-numbered harmonics. This holds true in practice, although mismatches and tolerances in PCU components or malfunctions may result in a very small amount of even harmonics. The three-phase configuration eliminates triplen harmonics (i.e., the third harmonic and all of its multiples), except perhaps when the load is unbalanced (i.e., when the currents are not equal in all three phases). The remaining harmonics are given by $n = pq \pm 1$, where n is the harmonic number, p is the number of pulses and q is 1, 2, 3, ..., etc. For the six-pulse configuration ($p = 6$), the lowest ($q = 1$) harmonics are the fifth and seventh ($5 = 6 \times 1 - 1$ and $7 = 6 \times 1 + 1$). The next lowest harmonics ($q = 2$) are the 11th and 13th. As can be seen, the ± 1 term in the expression for harmonic numbers means that harmonics appear in pairs. The magnitude of the harmonics is proportional to $1/n$. In practice, this is modified by filters.

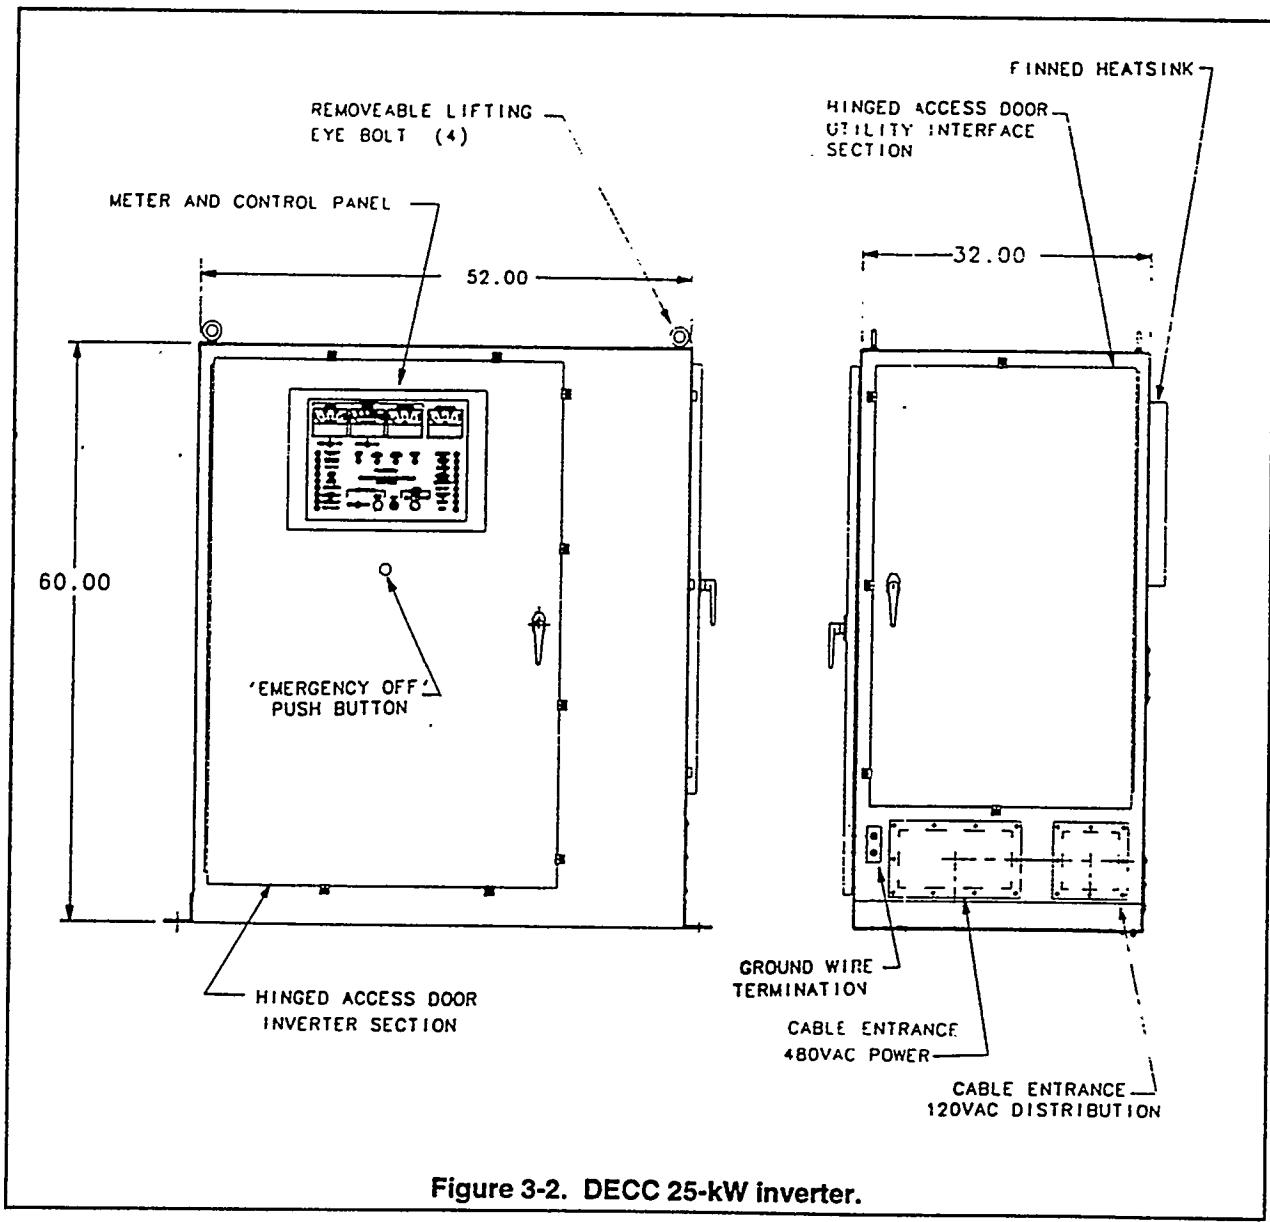
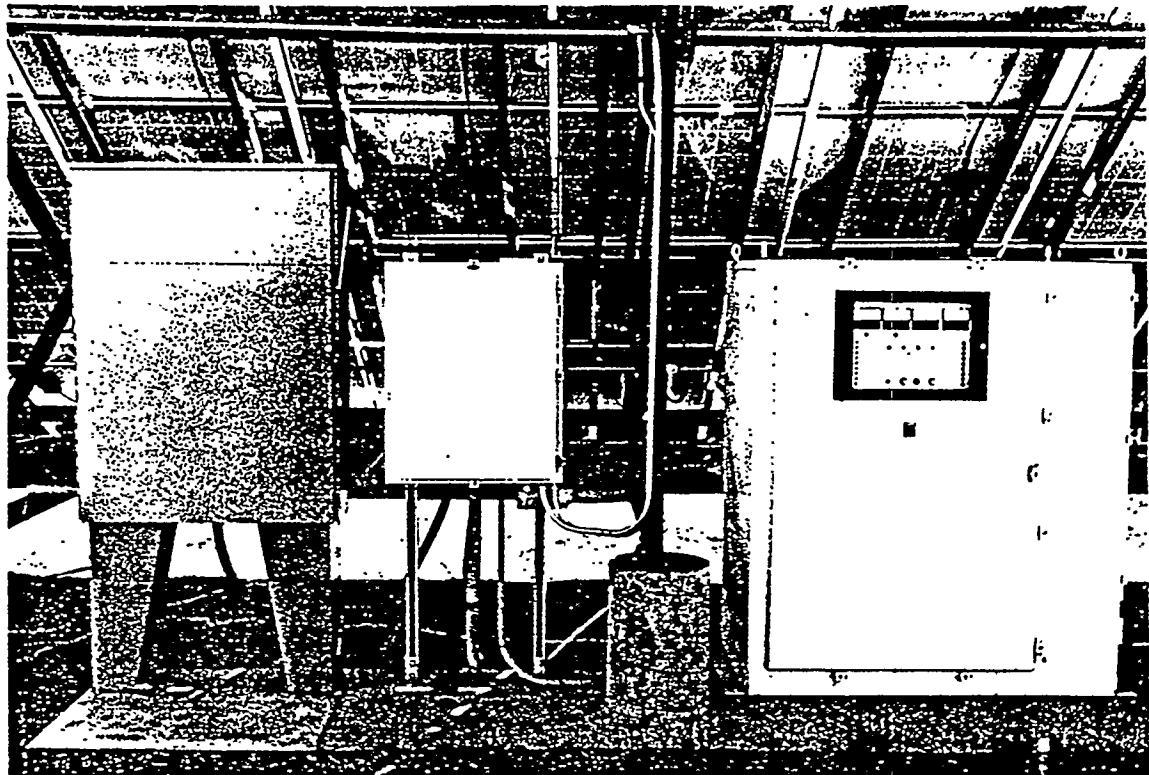
Figure 3-3. Exterior and interior of DECC PCU.

Figure 3-3 shows photographs of the exterior and interior of one of the DECC PCUs. The upper photograph illustrates placement of the PCU under a fixed-tilt array. It also shows a typical adjacent dc collection cabinet (far left) and data acquisition enclosure (center).

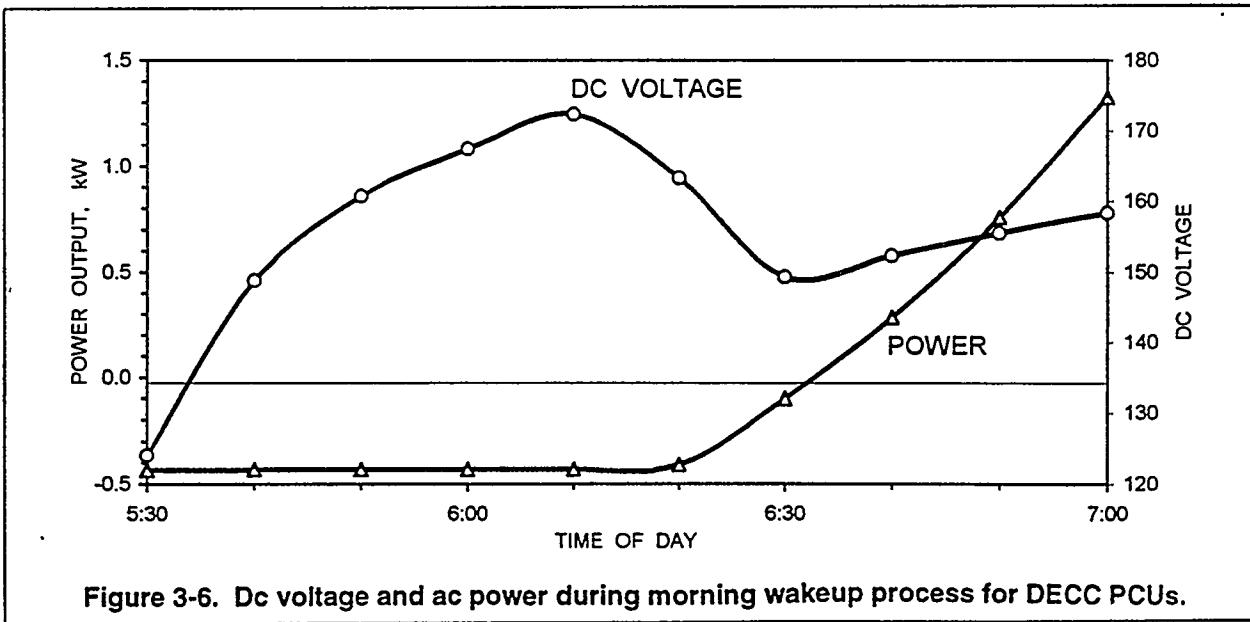
Figure 3-6. Dc voltage and ac power during morning wakeup process for DECC PCUs.

Figure 3-6 shows typical dc voltage and ac power profiles (10-minute averages) for a crystalline silicon array during the morning startup/wakeup process. The figure indicates a tare loss (ac power consumed by the PCU with zero dc input) of about 410 W. As the dc array voltage rises above the setpoint, the PCU starts operating. Experience with operation indicates that the startup voltage should be set close to the maximum power point voltage. After the start voltage has been reached, the dc contactor closes and the PCU draws array current to charge the input capacitors for approximately 10 seconds. The transistors are then gated on.

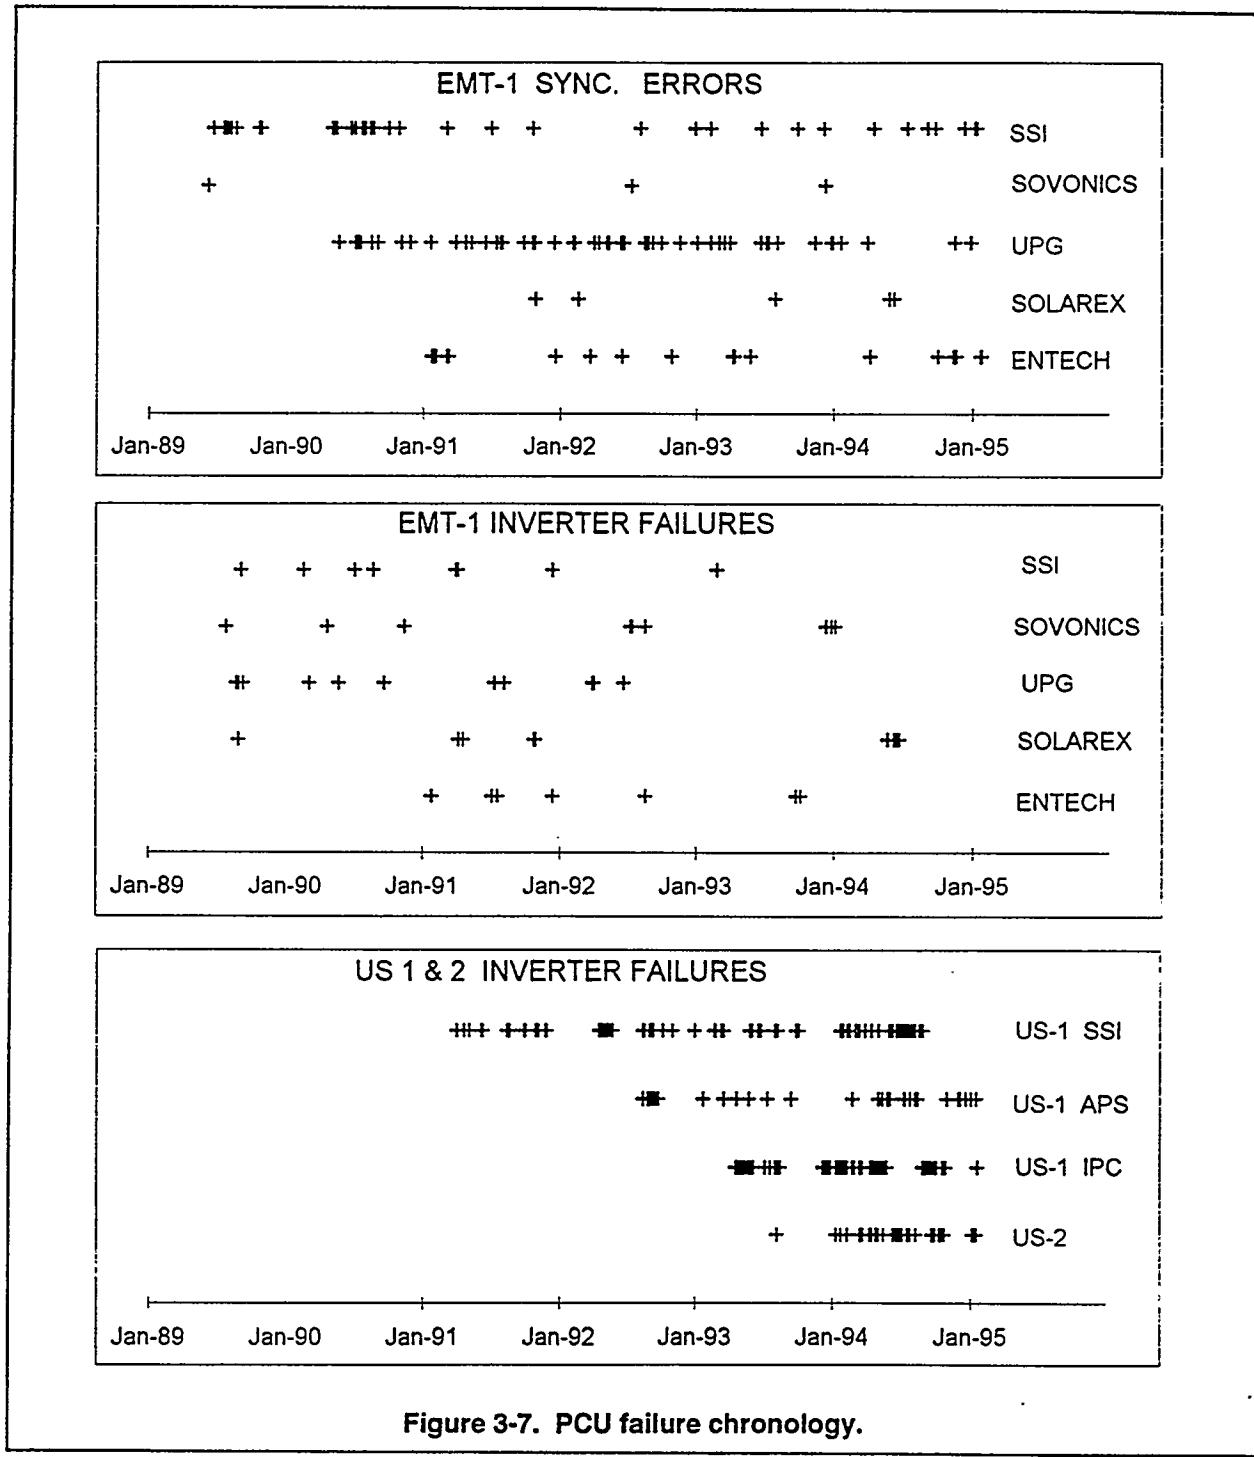
Figure 3-7. PCU failure chronology.

It was suspected that several of the PCUs had inaccurate power readings due to faulty sensors. These sensors are also used by the control circuits and were thought to be responsible for a series of intermittent failures to start properly, trip off line and/or not maximum power track. Corrective actions taken over a period of time included adding 100-pF capacitors across the ac power transducer terminals, adjusting the gain on the dc power transducer, and adjusting the inhibit and error cycle times.

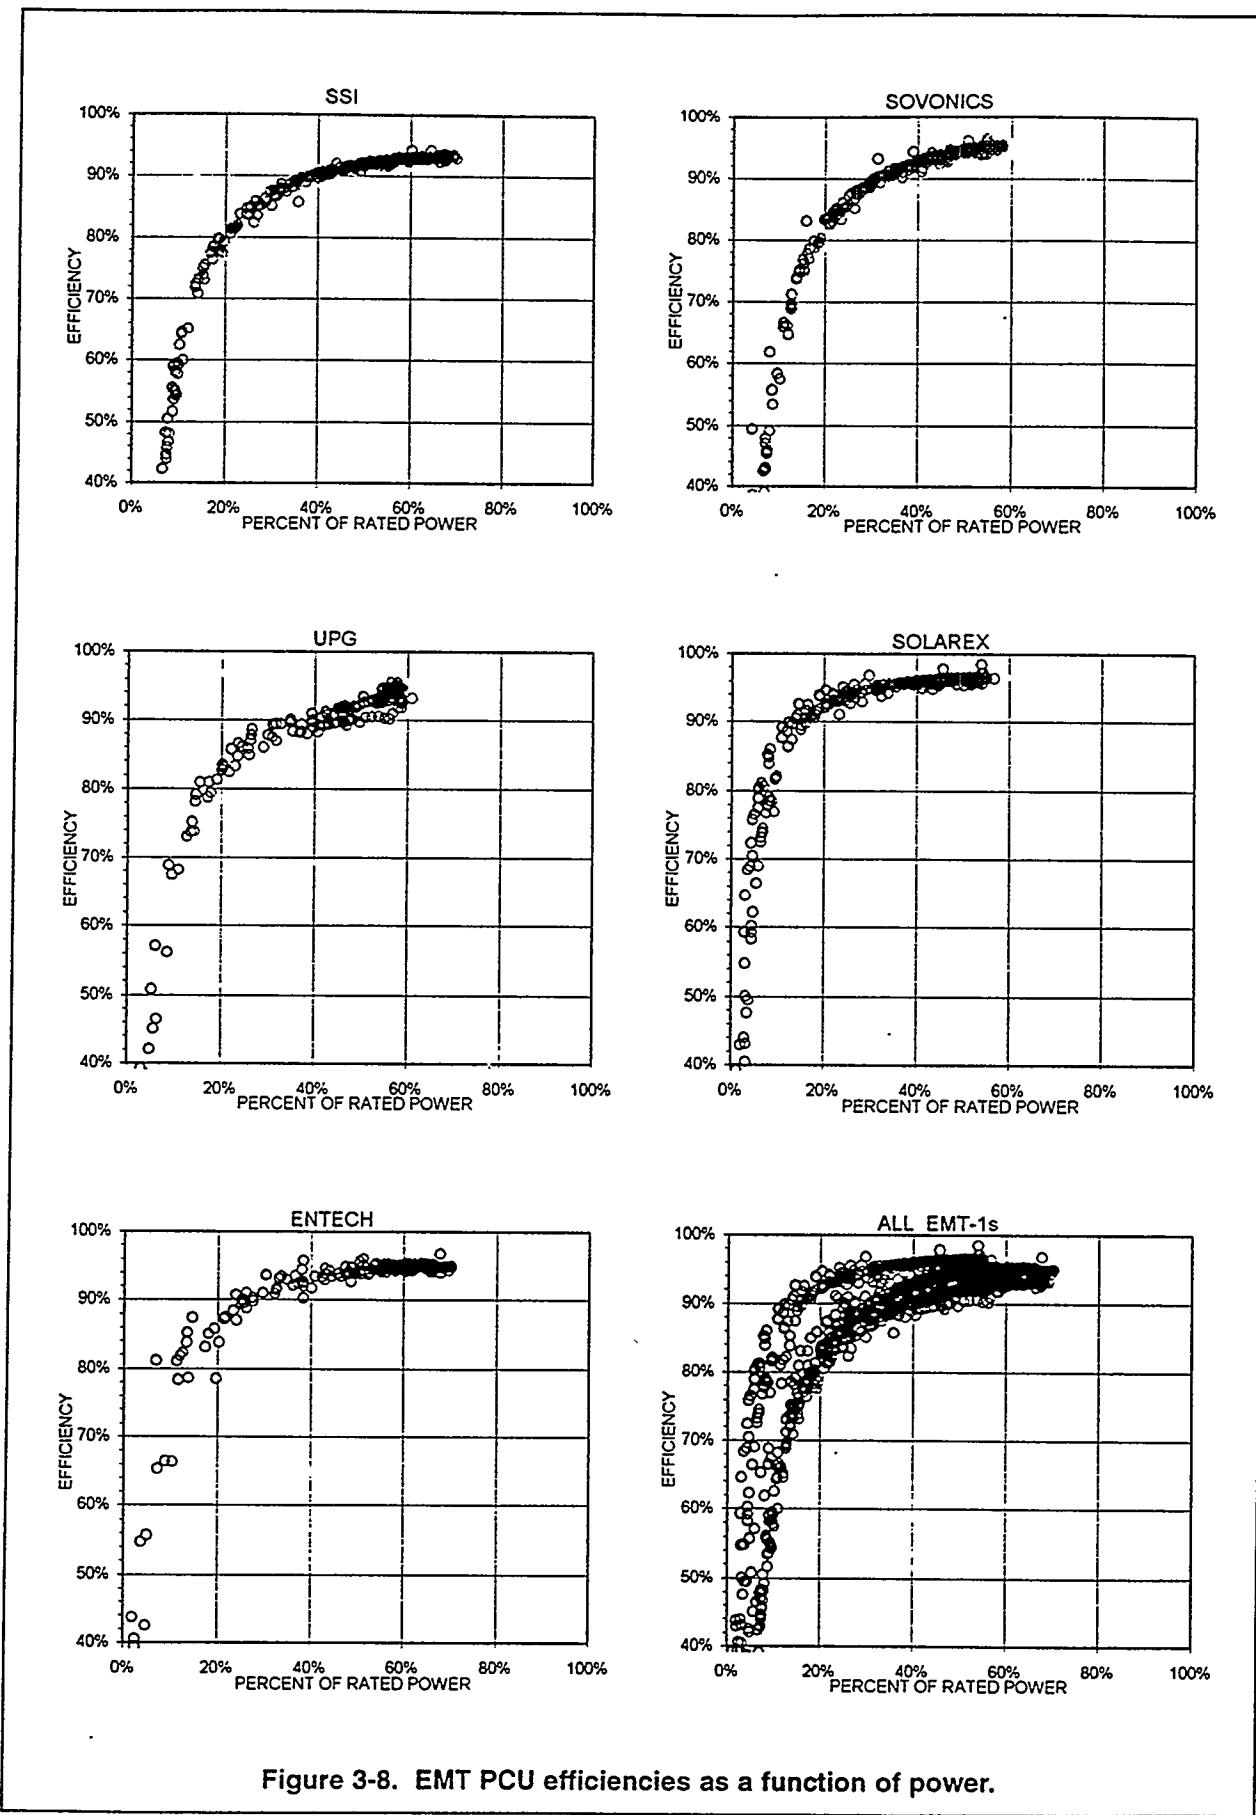
Figure 3-8. EMT PCU efficiencies as a function of power.

Figure 3-8 shows the PCU efficiency to be relatively constant in the region where the output is above 40 percent of rated power, as is typical for power conditioning equipment. Although not entirely evident from the graphs in Figure 3-8, the clustering of data points with the uniform measurement intervals indicates that (as expected) most of the energy is delivered with the array and PCU operating in this region.

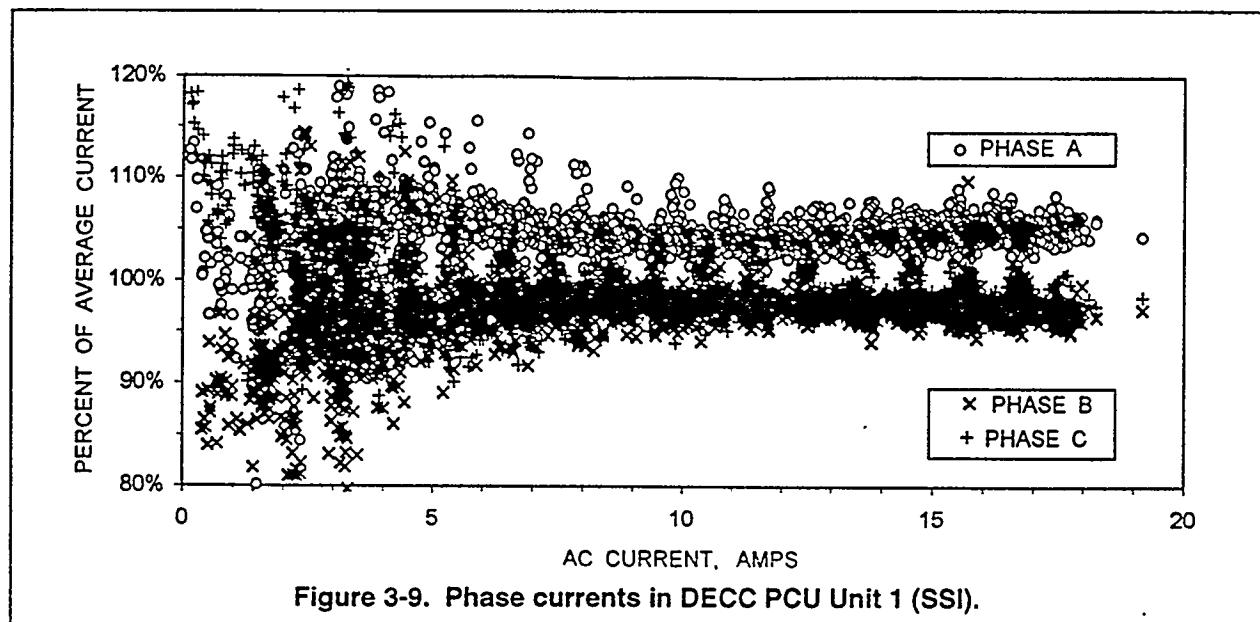
Figure 3-9. Phase currents in DECC PCU Unit 1 (SSI).

An unbalance in the 480-Vac output currents of Unit 1 (SSI) was noticed in February 1989. The exact cause was not determined, and no remedy was found. DECC believes the unbalance is due to mismatches among the line-tie inductors (series reactors) in the output circuit (see Figure 3-1). The manufacturer ensures that these reactors are within ± 5 percent of one another. Evaluation of data on phase currents indicates that these reactors may in fact not be within this tolerance. Figure 3-9 shows the currents in the three phases as percentages of the average current for Unit 1. Although there is considerable point scatter (particularly at lower current and power levels), the plot shows a definite trend for the currents in Phase A to be about 5 percent above the average. The currents in Phases B and C are approximately equal. It turns out that Unit 1 has the worst current unbalance of the first five EMT units, 5 percent on average.

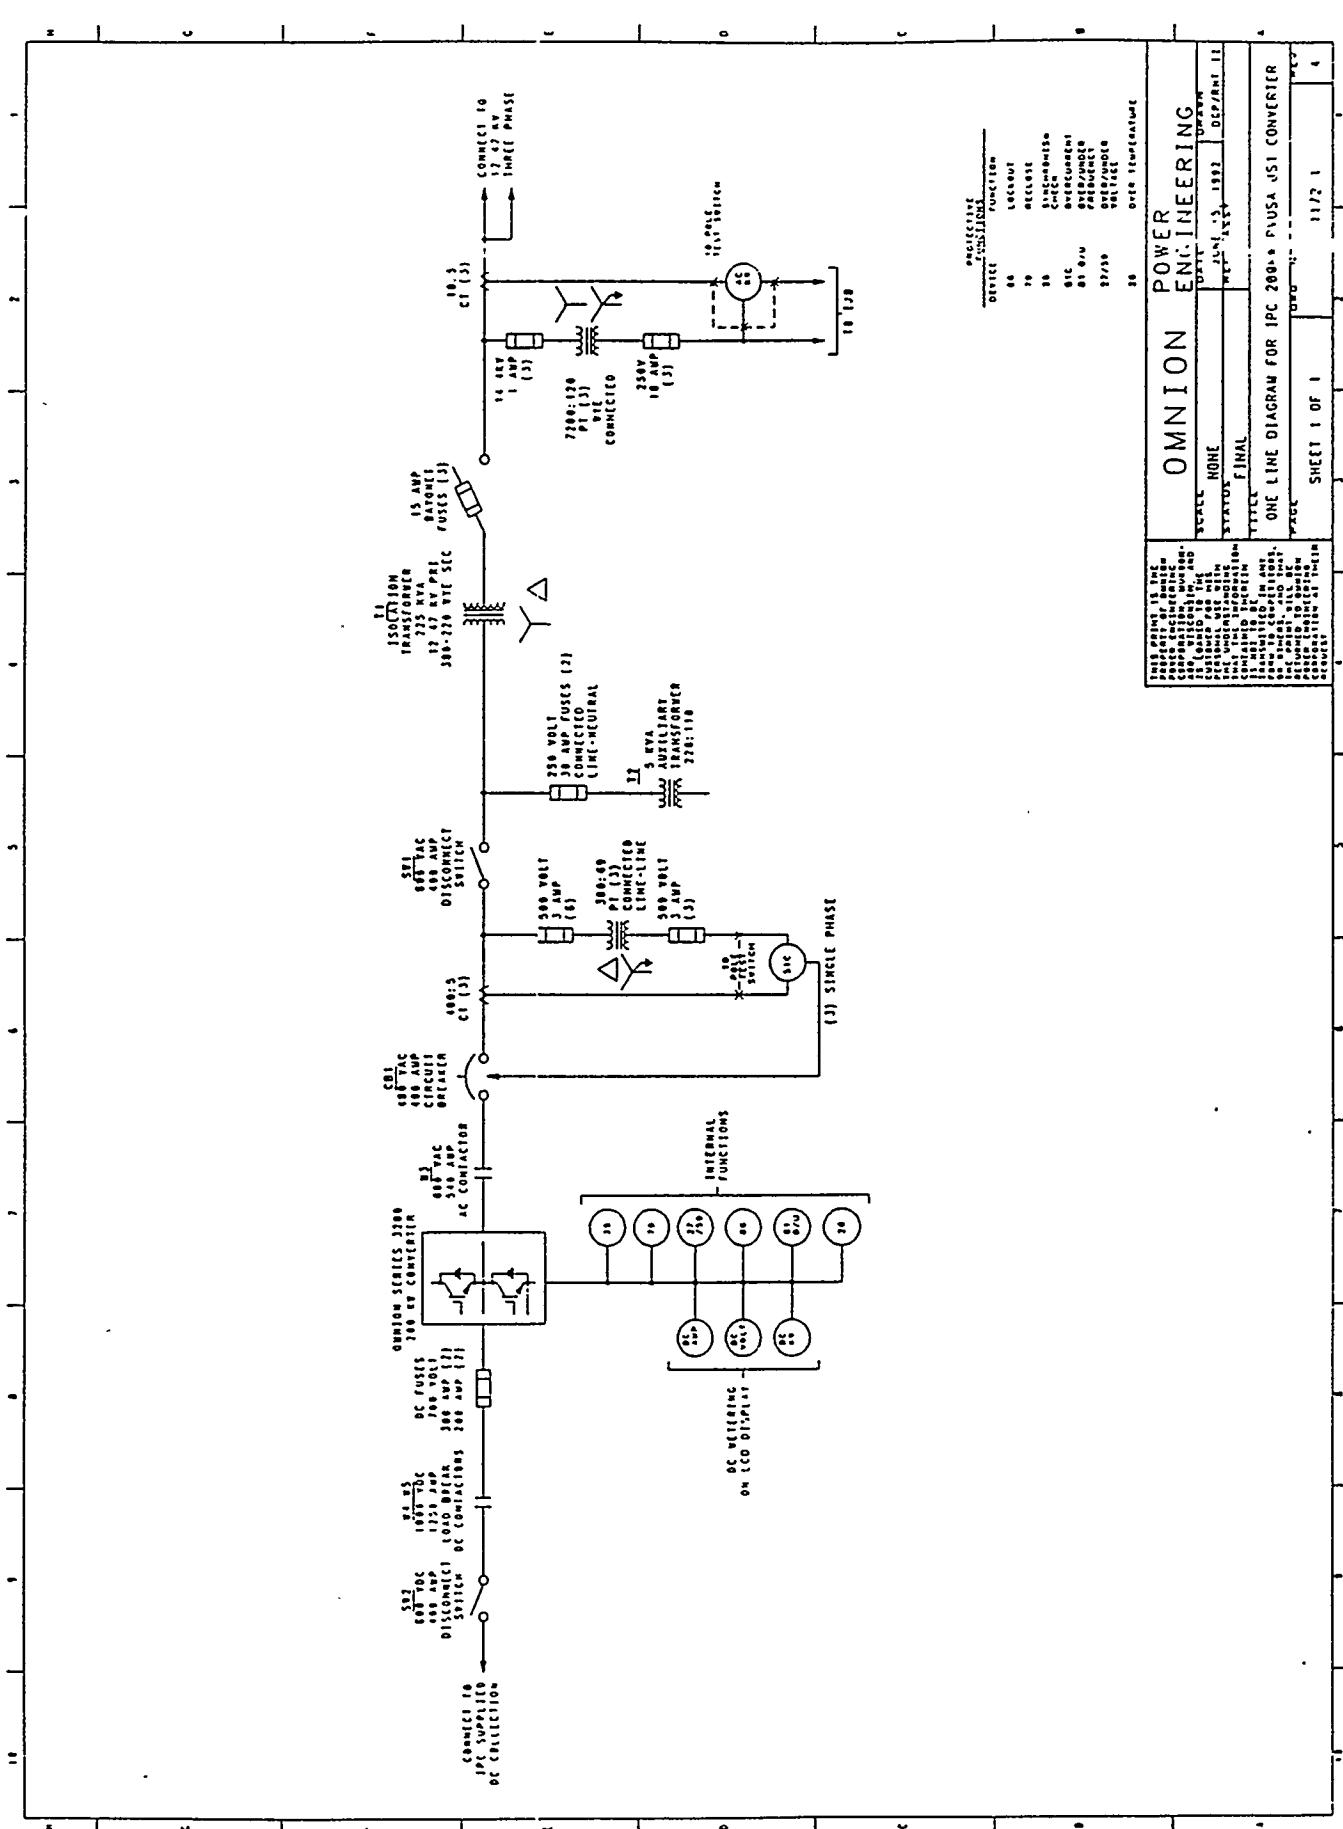
Figure 4-1. Single-line diagram of Omnitron/IPC US-1 PCU at Davis, California.

Features of the PCU include automatic wakeup (when the array voltage exceeds ± 413 Vdc for 1 minute, field-adjustable) and shutdown (when the power is less than 2 percent of rated power for 2 minutes, factory set). On/off cycling is prevented by the programmed times delays and by setting the startup voltage slightly below the open-circuit voltage at shutdown. The controls also include automatic restart after out-of-tolerance utility line conditions return to normal for 2 minutes (frequency ± 1 Hz, factory-set; voltage ± 10 percent, field-adjustable).

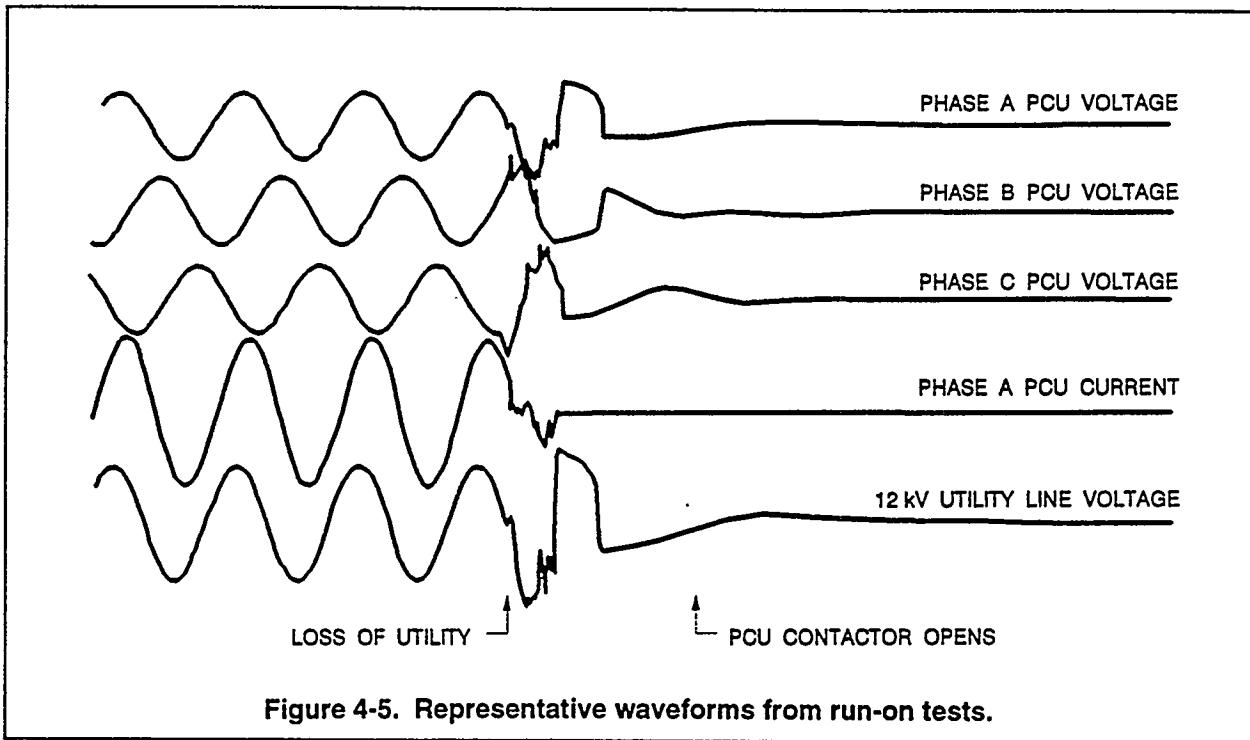
Figure 4-5. Representative waveforms from run-on tests.

Test results showed the IPC/Omnion PCU ac contactor opened in 0.025 to 0.110 second after the loss of utility voltage. This is better than the design value of 0.250 second. Figure 4-5 shows representative voltage and current waveforms from the first test (IPC at 78 kW ac and SSI disconnected).

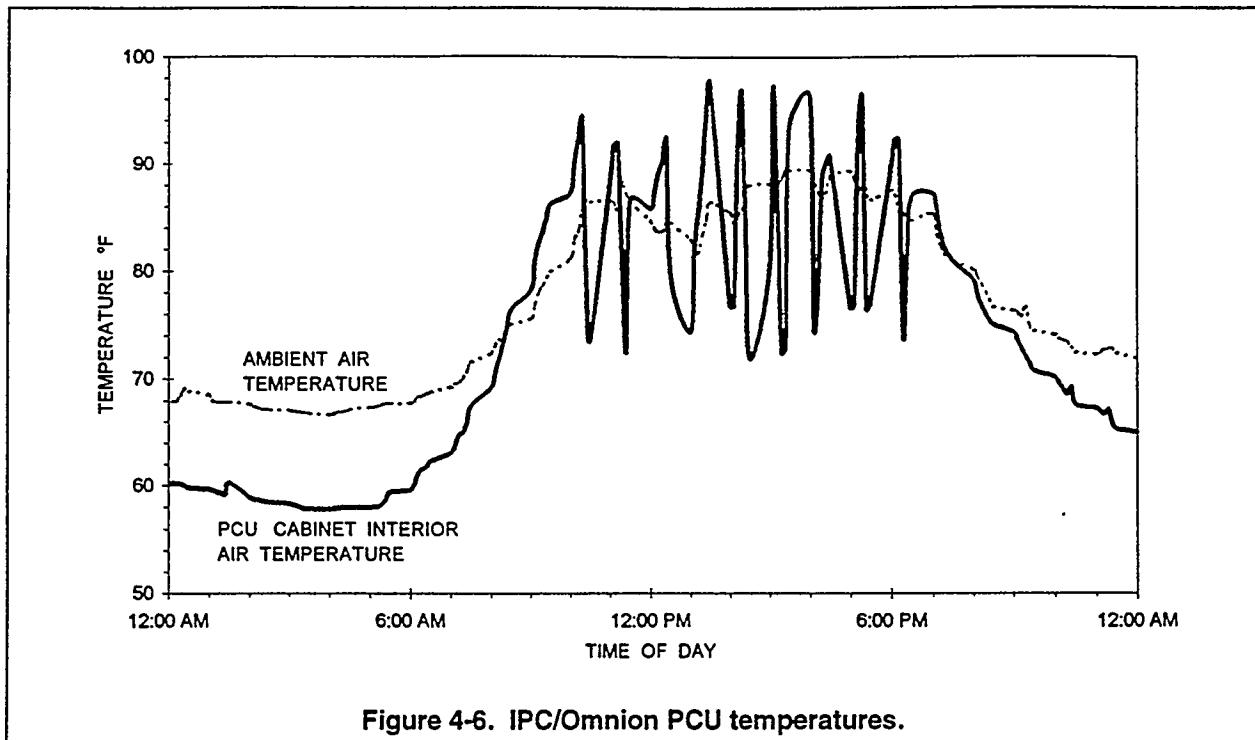
Figure 4-6. IPC/Omnion PCU temperatures.

Unfortunately, these changes had little effect on the failures. The master control board was returned to Omnion for evaluation at the factory. After repairs by Omnion and restart in early November 1993, there were seven occasions where the PCU did not come on line in the morning and displayed a dc overvoltage error message. In December 1993, a line disturbance resulted in several fuses clearing and failed IGBTs. After repair, the PCU continued to experience dc overvoltage trips.

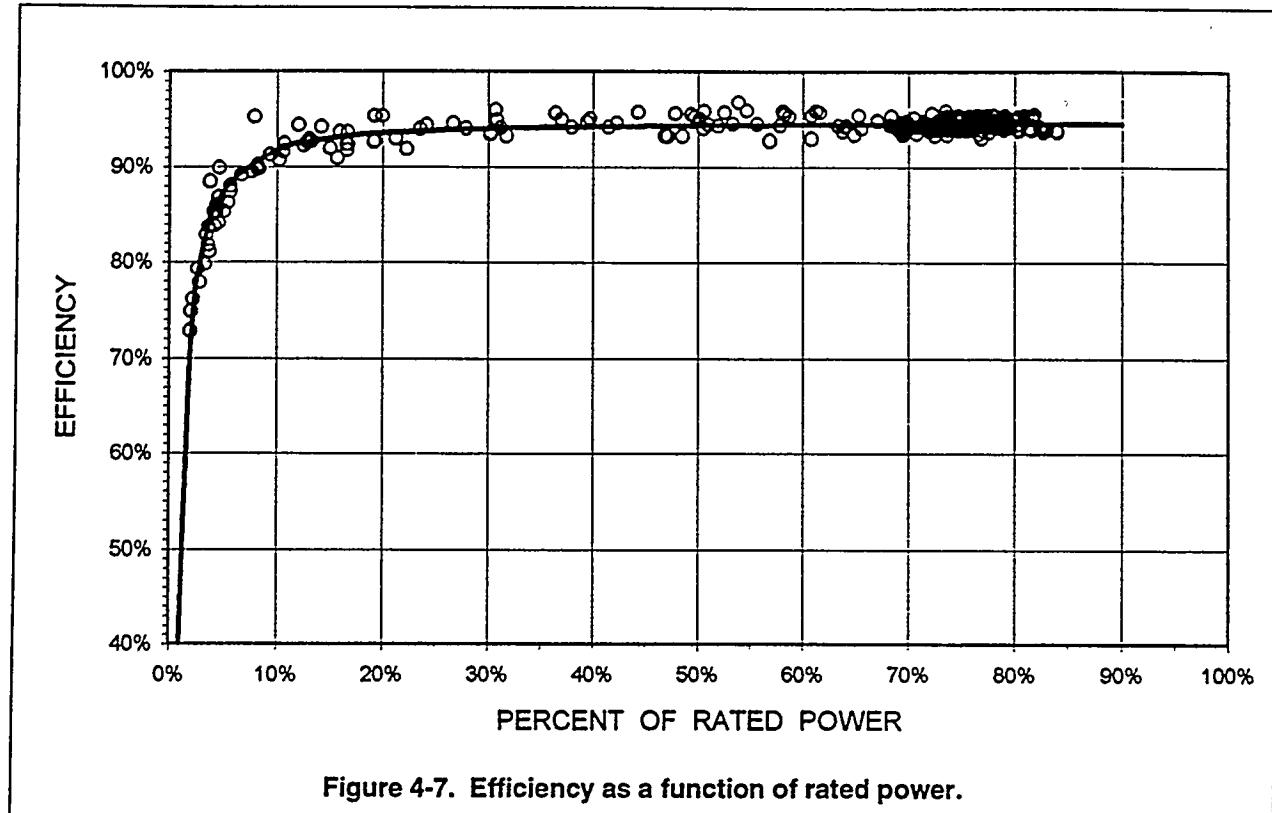
Figure 4-7. Efficiency as a function of rated power.

Figure 4-7 shows the efficiency of the PCU as a function of power. The rated power is that of the PCU, 200 kW ac. The ac output is measured at the 12.47-kV side of the isolation transformer. Several hundred

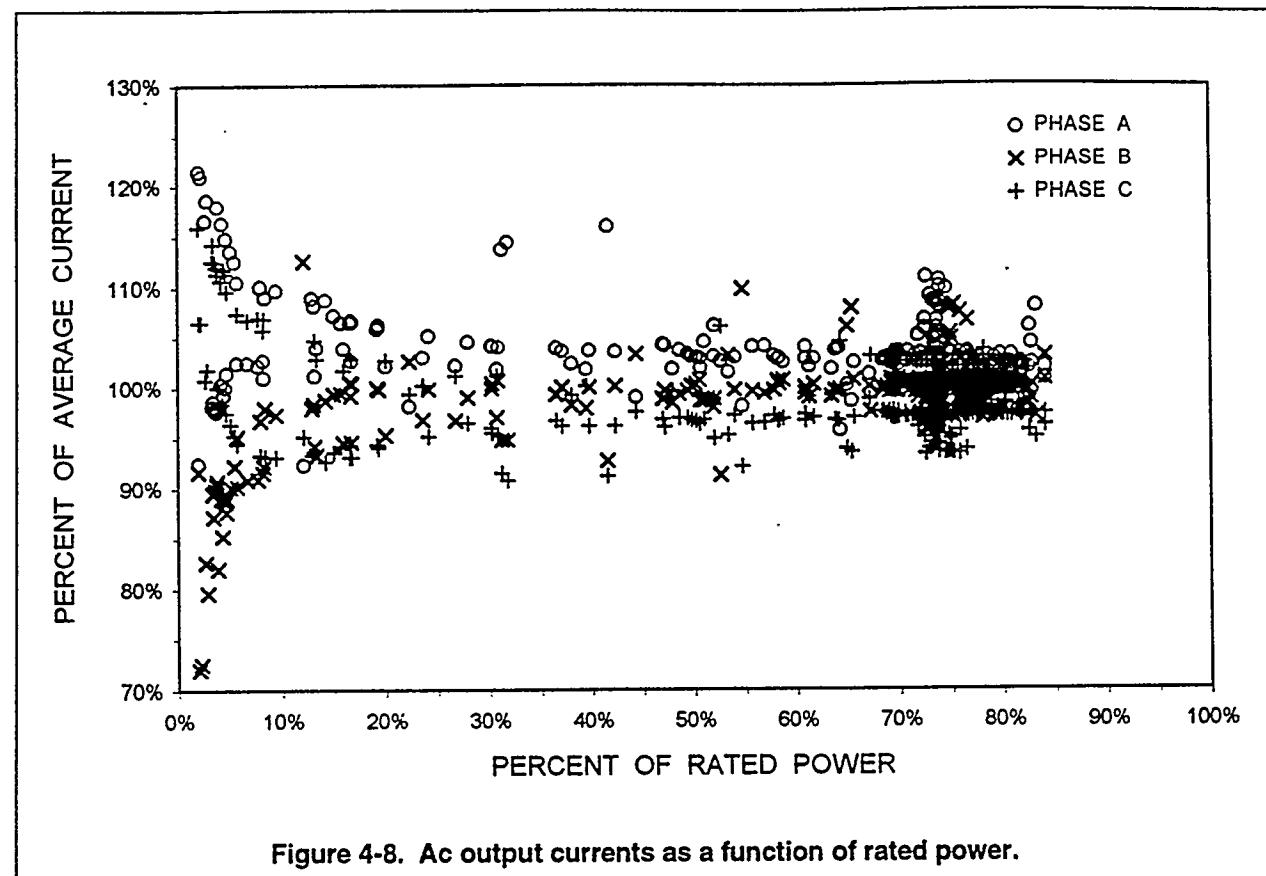
Figure 4-8. Ac output currents as a function of rated power.

Figure 4-8 shows the ac output currents as functions of power level. The phase currents exhibit a slight unbalance with respect to their average. Averaged over the 5-day data set in the region above 30 percent of rated power, Phase A is +2.9 percent, Phase B is +0.05 percent, and Phase C is -2.95 percent. The average unbalance is 2 percent.
