**PVUSA EXPERIENCE WITH POWER CONVERSION FOR
GRID-CONNECTED PHOTOVOLTAIC SYSTEMS**

Walt Stolte, Bechtel Corporation
and PVUSA Project Team

Pacific Gas and Electric Company
Research and Development
San Ramon, CA 94583

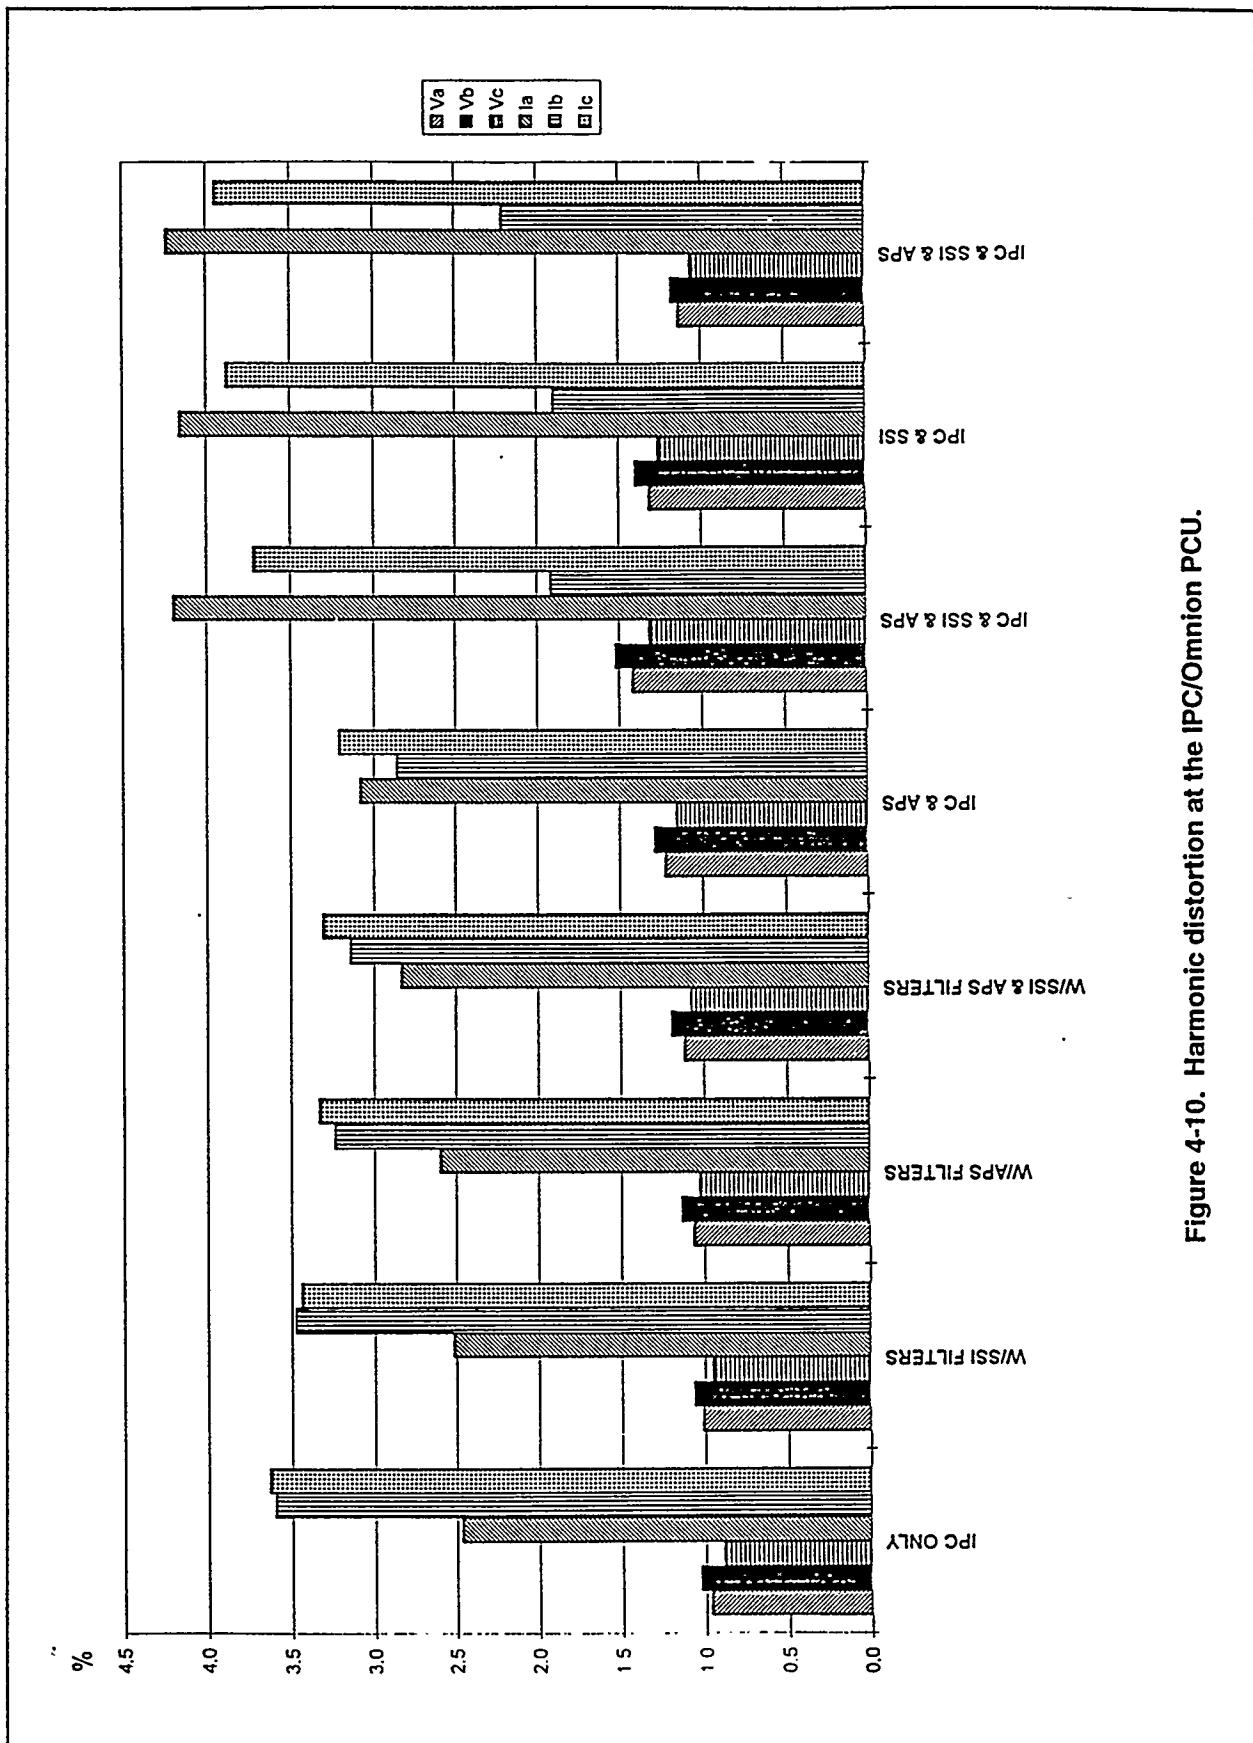
Figure 4-10. Harmonic distortion at the IPC/Omnion PCU.

Further harmonic distortion measurements were made in November 1994. These measurements involved testing with several configurations and measurement points (12.47 kV and 480 V) at the IPC, SSI, and APS PCUs. Details are presented in a separate report [4-3]. Figure 4-10 summarizes the percentage voltage and current harmonic distortions at the 12.47-kV side of the IPC/Omnion PCU with the

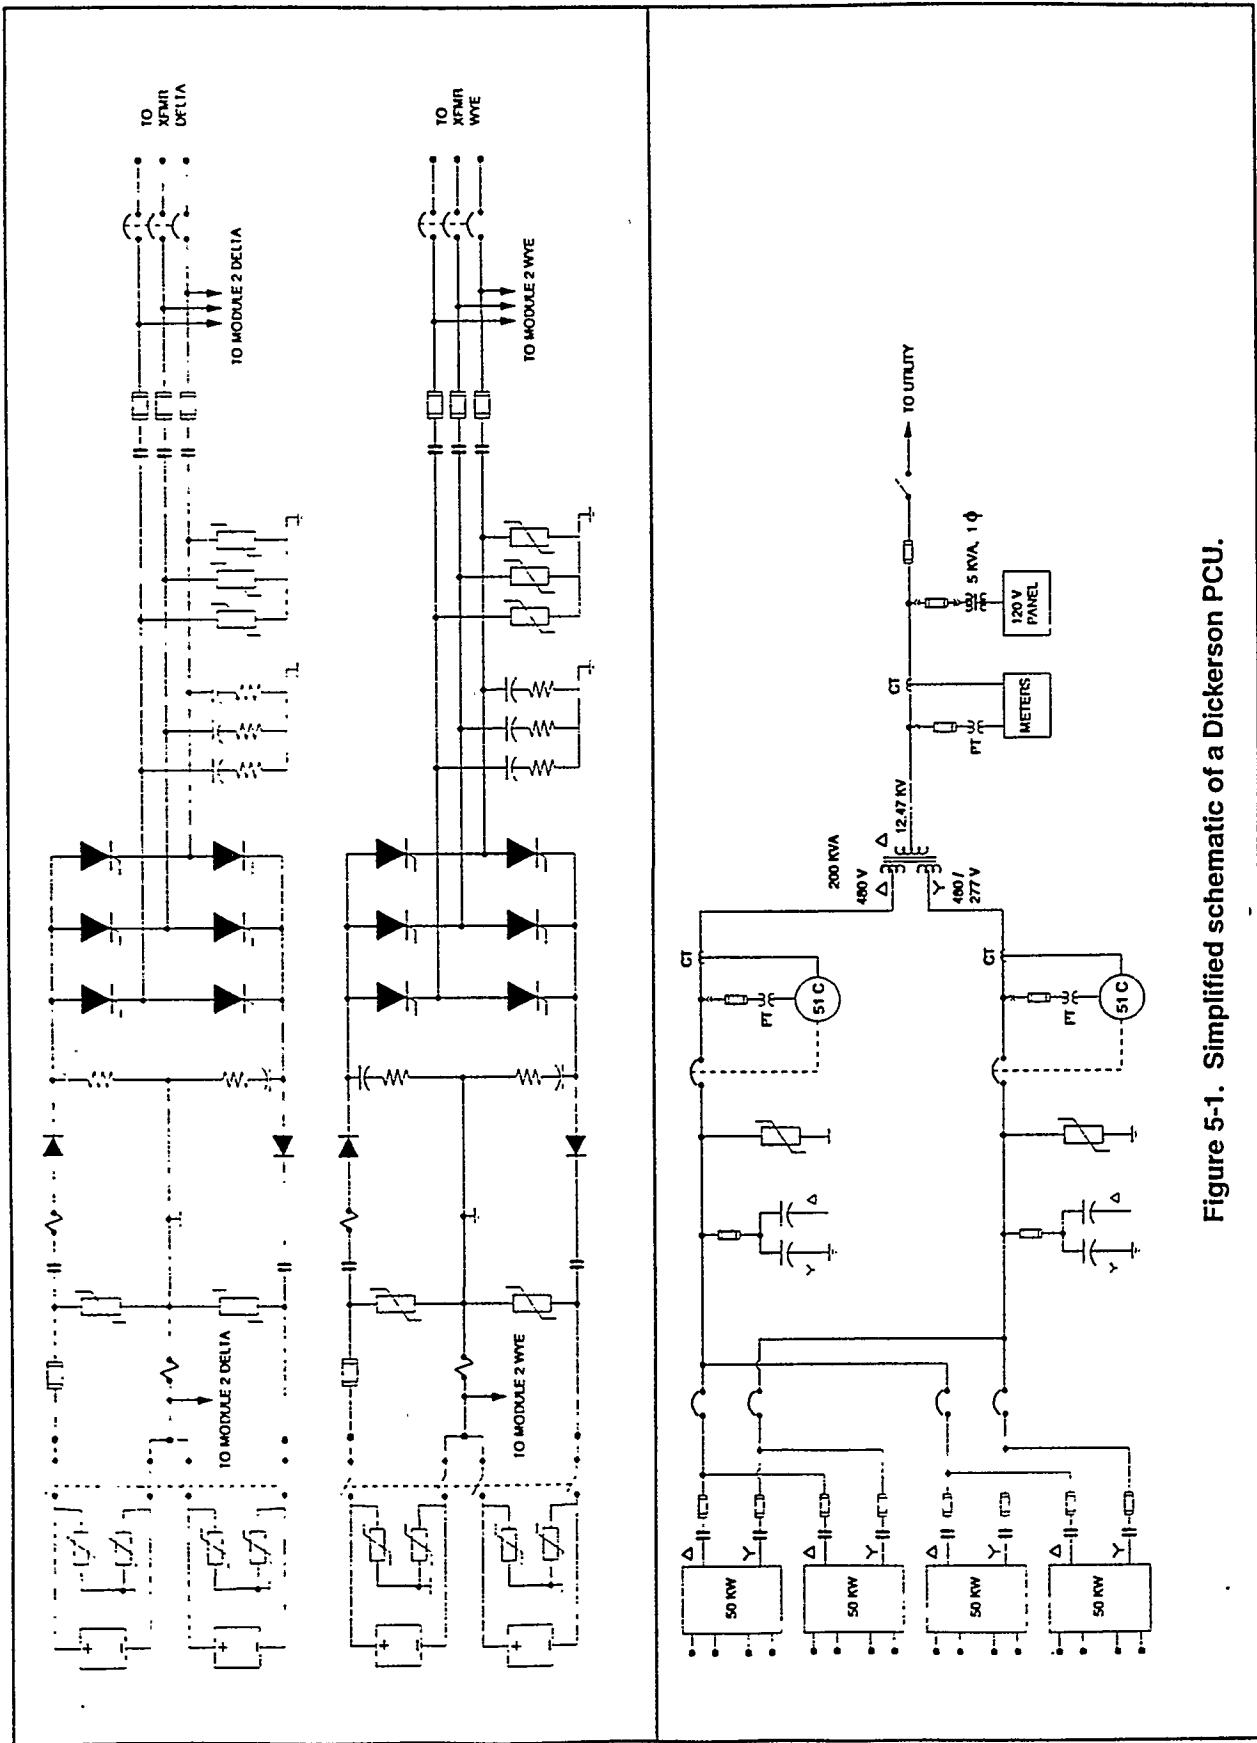
Figure 5-1. Simplified schematic of a Dickerson PCU.

The two Dickerson Model 3B 100-kW inverters are designated "Inverter A" and "Inverter B." Each of these inverters consists of two 50-kW inverter "cores." In turn, each of these core inverters consists of two 25-kW, 6-pulse SCR inverter bridges, which are phase-controlled and combined to yield a 12-pulse output. The electrical configuration of these two-bridge core inverters is shown in the schematic in the upper half of Figure 5-1. One of the 480-Vac outputs is connected to a delta winding on the low-voltage side of a 200-kVA output transformer. The other output is connected to a wye winding on the transformer. The delta and wye outputs of one 100-kW inverter are connected in parallel with the corresponding delta and wye outputs of the second 100-kW inverter. These connections and the configuration of the two 100-kW inverters are shown in the schematic in the lower half of Figure 5-1.

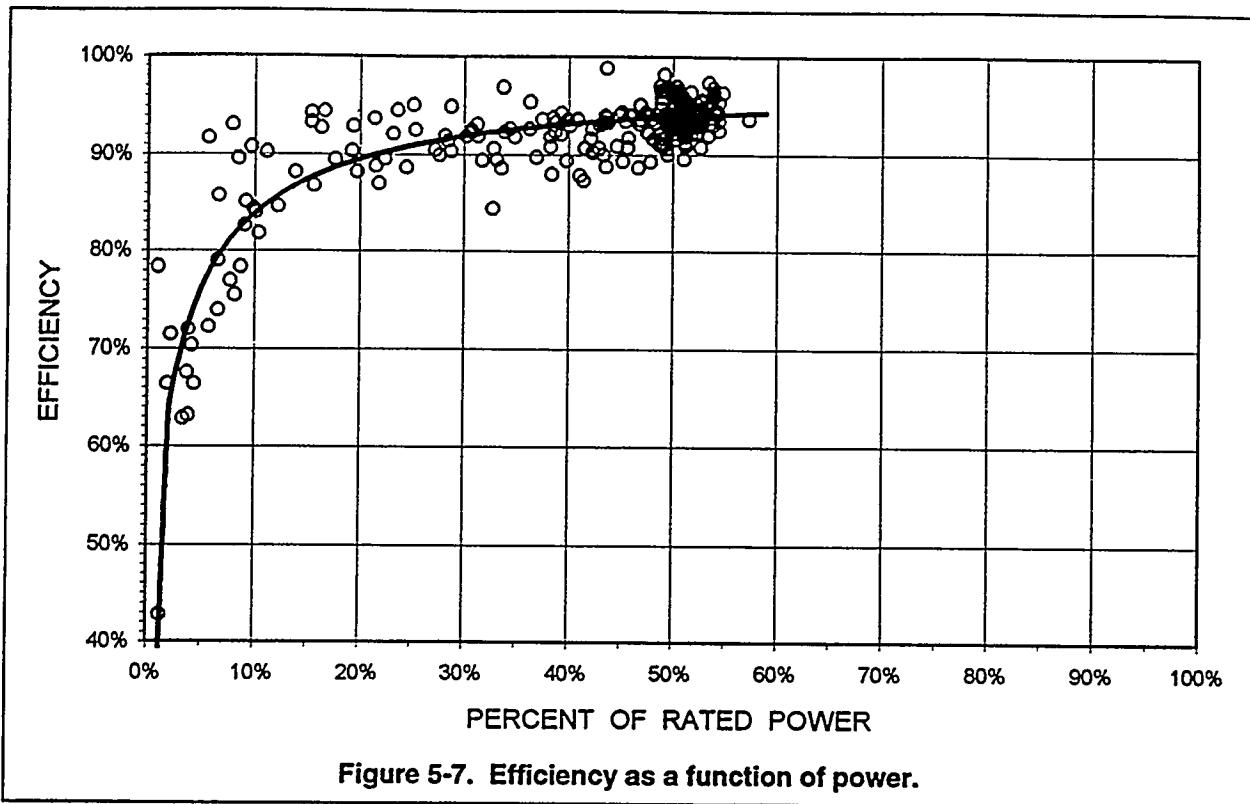
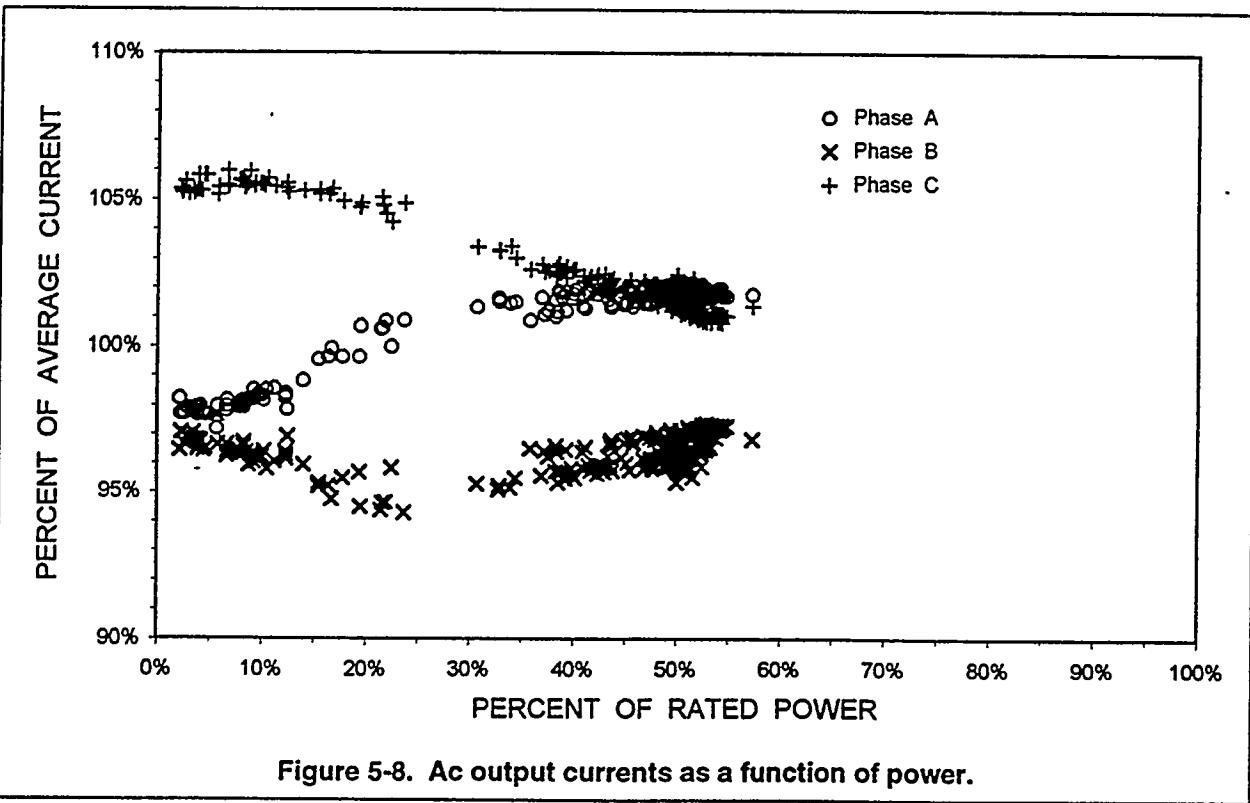
Figure 5-8 shows the ac output currents of Inverter B as a function of power level. The phase currents exhibit an unbalance with respect to their average. Averaged over the 5-day data set, Phase A is +1.8 percent, Phase B is -3.5 percent, and Phase C is +1.6 percent for power levels greater than 40 percent of rated power. The average unbalance in this region is 2.3 percent.

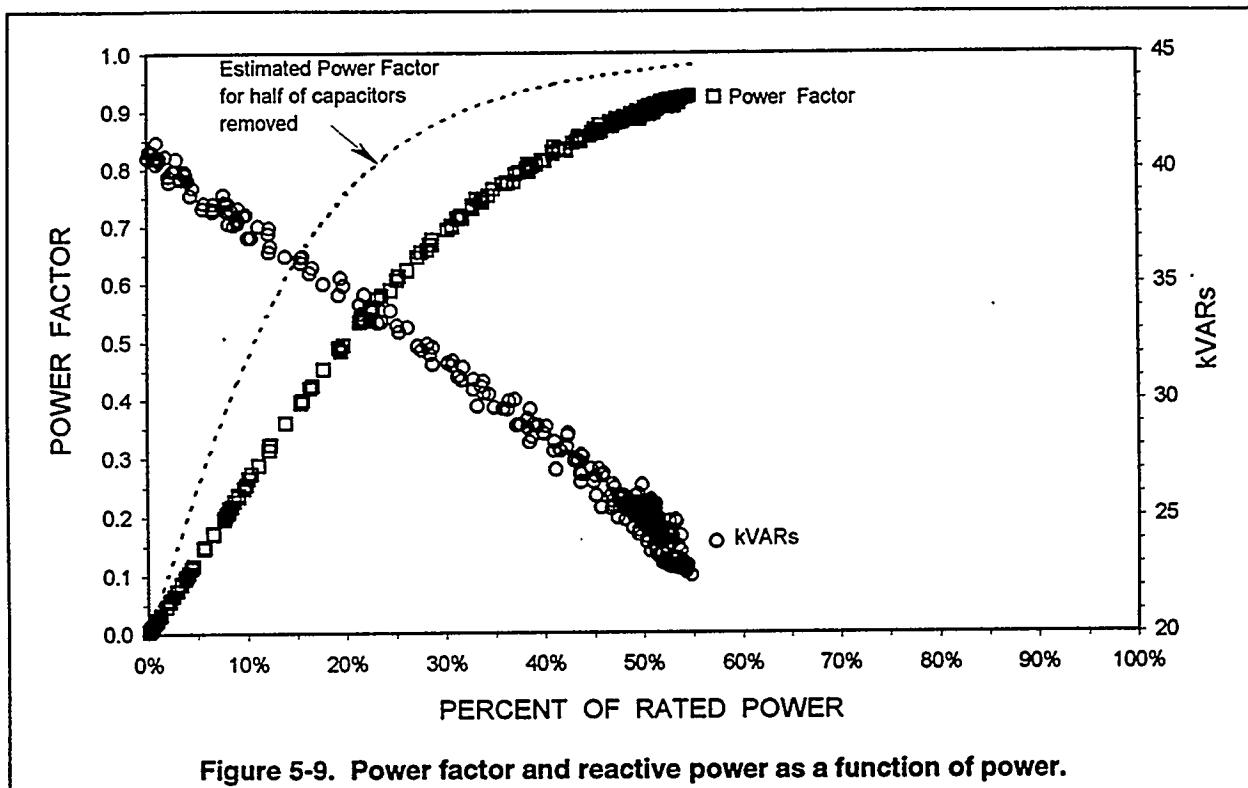
Figure 5-9. Power factor and reactive power as a function of power.

Figure 5-9 shows the power factor and reactive power as functions of output power level for the 5-day data set. As power levels decrease, the power factor becomes quite low.

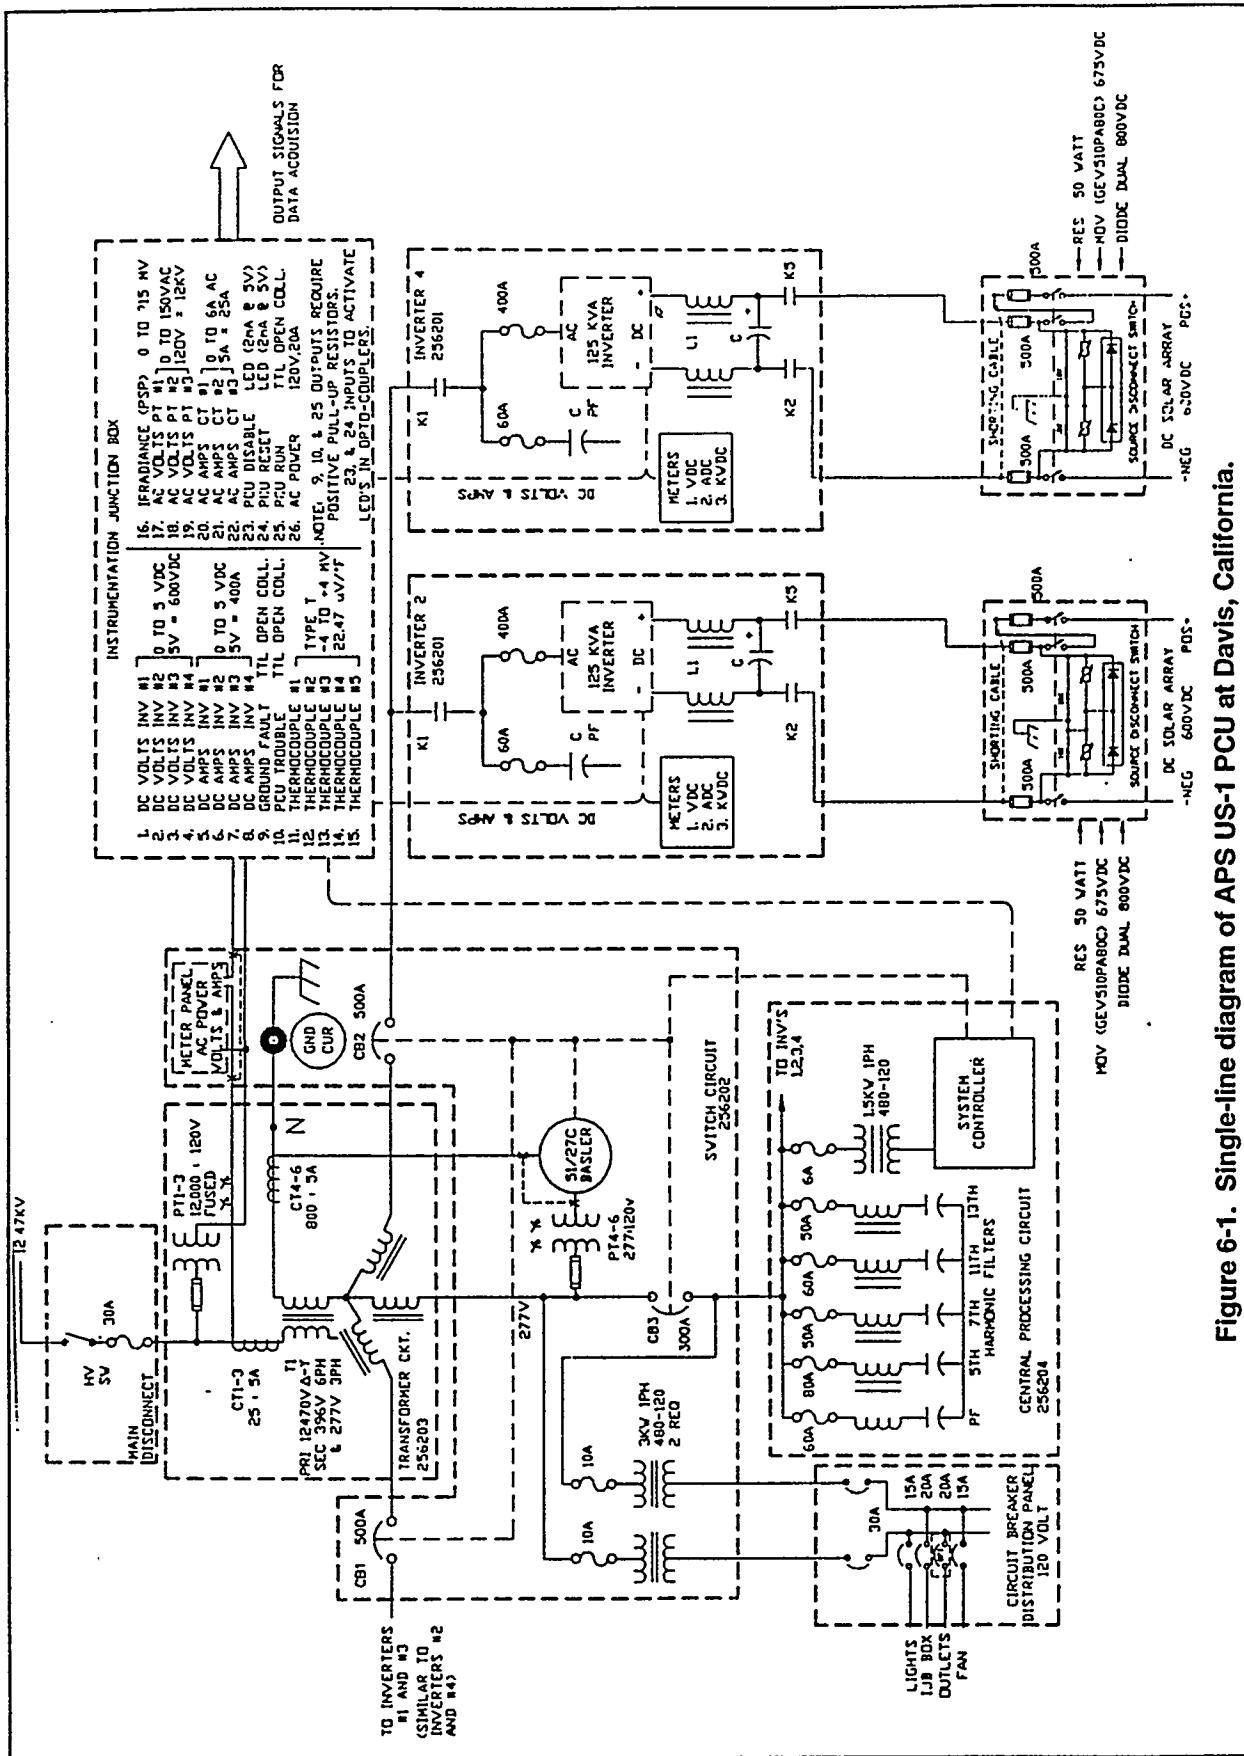
Figure 6-1. Single-line diagram of APS US-1 PCU at Davis, California.

Amorphous silicon modules mounted on five rows of south-facing, fixed-tilt arrays supply the dc input to the PCU. The rows are split by a north-south central roadway. Wiring from the arrays proceeds via underground conduit to a dc interconnection box mounted on the PCU enclosure. The wiring is connected to form four separate dc input circuits, each of which is made up of 240 parallel PV source circuits, nominally 350 Vdc pole to pole. A diode and parallel 10-k Ω resistor are connected from each

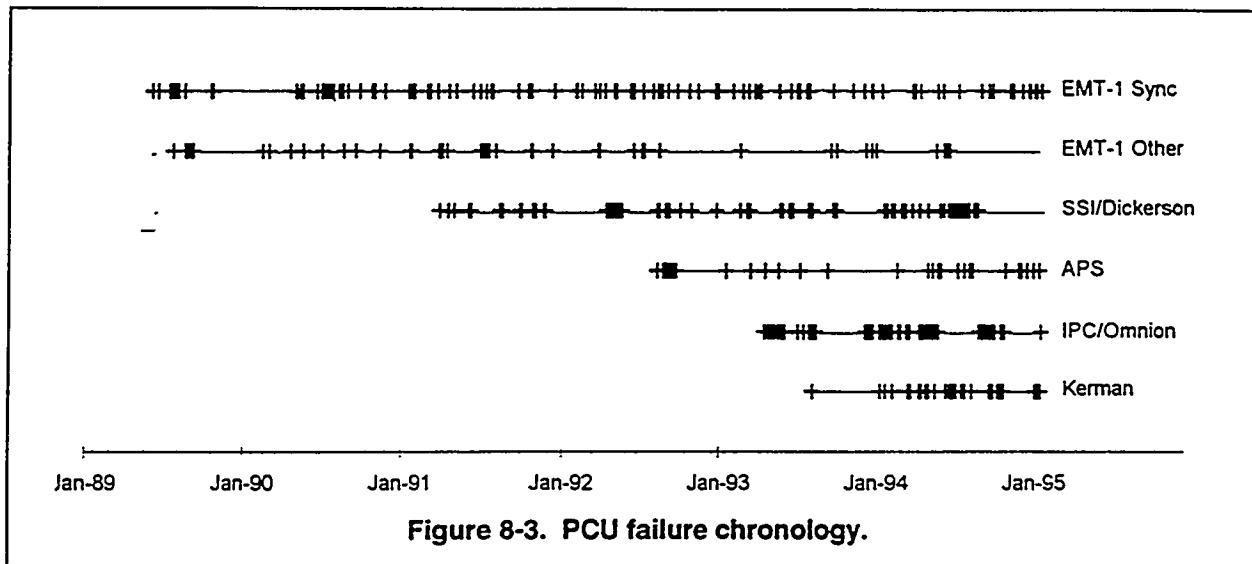
DECC. The Figure 8-3 data for EMT-1 are for five DECC units, brought on line when the EMT-1 PV systems were installed. These are presented in two categories: synchronization errors and other inverter failures. "Sync." errors have persisted and relate to the PCU morning wakeup process. This problem is largely ameliorated with biannual adjustment of the starting voltage to accommodate seasonal variations in array voltages. Other inverter failures included trips, failure to start, and failure to power track accurately. Corrective actions over time included adding capacitors across ac power transducer terminals, adjusting transducer gains, and adjusting delay times. Additionally, inverter failures were caused by loose or broken connections and faulty resistors. Also, the printed circuit (PC) boards were not identical for the several PCUs, which limited interchangeability and impeded maintenance.
