State-of-the-Art Severe Accident Analysis – Evolution of Reactor Safety after Fukushima Daiichi

In-Core Damage Progression – Signatures from Unit 2

Revised Conception of In-Core Accident Progression Scenario

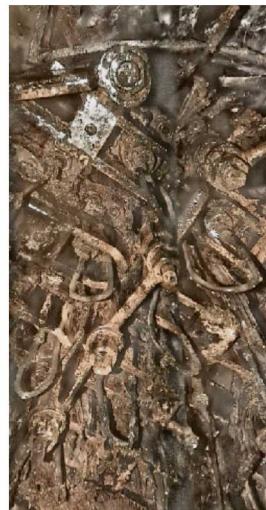
Molten Debris Attack of Lower Head Wall – Unit 2

Localized failure at upper portion of lower head

- Draining peripheral metallic core material
- Potential for localized Fe-Zr interactions

Remainder of lower head wall largely undamaged

CRDs largely undisturbed at Unit 2

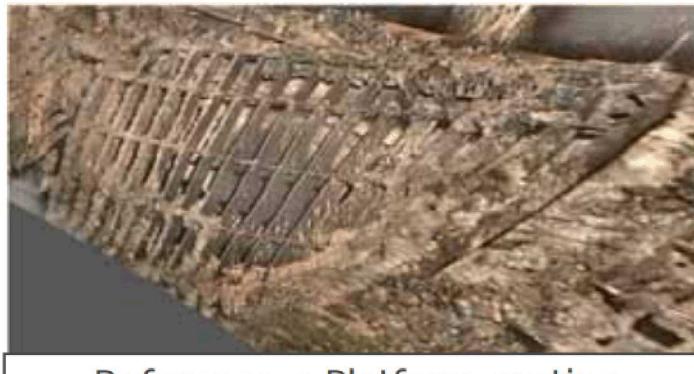
Platform grating attacked at periphery of vessel

- Draining metallic melt locally attacked grating
