Sandia National Laboratories Improving the Laser-Induced Damage Thresholds of Beam Splitter Coatings for High Transmission (527 nm) and High Reflection (1054 nm)

By: Ella Field and Damon Kletecka
2019 International Laser Operations Workshop

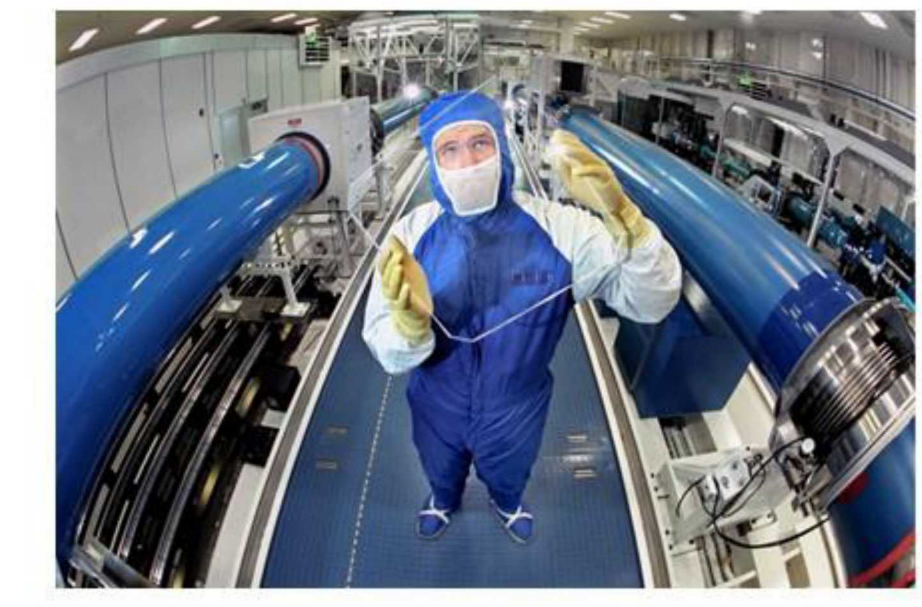
1 Sandia's Large Optics Coating Team

Provides high laser damage resistant optical coatings for large optics in support of Z-Backlighter terawatt/petawatt laser operations

Production: 50 – 100 anti-reflection (AR) coated debris shields & vacuum windows needed by backlighting operations per year, plus high reflection (HR) and polarizer coatings

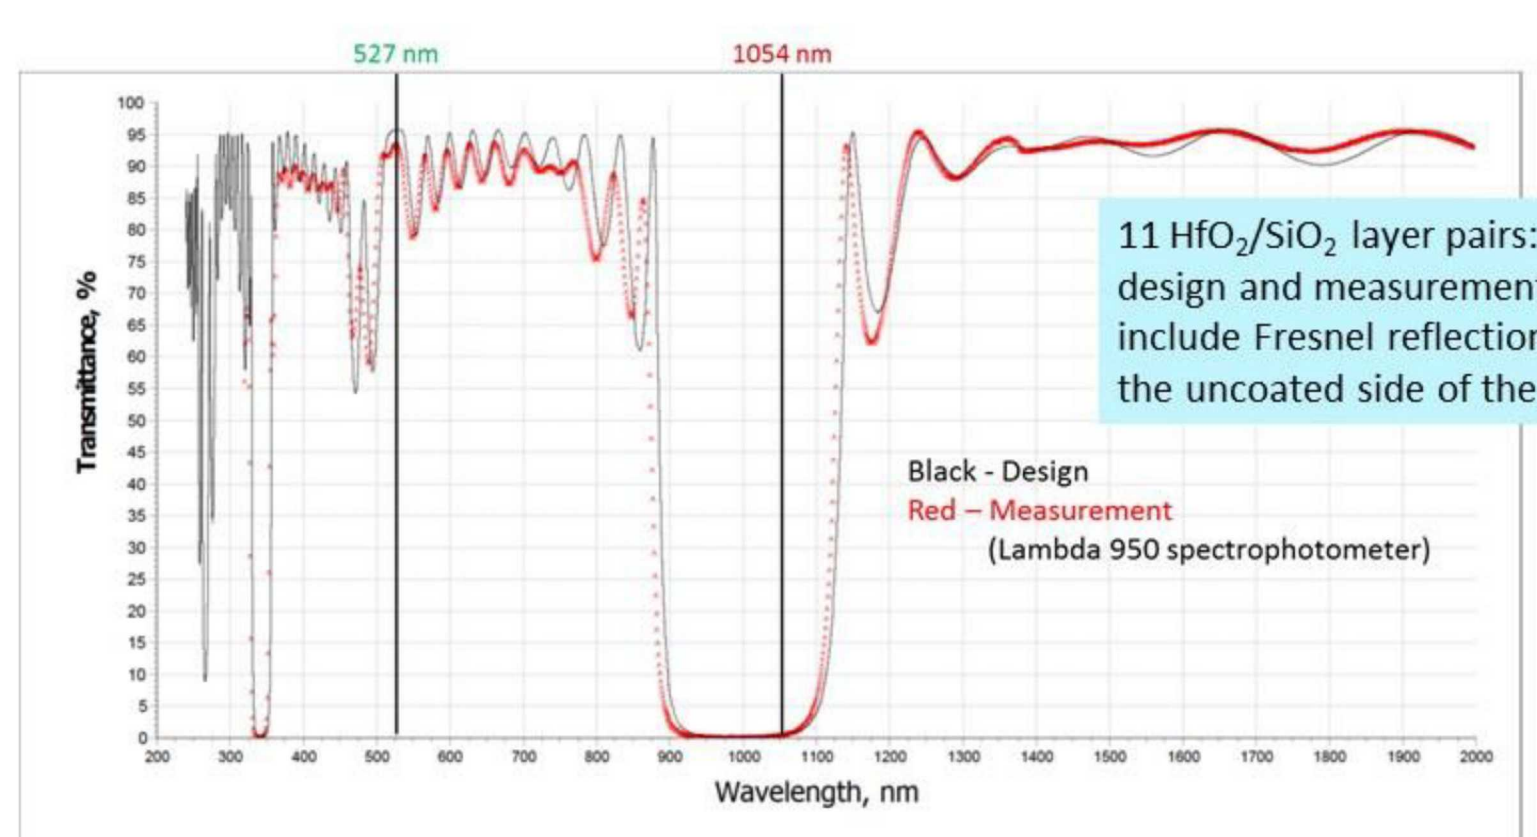
11 HfO₂/SiO₂ layer pairs → LIDT: 7 J/cm² (532 nm, 22.5° Spol, 3.5 ns NIF-MEL protocol). 7 J/cm² LIDT was attributed to the E-field intensity peaks in the outer two HfO₂ layers. Therefore, the outer two hafnia layers were replaced with a higher bandgap material Al₂O₃. The coating with Al₂O₃ layers did not show notable improvement (LIDT 7 – 10 J/cm²). [1]

11 HfO₂/SiO₂ layer pairs: Both design and measurement data include Fresnel reflection losses at the uncoated side of the optic

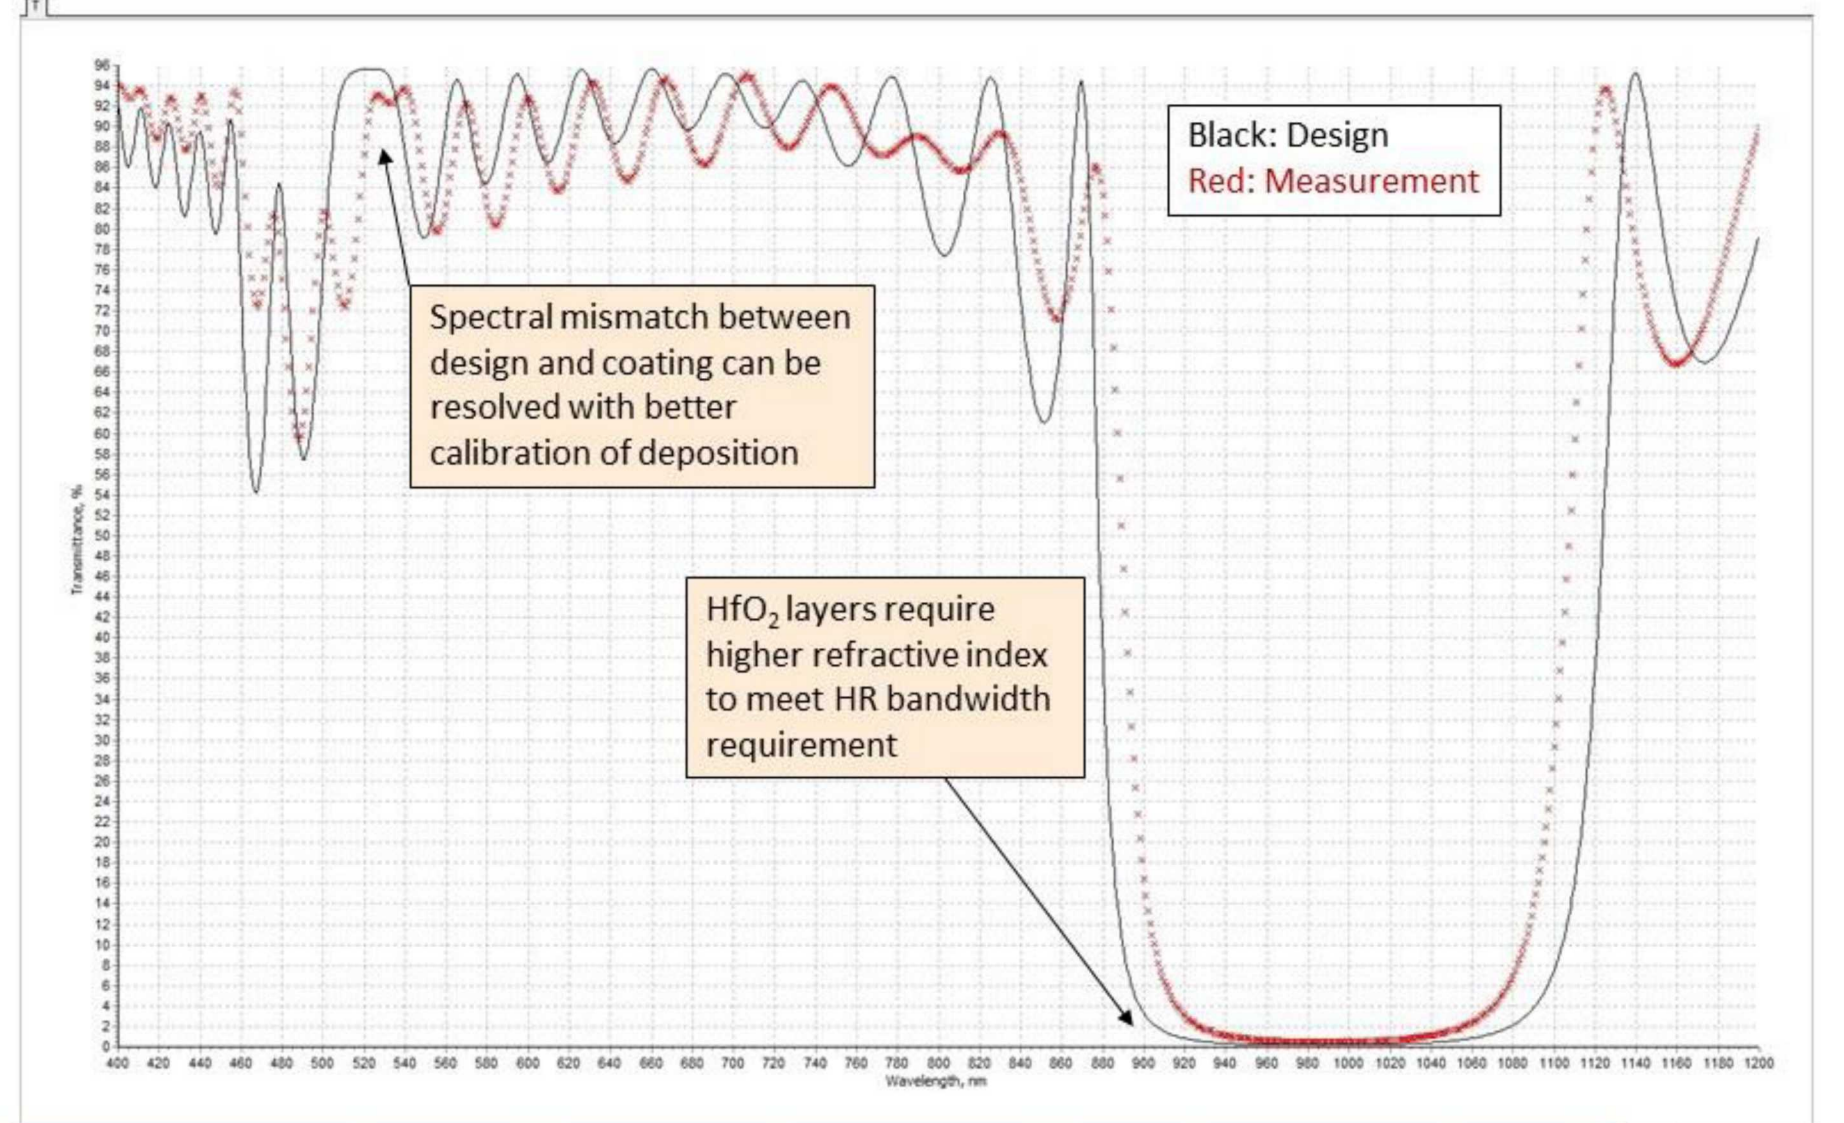
6 Spectral Characteristics

Both design and measurement data include Fresnel reflection losses at the uncoated side of the optic
