ICMAT, Singapore 6/25/2019

SAND2019-6956C

# AM Flaws, Material Properties, and Component Performance

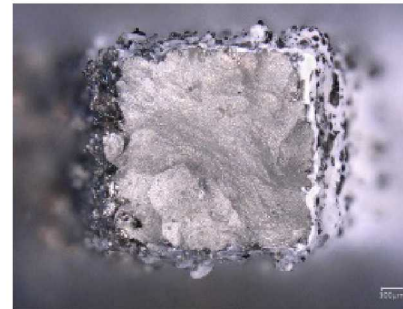
- Build Plate A Laser Power 370 W
- Build Plate B Laser Power 277.5 W
- Build Plate C Laser Power 185 W

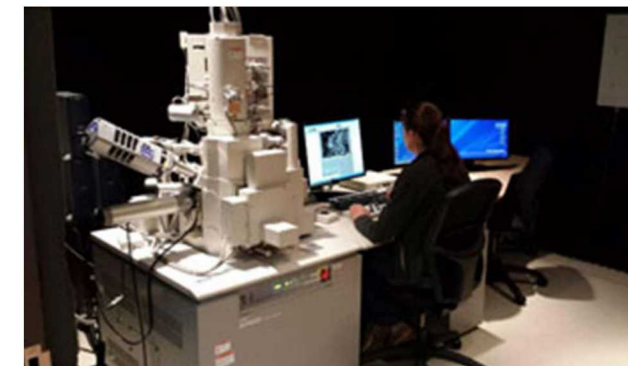
- Fractography at Clemson's Advanced Material Research Laboratory  
- Hitachi SU6600 SEM

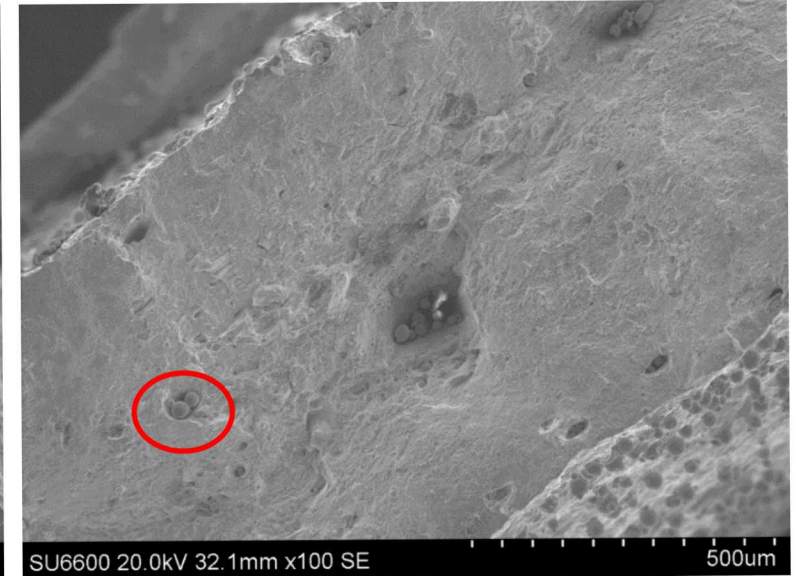
Unmelted particles on fracture surface

- Consistent with low post-peak ductility.
- Print location effects?
