# Abnormal Crystallization in Glass-Ceramic to Metal Seals

Rio Grande Symposium for Advanced Materials  
16 September 2019

Rachel White, Zahra Ghanbari, Don Susan, Steve Dai,  
Brenton Elisberg, Sara Dickens  
Sandia National Laboratory

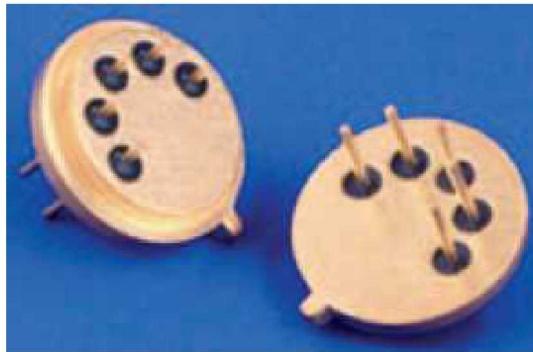
## Electrical Contact Pin Assemblies

Glass is used to bond or join materials in compression seals

- In this case, an precious metal pin to a stainless steel shell

Glass-ceramic is an improvement over traditional glass seals because it offers tunability with thermal expansion coefficients and improved mechanical properties
