# Thermal Runaway Testing and Database Development of Large-format Li-ion Cells at ORNL and SNL

J. Stanley, H. Wang, L. Torres-Castro, E. Deichmann, X. Zhu, S. Allu, J. Lamb, C. Grosso, and L. Gray

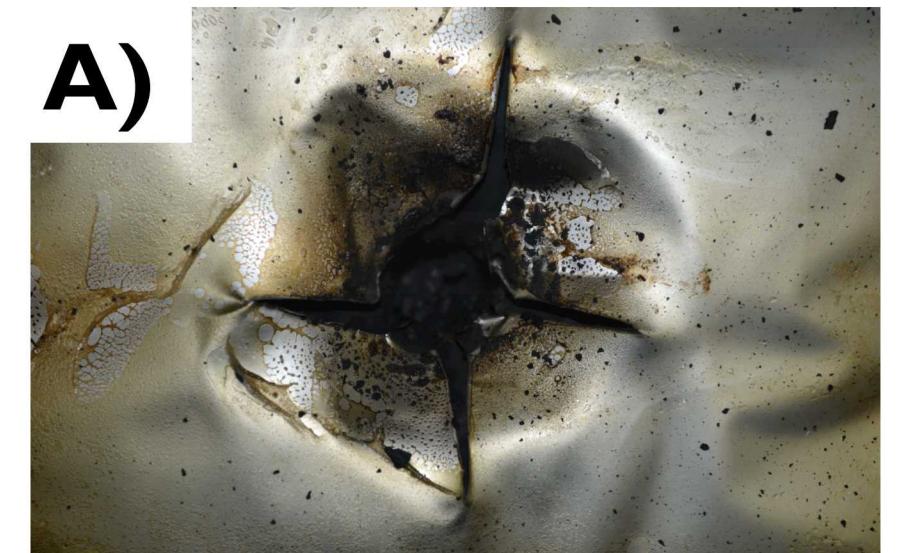
Image 3:  
A) Post-test Indenter hole of the 50% SOC cell  
B) Side view of cell swelling and seam separation, showing interior contents
