Experimental Testing of a 1MW sCO₂ Turbocompressor

Logan Rapp
Sandia National Laboratories
3rd European sCO₂ Conference
September 20, 2019

David Stapp
Peregrine Turbine Technologies

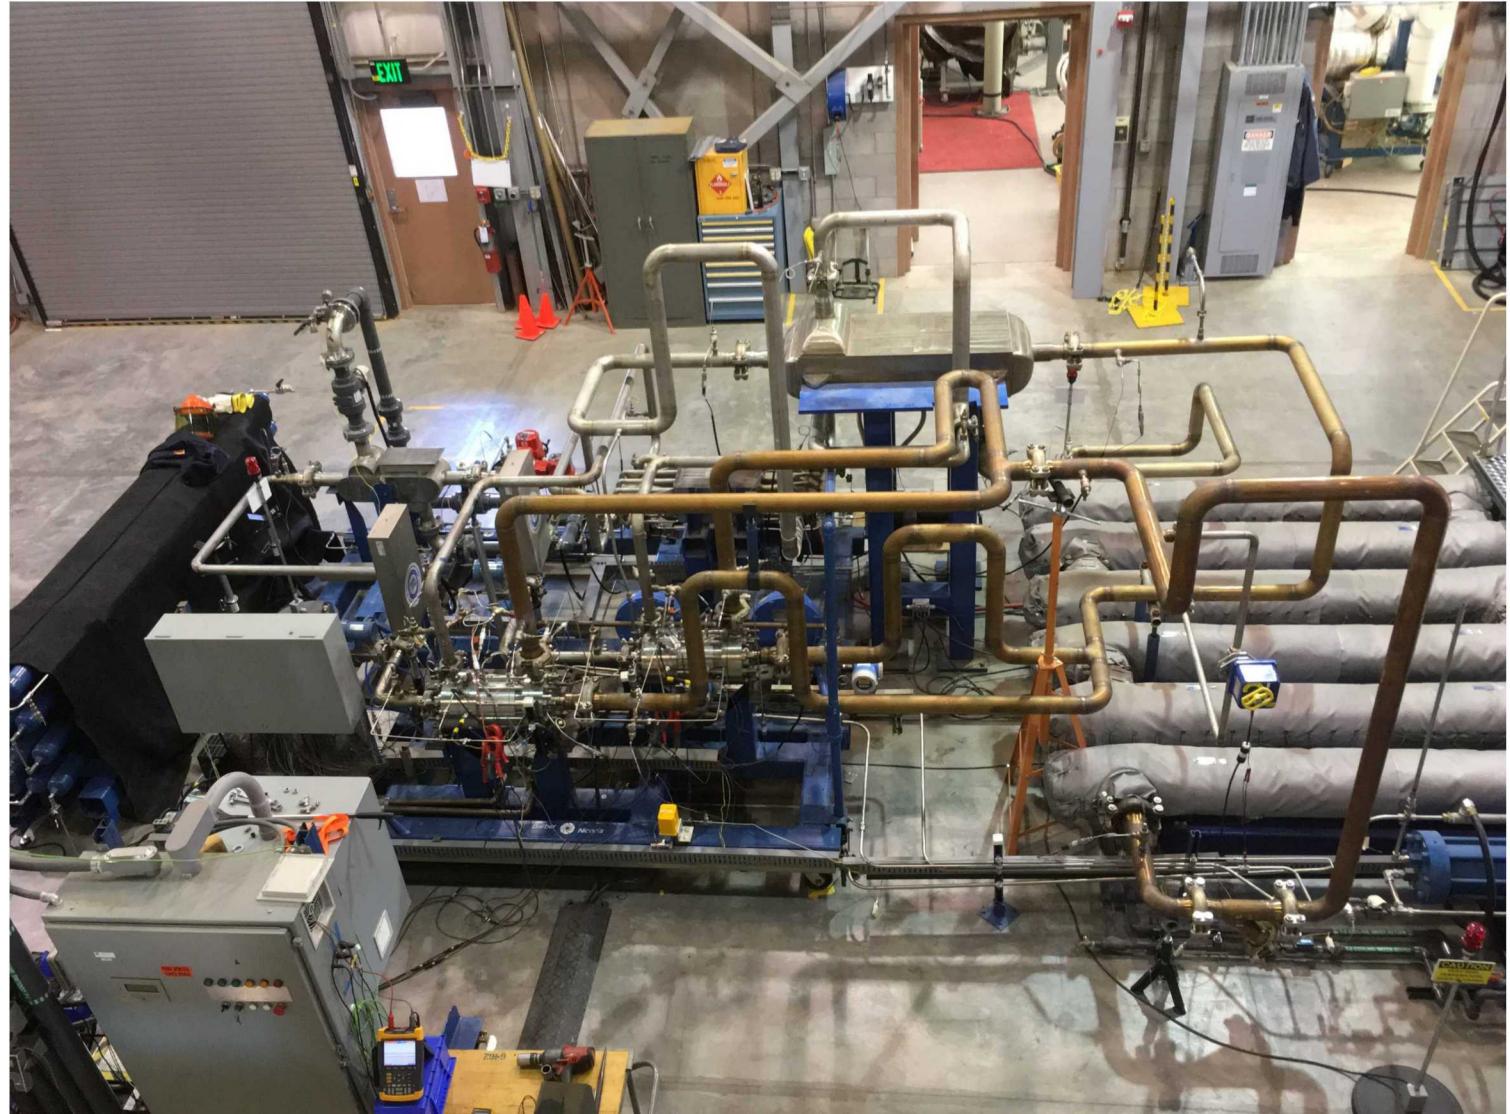
TurboMachinery Development Platform at SNL

780 kW electric immersion heat

2.3 MW duty High Temp
Recuperator

1.6 MW duty Low Temp
Recuperator

540 kW water/sCO₂ cooler

Hydro-Pac Piston compressor
pump

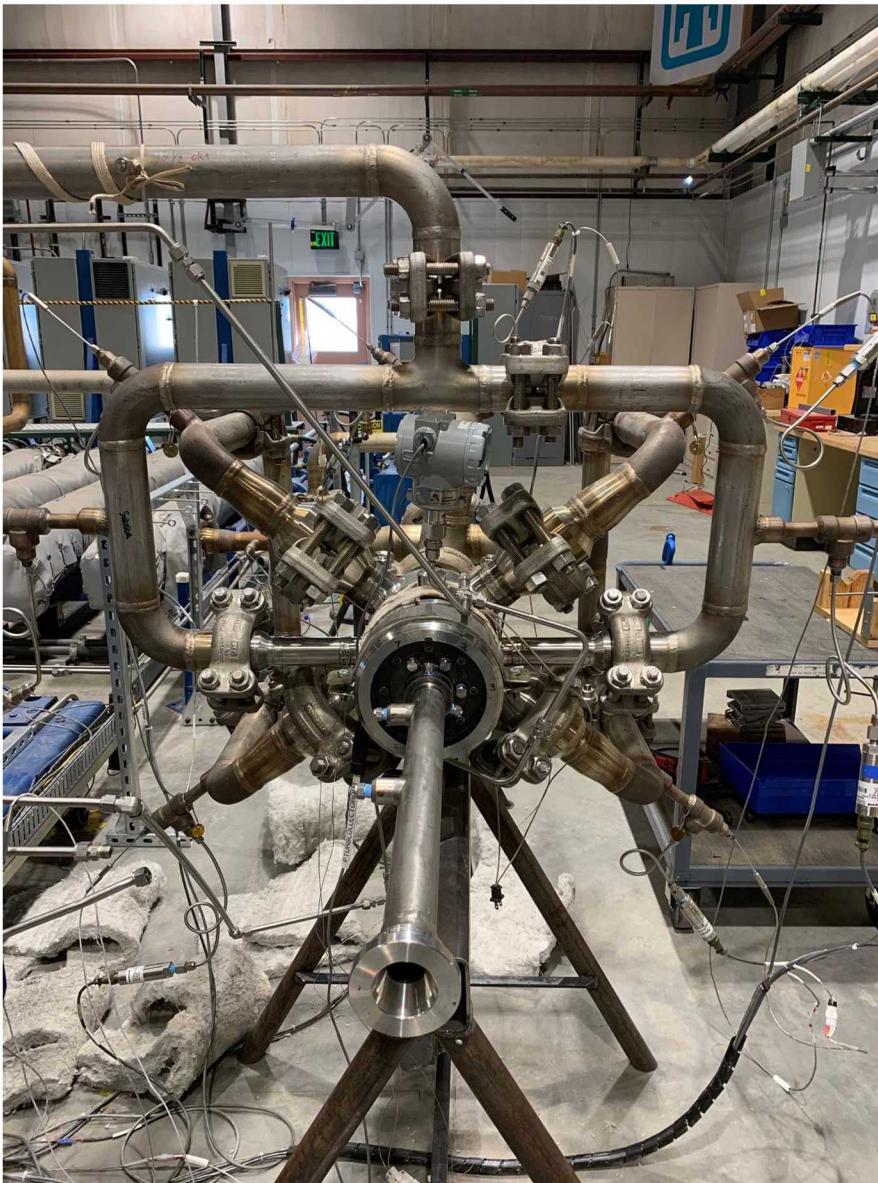
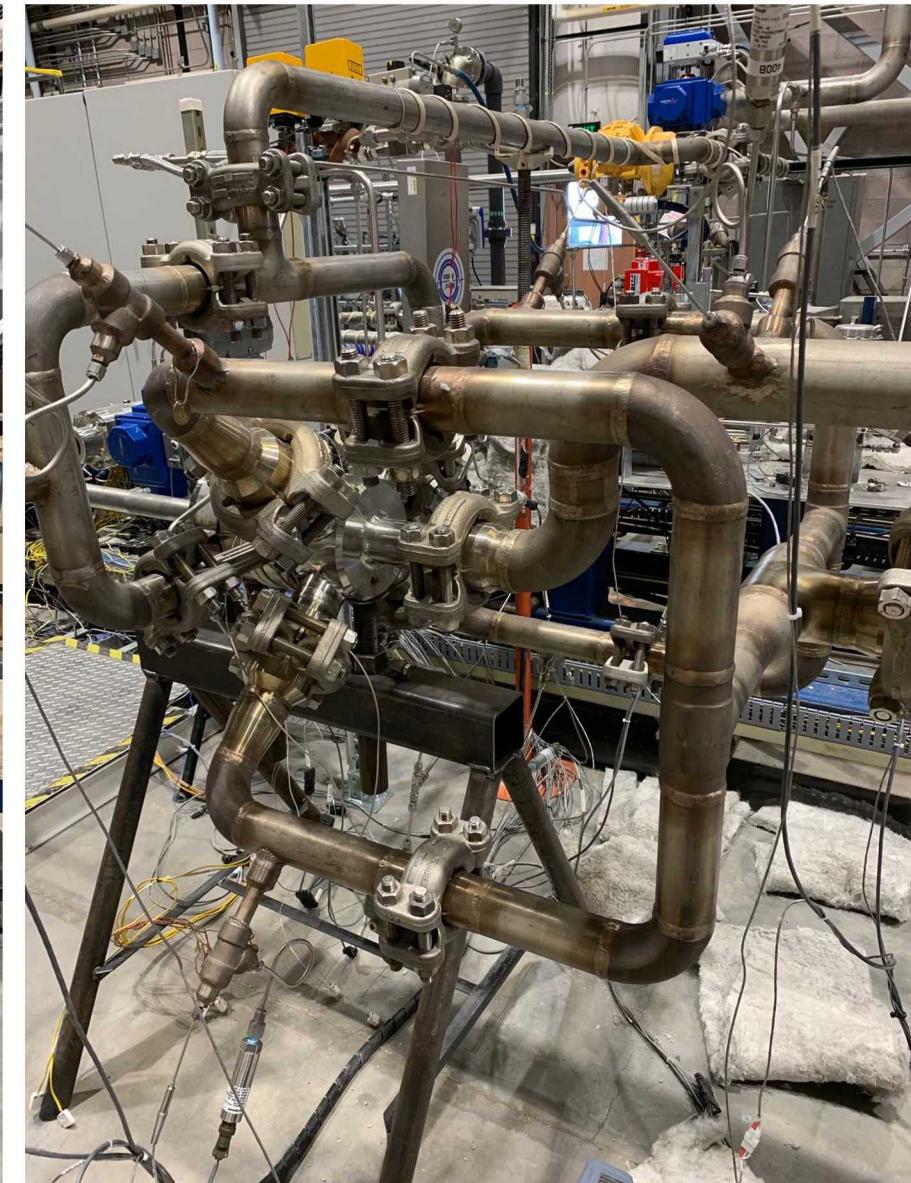
Peregrine Turbine Technologies Turbocompressor

Design Conditions:

- 118,000 RPM
- 750 C Turbine Inlet
- 42.9 MPa compressor discharge

Loop Maximum Conditions:

- 538 C Turbine Inlet (1000 F)
- 17.2 MPa compressor discharge (2500 psi)

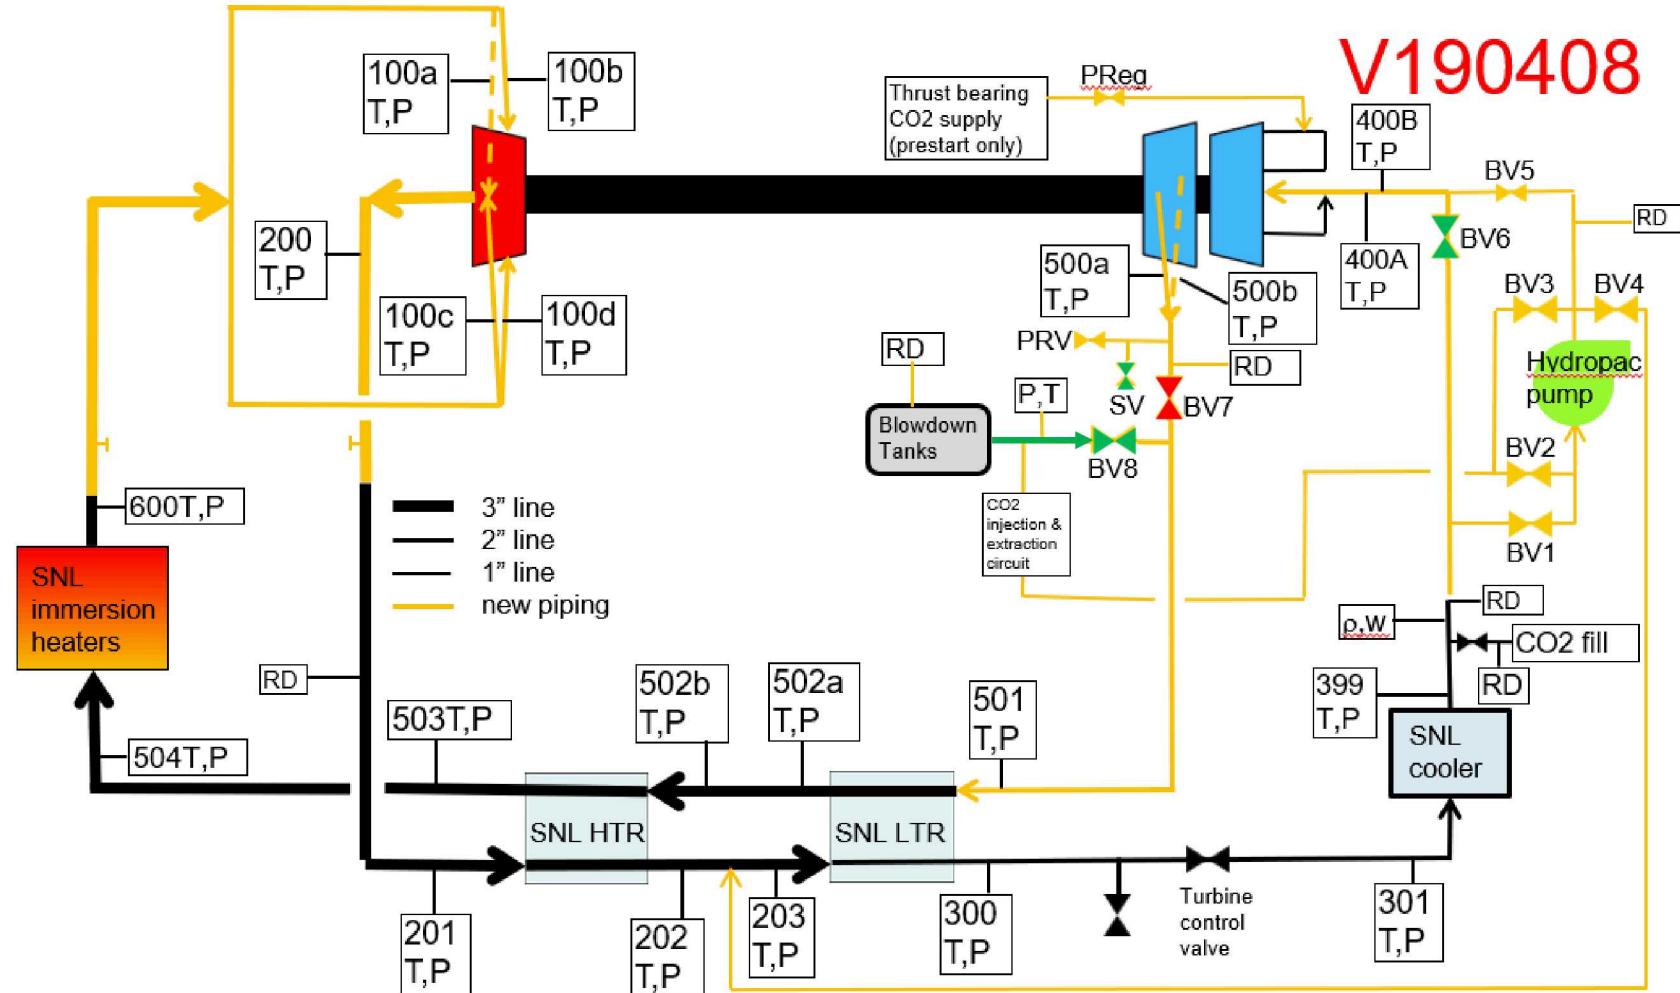
7 Blowdown Start Method

Loop is preconditioned using Hydropac

- Compressor inlet above supercritical conditions
- Turbine inlet at approximately target for test

Valve Positions

- BV7 is closed
- BV8 and SV are opened

Once $P_{500A} - P_{501} > dP_{min}$:

- BV7 is opened and BV8 and SV are closed

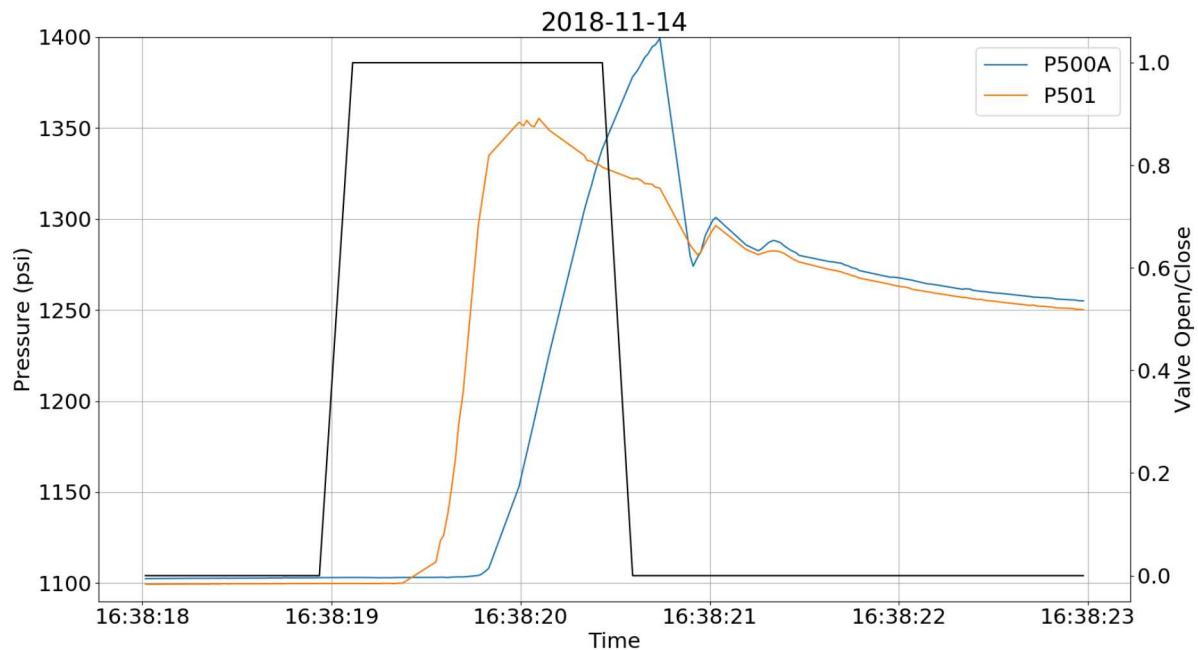
Blowdown start plots

Blowdown Pressure=1670 psi

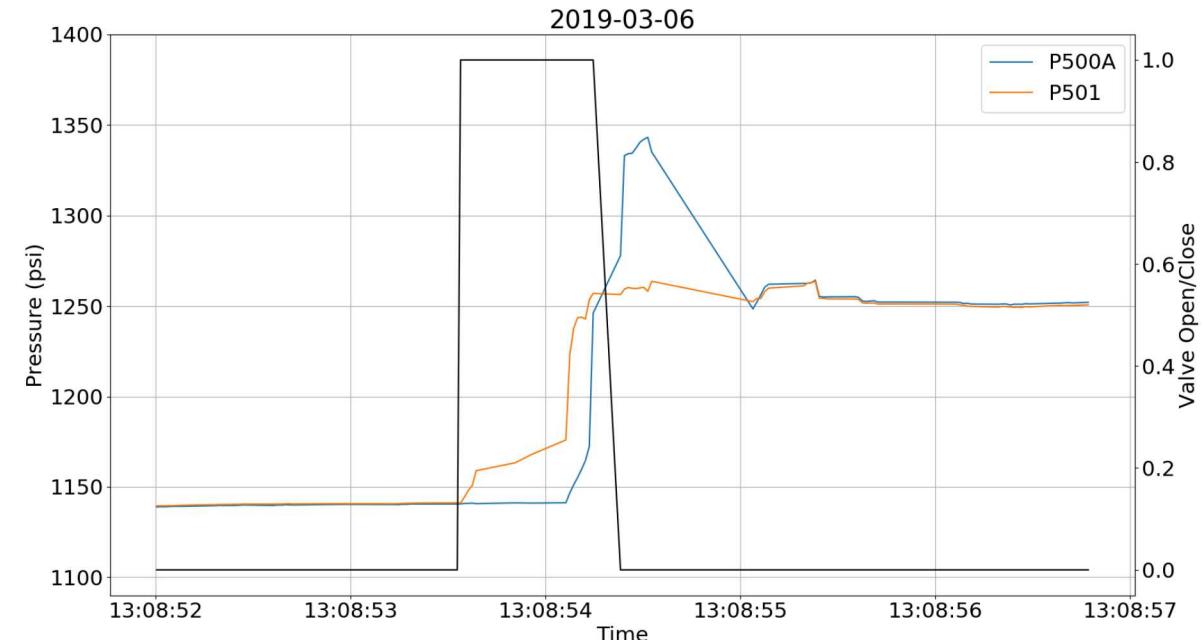
Blowdown Pressure=1400 psi

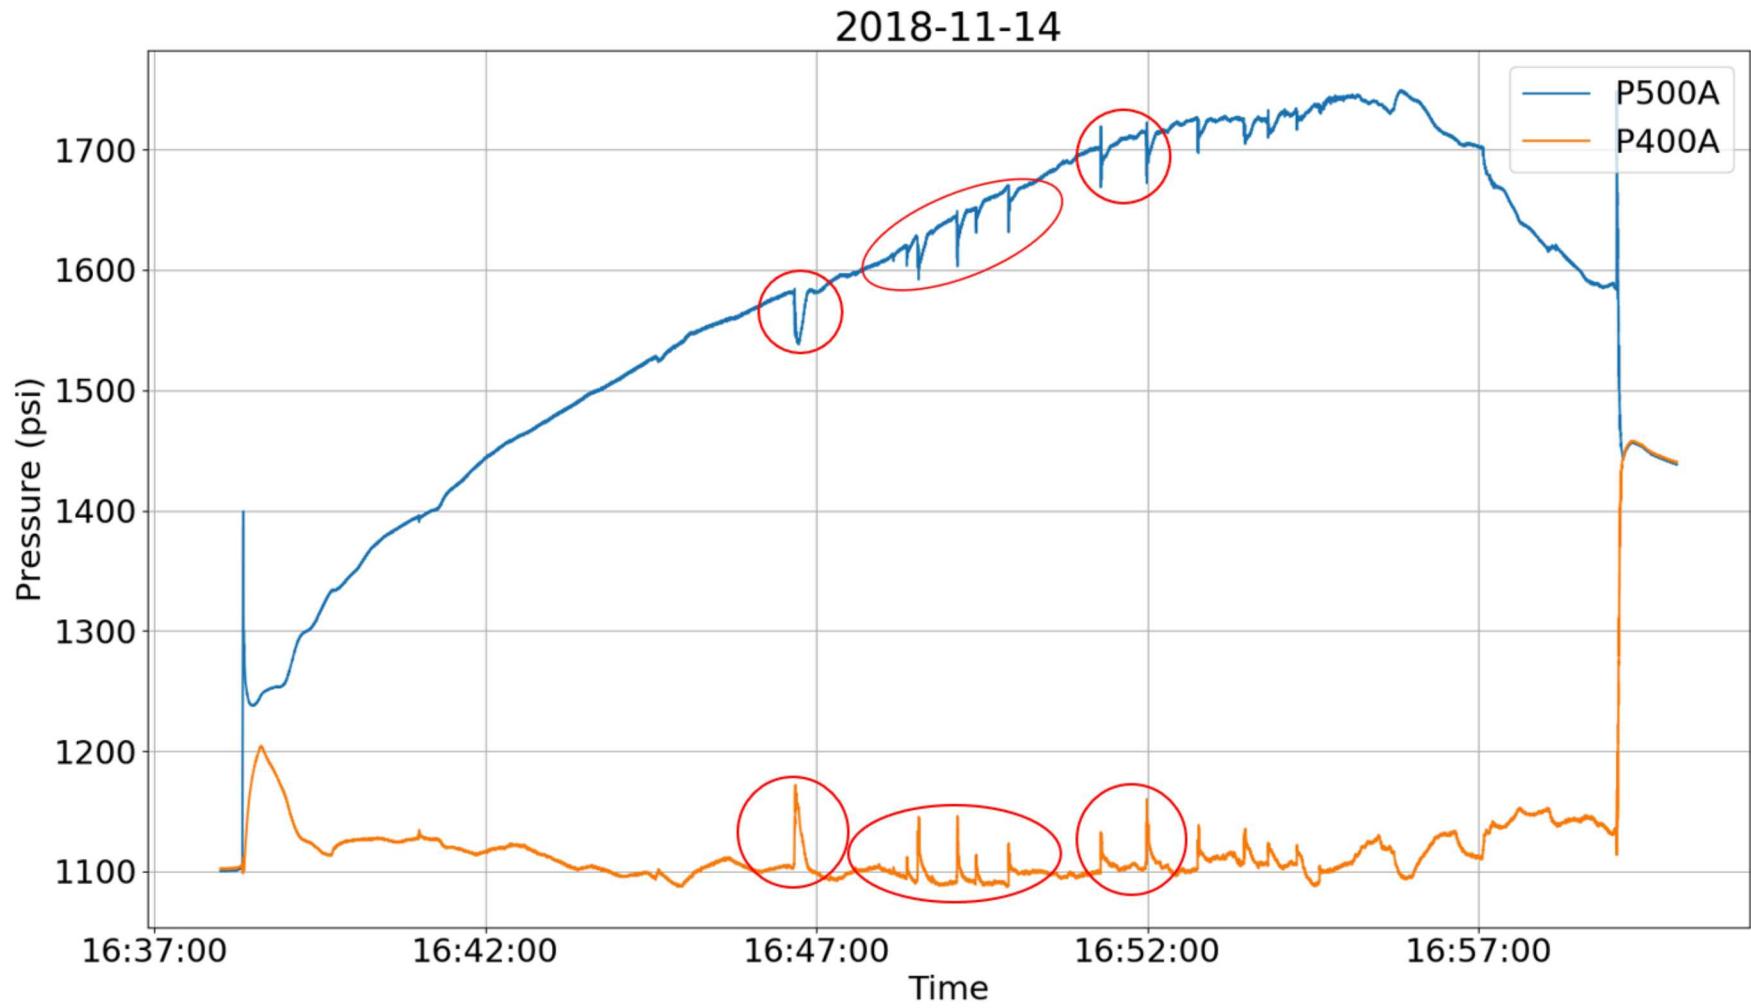
Bearing Issues

In Tests #1-3, both the thrust bearing and the radial bearings experienced rubs/failures

Spikes in pressure indicate thrust bearing rubs

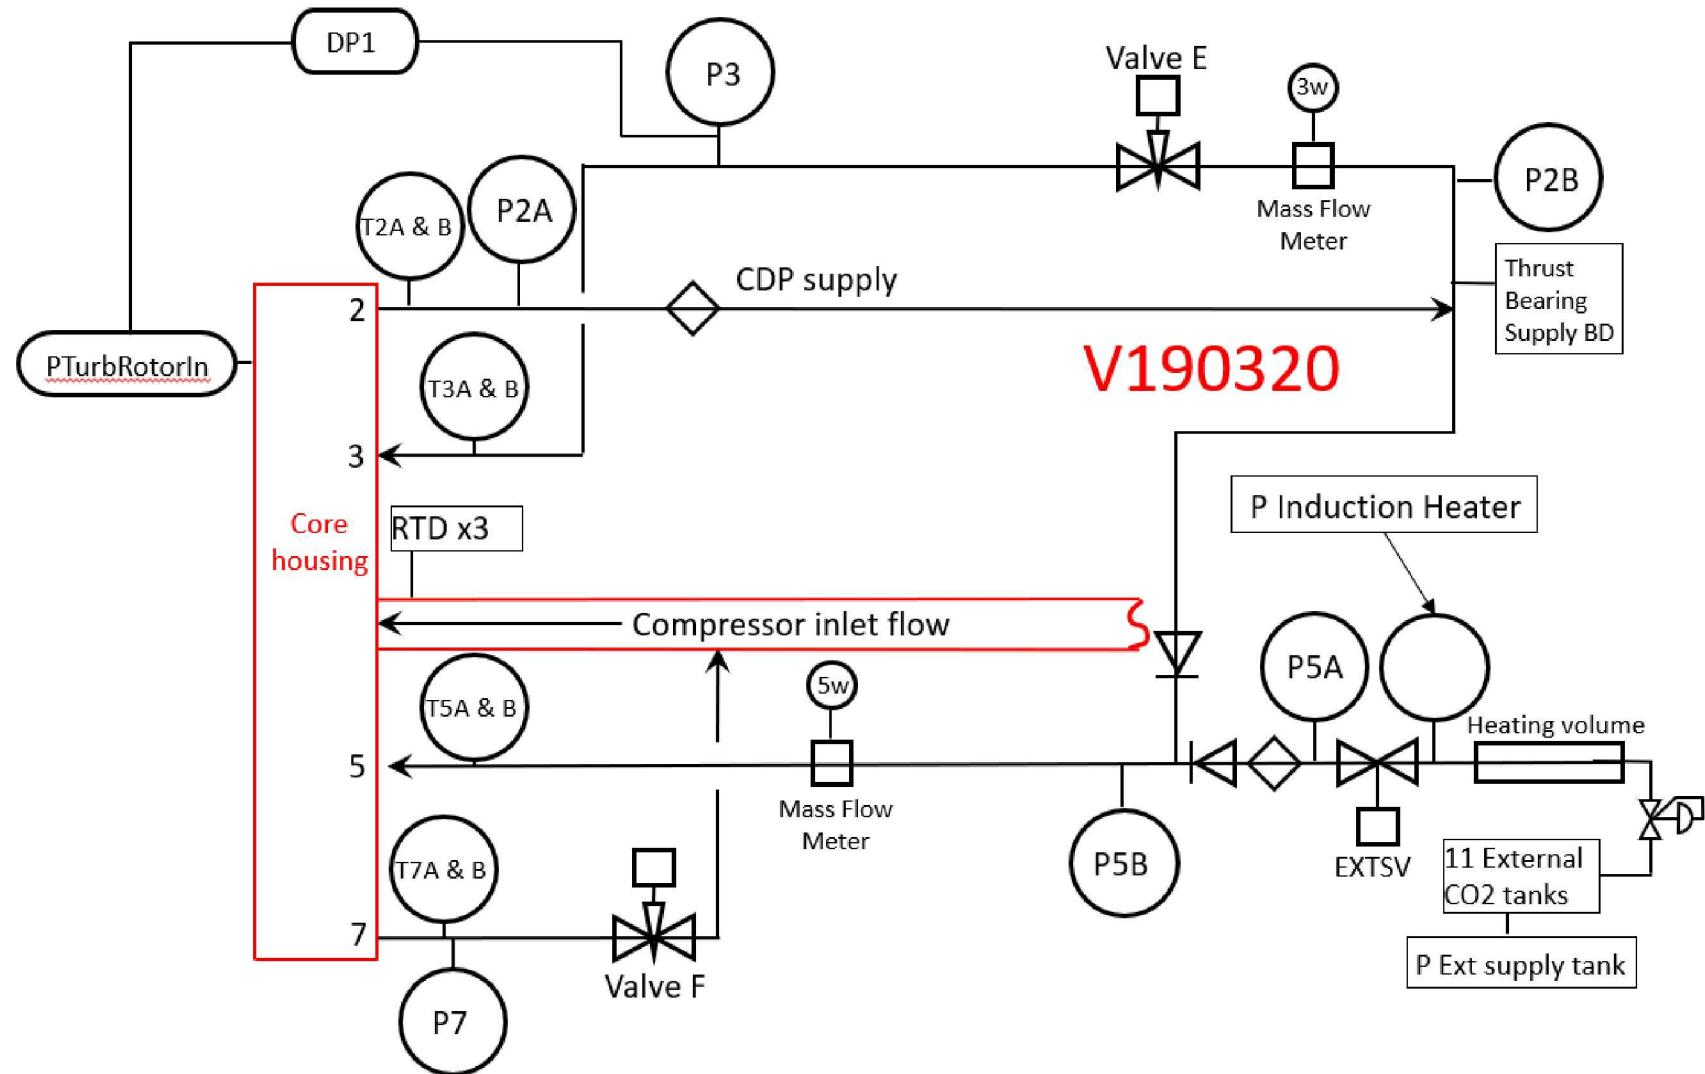
Secondary Flows

Valve F regulates venting pressure on aft side of thrust disk rotor – acts as balance piston

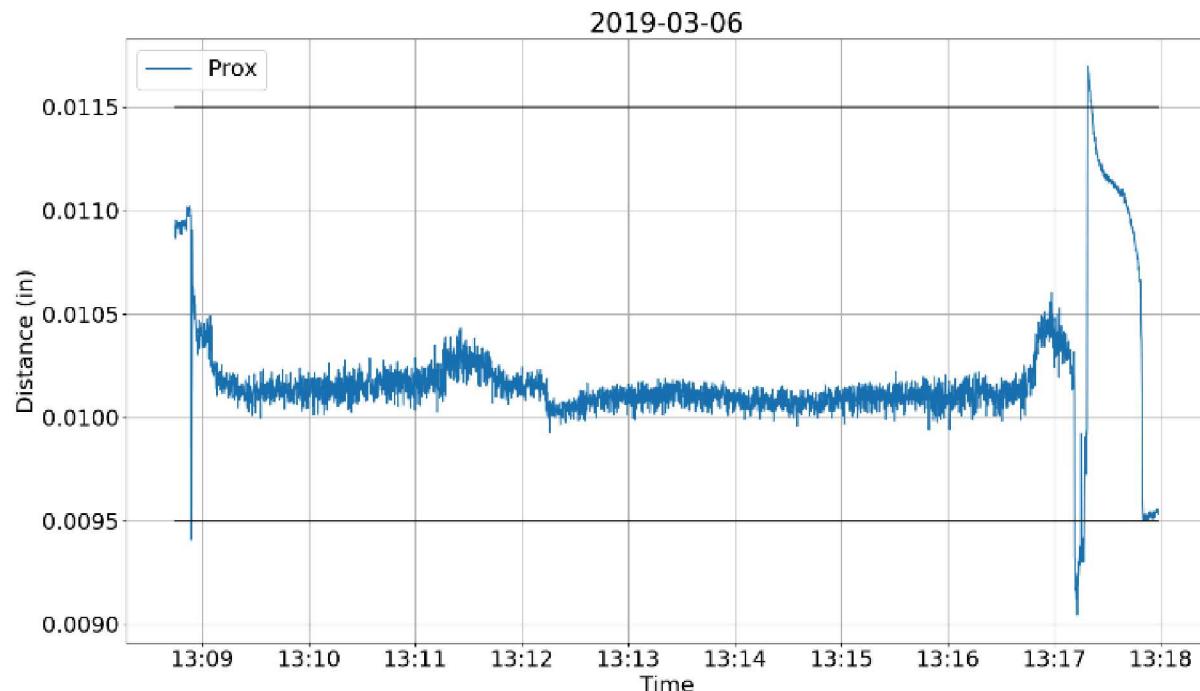
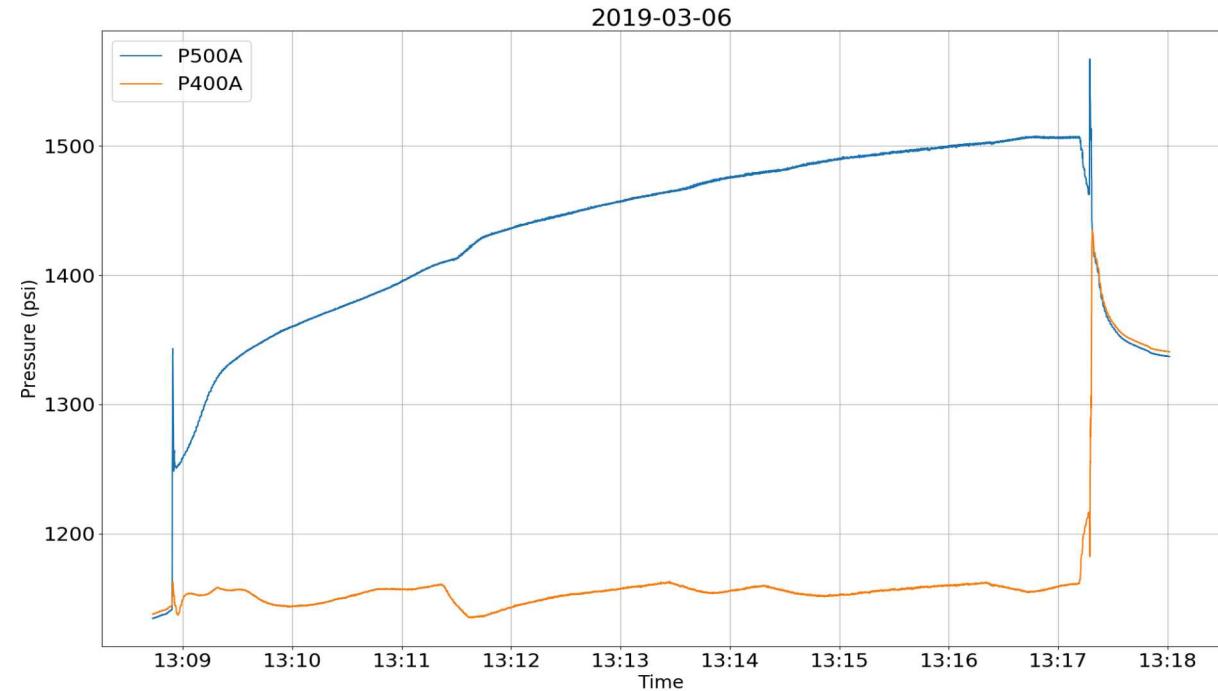
Thrust bearing issue resolved

By adjusting Valve F and the TCV the force on the rotor was balanced.

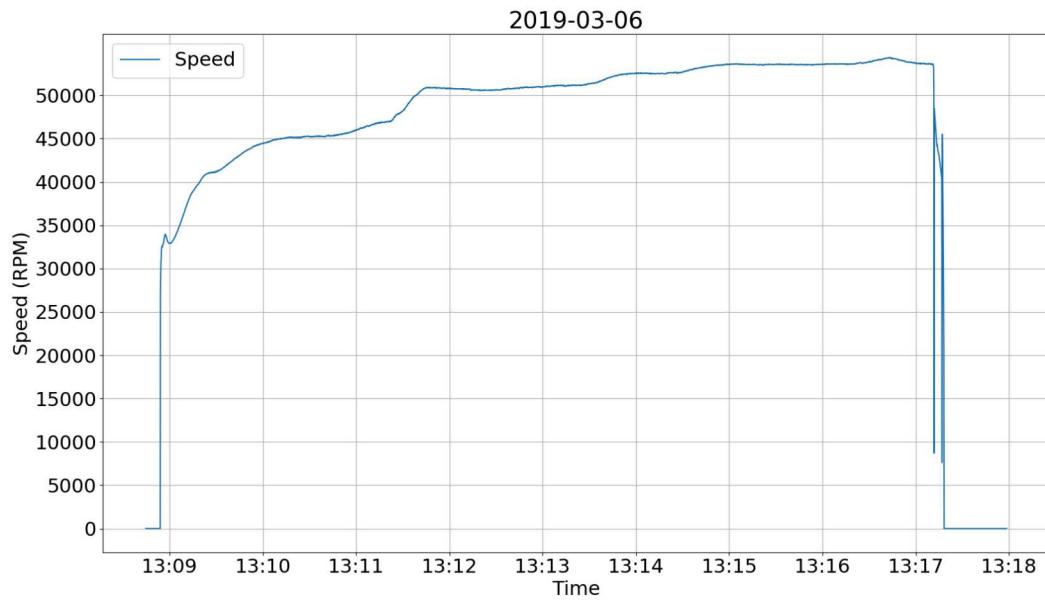
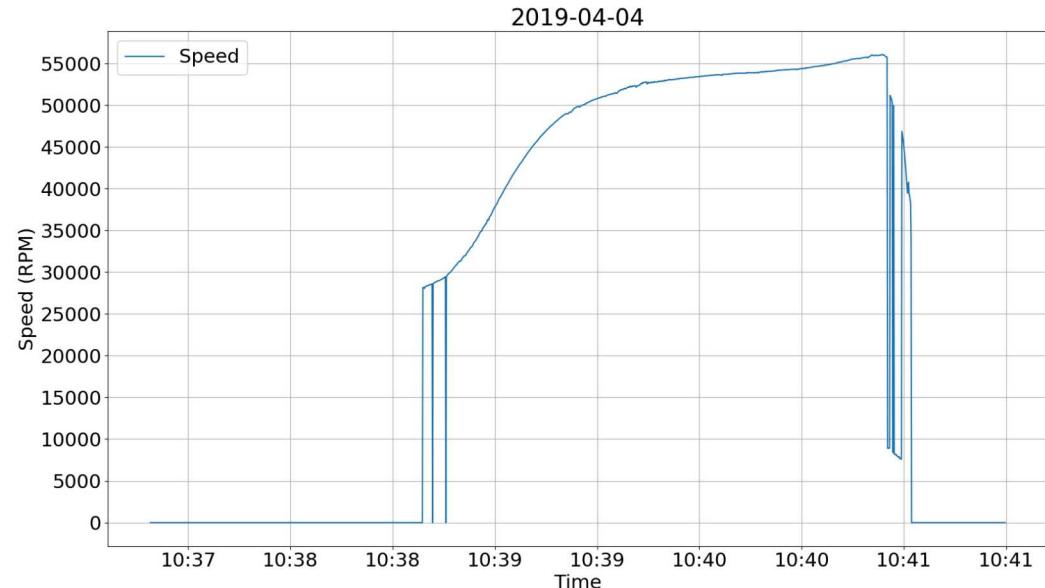
Radial Bearing Issues

In all tests (except #7 – 8 hr test), the turbine end radial bearing failed

Possible causes of failure:

- Blowdown start
 - Reduce blowdown pressure
- Critical speed causing rotor instability
 - Physical evidence of bearing failure shows yielded foils at a specific clocking; not indication of rotor instability
- Radial load caused by non-uniform turbine inlet conditions
 - Resolved with instrumentation

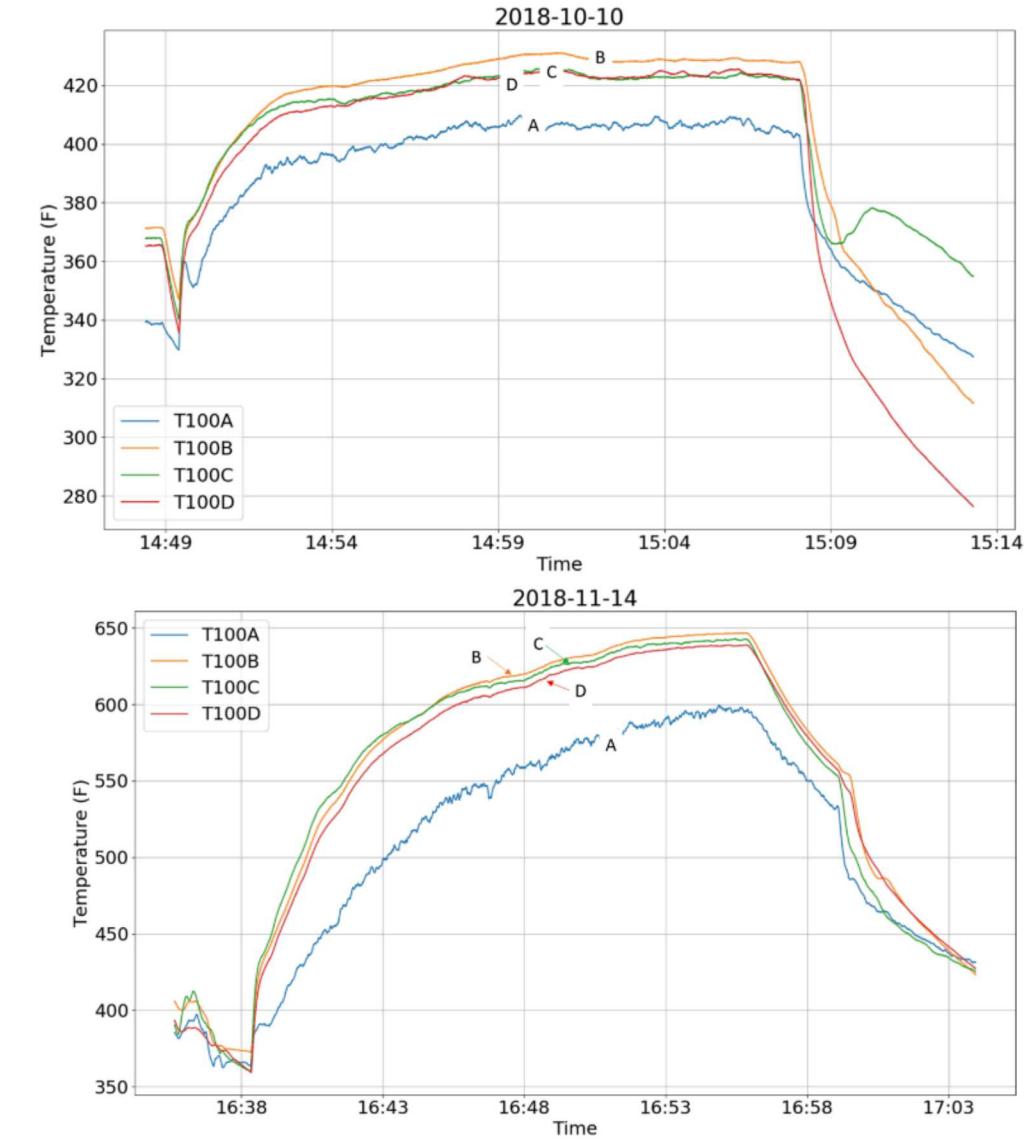
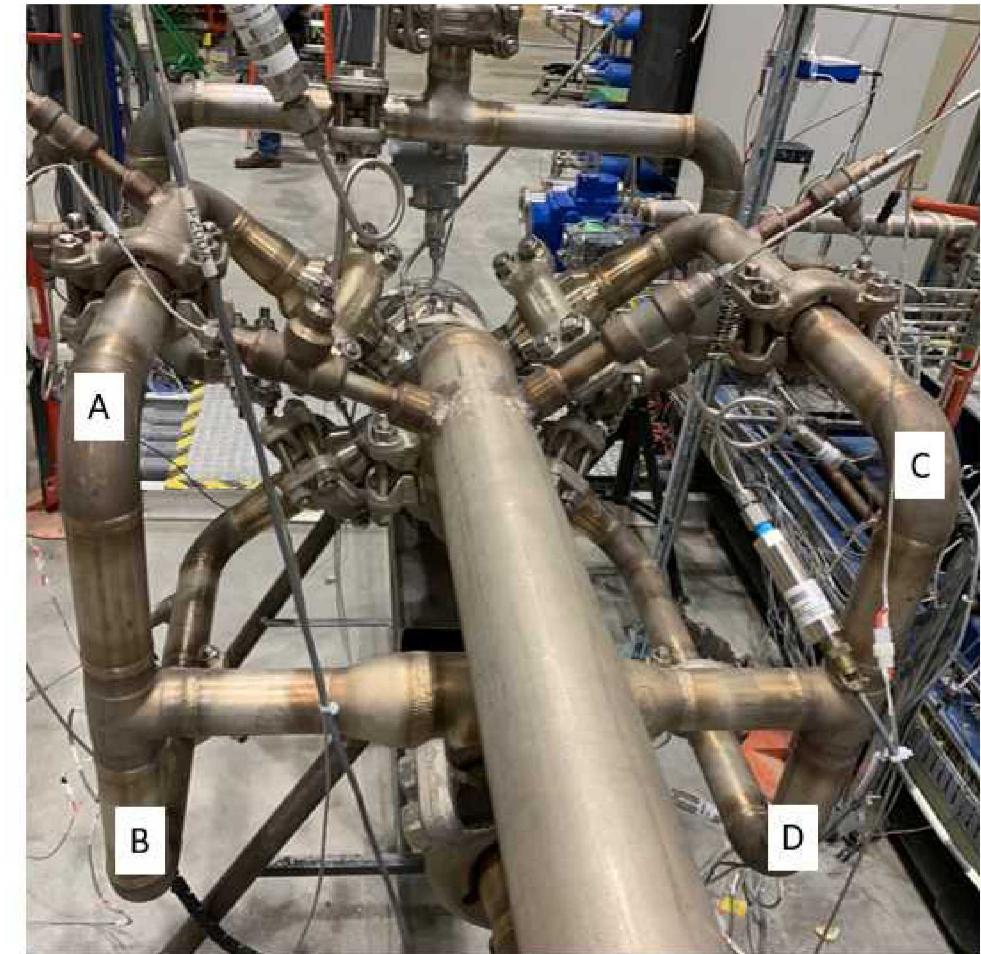
Turbine Inlets

Leg “A” was consistently lower temperature than the other 3

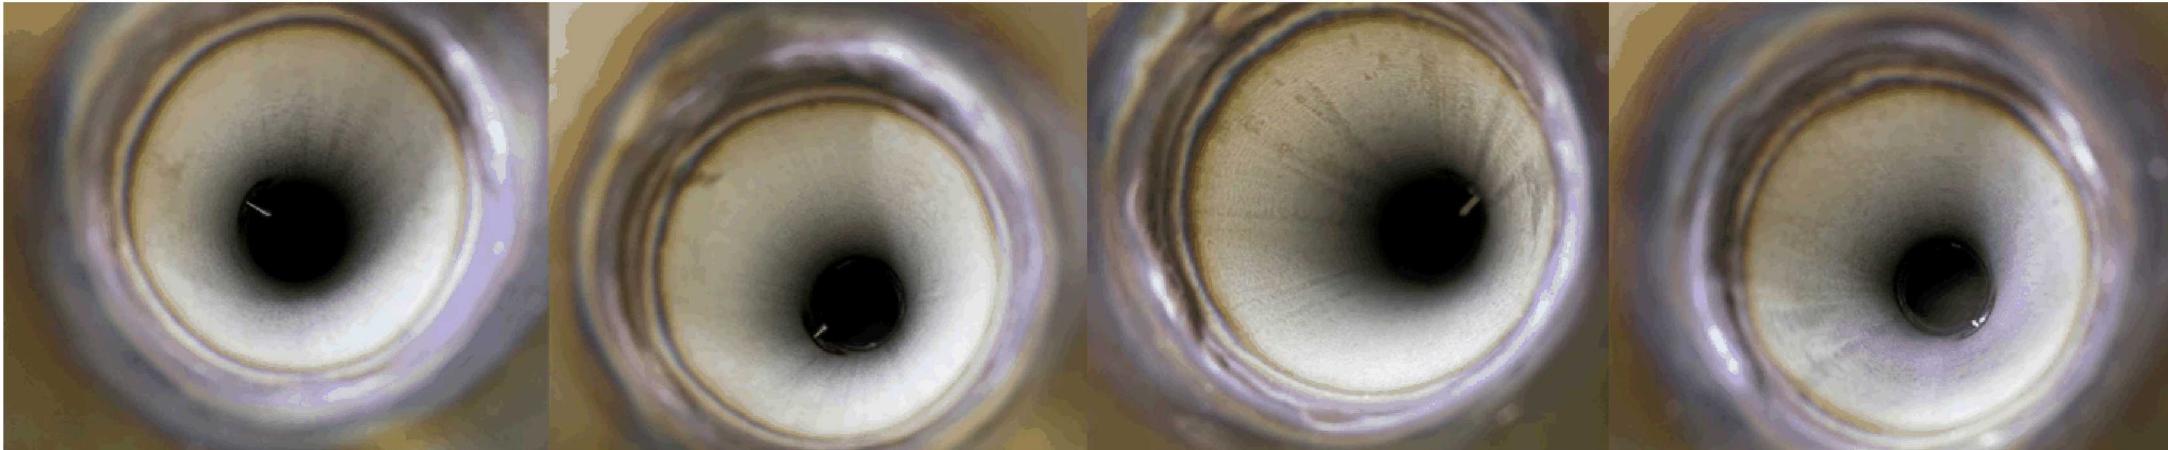
Original and New Turbine Inlet RTD insertions

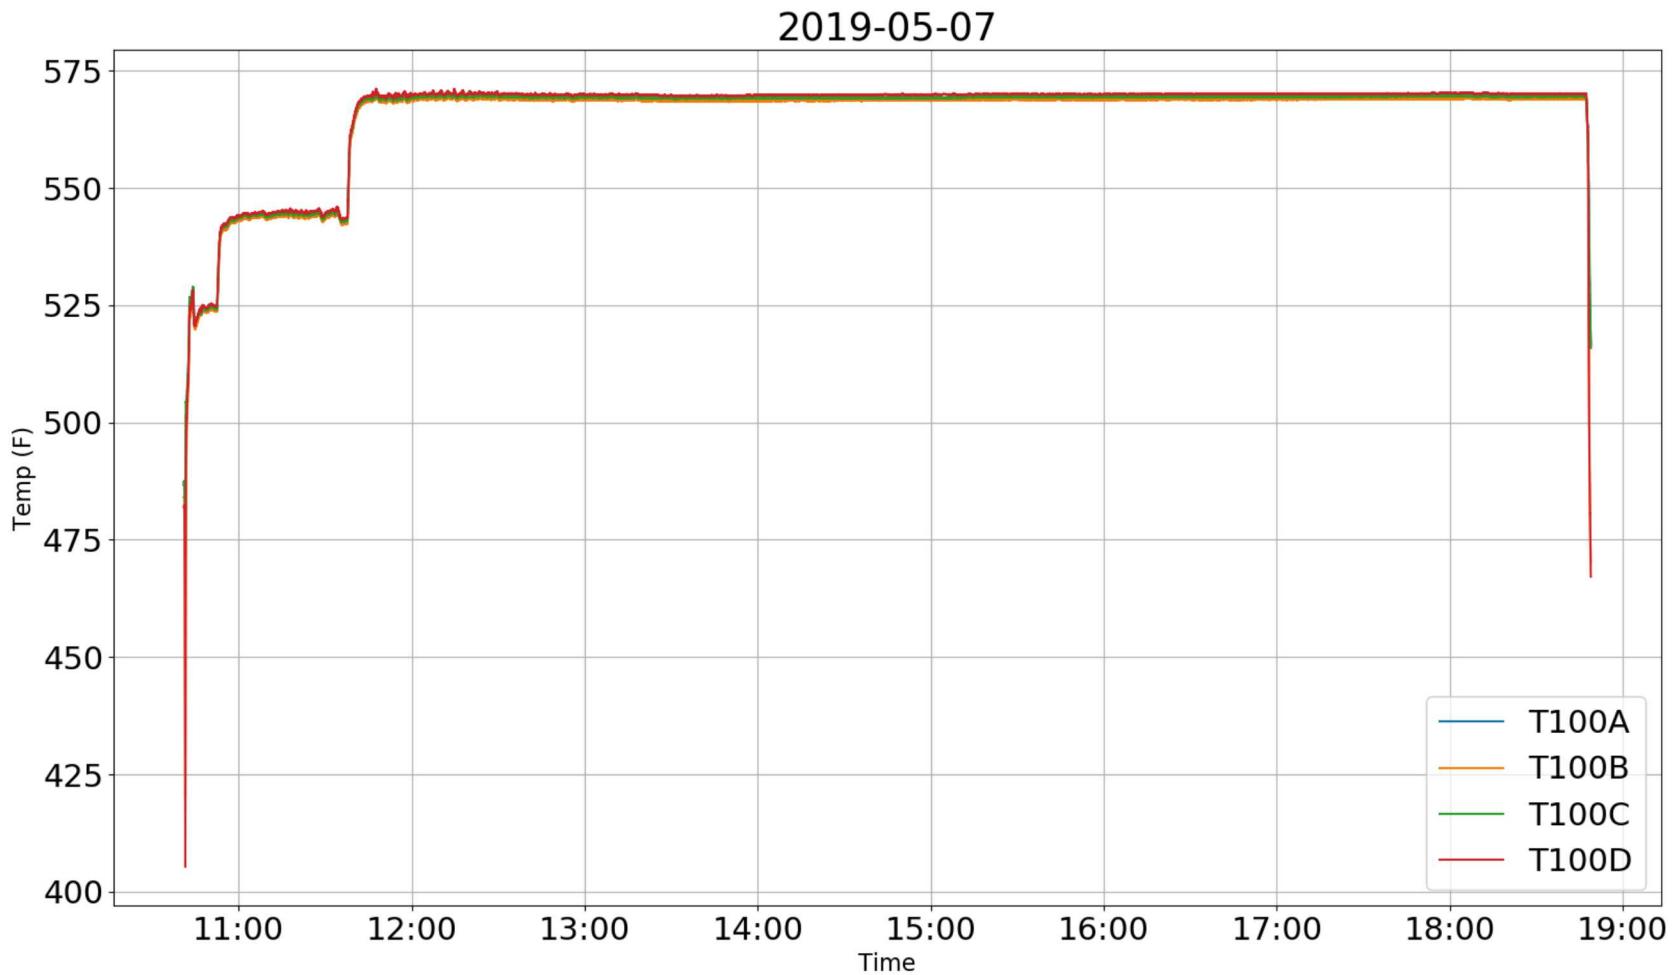
Turbine Inlet Temp with new Insertion depth

No difference in centerline temperature of turbine inlets

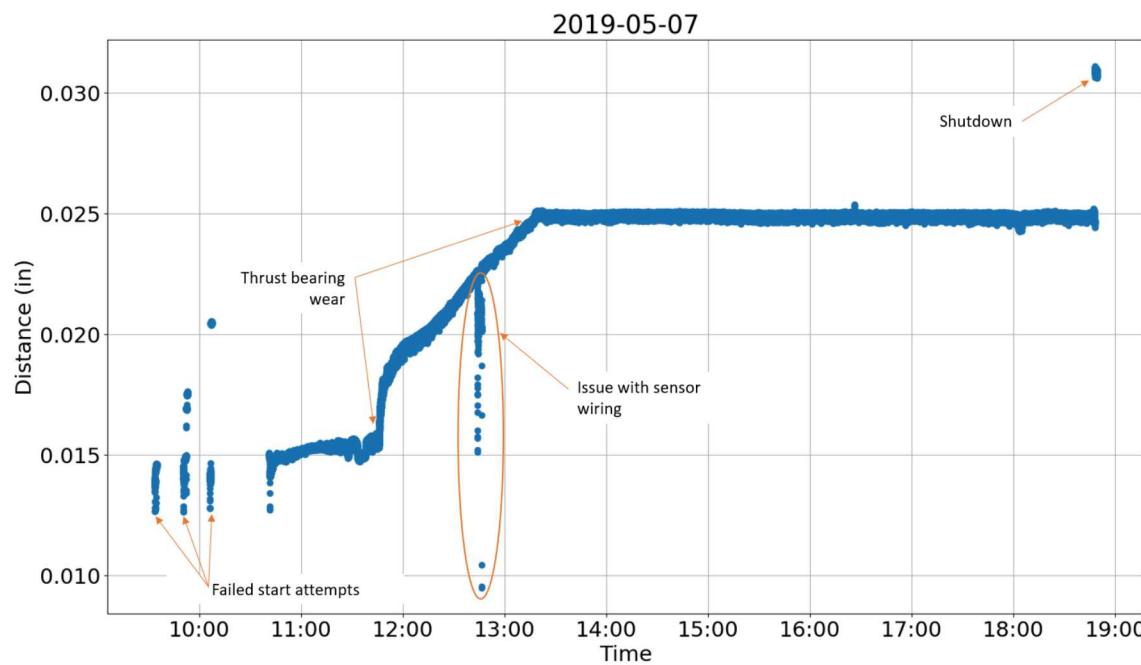
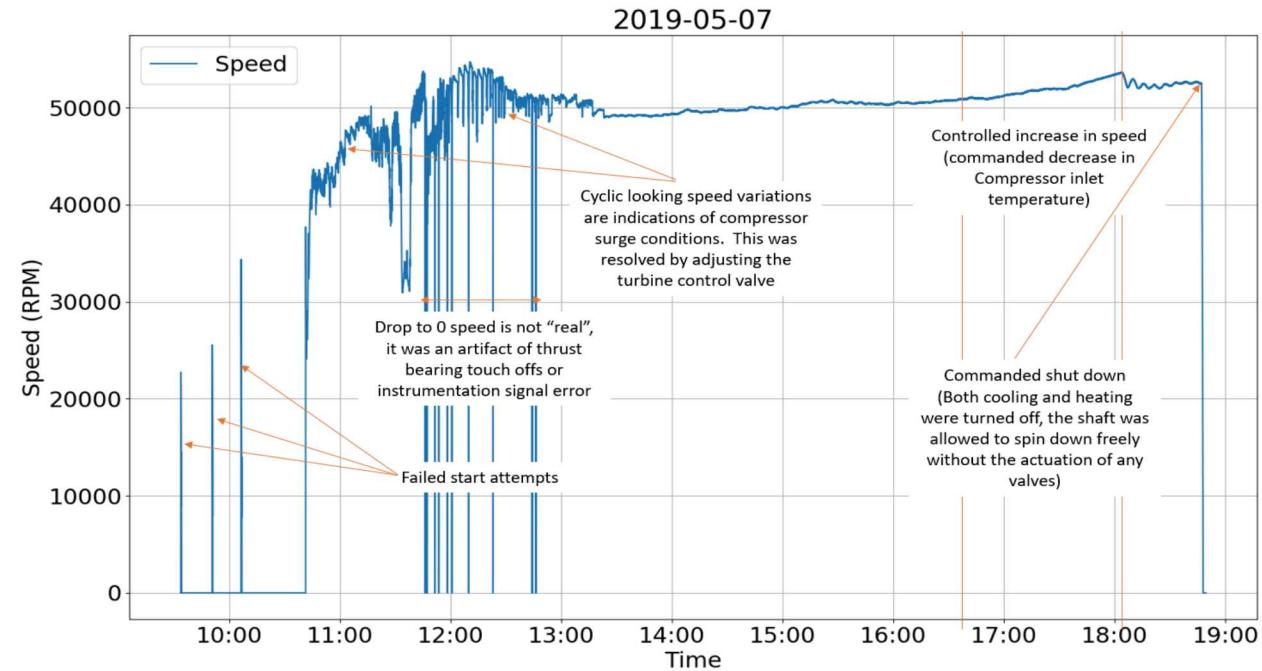
Increased L/D of aft radial bearing

The aft radial bearing length/diameter ratio was increased to increase load capacity and the damping of the bearing

Start Number	Turbine Inlet Temp (F)	Blowdown Pressure (psi)	Outcome
1	460	1330	Unsuccessful
2	500	1360	Unsuccessful
3	525	1425	Unsuccessful
4	550	1450	Successful
