Sandia  
National  
Laboratories

SAND2019-11271C

# Helium Bubble Evolution in Implanted Erbium Deuteride Bulk and Multilayered Structures

**Caitlin Taylor**, Sandia National Laboratories, ABQ, NM

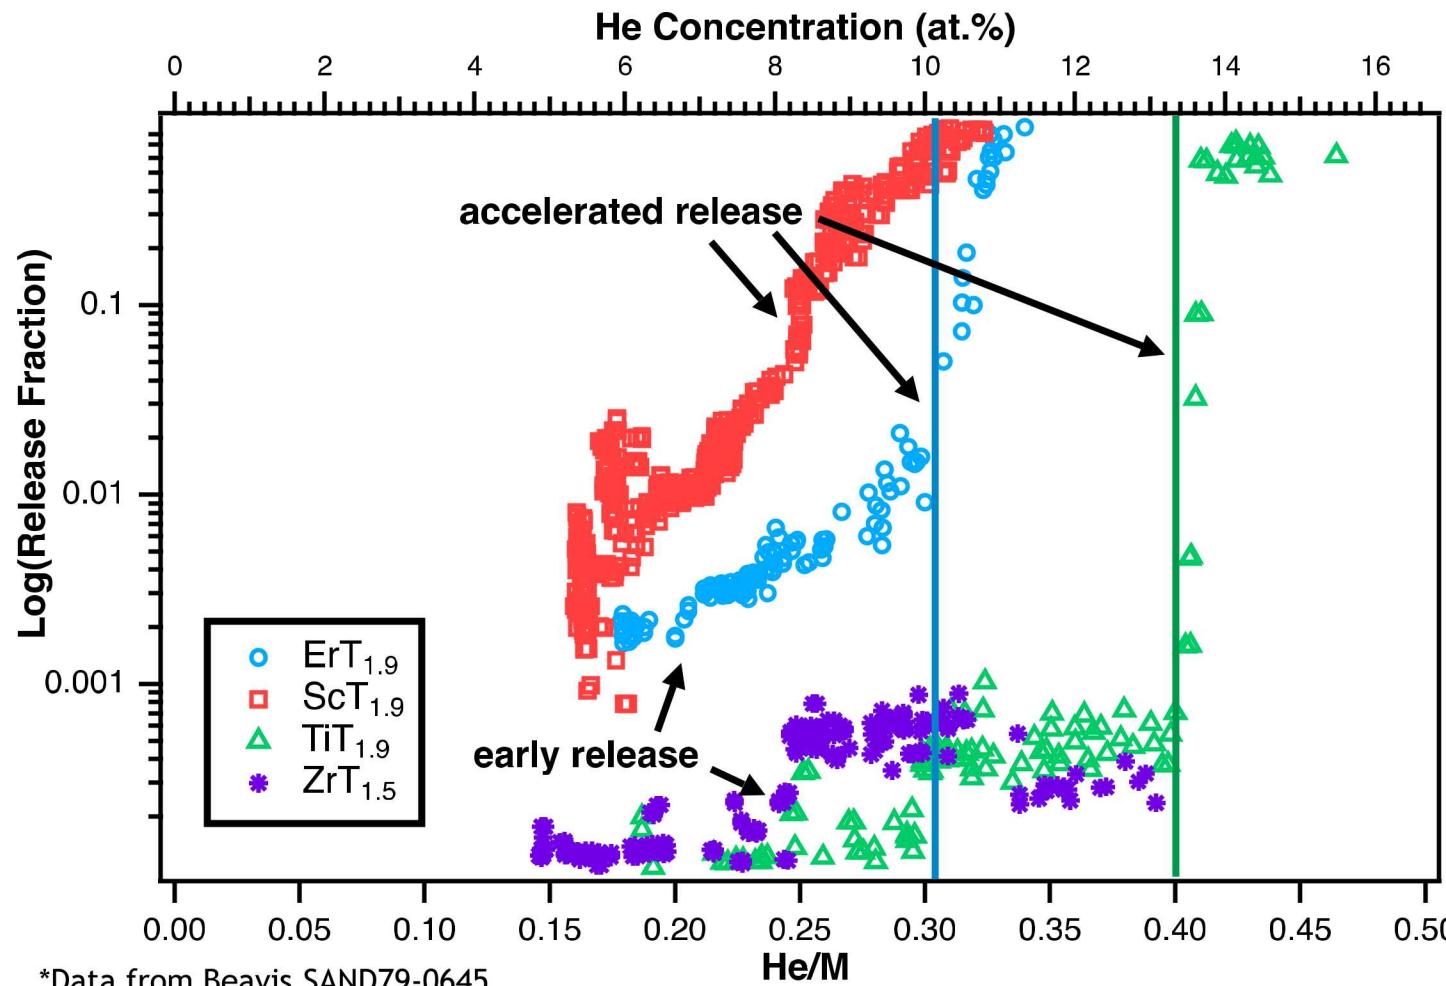
## Tritides Exhibit Accelerated He Release when ${}^3\text{He}$ Capacity is Reached

- Accelerated release occurs when  $\{\text{He release rate}\} = \{\text{He generation rate}\}$
- Timescale is 0 months for ScT<sub>2</sub>, ~35 months for ErT<sub>2</sub>, ~48 months for TiT<sub>2</sub>

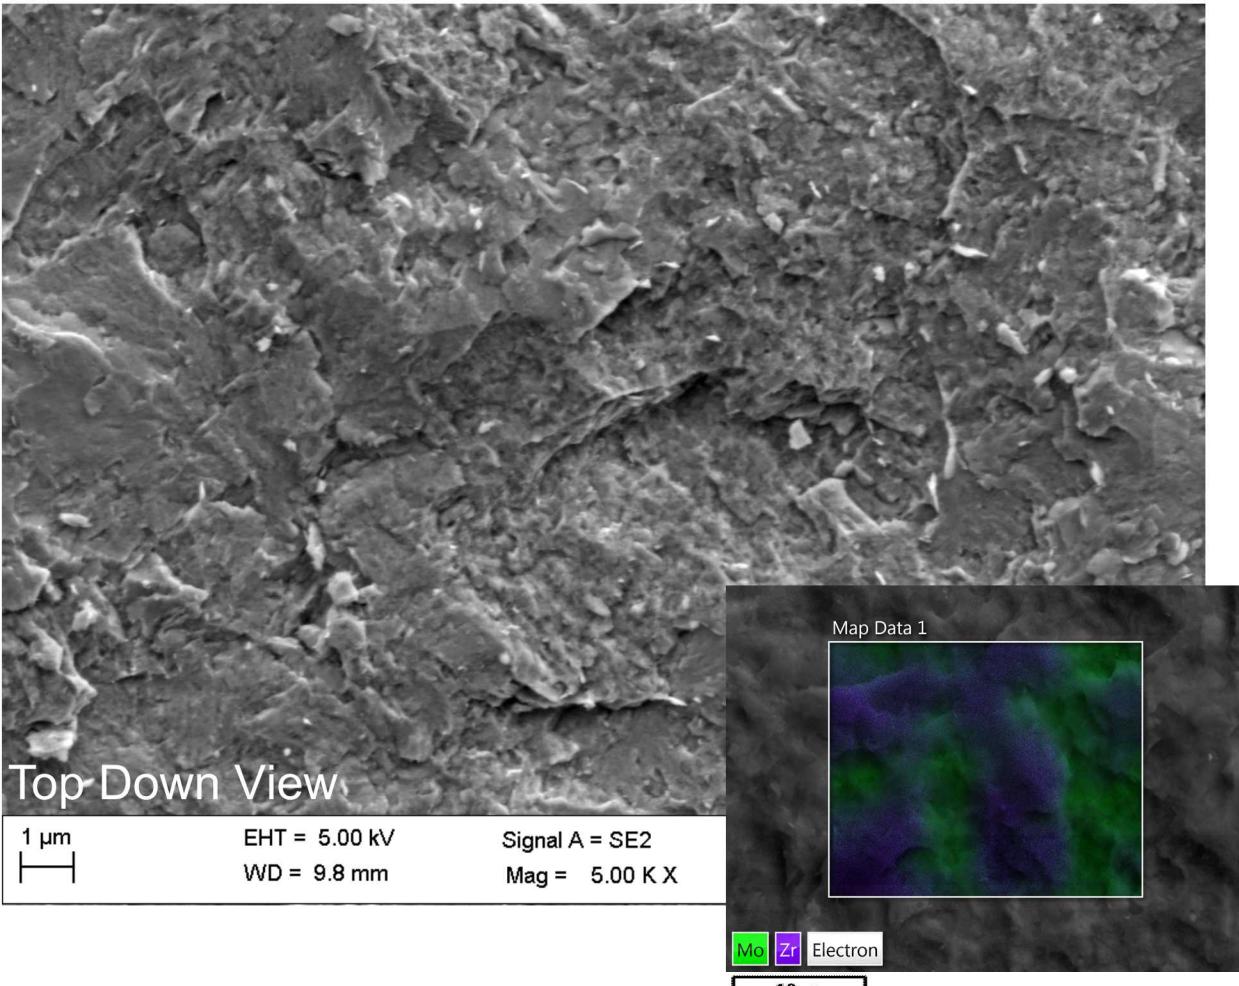
ZrT<sub>2</sub> Film in Accelerated Release (69 months)

# Spalling can Occur with Age, Especially Near Accelerated Release

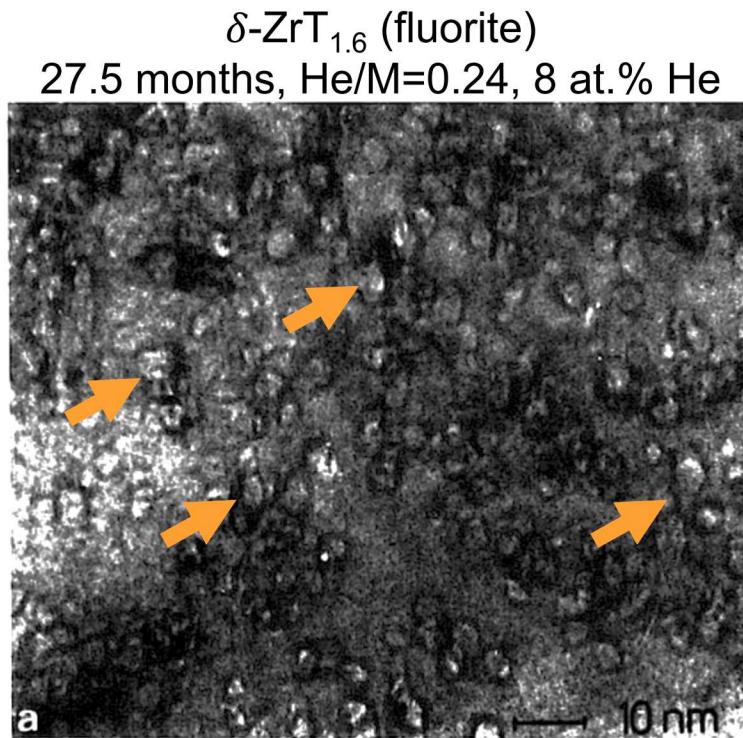
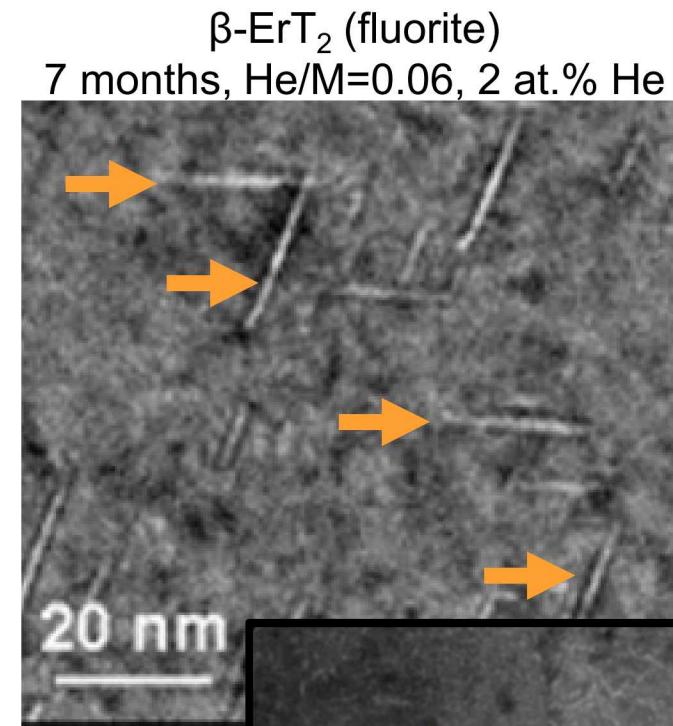
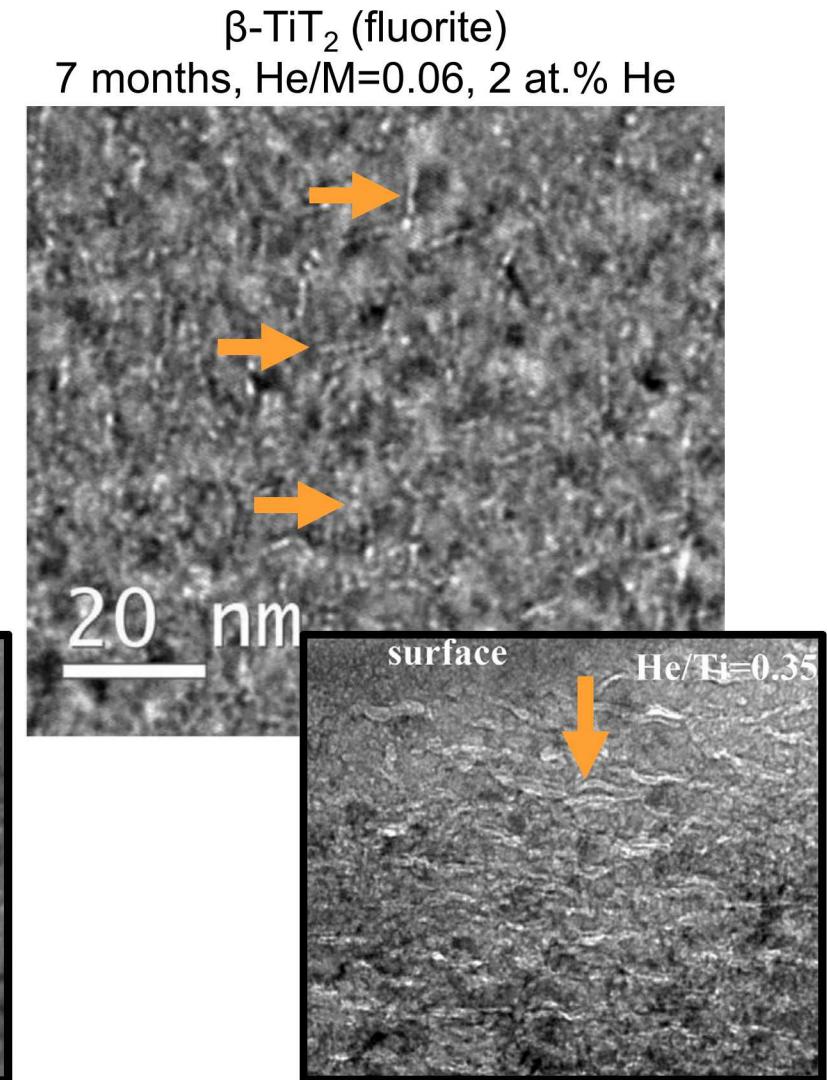
# Nanometer Sized He Bubbles form During Early Release Stage

- Bubbles become faceted in  $\text{ZrT}_{1.6}$ , so far no evidence of platelet or crack formation.
- He platelets form in  $\text{ErT}_2$  and  $\text{TiT}_2$ , eventually connecting to form large cracks that appear to reach the surface in some cases.
- No publications have connected surface microstructure with bubble microstructure (SEM to TEM).

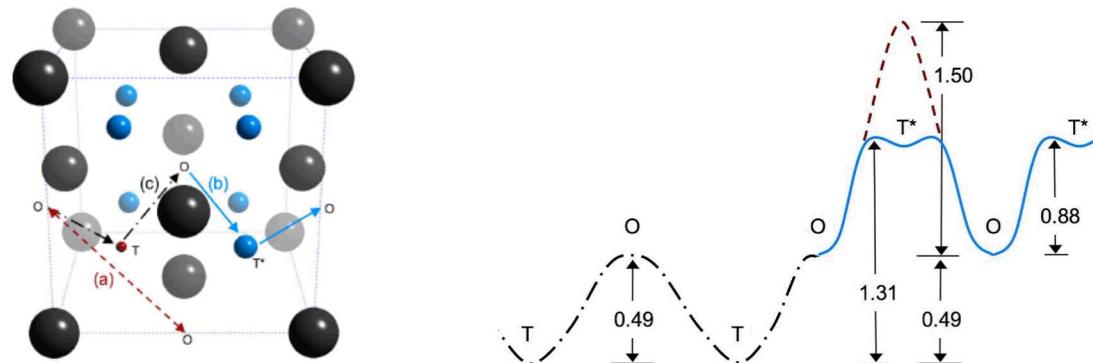
Helium Traps in T-site & Migrates through T-T diffusion in  $\beta$ -ErT<sub>2</sub>

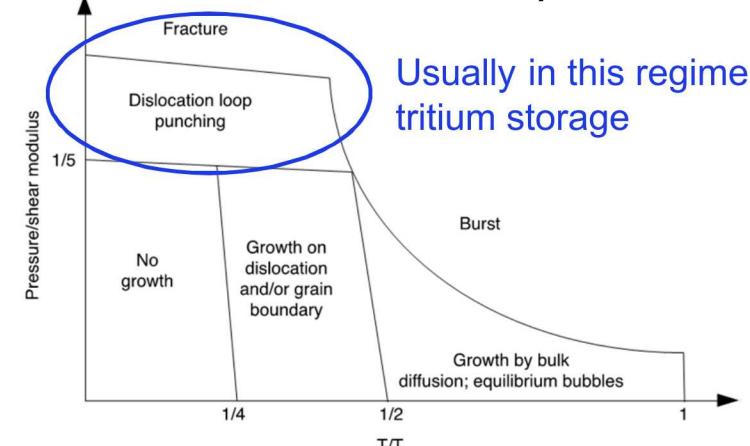
## Wolfer He Bubble “Growth Map” for Metals

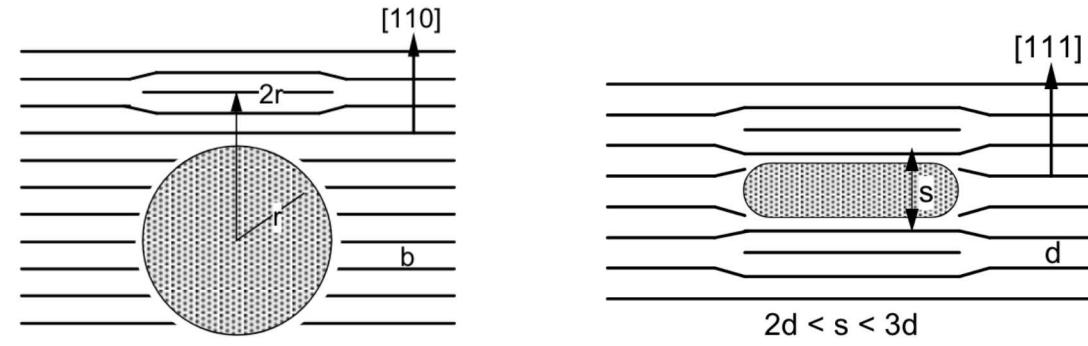
Spherical Bubbles Growth by “Dislocation Loop Punching” and Platelets can Grow by “Dislocation Dipole Expansion”

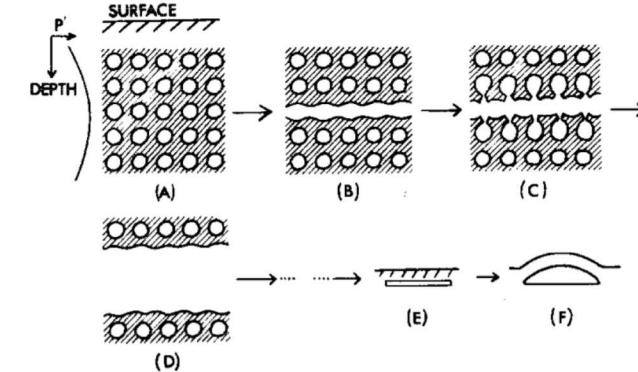
## Inter-Bubble Fracture Accelerated Helium Release Mechanism

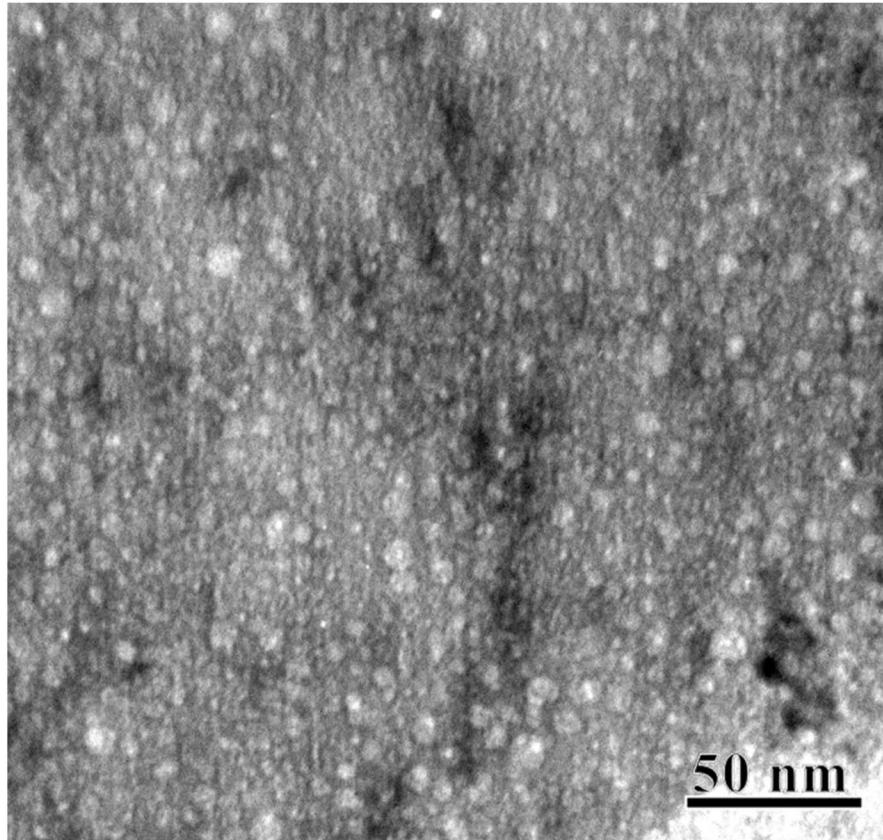
In-situ TEM anneal of **tritium aged Pd- 5% Ni** alloy containing ~12 at.% He

In-situ annealing at  $400^{\circ}\text{C}$  ,  $T/T_M = 0.37$

- Since bubble density is extremely high in tritides, growth occurs by 1) He diffusion to bubble or 2) absorption of nearby cavities (potentially by nanoscale inter-bubble fracture between cavities?). No cavity migration.

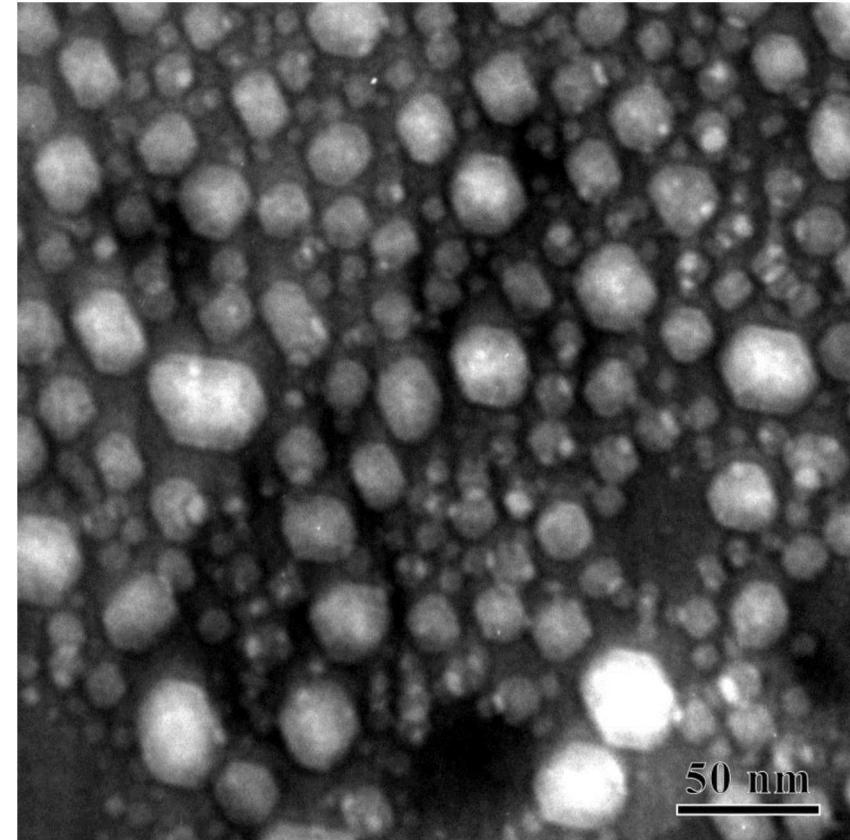
In-situ annealing at  $900^{\circ}\text{C}$  ,  $T/T_M = 0.64$

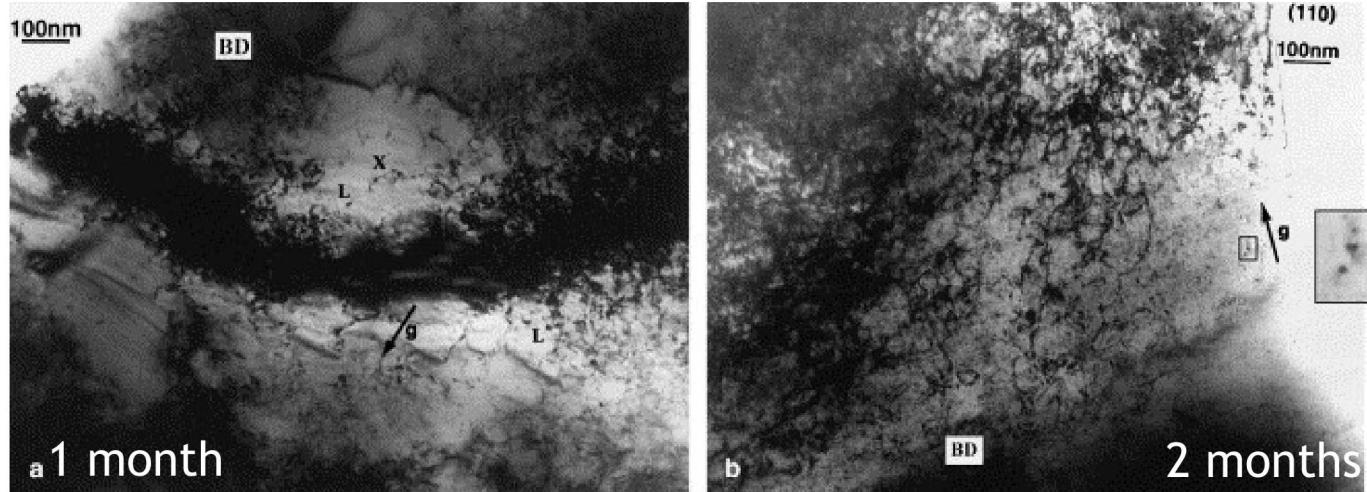
Dense Dislocation Network has been Imaged in PdT

- Dislocations are created in the metal phase during hydride formation.
- Dislocation density continues to increase with hydriding/de-hydriding cycles.
- Hydriding-induced dislocations may act as trapping sites for He as metal tritides age.

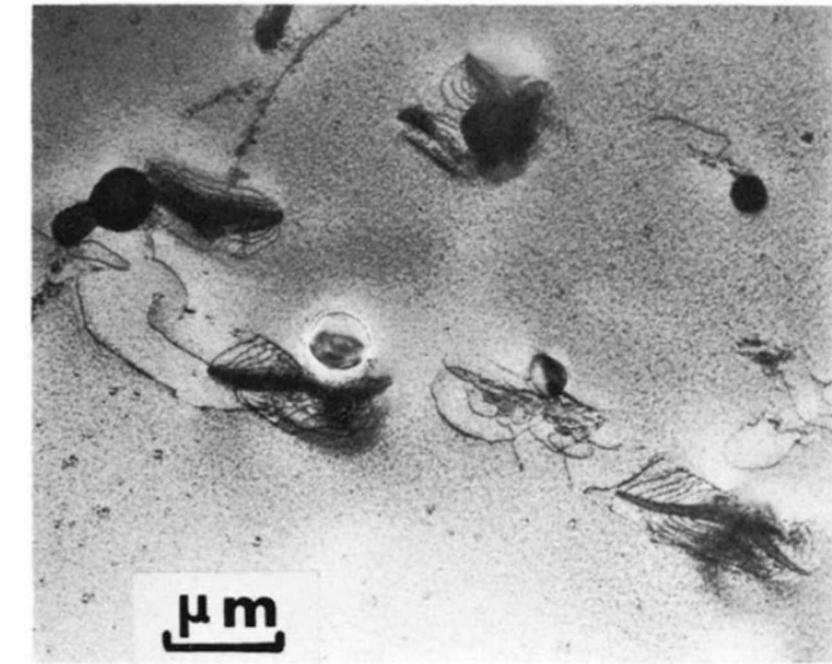
Dislocations Induced by Zr Hydride Nucleation in Zr metal

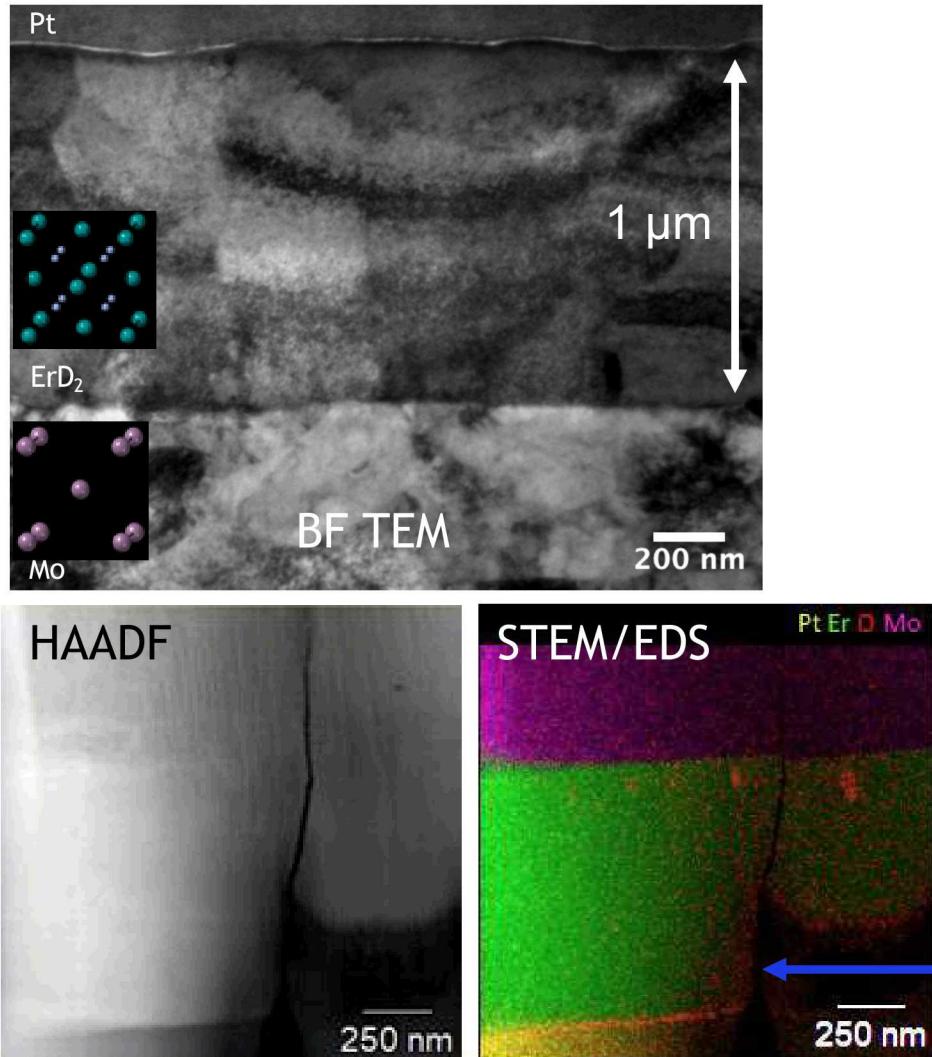
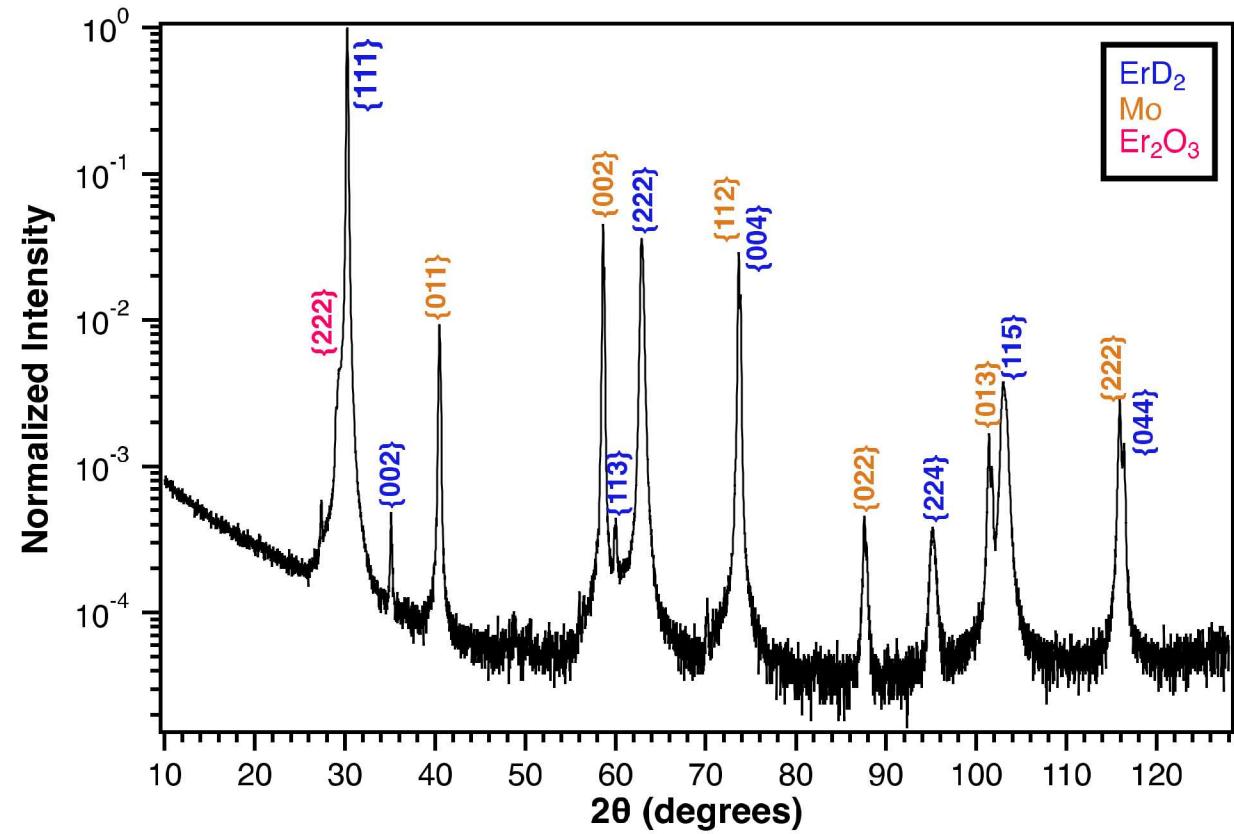
## As-Deposited/Loaded ErD<sub>2</sub> Samples were Characterized with TEM & XRD

- 1  $\mu\text{m}$  thick Er films were evaporated onto polished Mo substrates and loaded with  $^2\text{H}$ , a surrogate for  $^3\text{H}$ .

- Very little oxide in XRD pattern

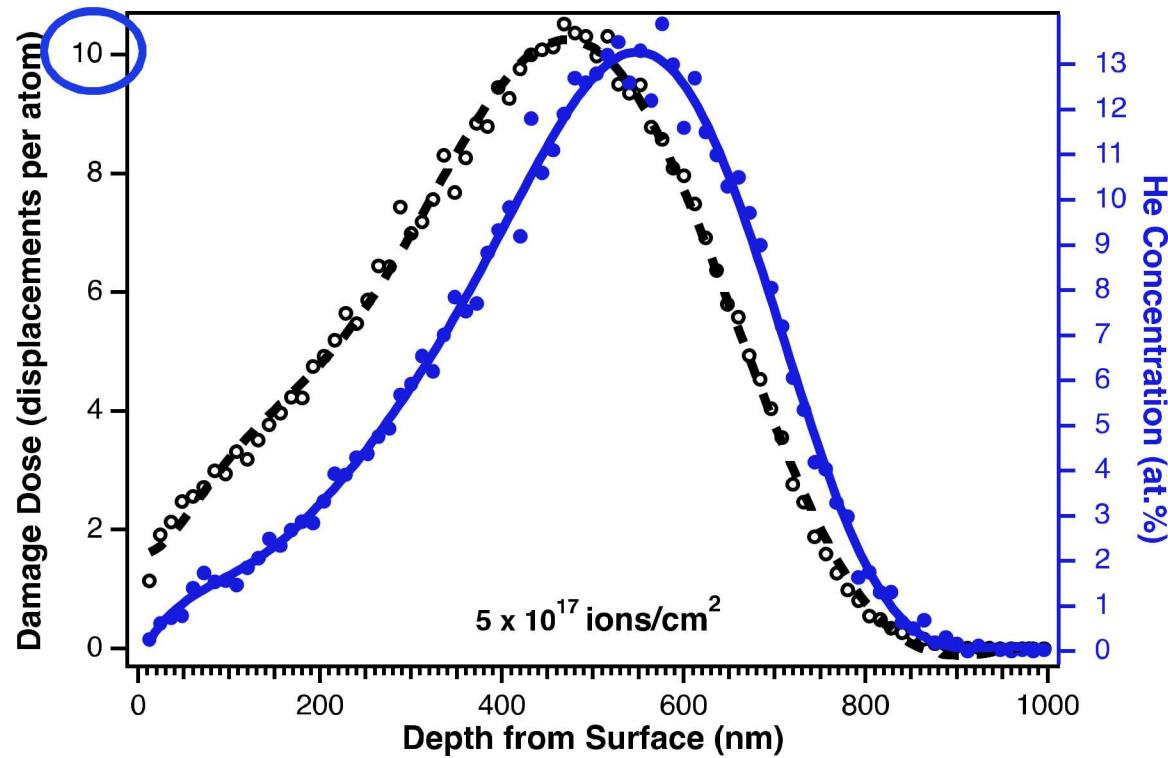
Bulk Implantations were done using 120 keV <sup>4</sup>He

- He implantation is used to reach “accelerated release” level He concentrations (>10 at.% He) in a day, rather than several years. Removes radioactive contamination hazards.
- Implantation is not an exact surrogate for <sup>3</sup>H β-decay, which causes zero atomic displacement damage and continuously removes H from the lattice.

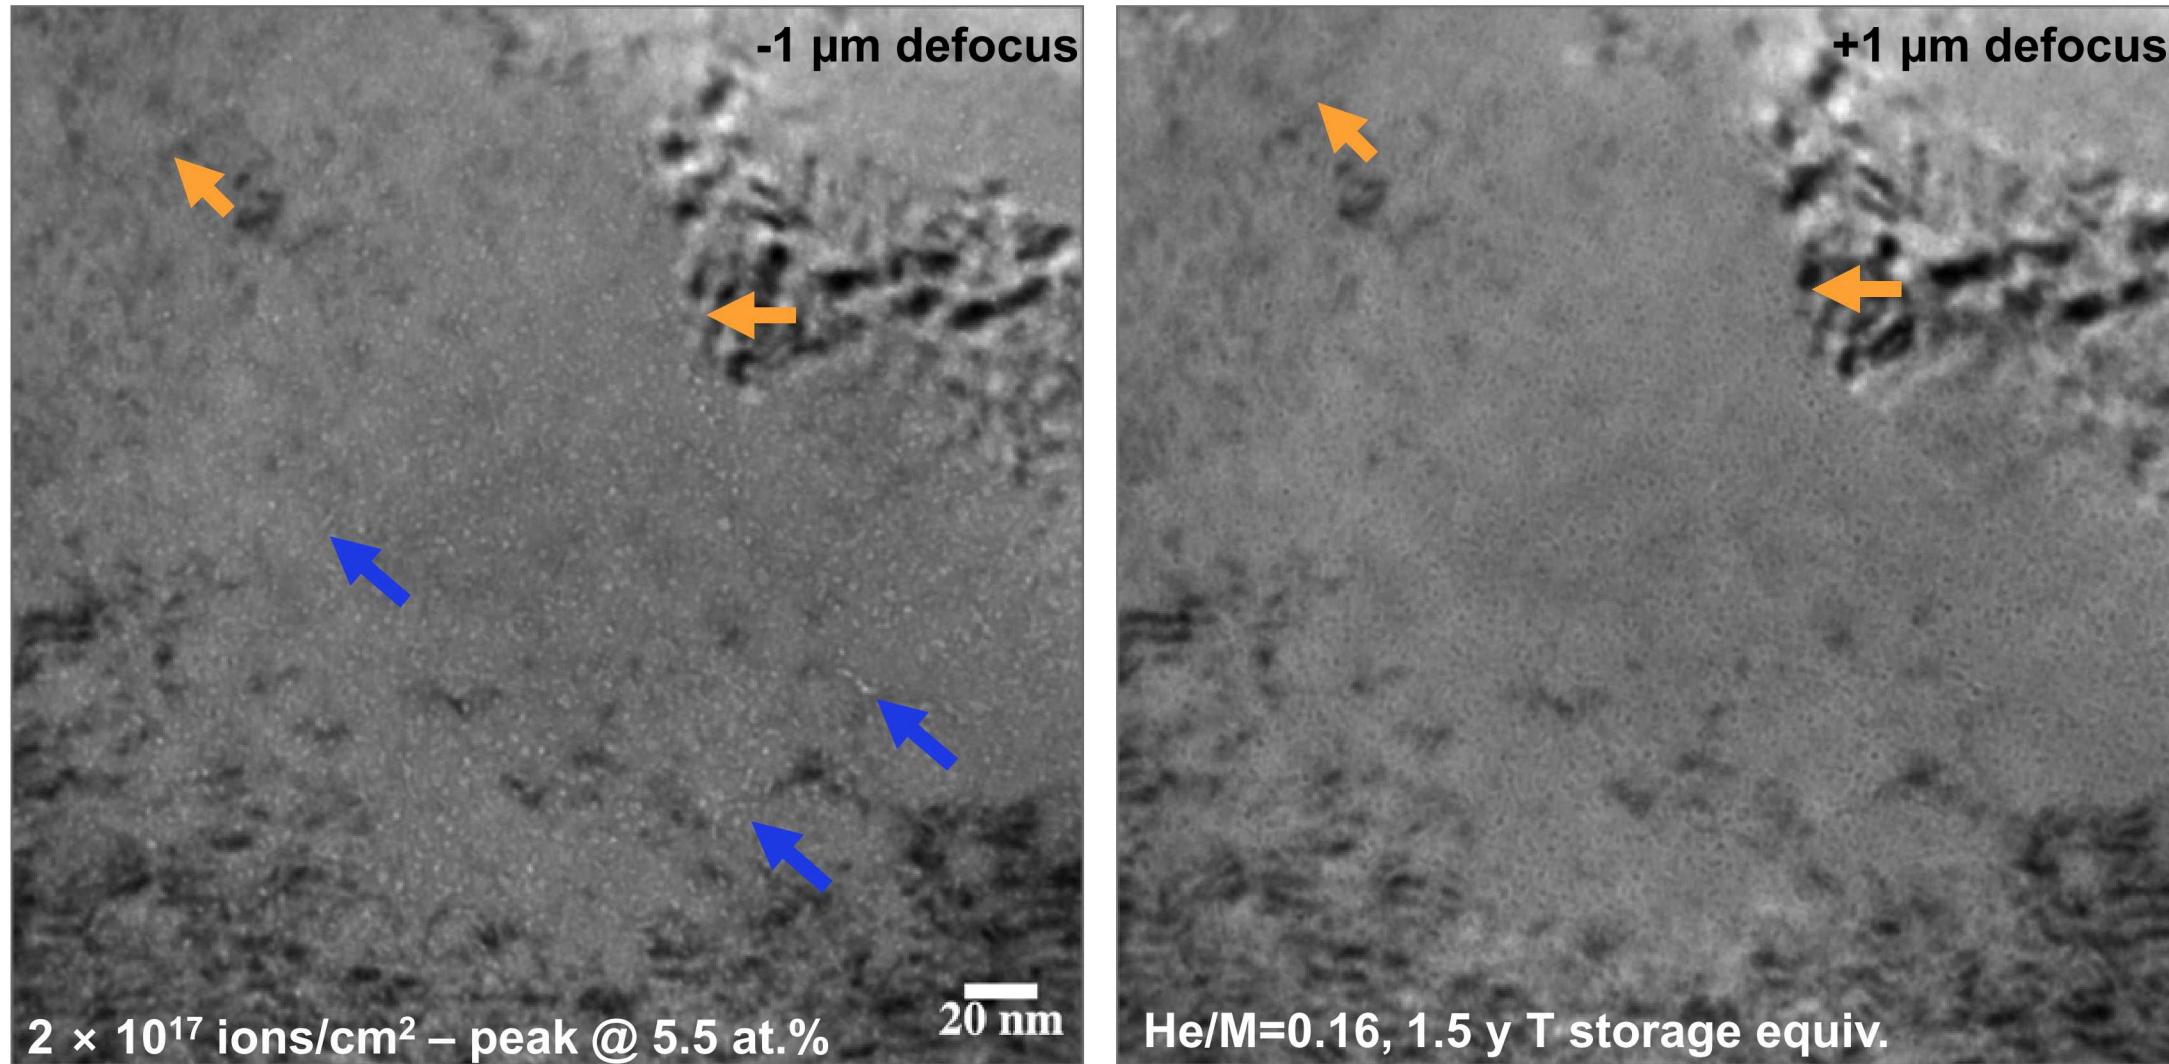
## Nanometer Sized He Bubbles were Observed After 1-3 at.% He

- He bubbles were found starting at 1.7 at.% (low density). Grain boundary nucleation & some evidence of linkage.

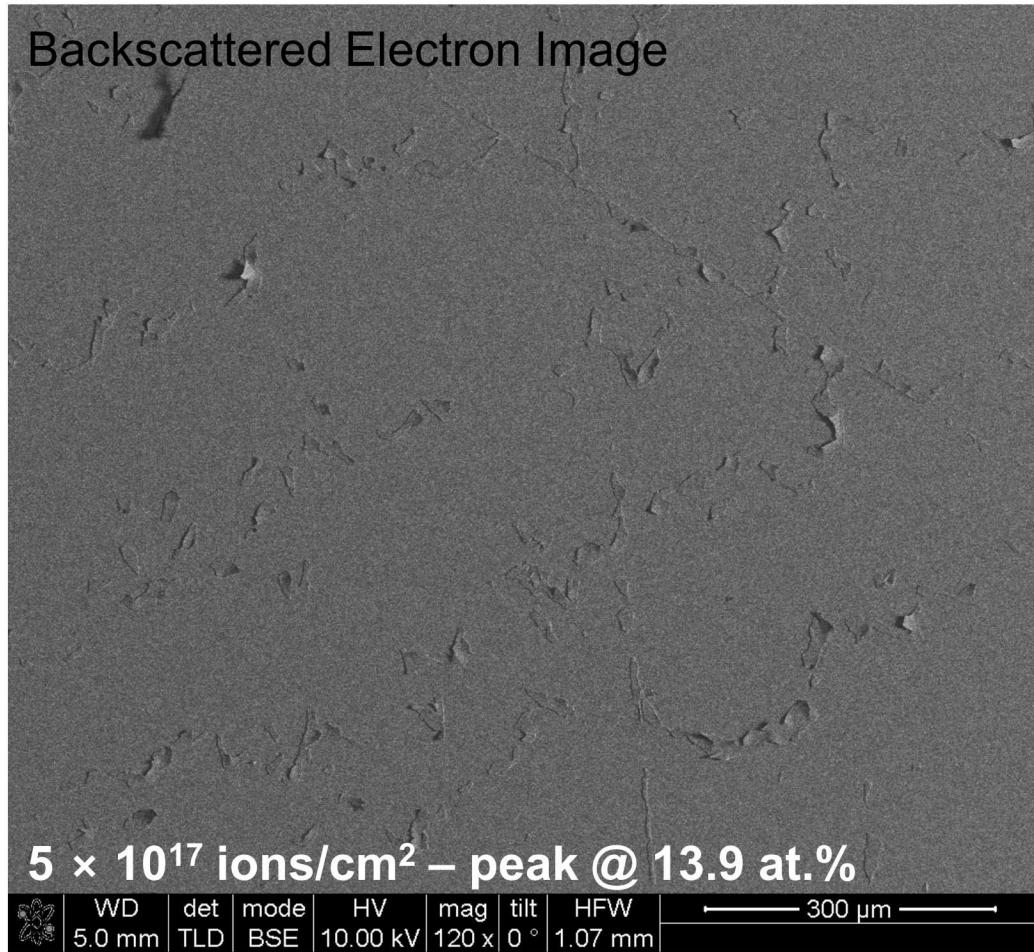
Backscattered Electron Image

# Significant Surface Spalling Occurred after Implantation to High Dose

- SE image shows that most of the surface spalled off, leaving a few un-spalled areas. Lack of contrast in BSE image shows that spalling occurred within the 1 μm film thickness, not at the substrate.
- Fracture surface does not appear to show intergranular fracture, no obvious failure mechanism.

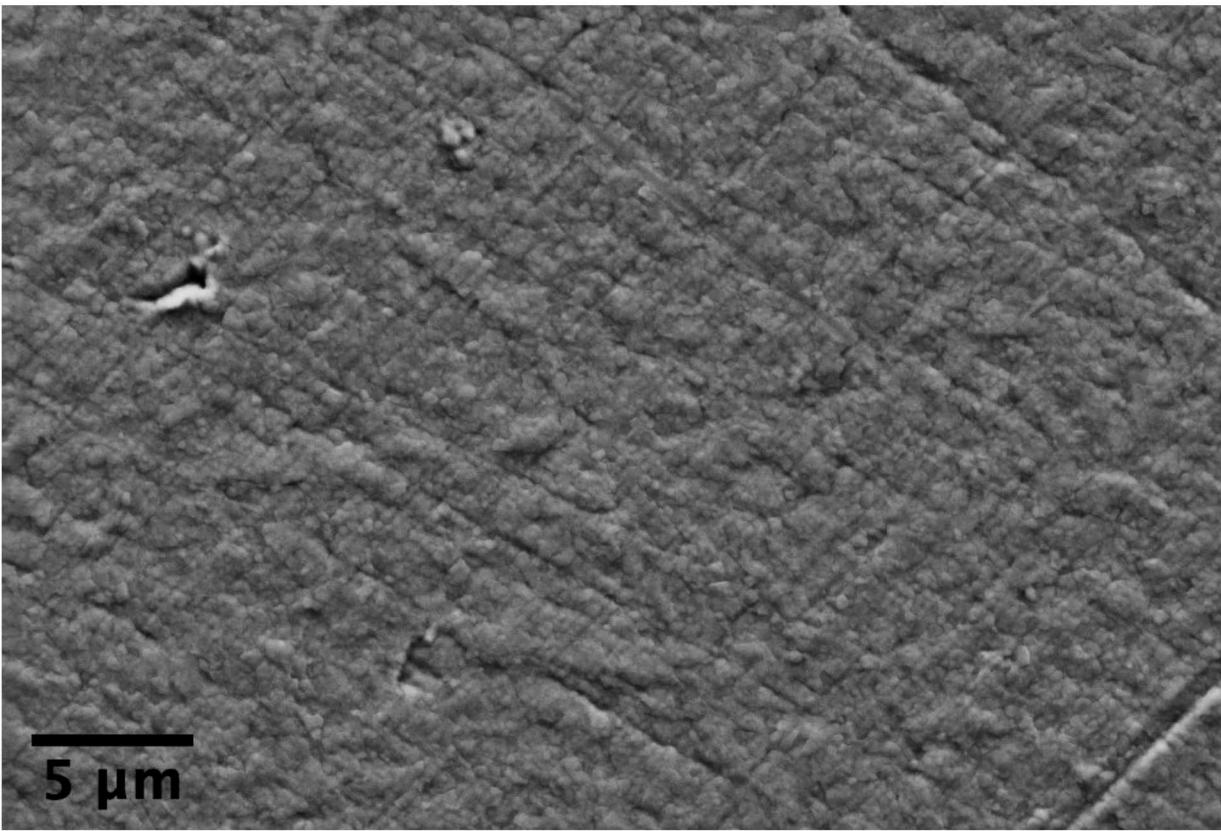
Unirradiated Surface

## No Evidence of Blister Formation in Un-Spalled Regions

- Un-spalled surfaces appear nearly identical to the unirradiated sample surface, with the exception of cracks and flaked regions.
- Edges of un-spalled areas appear very jagged, not round as one would expect if blisters had burst to form them.

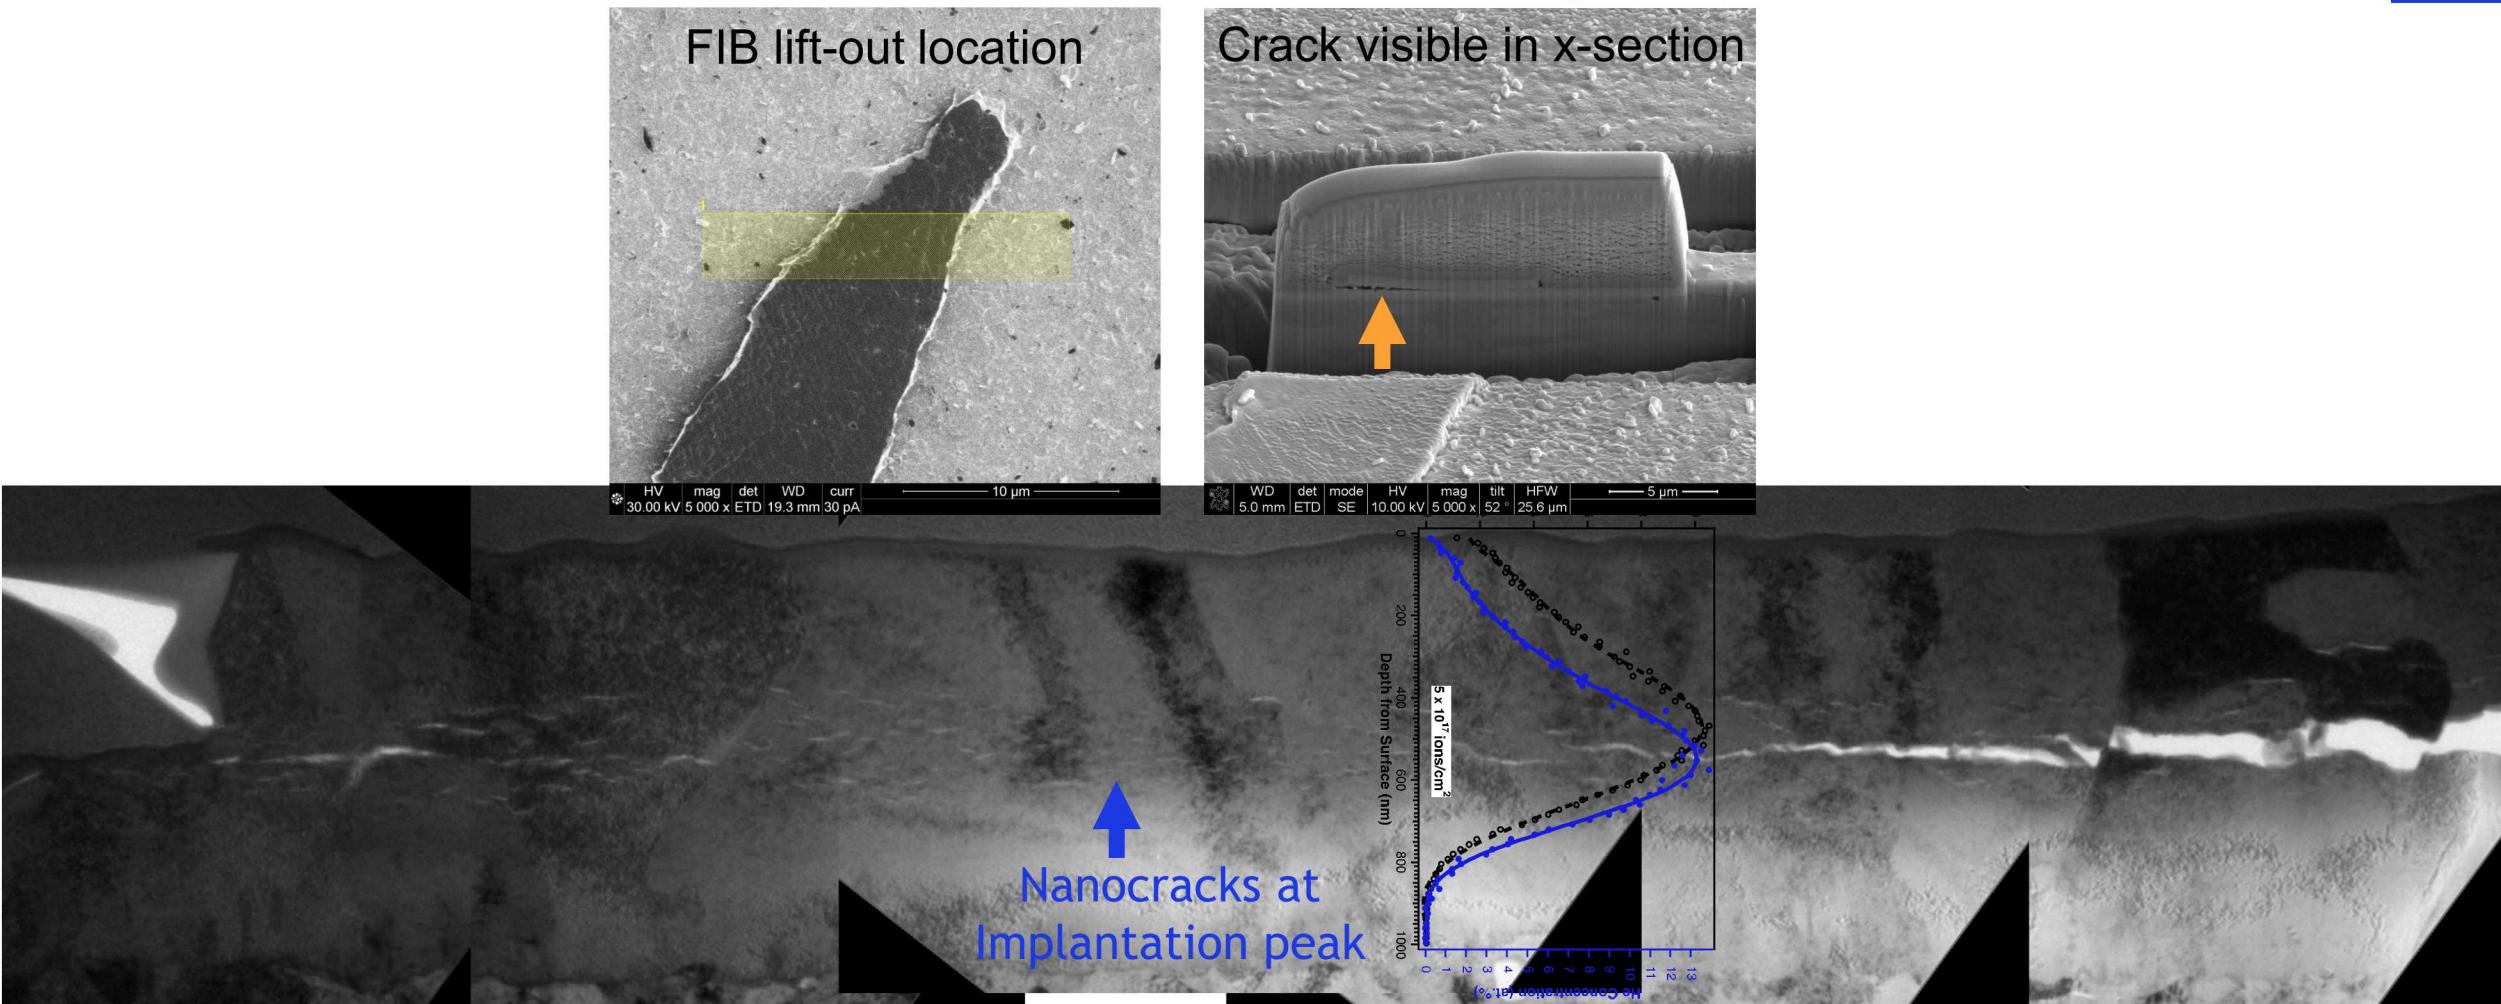
## Nanosized Cracks were Observed in the Un-Spalled Areas

- Nanocracks appear after ~7.5 at.% He. Stress between cracks causes linkage at the implantation peak, forming larger cracks that cause spalling.

- Intragranular nano-cracks were identified parallel to the surface in un-spalled areas of the implanted film.
- As stresses between the cracks increase, the cracks eventually link, forming larger cracks that cause spallation.
- A similar release mechanism may be occurring in  $\text{ErT}_2$ , where stresses between He platelets may cause linkage.

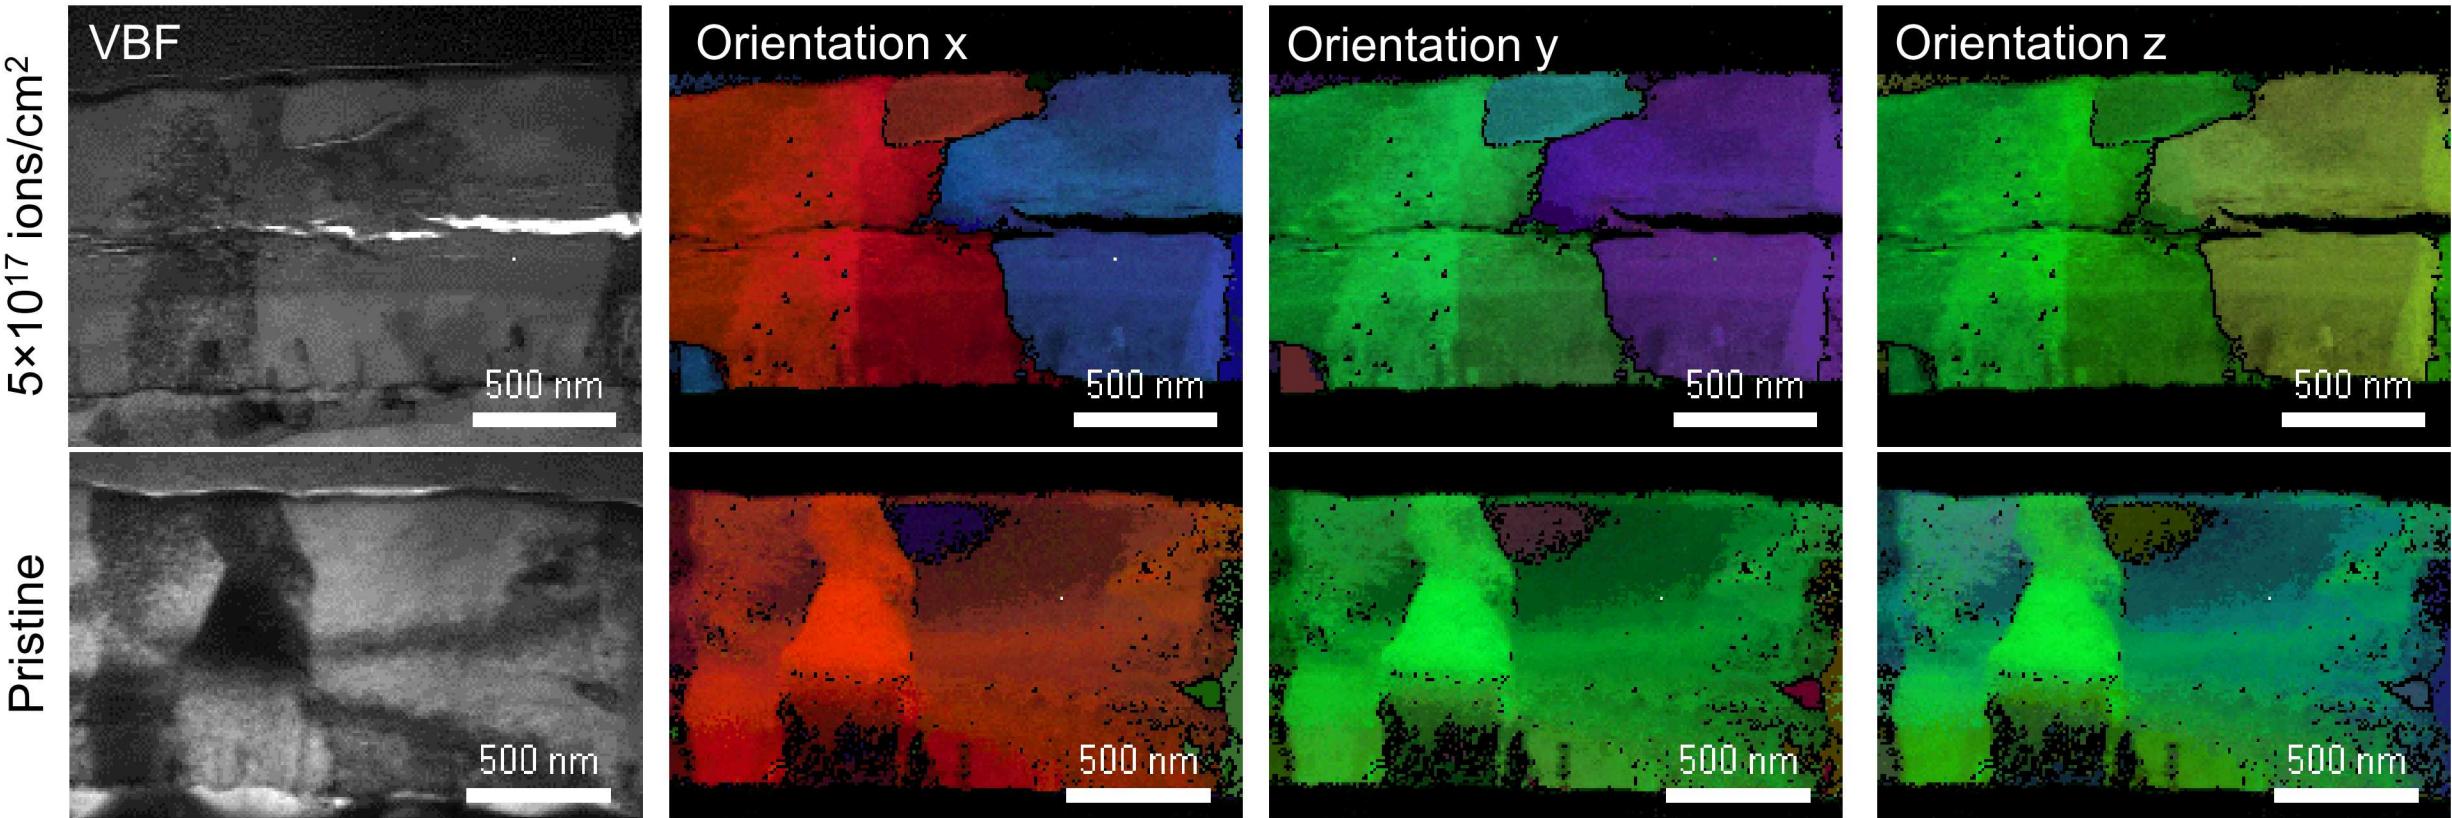
## Precession Electron Diffraction Confirmed Intragranular Cracking

- Crack clearly initiates inside the grain and propagates intragranularly.
- Small misorientations (<15°) were measured near the near the crack region in some samples but were believed to be due to bending in the FIB lift-out, as they are also present in the pristine (unirradiated) sample.
