Sandia  
National  
Laboratories

SAND2019-11271C

# Helium Bubble Evolution in Implanted Erbium Deuteride Bulk and Multilayered Structures

**Caitlin Taylor**, Sandia National Laboratories, ABQ, NM

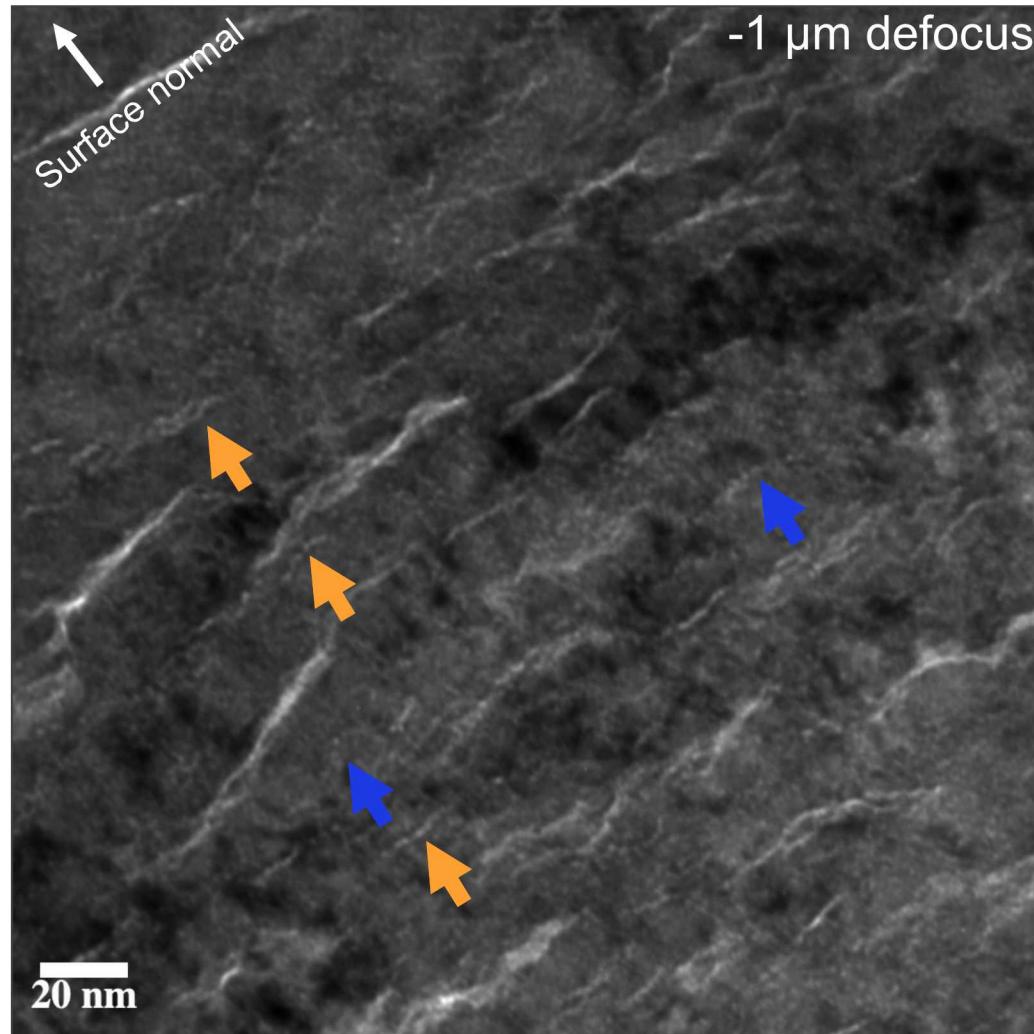
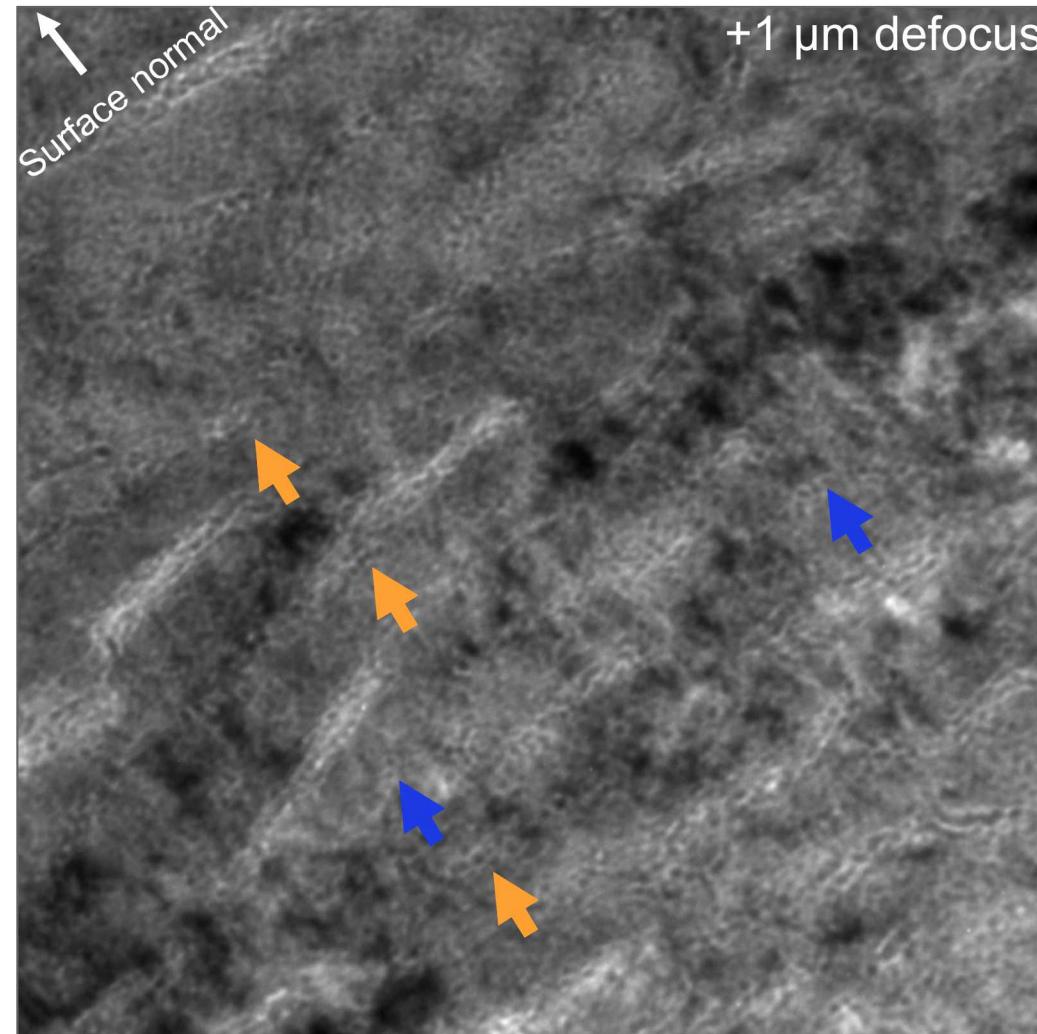
## Bubbles Appear to Form Chains that Lead to Nano-crack Formation

- Nano-cracks are spaced 4-15 nm apart and not always exactly parallel with the surface. In some cases, the bubble chains appear to be forming along **interfaces or defects**.

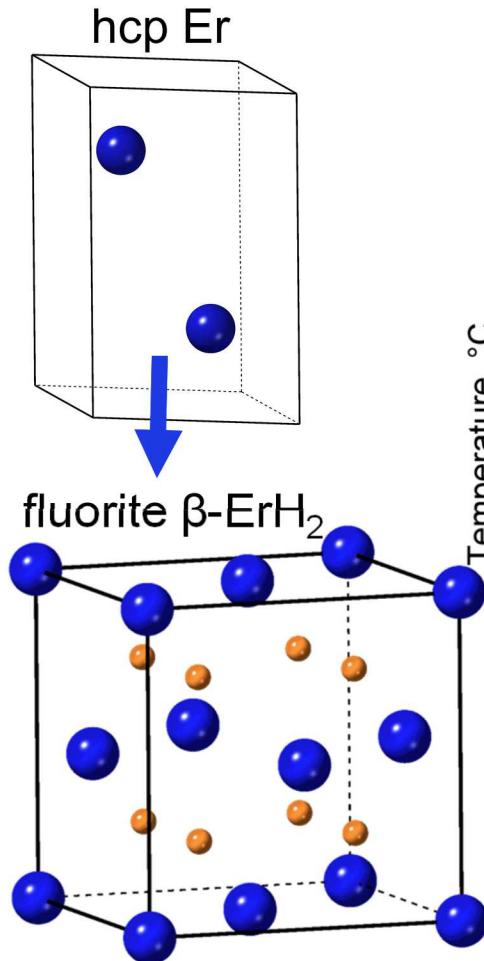
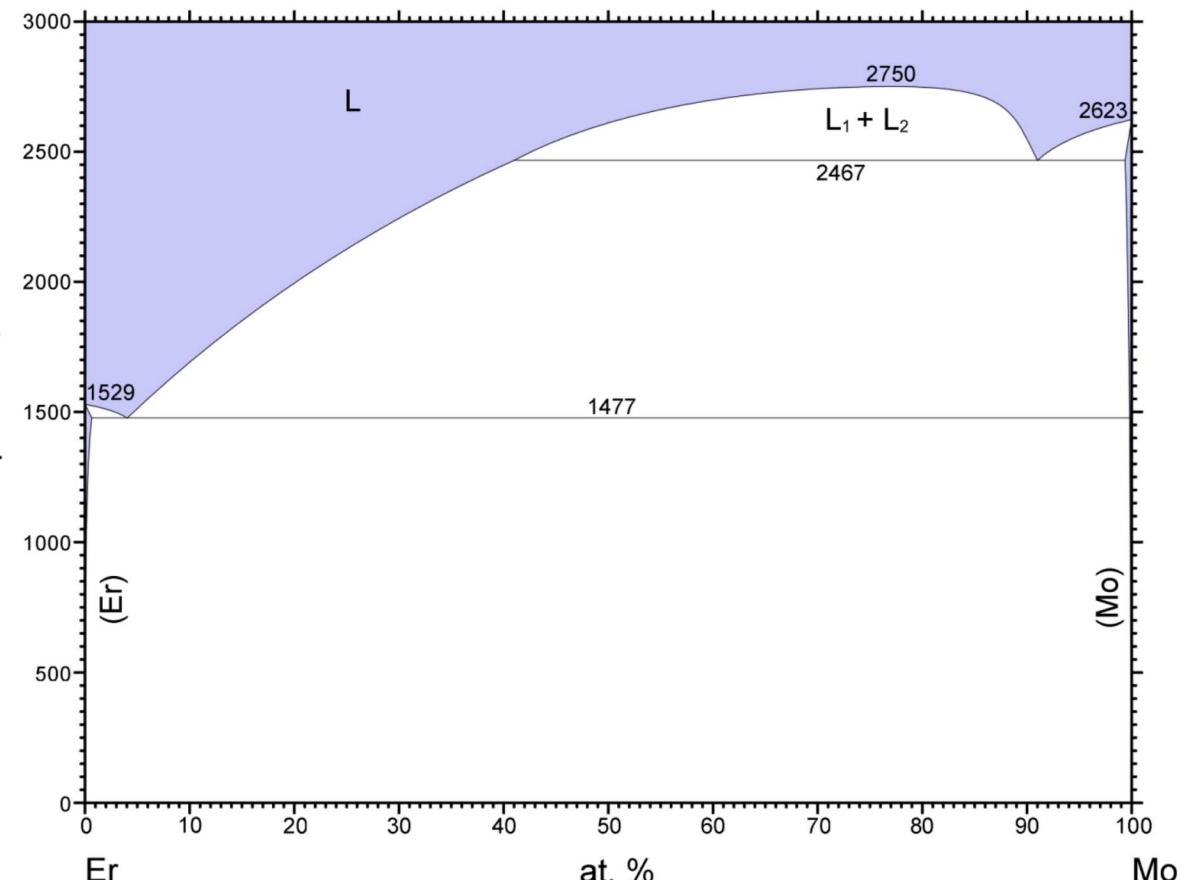
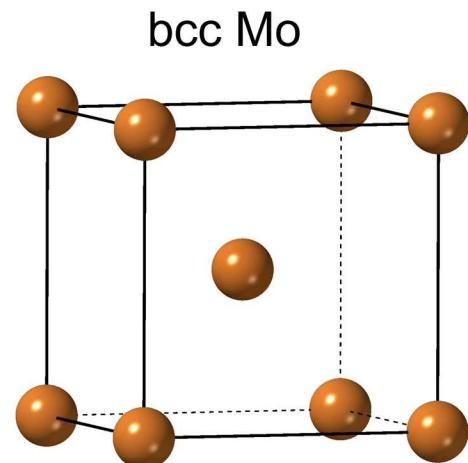
## All Multilayered Structures were Prepared with Er and Mo

- Er and Mo are fully immiscible up to 1477°C and remain immiscible after hydriding.
- Hydriding induces a 10% volume expansion, so significant residual stress is expected in the multilayered structure.
- Big Question: Can we initiate the hydride reaction in a multilayered structure?

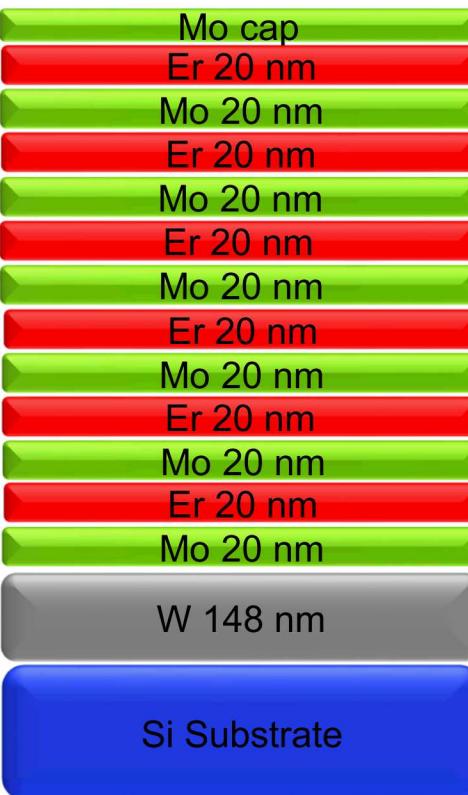
# Multilayer $\text{ErD}_2/\text{Mo}$ Films were Deposited and Successfully Hydrided

- W adhesion layer was sputter deposited at room temperature onto a Si substrate. 13 Er/Mo layers were electron beam evaporated.
- Samples were diced into 1 x 1 cm squares & successfully loaded with deuterium, as evidenced by the absence of hcp-Er & presence of fcc- $\text{ErD}_2$  in the XRD pattern.
- STEM/EDS maps of as-deposited/loaded structures showed no diffusion of adhesion layer, less oxide than previous films.

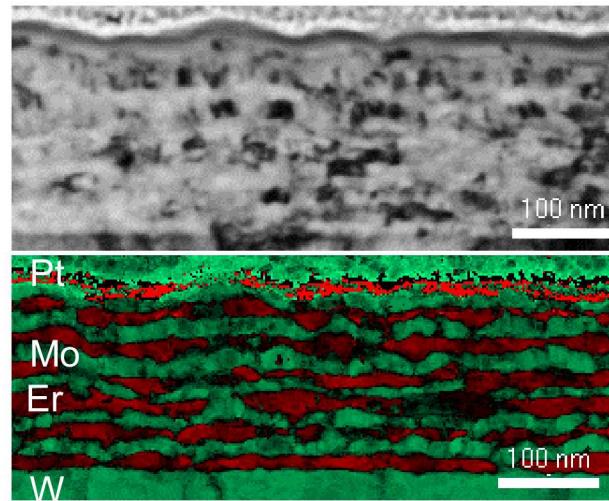
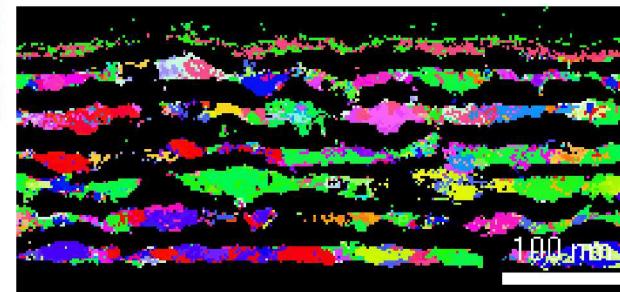
## Er/Mo (as-deposited) Multilayers

Max Er grain size: **31 nm**  
Max Mo grain size: **33 nm**

2 nm step size  
Smallest condenser  
Spot 5,  $\alpha = 3$   
0.1° precession angle

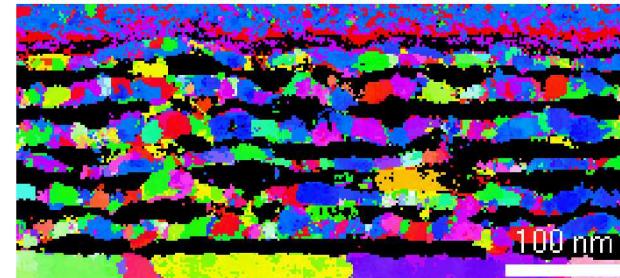
**Mo** z-orientation

### PED parameters

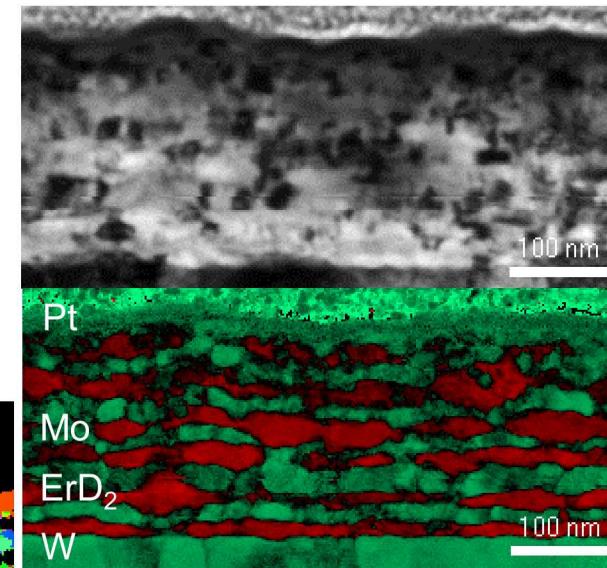
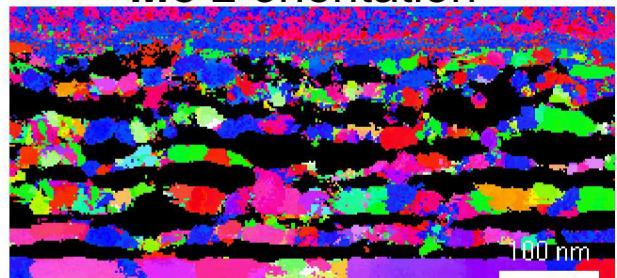
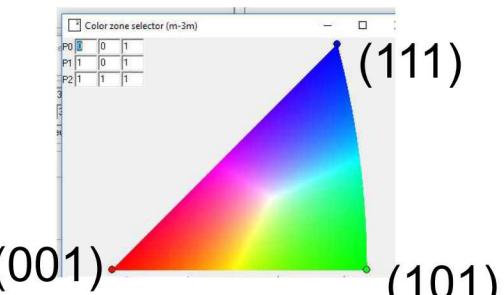
## ErD<sub>2</sub>/Mo (as-loaded) Multilayers

Max ErD<sub>2</sub> grain size: **62 nm**  
Max Mo grain size: **37 nm**

Hydride Reaction Causes 10% Volume Swelling

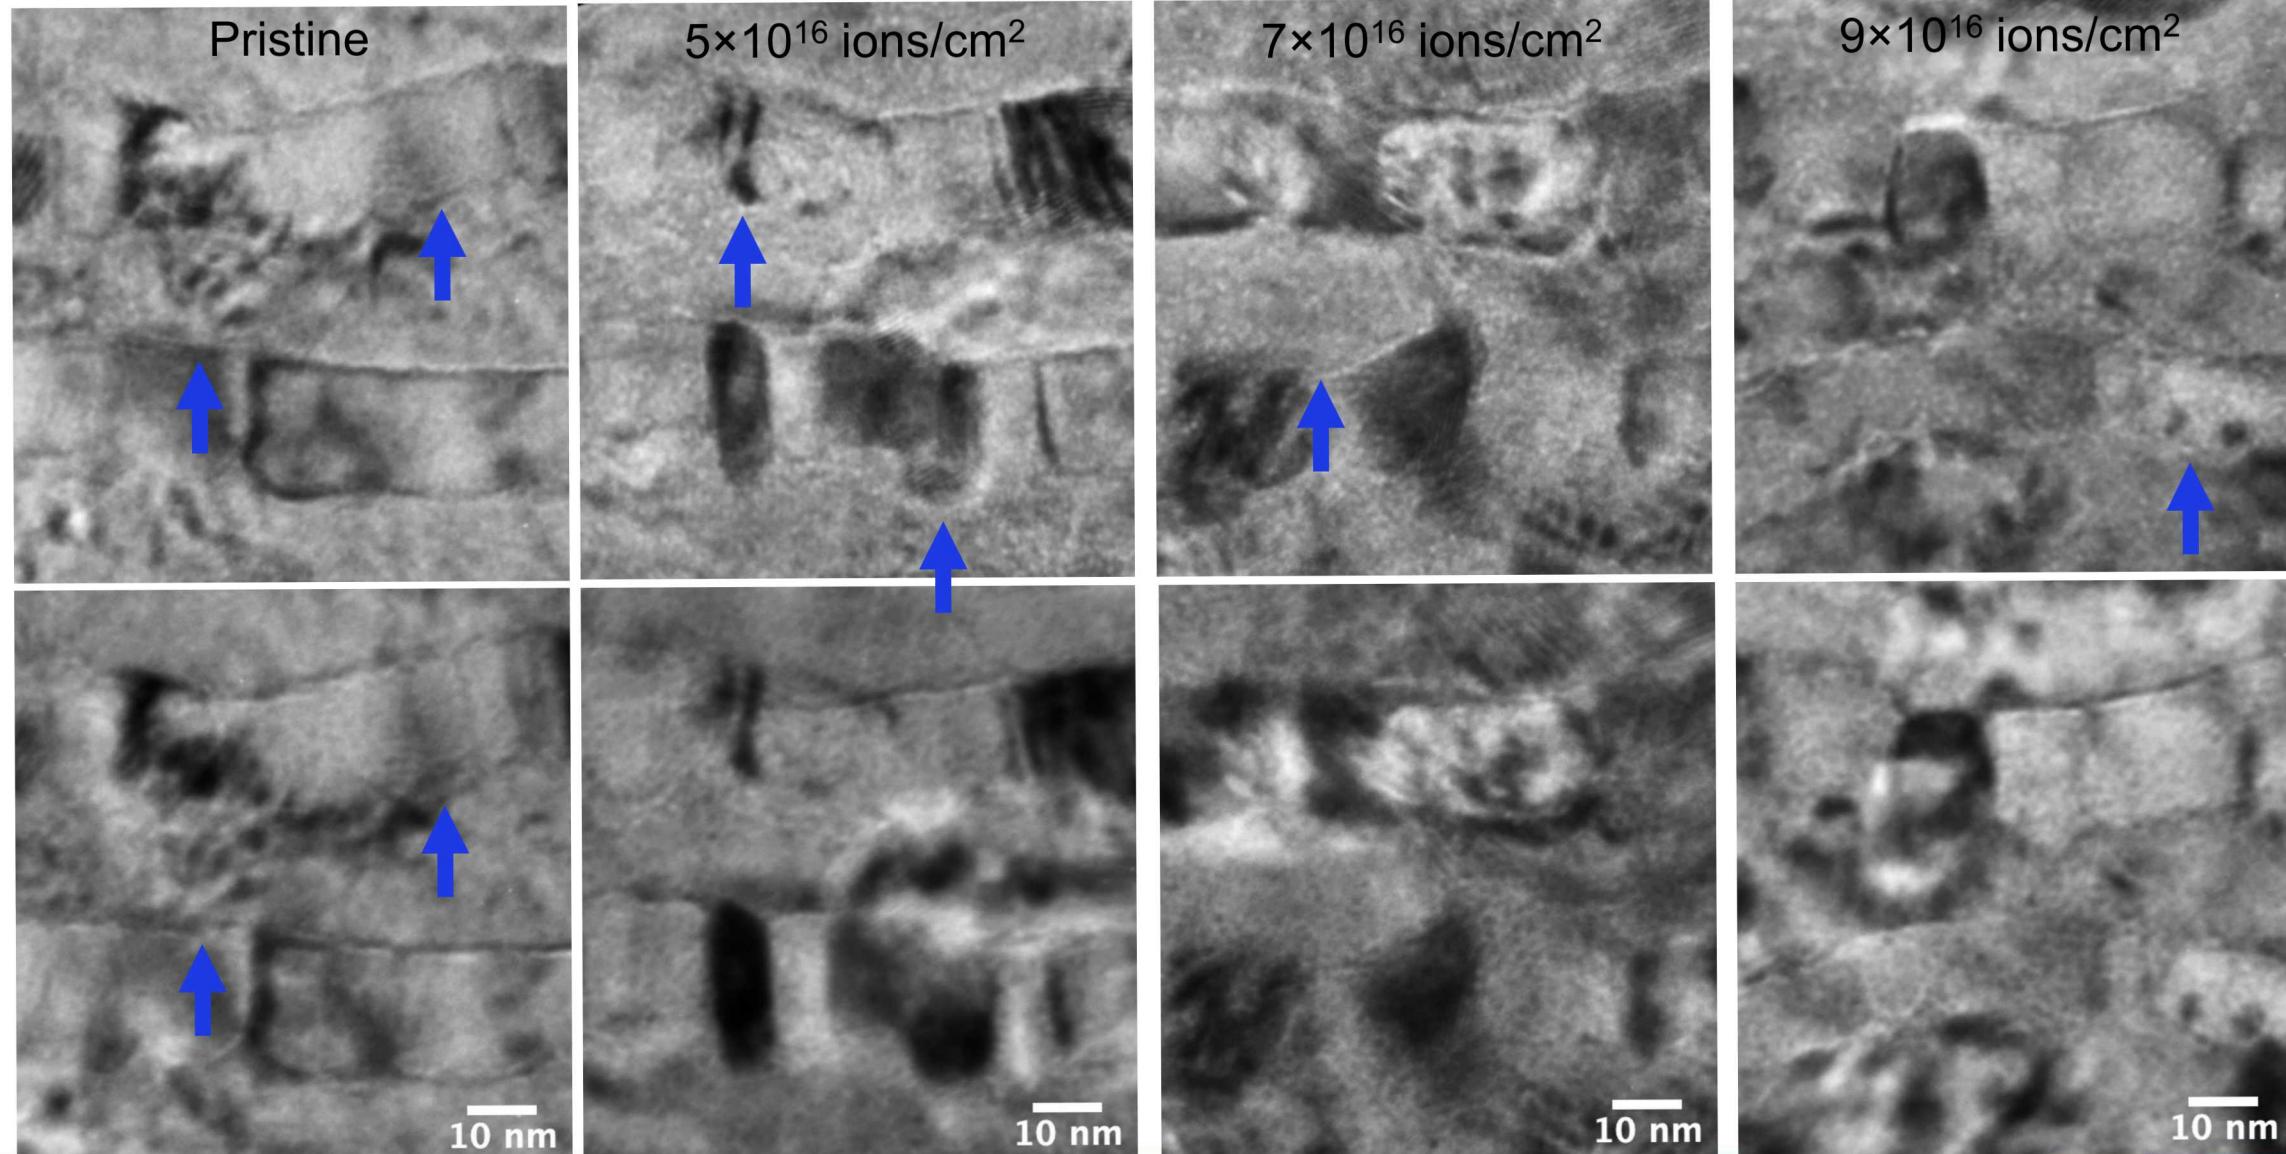
## He Bubbles were Identified at Interfaces and in Matrix

underfocus

overfocus

- Helium was found to trap at multilayered interfaces.
- Helium is being trapped inside the  $\text{ErD}_2$  layers, likely at oxide interfaces.

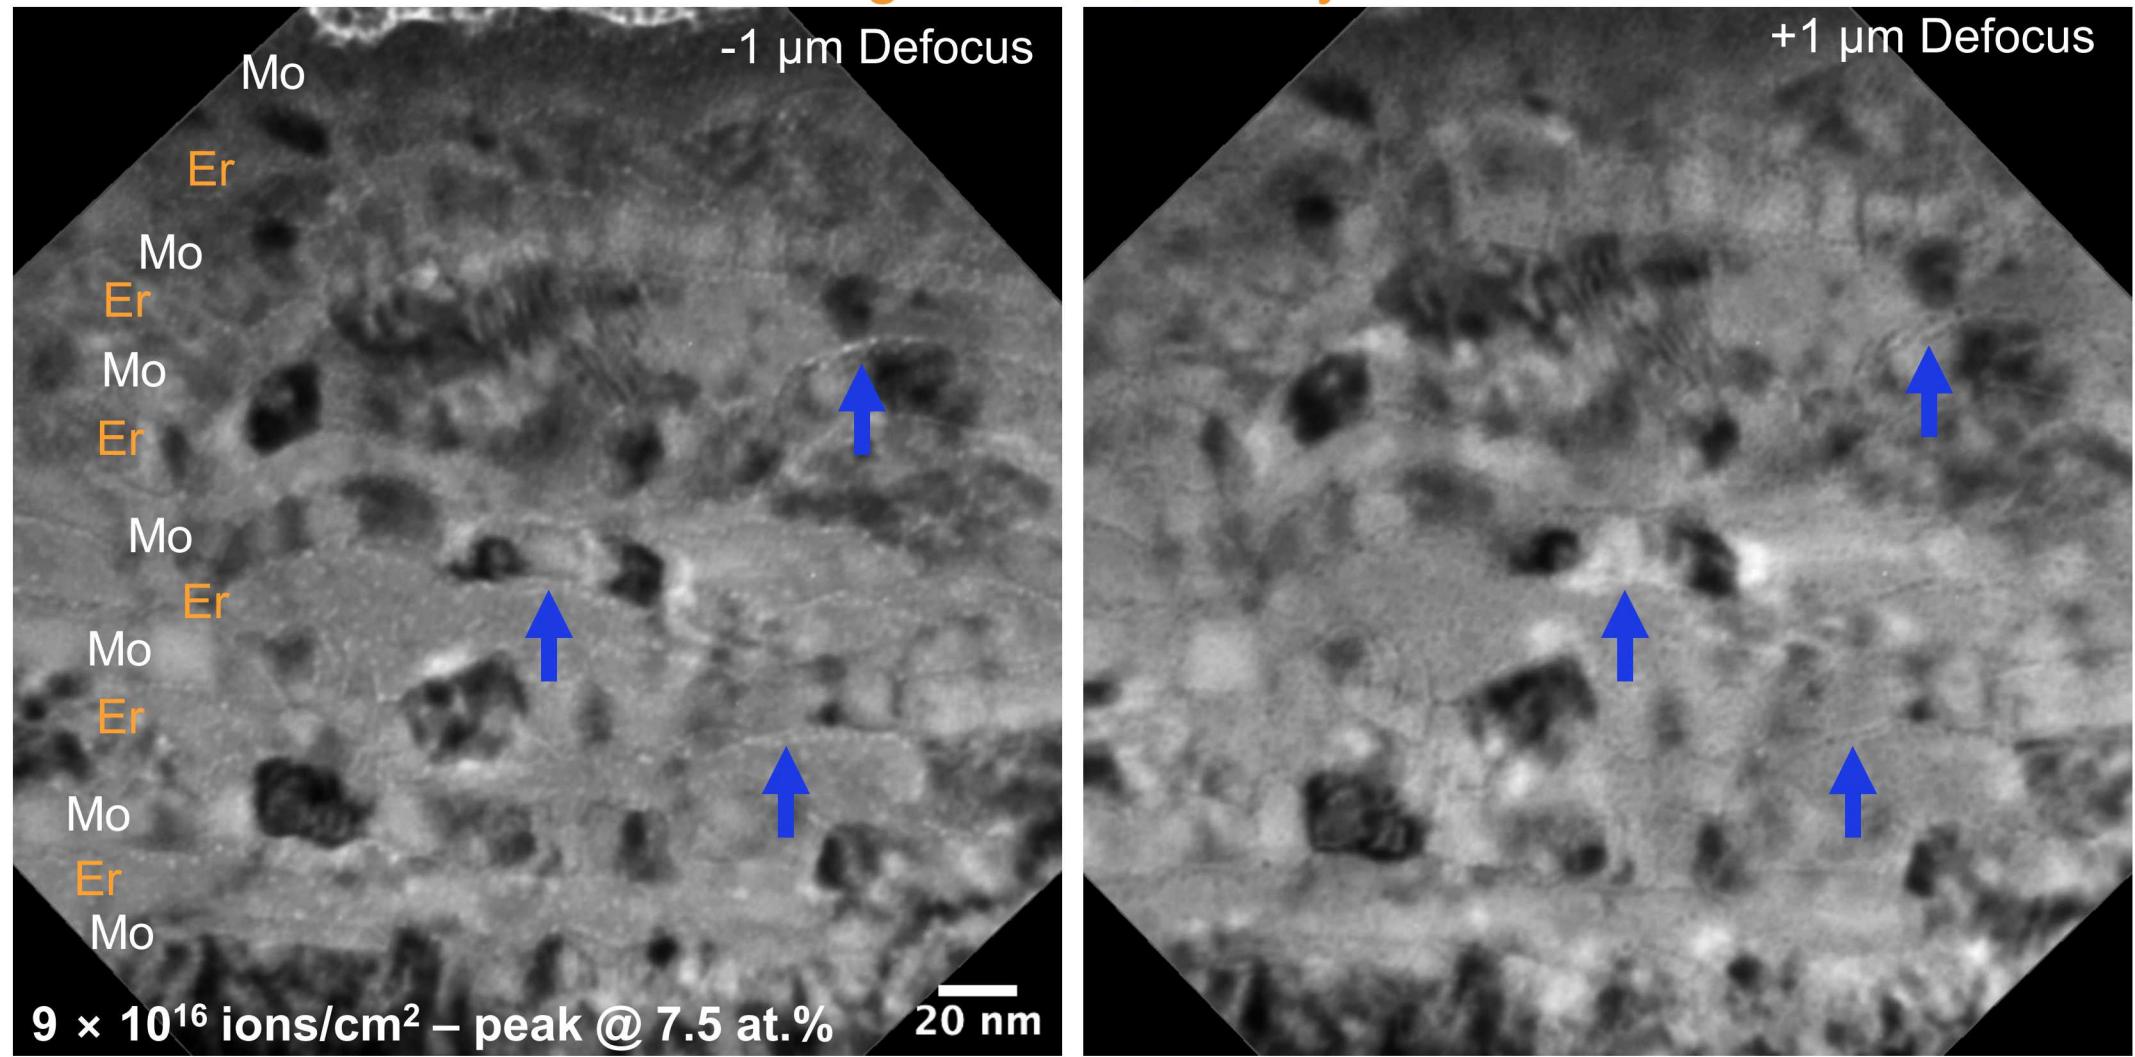
## Bubble Distribution is Inhomogeneous, Likely due to Oxide

- Layers are not uniform due to hydriding induced swelling, so PED was used to identify them.
- Helium bubbles likely inside the ErD<sub>2</sub> layers because of interstitial oxygen or Er<sub>2</sub>O<sub>3</sub> precipitates

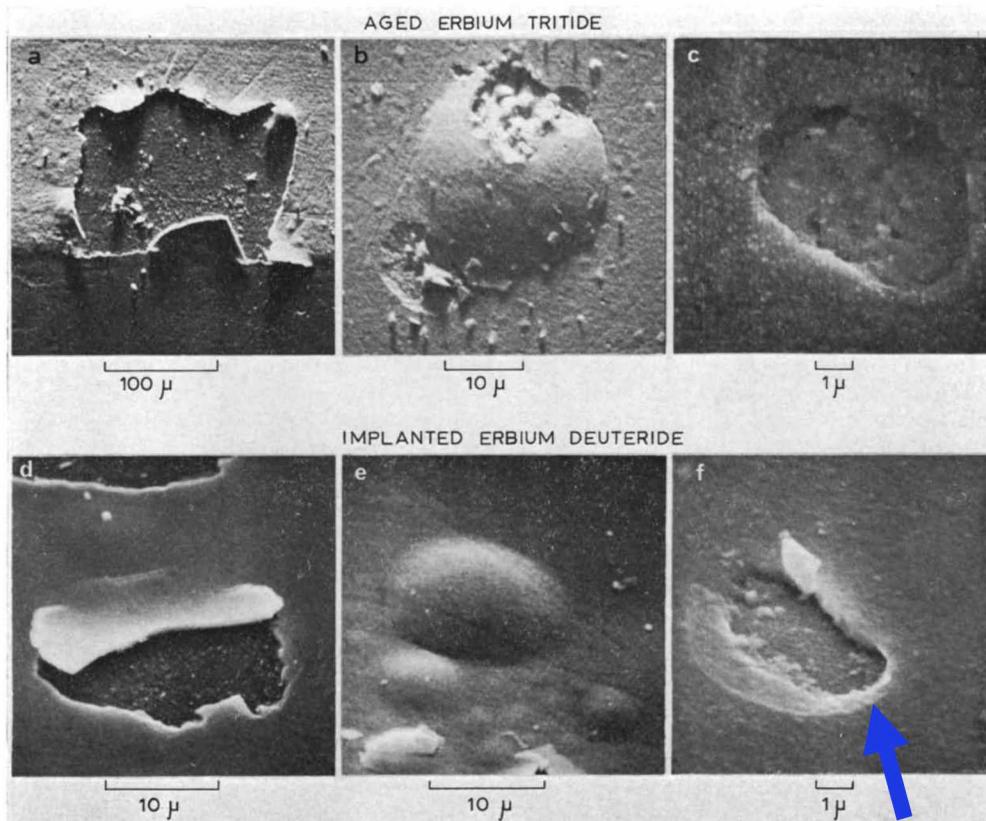
## Literature Reports Blistered Microstructure after He Implantation

Extends to substrate

- Previous results using 120 keV <sup>4</sup>He produced blisters and craters in the material, similar to the microstructures present on the perimeter of the samples implanted in this work.
- This microstructure was similar to the aged ErT<sub>2</sub> images available in literature.

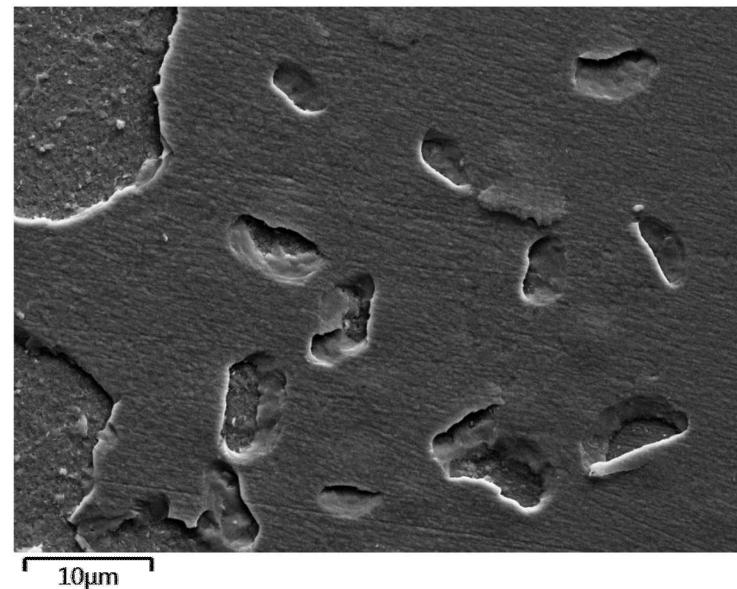
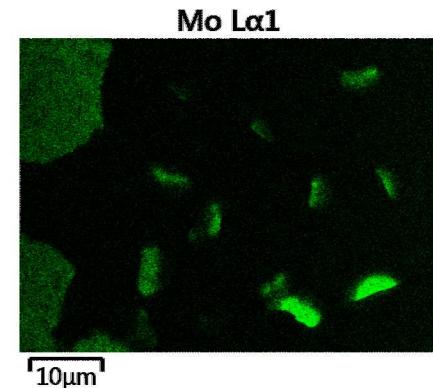
Similar Features in this Work

Some Extend to Substrate

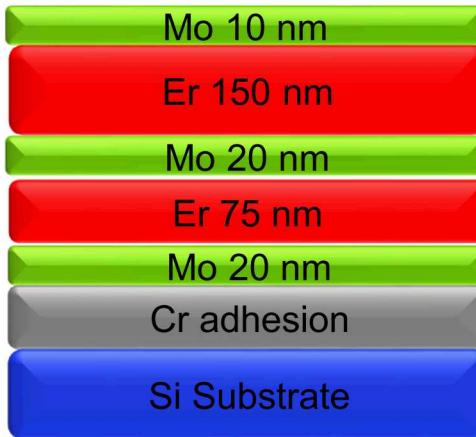
# As a First Attempt, Samples were Prepared with a Single Mo Layer

- Cr/Mo layers were sputter deposited at room temperature onto a Si substrate. 4 Er/Mo layers were electron beam evaporated.
- Samples were diced into 1 x 1 cm squares & loaded with deuterium.
- EDS maps of as-deposited structure showed Cr diffusion through the sputtered Mo layer and some  $\text{Er}_2\text{O}_3$  grains.

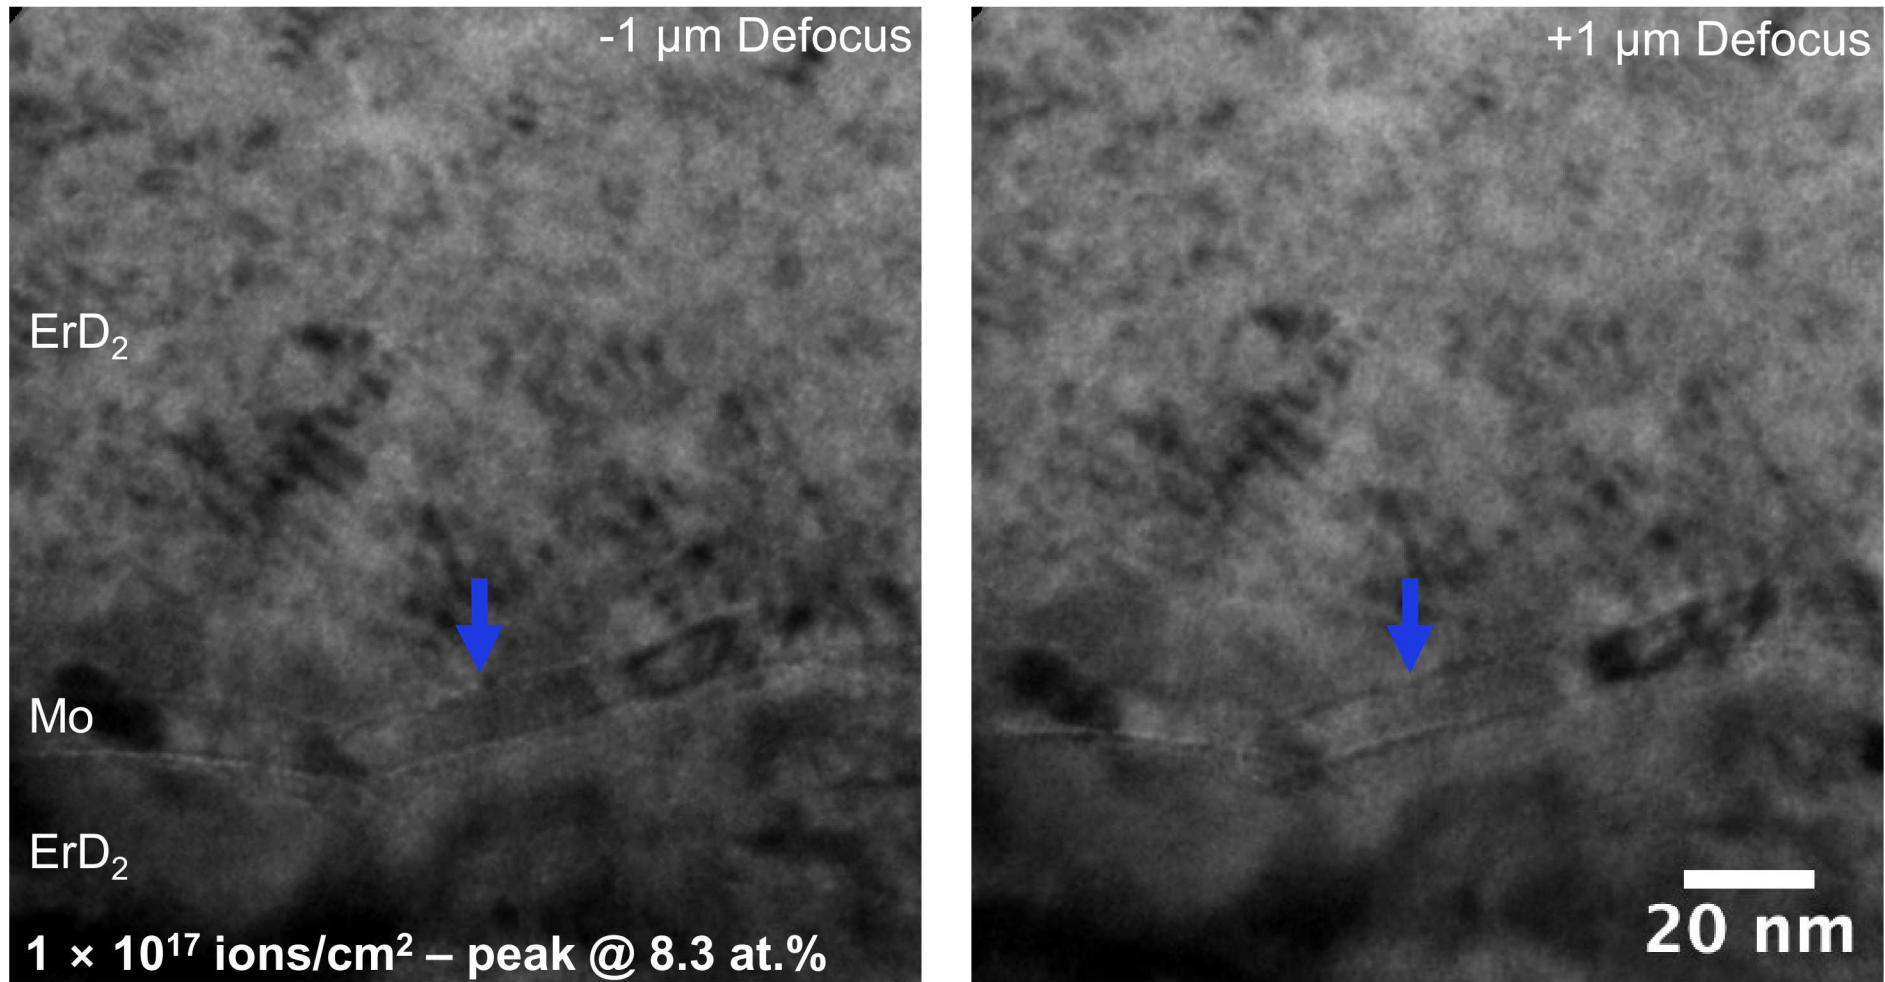
## He Clearly Traps at Mo Interfaces in $\text{ErD}_2/\text{Mo}$ Structure

- Bubbles formed along the Mo interface after “in-situ” implantation to  $8 \times 10^{16} \text{ ions/cm}^2$  (6.7 at.%)
- After implantation to  $1 \times 10^{17} \text{ ions/cm}^2$  (8.3 at.%) bubbles were clearly visible inside grains and along boundaries.

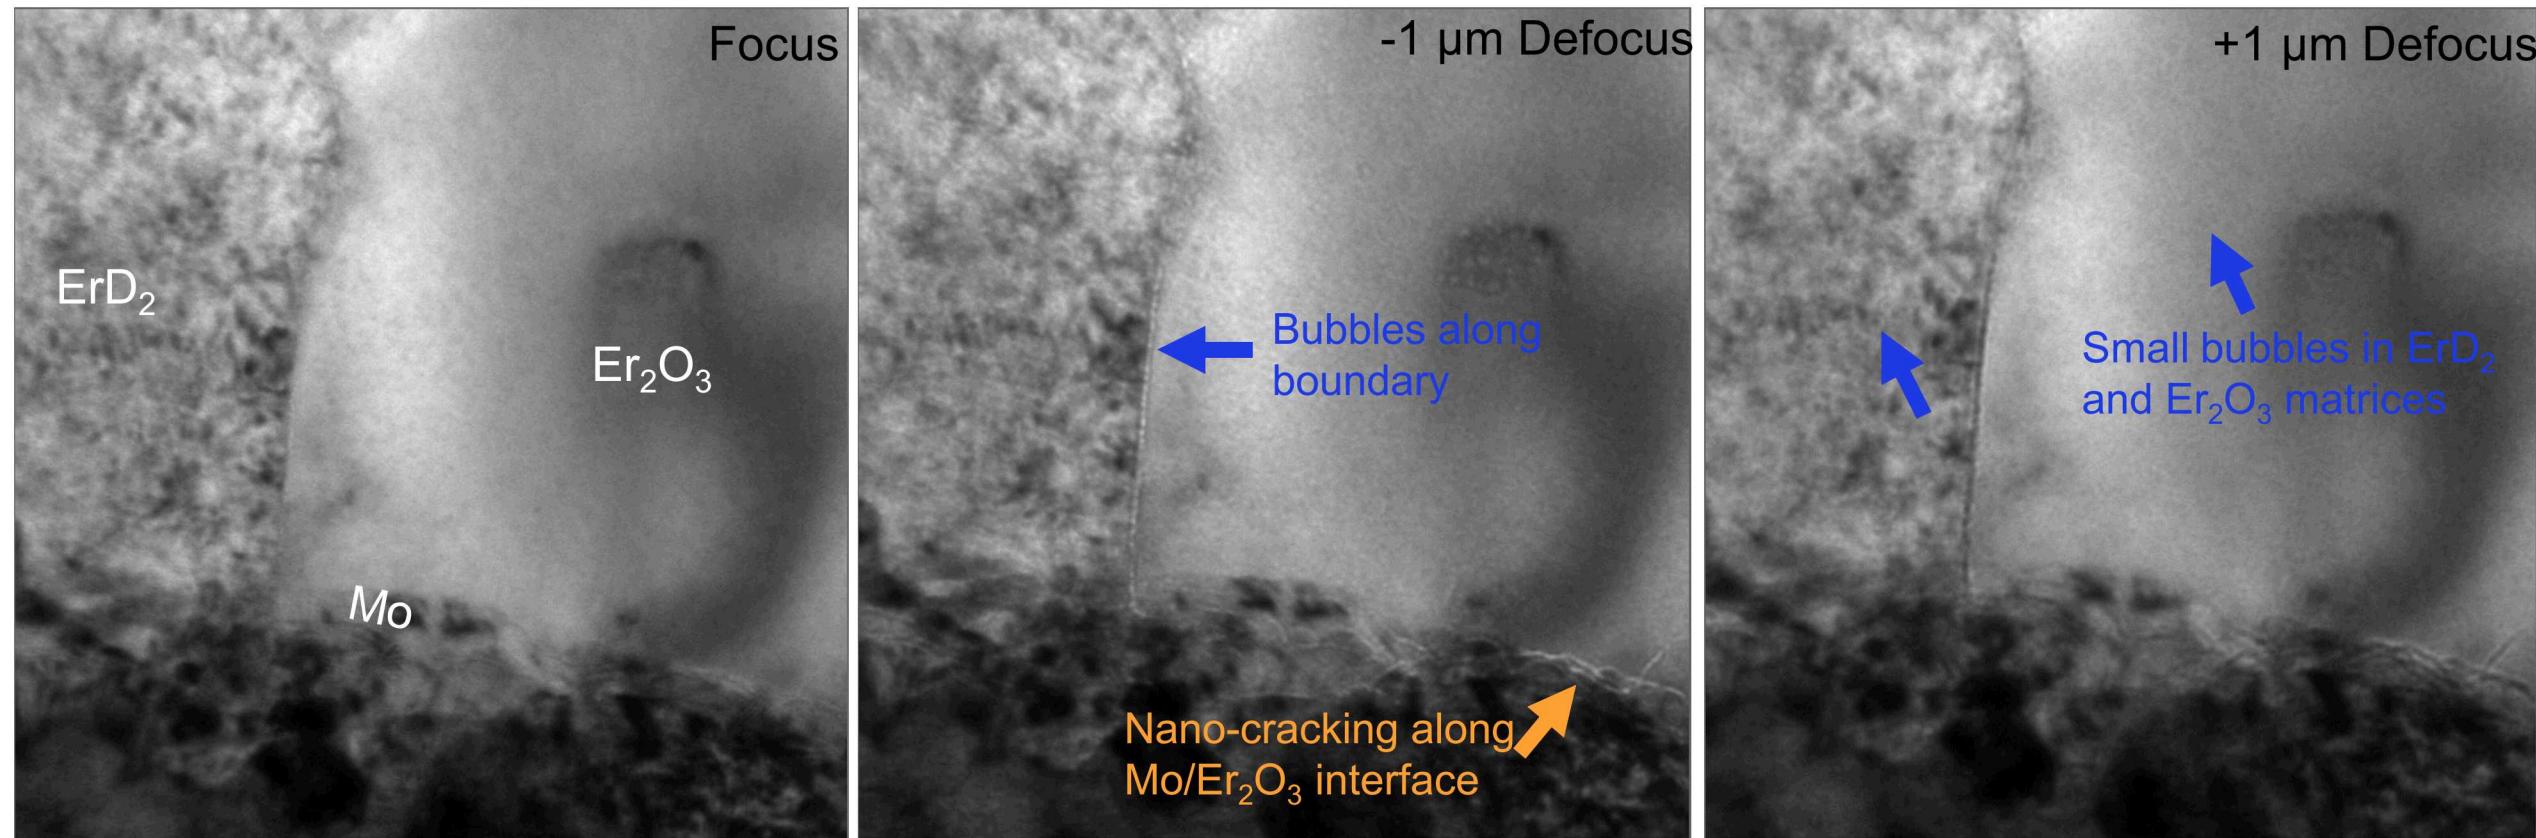
## Oxide Interfaces also Effectively Trapped He
