# Investigations of the structural and electrochemical properties of overheated Li-ion batteries

Lorraine Torres-Castro, Joshua Lamb, Eric Deichmann,  
and Mohan Karulkar

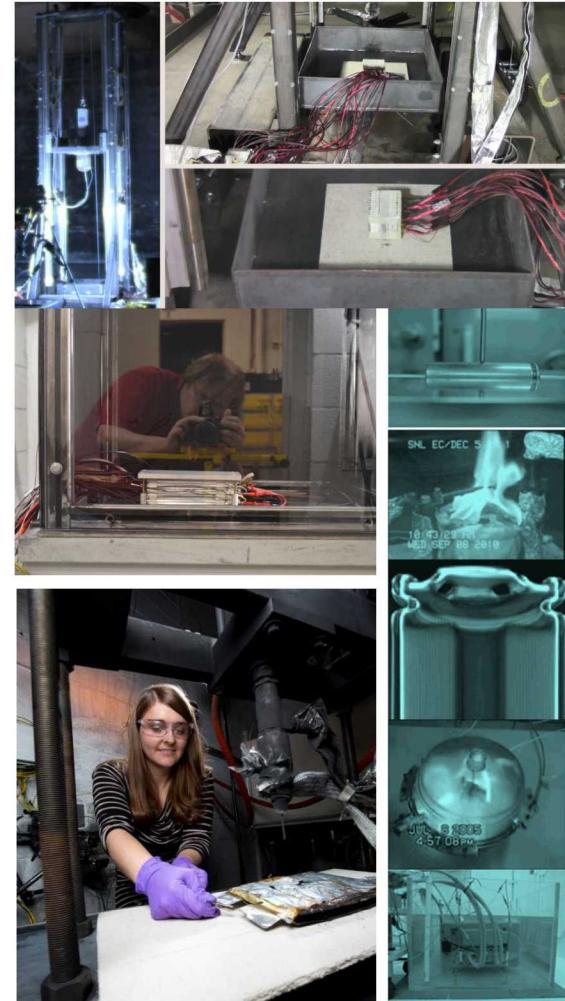
# Capabilities and Infrastructure: Battery Abuse Testing Laboratory (BATLab)

Comprehensive abuse testing platforms for safety and reliability of cells, batteries and systems from mWh to kWh.

Penetration  
(max. force 25 klbs, max speed 10 mm/s)

Crush  
(max. force 100 klbs, max speed 2 mm/s)

Impact  
(max. height 8'8", max. drop weight 700 lbs)

**Over temperature**  
(250 °C, 5 °C/min)

Overcharge  
(max. current 300 A)

Short Circuit  
(max. current 2500 A)

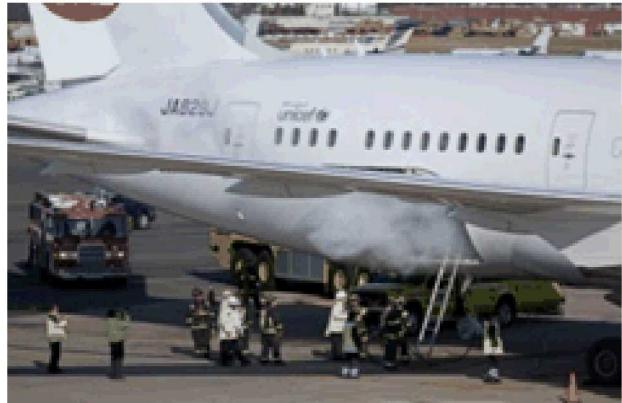
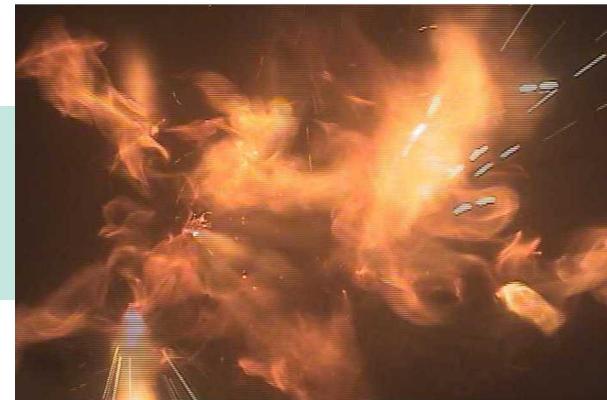
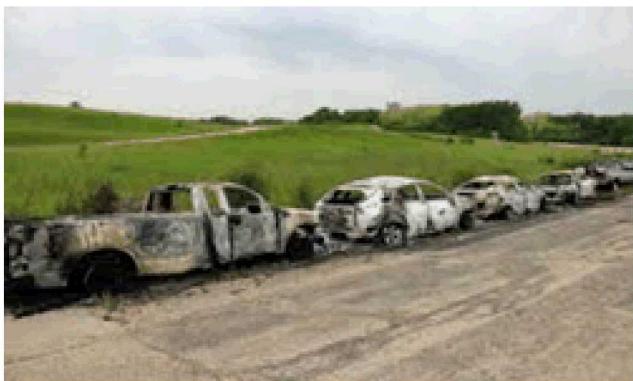
# How do you know if a potentially abused battery is unsafe or unstable?

Voltage and temperature are often lagging indicators of a battery failure.

By the time a measurable trend is detected, it may be too late to arrest a catastrophic thermal runaway.

Batteries may also be unstable due to previous exposure to abusive conditions, but show little sign of problems during initial monitoring.

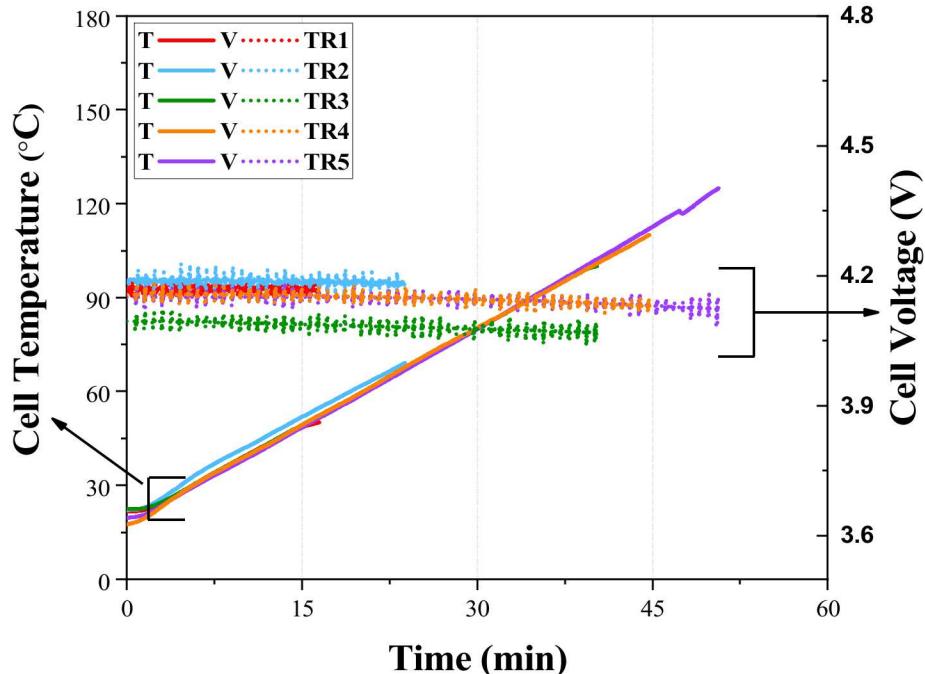
## Temperature and voltage profiles during over-temperature

Five individual cells, TR1, TR2, TR3, TR4 and TR5 were heated to 50 °C, 75 °C, 100 °C, 110 °C and 125 °C, respectively.

Test parameters	
Heating rate	2 °C/min

Initial T (°C)	Max. T (°C)	ΔT (°C)
TR1 - 50 °C	21.6	50	28.4
TR2 - 75 °C	22.1	75	52.9
TR3 - 100 °C	22.4	100	77.6
TR4 - 110 °C	17.6	110	92.4
TR5 - 125 °C	19.5	125	105.5

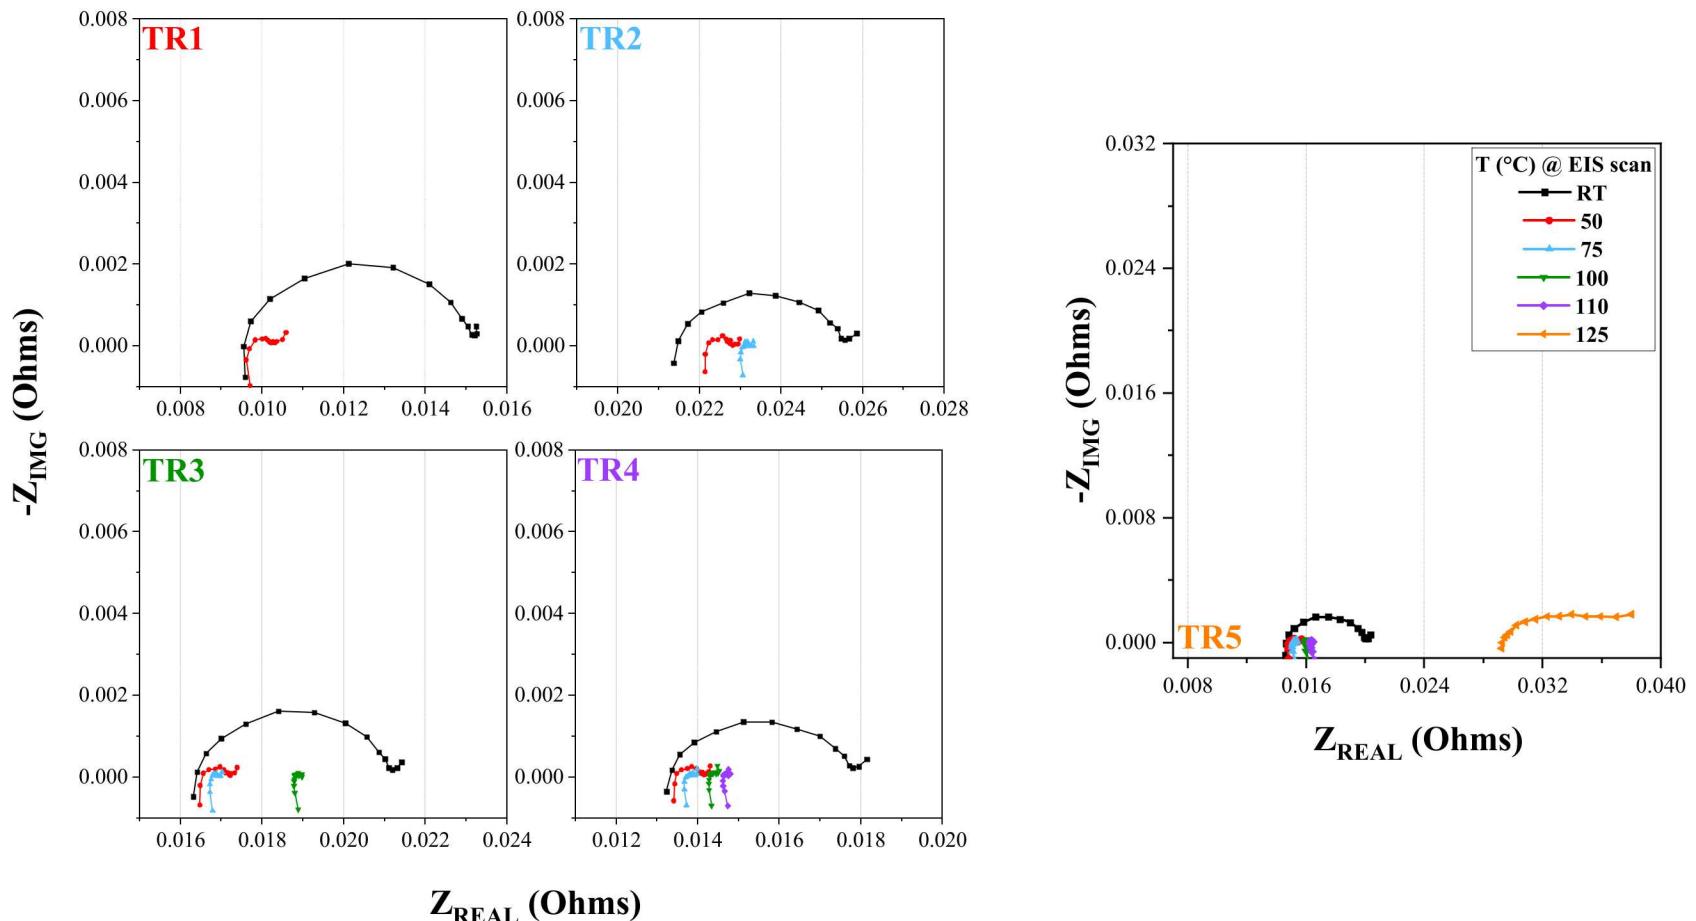
# In-operando EIS

- Minor changes observed up to 100 °C, while significant changes began to develop in the EIS curves above that point.
- The technique is most effective at detecting temperatures that approach dangerous levels, and would likely not provide a signal at more moderate temperatures.

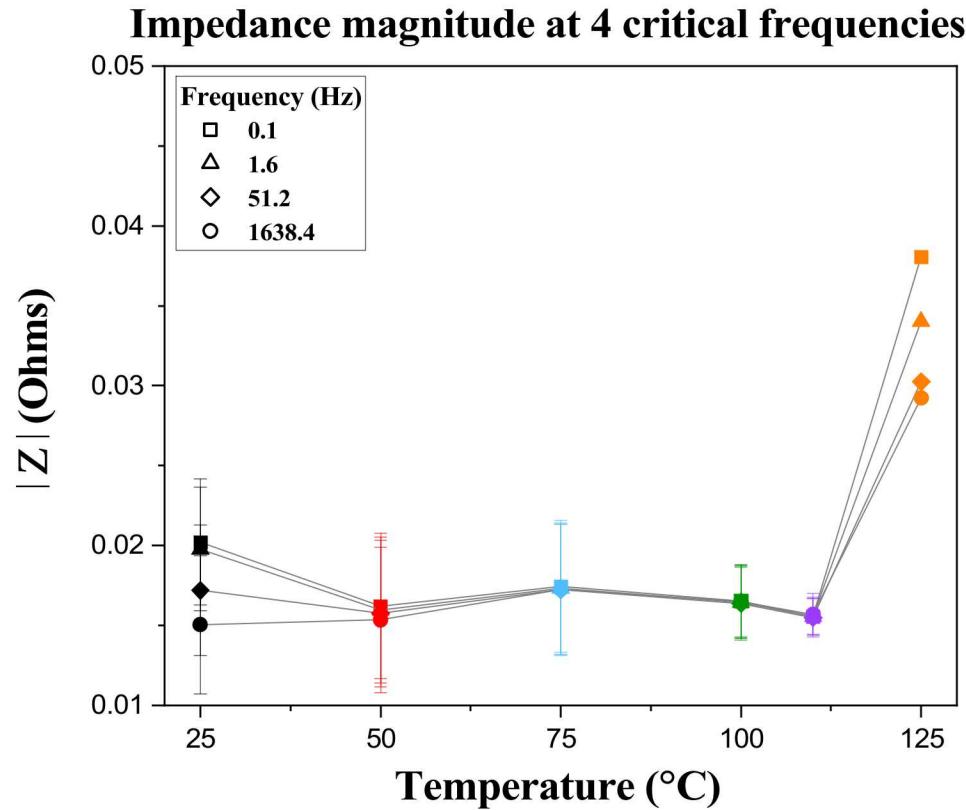
# TR5-125°C : Magnitude of the complex impedance

$$|Z| = \sqrt{Z_{REAL}^2 + Z_{IMG}^2}$$

- To better understand the changes after 100°C, we analyzed the magnitude as a function of T.
- The data showed significant increments in resistance after ~110°C for all frequencies.

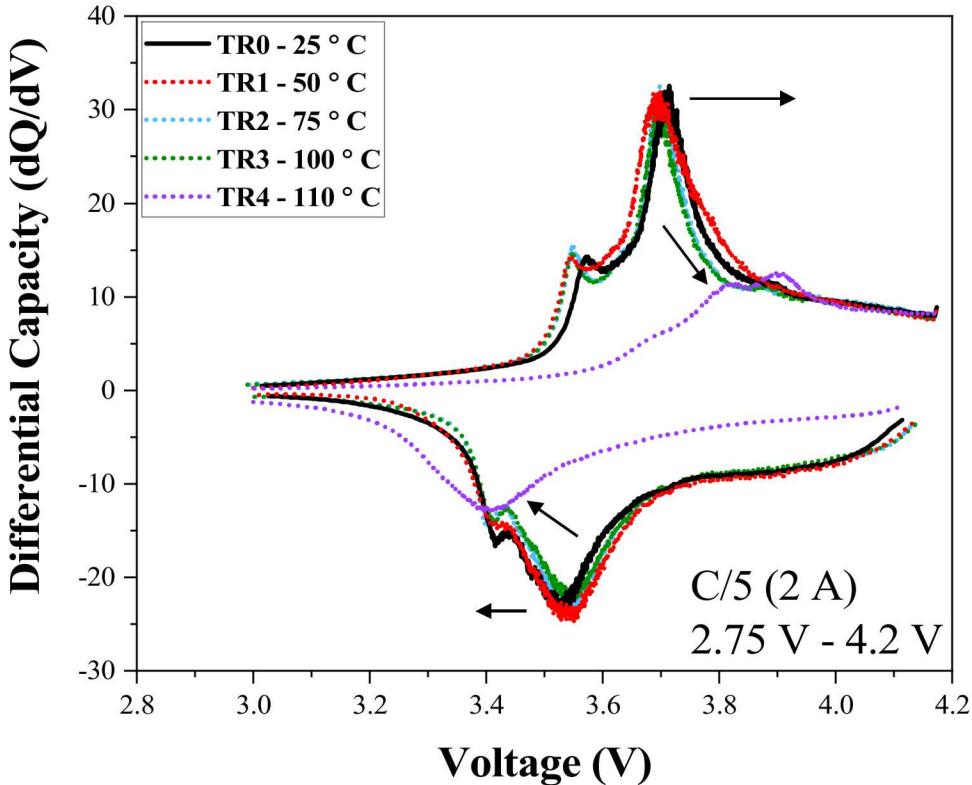
## Differential capacity after over-temperature

- Minor changes observed until above 100 °C, where we begin to see signs of significant damage to the battery.
- TR5 (125 °C) was significantly damaged by the over-temperature procedure to the point of not being operational.

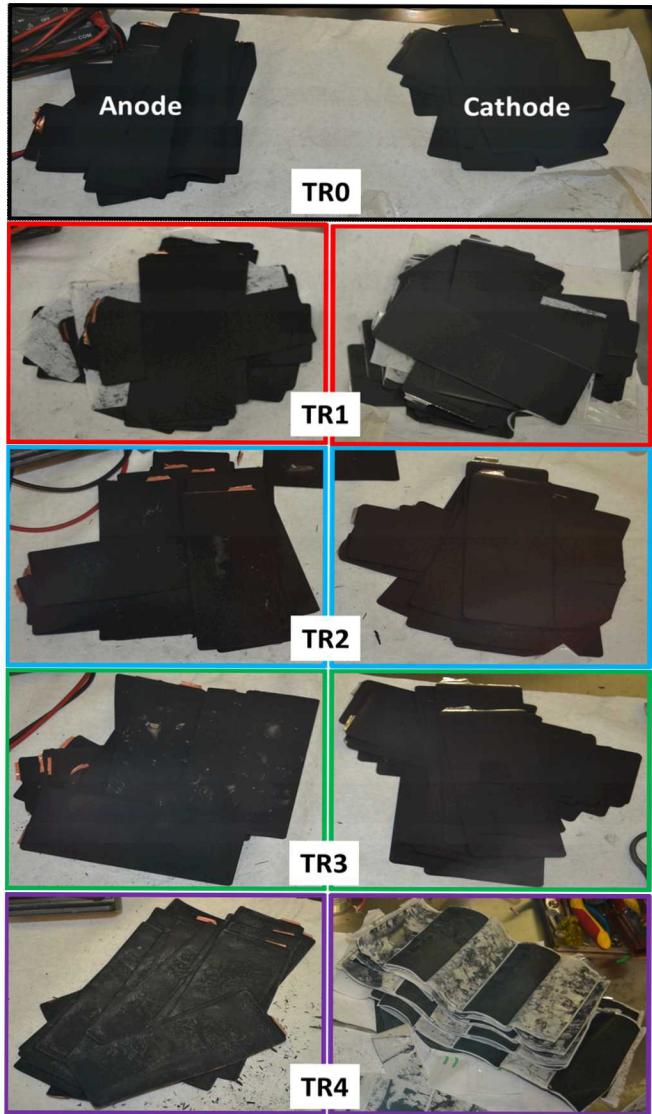
# Disassembly Images

The electrodes were harvested at 0% SOC after the overtemperature procedure was completed (fully lithiated cathode).

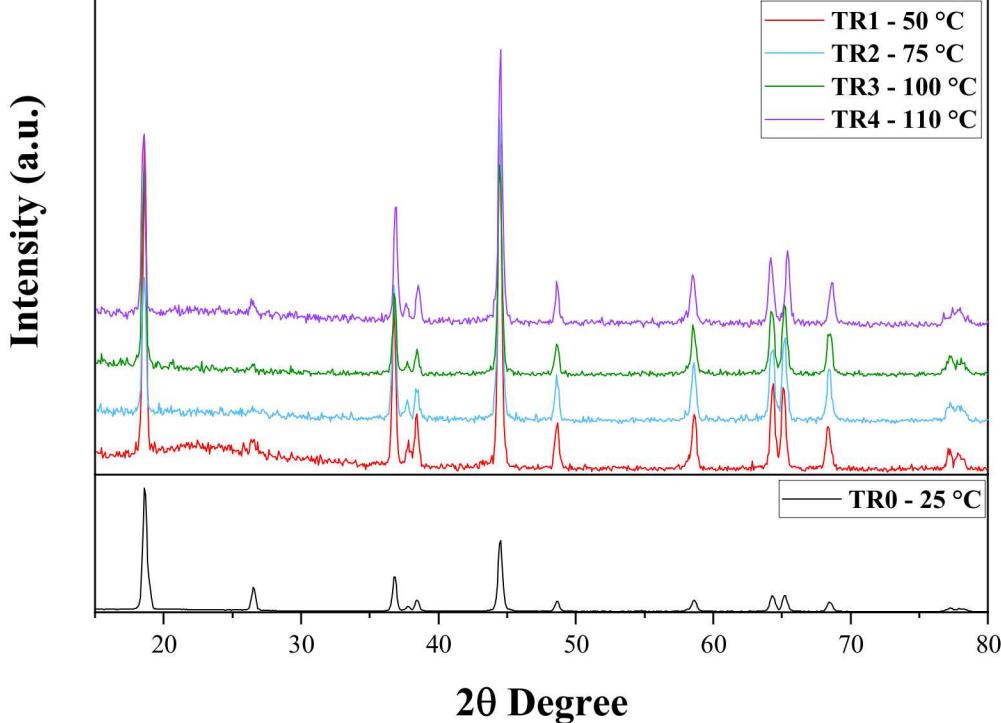
# X-ray Diffraction (XRD): Cathode

TR4 peaks shifted to higher degree

- XRD diffractograms of the positive electrode revealed changes for  $T > 100$  °C.
- TR4 diffraction peaks were slightly shifted to higher degree values, indicating a general shrinkage of the lattice.

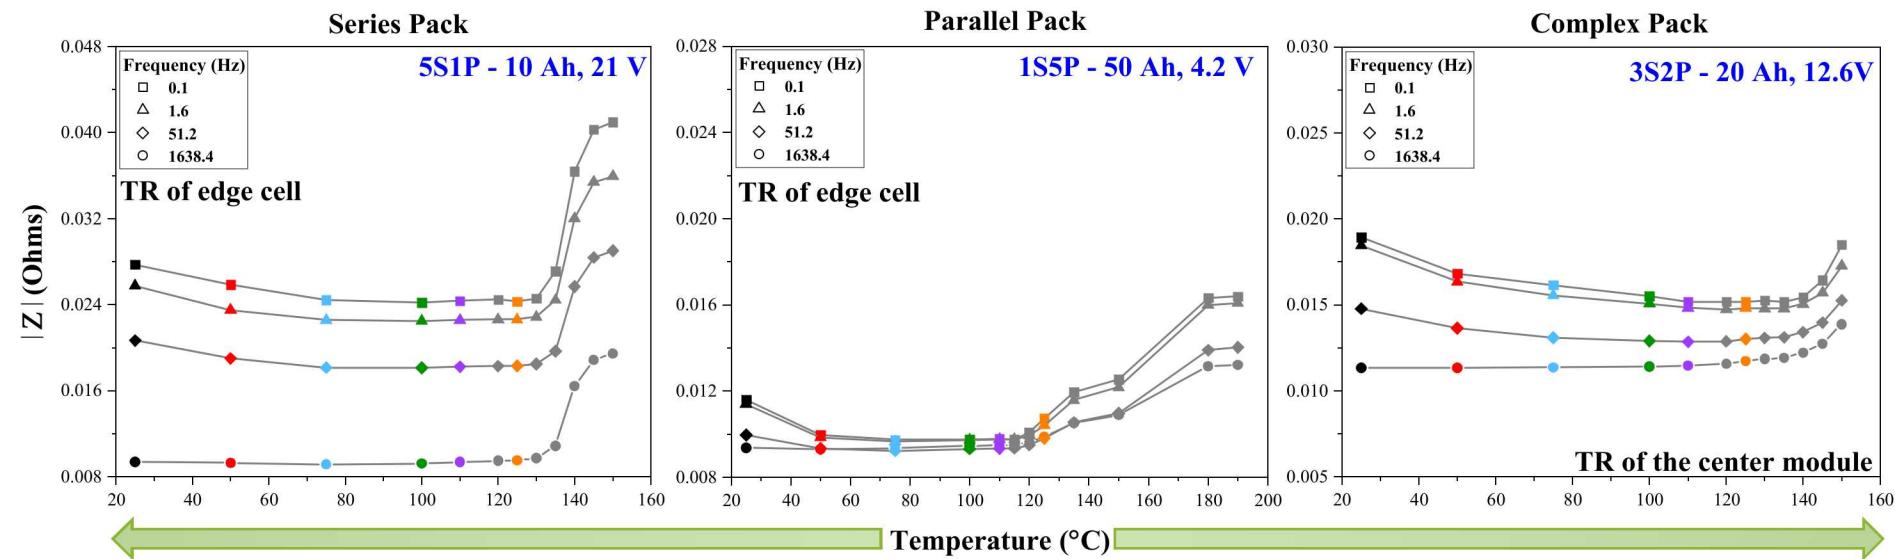
# Identified marker applicable to battery packs in series, parallel or complex configurations?

- *Series Pack:* Signals of cell damage detected at high temperatures (130  $^{\circ}\text{C}$  and above).
- *Parallel Pack:* Increases in the scalar impedance were identified at temperatures above 120  $^{\circ}\text{C}$ . However, the parallel packs did further limit the detection capabilities.
- *Complex Pack:* At this level of complexity, we begin to see the signal becoming washed out as the resistances detected within the entire pack begin to counteract any behaviors observed due to cell failure

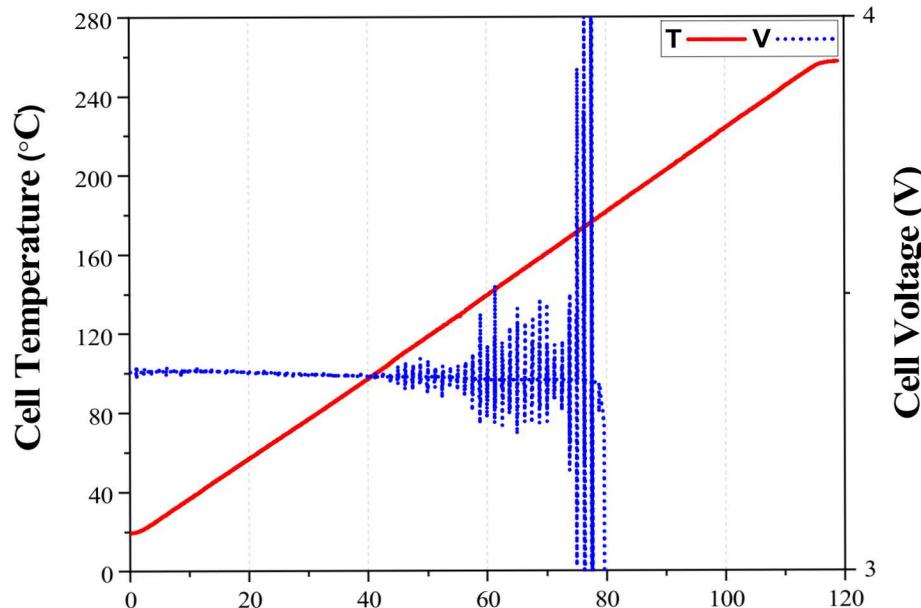
Temperature and voltage profiles during overtemperature

Test parameters	
Heating rate	2 °C/min

- There is minimal voltage loss as the cell reaches temperatures  $> 160$  °C.
- Identifying these minor changes may be difficult if it occurs within a localized area of a battery pack.

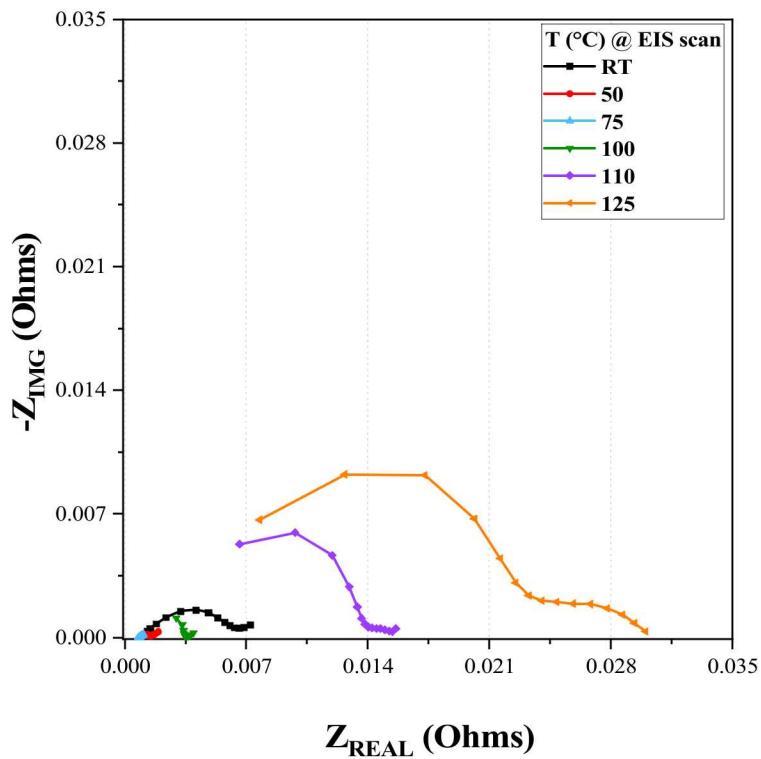
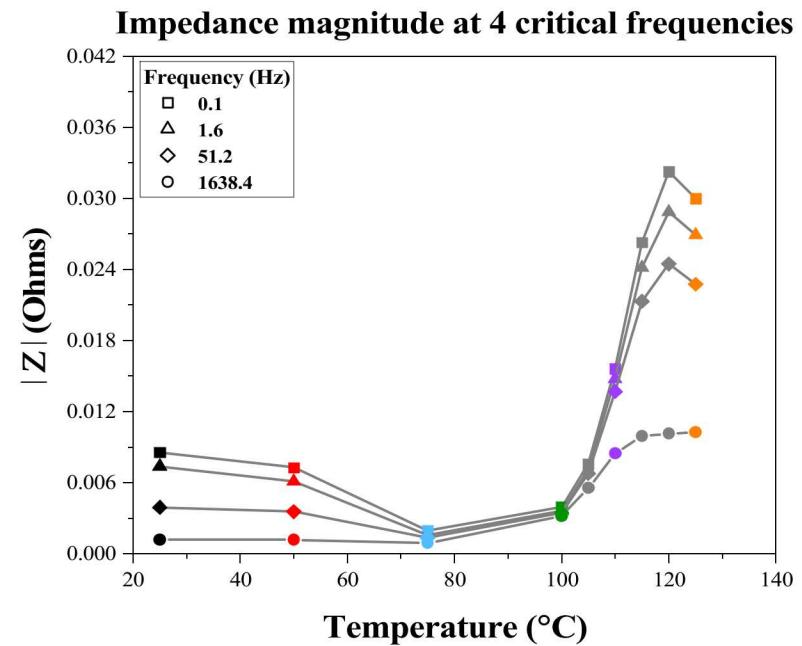
# In-operando EIS

$$|Z| = \sqrt{Z_{REAL}^2 + Z_{IMG}^2}$$

- The complex impedance (left) shows that significant changes are observed between 75 °C and 100 °C, and past that point the damage is evident with the rise of the solid electrolyte interface resistance, and charge transfer resistance .
- The scalar impedance (right) shows that all frequencies start exhibiting changes at temperatures above 80 °C, and past 100 °C the IMB tool delivered a strong detection signal.
