First SNL/NM Tritium TPD Results and a Request for Help/Advice

Clark S. Snow, Sandia National Labs

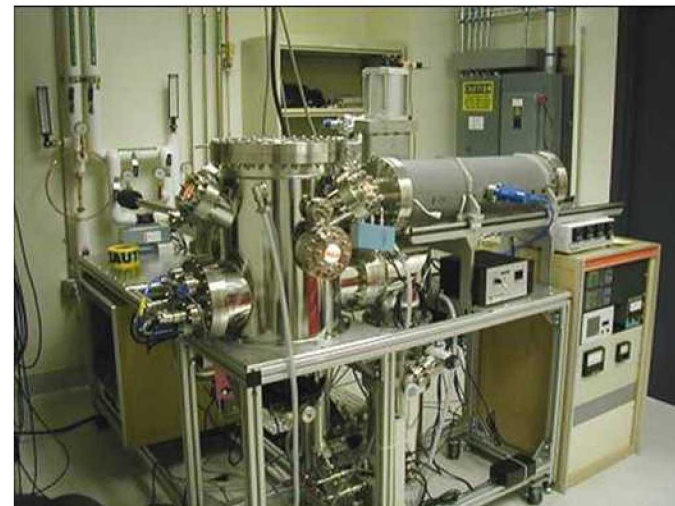
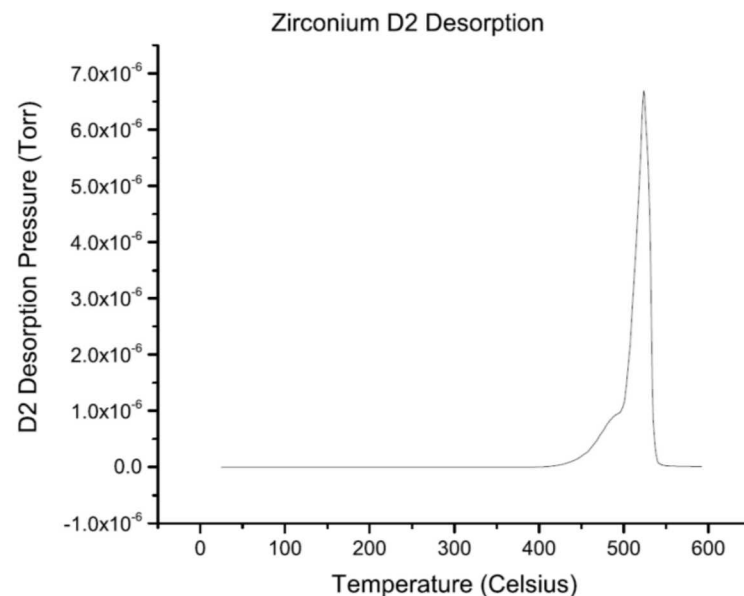
Introduction to Temperature Programmed Desorption (TPD) aka Thermal Desorption Spectroscopy (TDS)

Linear temperature ramp, 0.5 C/s to 10 C/s are typical ranges

Detector either Time-of-Flight or quadrupole mass spectrometer.

Ours is optimized with a 1-6 AMU quadrupole

Also has TOF

Other analytical tools, can also do electron and ion stimulated desorption

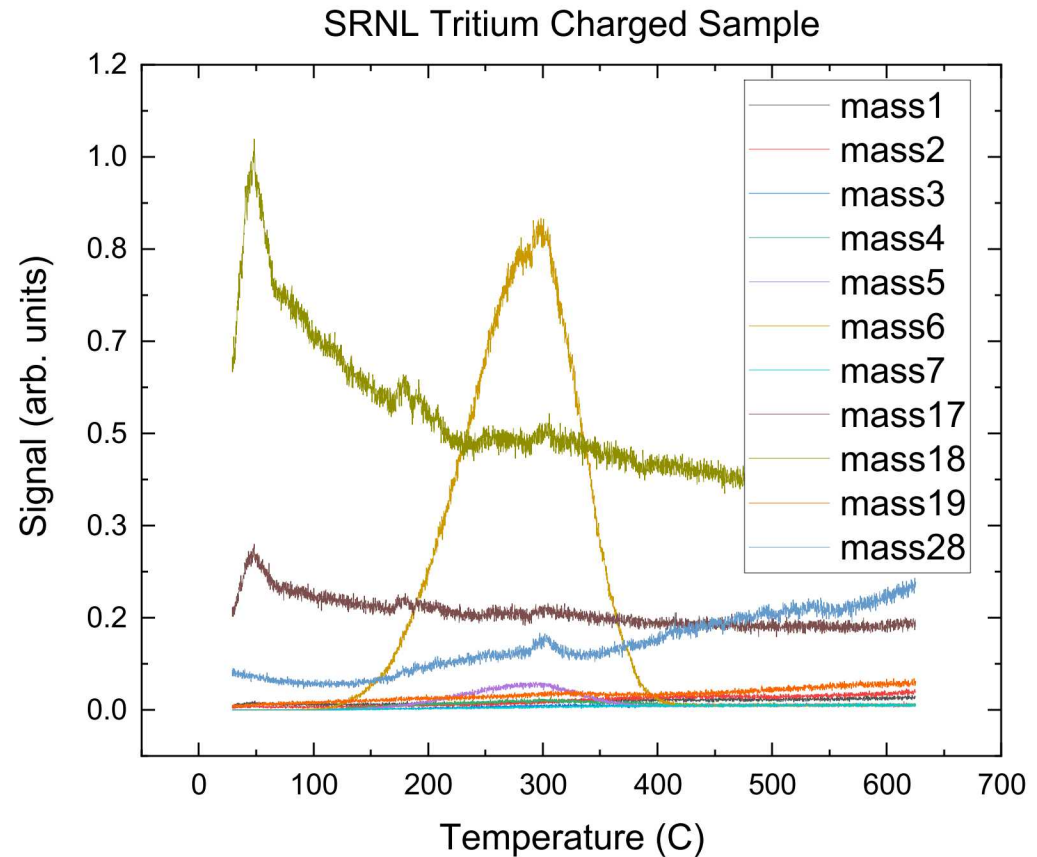
| Model | Gauss | |
| Equation | $y=y_0 + (A/(w*\sqrt{\pi/2}))*\exp(-2*((x-xc)/w)^2)$ | |
| Plot | Peak1(mass6) | Peak2(mass6) |
| y0 | 355.16374 ± 12.25785 | 355.16374 ± 12.25785 |
| xc | 308.0707 ± 0.2836 | 259.90097 ± 1.50749 |
| w | 66.06252 ± 0.71229 | 94.82238 ± 1.02349 |
| A | 2336587.35765 ± 131262.67005 | 3835966.10536 ± 133998.6802 |

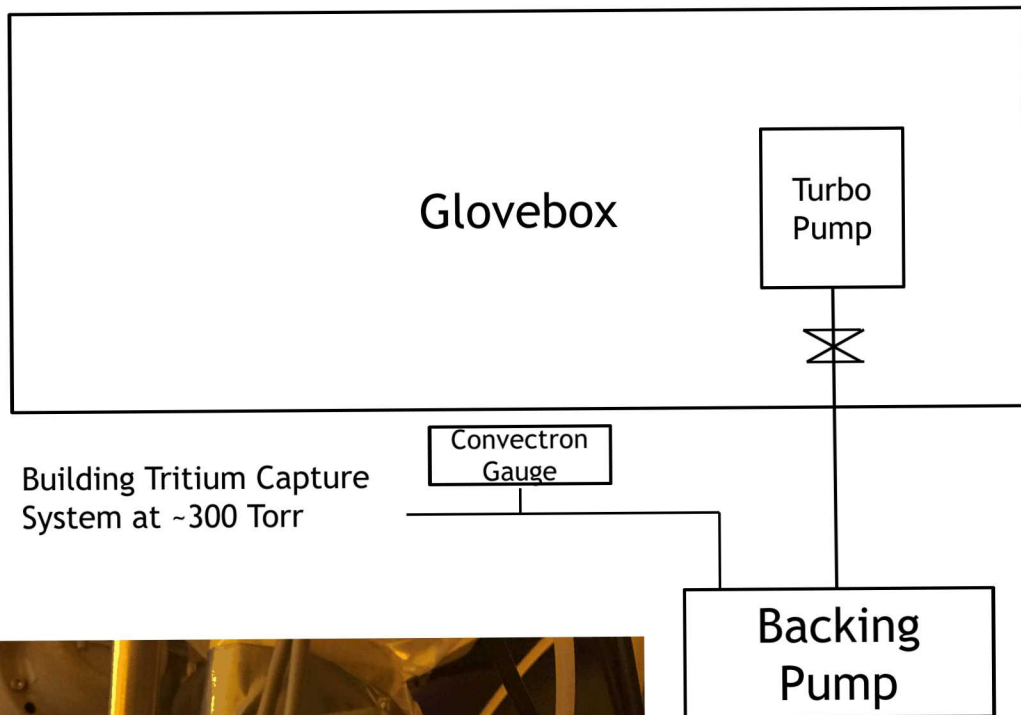
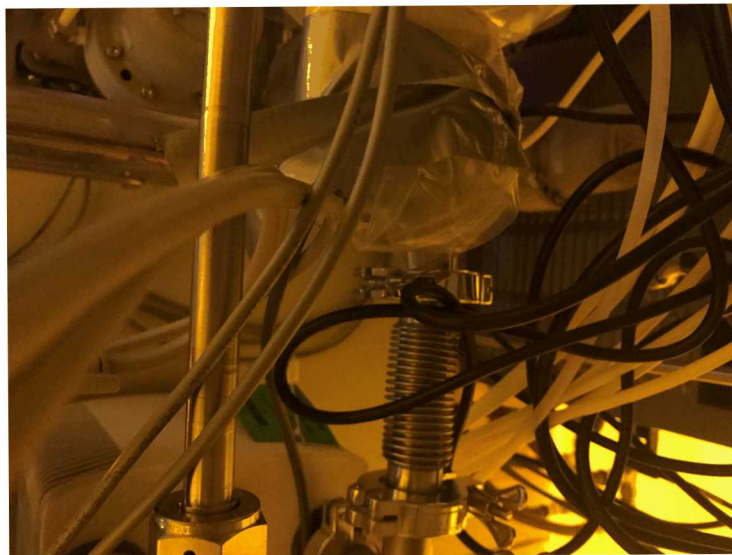
8 Schematic and pictures of the System

Recent routine surveys found an increase in room contamination

Analysis determined several leaks in a manifold constructed from multiple KF fittings

Previous work had broken into a different section of this piping with minimal outgassing of tritium

I still need to do the repairs.

Are there any procedures that I can use to minimize tritium release to room?

- “Burp” the system?
- Purge the system with Nitrogen/Argon?
- Wrap heat tape and outgas the lines?
- ????

Are there any engineering controls that I can use to minimize tritium release to room?

- “Elephant trunk” to pull local air into building exhaust?
- Wrap in plastic?
- ????
