Thermal Processing Effects on Heat Affected Zone Liquation Cracking Susceptibility of Boron Micro-alloyed 304L Stainless Steel

Metallurgy & Material Joining Department
Sandia National Laboratories, Albuquerque, NM

American Welding Society 2019 Professional Program: Welding Metallurgy I

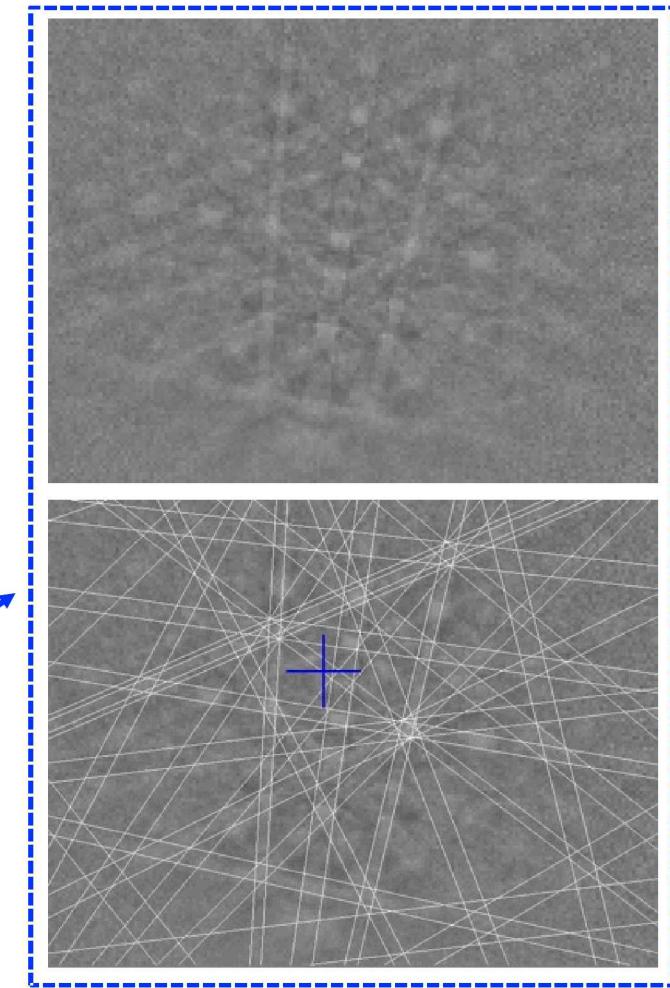
Electron Backscatter Diffraction (EBSD) patterns ID'ing boride phase

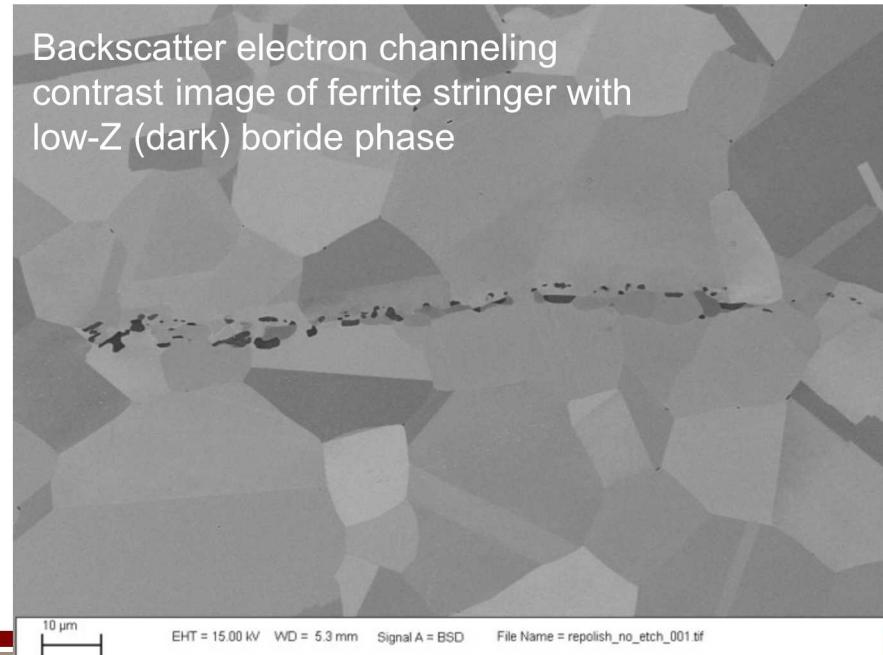
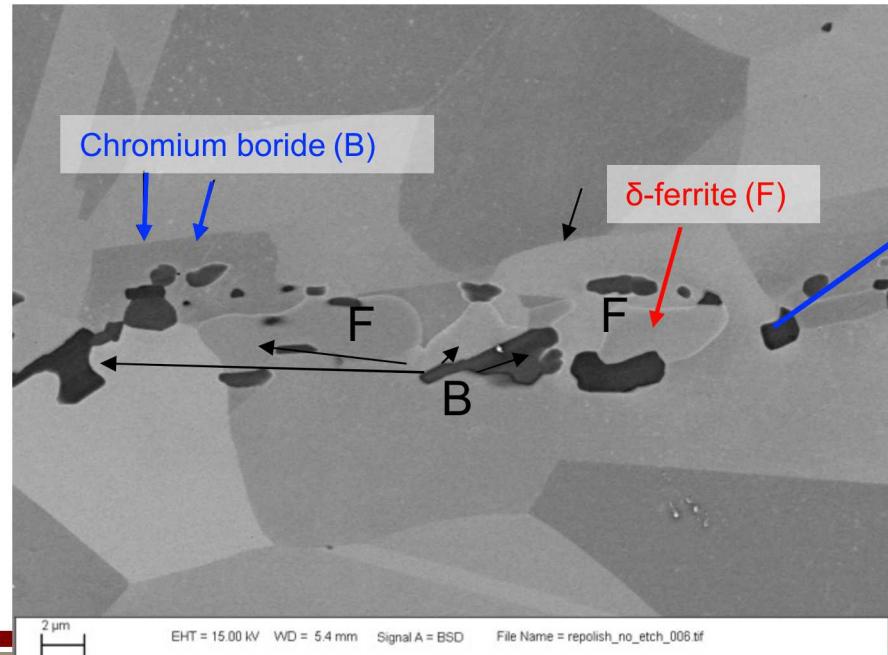
Backscatter electron channeling contrast image of ferrite stringer with low-Z (dark) boride phase

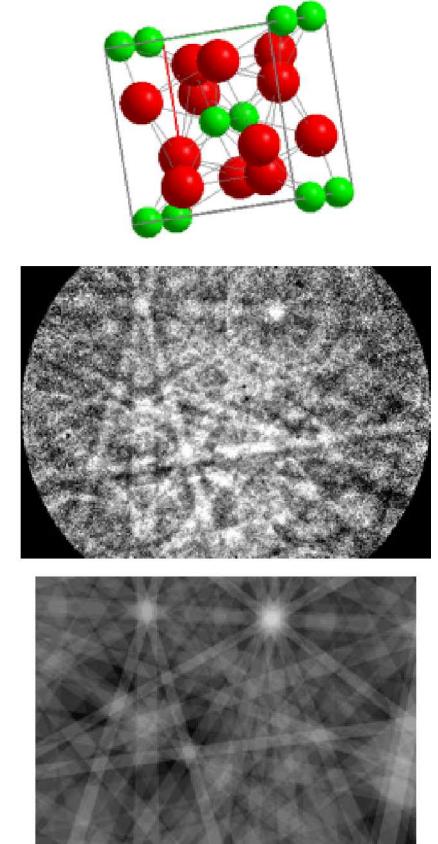
EBSD of Boride

Kikuchi patterns index as tetragonal M_2B

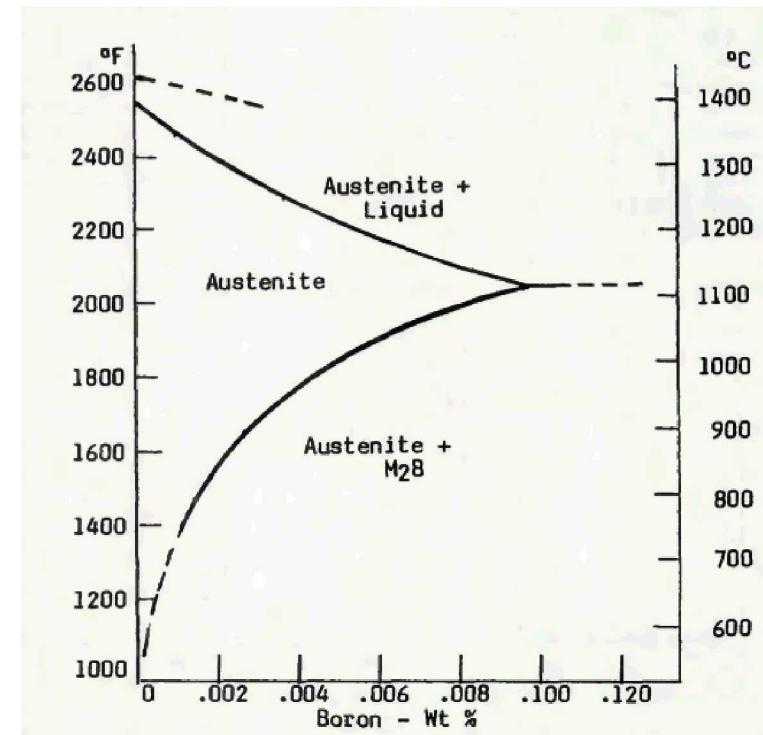
Solubility of B in Fe-18Cr-15Ni
(from Goldschmidt, 1971)

- The limit of 20 wt.ppm B was implemented based on quaternary phase equilibria data from Goldschmidt (1971).
- More recent multicomponent thermodynamic simulations performed at SNL show that solubility of boron in austenite during homogenization is closer to 5 wt.ppm!

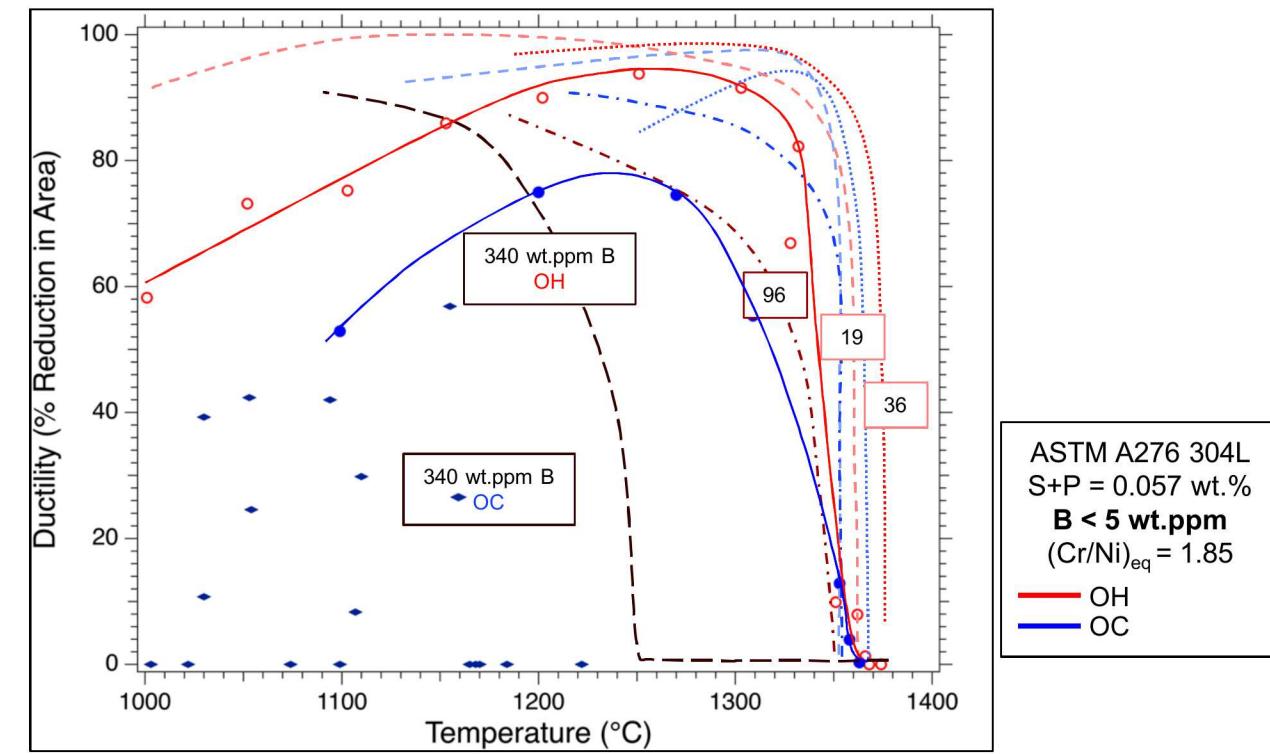
Gleeble hot ductility signatures for B-containing 304L

- Only the highest boron content heat (340 wt.ppm B) shows markedly decreased hot ductility indicating HAZ cracking risk.
- For heats with <100 wt.ppm B., ductility recovers sharply on-cooling near the on-heating NDT

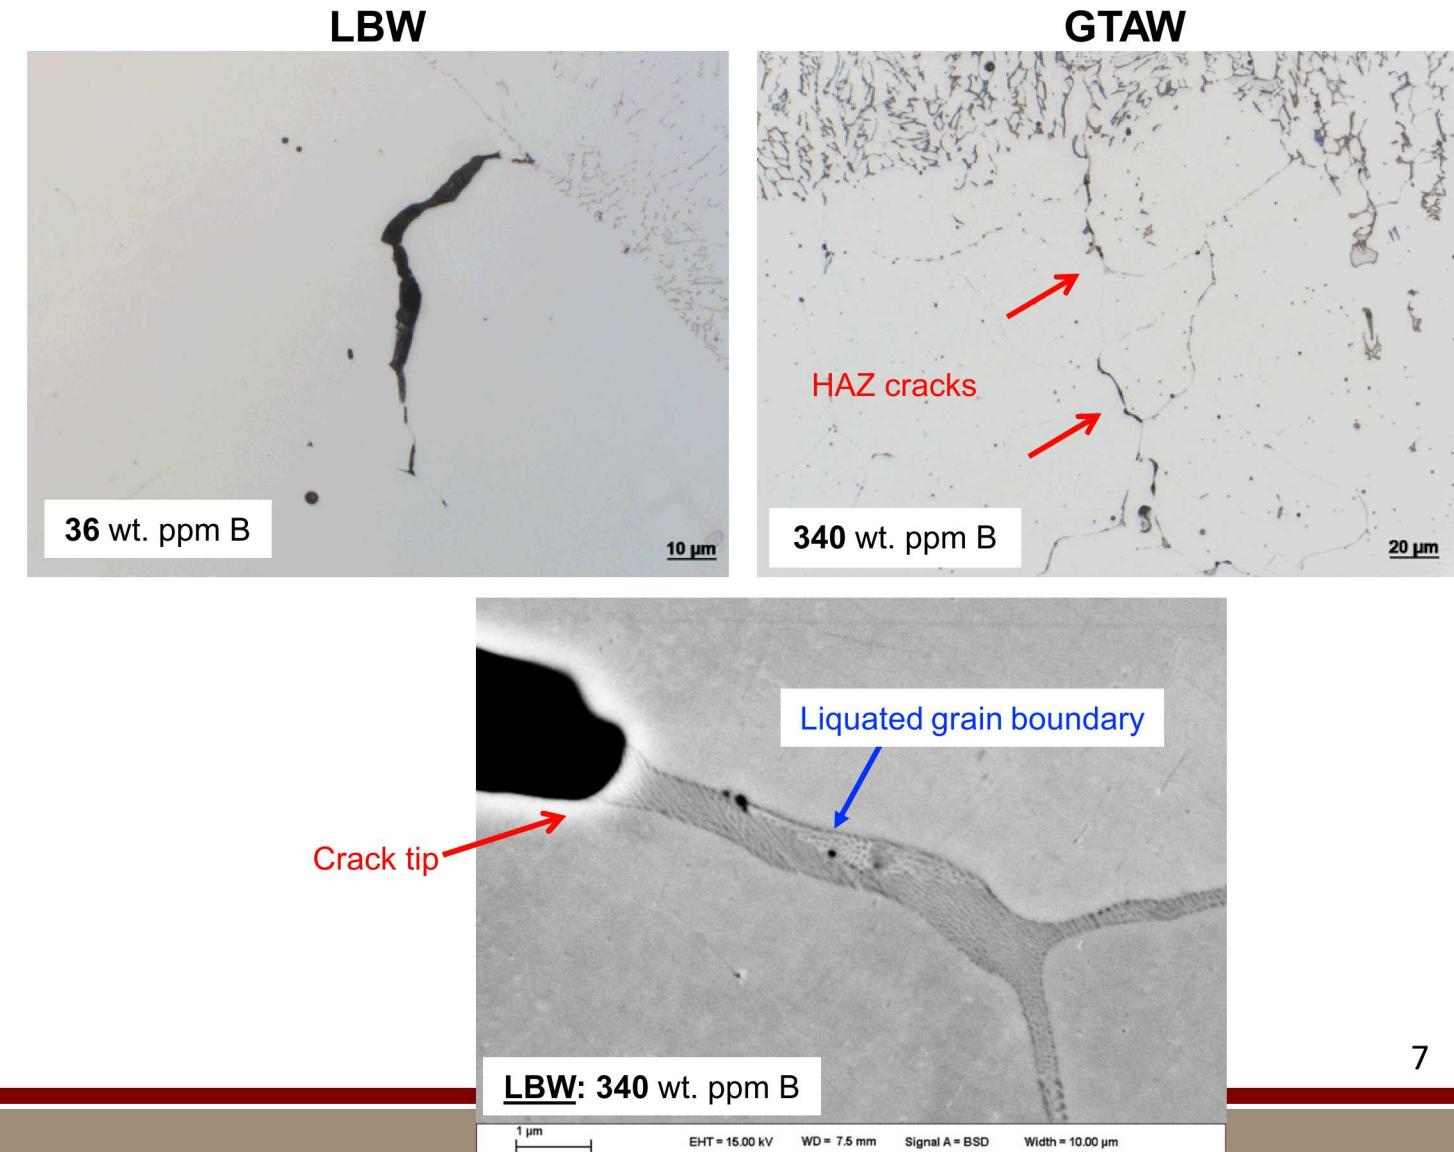
- Testing showed no weldability issues for material at 20 wt.ppm B for both GTA and laser welds
 - Cracking in GTA HAZs was observed at 340 wt.ppm B material which is in good agreement with Gleeble Hot Ductility Testing
 - Laser welds showed considerably less margin with respect to cracking. HAZ cracks were observed at 36 wt.ppm associated with grain boundary borides

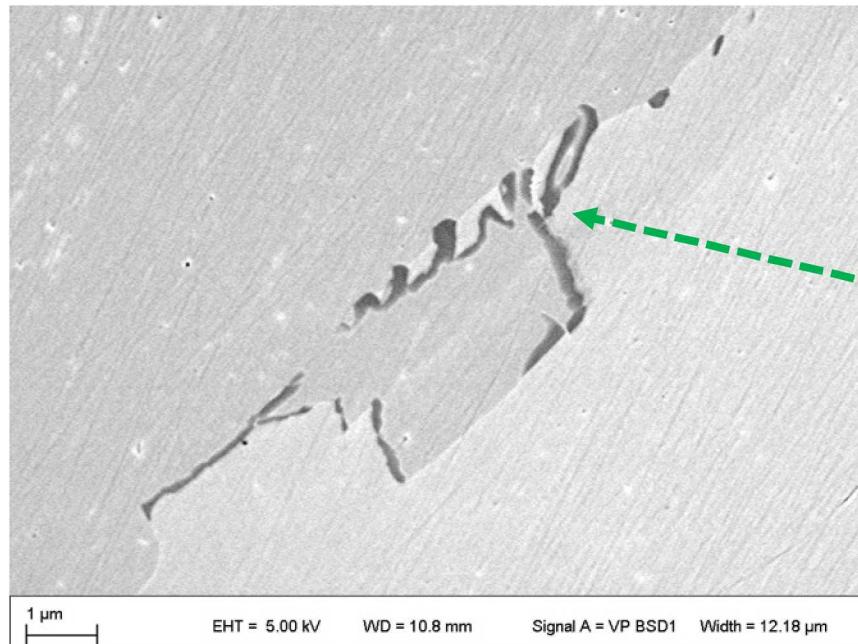
Laser welds on WC 304L parts with ~20 wt.ppm B

Low-Z intergranular boride phase. (ID'ed using TEM/EELS)

- Routine metallographic examination of laser welded hermetic prototype electrical feed-through assembly revealed HAZ cracks on part that underwent brazing. The braze was performed prior to welding
- Microstructural examination of brazed part showed unexpected intergranular phase formation. This phase was later determined to be boron-rich

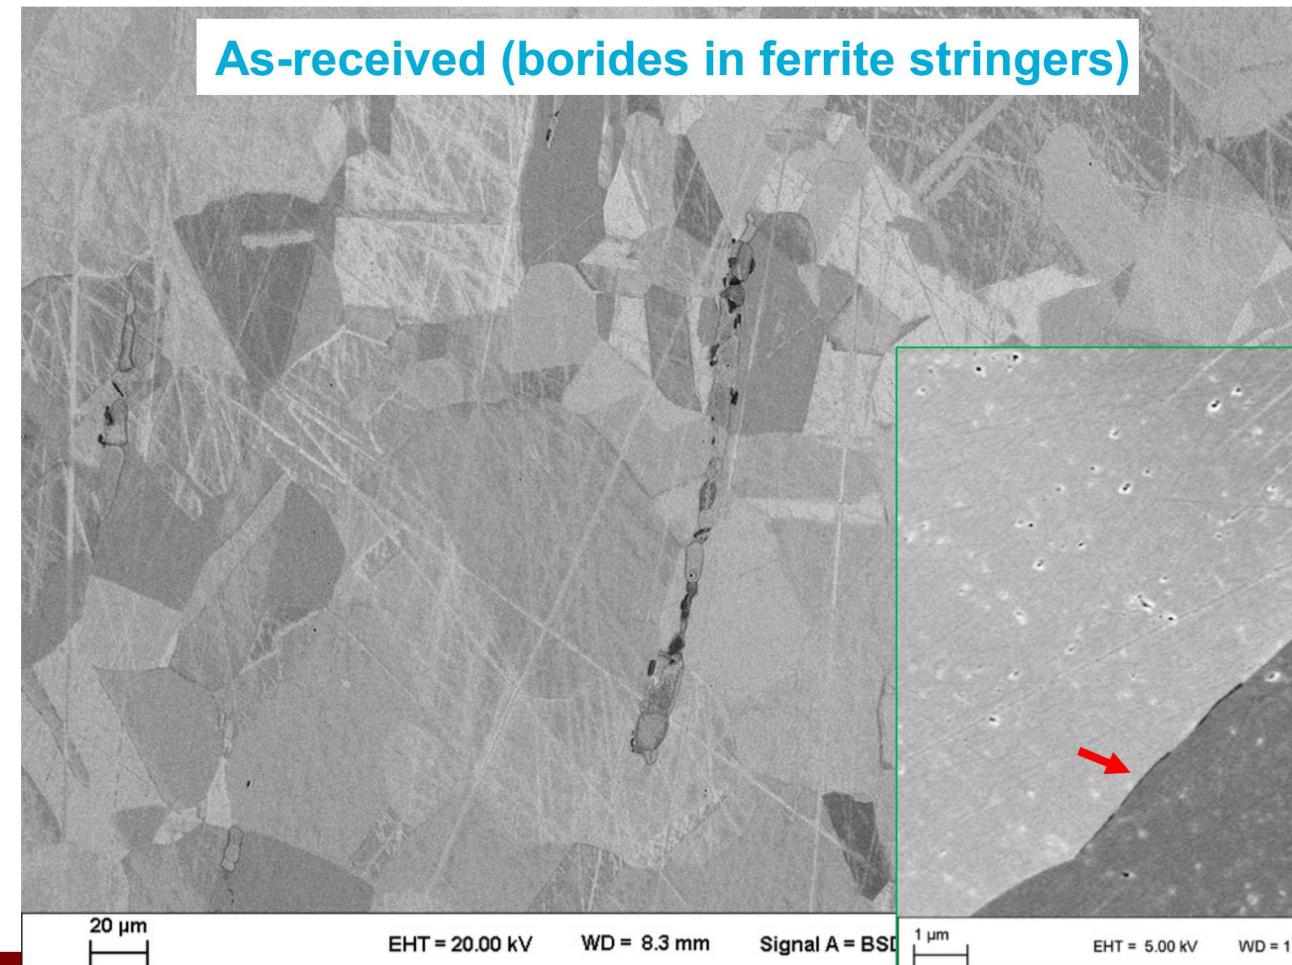
As-received (borides in ferrite stringers)

- Exposure to elevated temperature can provide opportunity for boride to change morphology and distribution

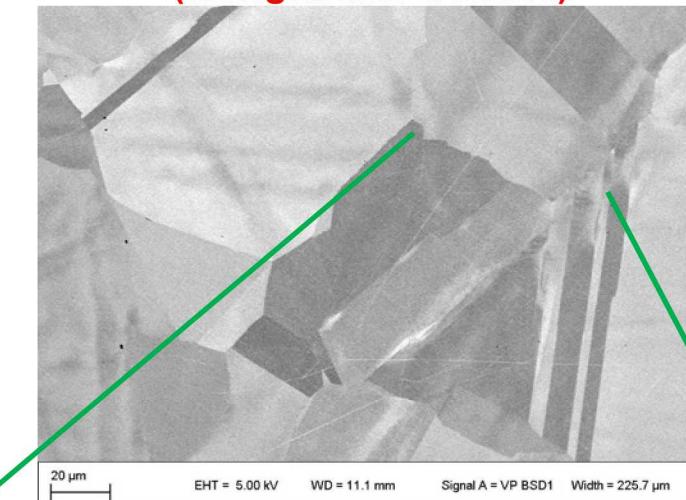
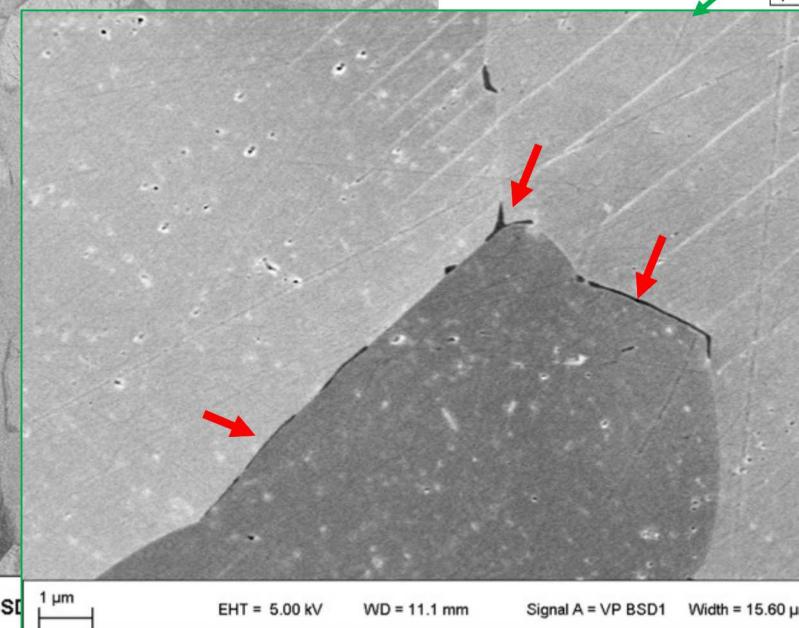
1100°C, 1 hr.
(intergranular borides)

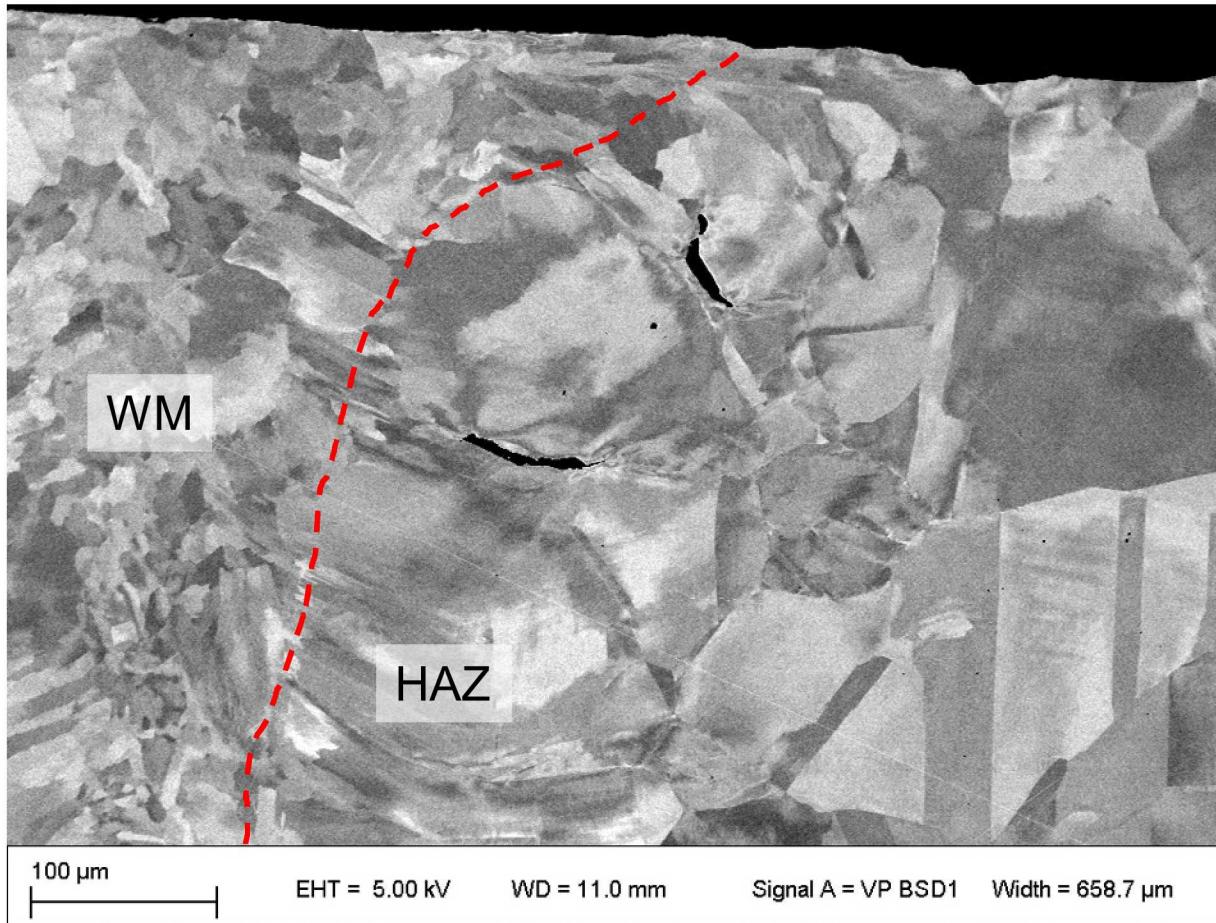
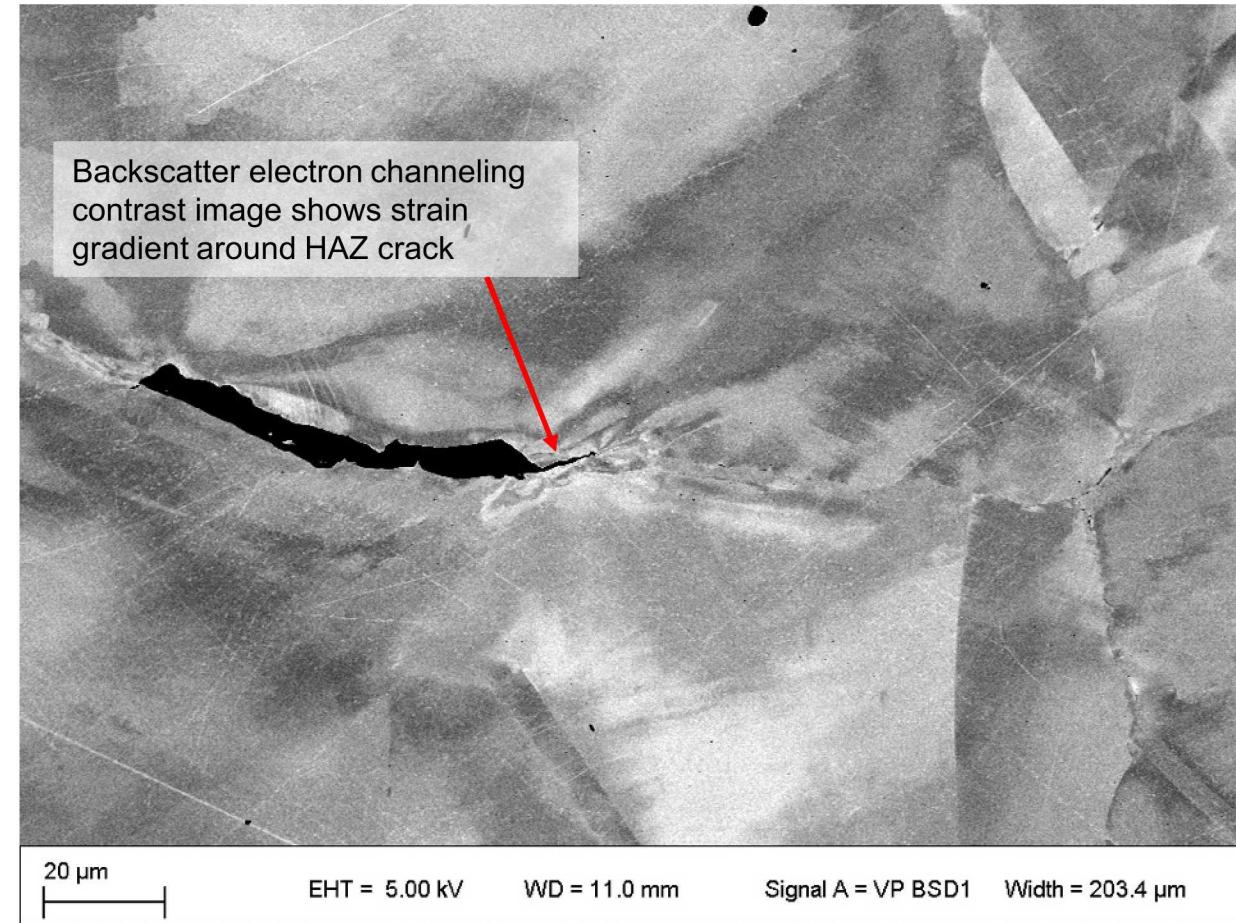
Detail: SEM Examination of HAZ Cracks

Pulsed Laser Seam Weld on WC 304L (~20 wt.ppm B) thermally treated 1100°C, 1 hr.

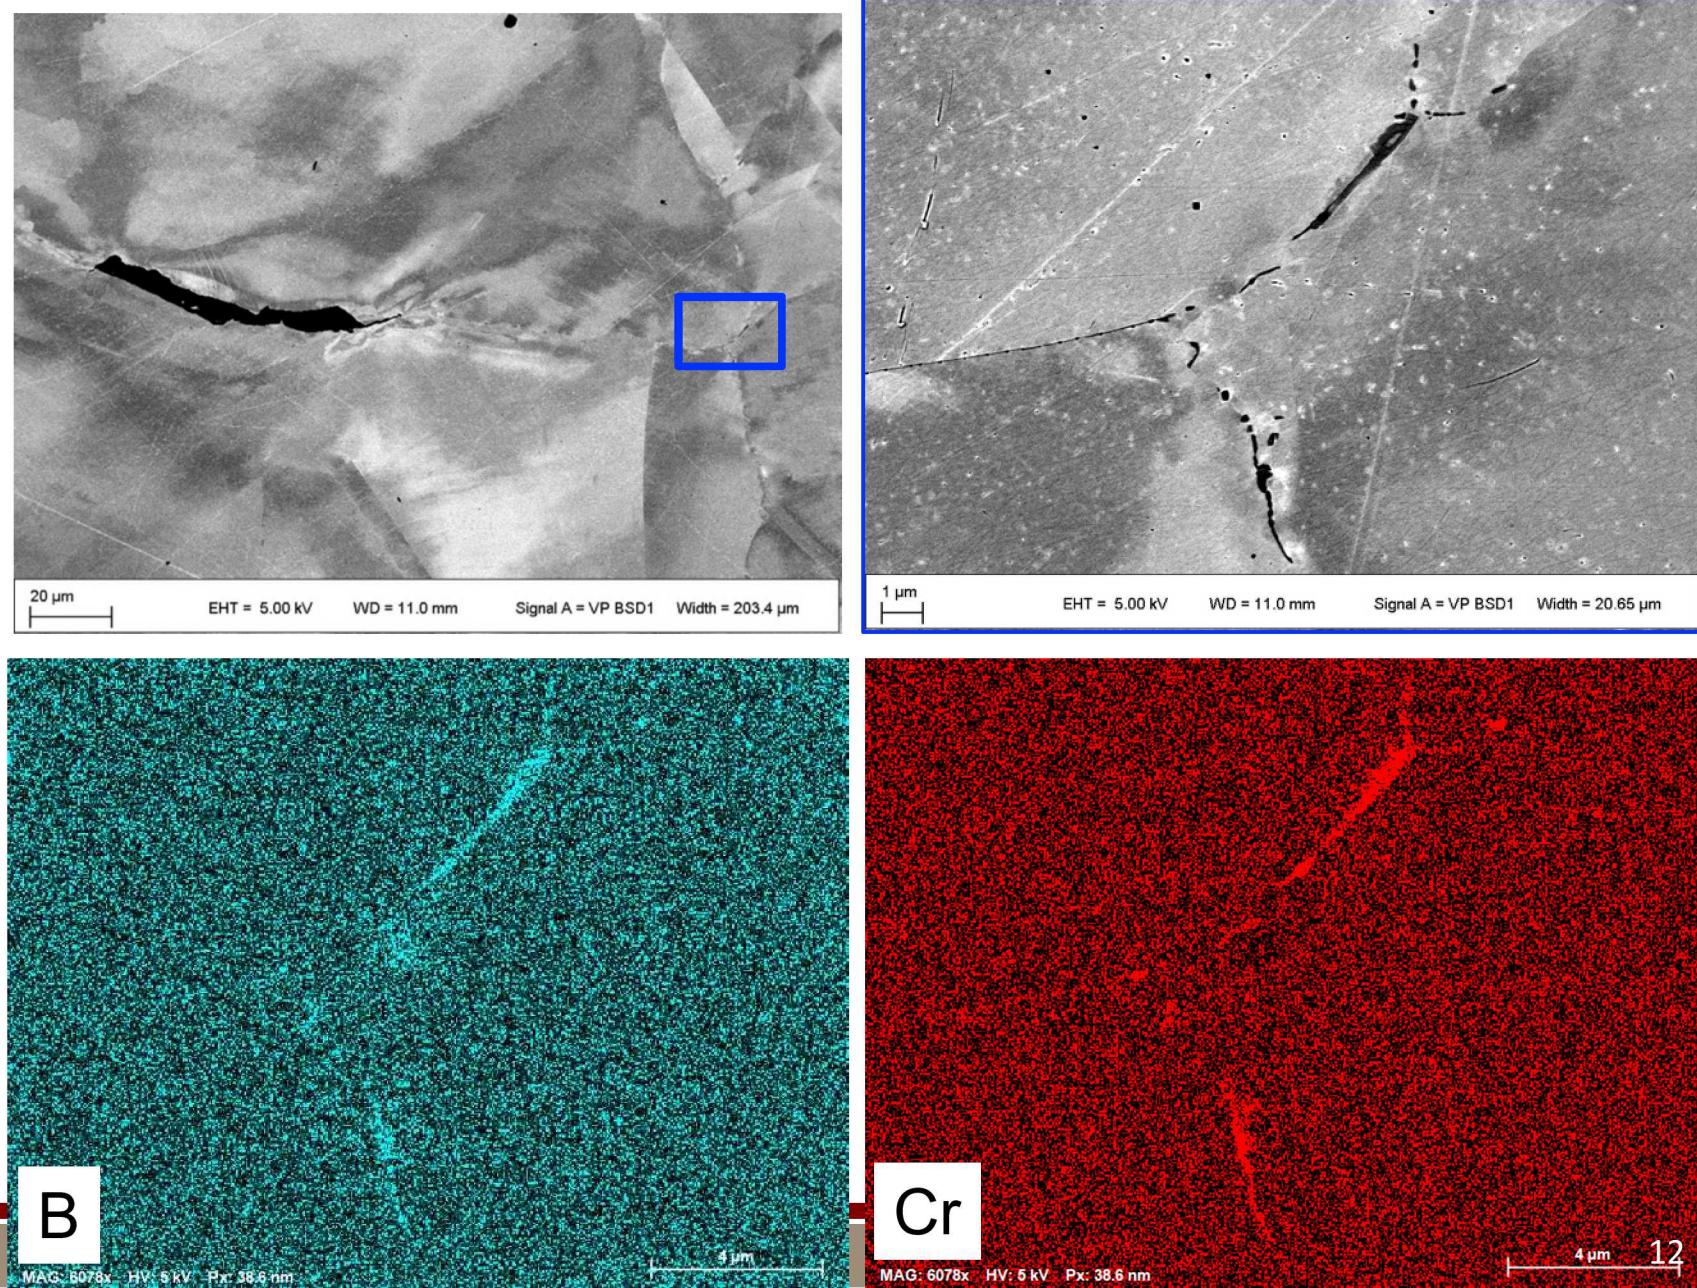
X-ray spectral imaging of intergranular phase

- Special energy dispersive spectroscopic analysis conditions provide qualitative map of boron concentration around HAZ grain boundaries
- Thermal treatment resulted in grain boundary boride film

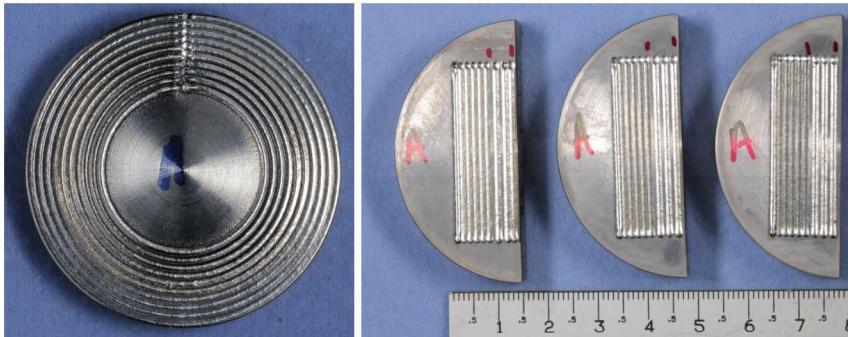
Autogenous laser weld trials

HAZ cracking susceptibility depends on time-temperature history

- Continuing work to determine time-temperature dependence on weld HAZ crack susceptibility for boride-containing 304L
- Weld cracking risk for parts that undergo glass/glass-ceramic/brazing thermal cycles need to be evaluated on case-by-case basis due to vendor-specific high-temperature processing prior to hermetic sealing (e.g., 'fire-off' cleaning)

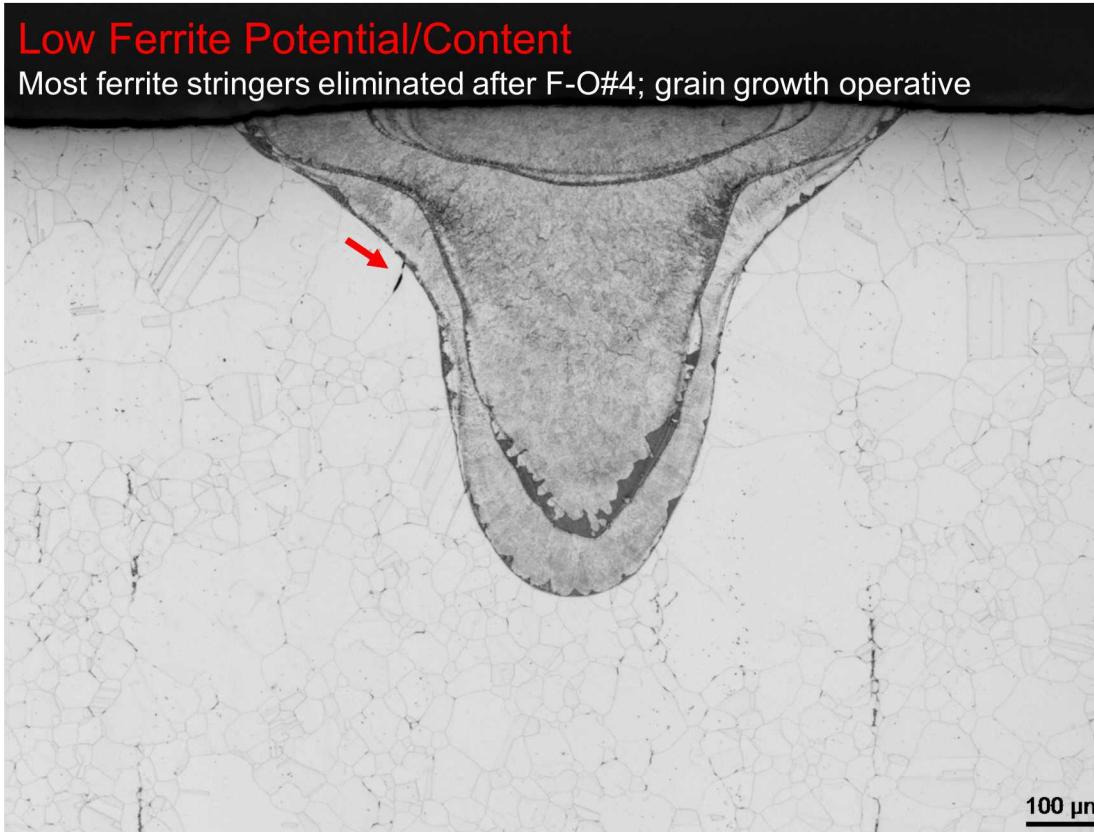
Low Ferrite Potential/Content

Most ferrite stringers eliminated after F-O#4; grain growth operative

- $(Cr/Ni)_{eq}$ ratio is generally used as a predictor of weld solidification mode; however, it can also be a measure of ferrite stability in 304L. Ratio is directly proportional to ferrite potential.
- HAZ liquation cracking susceptible microstructure appears to be predicated on complete dissolution of ferrite stringers during heat treatment
 - Elimination of ferrite stringers promotes larger grain size and formation of intergranular borides—both factors increase HAZ liquation crack susceptibility

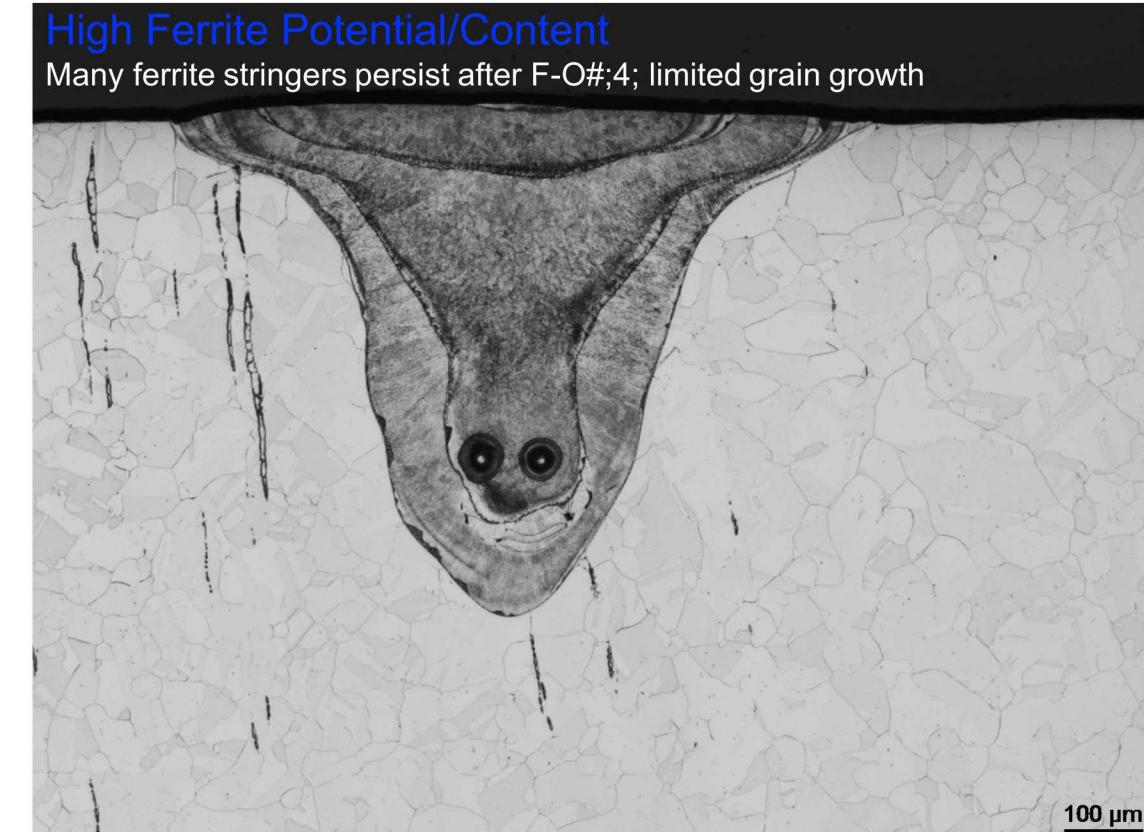
High Ferrite Potential/Content

Many ferrite stringers persist after F-O#4; limited grain growth

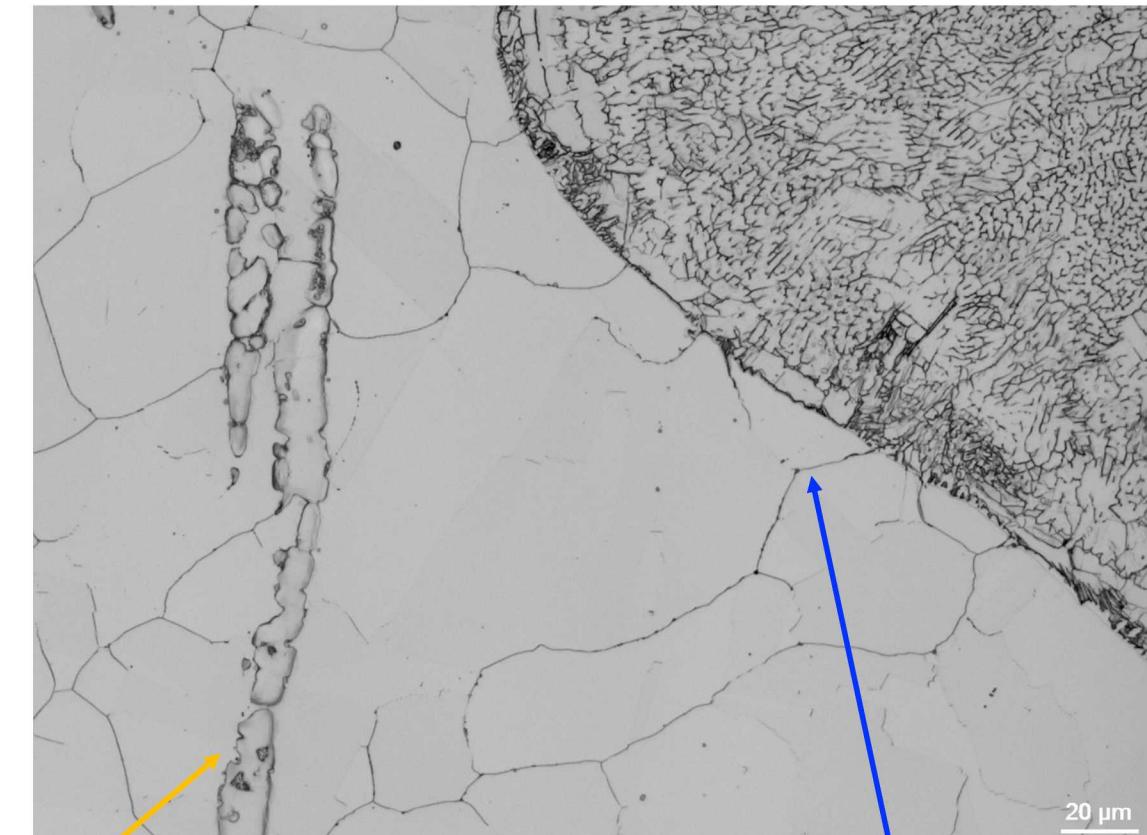
Ferrite+boride stringers largely persist after heat treatment

Serrated ferrite/austenite phase boundary suggests some operative dissolution operative as a result of heat treatment; however, complete dissolution of stringer did not occur

Limited intergranular boride formation

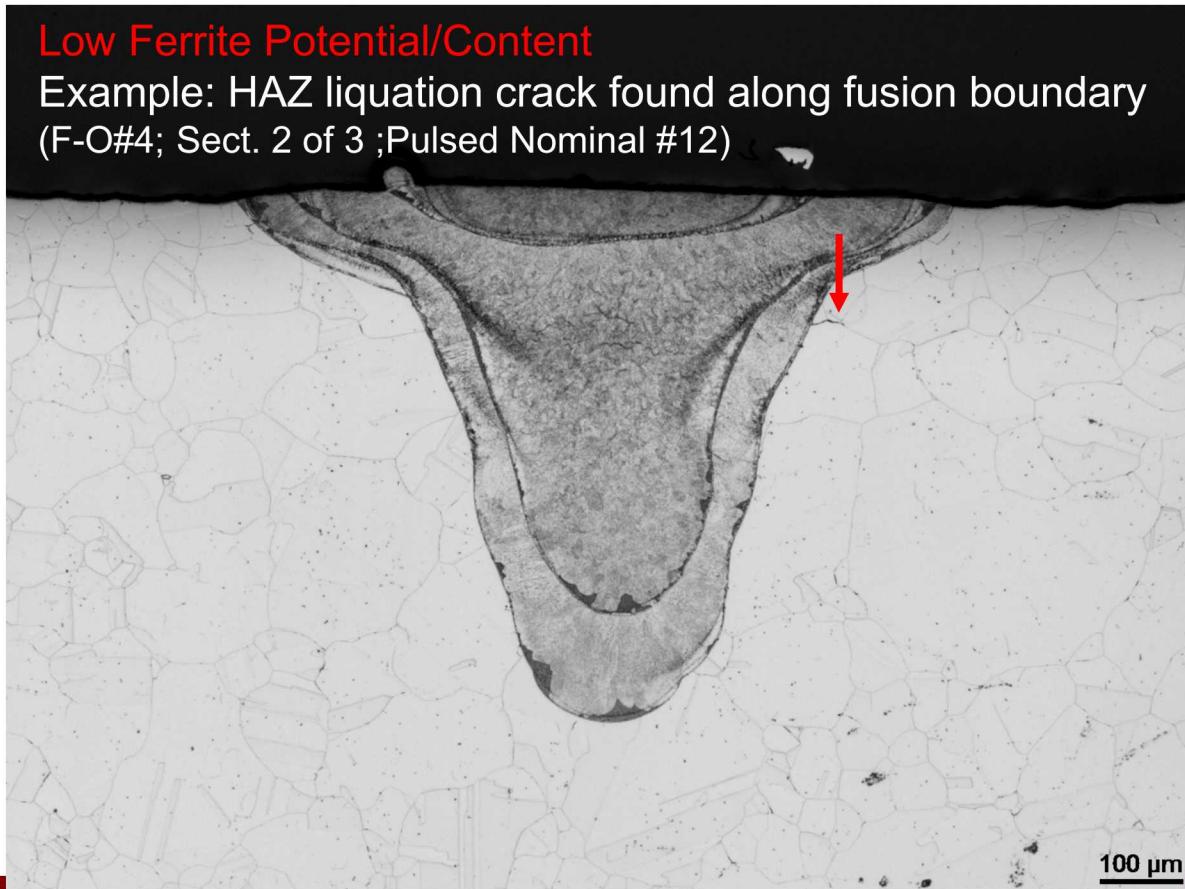
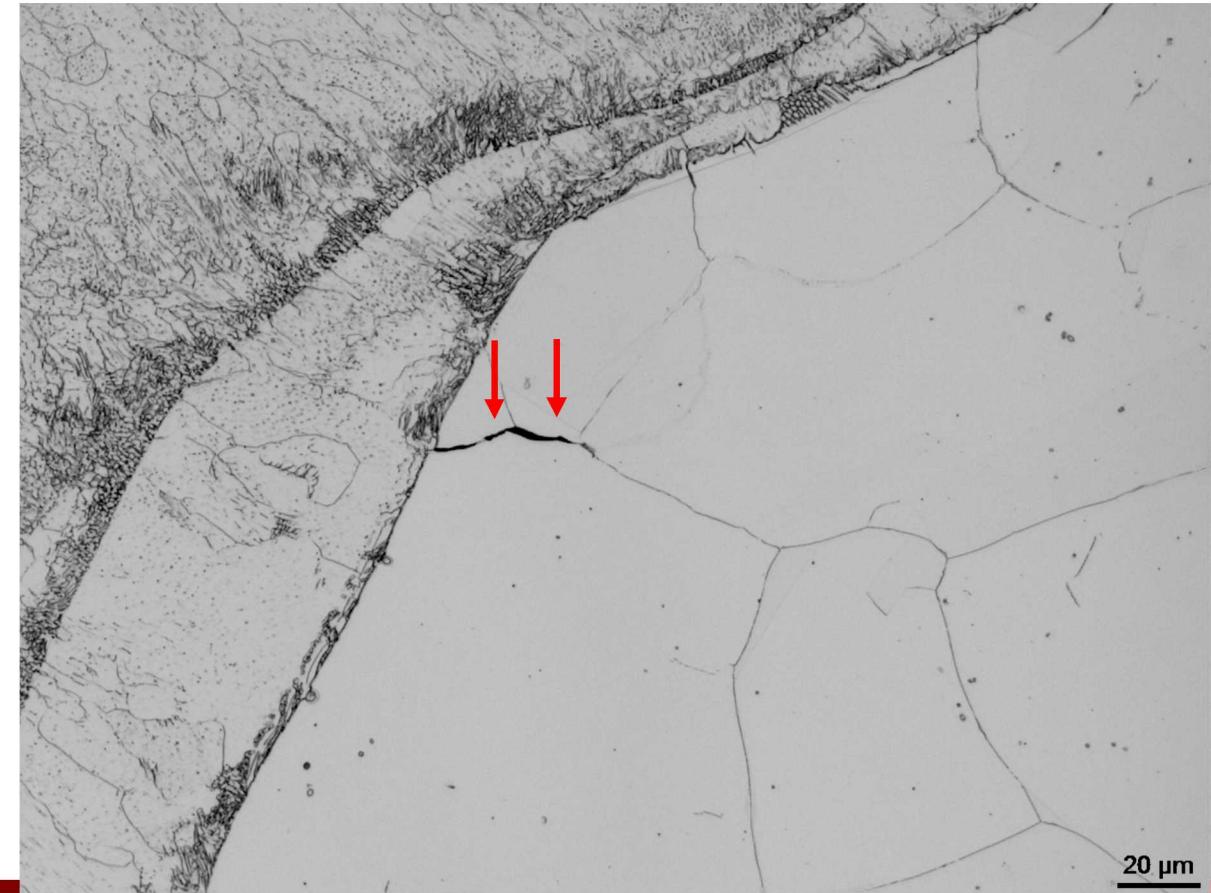
Low Ferrite Potential/Content

- Highest peak temperature (1040C) of F-O#4 thermal cycle resulted in microstructural changes that led to HAZ liquation cracking susceptibility
 - Ferrite+boride stringer dissolution + grain growth + intergranular Cr₂B formation
- No HAZ cracks found in any other conditions with lower peak temperatures (F-O#1 – F-O#3) for this heat

Example: HAZ liquation crack found along fusion boundary
(F-O#4; Sect. 2 of 3 ;Pulsed Nominal #12)

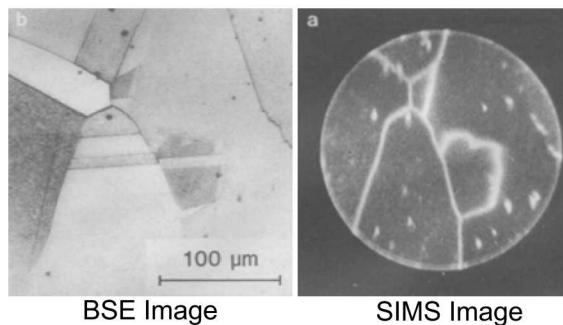
Grain boundary B segregation in 316L with 40 wt.ppm B¹

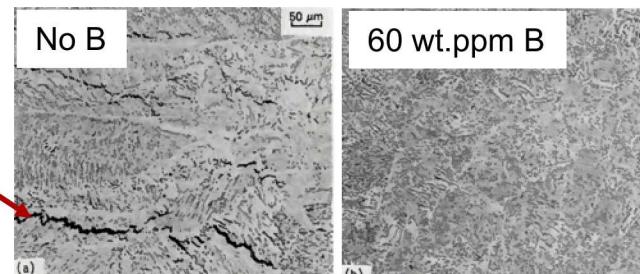
Creep-life enhanced 308 filler metal²

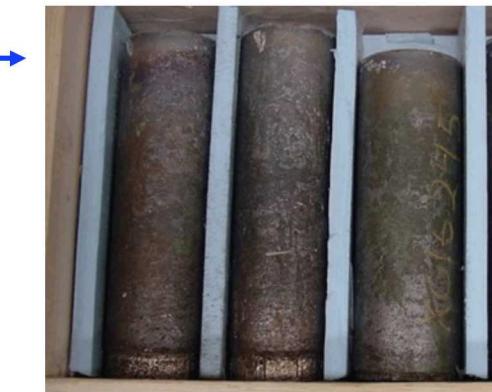
Production-scale melt
hot worked into 4" bar

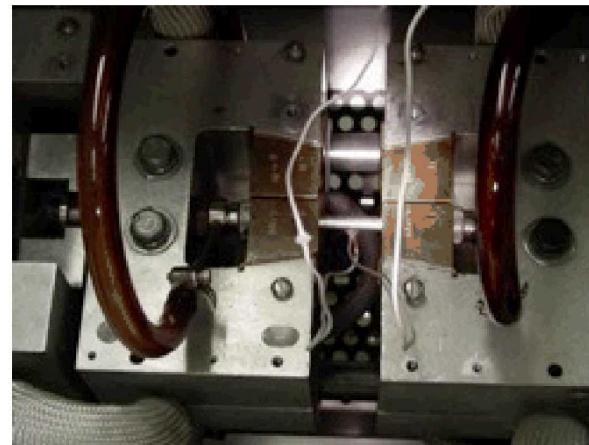
#1:
Evaluation of elevated temperature ductility

Gleebel Thermomechanical Simulator

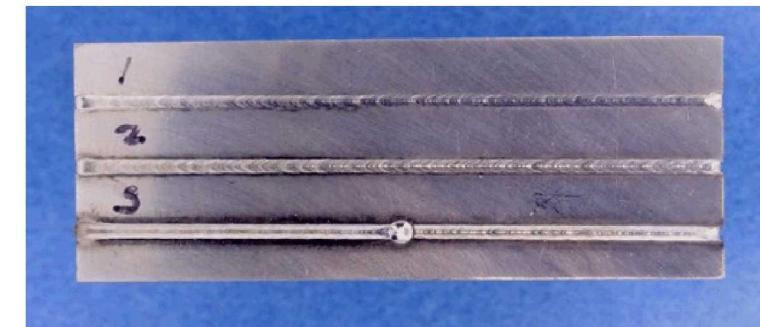
#2:
Autogenous GTA and laser welds

- Assessing boron micro-alloying effects on HAZ liquation cracking susceptibility will utilize both simulative weldability testing and autogenous weld trials

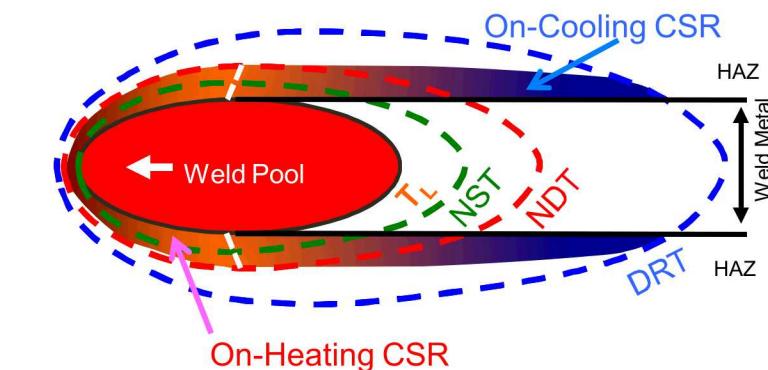
Translation of Measured HDT Temperatures to HAZ Crack Susceptible Regions (CSR)

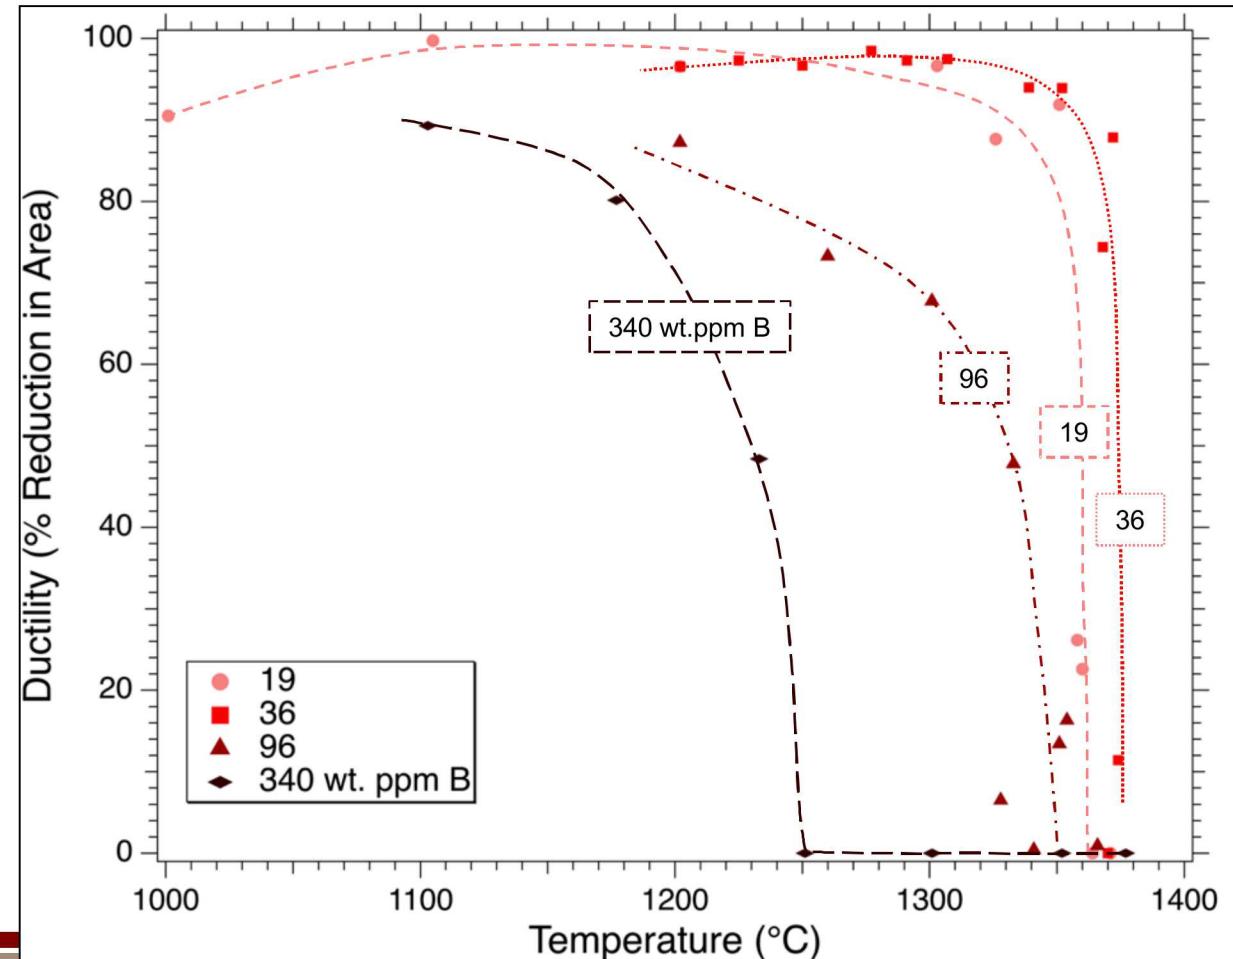
On-heating ductility signature

- Ductility decreases precipitously for B contents \leq 96 wt. ppm around 1350°C; with the 96 wt.ppm B condition exhibiting a wider temperature range over which ductility decreases
- Highest B condition (340 wt.ppm) demonstrated nil-ductility temperature (NDT) approximately 100°C lower than other conditions

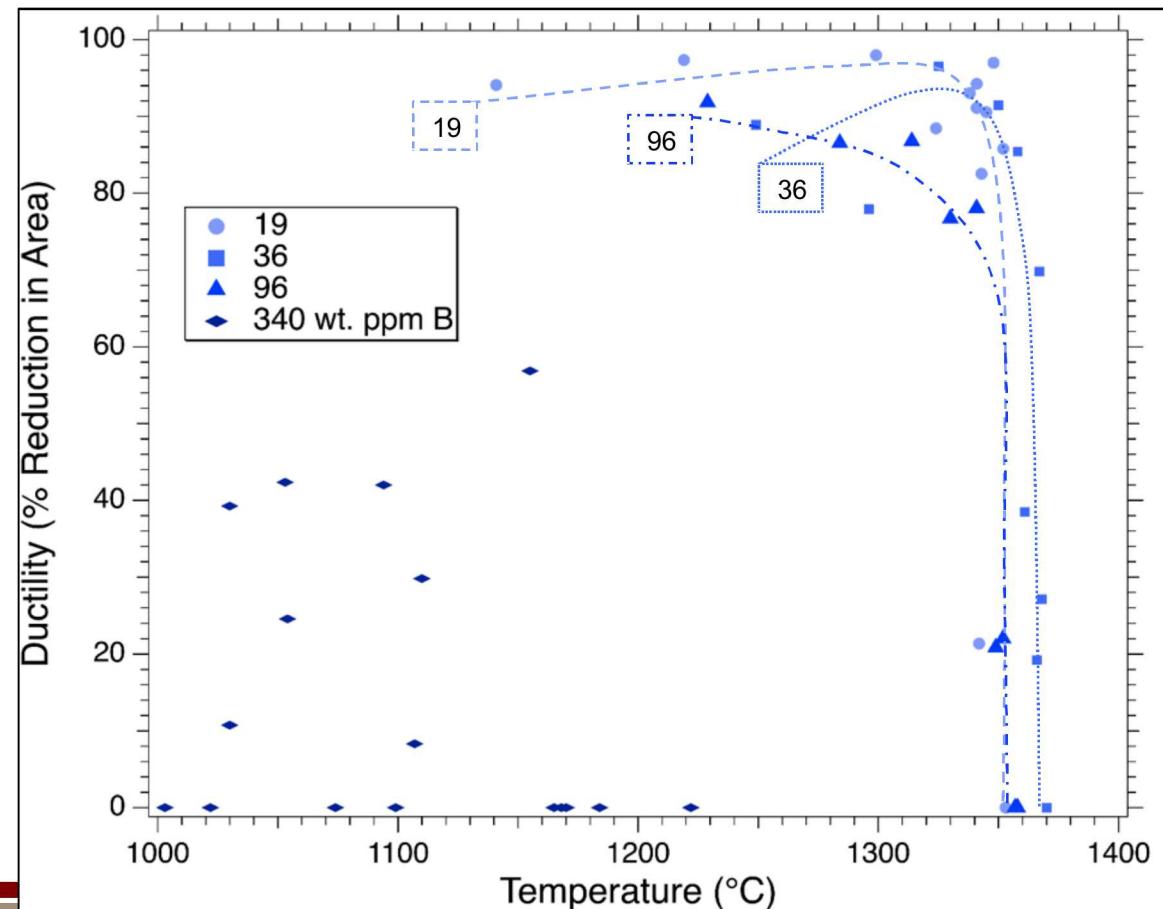
On-cooling ductility signature

- 19, 36, and 96 wt.ppm B specimens exhibited rapid ductility recovery on-cooling
- 340 wt.ppm B condition exhibits ductility recovery 200+°C lower than other conditions evaluated
- Longitudinal cross sections near fracture for 340 ppm needed to better understand ductility variability
