Thermal Processing Effects on Heat Affected Zone Liquation Cracking Susceptibility of Boron Micro-alloyed 304L Stainless Steel

Metallurgy & Material Joining Department
Sandia National Laboratories, Albuquerque, NM

American Welding Society 2019 Professional Program: Welding Metallurgy I

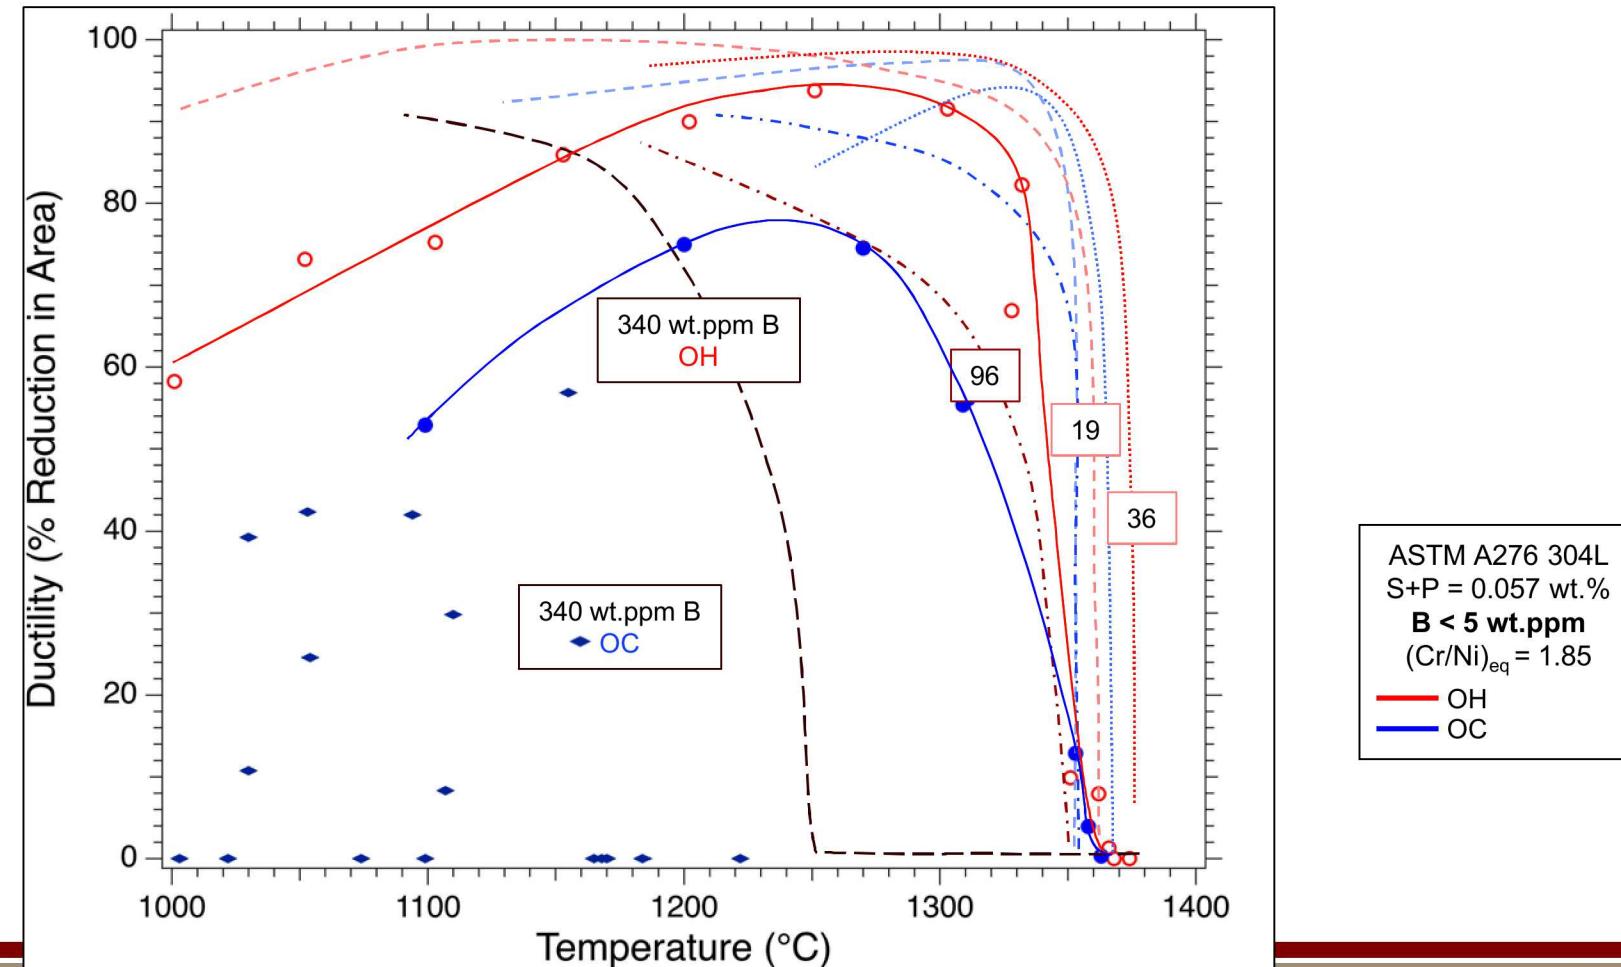
Hot ductility testing does not indicate liquation cracking risk for 304L with < 100 wt.ppm boron

- Boron-containing 304L with < 100 wt.ppm B shows similar ductility signature as commercial ASTM A276 304L with no B micro-alloying addition

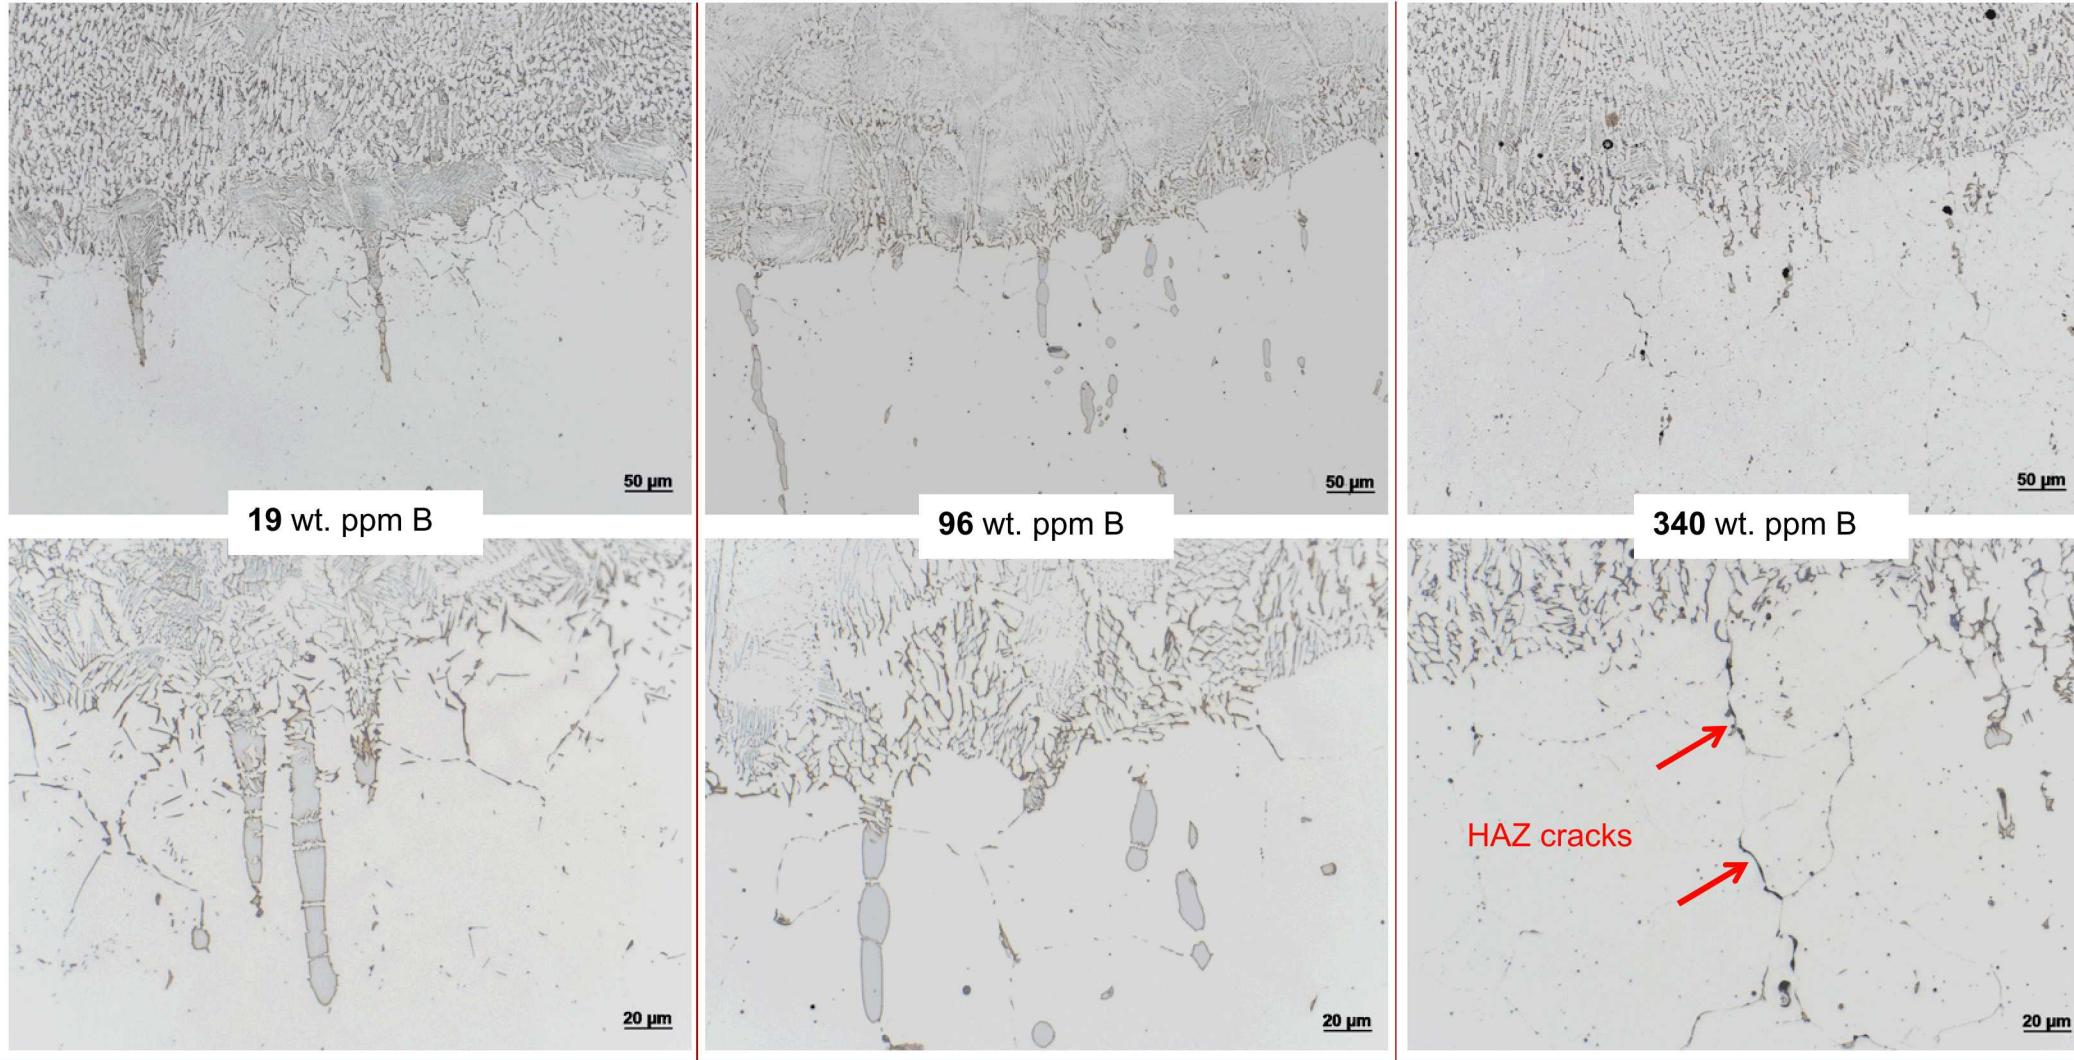
GTA Welds: Light optical microscopy

- Near fusion boundary HAZ liquation cracks only observed in highest B content condition
- Examination of autogenous GTA weld samples exhibits similar trend predicted by Gleeble hot ductility

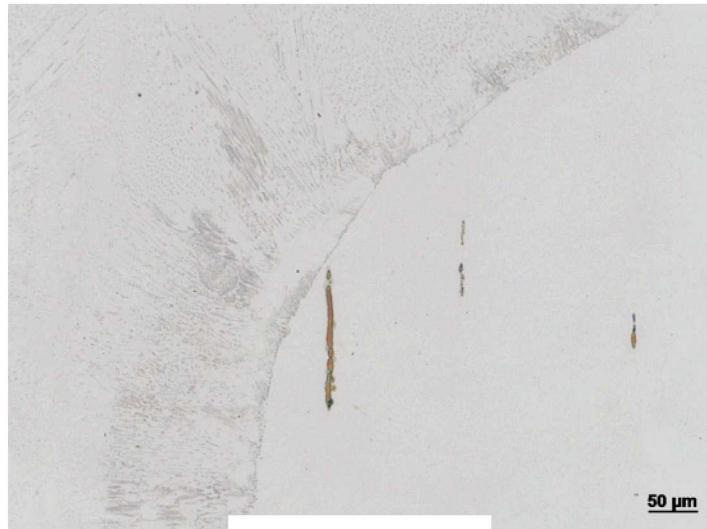
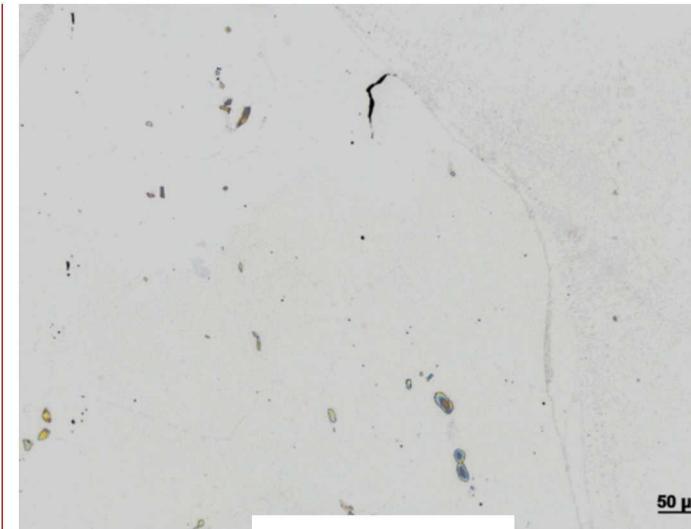
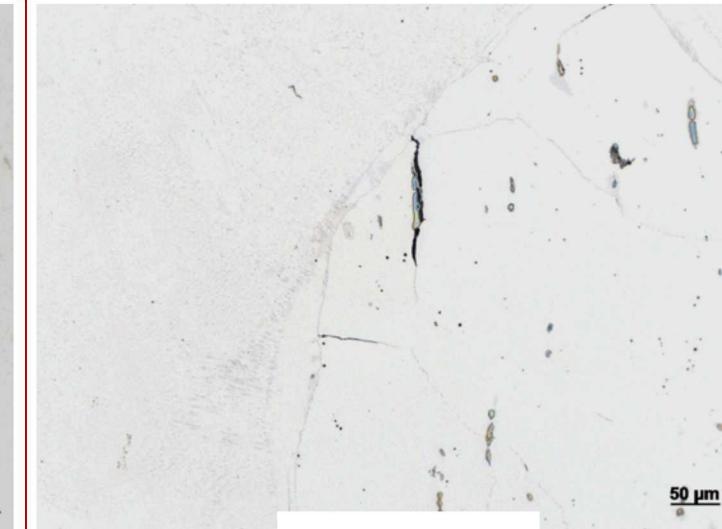
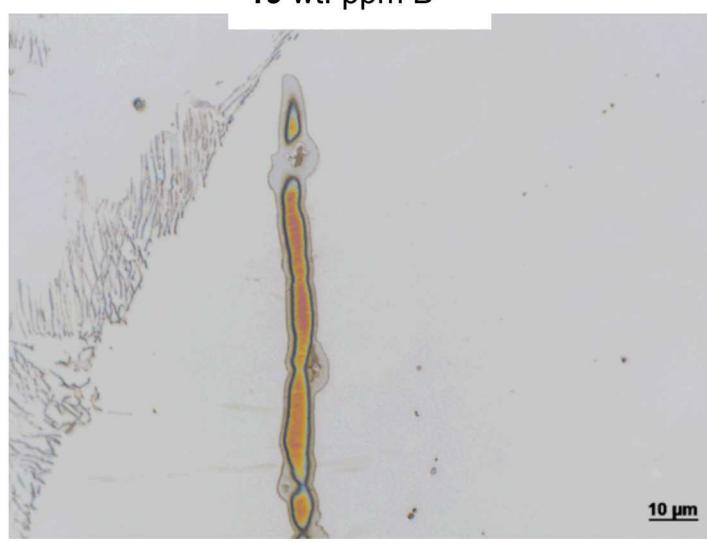
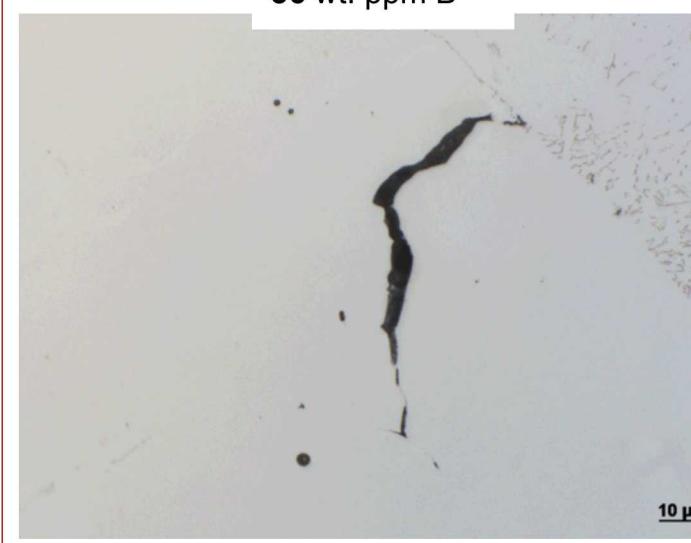
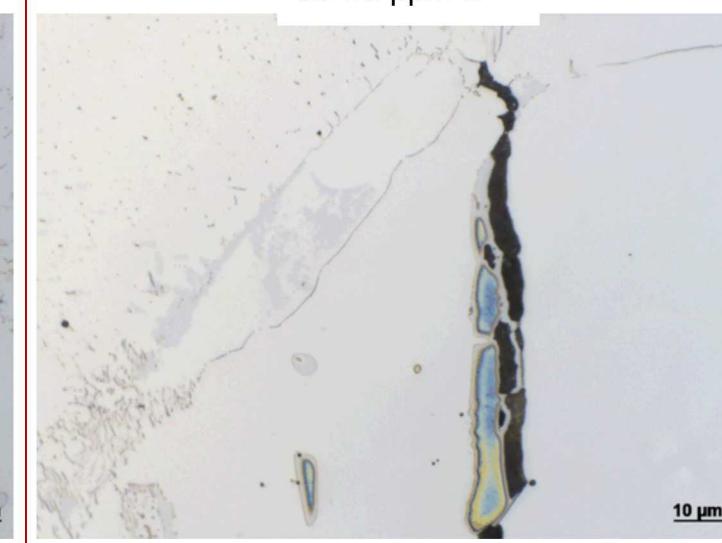
CW Laser Welds: Light Optical Microscopy

- Intermittent HAZ cracking observed in laser welds at significantly lower B content compared to autogenous GTA welds.

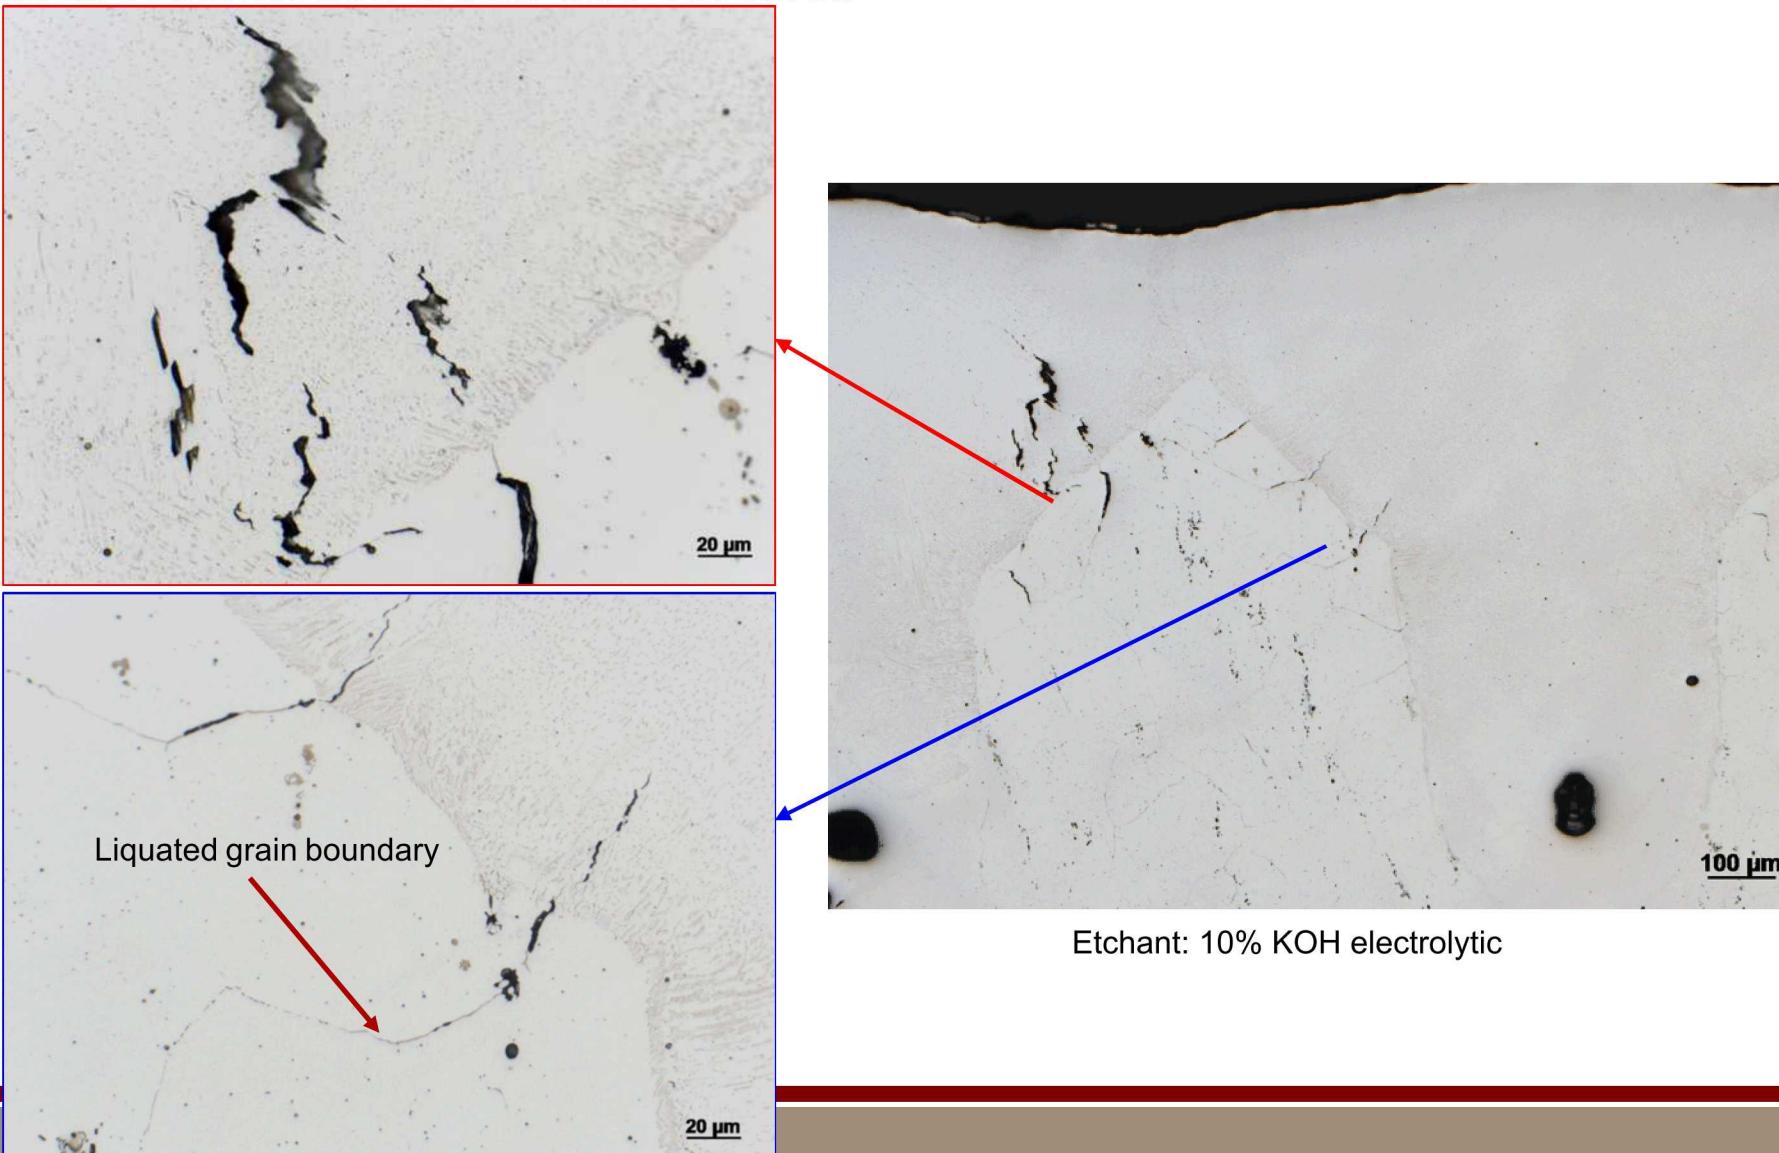
CW Laser Weld: 340 wt.ppm B

- Extensive HAZ liquation cracking in highest B condition
- Weld metal solidification cracks also observed

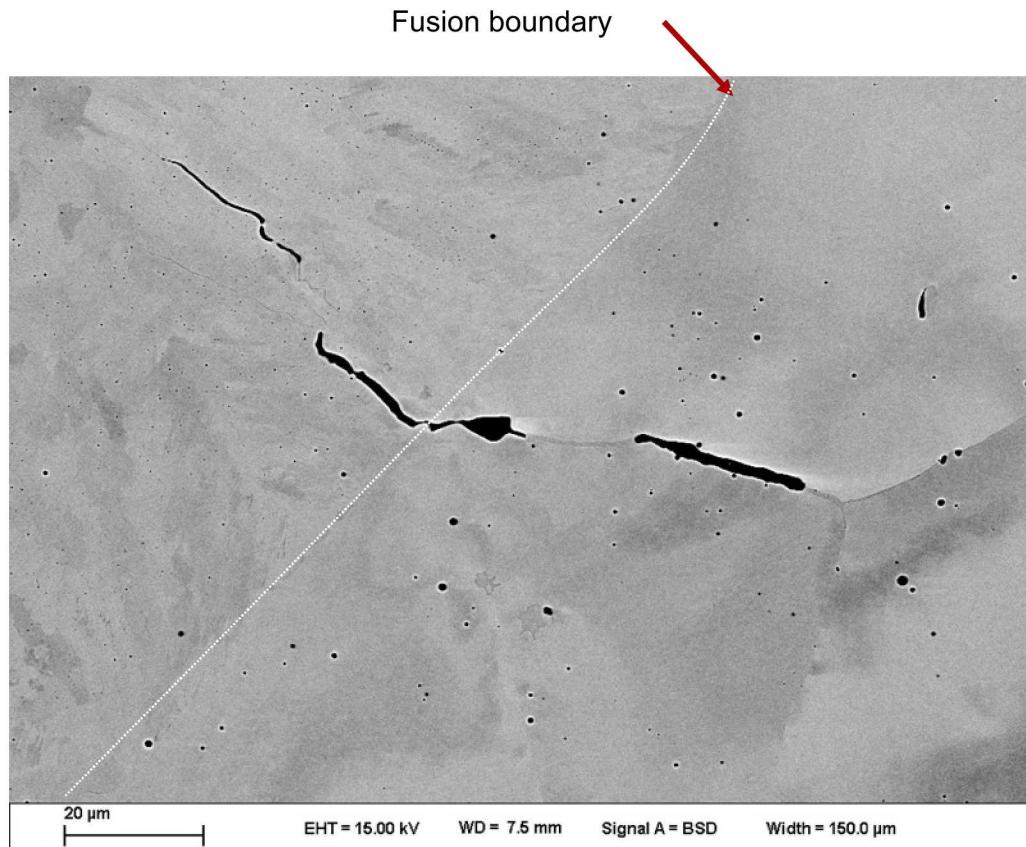
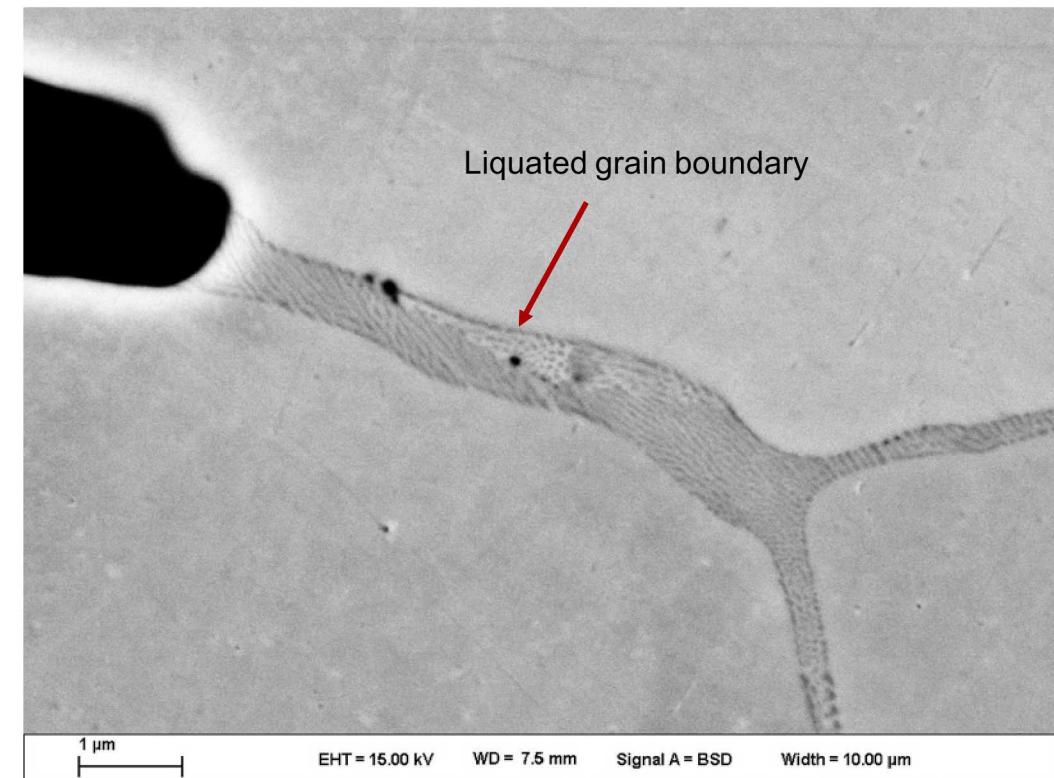
CW Laser Weld: 340 wt.ppm B: Electron Microscopy

- High-resolution backscatter electron imaging reveals fine-scale microconstituent decorating liquated HAZ austenite grain boundaries
 - Eutectic structure considerably finer in LBW vs. GTA welds exhibiting liquation
