Lessons Learned: Tension Member Failure on Force Calibration Frame

Project Lead: Length, Mass, Force Lab
DOE Primary Standards Lab, Sandia National Laboratories

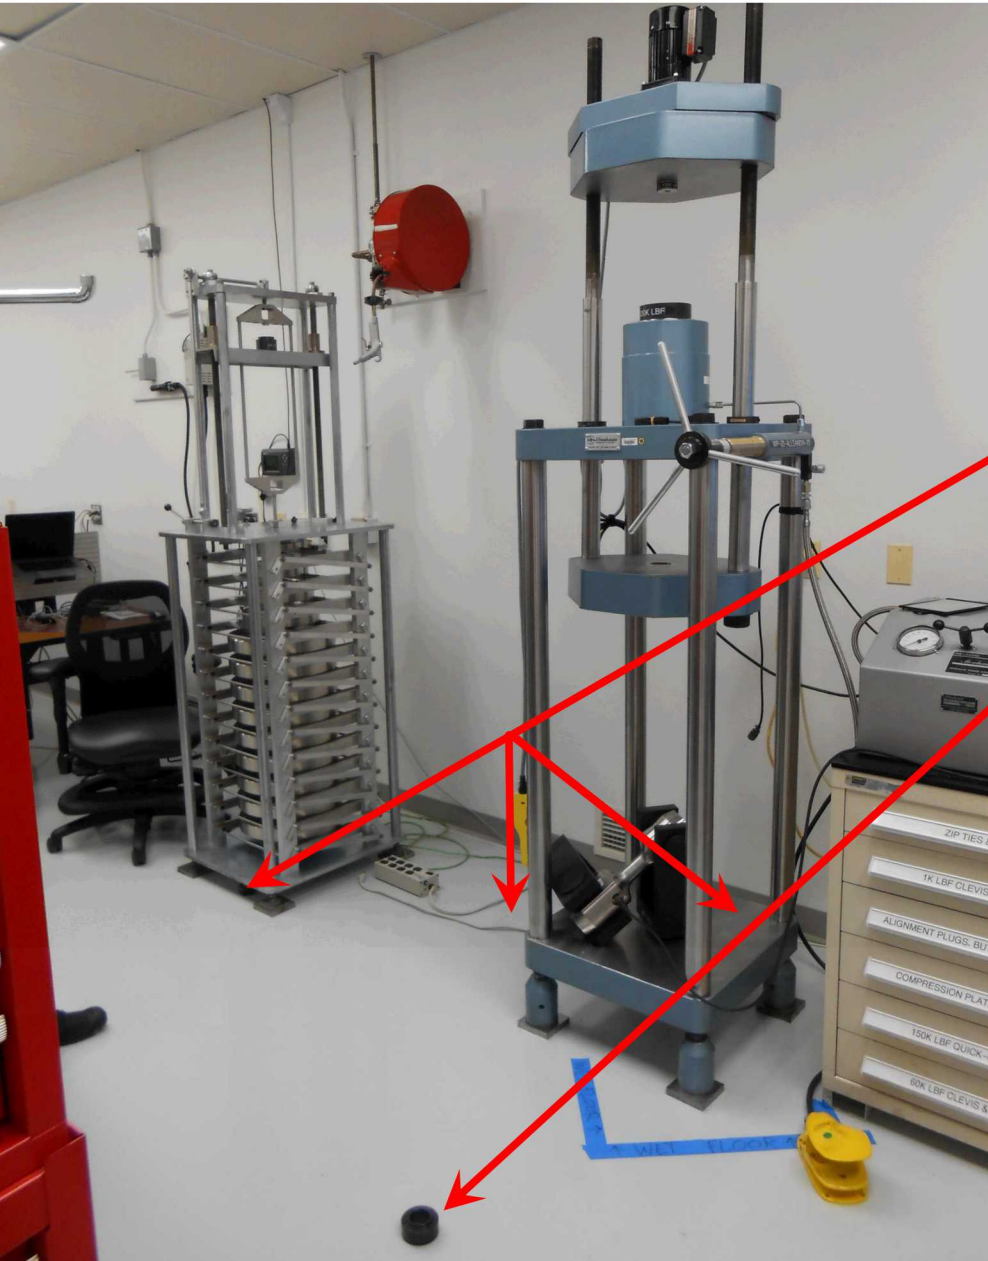
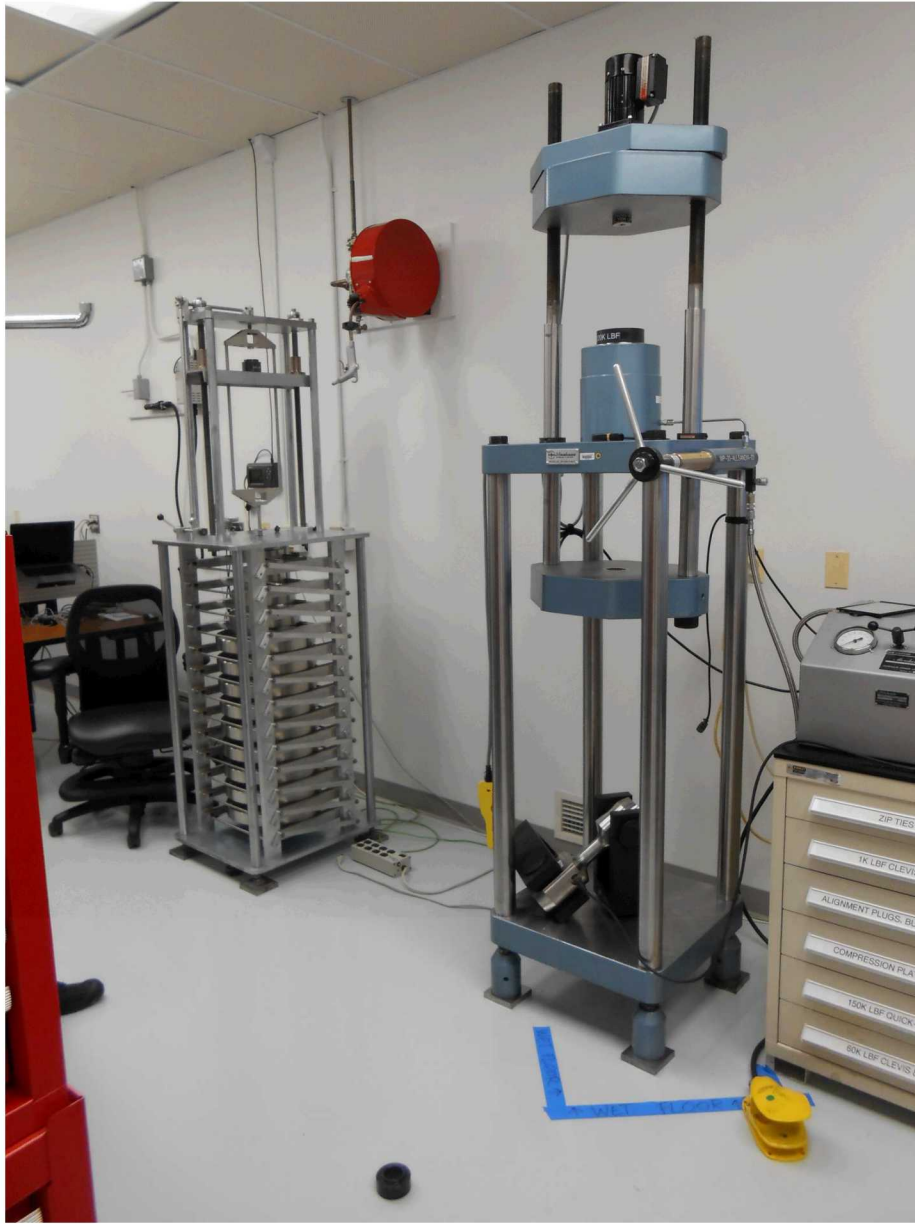
The Big Bang

1. Confirm no injuries
2. Secure unstable equipment
3. Notify management
4. Begin taking photographs/documentation
5. Notify manufacturer
6. Hold first meeting with incident investigation team

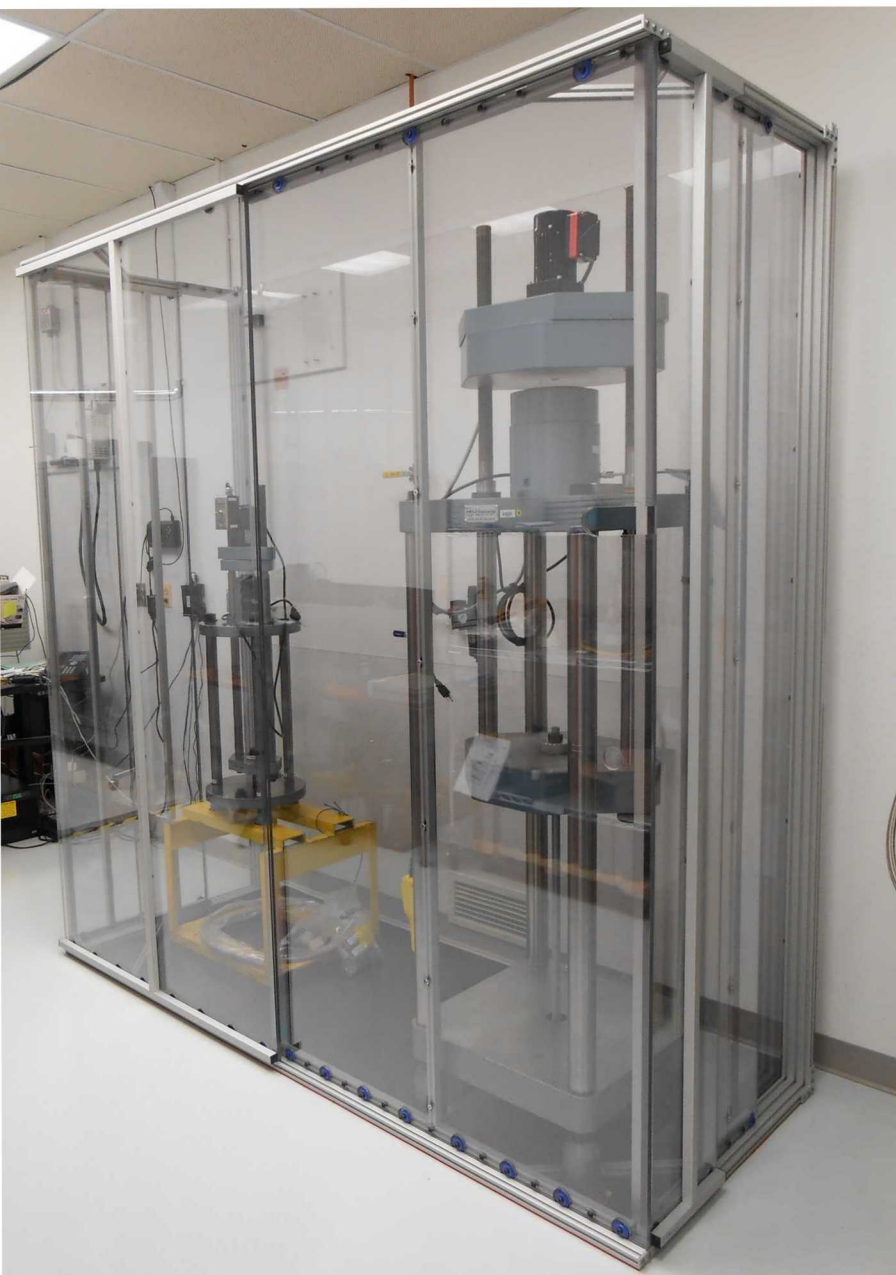
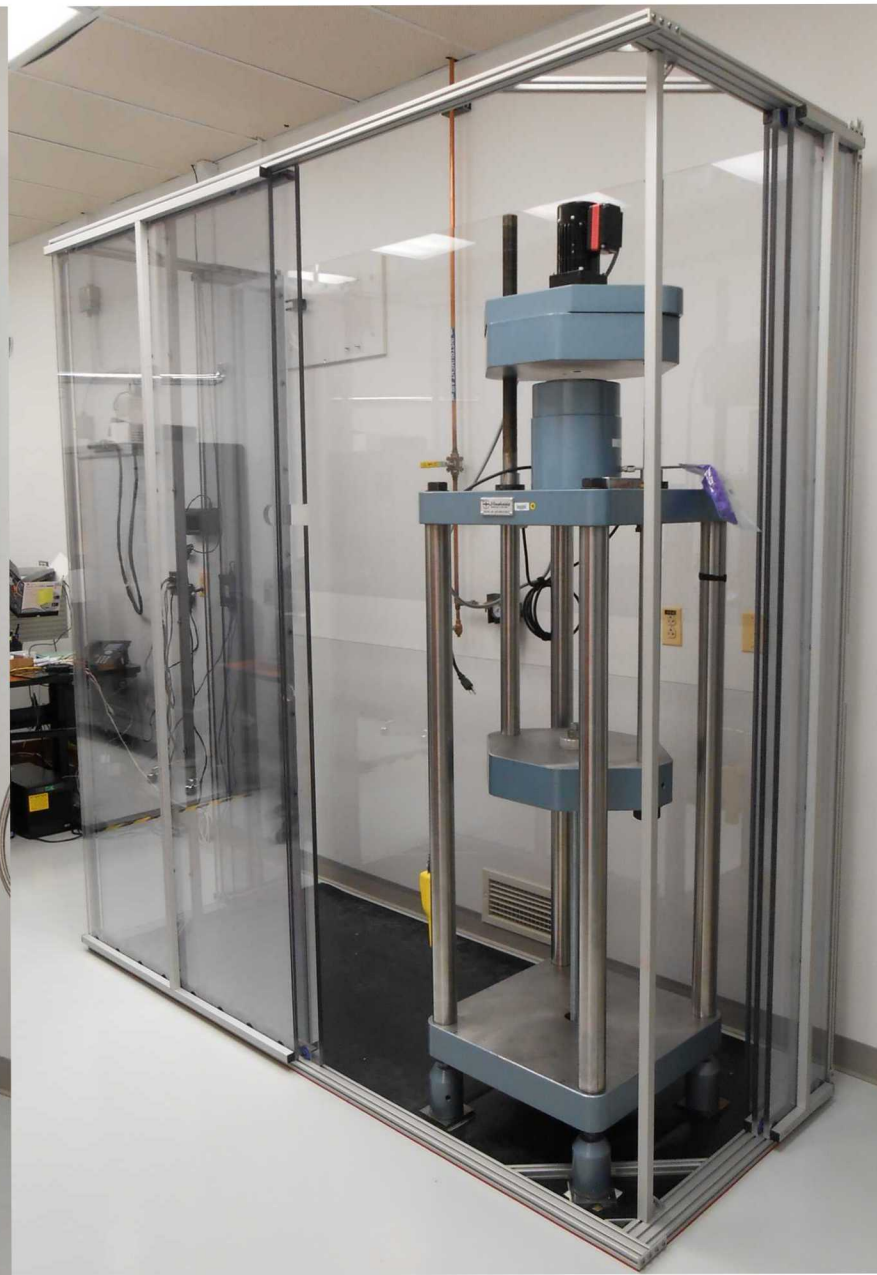
Corrective Action: Engineered Containment

- 2 layers of LEXAN™ (polycarbonate)
 - 1/4 inch
 - 3/8 inch
- 80/20 Framing
 - Minimal in-house machining required
- Sliding doors with large access area
- Rubber mat
