Sandia
National
Laboratories

SAND2019-8408PE

Determining Steel Corrosion Rates Under Waste Isolation Pilot Plant Conditions

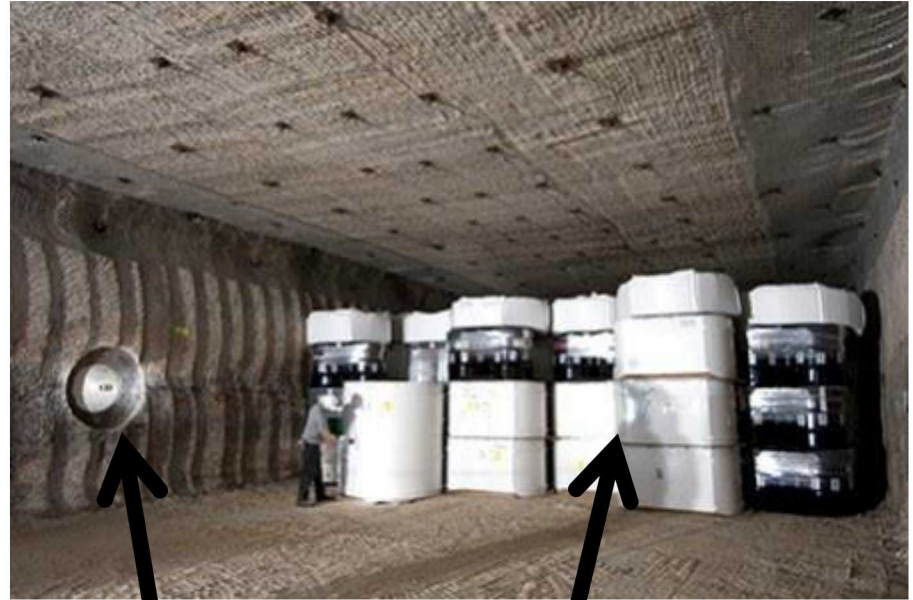
Remote-Handled
Waste

Contact-Handled
Waste

Figure 1. Waste emplaced in panels underground at the WIPP

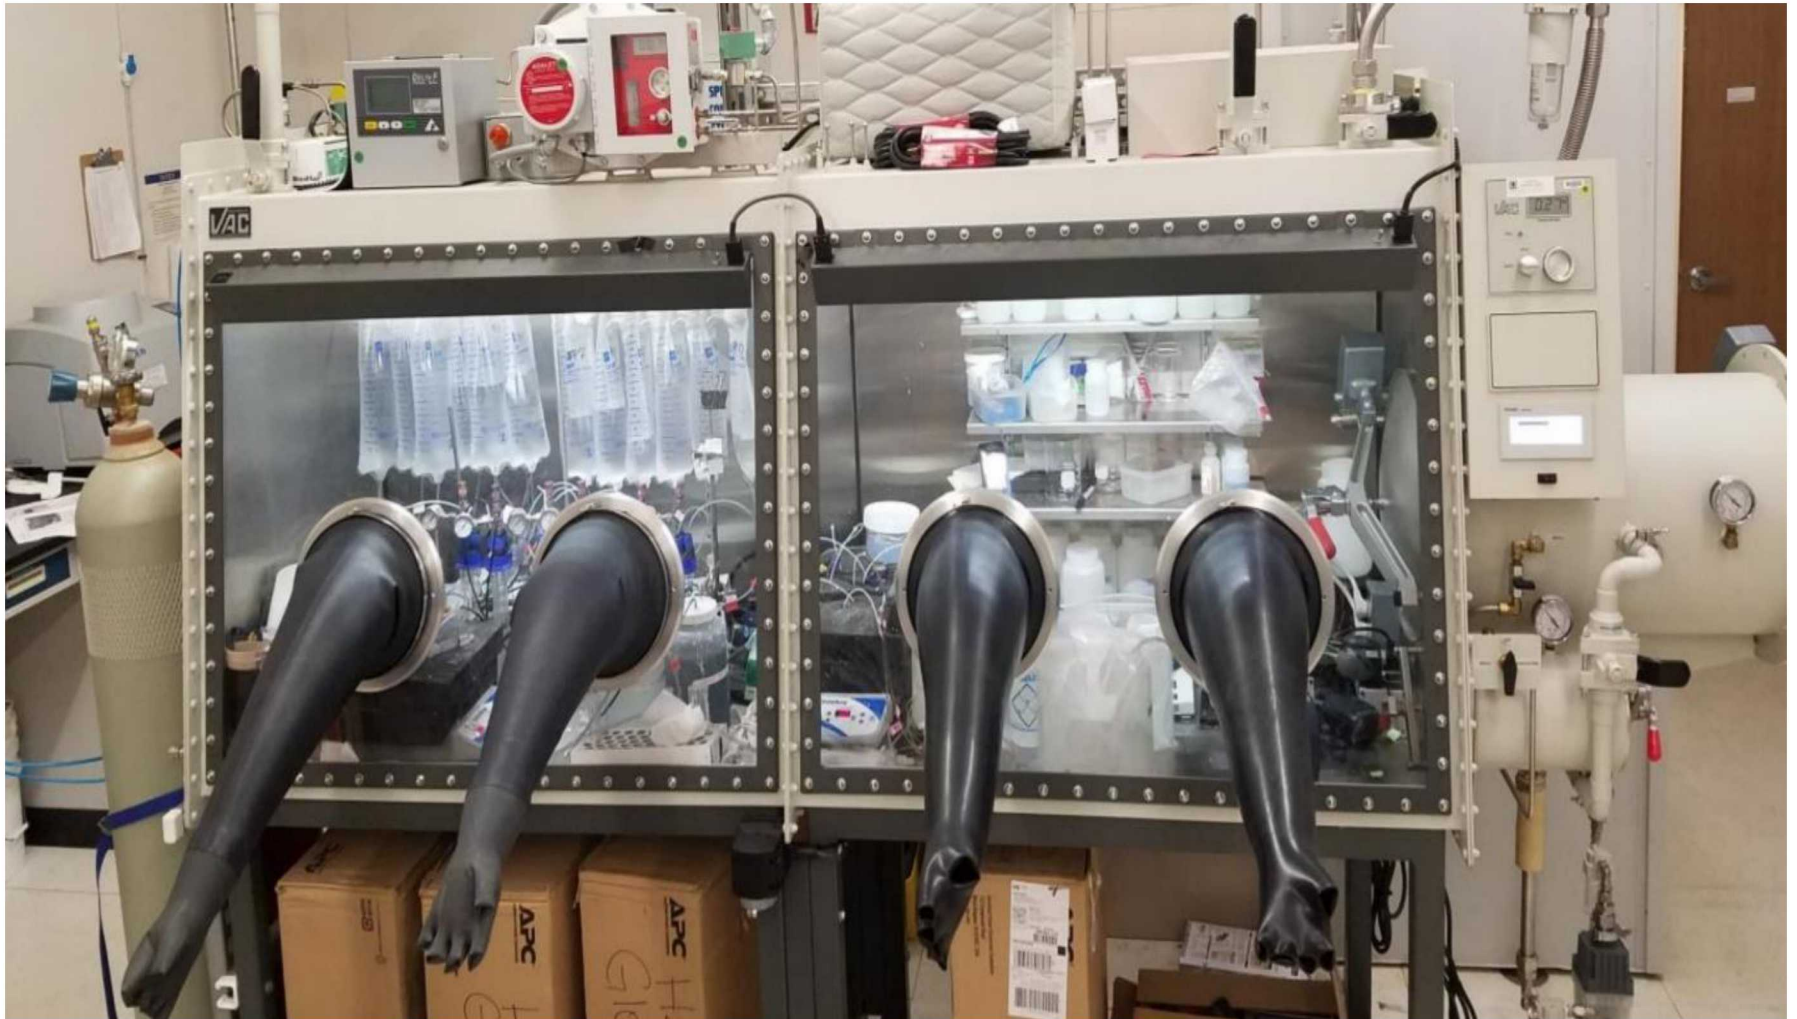
Figure 2. *Glovebox setup for anaerobic flow-through experiments at Sandia Carlsbad facilities.*

- Steel corrosion could produce significant gas generation
- Corrosion rate and mechanisms must be determined
- Various rate determination methods
- Static, Flow-thru, and Electrochemical set-ups
- Experiments conducted at 90 C

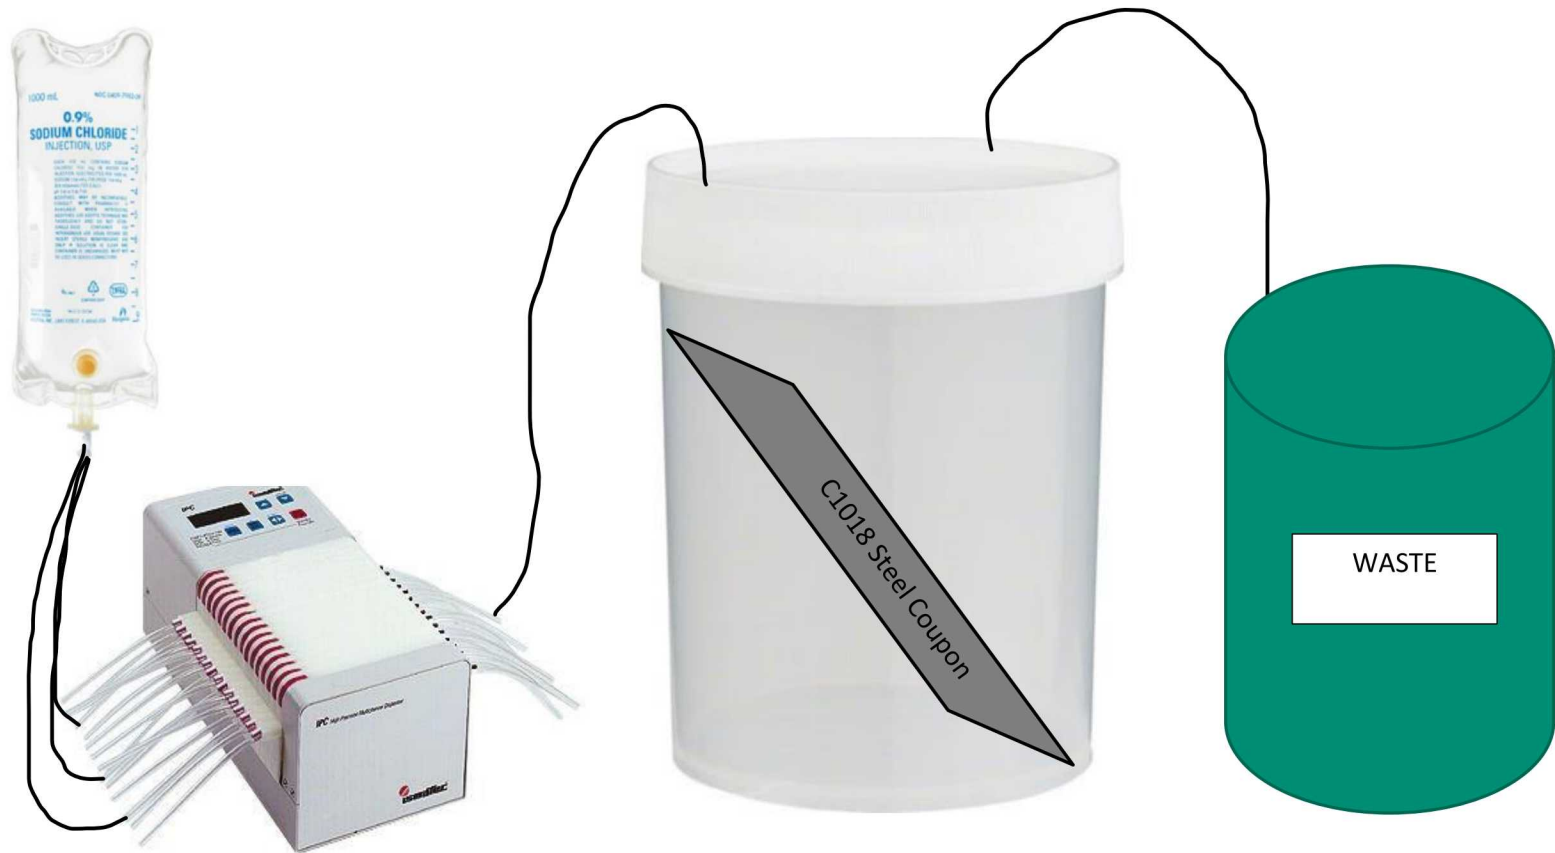
Figure 3. *Simplified schematic of flow-through setup process*

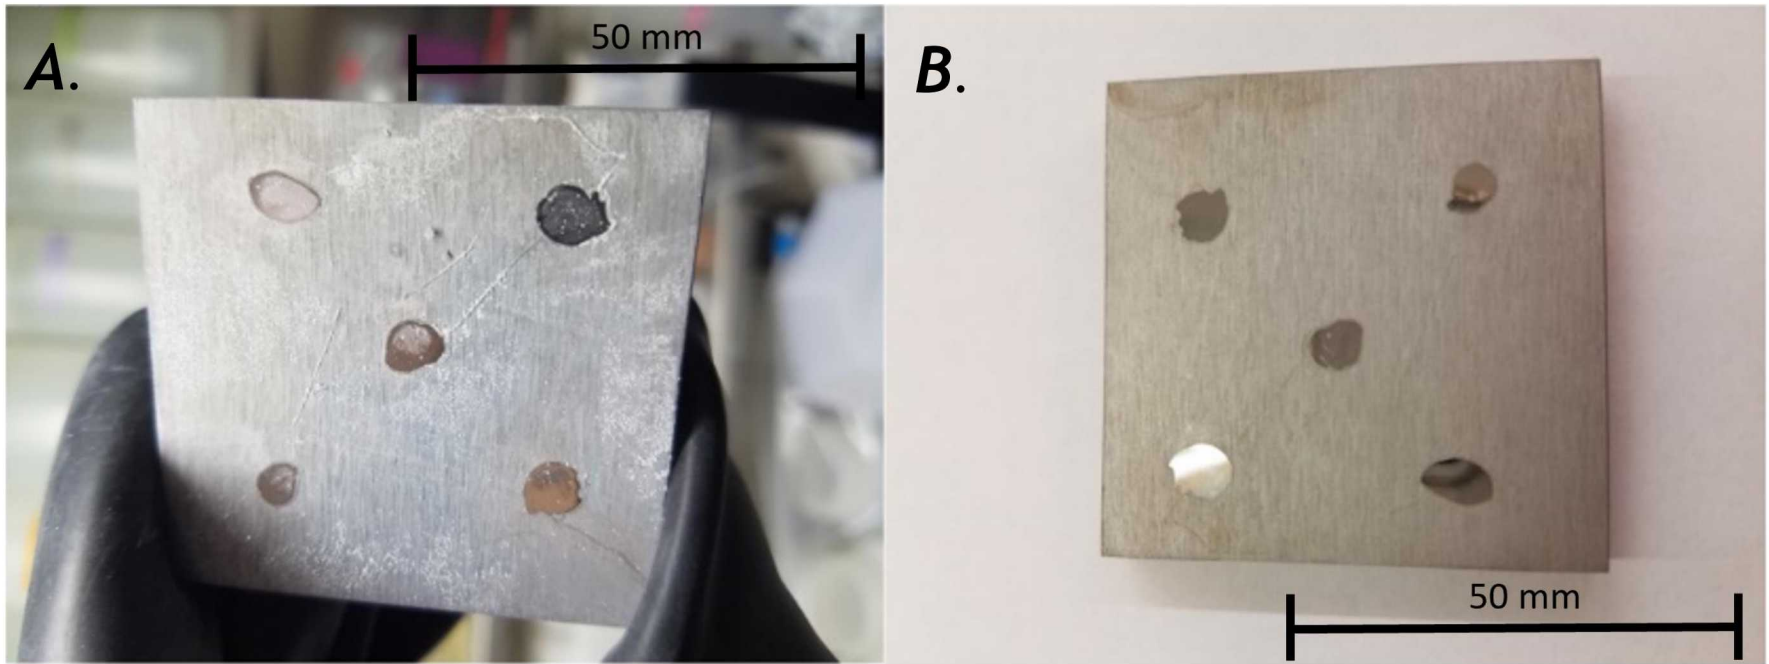
- Simplified Brine Solution (no sulfide)
- 3.5 M NaCl + 1.0 M MgCl₂

Figure 4a. C1018 steel coupon with masking removed after ~5 months in the flow-through setup (sulfide free simplified brine). **Figure 4b.** C1018 steel coupon after cleaning procedure (ASTM G 1 - 03)

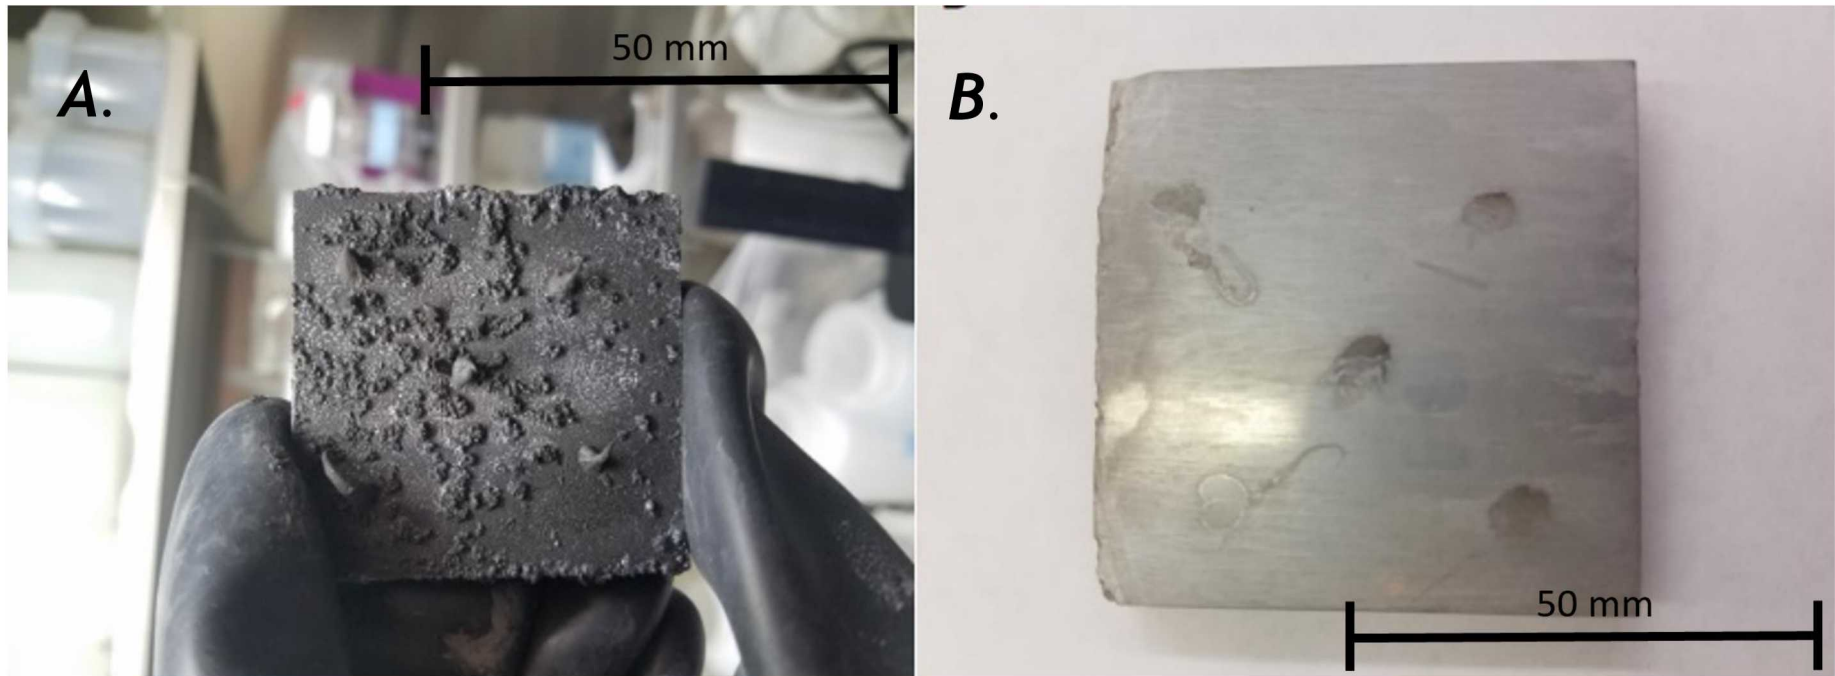
- Simplified Brine Solution (with sulfide)
- 3.5 M NaCl + 1.0 M MgCl₂ + 10mM NaHS

Figure 5a. C1018 steel coupon with masking and corrosion products after ~5 months in the flow-through setup (sulfide bearing simplified brine). **Figure 5b.** C1018 steel coupon after cleaning procedure (ASTM G 1 - 03)

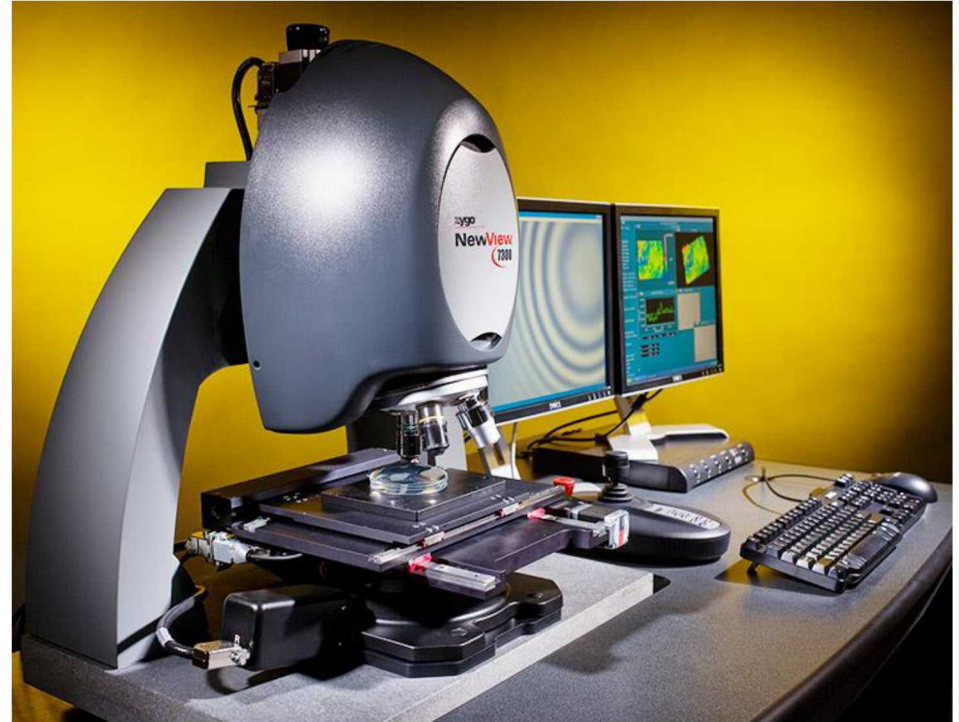
- Used to measure small displacements, typically in astronomy, seismology, etc.
- Novel idea for measuring corrosion rates

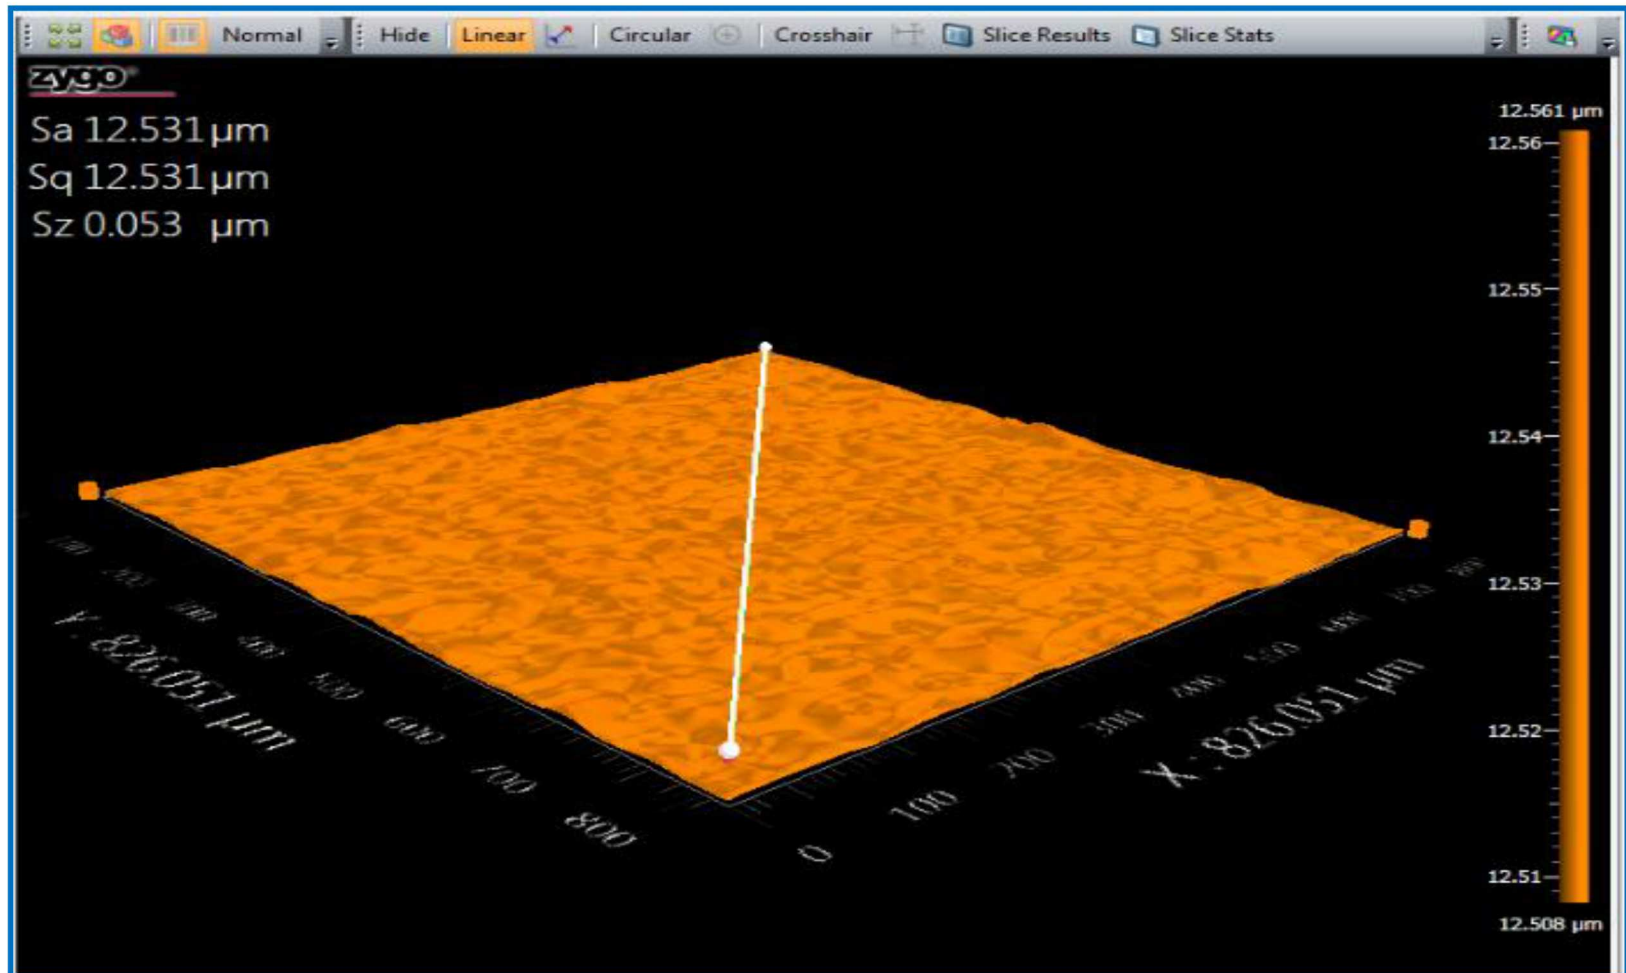
Figure 7. *Interferometry image of unreacted pristine surface*

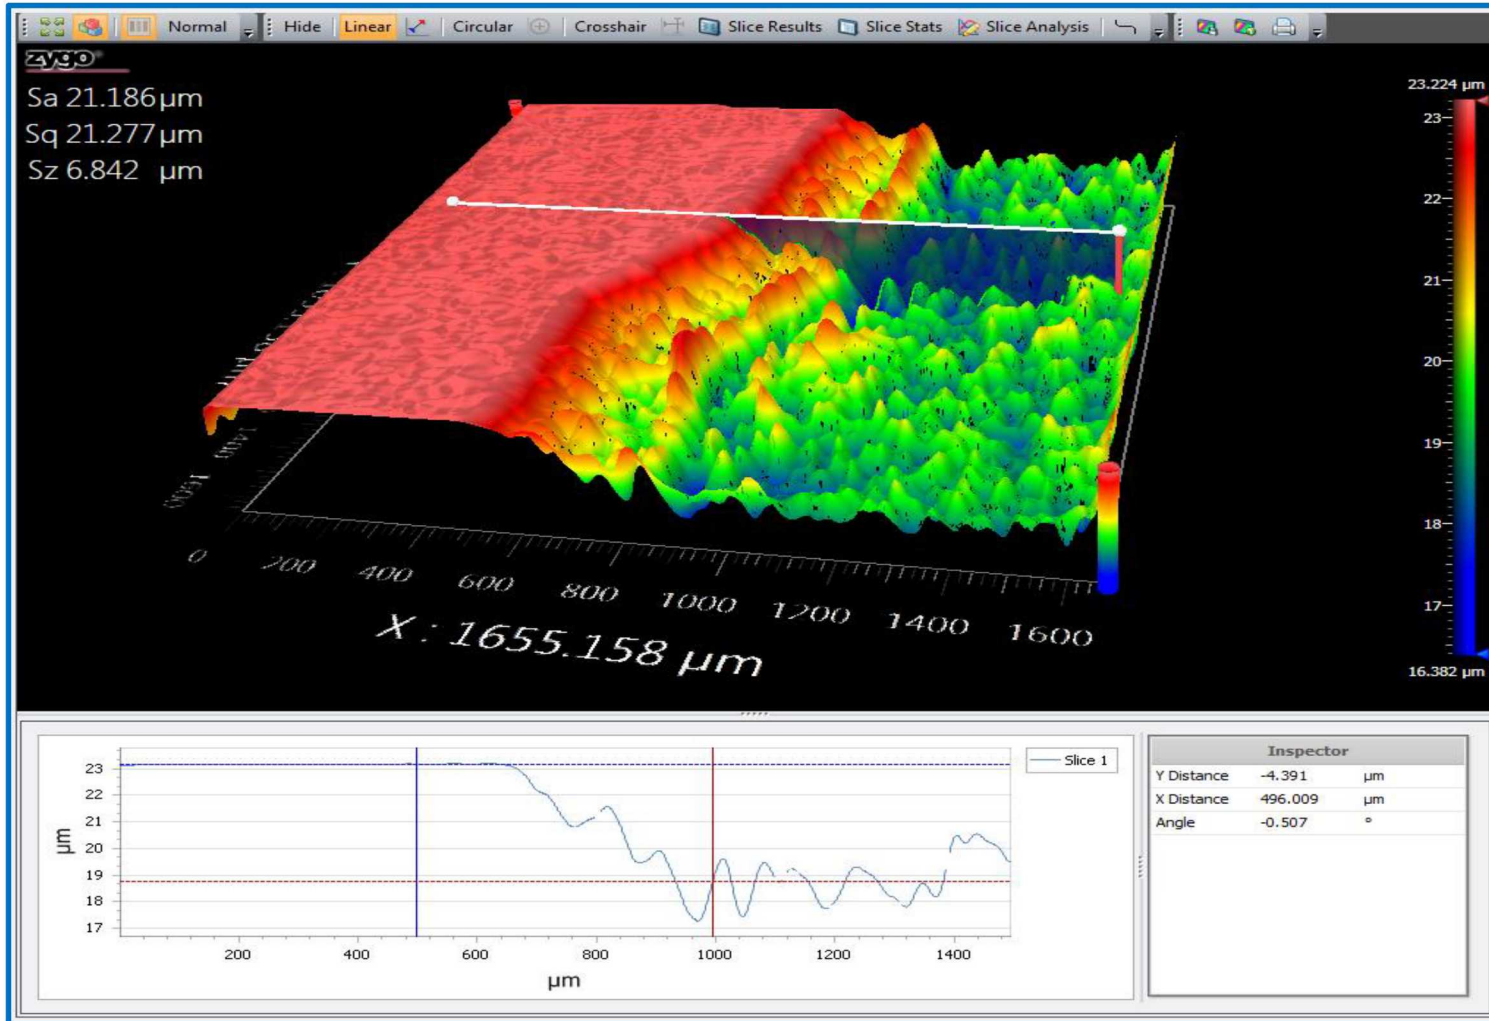
Figure 8. Interferometry results of coupon reacted in sulfide bearing simplified brine. Step change ~ 5 micrometers

- Interferometry seems to be a promising method for determining corrosion rates
- Corrects for inaccuracies in other methods like weight loss
- Interferometry measurements will be confirmed with electrochemical tests
