SAND2019-8641PE

# Inconel X750 Spring Wire Characterization

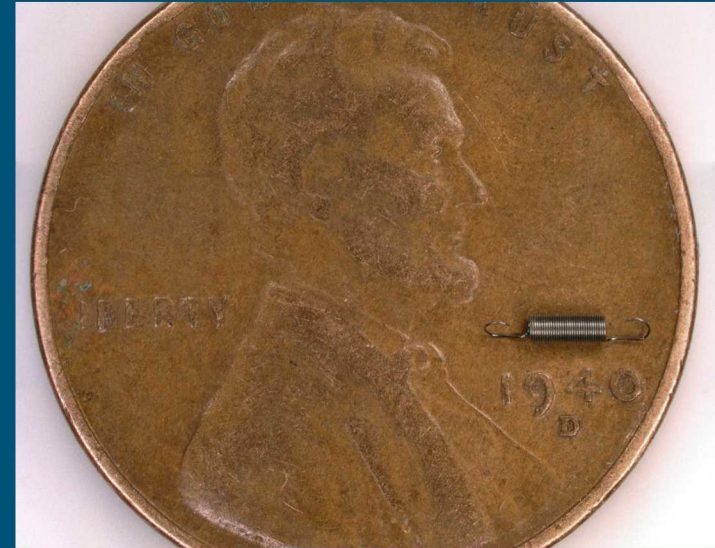
How small?

The springs (Inconel X750 spring wires) need to provide specific force values, which we will call “Load 1” and “Load 2” at positions 1 and 2.

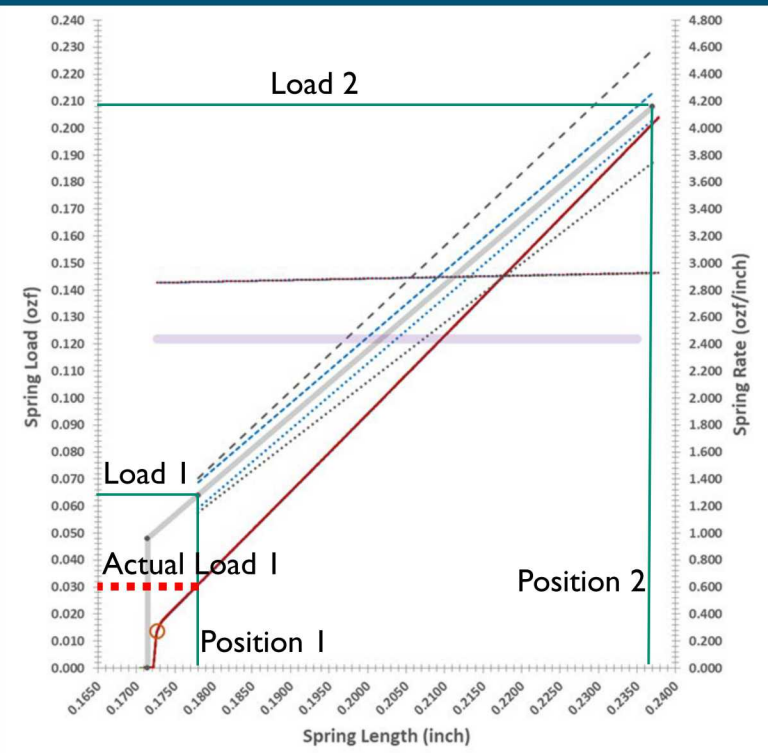
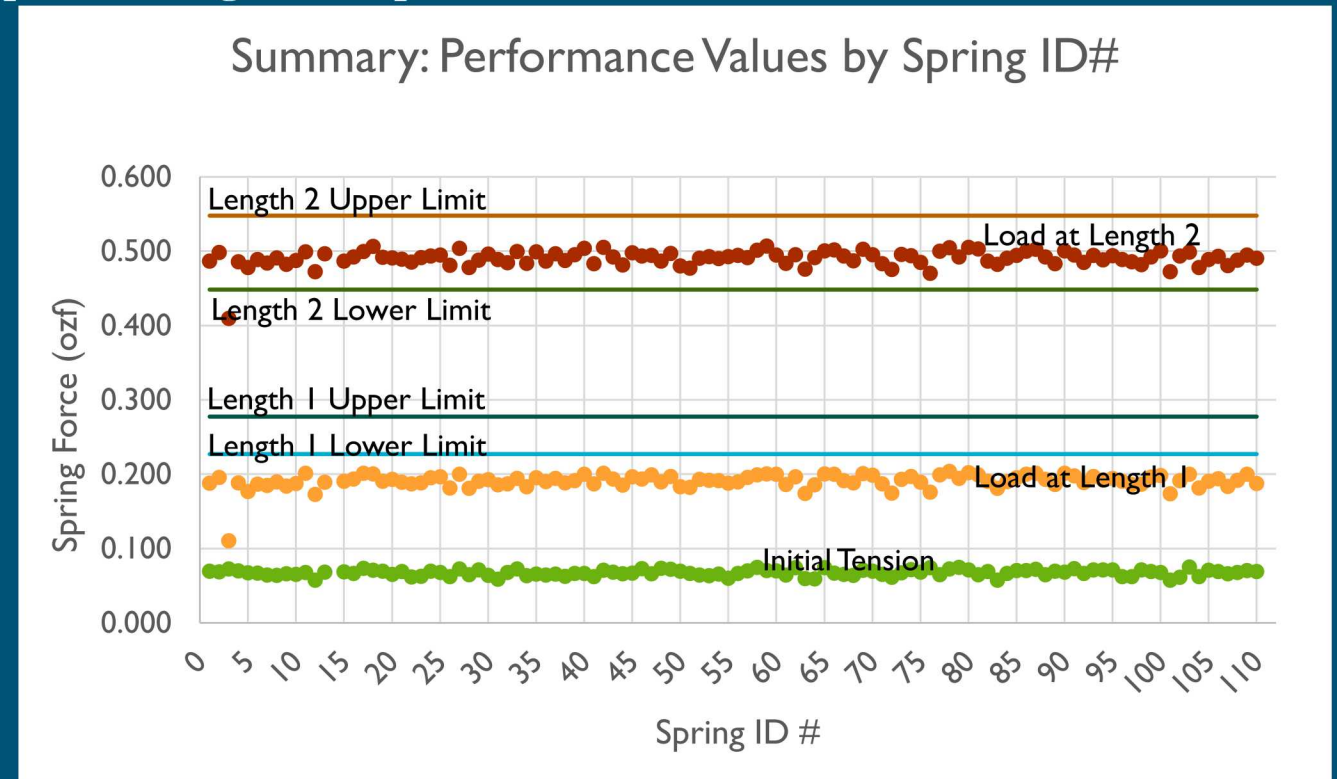
When the spring is pulled, its force goes up, passing under the first point and going through the second. What is supposed to happen is the line should pass through both points.

As can be seen, the spring force is consistently lower than needed for Load 1.

The question that's being asked is, why? Why does the spring go through Load 2's limits (between its minimum and maximum values) but not through Load 1's.

One hypothesis we have is that some unexpected microstructural feature is interfering with the part's performance.

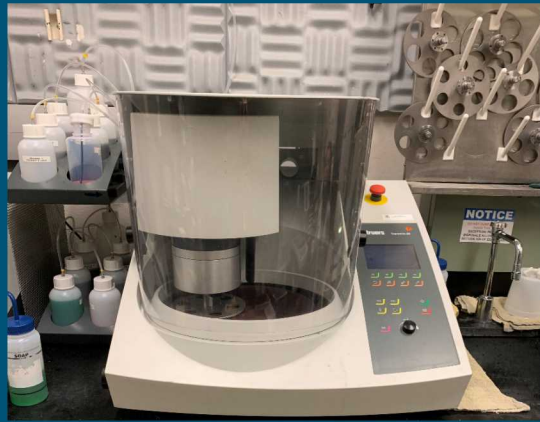
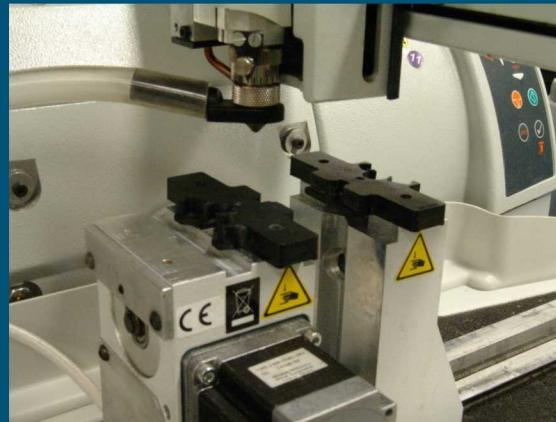
We also had to polish the mounts in order for the samples to be more easily seen through microscopes (the clearer, the better). Different grain-sized polishing cloths are used to polish mounts. For example, 9, 6, 3, and 1 micron cloths were used for the spring wires.

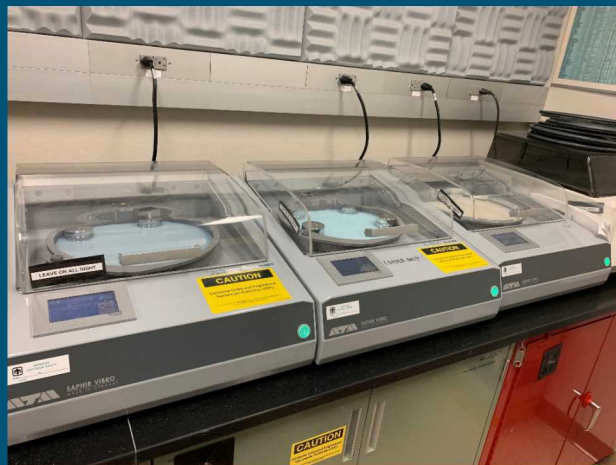
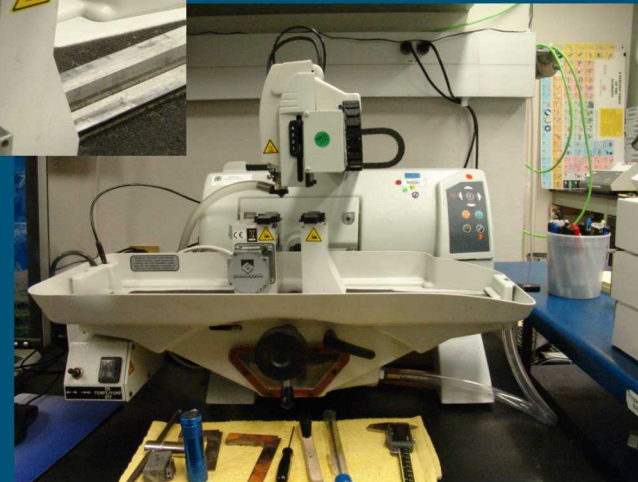
We also use an engraving machine to label our samples.

After polishing on the machine, samples sometimes even go through the vibratory to make the sample even more shiny.

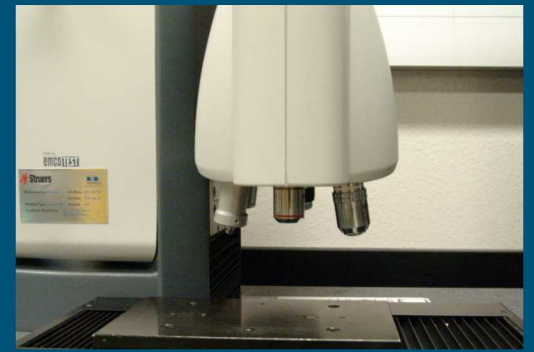
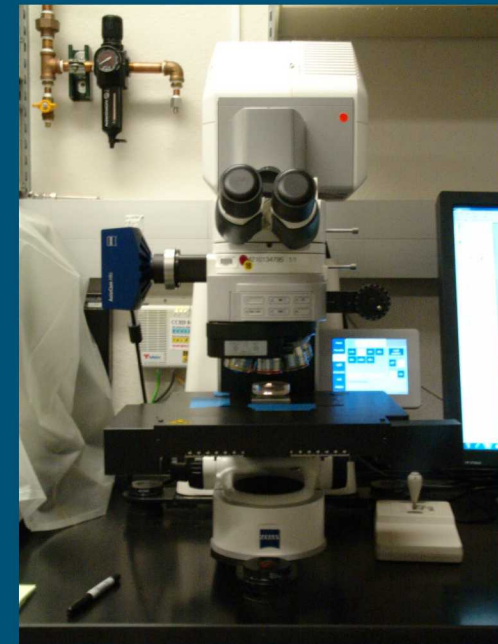
We also needed to take microhardness tests using a microhardness tester.
