Thunder Range Shock Incident Technical Advisory Team Investigation

DOE Explosives Safety Committee Meeting

Idaho Falls, Idaho – Oct. 22-24, 2019

Electrical Shock Incident - June 12, 2018

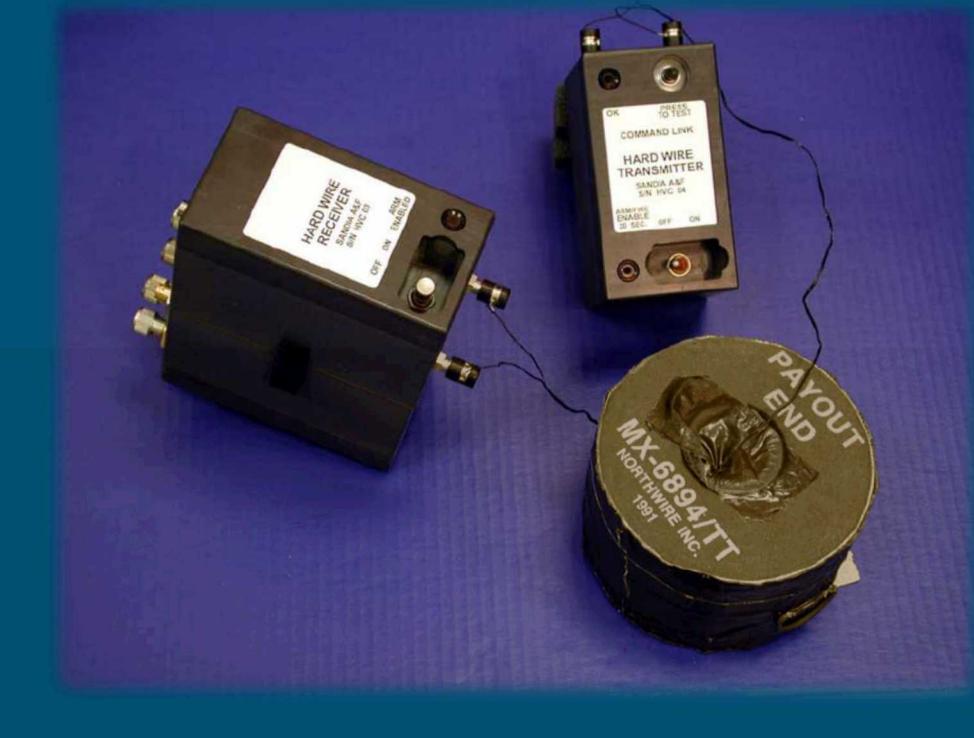
Remote Command Firing System

- Designed by Sandia's by Arming & Firing Systems group for NNSA to be portable, compact, rugged, and simple to use.
- Fielded ca 2002; design modified 2009.
- Not traditionally used at Thunder Range.

- Transmitter and Receiver are hardwired together through a low-voltage twisted pair connection.
- Transmitter sends low voltage DC ARM signal to Receiver when operator holds switch in ON position.
- Receiver charges CDU and delivers FIRE signal after 20 sec, then turns off.
- CDU bleeds down internally, $\tau \approx 13$ sec.

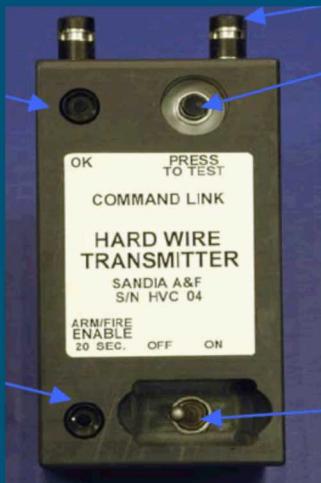
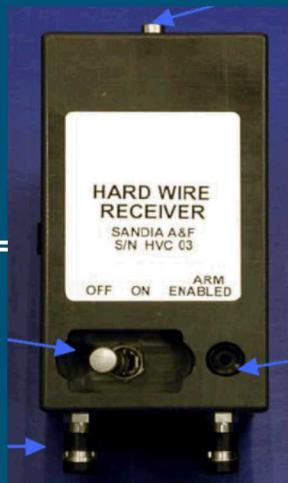
Transmitter

Receiver

Capacitive Discharge Unit (CDU)

Low Voltage Twisted Pair

Eight Banana Plugs (LV)

C-Cable to Detonator

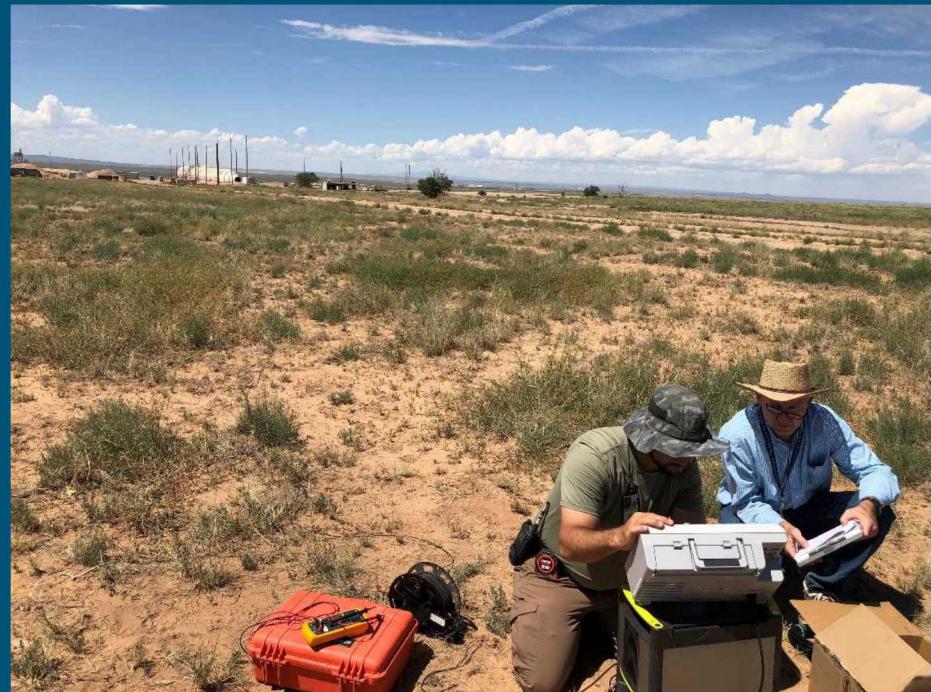
- Field testing found the following:
 - Up to 496 mVp-p from cables to ground into 50 Ohm load at 20 Hz from EMR
 - Equivalent to 17.5 Vrms into 5000 Ohm load, enough to arm Receiver
 - System did not arm when connected as in incident.
 - Simplified analysis predicts system should have armed, but many factors not included.
 - Did not fire the system into open circuit like before the incident.

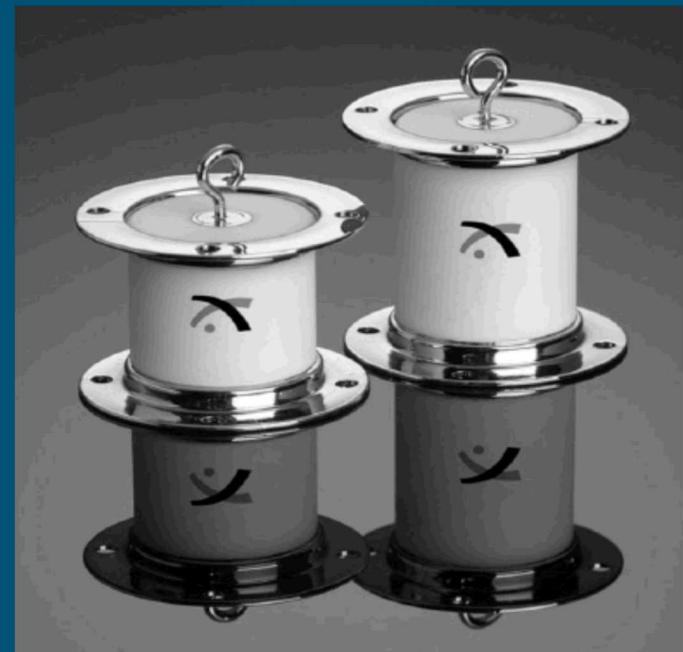
Triggered Spark Gaps

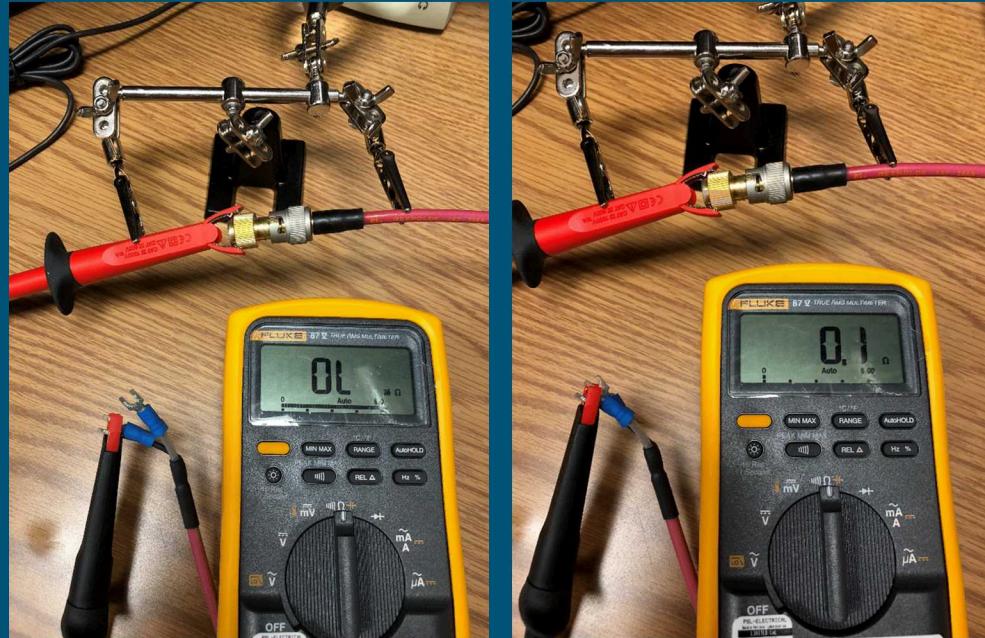
Bench demonstration of contact on center conductor before shield.

- Unknown; however,
 - Reynolds 31, 310, 311 HV connectors are not finger safe.
 - Reynolds 31, 310, 311 HV connections can make contact between center conductors before shield, causing the operator to close a circuit.
 - Uniform-field arcing distance in air at 3 kV and 5000 ft elevation is 0.6 mm
 - C-cable could have provided path to ground at Ground Zero.

- For RCFS, turn off the Receiver power switch and wait one minute before handling the CDU.
- Verify zero energy before handling high-voltage equipment.
- Use firing sets with built-in voltage monitoring or externally accessible capacitor voltage divider contacts.
- Know your equipment.
