Cold Spray Repair & Mitigation of Stress Corrosion Cracks in Spent Nuclear Fuel Dry Storage Canisters

ESCP

5th November 2019

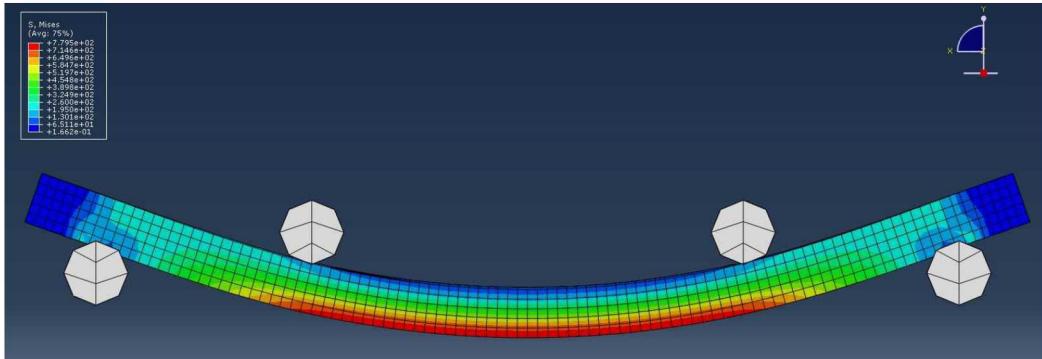
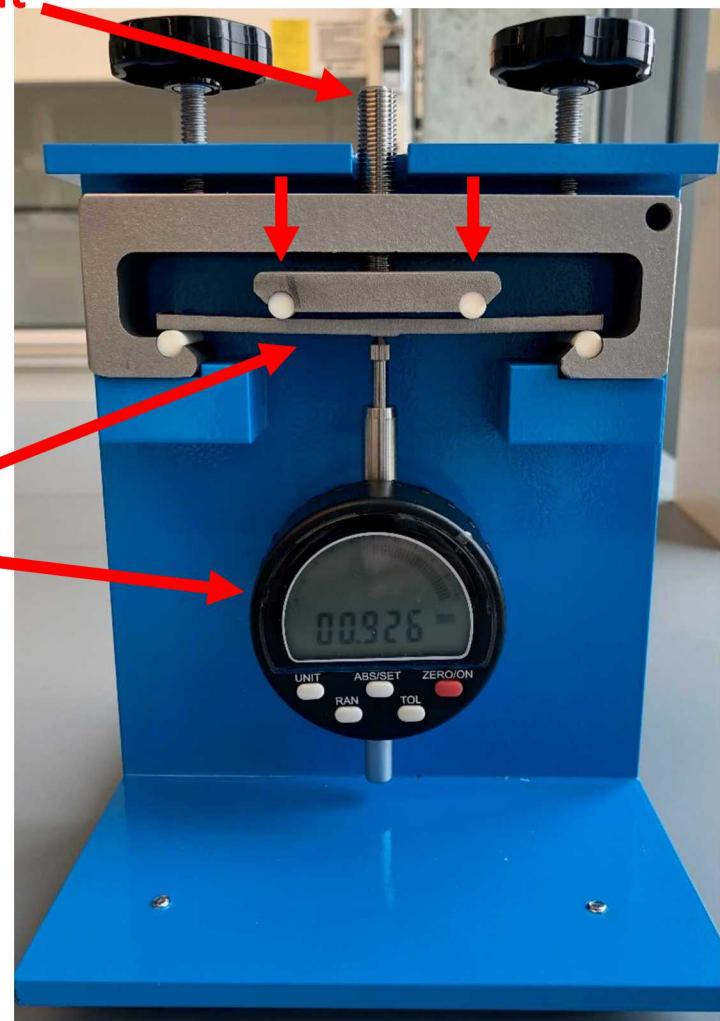
4-Point Bending Test

- Test coupon dimension:
 - 4''(L) x 0.735''(W) x 0.14''(T)
- FEA & bending σ : 400 Mpa
- ASTM G-39

Loading bolt

Test coupon

Dial Indicator

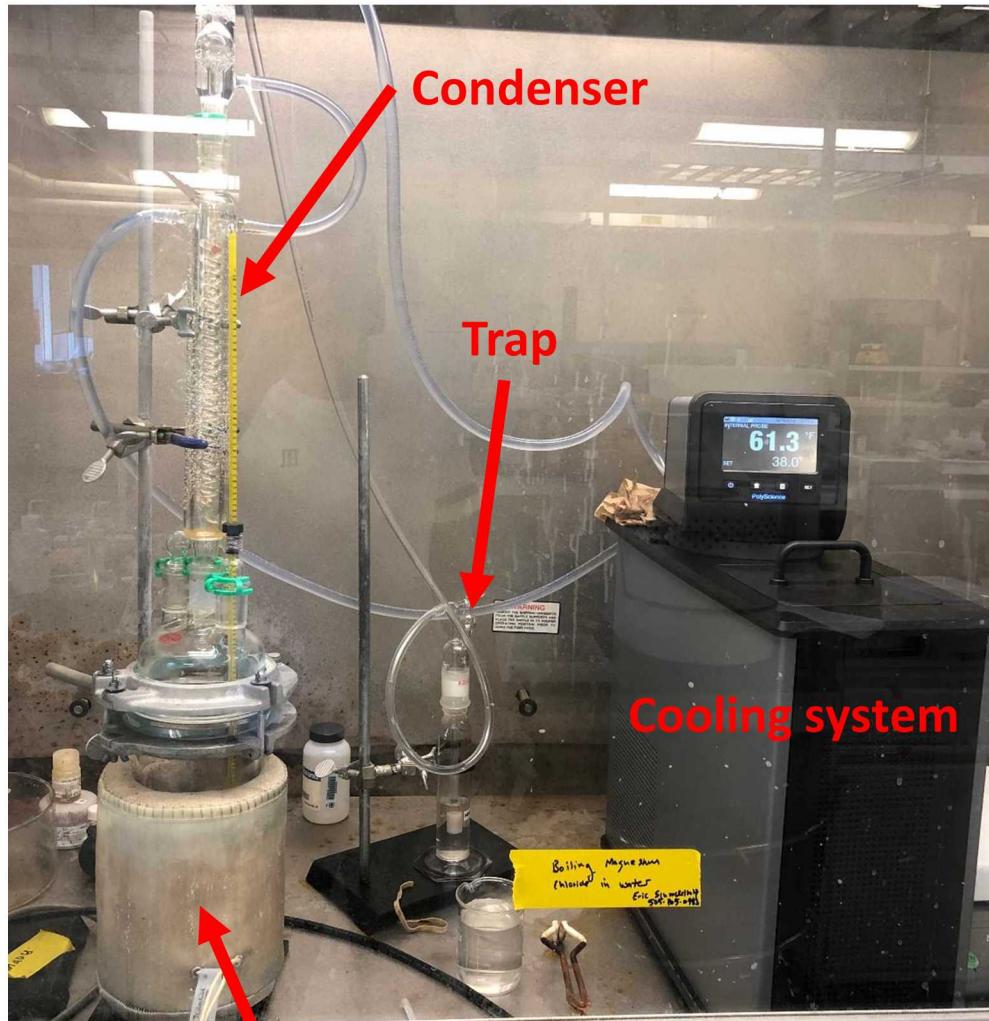
Corrosion test

- Boiling $MgCl_2$ test
 - ASTM G-36
 - Boiling at 155 ± 3 °C
 - Crack examination 20x
- $FeCl_3$ pitting test
 - ASTM G-48
 - 22 ± 2 °C
 - 72-hour immersion

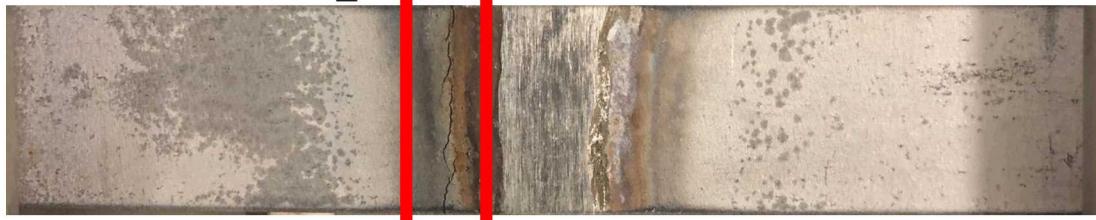
As-received coupon
(Crack after 17h)

Particle material	Surface treatment	Accelerating gas	4-point fixture	Time boiled (h)	Crack
304L SS	Ground	Helium	Y	197	N
304L SS	Mill Finish	Helium	Y	24	N
Inconel 625	Ground	Nitrogen	Y	216	N
Inconel 625	Mill Finish	Nitrogen	Y	60	N
N/A	Ground	N/A	Y	17	Y
N/A	Mill Finish	N/A	Y	8	Y (ruptured)

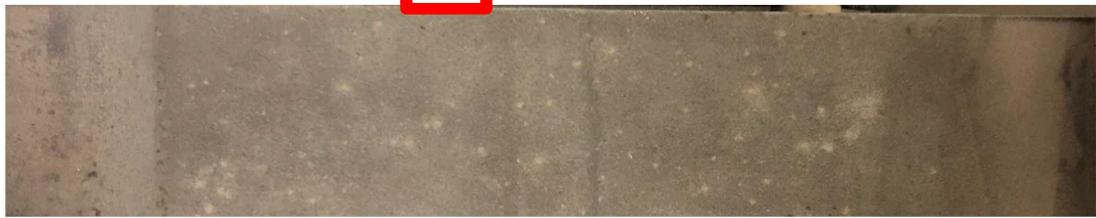
Inconel 625 sprayed coupon
(No crack after 216h)

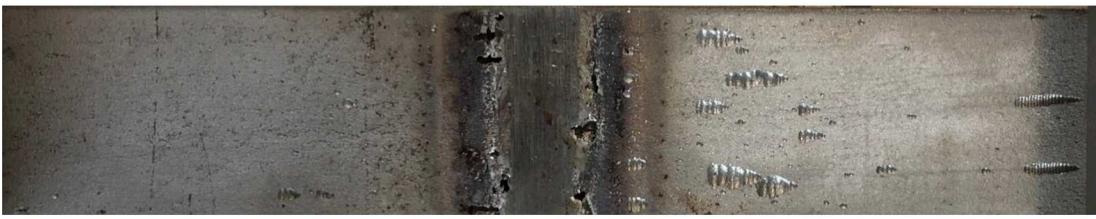
As-received coupon

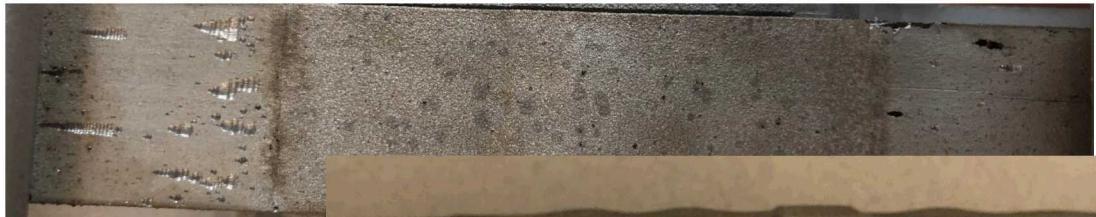
Inconel 625 sprayed coupon
(Delamination happens)
