# SNF Storage Canister Corrosion: Current Research at Sandia National Labs

EPRI ESCP Fall Meeting  
Charlotte, SC  
November 6, 2019

## **Overall objective: Improve the ability to predict timing and location of potential canister penetration by SCC cracks**

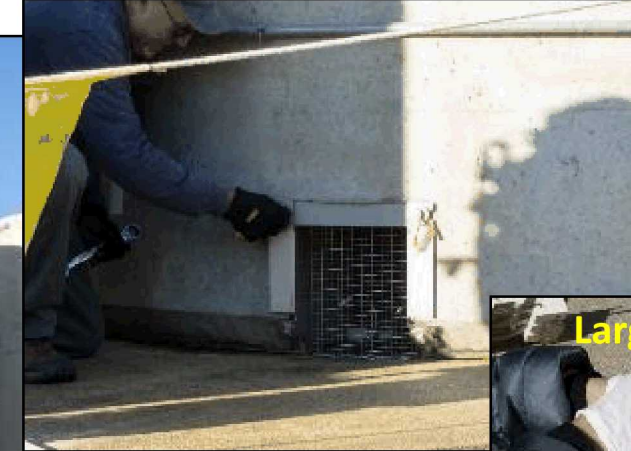
Sampling at Maine Yankee ISFSI, October, 2017

- Samples placed in inlet and outlet vents of four storage systems (SNF canisters) by CSM in 2017; transferred to SNL ownership with end of CSM IRP.
- Locations (8 total): high and low heat flow, sheltered and exposed inlet and outlet vent locations
- At each location:
  - 1 large 4-pt bend specimen, with attached dust collection coupons.
  - 3 small 4-pt bend specimens (varying surface finishes and stress levels)

Specimens examined, all 8 dust collection coupons collected and replaced, two small 4-pt bend samples collected.

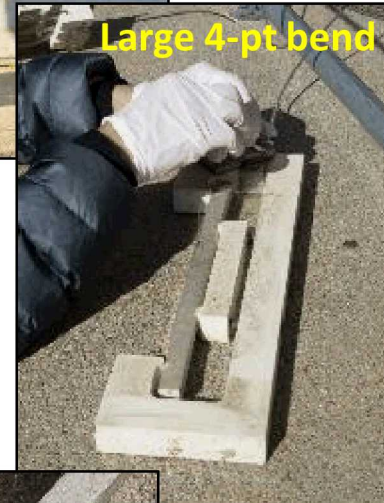
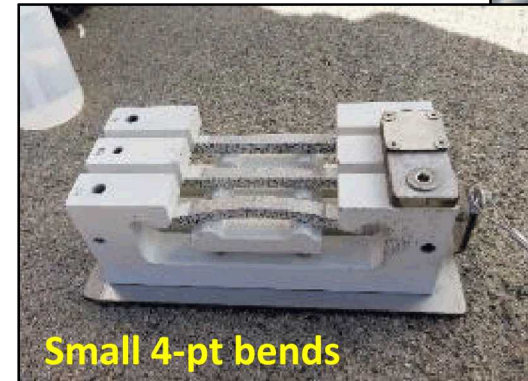
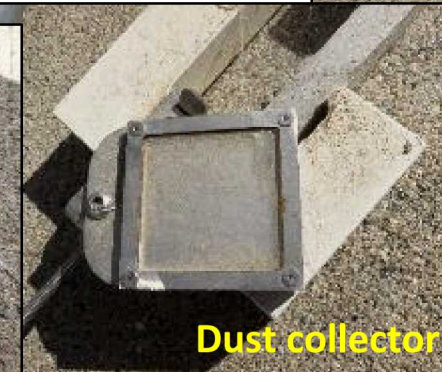
- Samples tethered to vent screens, close to the screens
- Samples dirty with wind-blown dust and plant debris, and spider webs and other insect debris; inlet samples much dirtier (in general) than outlet samples
- Much lower deposition on vertical surfaces (*tension surface of large 4-point bend*)
- Many samples show evidence of wetting—rain spatter, condensation(?), or accumulation of wet fog(?) (rings or droplet patterns in the dust; rust under dust collector)

Sampled 4 storage systems (inlets & outlets), ~2 years exposure. Corrosion test samples examined, dust coupons collected and replaced.

- Samples were close to vent screens, had heavy dust loads
- Dust primarily silicate minerals and biologicals
- Soluble salts a mixture of sea salts and continental salts
  - Sea-salt (sea fog?) particles observed
  - Soluble salts relatively chloride-rich; more chloride observed than in dust previously collected from canister surfaces
- Salts occurred as tiny aerosol particles, frequently attached to pollen or mineral grains. Salt redistribution on coupons wetted by rain.
  - Chloride wicked into organic materials during drying.
  - Recrystallized as coarser salt crystals or as more extensive, finely crystalline surface coatings.

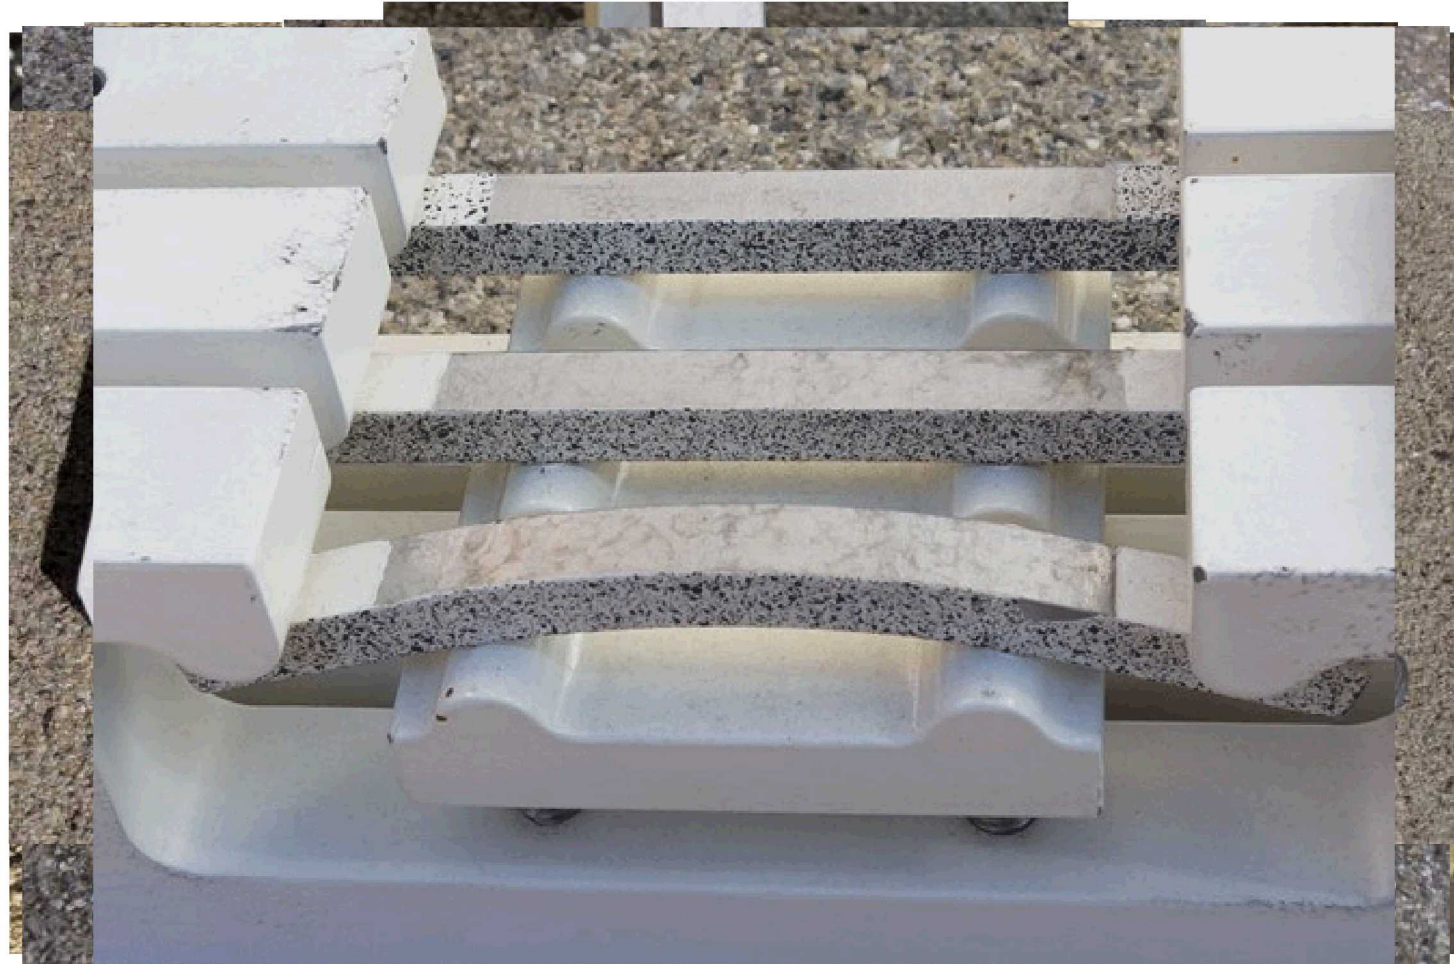
Important to note that these samples are **not representative** of the canister surface environment (exposure to wetting, ambient T and RH, horizontal orientation leads to heavy dust loads). But they do provide some information on salt compositions, and potentially, on salt corrosiveness.

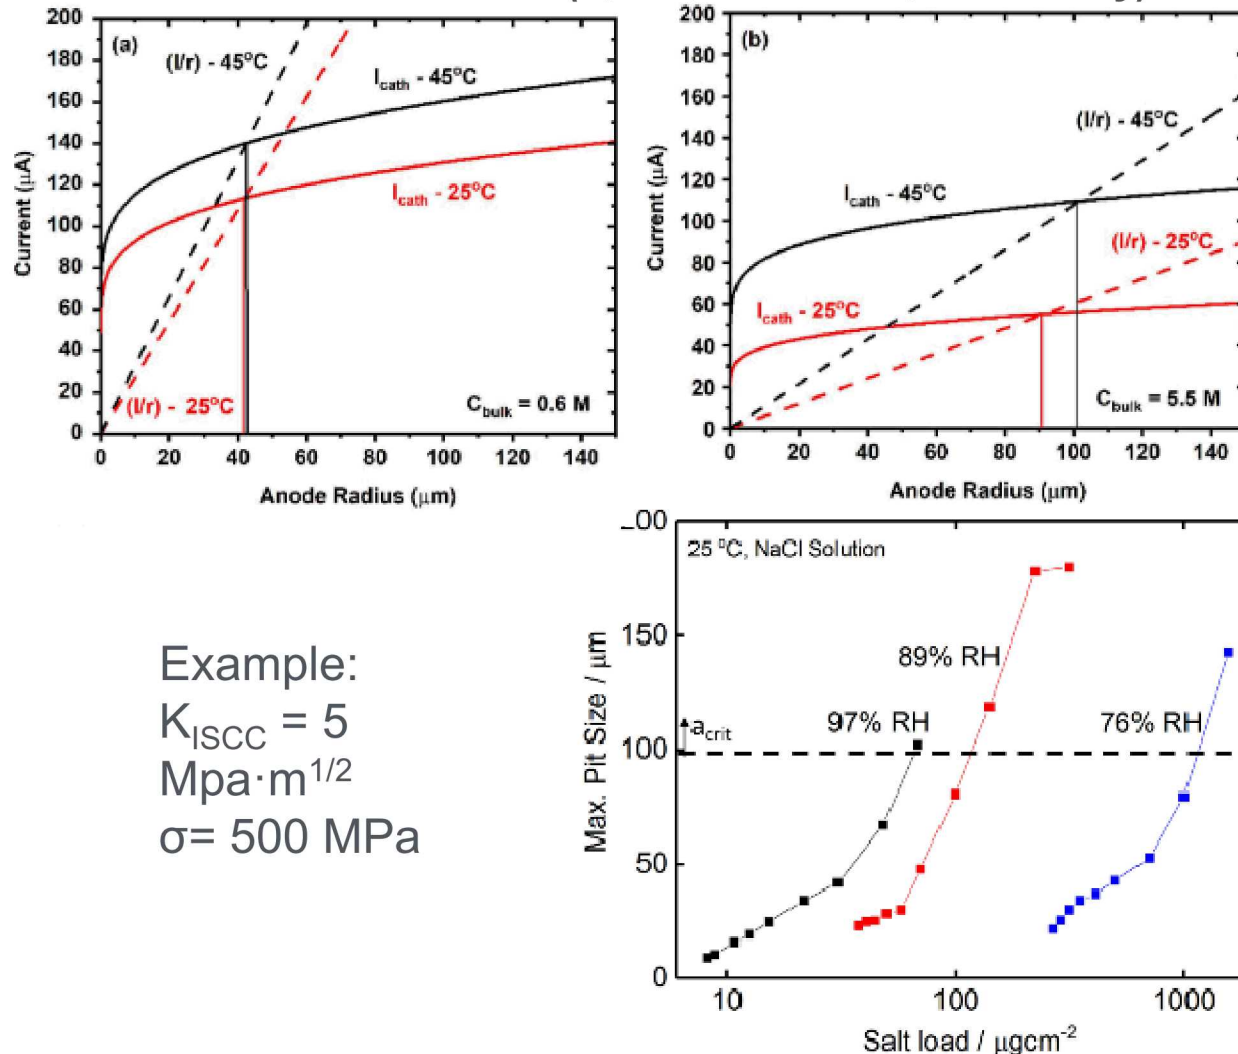
## Predictions as $f$ (T, RH, Salt Load, Chemistry)

- Predicted max pit size includes the following assumptions:

1. Continuous brine layer
2. Hemispherical pit
3. Kinetics independent of  $t$  (fixed electrolyte)

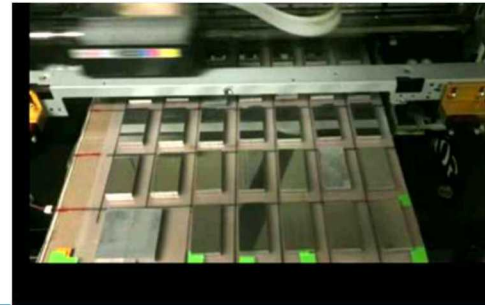
Inkjet Deposition

Mirror,  $R_a = 0.05 \mu\text{m}$   
Ground,  $R_a = 2.83 \mu\text{m}$

Salt	g/L	DRH
NaCl	24.53	75%
MgCl <sub>2</sub>	5.2	32%

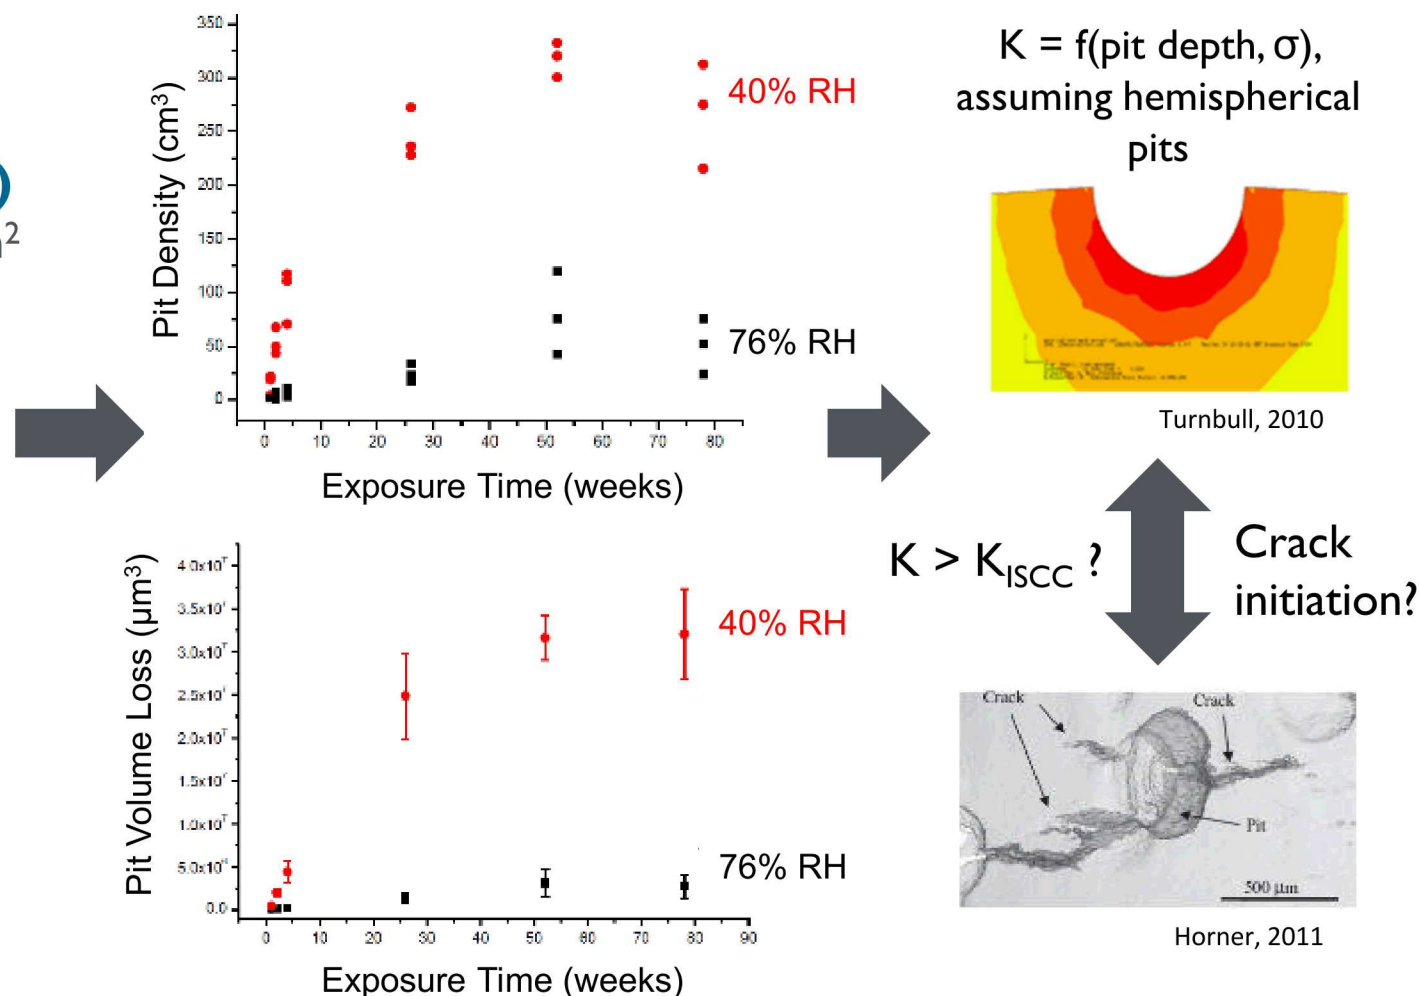
RH, T, seasalt,  $10 \mu\text{g}/\text{cm}^2$   
and  $300 \mu\text{g}/\text{cm}^2$

304H (unsensitized)

ground

- **Similar depth distribution, but diameters and shape RH dependent**
- **Maximum pit size model validated by atmospheric exposure with critical assumptions**
- **JECS 2019 paper**

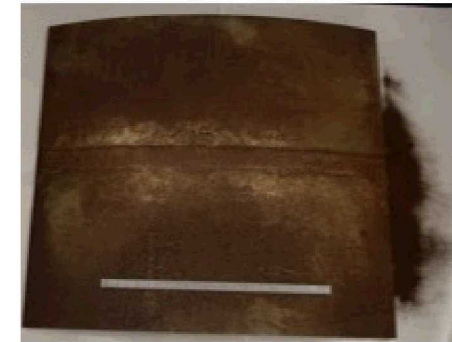
*Circumferential Weld*

- 8 g/m<sup>2</sup> MgCl<sub>2</sub>
  - Exposure: 80°C, 35 % RH, 12 months
  - 3 % Potassium Tetrathionate, pH =1, 6 mo. (3 mo. 40°C)
- Analysis
  - Composition of brine and corrosion products
  - NDE inspections for SCC
    - Fluorescent Dye Penetrant
    - UT Phased Array & Eddy Current Array
- Goals
  - Determine orientation and location of SCC around canister welds
  - Evaluate brine evolution under corrosion

80°C, 35 % RH

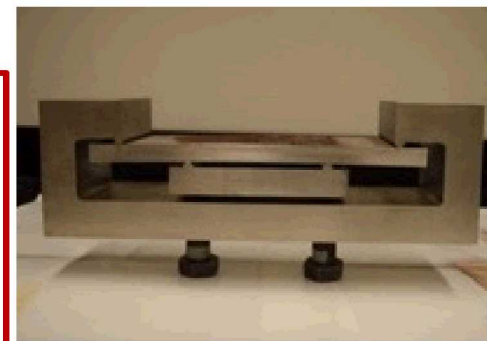
*Longitudinal Weld*

80°C, 35 % RH

*4-point bend specimen*

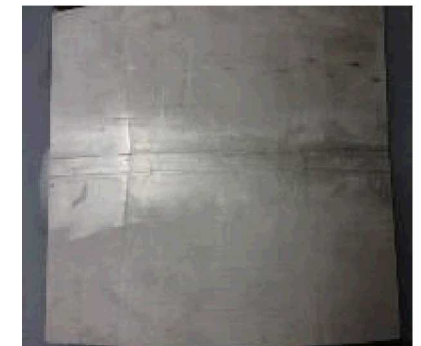
*Potassium  
Tetrathionate*

*Circumferential Weld*

- 8 g/m<sup>2</sup> MgCl<sub>2</sub>
  - Exposure: 80°C, 35 % RH, 12 months
  - 3 % Potassium Tetrathionate, pH =1, 6 mo. (3 mo. 40°C)
- Analysis
  - Composition of brine and corrosion products
  - NDE inspections for SCC
    - Fluorescent Dye Penetrant
    - UT Phased Array & Eddy Current Array

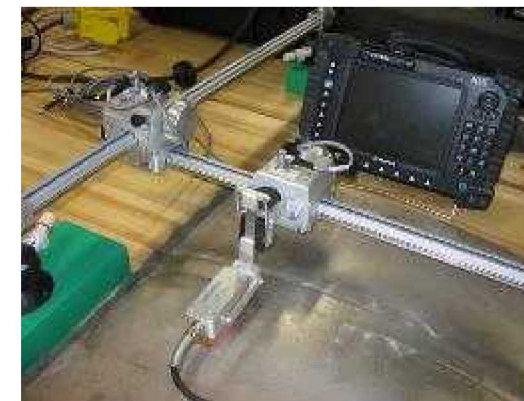
*Fluorescent Dye  
Penetrant*

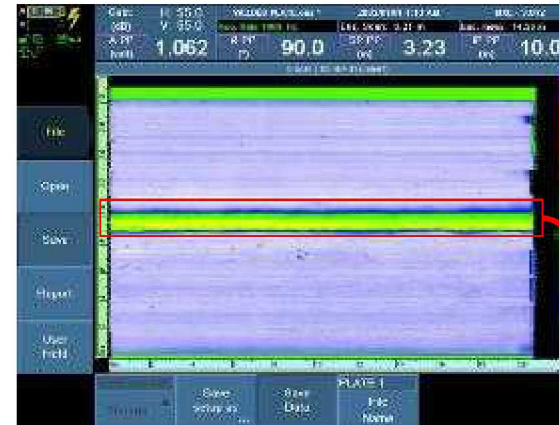
## Eddy Current

Circumferential weld, 80 C, 35 % RH

Top: No flaw indications.

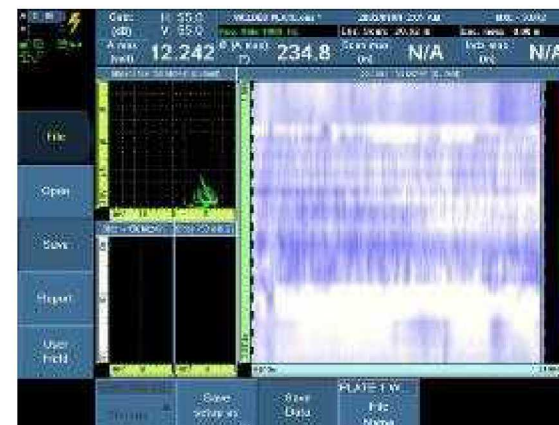
Top scan of weld: No flaw indications.

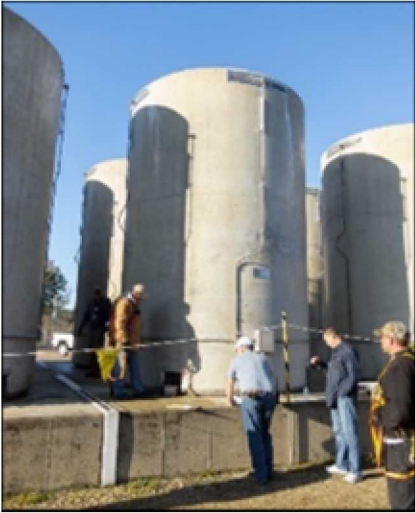
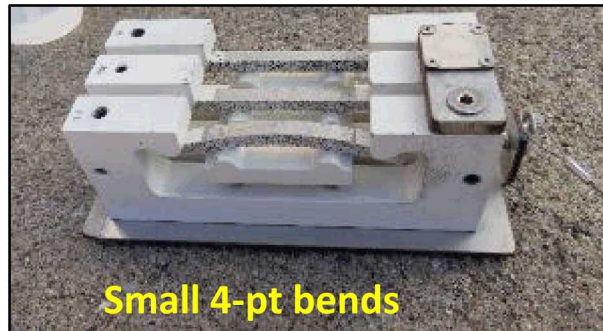
## Maine Yankee ISFSI Sampling, Aug. 2017 - Oct. 2019

Small 4 Pt Bend: Outlet Location

- Experimental Results:
  - Large scale atmospheric exposures displayed dependence of pitting and morphology as a  $f(\text{Environment})$
  - SCC atmospheric weld exposures displayed very few detectable cracks
  - Corrosion field exposures displayed small amounts of corrosion after two year exposures
- *Implications: SCC Model Assumptions may be challenged by:*
  - $f(\text{environment})$
  - Material microstructure
  - Brine evolution during corrosion processes
- Next steps:
  - Determine validity of SCC model assumptions with respect to **pitting, pit-to-crack, and crack growth** as a  **$f(\text{Environment and material})$** 
    - *What is the primary factor that governs pit morphology?*
    - *Is pit-crack transition influenced by  $f(\text{Environment})$  and pit morphology?*
    - *Is crack growth rate a  $f(\text{Environment})$ ?*

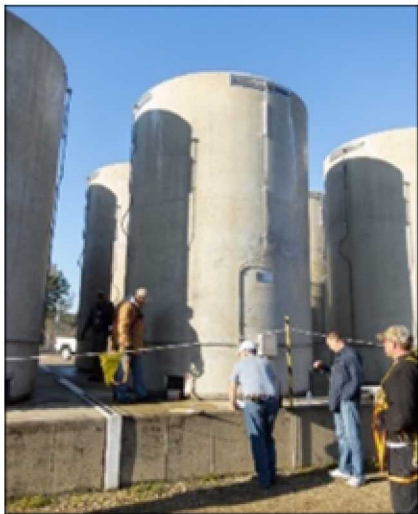
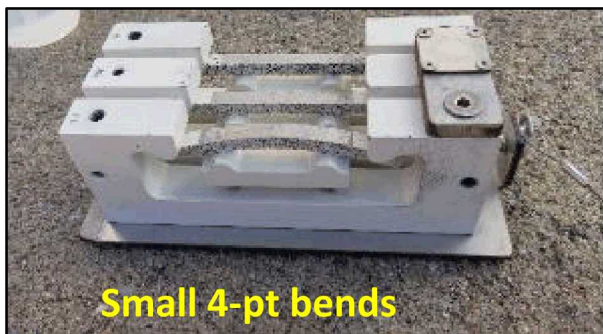
## Maine Yankee ISFSI Sampling, Aug. 2017 - Oct. 2019

Small 4 Pt Bend: Outlet Location
