# WHI09 Cemented-Annulus Flow Monitoring During Seal- Tite Treatment

SNL-SPR PROJECT REVIEW – NOVEMBER 2019

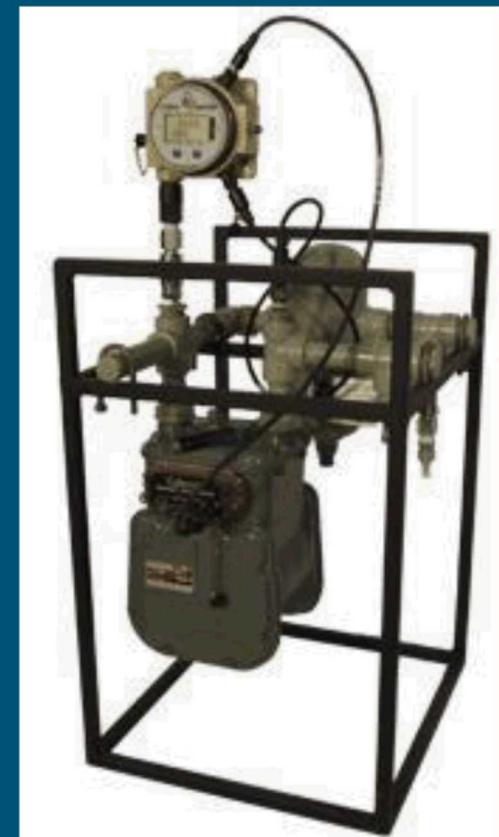
- During the WH109 Seal-Tite treatment, a flow meter was placed after the 20" x 26" cemented-annulus valve
  - Calscan Hawk
- First time this has been attempted at SPR
- Purpose was to determine whether Seal-Tite treatments were effective
  - Semi real-time measurement of the tightness of the cemented annulus
  - Potentially see if cemented-annulus diagnostic information can be obtained via flow and pressure measurements
