Investigation of the Hydrogen Release Incident at the AC Transit Emeryville Facility

November 6, 2012

Chris San Marchi, Aaron Harris and Daniel Dedrick
Sandia National Laboratories

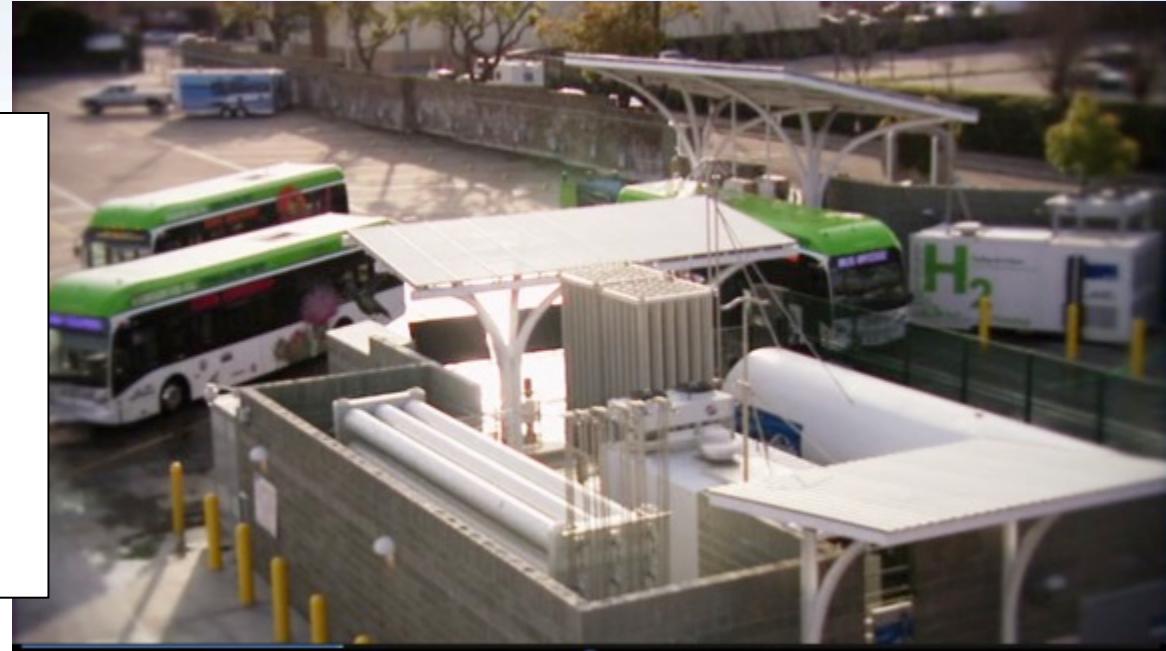
Summary of the Event

May 4, 7:45 AM
pressure relief valve fails

May 4, 10:12 AM
failed valve isolated

- Vented approximately 300 kg of hydrogen (150kg in first 15 min)
- Venting hydrogen ignited at vent stack outlet
- Hydrogen flame impinged upon canopy (making flames visible)
- 9th Alarm fire event – local and county police/fire response
- Evacuation of local businesses, including Pixar Studios and two nearby schools

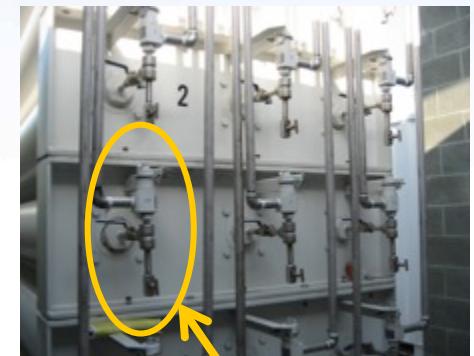
Pressure Relief Vents

7:45 AM	<ul style="list-style-type: none">• Pressure relief valve fails, releasing hydrogen• Hydrogen ignites and impinges on nearby canopy• Employee presses e-stop isolating high pressure gas storage
7:57 AM	<ul style="list-style-type: none">• Fire Department arrives• About 150 kg of high pressure hydrogen already released• Gas supplier technicians remotely access station data

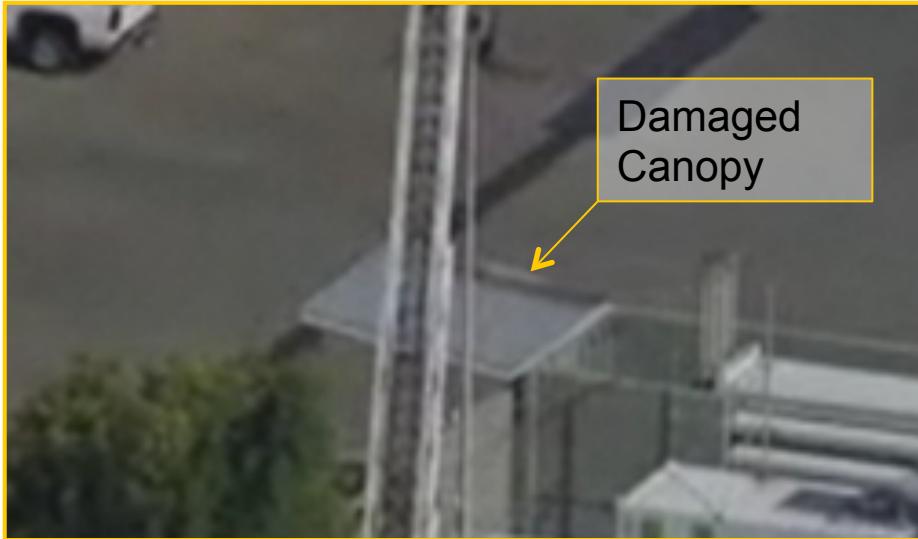
Contributing Factors

- Vent system was too close to the canopy
- First responders did not tailor the response to the conditions, due to:
 - Poor communication of critical data during the event
 - Poor understanding of written emergency protocols
- No mechanism for subsystem isolation
 - Isolation would have limited the release and shortened the event

1. Replace pressure relief valves with devices specifically designed for hydrogen service
 - evaluate all material of construction as part of safety review process, particularly safety critical components
2. Update communications plan
 - establish process 'ownership' to better centralize the flow of information
3. Update training documentation based on timeline analysis
4. Perform emergency action plan drills with key response personnel
5. Evaluate and implement vent systems relative to surrounding structures
 - Lesson Learned: communicate design changes to all project participants
6. Identify opportunities to limit the quantity of hydrogen released from a single point failure (Lesson Learned)
7. Evaluate and implement changes to fire detection system to identify hydrogen flames on the system
