Lincoln 6 Post-Shot Update

D.B. Sinars, C.A. Jennings, R.D. McBride *et al.*

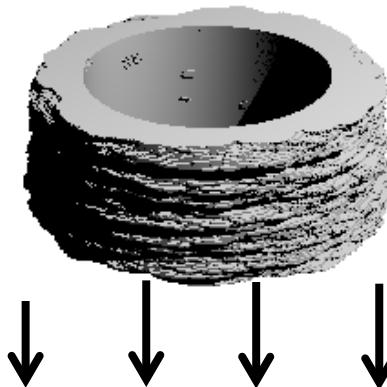
Modeling by Chris Jennings using Gorgon suggests that even a small amount of azimuthal correlation can be damaging

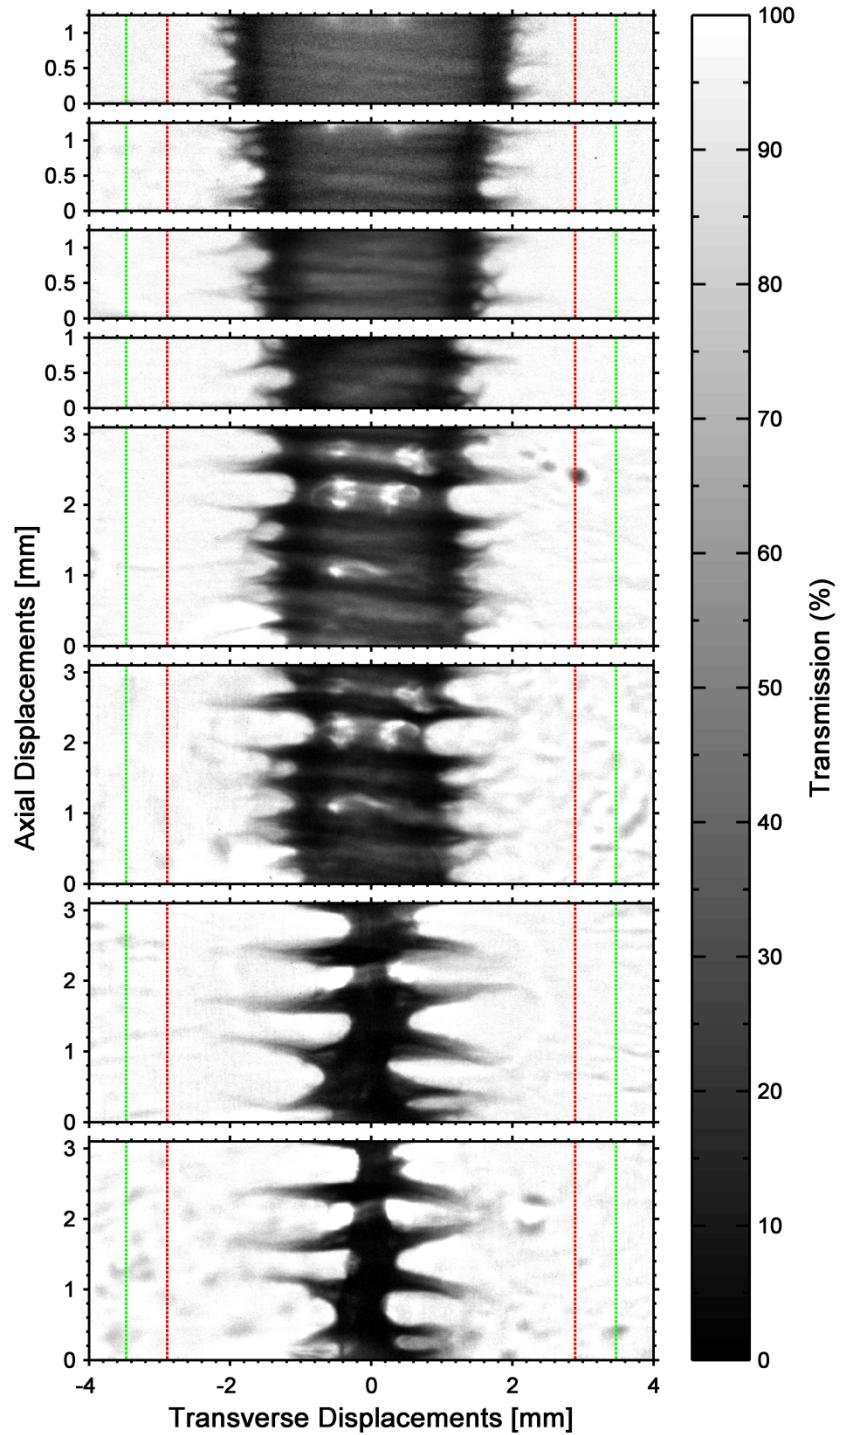
6 keV Transmission Radiographs taken of imploding liners

The effect of correlation is most evident late in time

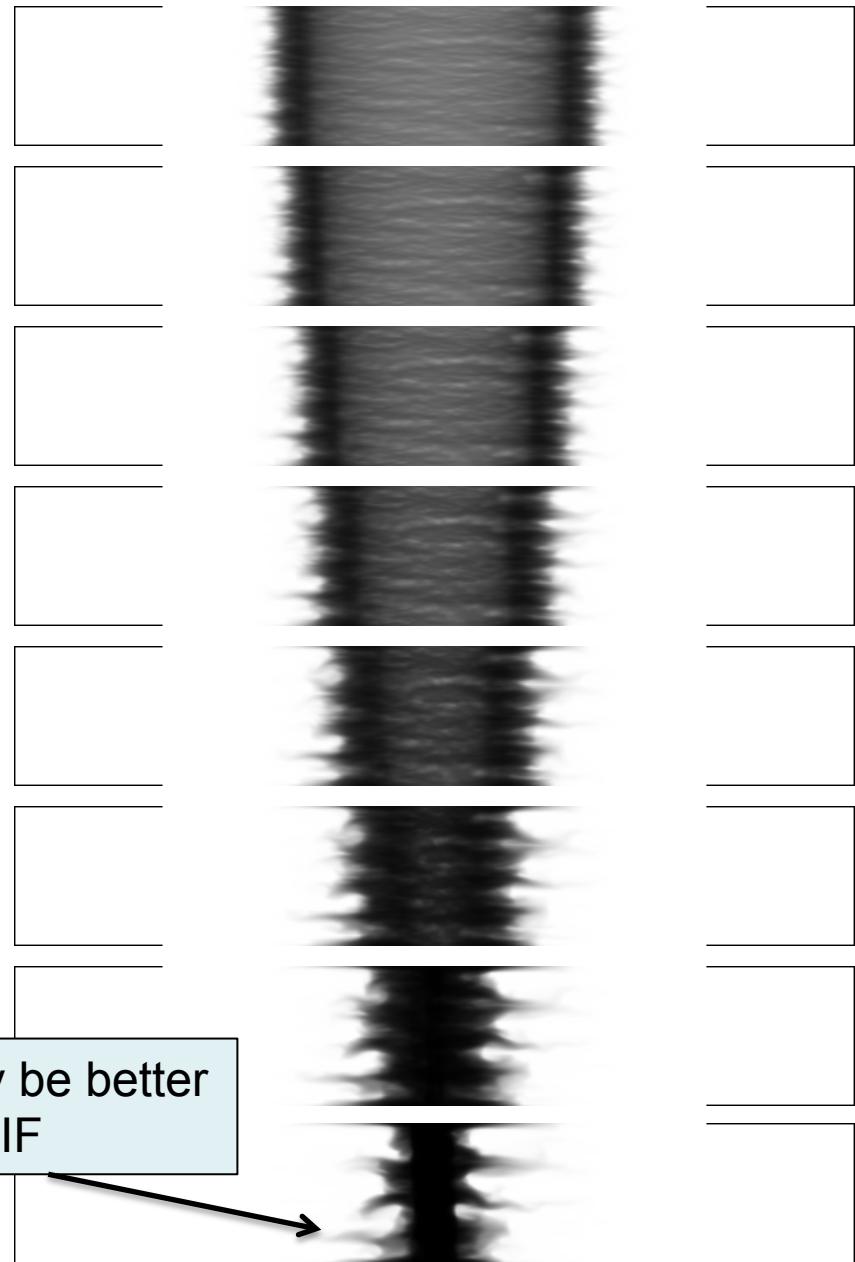
Random surface perturbation

This may be better
for MagLIF

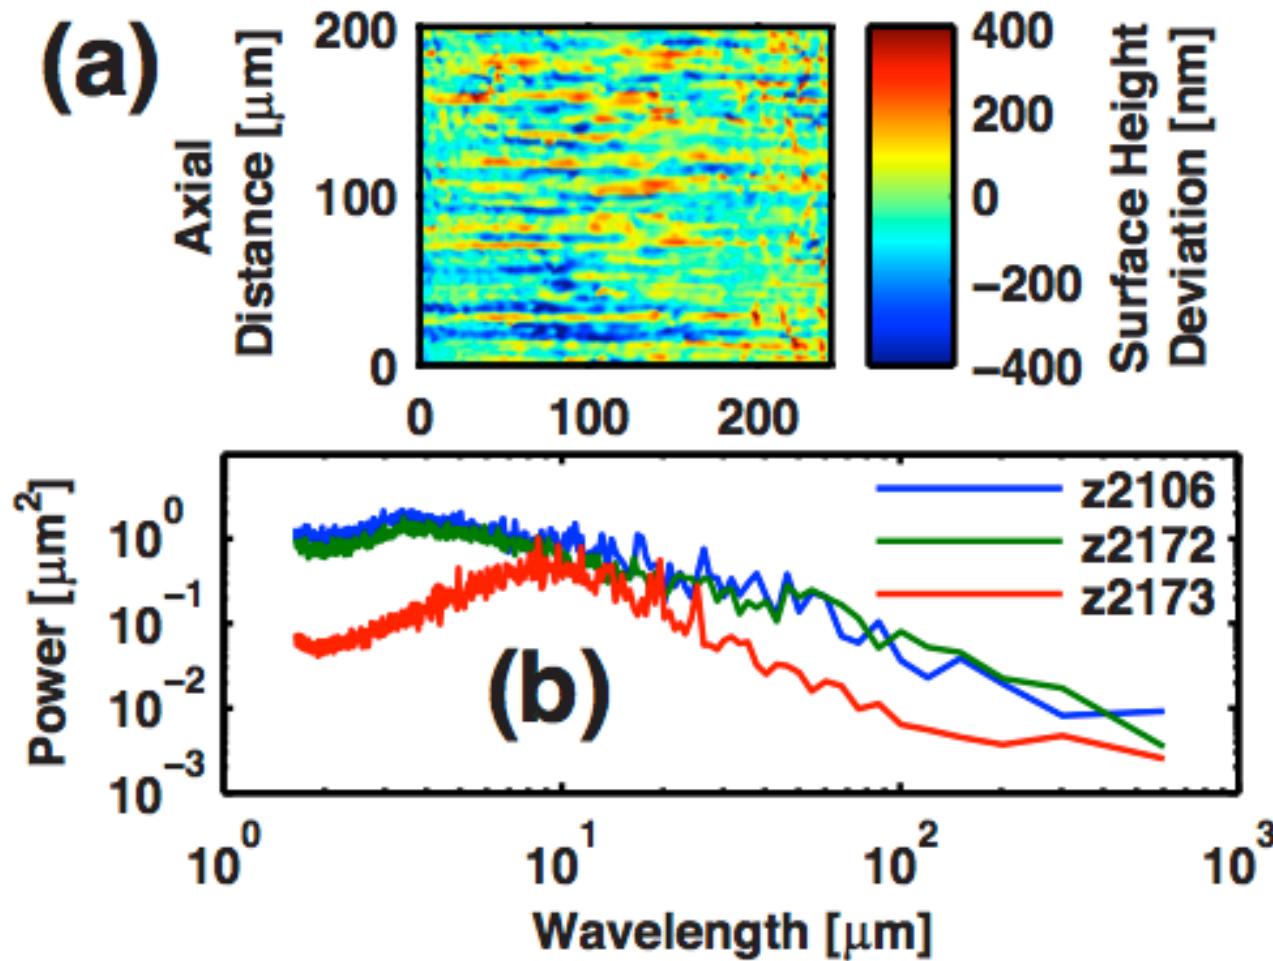
Our liner targets are typically diamond-turned on a lathe to get good surface finish, but this results in azimuthal machining marks that may be seeding MRT growth

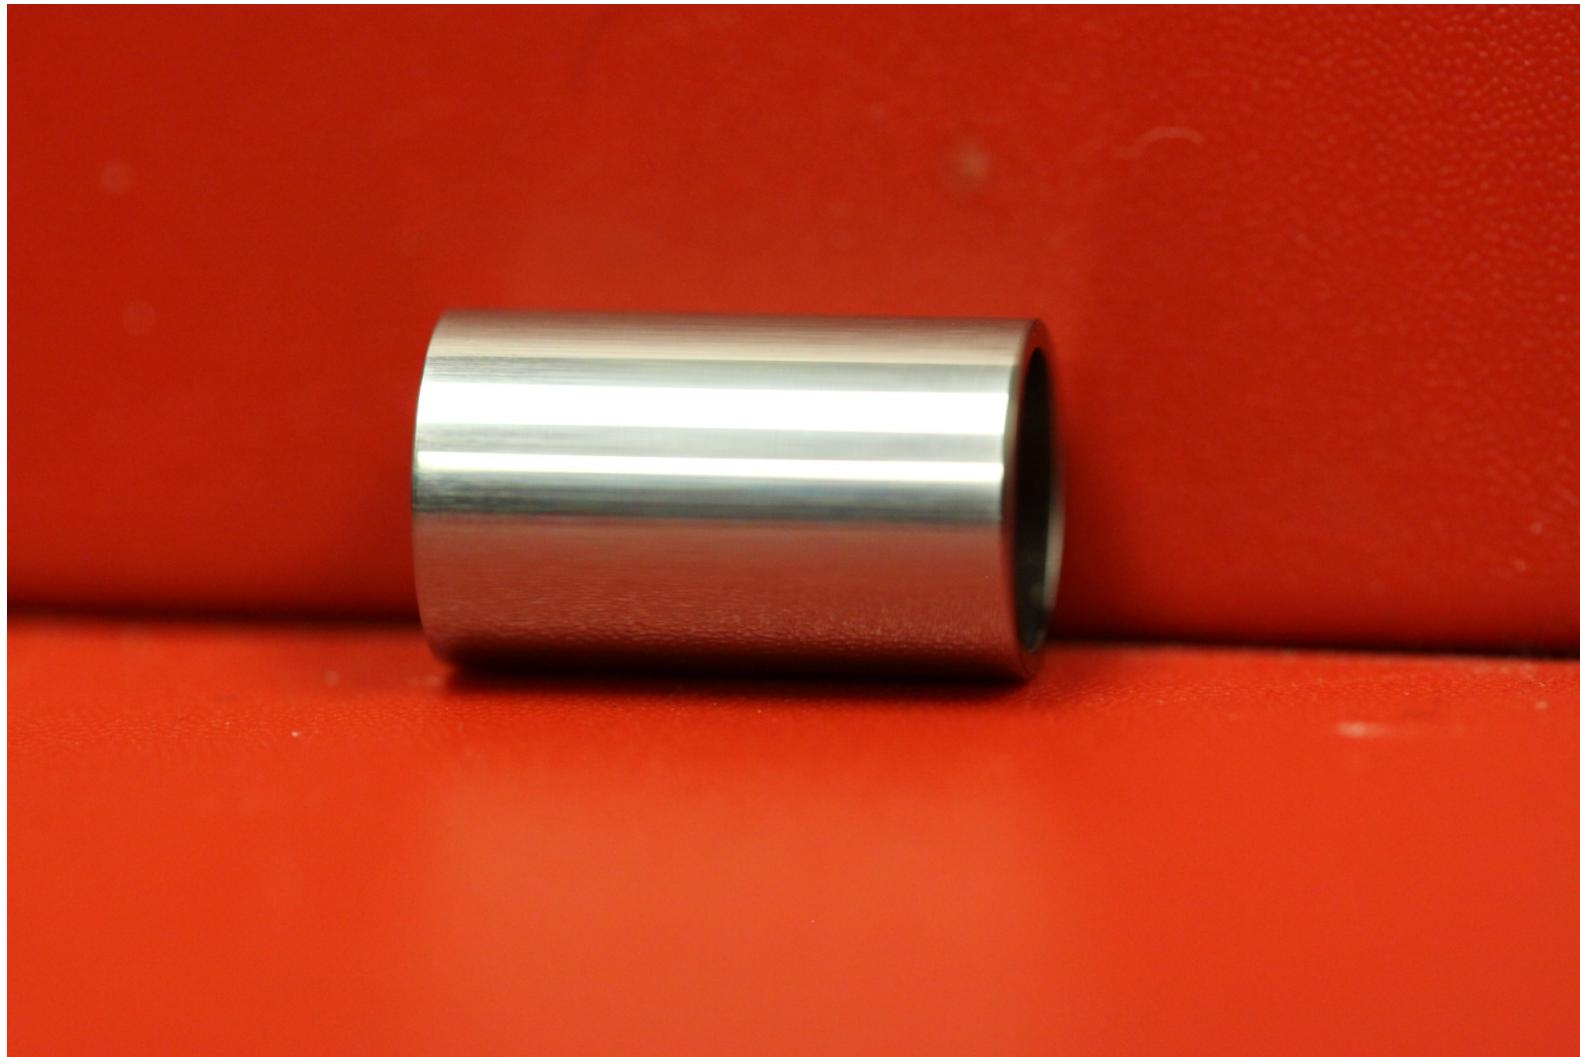
For Lincoln 6, we worked with General Atomics to develop a post-machining, axial polishing technique

No Azimuthal Lines Are Obvious To The Naked Eye

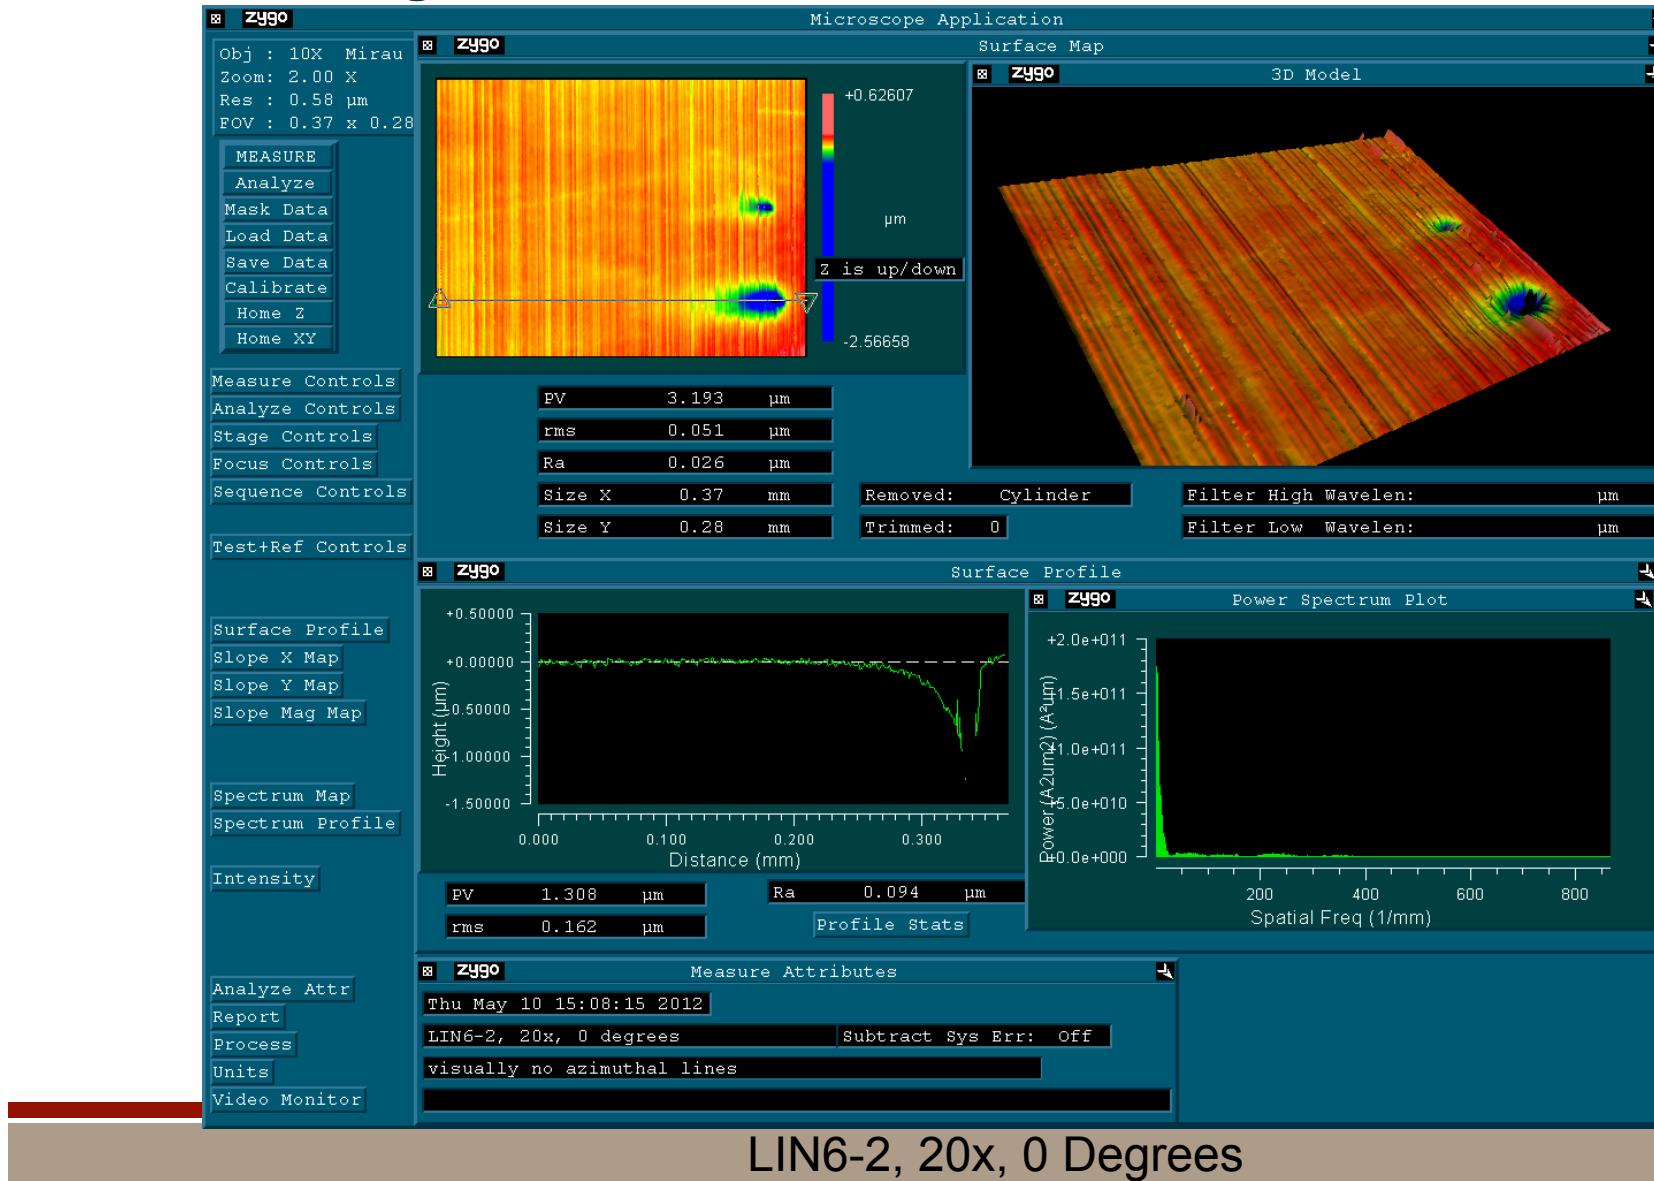
Example surface characterization data from Lincoln 6 target shows that axial polishing results in only z-oriented grooves and overall better surface finish

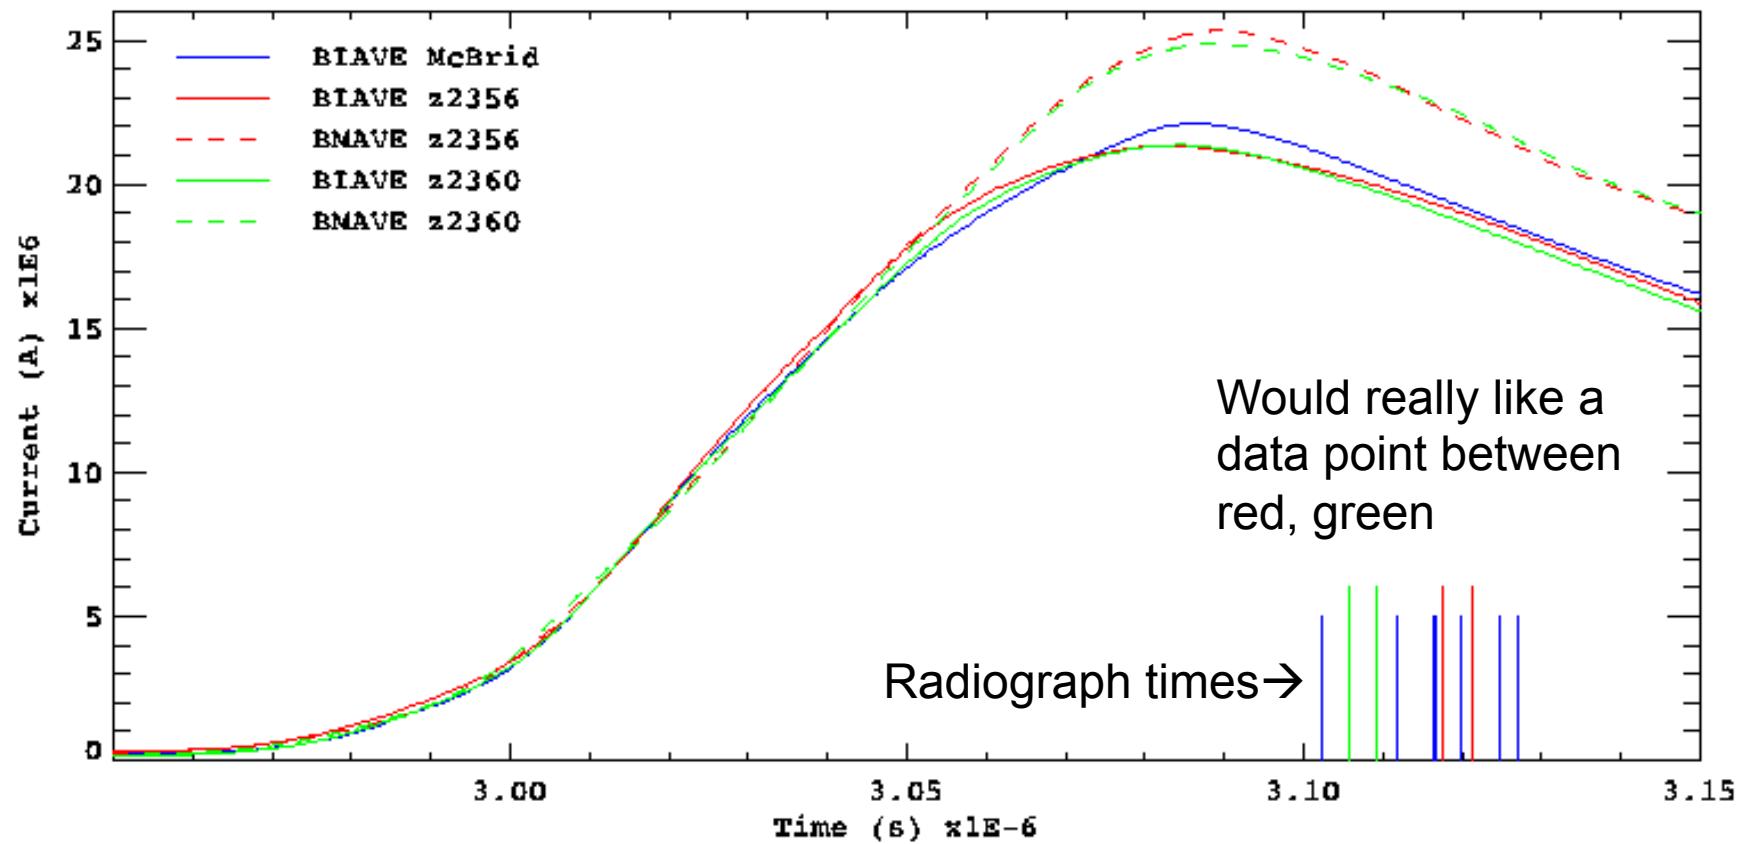
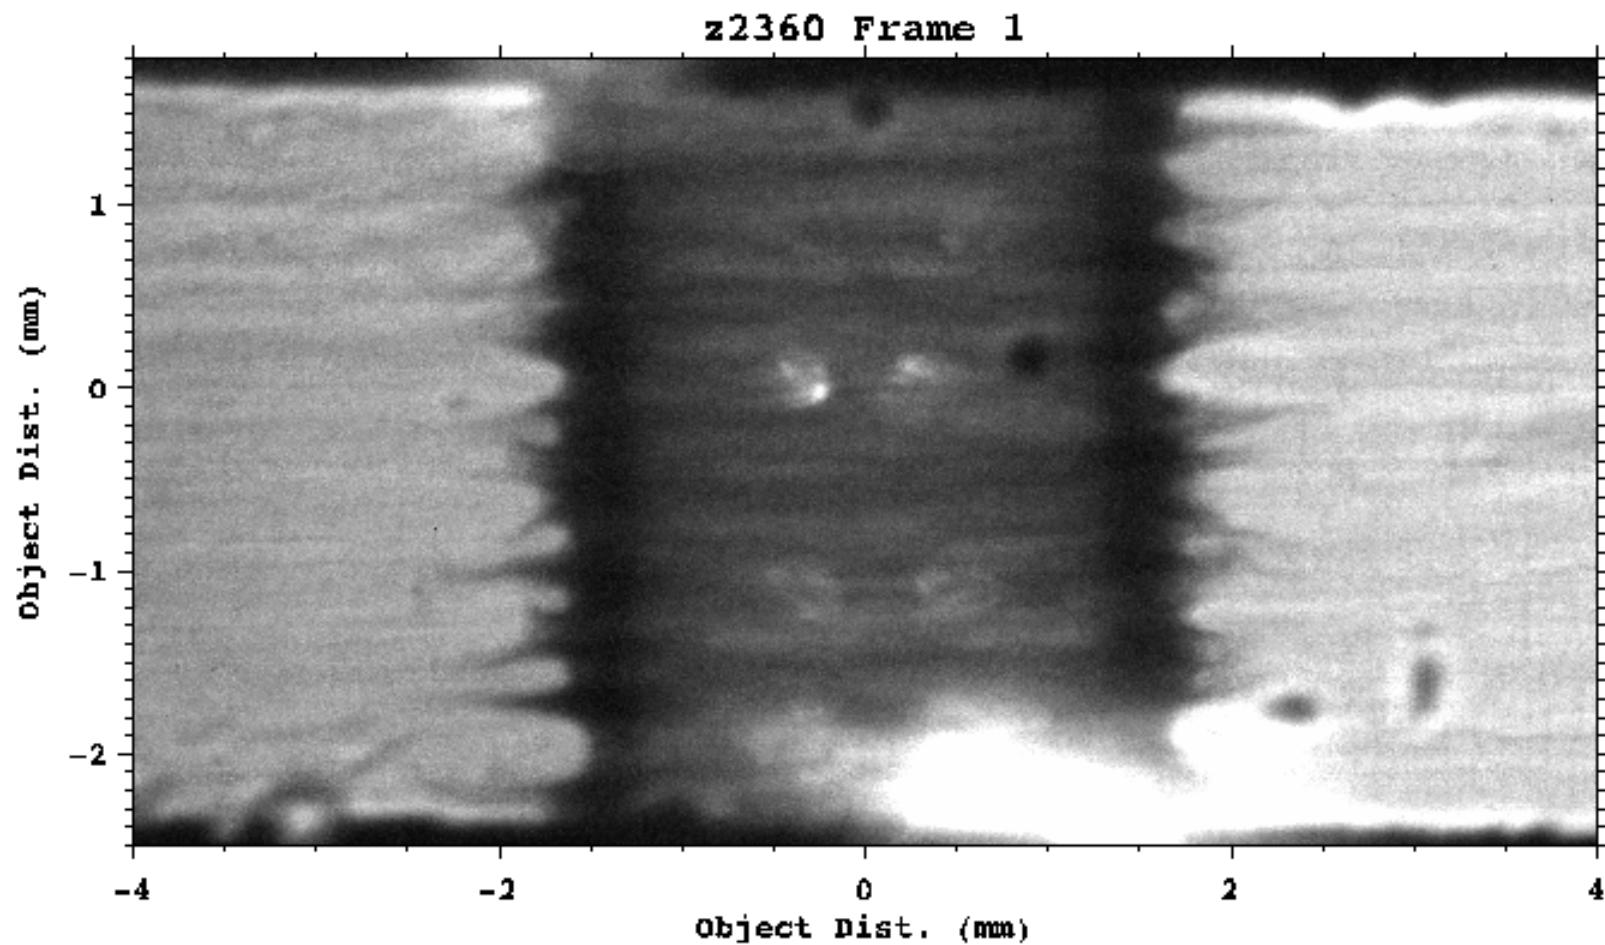
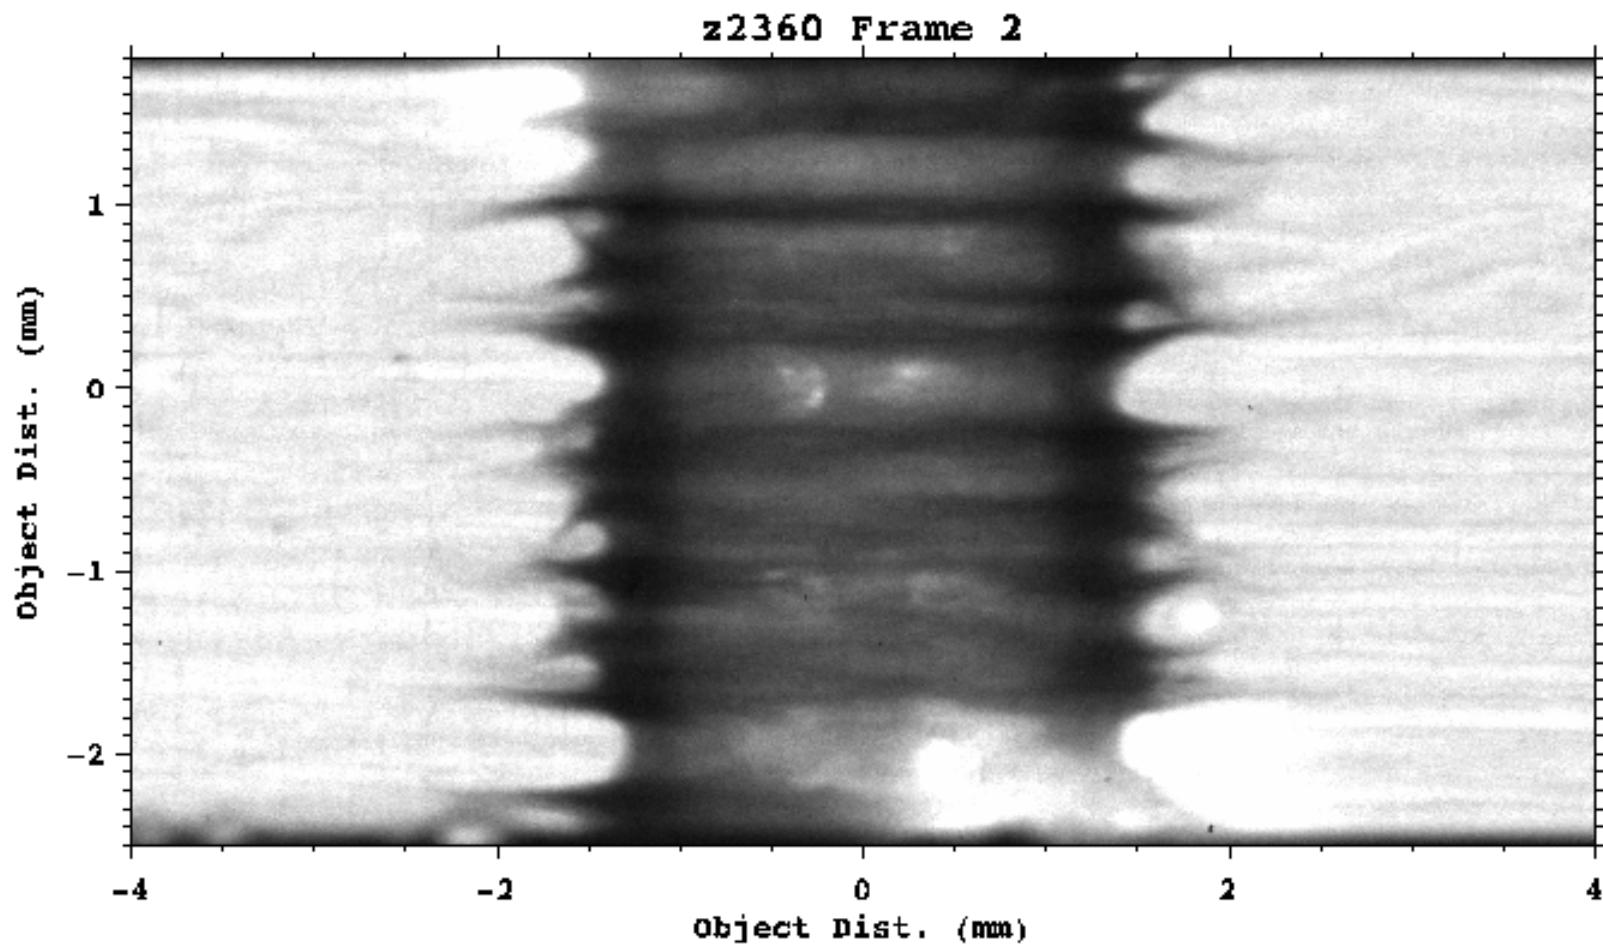
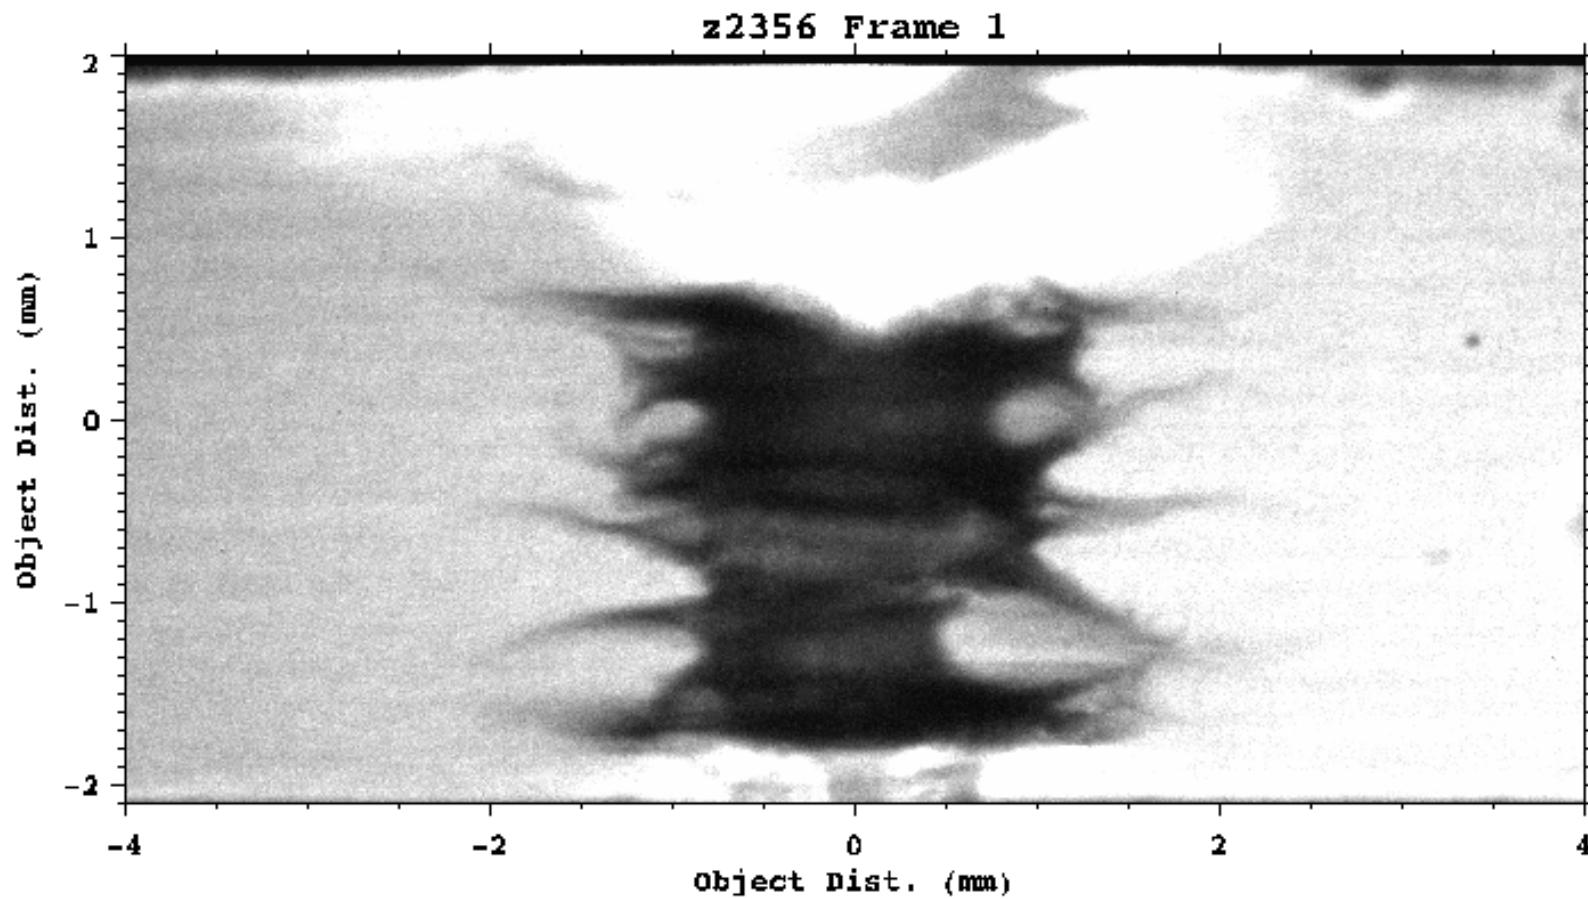
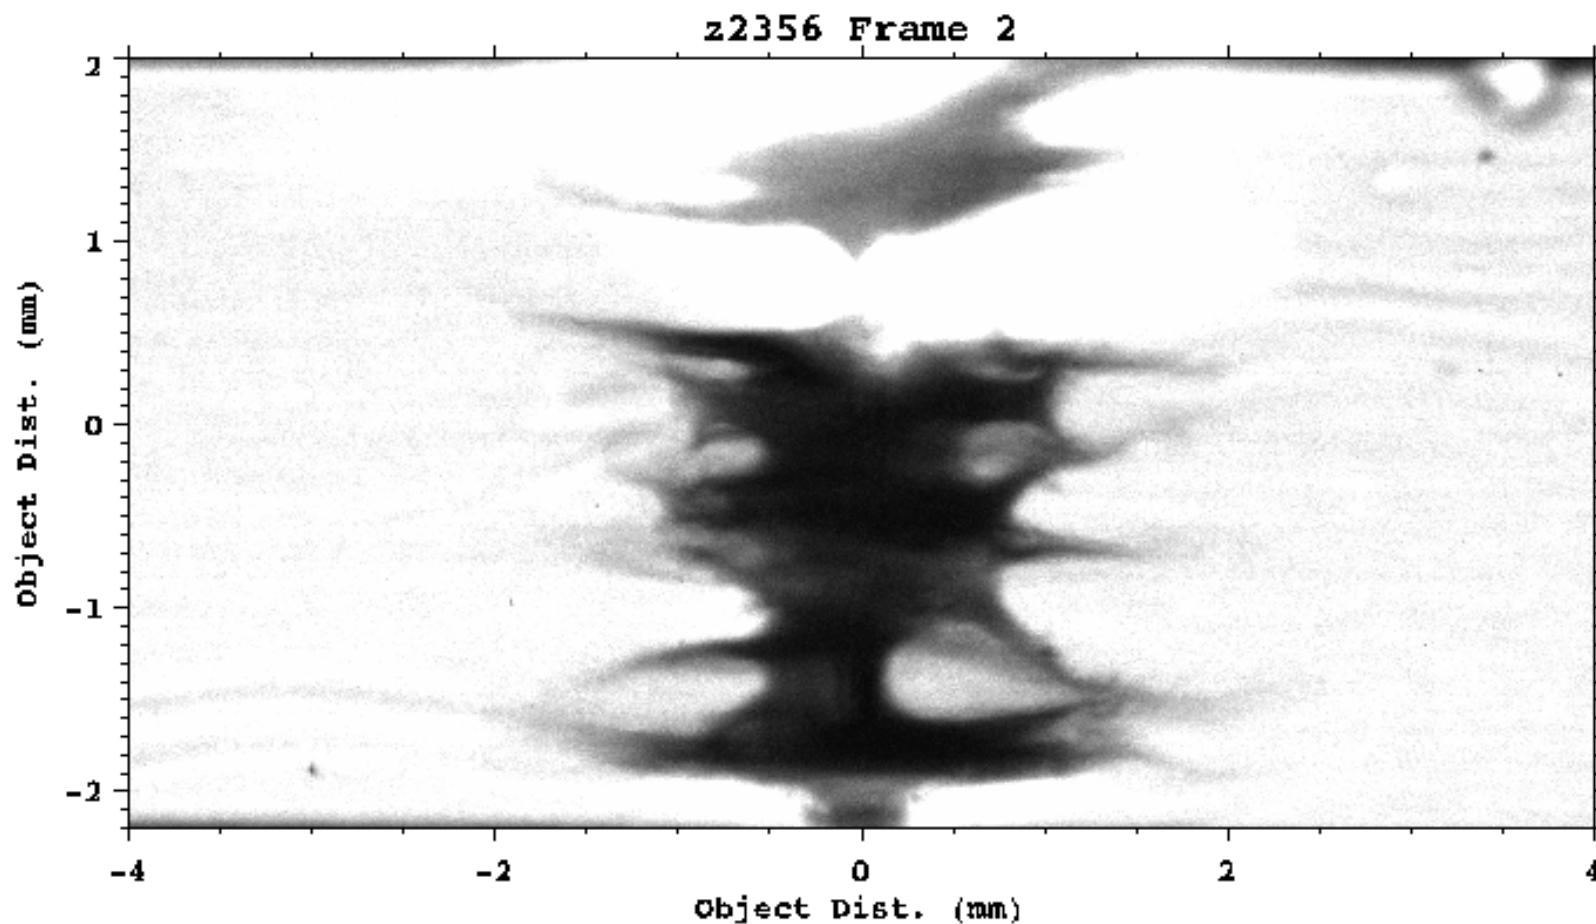
We obtained similar BIAVE currents to Ryan's original series, as well as radiography data at times close to several of his radiographs

There is a few ns variation in timing

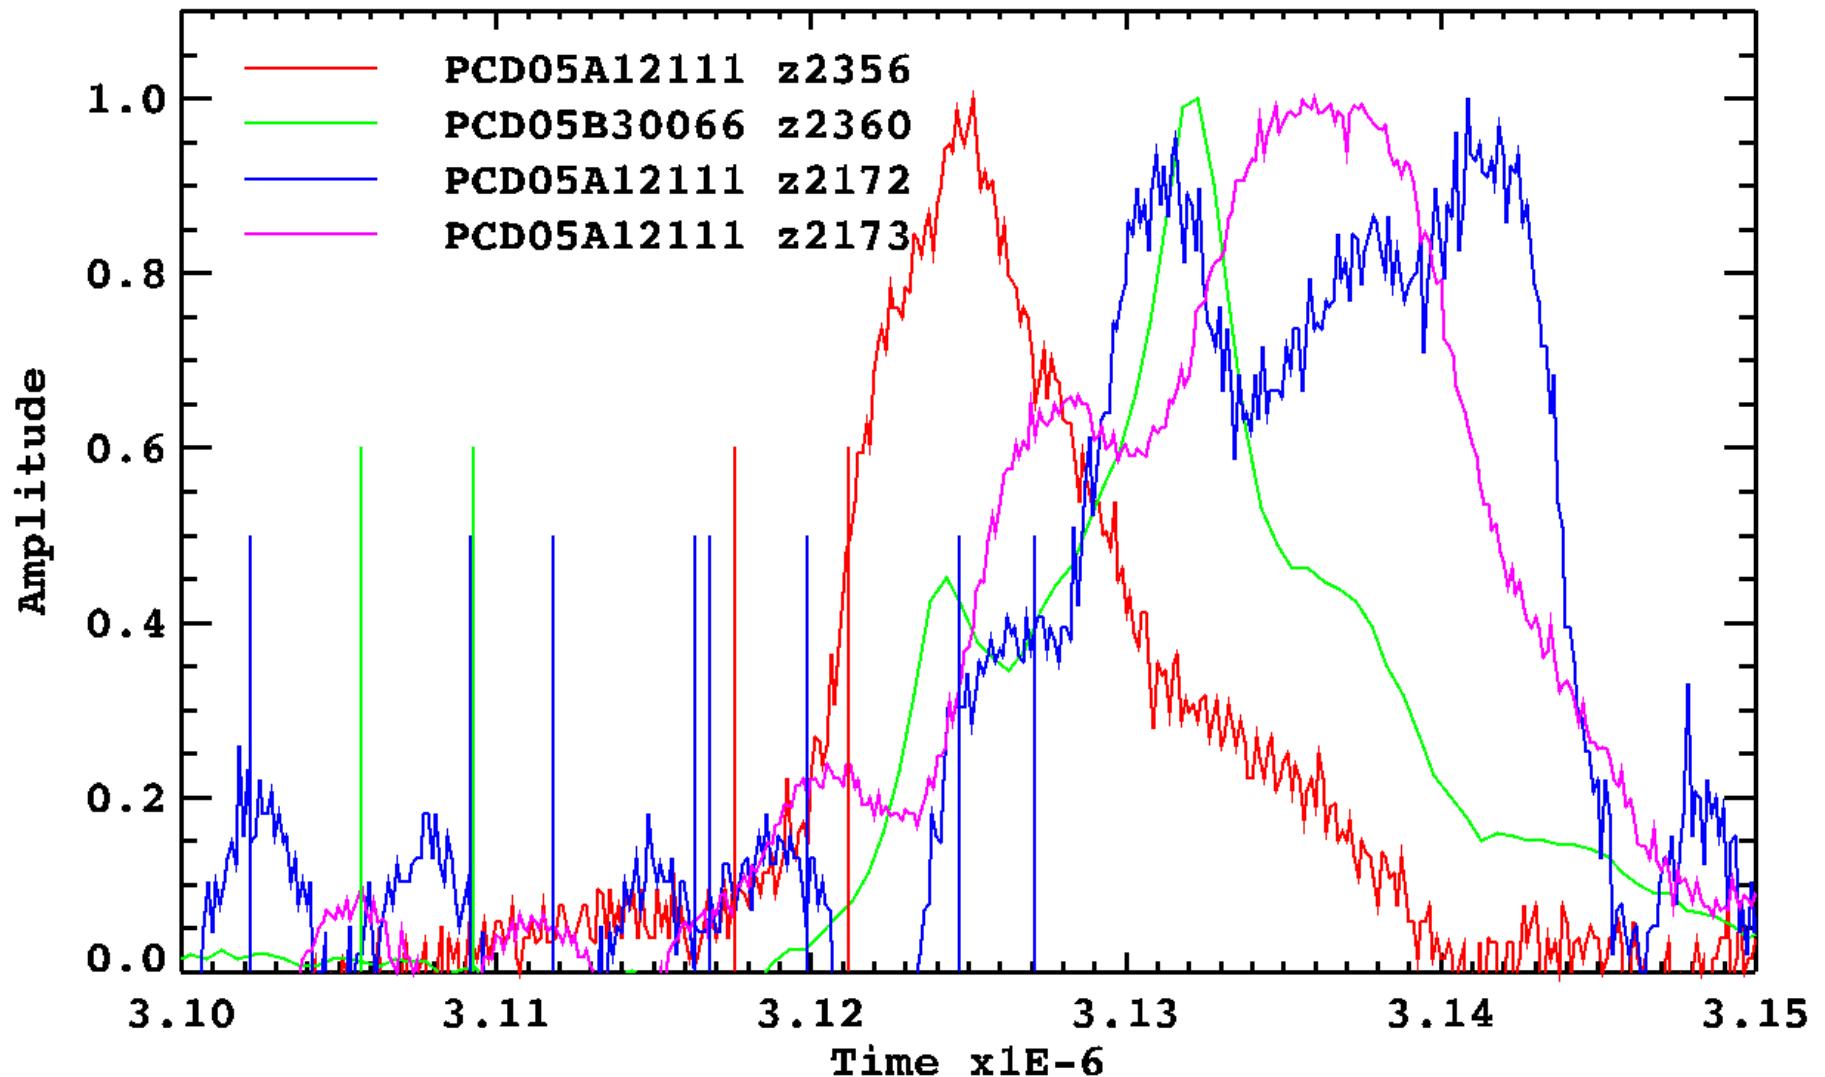
Comparison to previous data appears to show very similar structure at early time

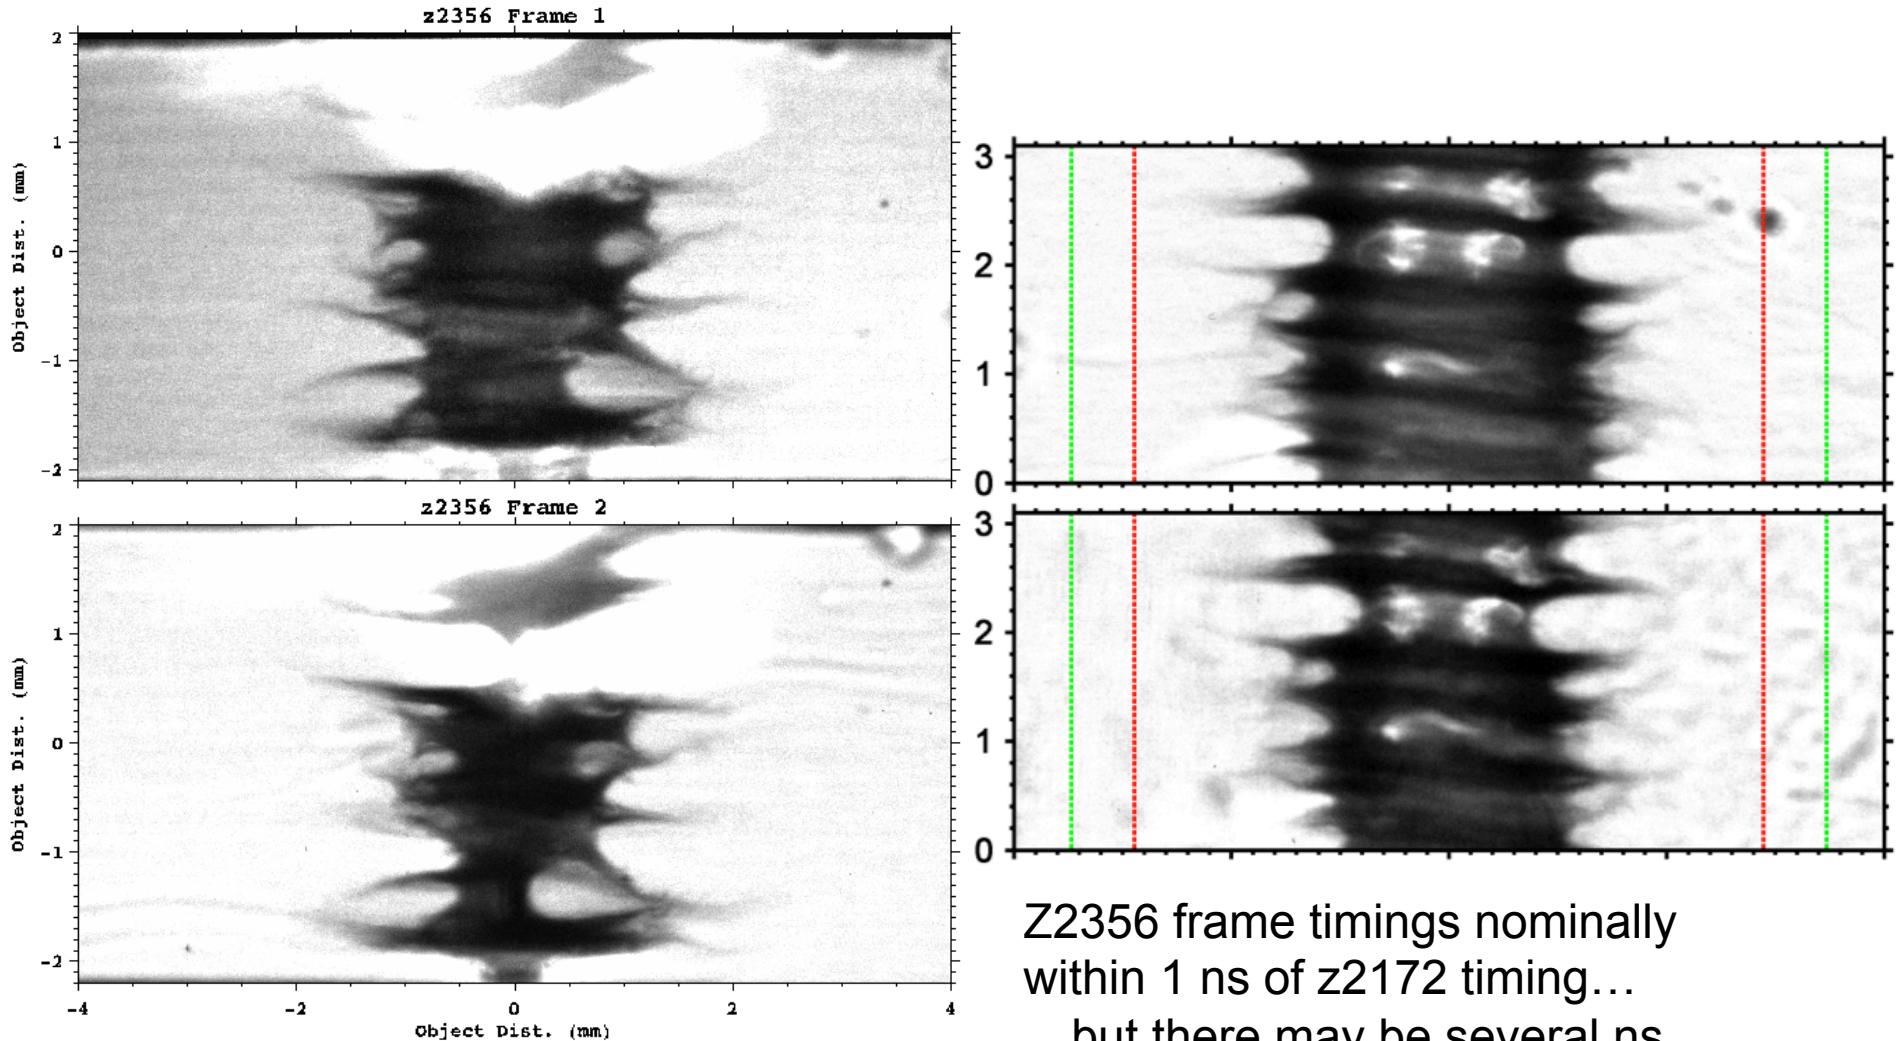
Comparison to previous data appears to show differences at late times

Z2356 frame timings nominally
within 1 ns of z2172 timing...
...but there may be several ns
implosion timing difference?

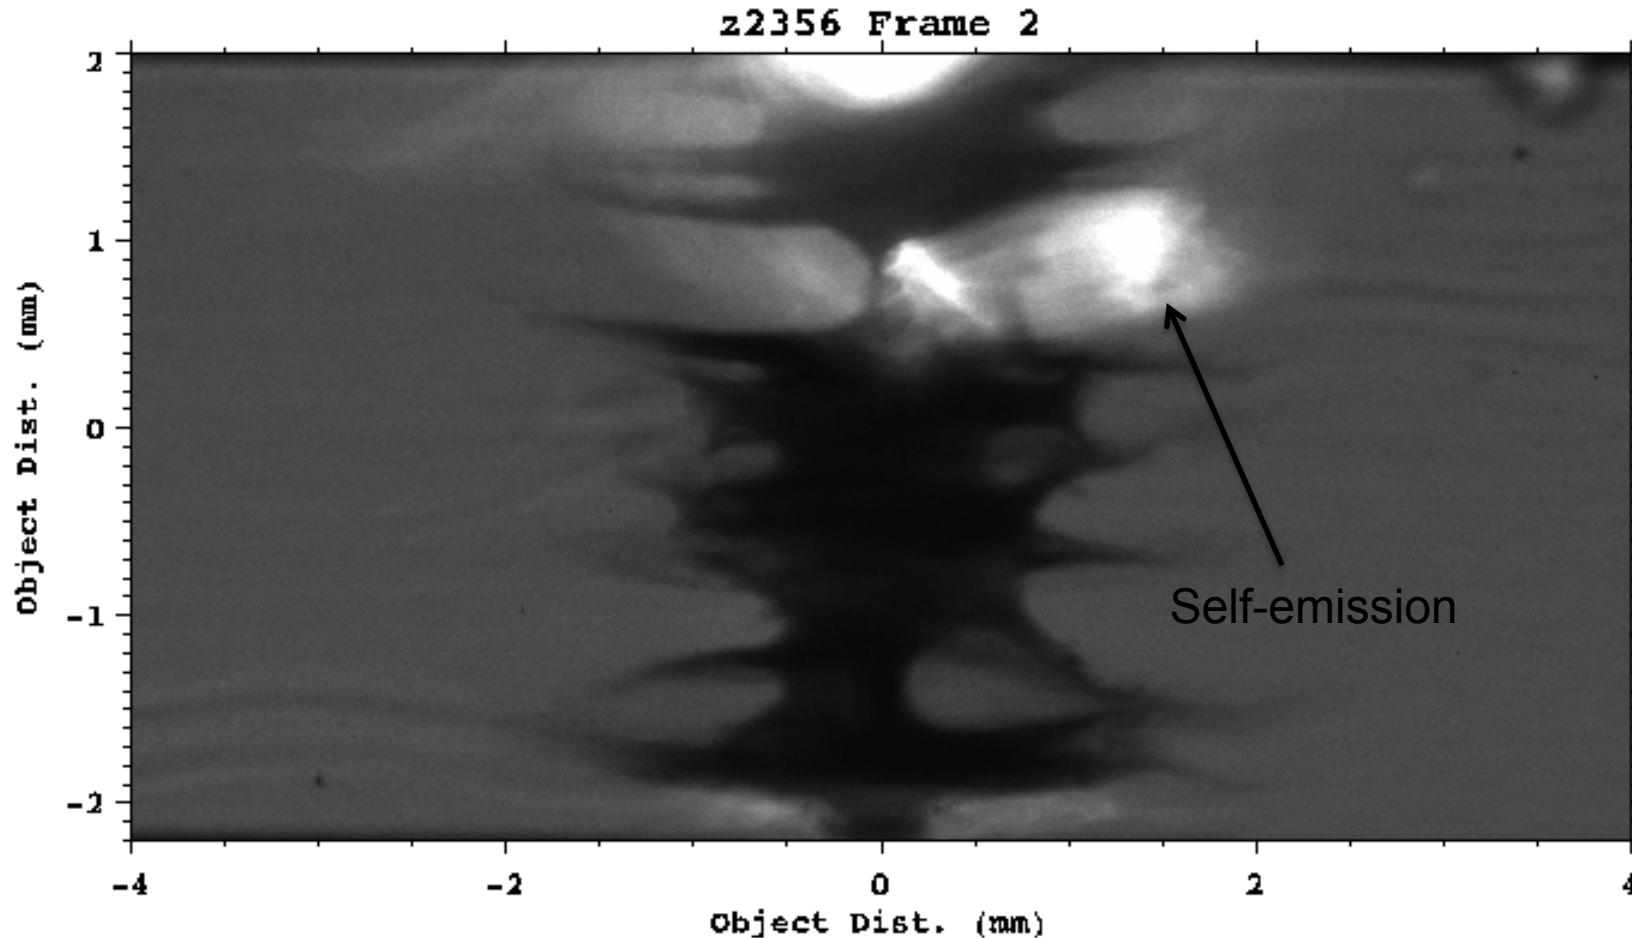
A re-scaled image that shows the self-emission structure better

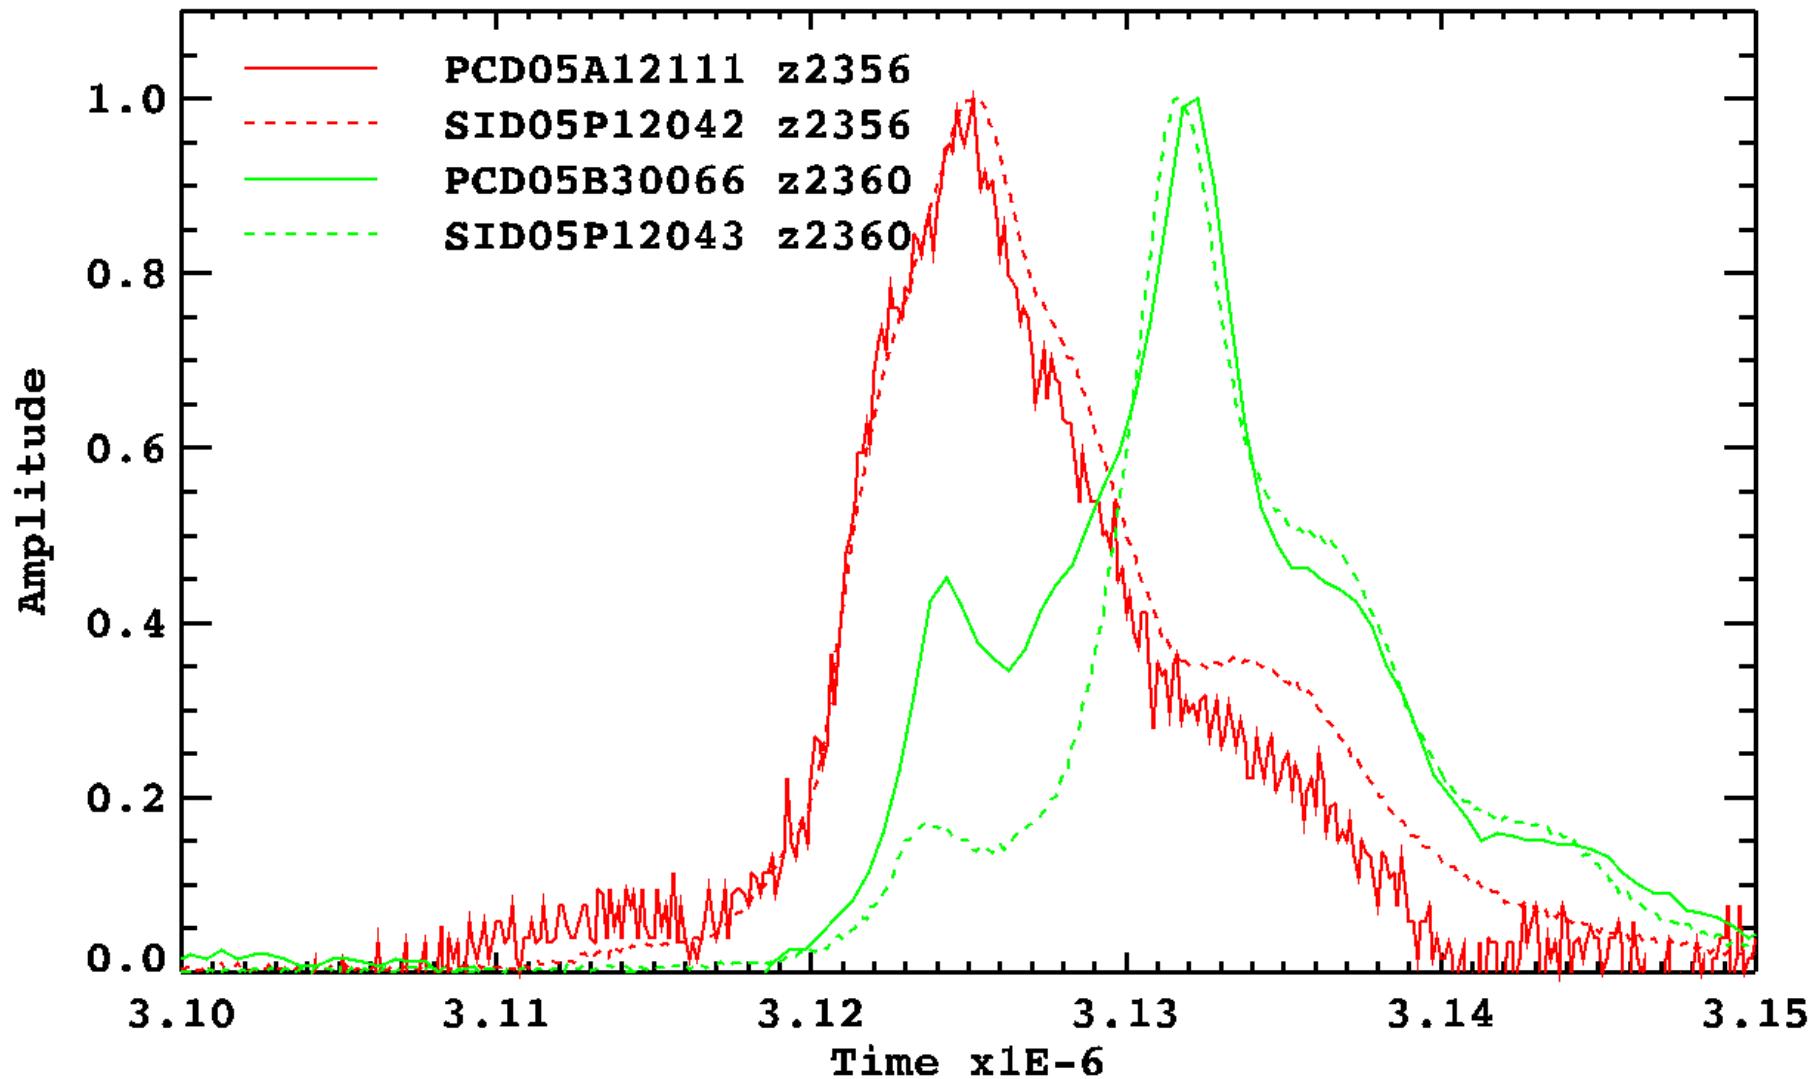
We fielded 4 PCDs + 2 SiDs, and obtained very nice SiD data
