FCT UFD Crushed Salt Mechanical Testing Results to Date

3rd US/German Workshop on
Salt Repository Research, Design and Operations

October 9-10, 2012

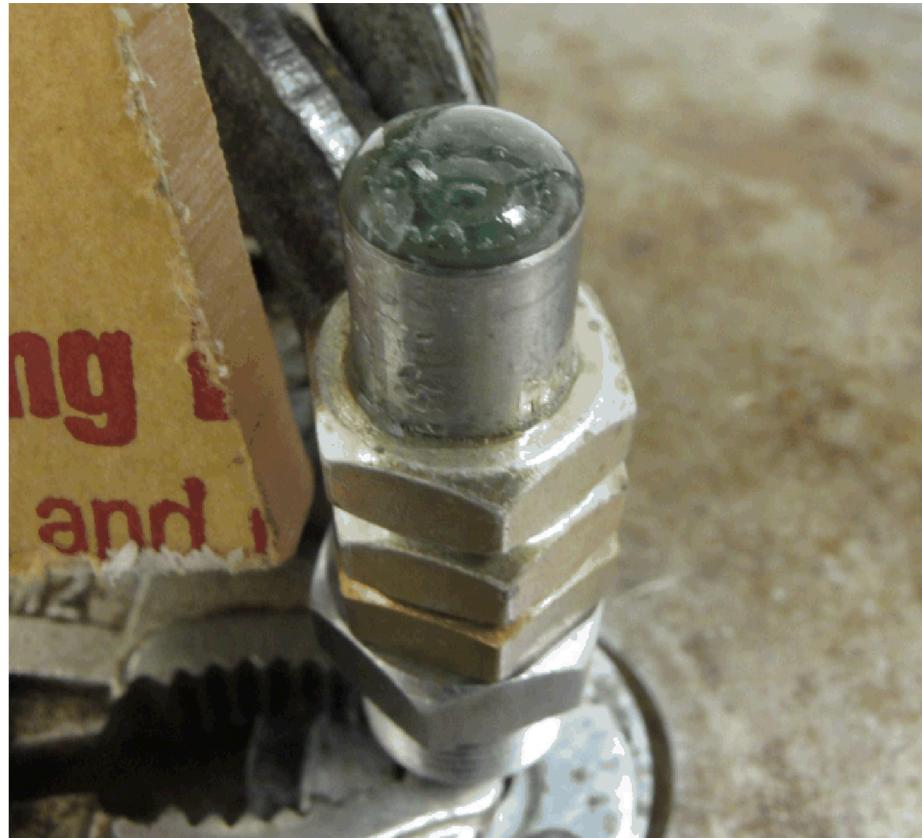
Challenges and Observations

- Water was observed existing sample vent hole on 250°C tests during heating
- This observation begs the question of the potential for a dry environment for high level waste disposal in (this) bedded salt

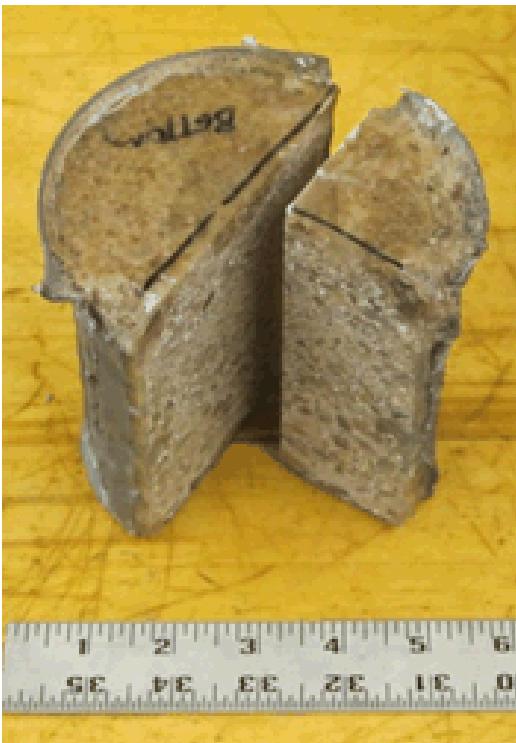
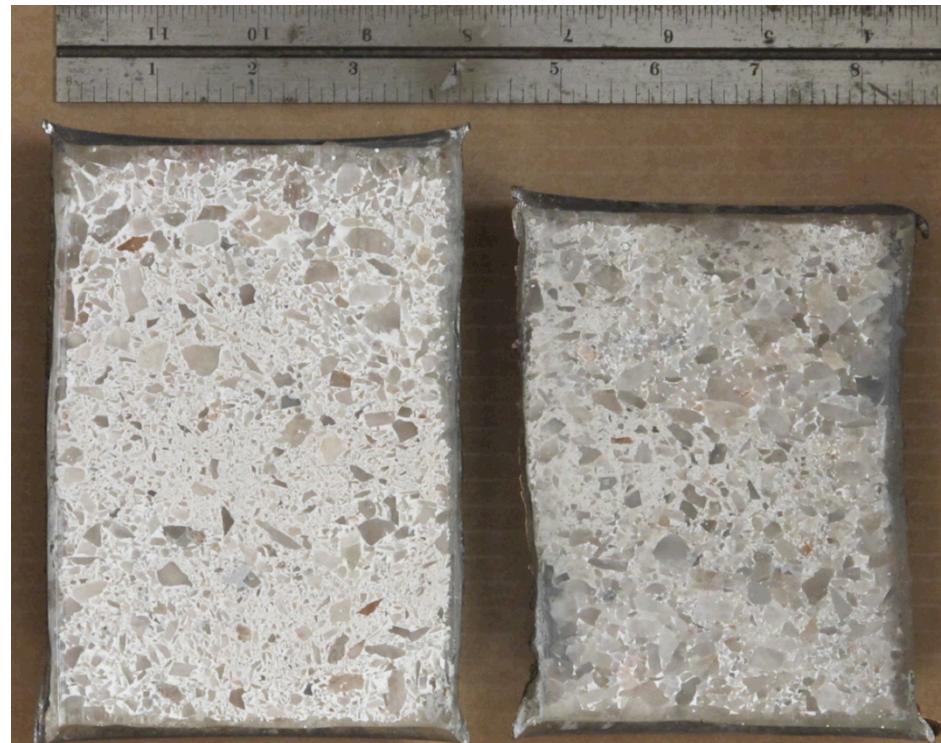
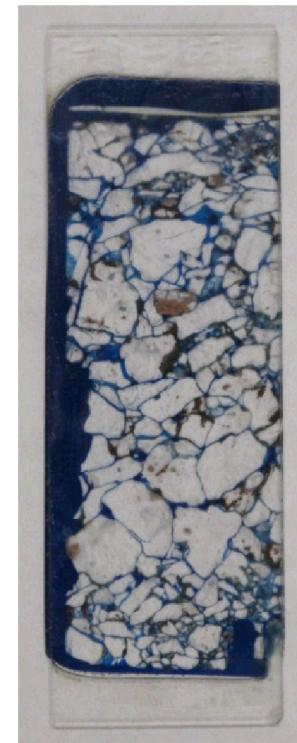
Microprocesses of Reconsolidation

- Samples cut in half, then quartered with a low damage wire saw
- “Thick” optical slides were made for most material
- Freshly broken faces were coated and examined in the SEM
- Individual crystals were cleaved and etched in some cases

100°C

250°C
