# Examination of Techniques for Internal Short Circuit Testing on Lithium-Ion Batteries

**Joshua Lamb, Christopher Orendorff and William  
Averill**  
**Sandia National Laboratories**

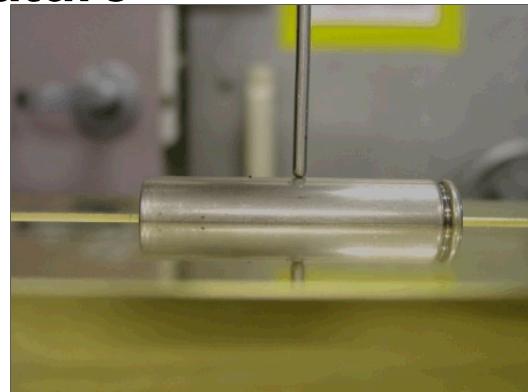
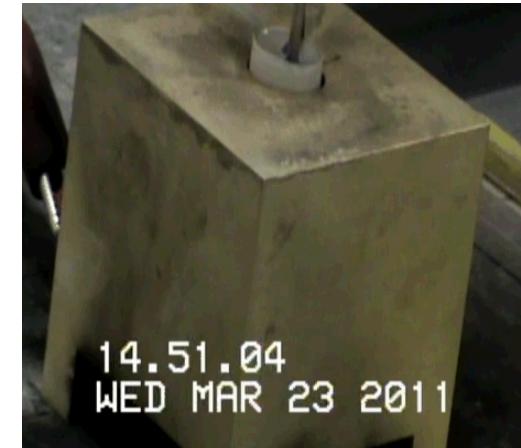
- **Blunt rod and sharp nail**
- **Hydraulic and mechanical crush**
- **Transverse and axial loading cells**
  - Elevated temperature testing
- **Post-mortem CT examination**

Test conditions		
Speed	2 mm/min	
Construction	316 SS	
Nail Tip	5 mm	
Temperature	RT	60C
End Conditions	100 mV drop	20 mm penetration

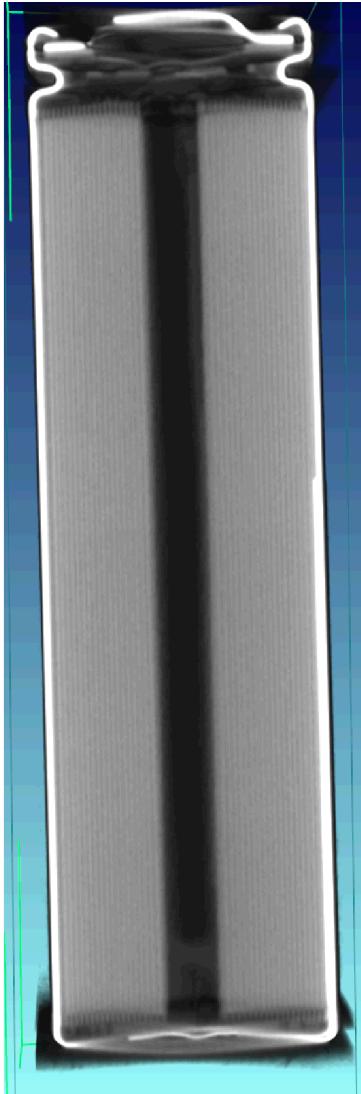
Cell type A

Differences in basic cell construction may lead to differing responses to abuse conditions

- Presence/absence of center rod
- Dead space in can
- Differing size/position of negative tab

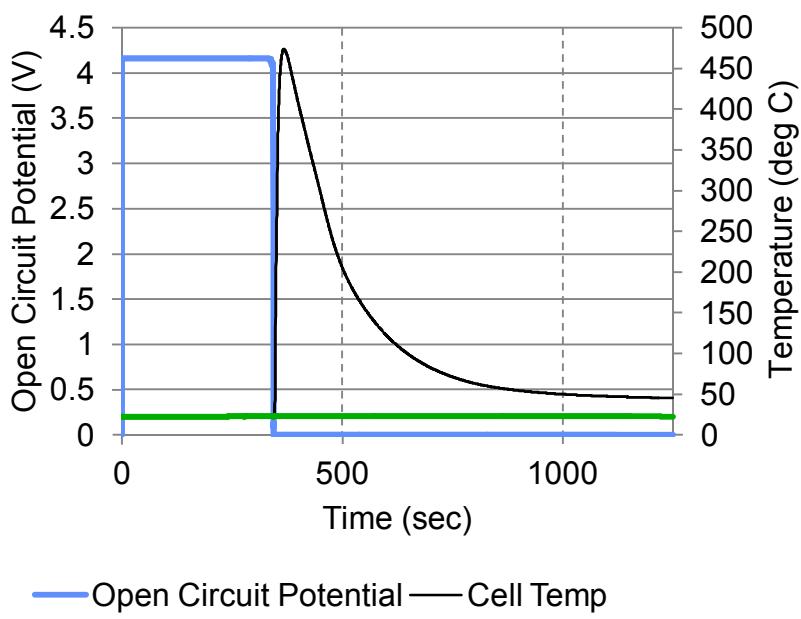
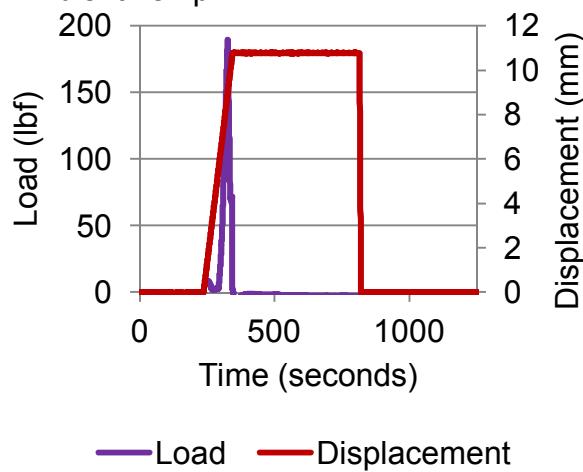
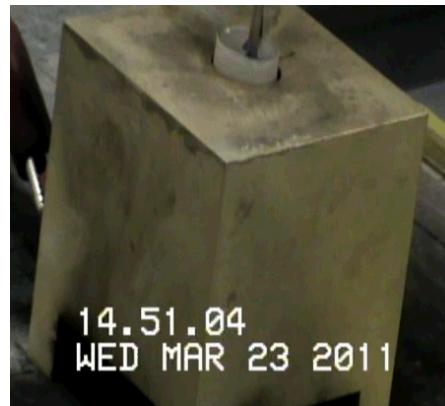
# Results: Axial Loading

- Blunt rod off center, off negative tab.
- Resulted in hard short with high temperature and sharp drop in voltage
- Not shown: crush directly on center difficult to fully short as rod passed through empty center

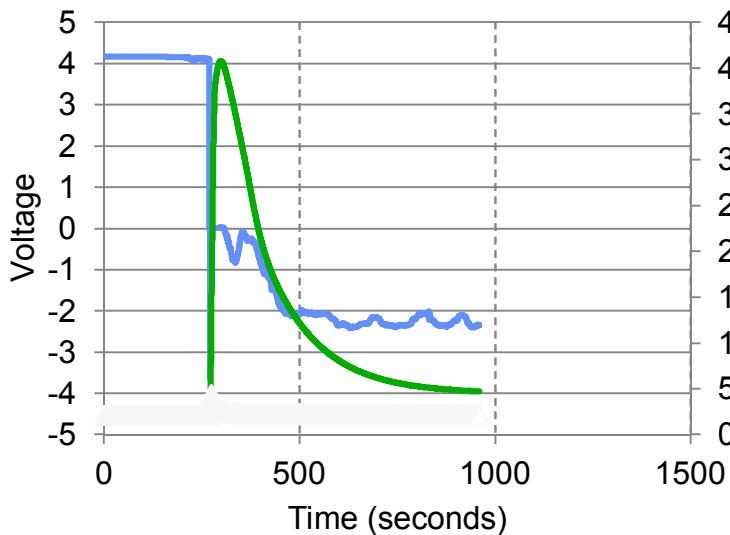
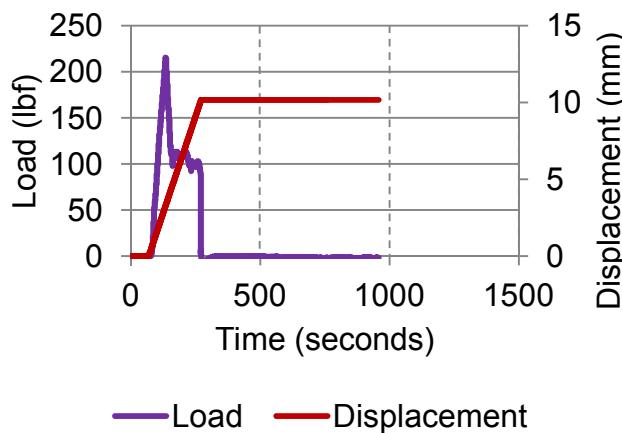
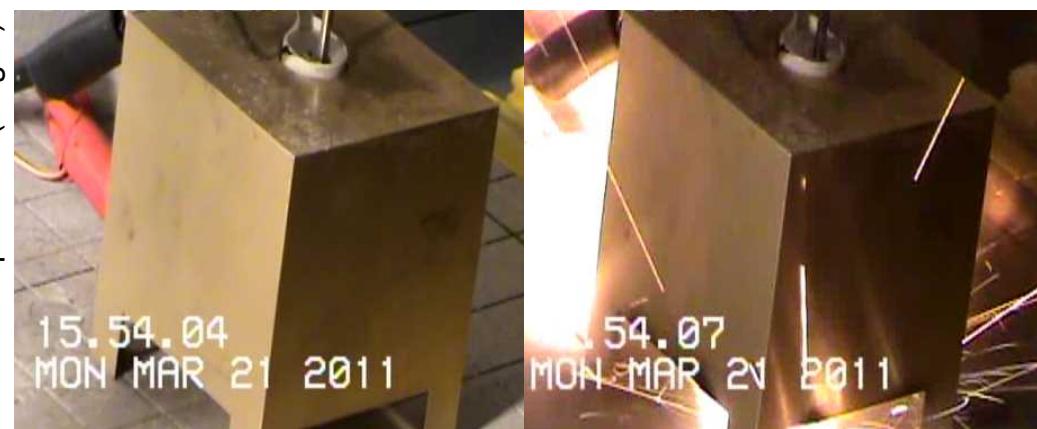
# Results: Axial Loading

— Open Circuit Potential — Cell Temp

△ Ambient Temp

— Load — Displacement

- Off center, on negative tab
- Noisier voltage curve after short
- Hard short occurs shortly after penetration

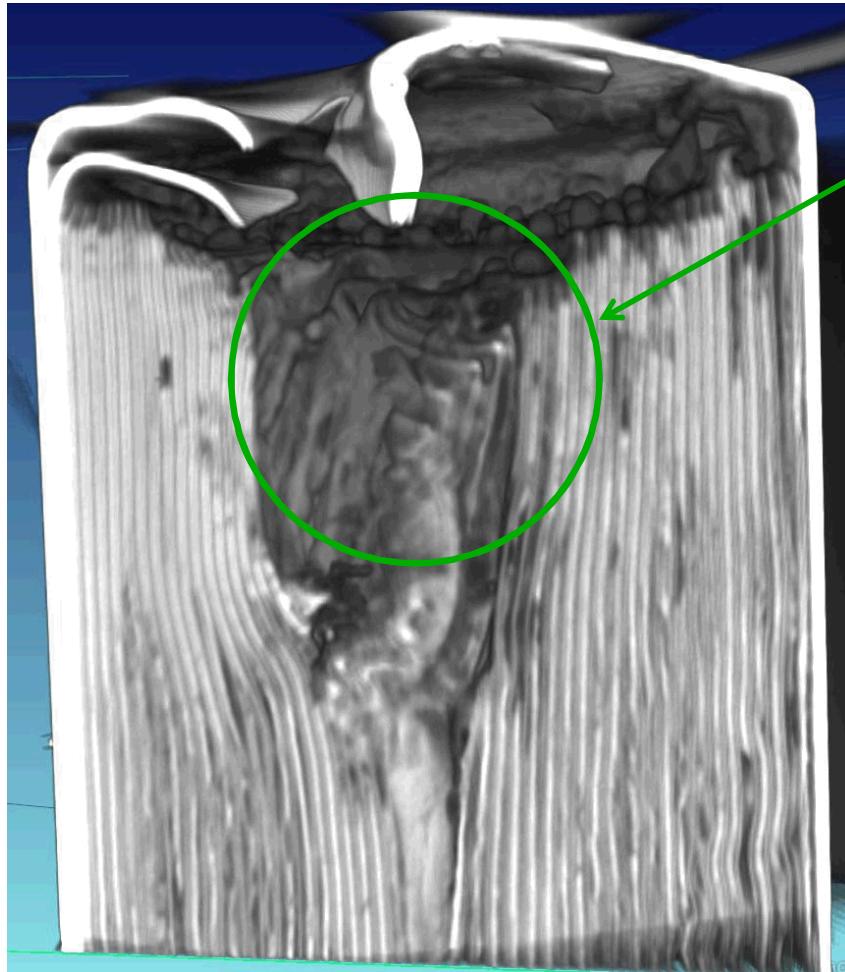
Short location

Propagation of short through cell towards vent.  
Damage becomes more extensive near vent from flow of escaping gas

Large gap between can and electrodes prevent contact without cell puncture

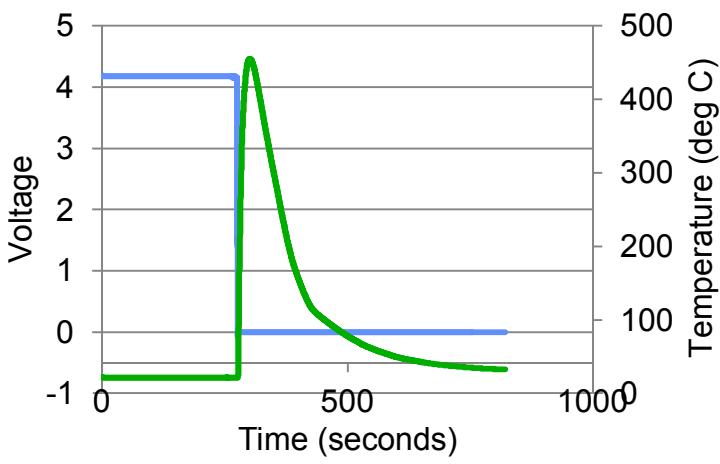
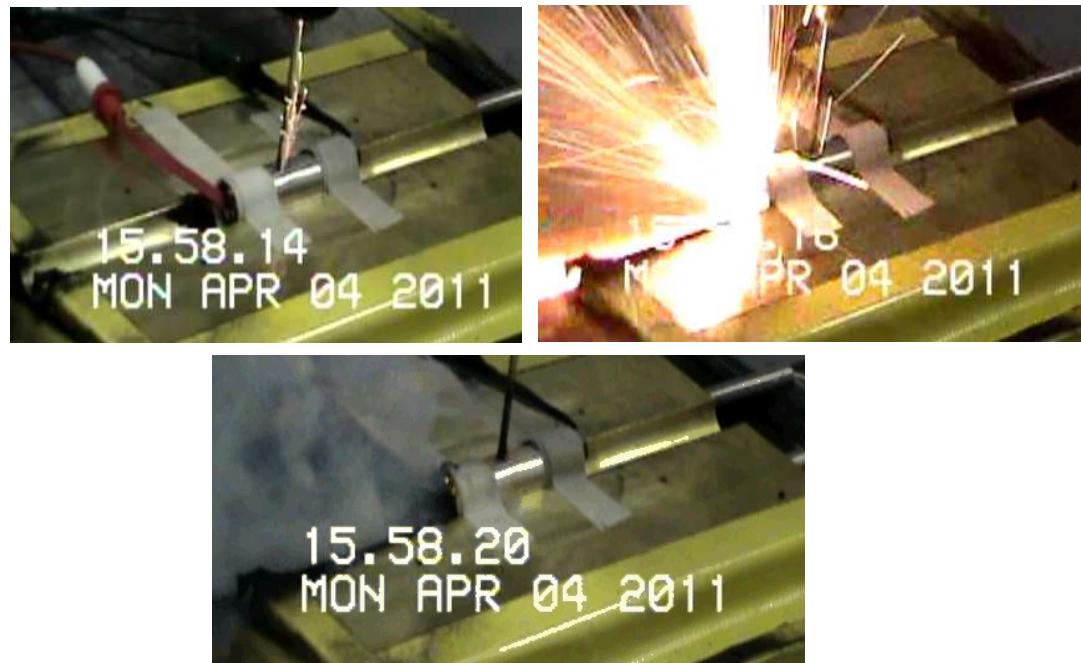
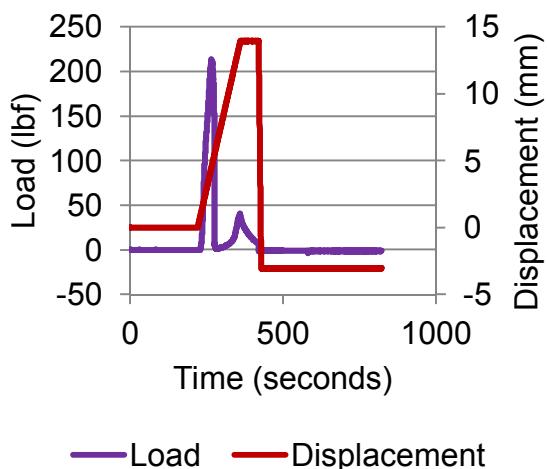
# Results: Transverse load

Cell type A: no internal core  
Catastrophic cell failure; all  
escaping gas comes through  
puncture or vent

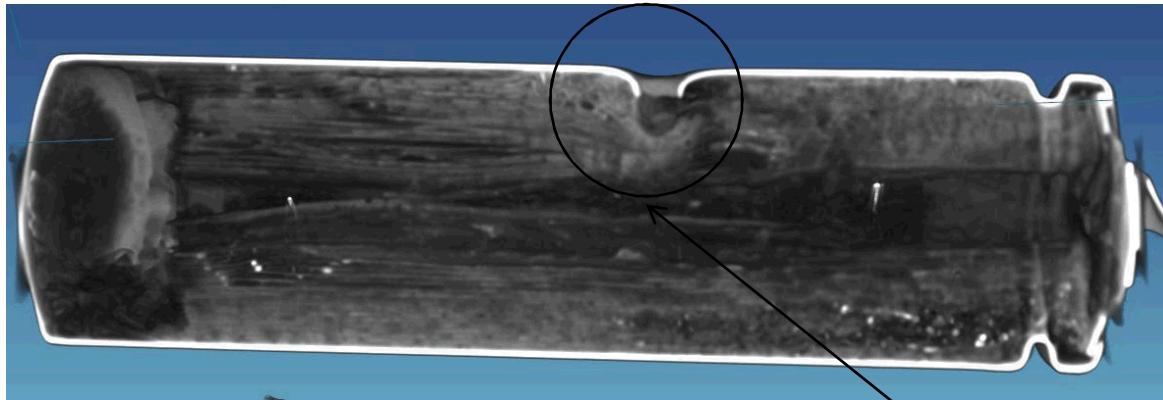
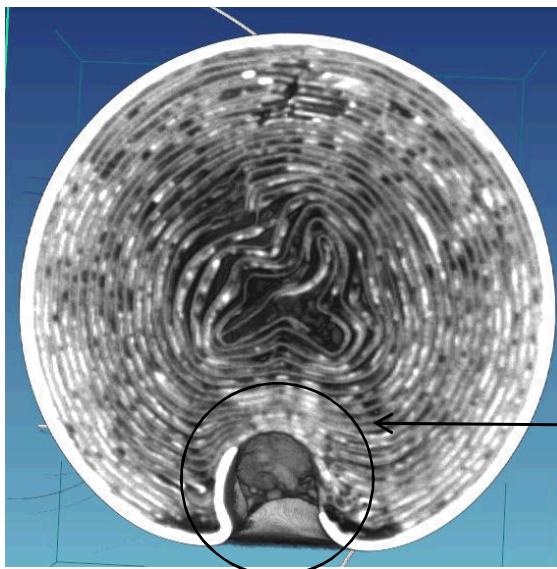
Propagation  
of failure  
through cell

Short location – electrode collapses  
into core and escaping gas through  
vent forces jelly roll up towards  
vent

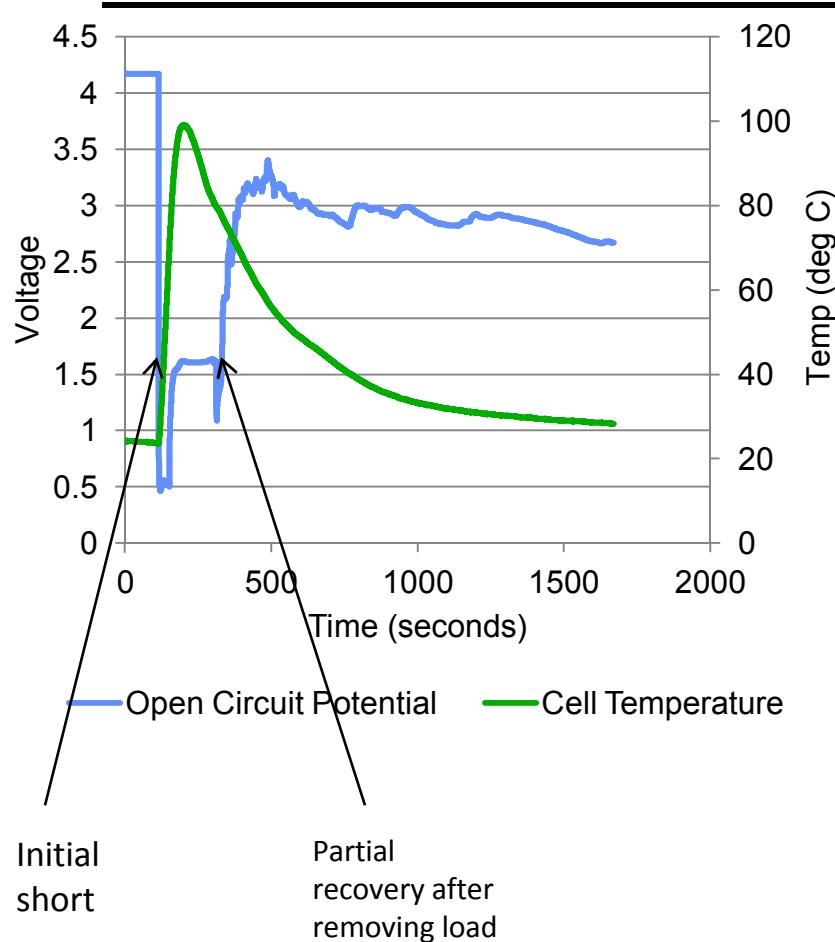
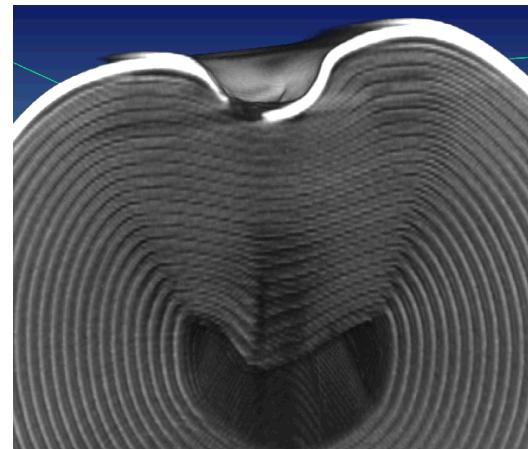
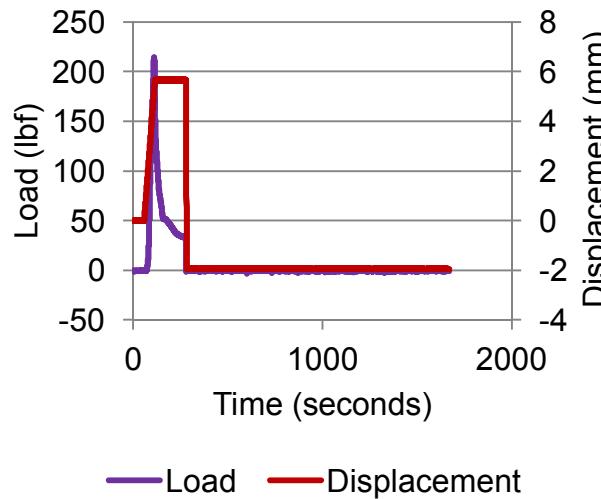
# Failure: Soft short with partial recovery

Cell shorting between layers. Electrode is able to deform and collapse into open space in core of cell.

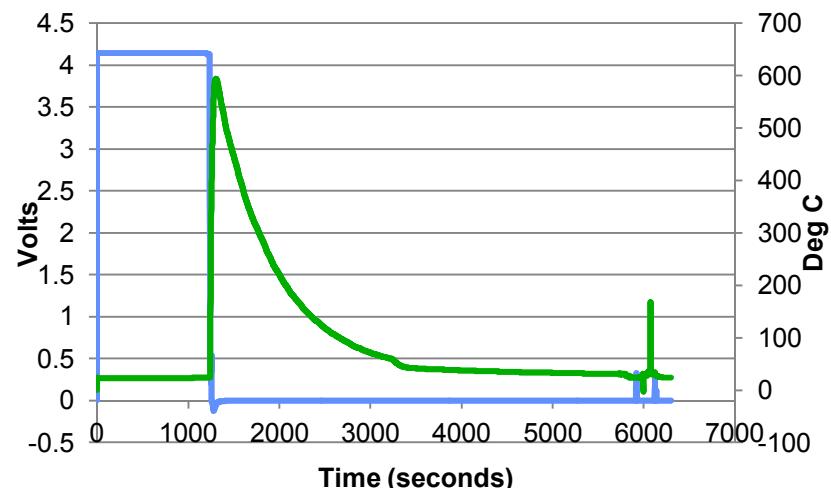
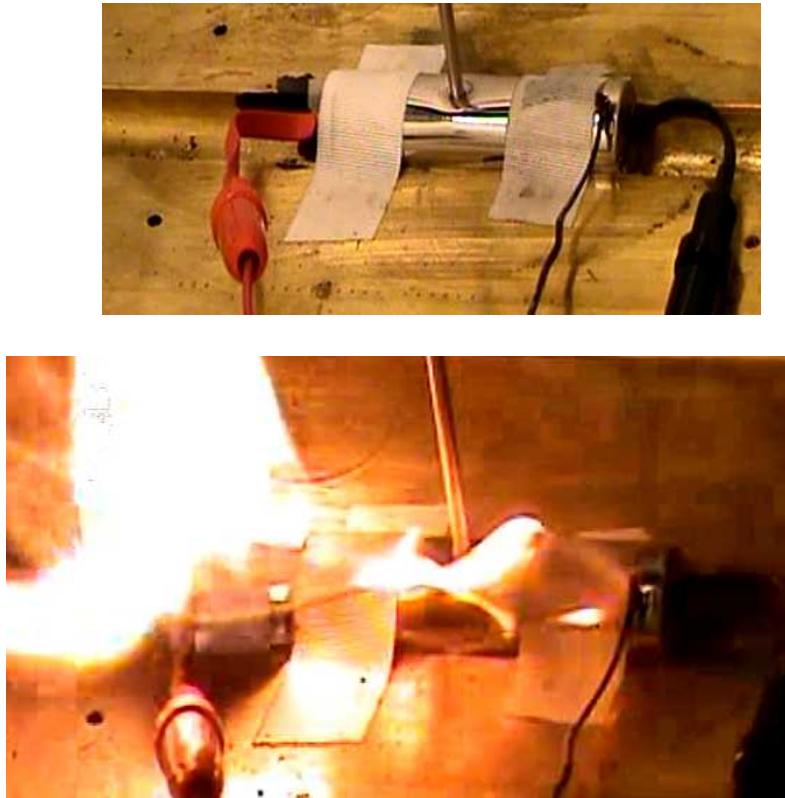
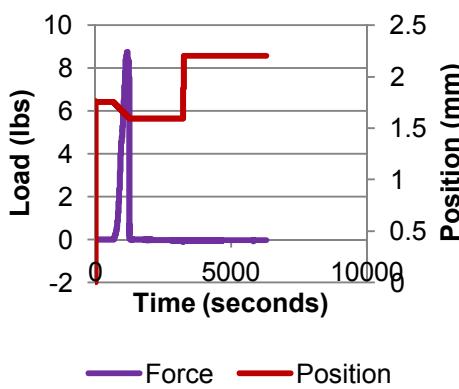
## Effect of Cell construction: Cell type B

- Catastrophic failure readily seen
- Very high temperatures with spark source allowing for fire

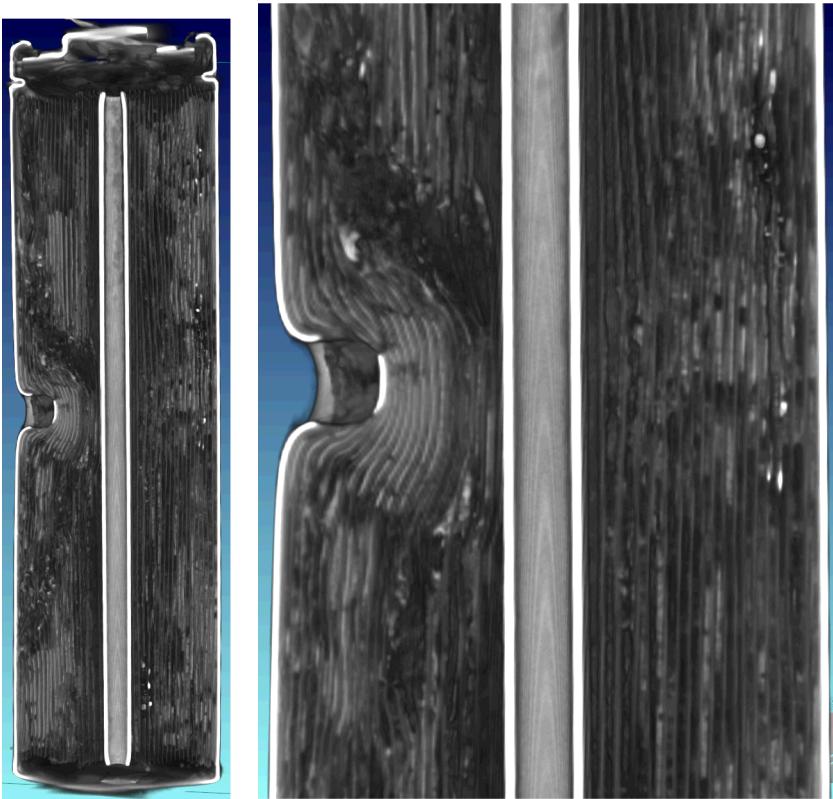
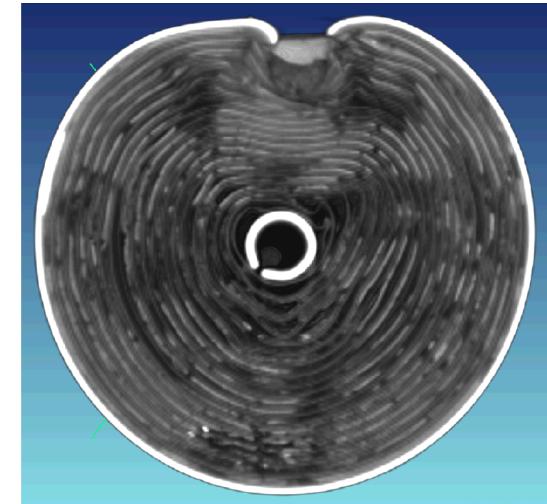
## Cell type B continued

- Center core restricts contents during catastrophic failure
- Creates an effective “backing plate” allowing the electrode to be sandwiched between blunt rod and core

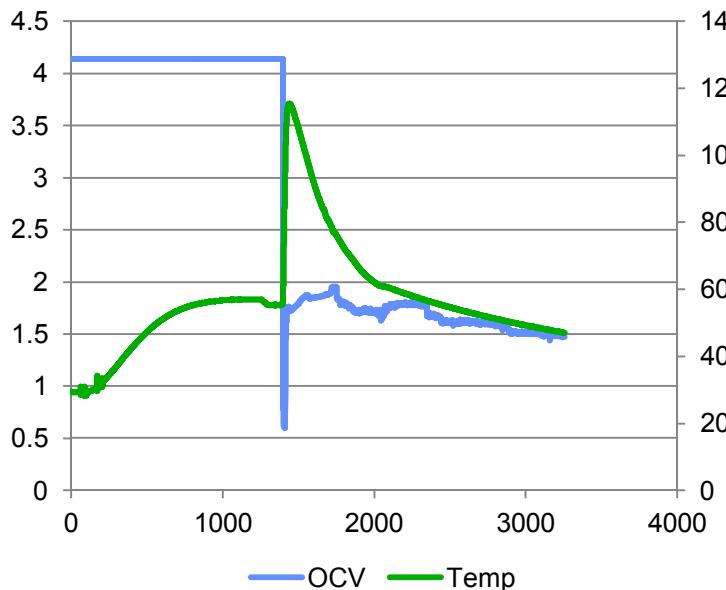
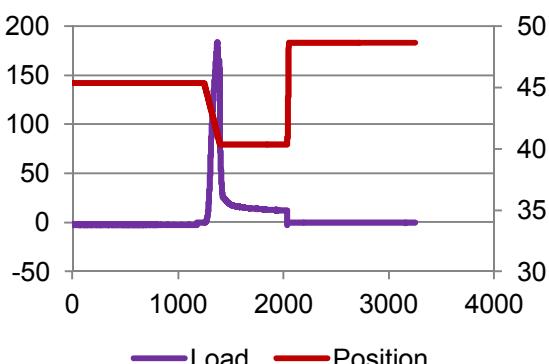
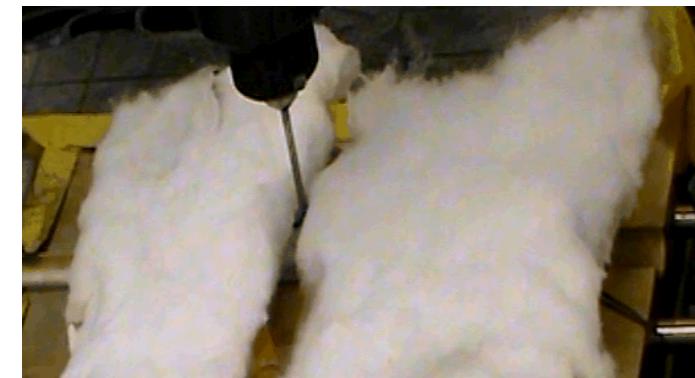
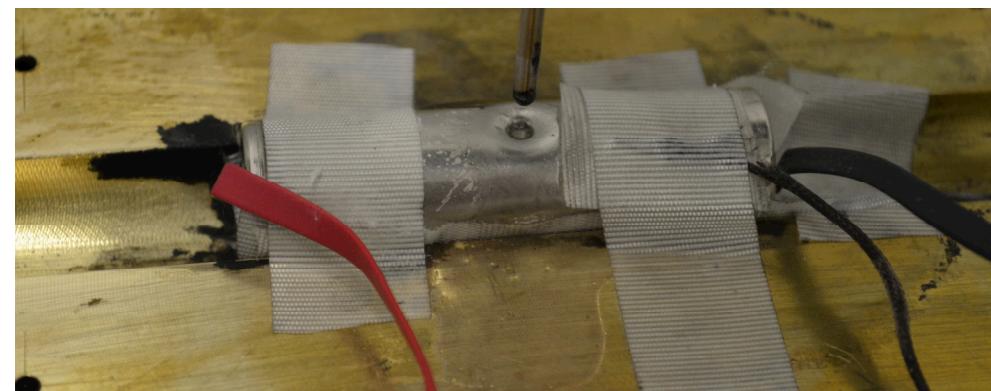
# Elevated temeprature - Cell type A

Full short observed, but no catastrophic failure

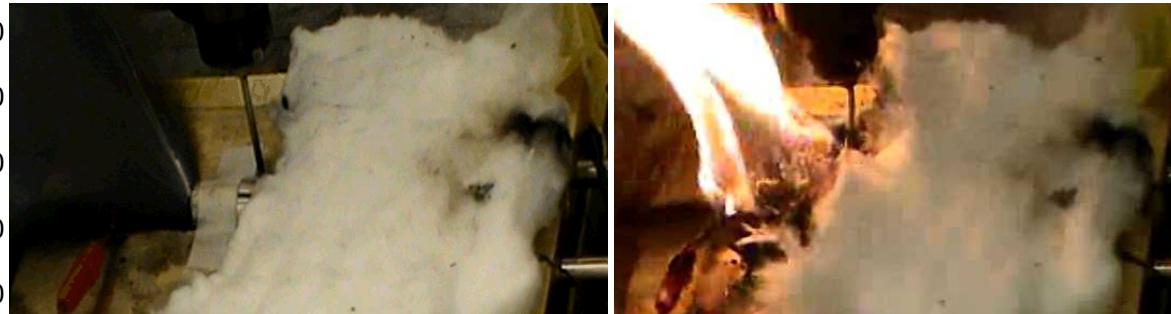
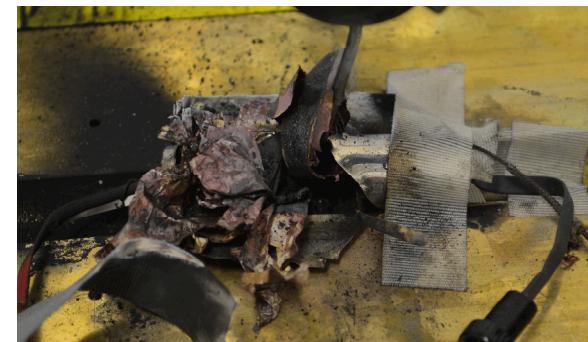
# Elevated temperature – Cell type B

Two photographs showing the physical damage to the cell components. The left image shows the cell's housing and internal structure severely damaged, with the can ruptured and contents ejected. The right image shows a close-up of the damaged can and internal components.

- Very catastrophic failure
- Rupture of can
- Ejection of cell contents
