Cadmium Whisker Growth on Cd-Plated Steel Fastener Hardware

Donald F. Susan, Zahra Ghanbari, Rachel White,
Jamin Pillars, Bonnie McKenzie, Sara Dickens,

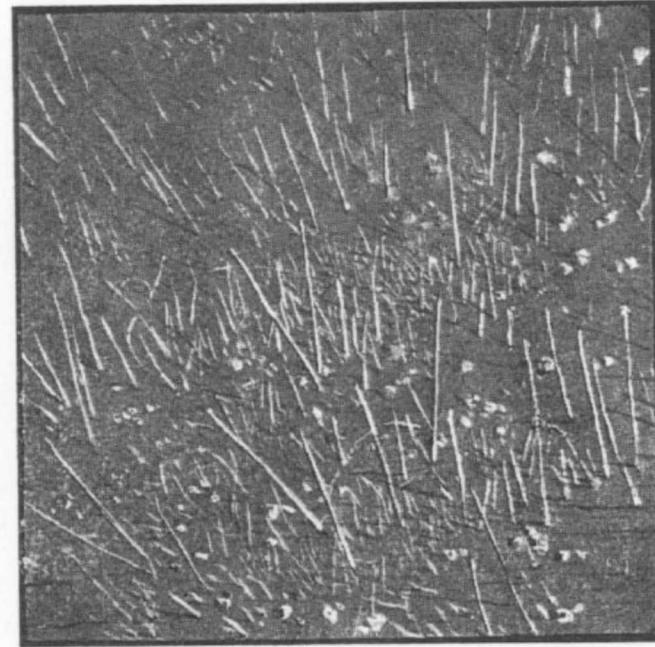
Fig. 4. Perspective view of cadmium whiskers. Found in the square shown in Fig. 5. Hand drawn. X22.

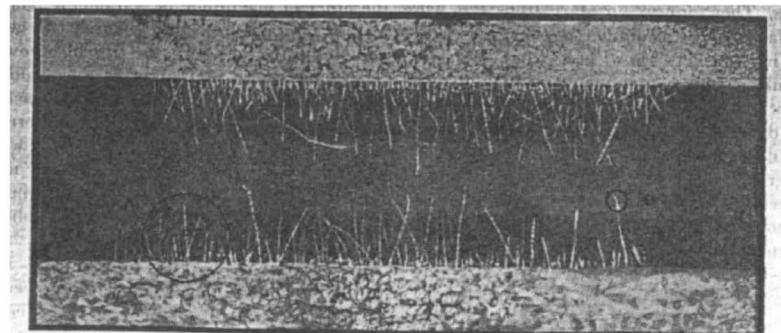
Fig. 5. Cadmium whiskers between ten-year-old condenser plates spaced 0.080 in. apart. Hand drawn, enlarged.

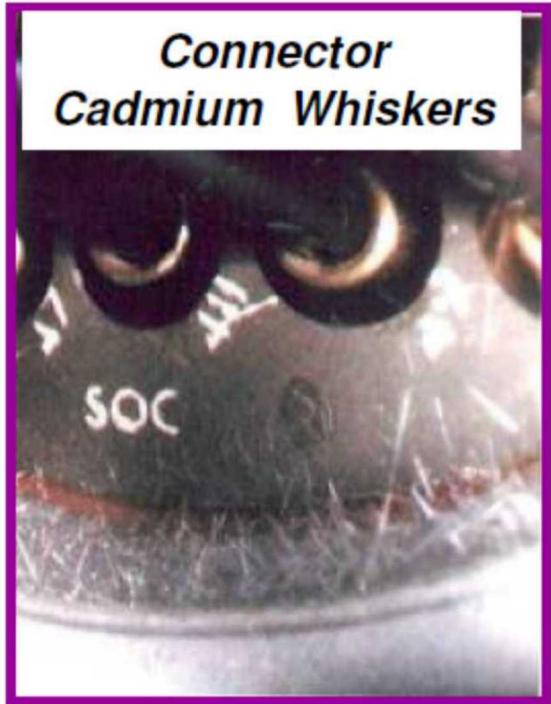
- Cd whiskers on a feedthrough connector for a thermal-vacuum chamber. Several mm long, produced electrical shorts from shell to pins that interrupted testing of a spacecraft system
- NASA prohibits Cd in all spaceflight systems
 - Cd sublimates in vacuum environments (the main reason for the ban)
 - Cd is toxic
 - NASA also mentions Cd subject to whisker growth
- The NASA ban mentions that Cd is used on fastener hardware. However, to date, no literature found specifically on the subject of Cd-plated **fasteners**...

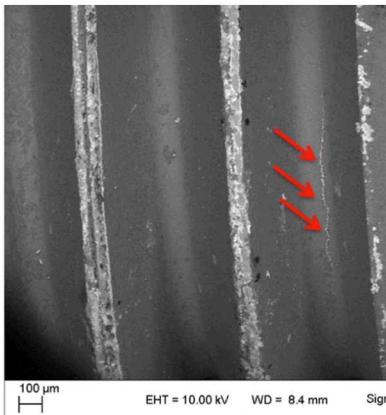
Whiskers initially observed growing from a crack in the thread root

- In 2016, a failure analysis investigation began on a cadmium- (Cd-) plated, high strength screw failed upon insertion into an assembly
 - Cause of failure:** Use of incorrect (brittle, high carbon) alloy led to embrittlement and compromised mechanical integrity
 - During the investigation, whiskers were observed growing from a crack in the thread root and on the fracture surface

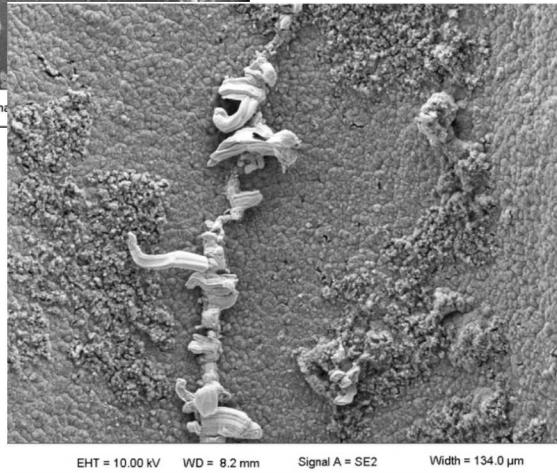
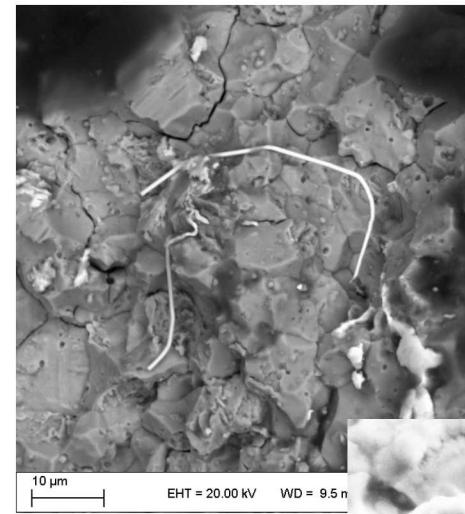
Also found growing directly from the fracture surface, where Cd had been plated inside a pre-existing crack

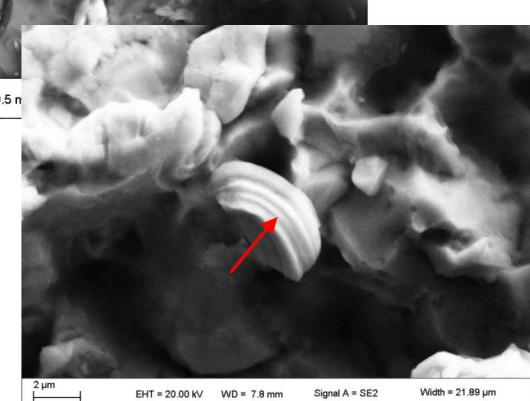
- Long Cd whiskers were subsequently found on the surface of the failed fastener and other fasteners from the same investigation

Bent whisker
spanned between
thread turns
(~300 microns)

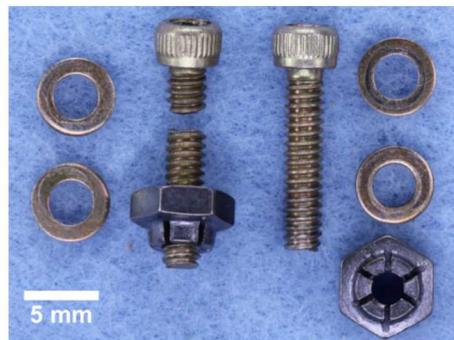
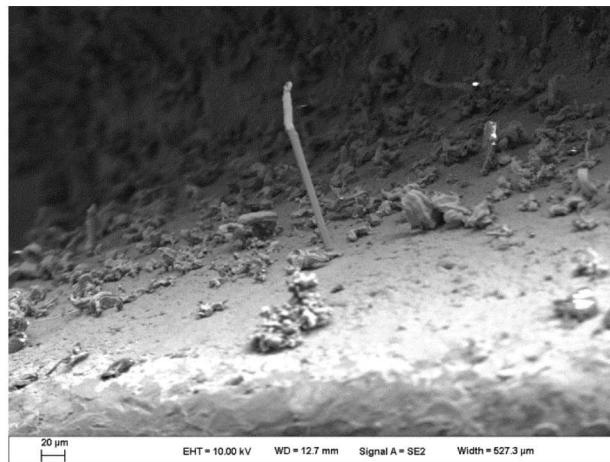
EDS mapping confirmed whiskers as pure Cd.

(Cr signal confirms chromate coating)

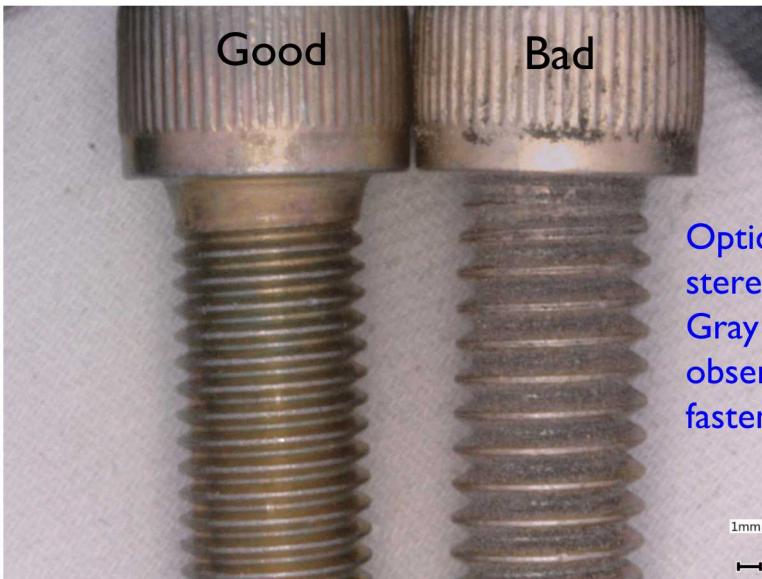
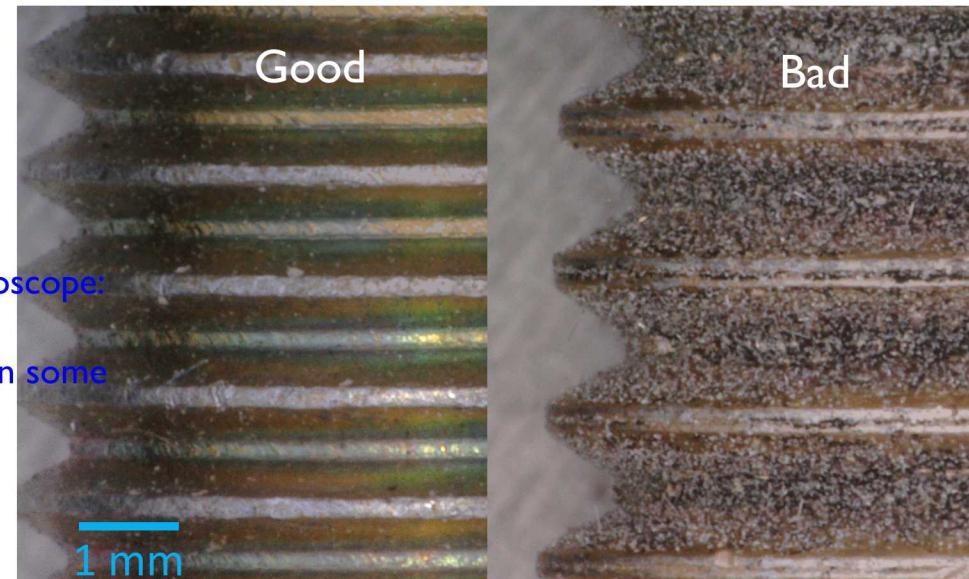
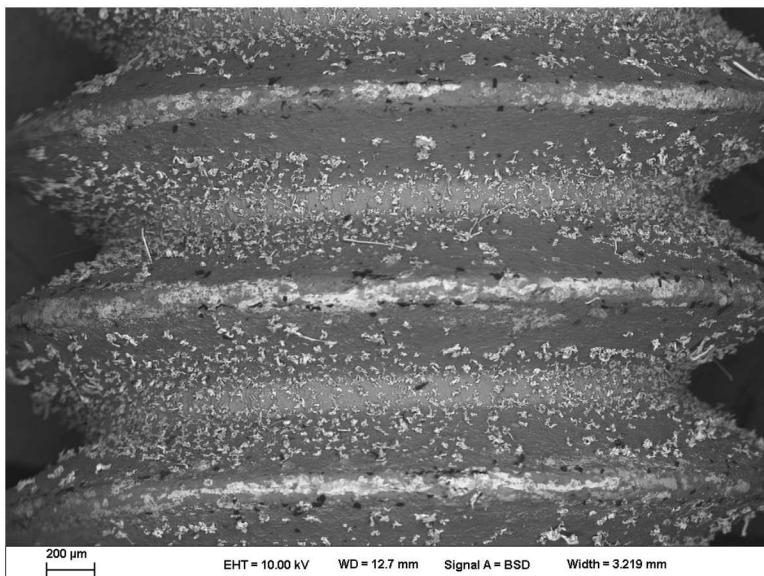
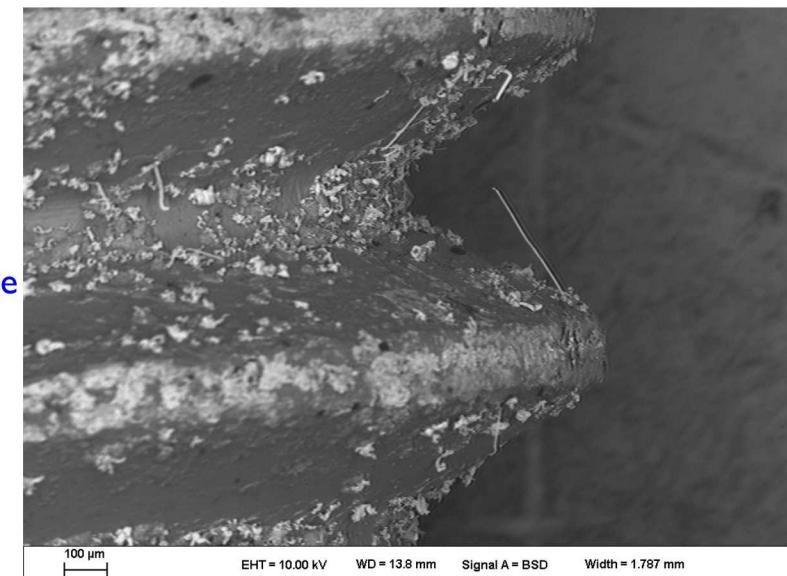
Fasteners found in laboratory drawers. Unknown age... probably 20 years or more.

- In 2017, a project was initiated to collect Cd-plated fastener hardware. Abundant Cd whiskers were found, i.e. Cd whiskers on fasteners are commonplace, not unique.

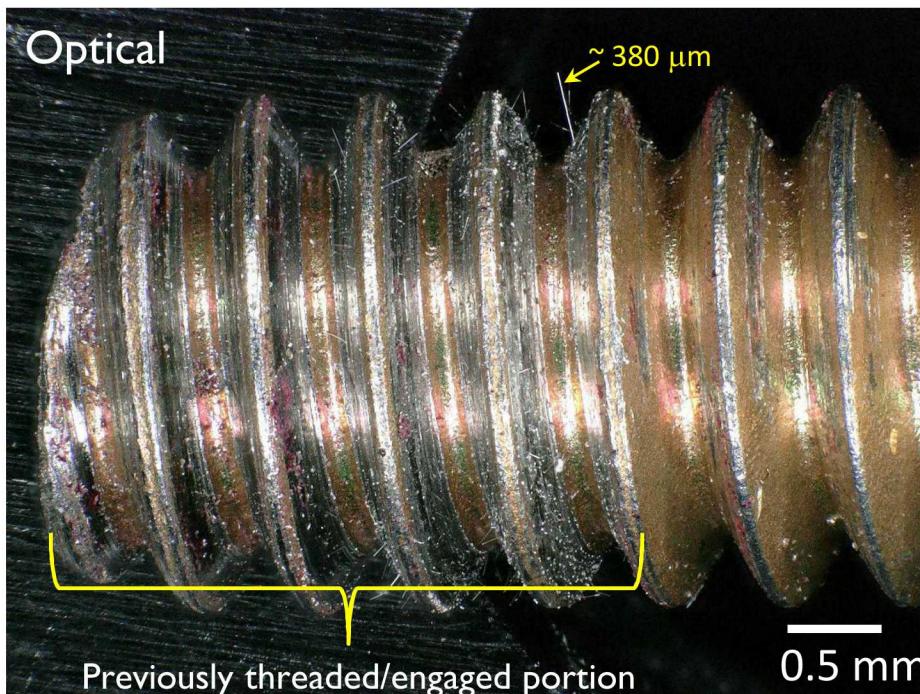
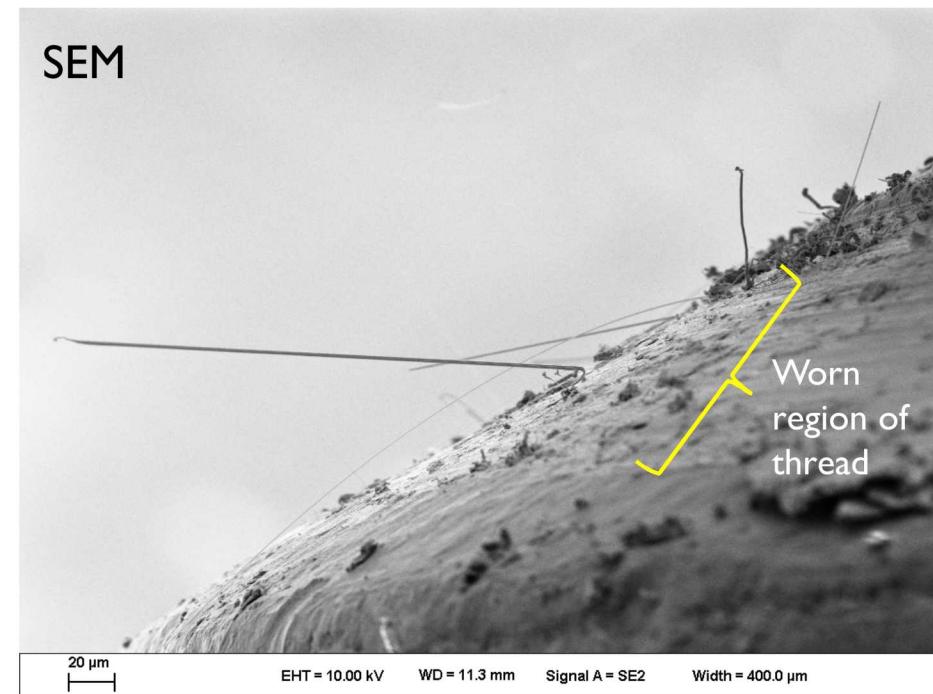
- Whiskers were found mainly, though not exclusively, in the worn previously engaged regions of threads, suggesting that majority of growth may occur *after* disassembly. Whisker growth from externally applied stress or deformation is well-known for tin whiskers.

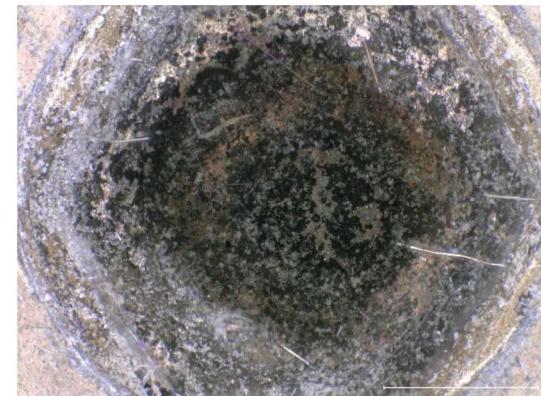
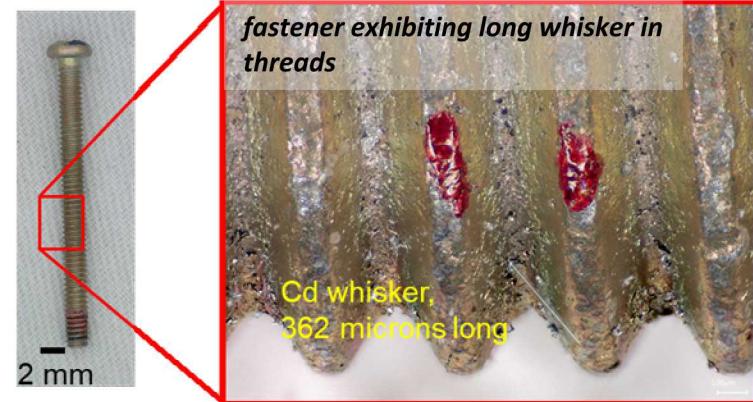
Head of field returned fastener exhibiting numerous whiskers

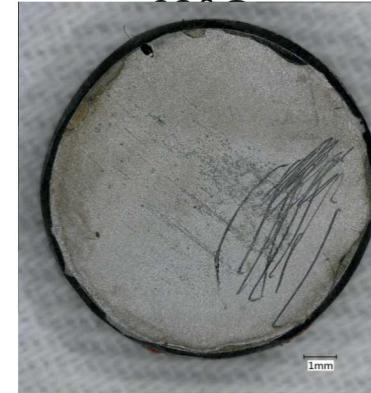
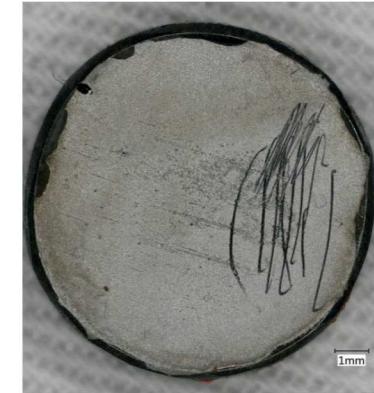
Sample D

As-plated+abrasion

48hr at

96hr at

144hr at 83°C

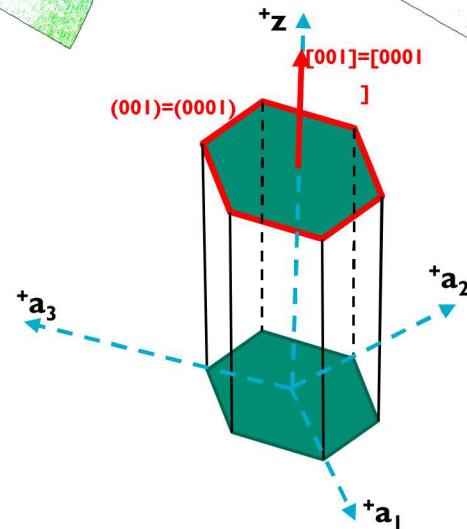
EBSD performed after heat treatment for a total of 144hr at 83°C. Uniform plating texture is not obvious, although many points correspond to [001] (or [0001]) in Z-direction (ie basal plane growth in HCP system)

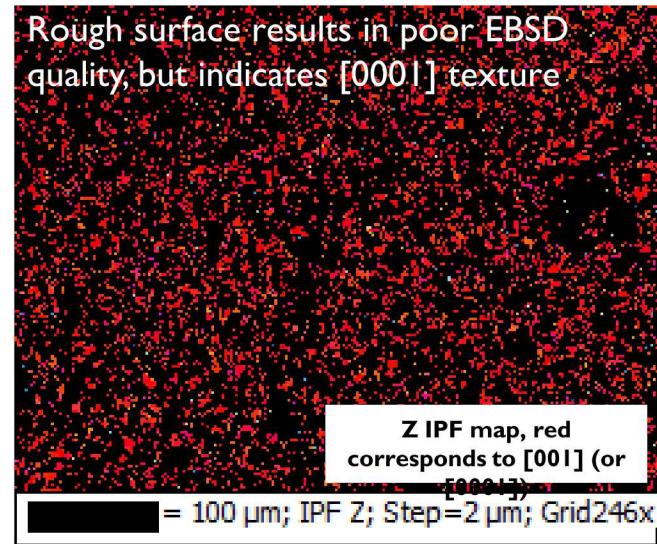
Rough surface results in poor EBSD quality, but indicates [0001] texture

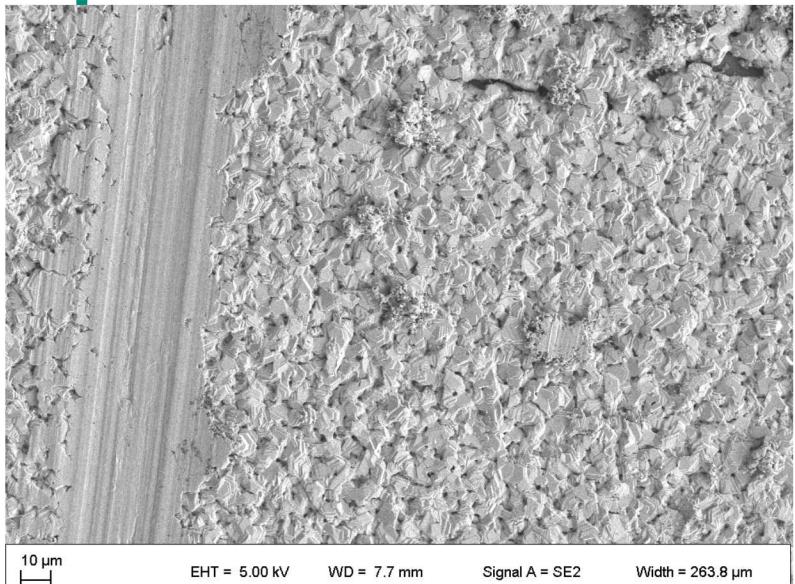
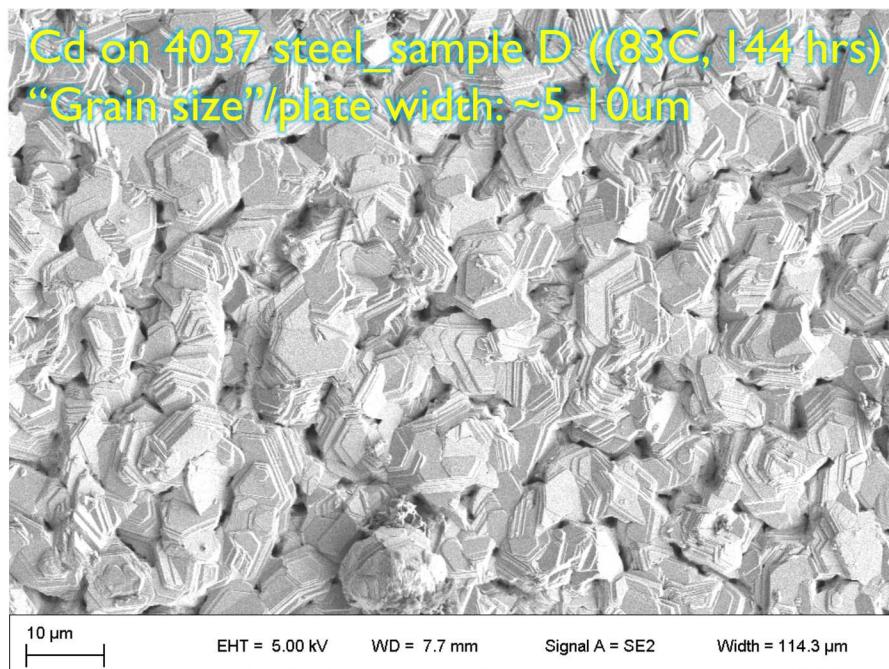
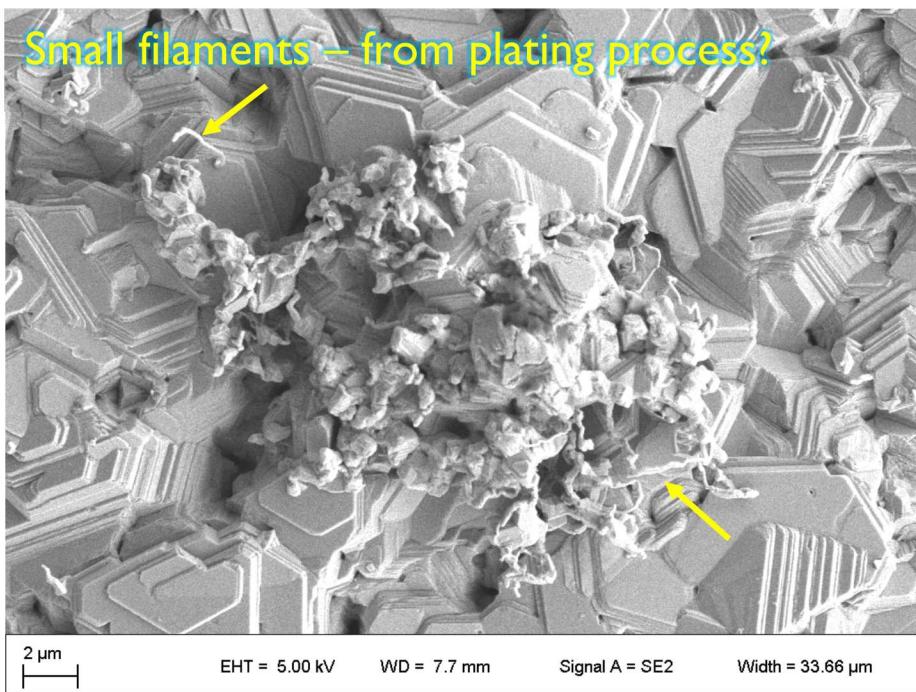
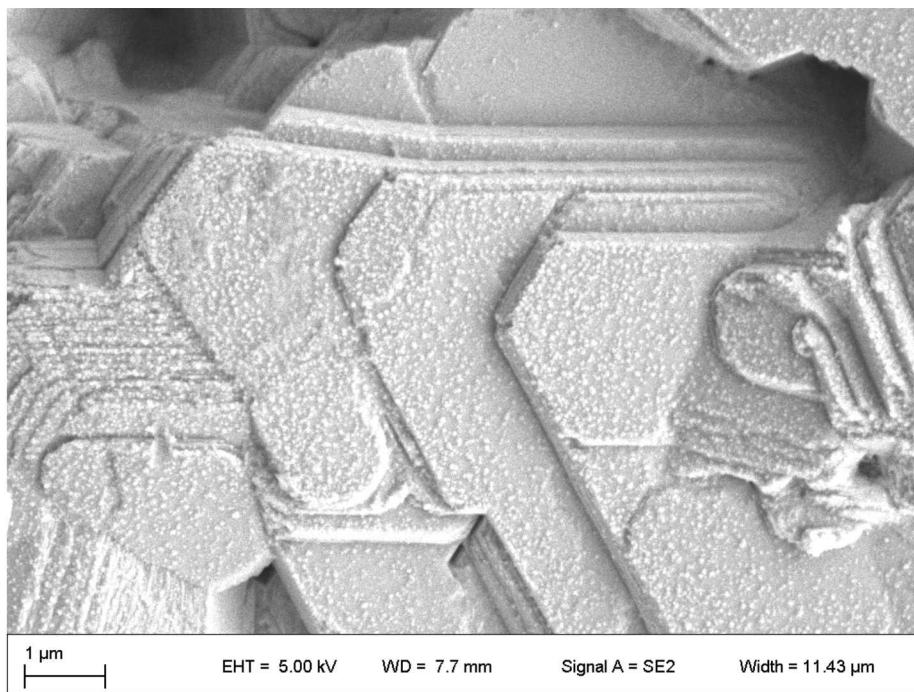
Cd on 4037_sample D (83C, 144 hrs)

Coarse crystalline plating results

“Grain size”/plate width: ~5-10um

“spaghetti-like” filaments, primarily near scratched/highly deformed region

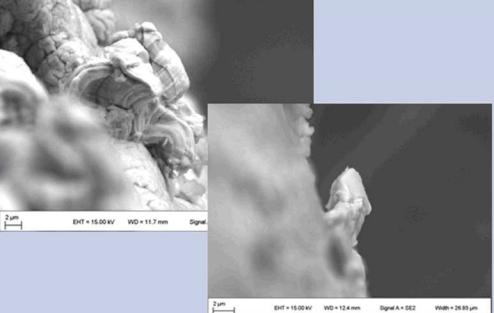
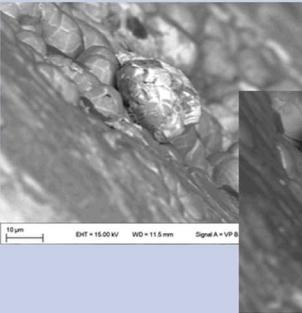
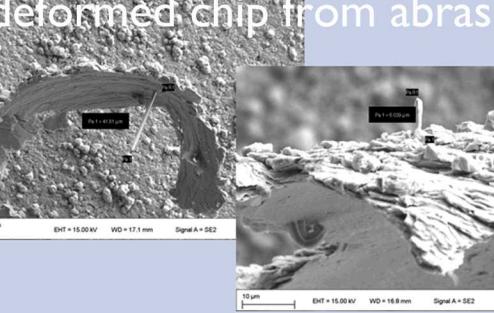
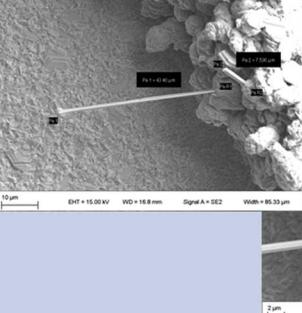
- Heat treatment of multiple Cd platings (and multiple substrates) has yielded a few Cd whiskers.
 - Observations of whiskers or nodules forming on each Cd plated washers or Cu coupons suggest that temperature range needed to promote accelerated whisker growth may be near 138°C-170°C (for 6-9 days). Deformation appears to play a key role in promoting whisker growth.

| | 138°C, 9 consecutive days | 170°C, 9 consecutive days |
|--|--|--|
| Undeformed Cd coating (w/chromate layer) on steel washer | | |
| Highly deformed chip from abrasion | | |

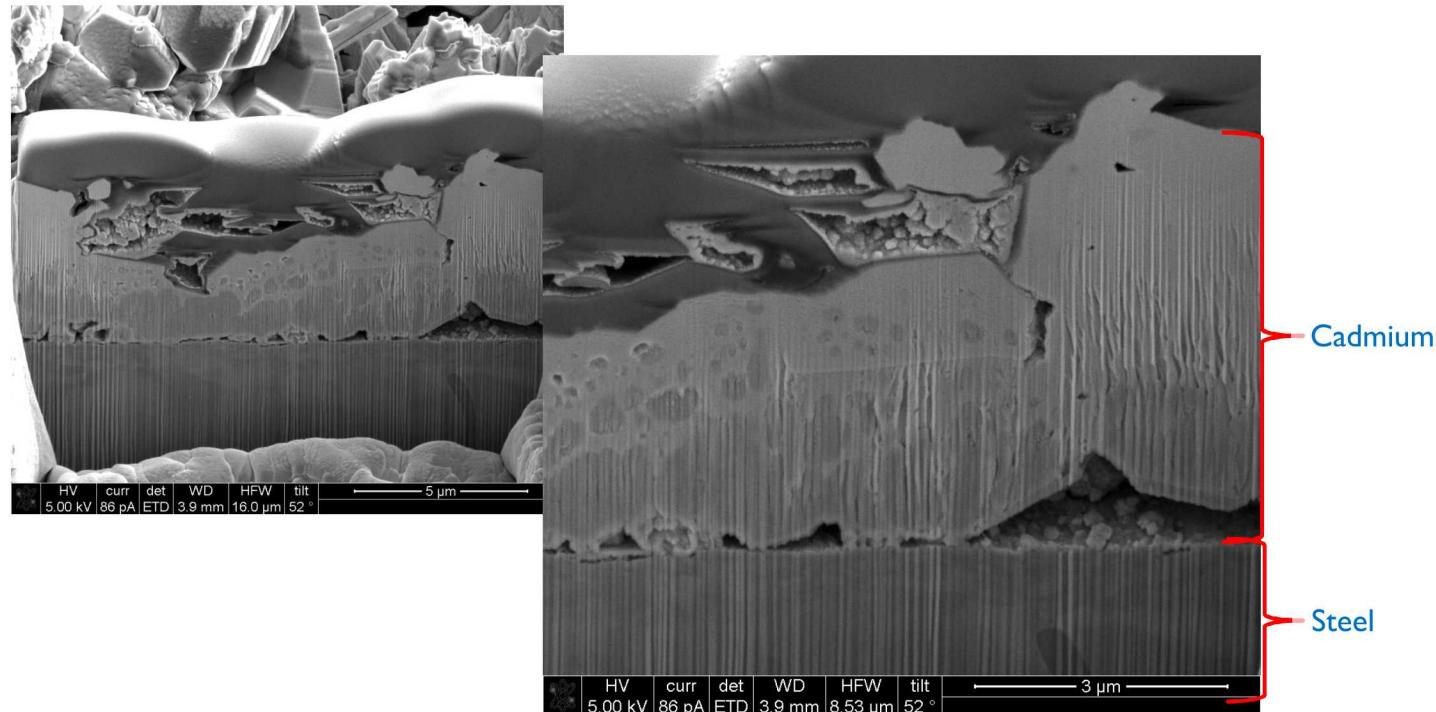
- AISI 4037 steel was plated with Cd at SNL to simulate Cd on a typical fastener steel
 - The Cd plating was quite rough compared to industrially plated Cd and showed intermittent adhesion to the substrate
- Cd plating thickness of $4.5 \pm 1.7 \mu\text{m}$ measured from focused ion beam (FIB) cut

- Substrate: AISI 4037+
- Cadmium Sulfate-based bath chemistry
- Measured Cd thickness: $4.5 \pm 1.7 \mu\text{m}$

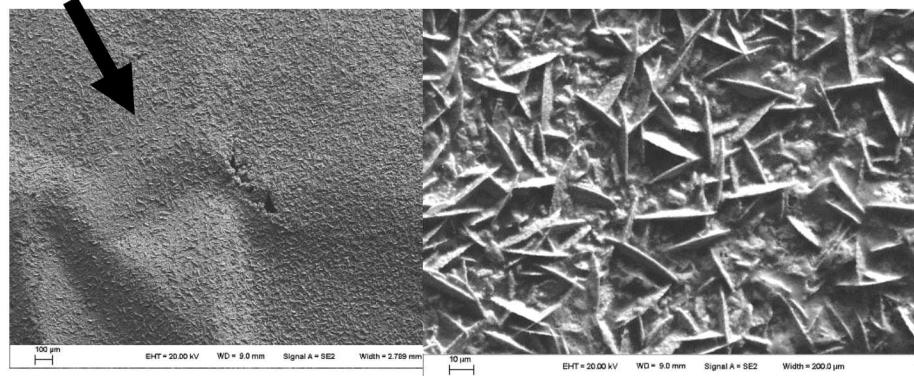
Coupon plated in a CdCN bath (0.03M Saccarin) exhibited delamination and plate-like Cd on surface. The lack of contact between the coating and substrate and surface roughness are expected to be undesirable for Cd whisker growth.

Delamination

- Morphology of CN bath specimens much different from previous sulfate-based platings.
- Poor adhesion still a concern
