Characterization of Cadmium Whisker Growth Environment and Microstructure

Rachel White, Zahra Ghanbari, Donald Susan, Sara Dickens

Sandia National Laboratories; Albuquerque, NM

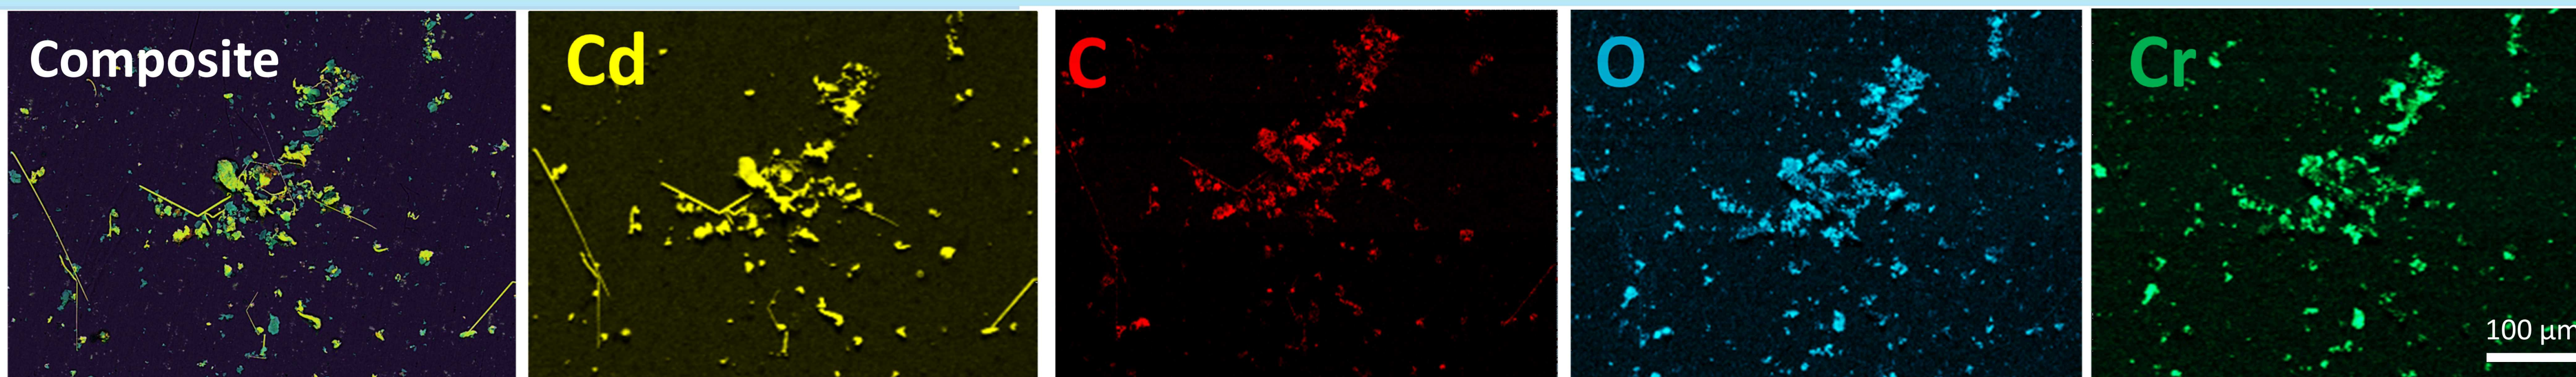
Figure 2: SEM EDS results of removed whiskers and debris, showing the composite and elemental maps for Cd, C, O, and Cr. Cr + O identifies pieces of the chromate layer. Pure Cd shows whiskers or non-whiskers. C may identify dirt or a carbonate.

Figure 2 shows EDS results for the whiskers, non-whiskers and debris rinsed off of the fasteners with alcohol. Pure Cd and chromate (Cr_2O_7) are easily identifiable; other debris may include cadmium oxide, cadmium carbonate, or dirt, though the results are not conclusive. XRD on this material (not shown here) resulted in three unidentifiable peaks at low 2θ angles, suggesting that a mineral may be present other than a simple carbonate or oxide.

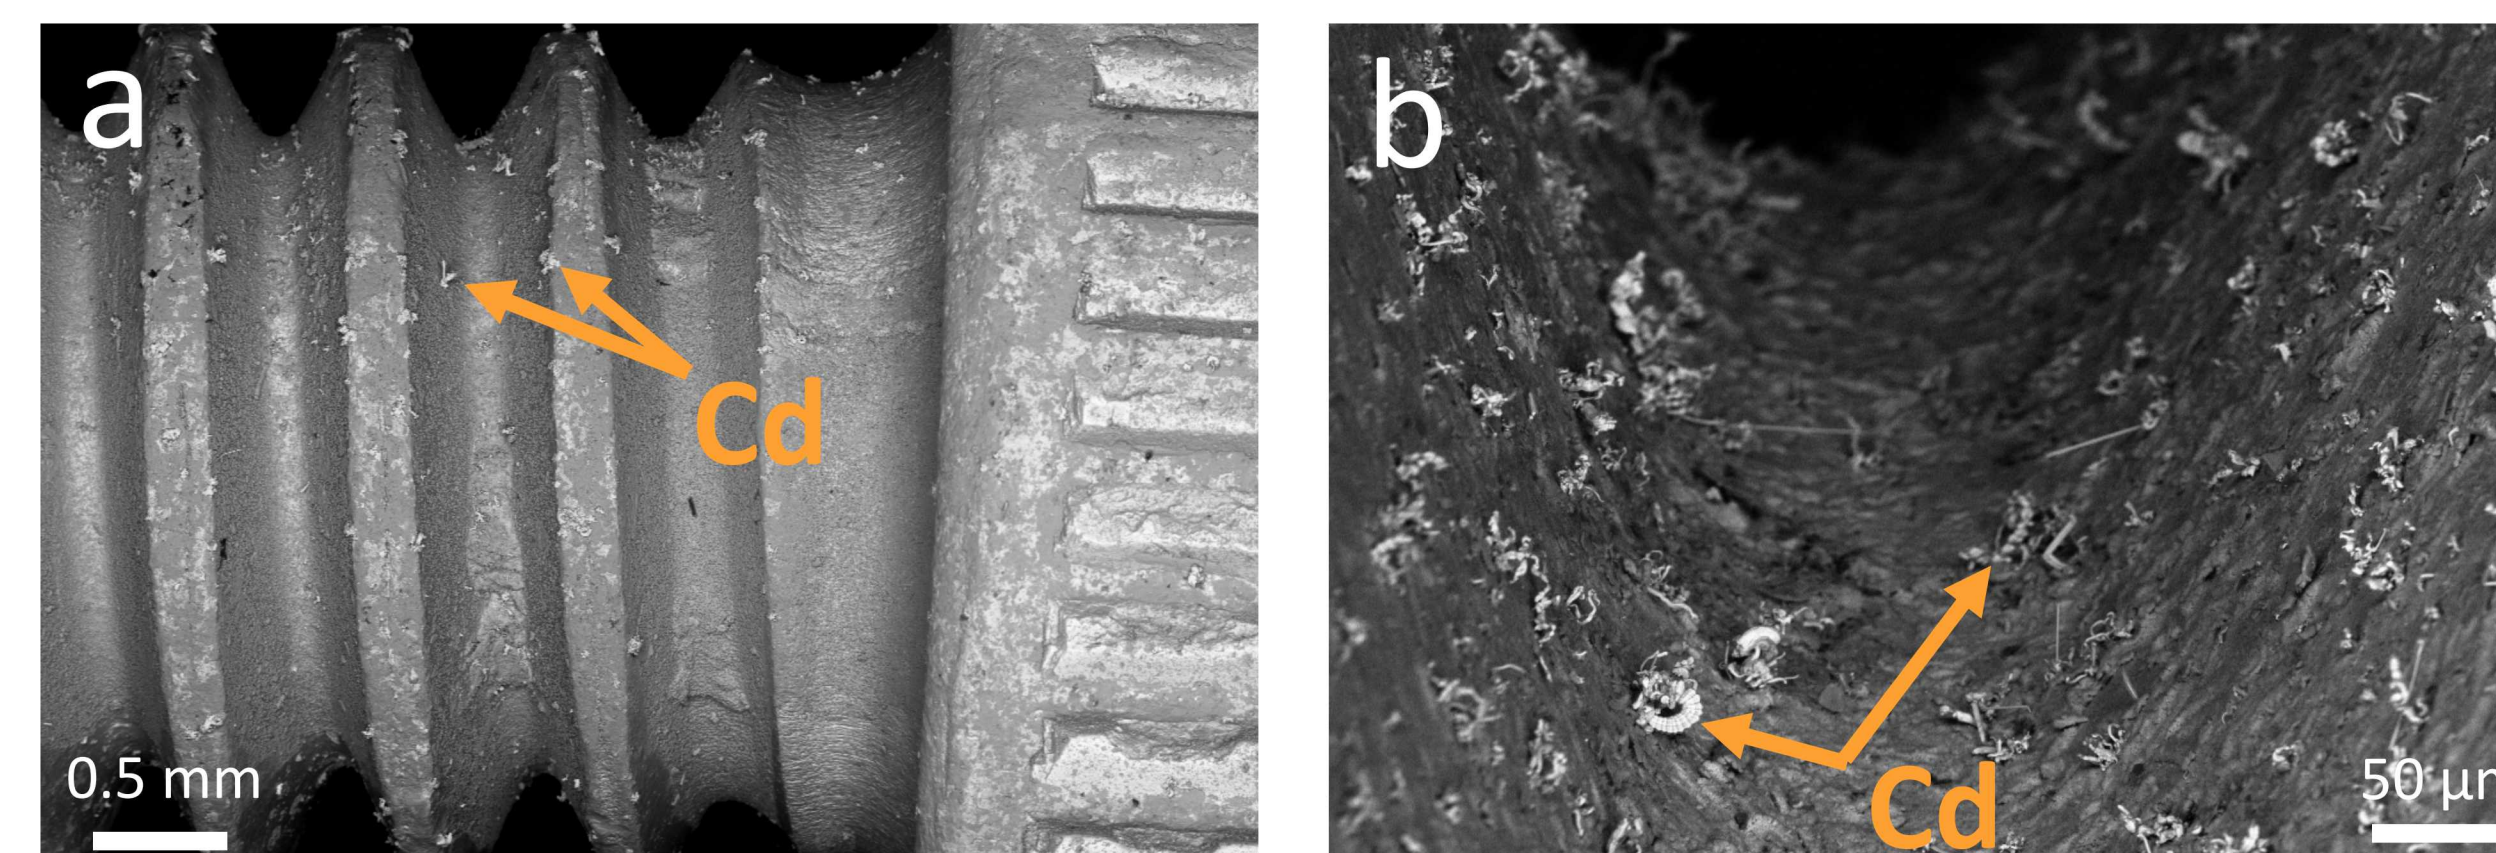
Figure 1: SEM backscatter images showing high Z Cd whiskers and non-whisker growths on (a) a worn fastener, and (b) a higher magnification between the fastener threads. Arrows indicate Cd features.

An optical microscopy survey of field return fasteners and nuts showed that Cd whiskers were found on 74% of the 32 batches surveyed. The batches which showed no whisker growth were new or almost new, showing very little wear and debris. The most dense whisker growth was observed on debris-covered, worn parts. Whiskers were found on fastener threads, inside and below the head. For nuts, whiskers were found only on the threads.

Figure 1 shows SEM characterization of a fastener with dense Cd whiskers and non-whisker features. Non-whisker features include pure Cd protrusions through the chromate top layer that are bulbous, curly, or agglomerates. It is common to see Cd whiskers growing out of agglomerates.

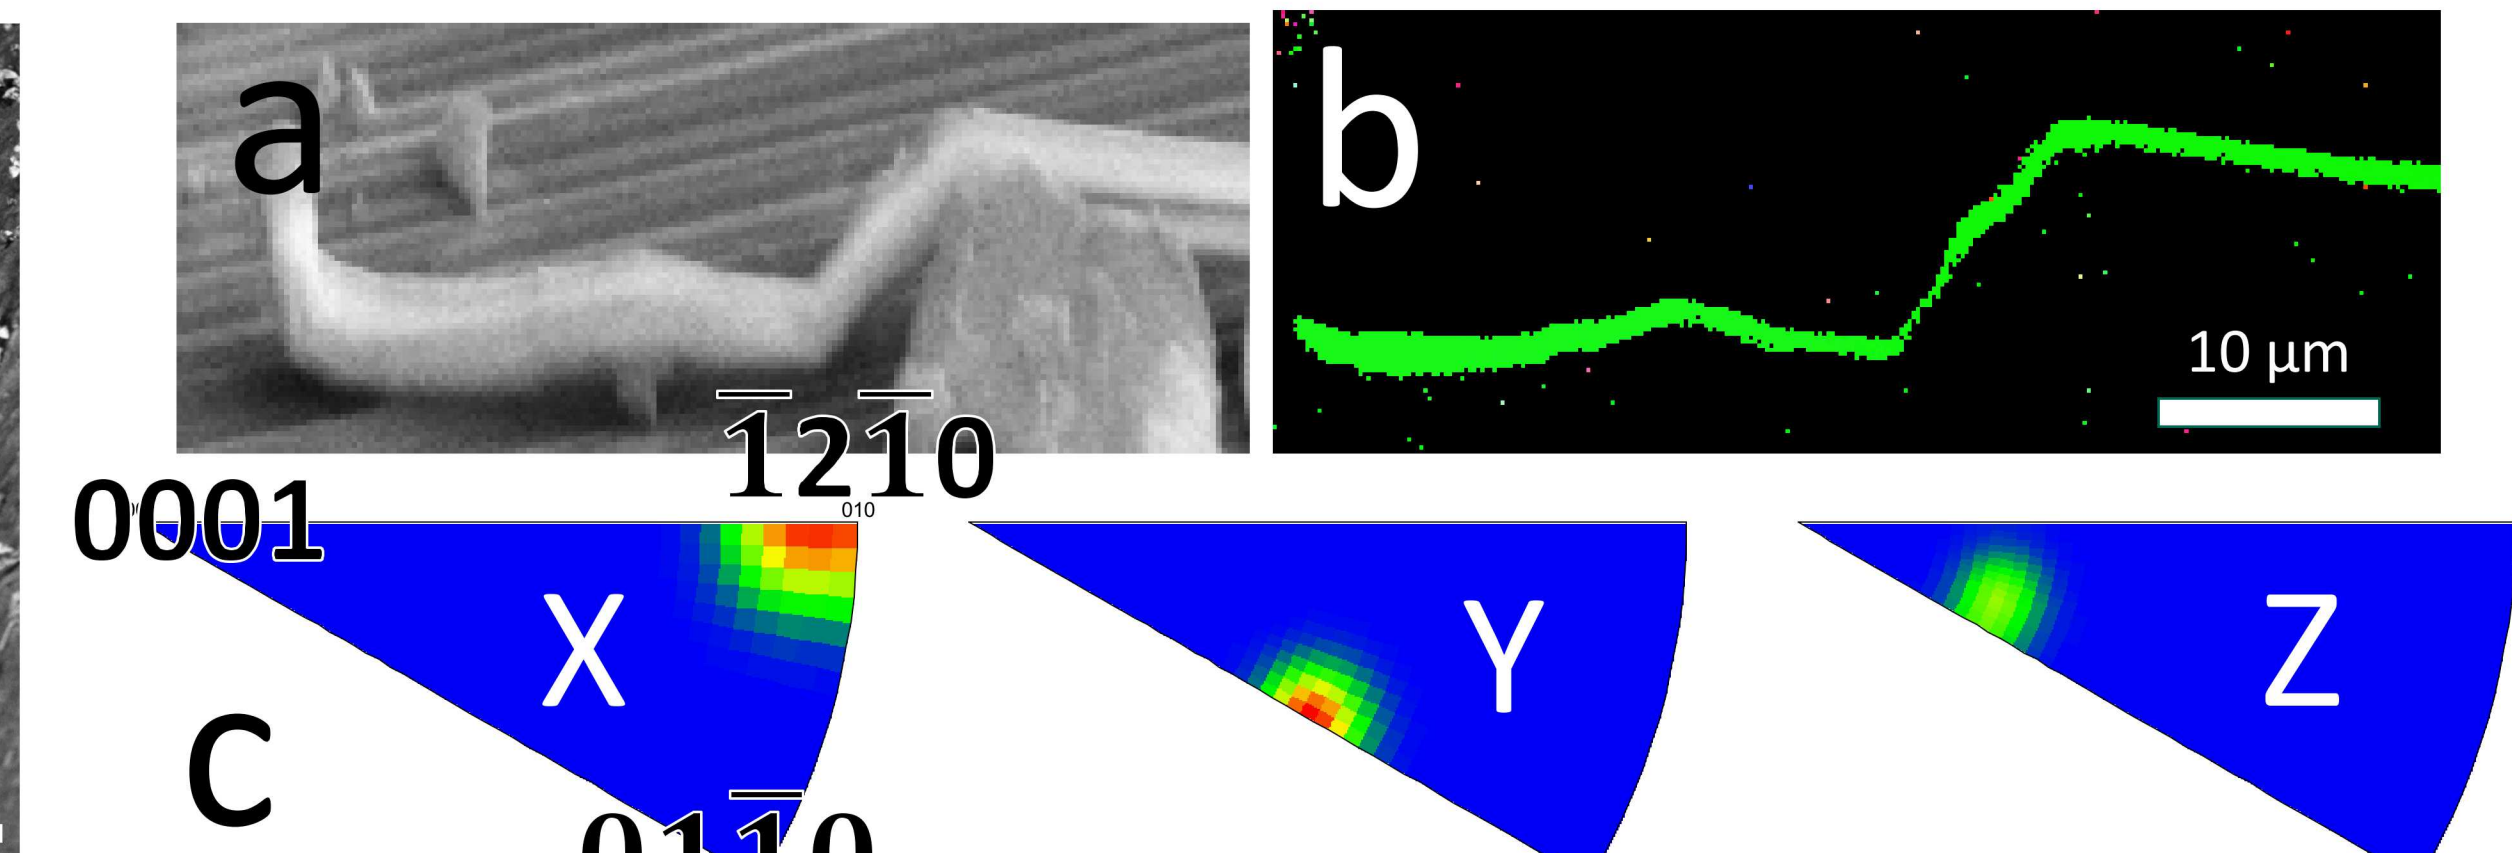
Figure 3: A typical Cd whisker exhibiting two kinks, but no change in crystal direction (a) the SEM image, (b) EBSD IPF-X map, and (c) inverse pole figures. Note that the IPF-X direction is horizontal.

Thirty one whiskers were surveyed via EBSD. Figure 3 shows a typical whisker exhibiting sharp bends, or kinks, where the crystal direction remains the same but the whisker growth direction changes. All but one whisker was single crystal. A dominant $\bar{1}2\bar{1}0$ growth direction was observed in 25/31 whiskers, shown in Figures 3 and 4. In hexagonal materials like Cd, this corresponds to a close packed direction.

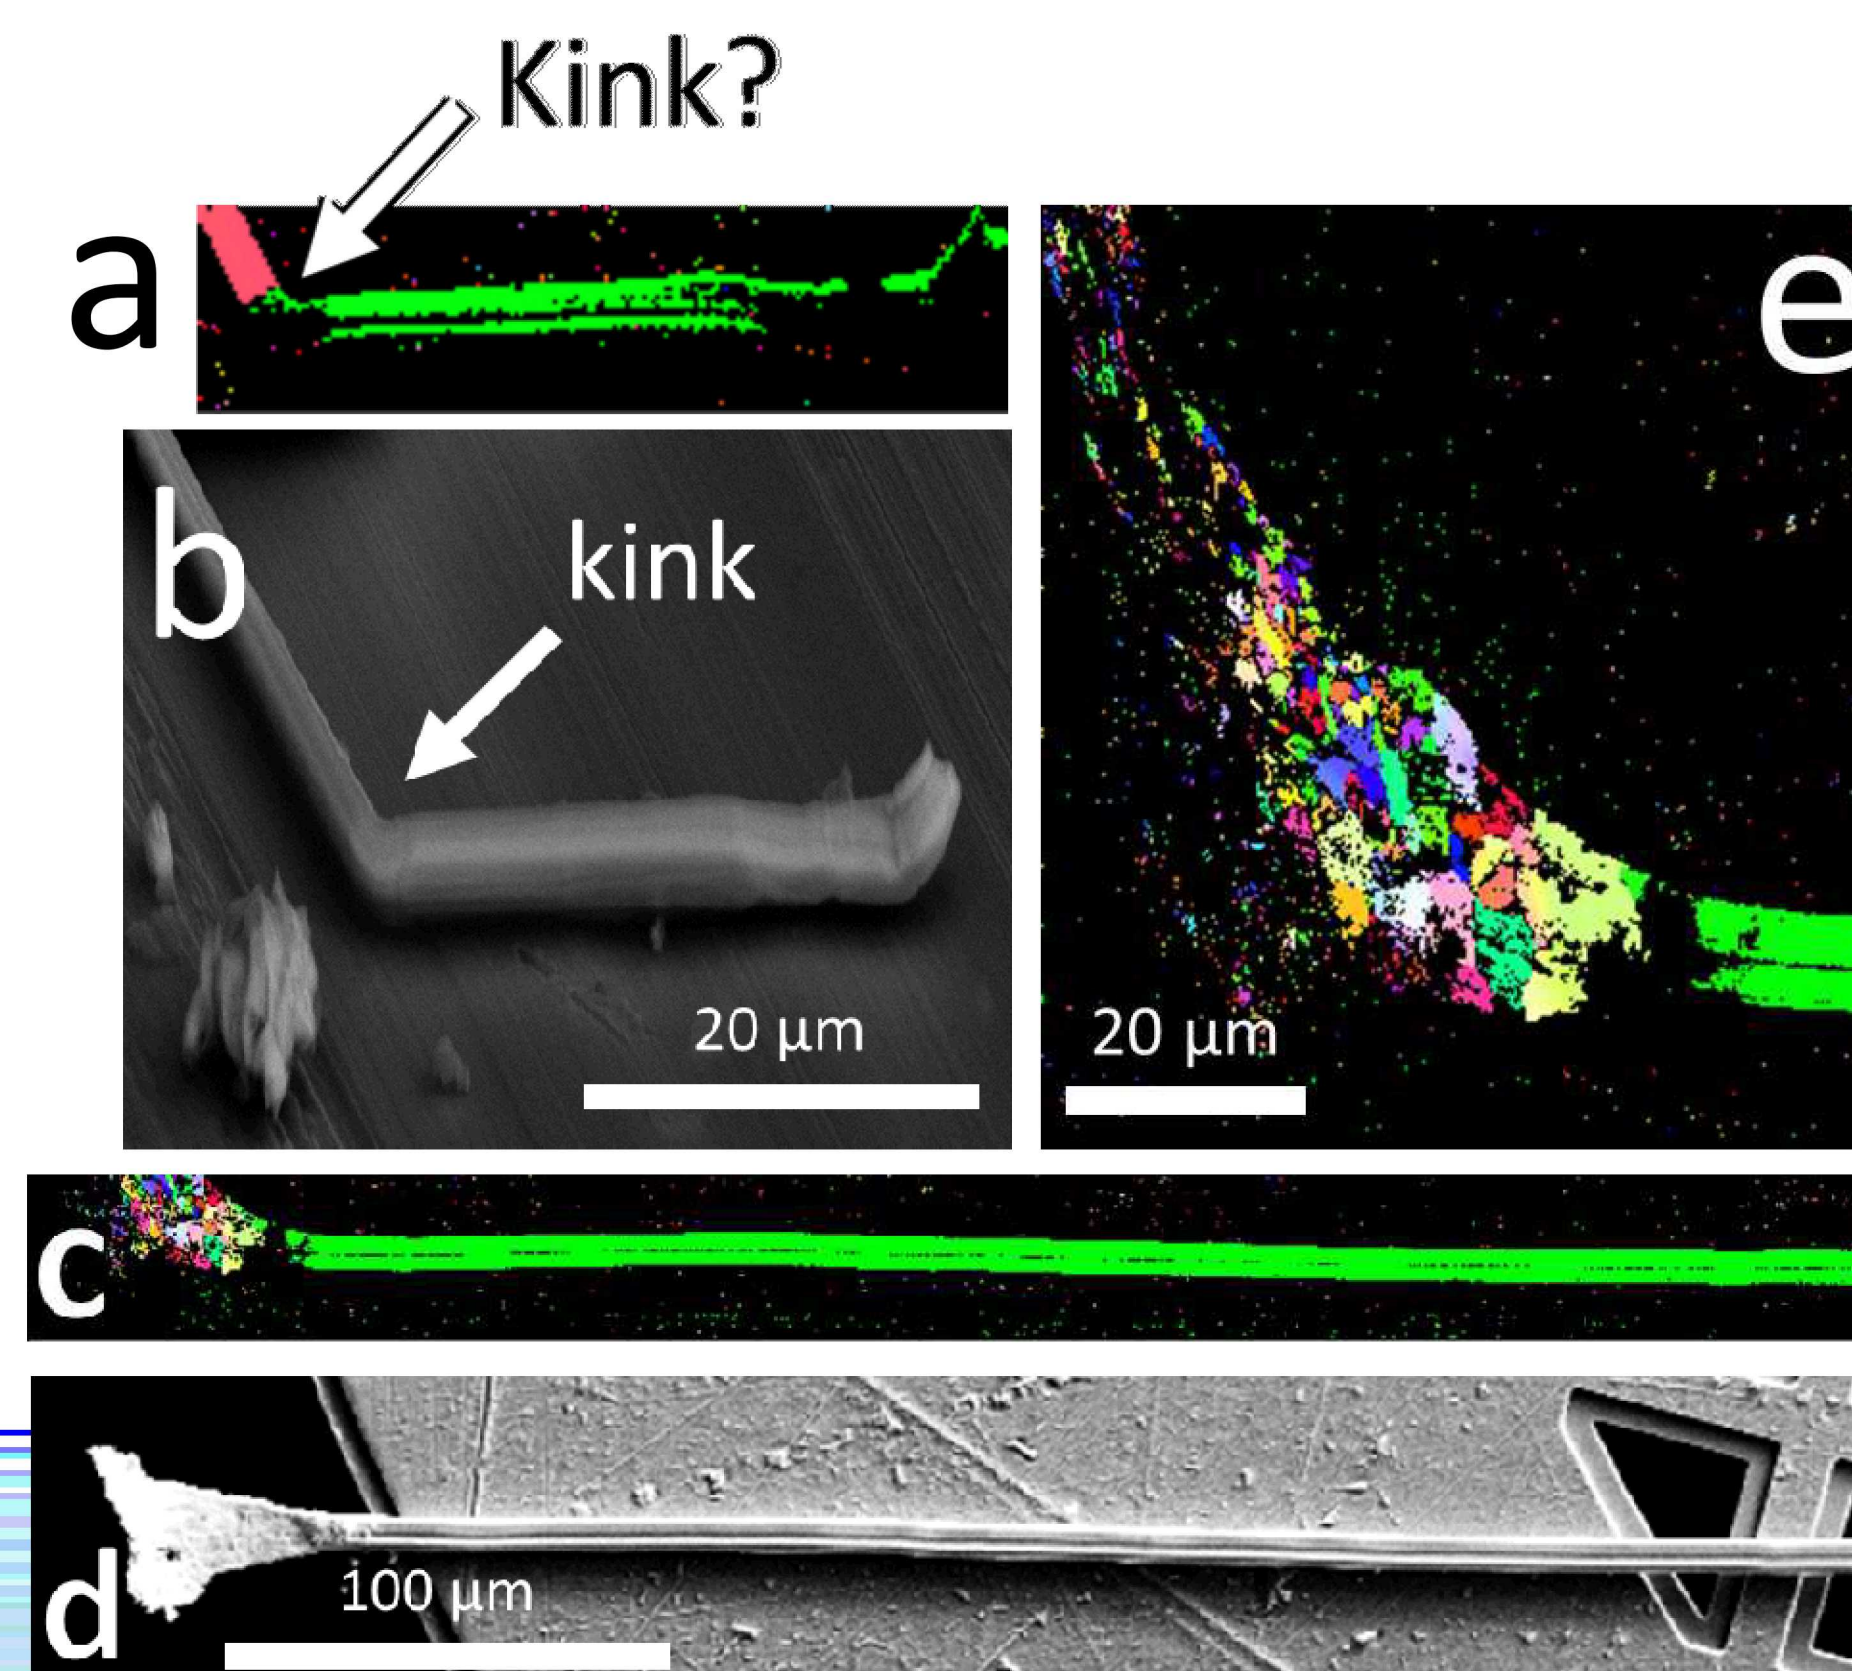
Figure 4: The two-grain whisker (a) EBSD IPF-X map, and (b) the corresponding SEM image. Also (c) map, (d) the corresponding SEM image, and (e) a higher resolution map of the Cd plating attached to the fastener.

Figure 4 presents two abnormal but interesting whiskers. Figure 4(a,b) shows the only whisker that was not single crystal. The two grains are joined at a 62° grain boundary. This two-grain structure has not been observed in previous studies of metal whiskers. The growth direction of both grains is $\bar{1}2\bar{1}0$.

Figure 4(c,d,e) shows a 600 μm long whisker which still has a piece of the cadmium plating attached; this whisker was removed from the fastener via tweezers. Notably, the whisker diameter is much larger than the plating grain size.
