# ***Surrogate Assembly 30 cm Drop Test***

## **Spent Fuel and Waste Disposition**

**September 28, 2020**

**M2SF-20SN010202022**

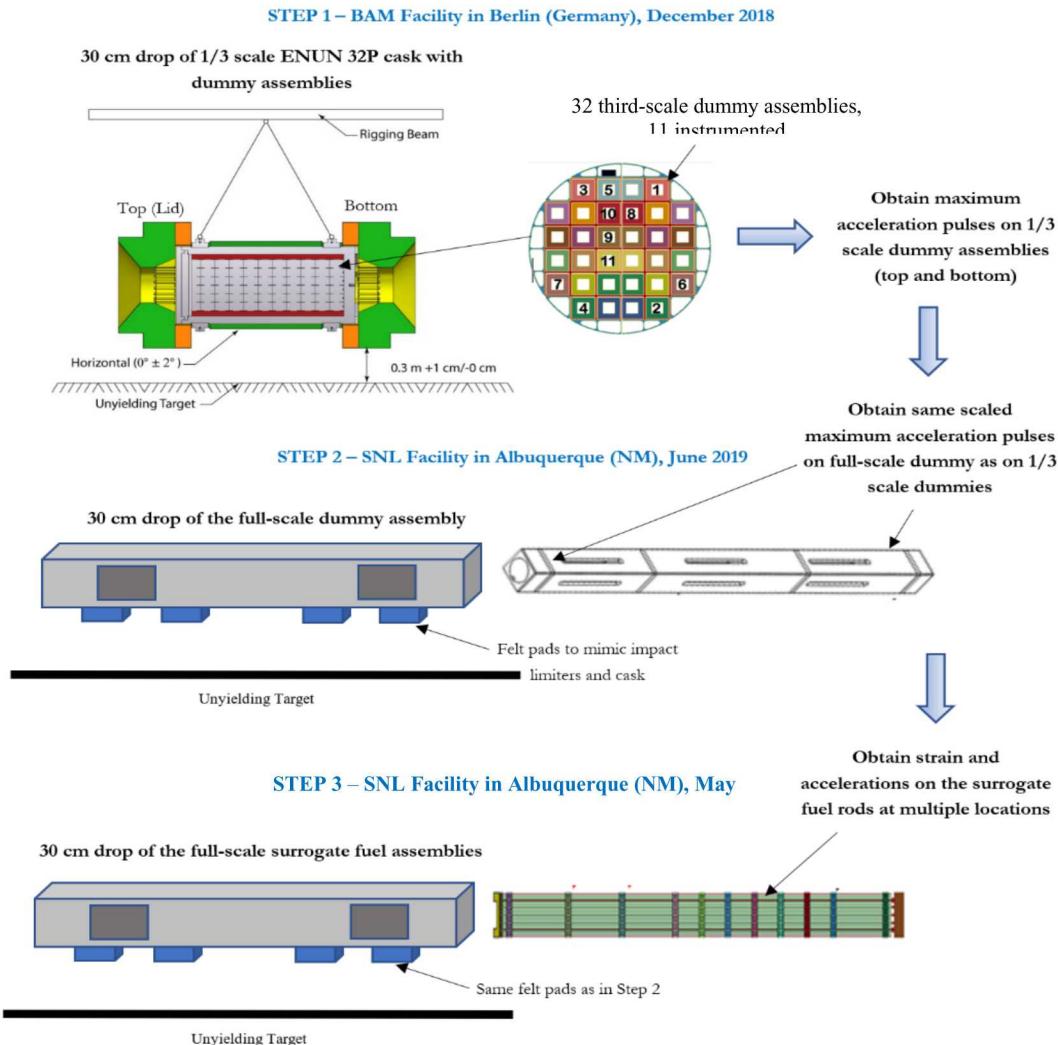
**Step 2** was a 30 cm drop of the full-scale dummy assembly. The goal of this test was to find the condition under which the observed acceleration pulse would be in good agreement with the expected acceleration pulse derived from Step 1. Achieving this condition means that the effect of the cask and the impact limiters are adequately represented. This step was required because the accelerations on the 1/3 scale dummy assembly were only applicable to the full-scale dummy assembly which was structurally very different from the full-scale surrogate assembly. This involved a series of 30 cm drop tests using different shock absorbing conditions in order to select the shock absorbing material that best mimics the cask and impact limiters. These tests took place in June 2019 at the SNL drop tower facility in Albuquerque (NM).

**Step 3** was a 30 cm drop of the surrogate assembly. The goal of this test was to obtain the accelerations and strains at multiple locations on the full-scale surrogate fuel assembly. The test took place on May 7, 2020 at the SNL drop tower facility in Albuquerque (NM). The test was conducted using the shock conditions derived in Step 2.

**Figure 1-1. Three Steps to Obtain Accelerations and Strains on the Full-Scale Surrogate Assembly.**

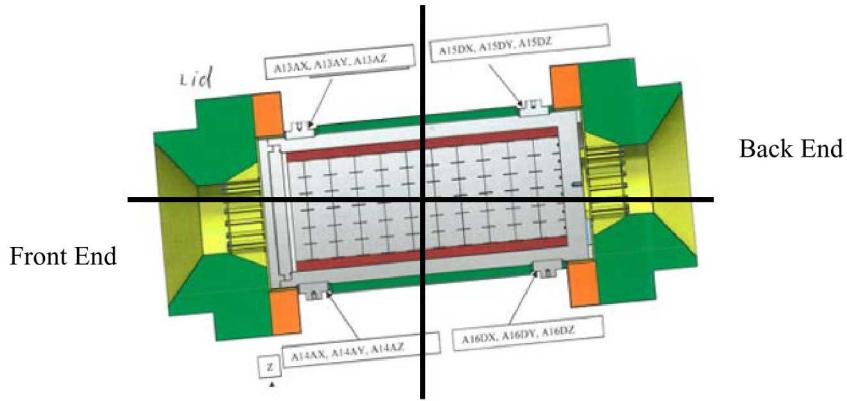
The maximum accelerations on the dummy assemblies varied significantly depending on the location within the cask (Figure 1-3) with the maximum observed accelerations being ~2.4 times higher than the minimum. The locations closer to the top (location 10 on side A and location 5 on side D) were the ones with the highest accelerations. The accelerations in these locations during the first impact are shown in Figure 1-4. These accelerations were converted (scaled) to the accelerations expected in the 30 cm drop of the full-scale dummy assembly (Figure 1-4).

Note: the angle between the lateral cask orientation and horizontal surface shown in diagram is not to scale.

**Figure 1-3. Maximum Accelerations on Assembly Front End (Side A) and Back End (Side D).**

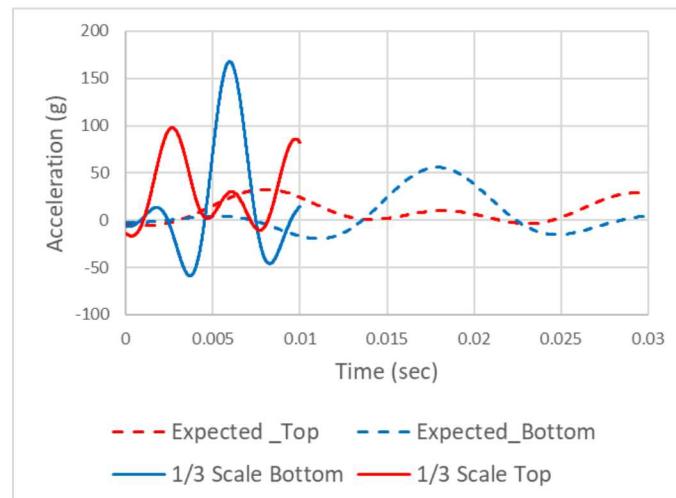
**Figure 1-4. Observed 1/3 Scaled and Projected Full-Scale Dummy Assembly Accelerations in 30 cm Drop.**

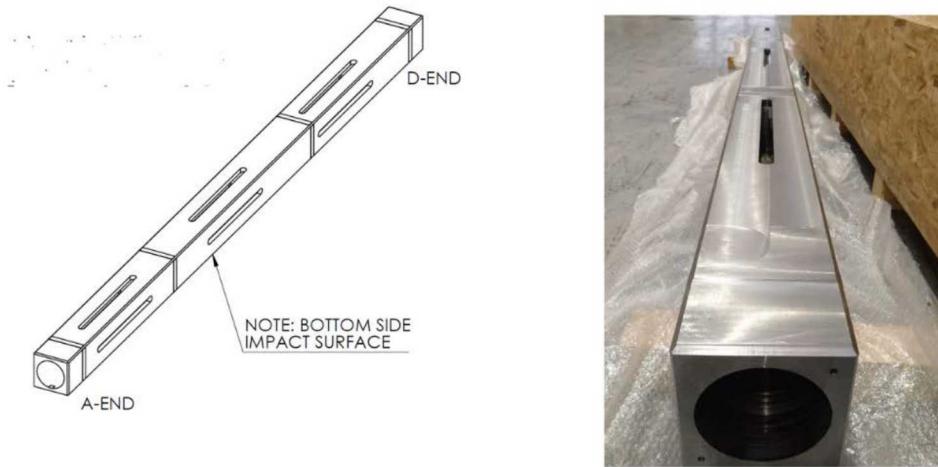
The full-scale dummy assembly is the enlarged by 3 times equivalent of the 1/3 scale dummy assembly (Figure 1-5). It was manufactured by ENSA using the same materials, scaled dimensions, and manufacturing processes as the 1/3 scale dummy assemblies.

**Figure 1-5. Drawing (left) and Photo (right) of the Full-Scale Dummy Assembly.**

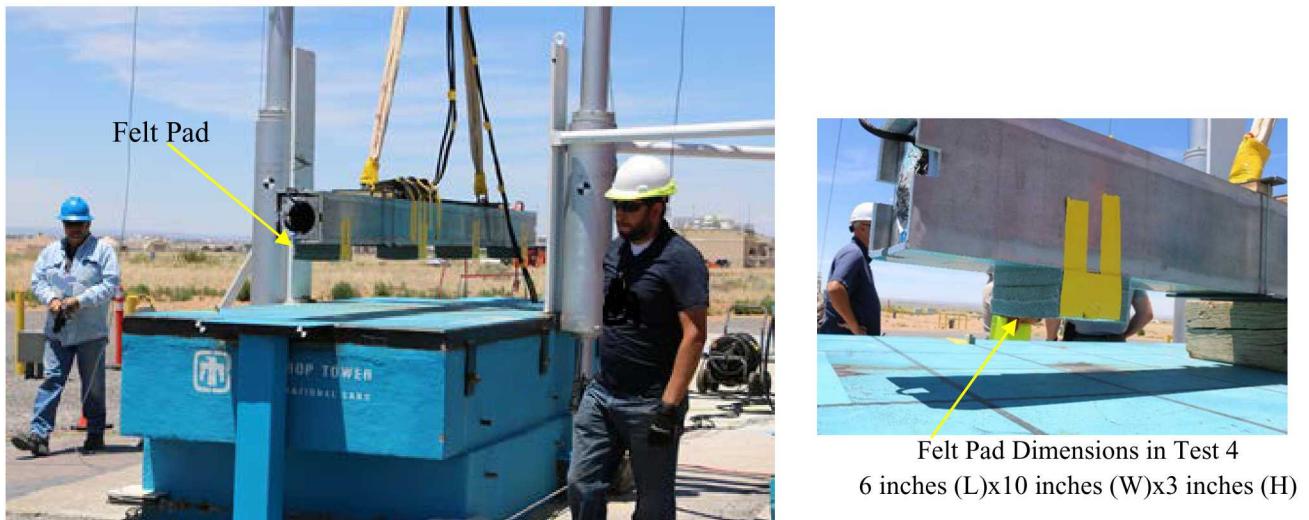
Figure 1-6. Felt Pad Locations (left) and Configuration in Test 4 (right).

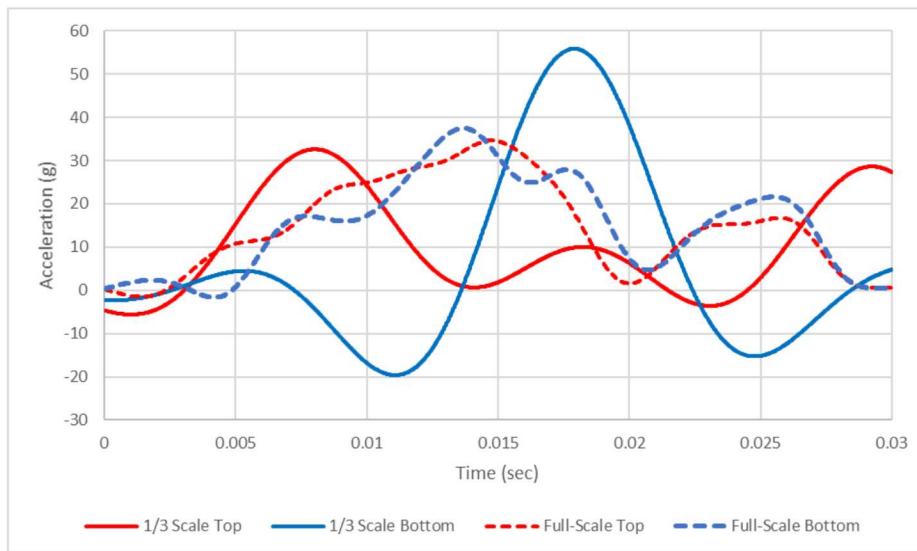
Figure 1-7. Scaled Acceleration Pulses on 1/3 Scale Dummy Assembly Compared to Test 4 Acceleration Pulses.

The expected acceleration pulses and the acceleration pulses observed on the full-scale dummy assembly are discussed in Section 1 and are shown in Figure 1-7. The expected peak acceleration on the top nozzle end was 33 g (this end hit the target first) and on the bottom nozzle end was 56 g. The observed peak acceleration on the dummy assembly was 37.5 g (both ends hit the target practically at the same time).

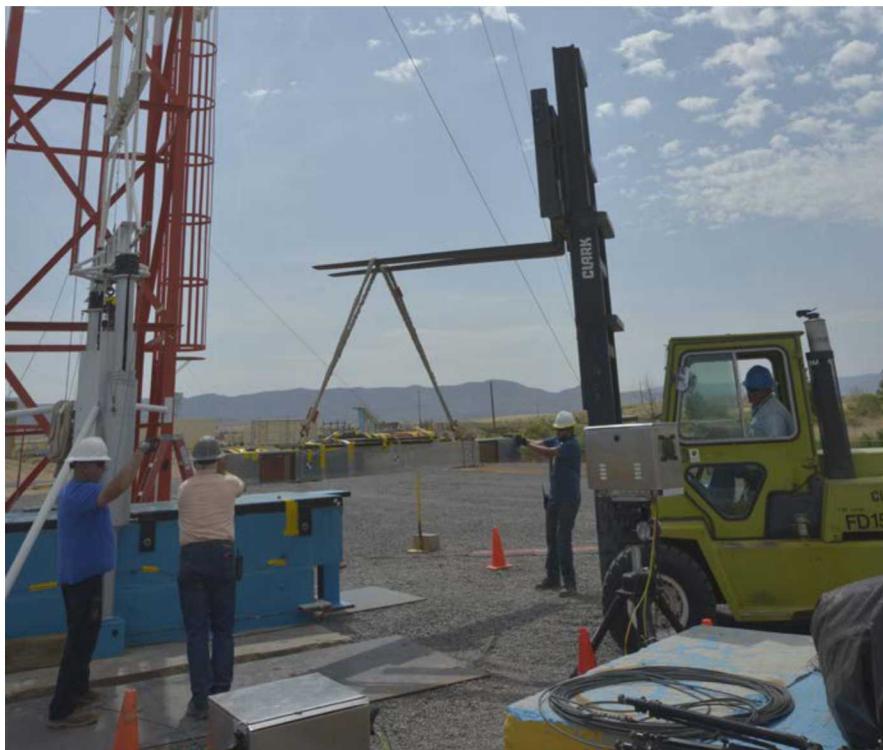
**Figure 2-1. Forklift with the Surrogate Assembly Shortly Before the Accidental Drop.**

An old surrogate assembly, the one that was used in MMTT, was instrumented, inserted in the basket tube and ready for the 30 cm drop test on June 12, 2019. The test hardware was the same as described in Section 3.1. The handling and test set up were the same as described in Sections 3.1.3 and 3.1.7. The instrumentation was the same as described in Section 3.1.8. The surrogate assembly was transported from the SNL test facility to the drop tower in the morning of June 13, 2019. A forklift was used to unload the surrogate assembly from the transportation vehicle. When the forklift approached the target as shown in Figure 2-1, the left sling slid off the fork tine. The left end of the unit fell onto the target with no felt on it. Figure 2-2 shows how the approximate drop height was estimated from the photo taken just before the accident. It was estimated that the accidental drop height was 6.9-7.8 inches (17.5-19.8 cm).

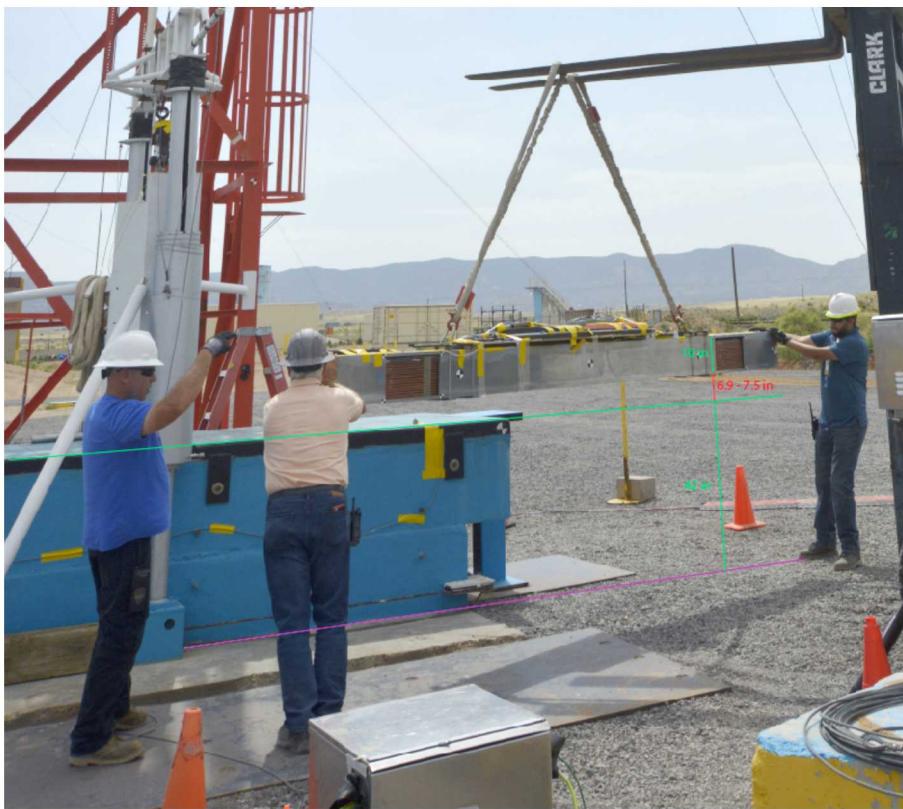
**Figure 2-2. Pre-Accident Photo Used in Estimating Accidental Drop Height.**

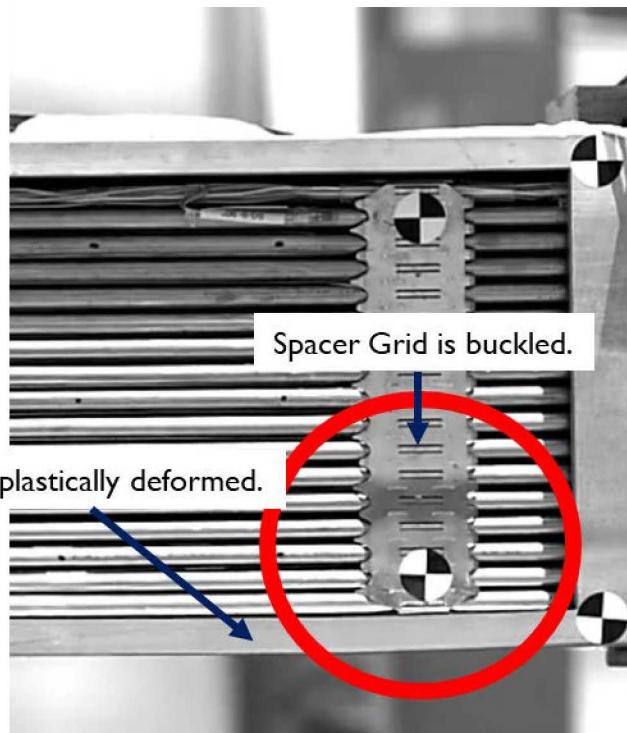
Buckling of the surrogate assembly spacer grids after the accidental drop was observed in the two windows cut in the basket tube. Only two spacer grids were visible to check. The bottom of the basket tube experienced slight plastic deformation. This is illustrated in Figure 2-3. Rod-to-rod contact was also observed on the visible parts of the pressure paper sheets.

**Figure 2-3. Damage Observed After the Accidental Drop Shortly before the 2019 Test.**

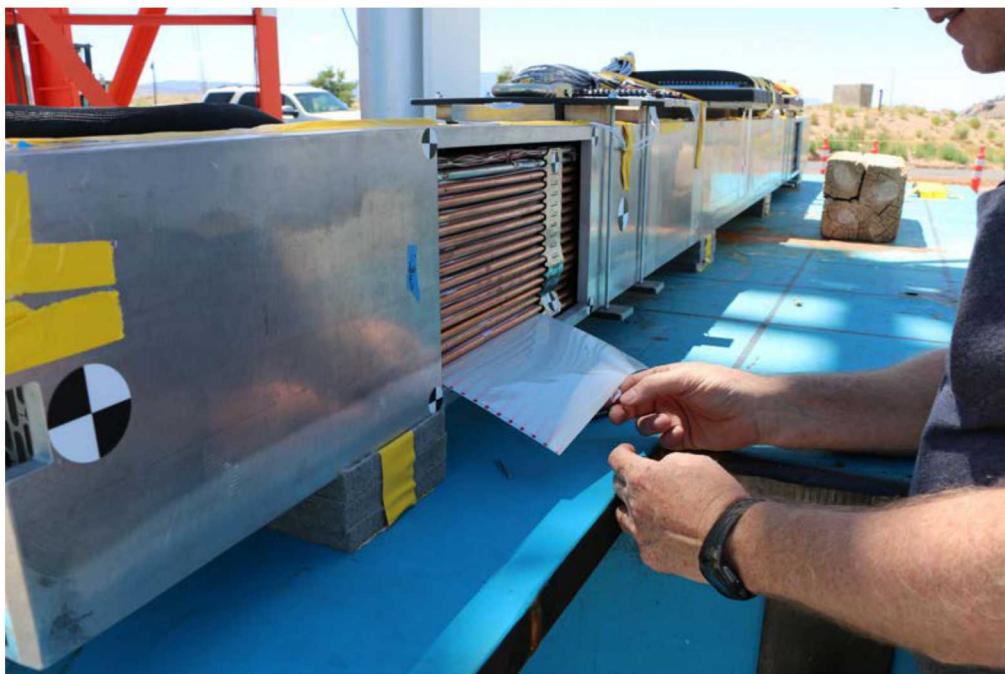
Figure 2-4. Additional Pressure Paper Installed before the 2019 Test.

Three additional pressure paper sheets were placed between the bottom rods through the window in the basket before the test (Figure 2-4).

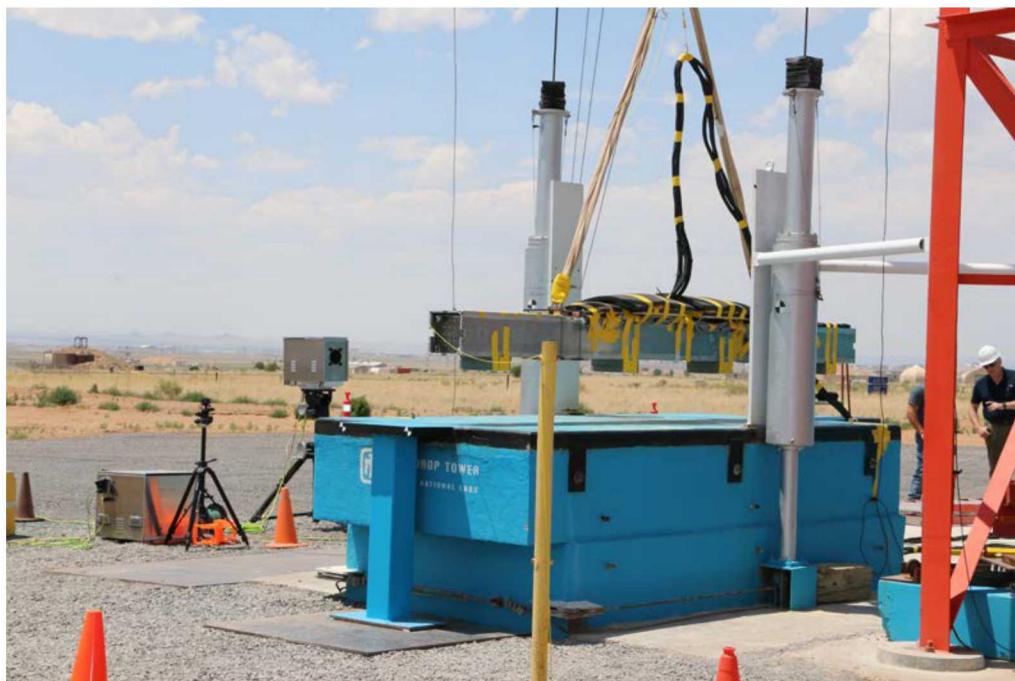
Figure 2-5. 30 cm Drop Test Setup, June 13, 2019.

The test took place on June 13, 2019. Figure 2-5 shows the test setup. Figure 2-6 shows the positions of the high-speed cameras looking at the two windows in the basket tube. The high-speed camera videos showed the upward and downward bending of the rods after the impact. Figure 2-7 shows a snapshot of the window view shortly after the impact and illustrates the rod-to-rod contact.

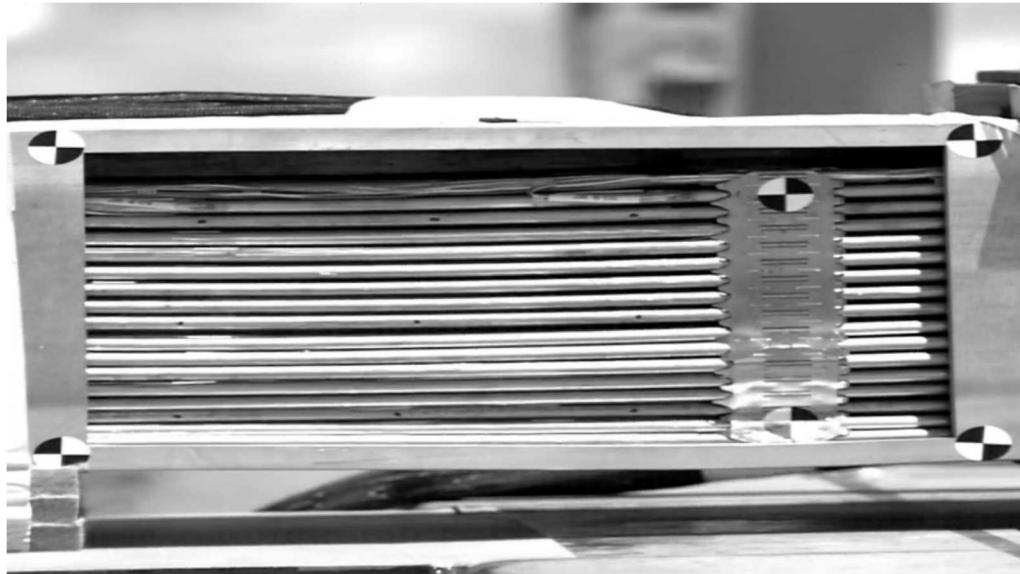
**Figure 2-7. Snapshot from the High-Speed Camera Looking at the Basket Tube Window Shortly after the Impact (2019 Test).**

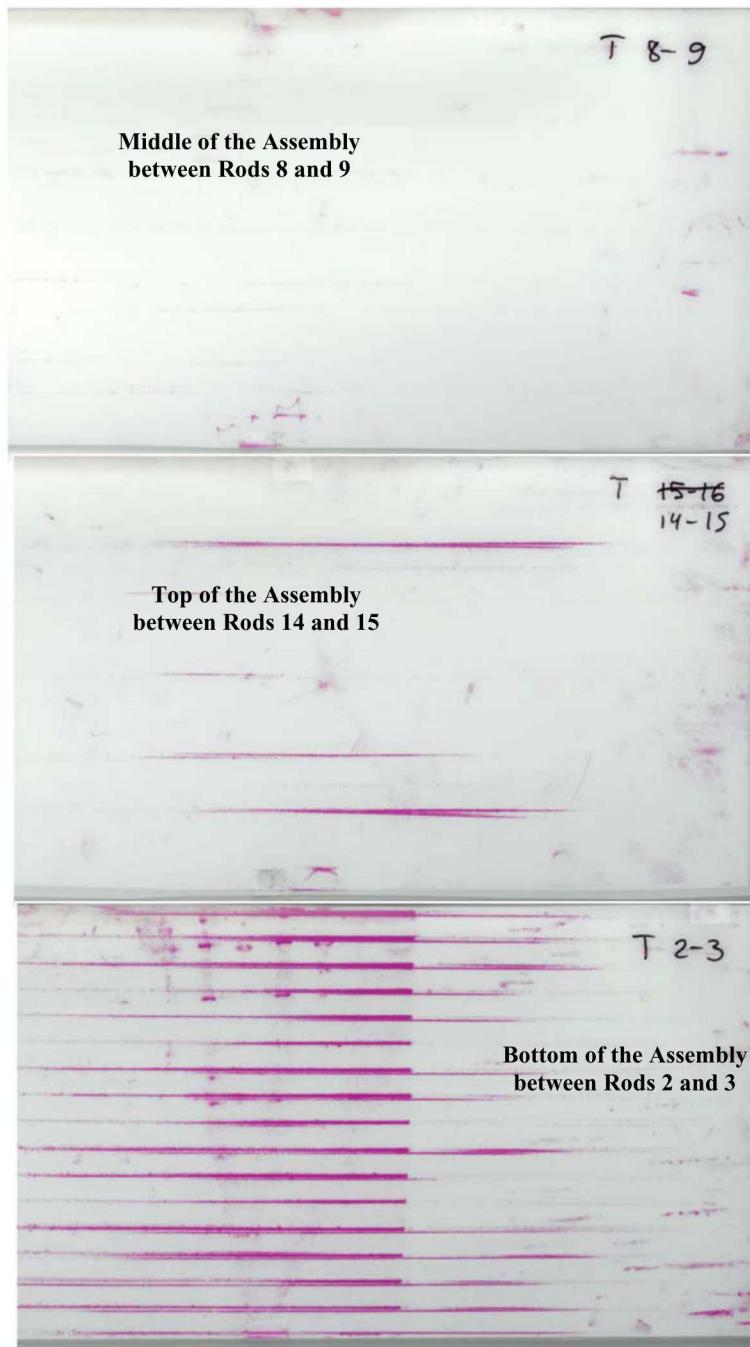
**Figure 2-8. Pressure Paper Sheets from the Long Span Next to the Assembly Top (2019 Test).**

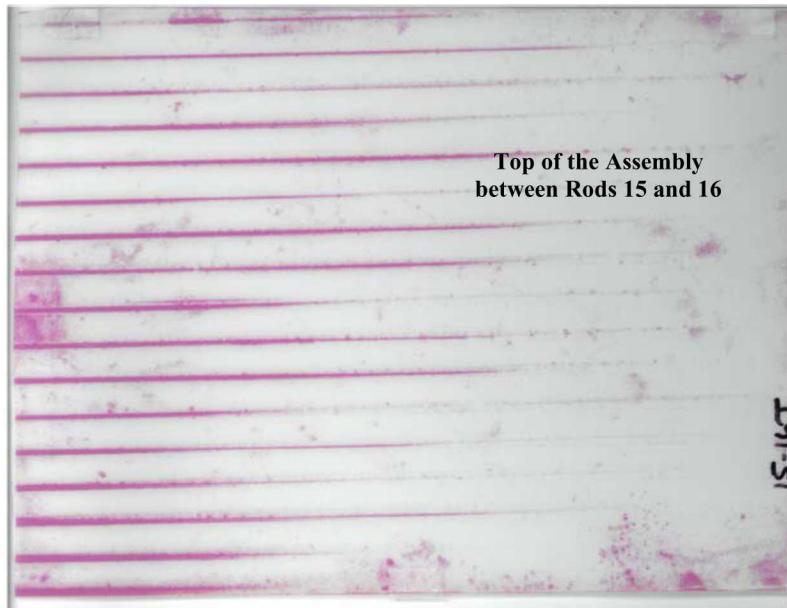
the test showed rod-to rod contact. The pressure paper sheet from the long span next to the assembly top inserted between the 15<sup>th</sup> and 16<sup>th</sup> rods (rods were counted from the assembly top) is shown in Figure 2-9.

**Figure 2-9. Additional Pressure Paper Sheet from the Long Span Next to the Assembly Top (2019 Test).**

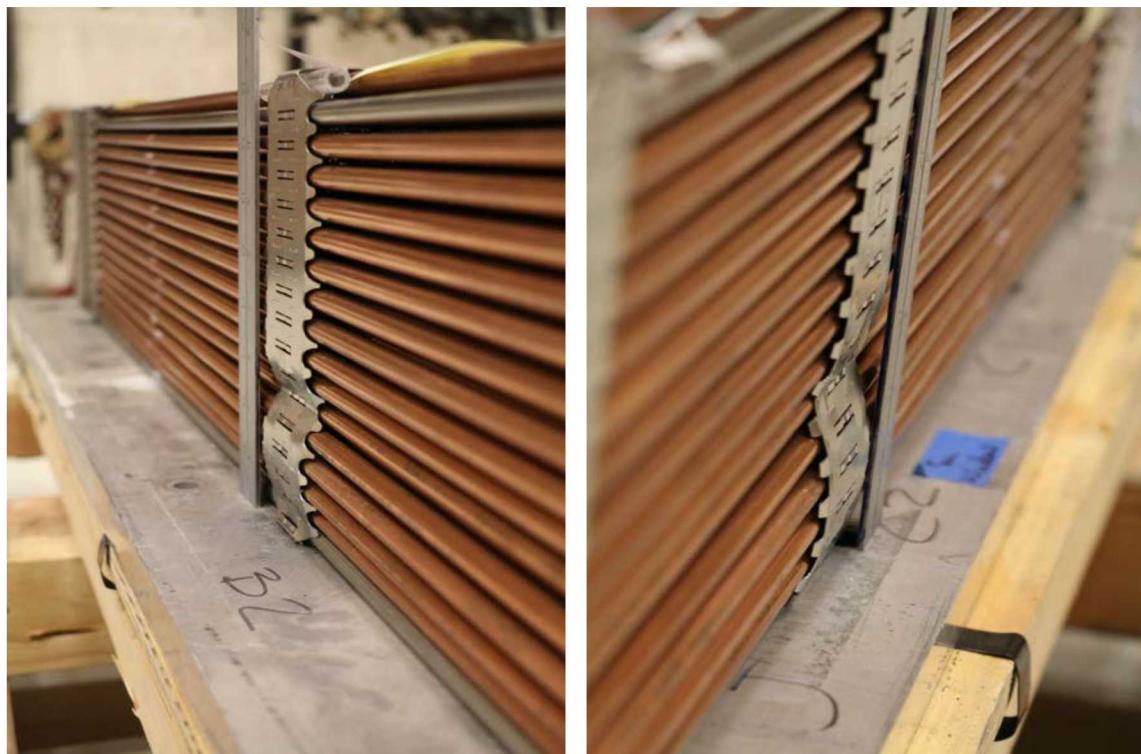
The assembly examination showed that the spacer grids with long spans on either side were significantly buckled (Figure 2-10). The spacer grids with short spans were barely damaged (Figure 2-11).

**Figure 2-10. Long Span Spacer Grid After 2019 Test.**

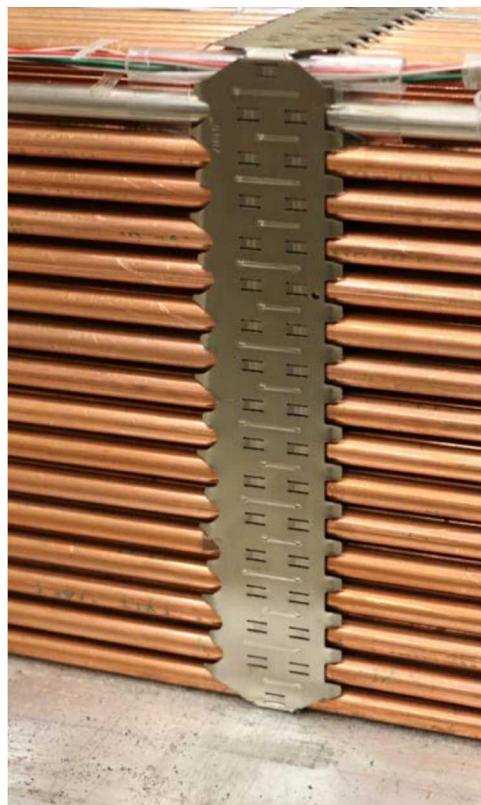
**Figure 2-11. Short Span Spacer Grid After 2019 Test.**

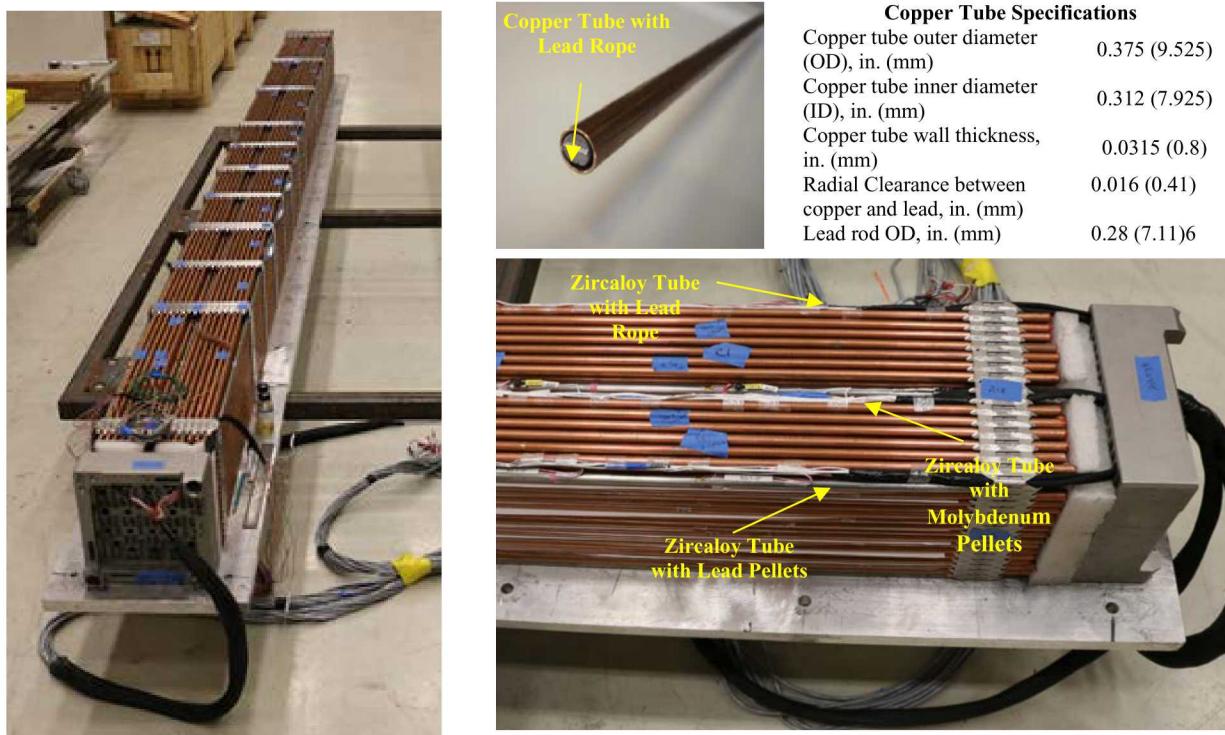
The weight of the surrogate assembly was 785 kg. A few photos of the new full-scale surrogate assembly with different level of details are shown in Figure 3-1. The locations of zircaloy tubes are identified on the bottom right photo and the copper tube and its specifications are shown in the top right photo. A full-scale surrogate assembly drawing is shown in Figure 3-2.

Figure 3-1. New Full-Scale Surrogate Assembly Photo.

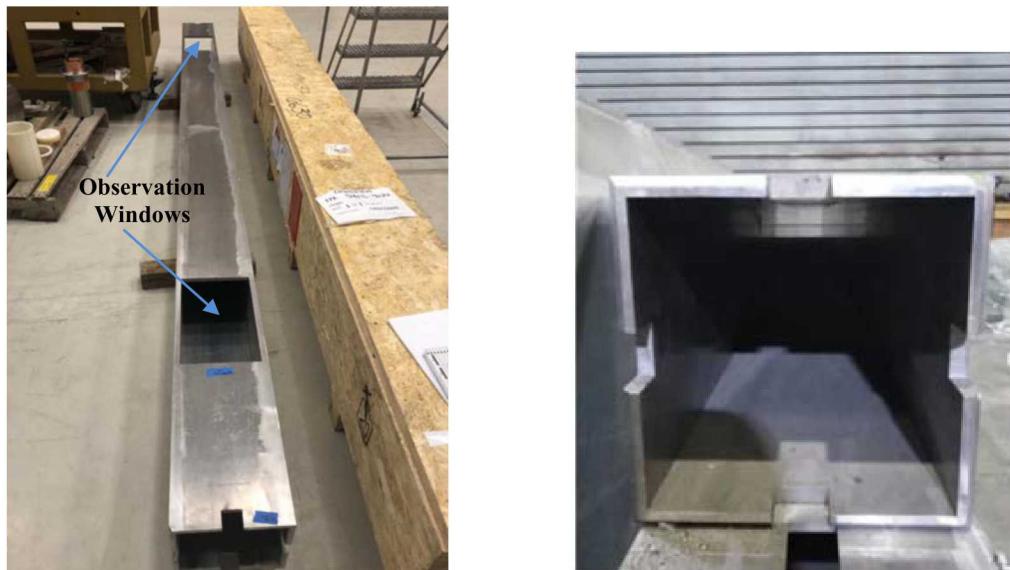
Photos of the basket tube are shown in Figure 3-3 and a drawing with associated dimensions is shown in Figure 3-4.

Figure 3-3. 17x17 PWR Assembly Basket Tube Photos.

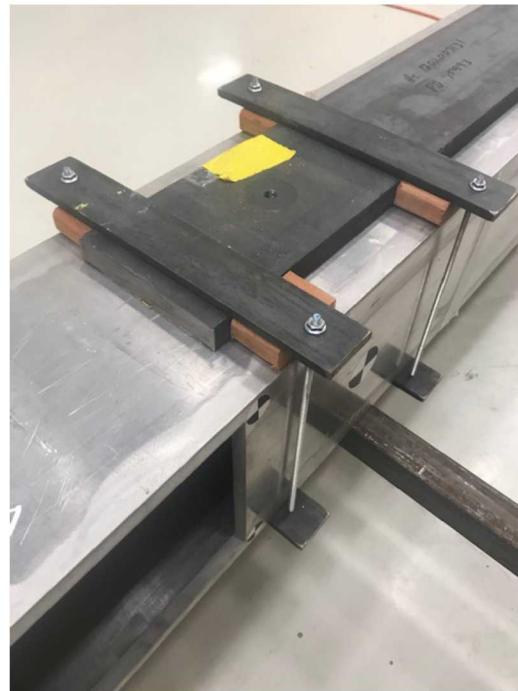
**Figure 3-5. Drawing (top) and Photo (bottom) of the Handling Hardware Components.**

A single steel plate (lift plate in Figure 3-5) was mounted to the top of the basket tube using a custom bracket assembly. The bracket assembly consists of support plates, wood spacers, and steel thread supports. Two support plates were placed atop the lift plate and two were placed beneath basket tube. Wood spacers were placed on either side of the lift plate between the support plates and basket tube. This decreases bending in the support plates while the surrogate assembly is being lifted. The steel thread supports were used to keep the support plates in contact with the lift plate and basket tube. Finally, the hoist rings were threaded into the threaded hole insert of the lift plate. All lifting hardware was manufactured at SNL. Figure 3-6 shows the surrogate assembly lifting hardware. Analysis of the capacity of the lifting hardware is documented in [15].

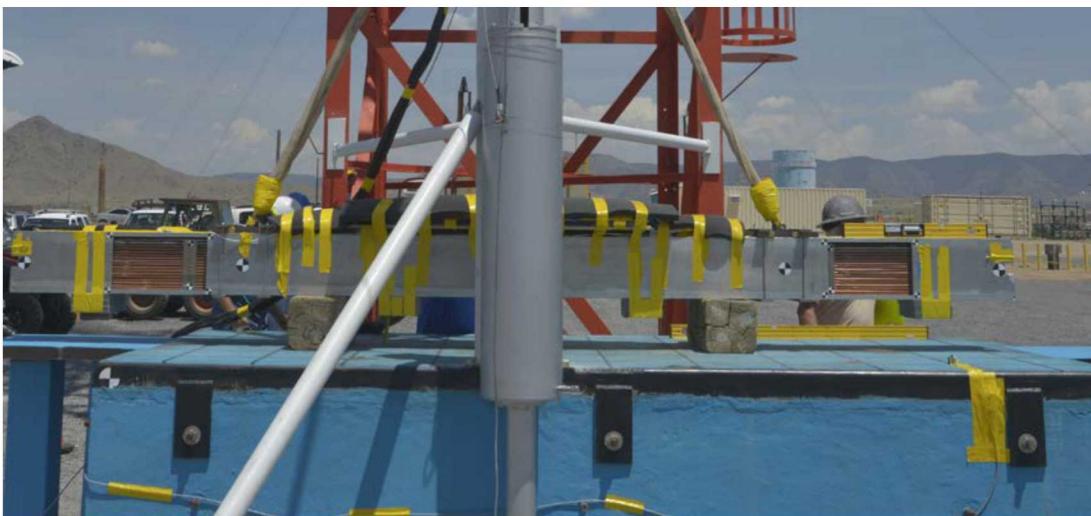
Four felt pads 6 inches (L)x10 inches (W)x3 inches(H) were used in the 30 cm drop test with the damaged surrogate assembly in June 2019. Figure 3-7 shows the configuration and locations of these felt pads. These are the same locations and the same configuration as in the Test 4 with the full-scale dummy assembly (Figure 1-6). Note that felt “programming material” has been used extensively in past drop tests and is known to be a good material for programming a desired shock pulse.

**Figure 3-7. Configuration of Felt Pads in 30 cm Drop Test with Damaged Surrogate Assembly (June 2019)**

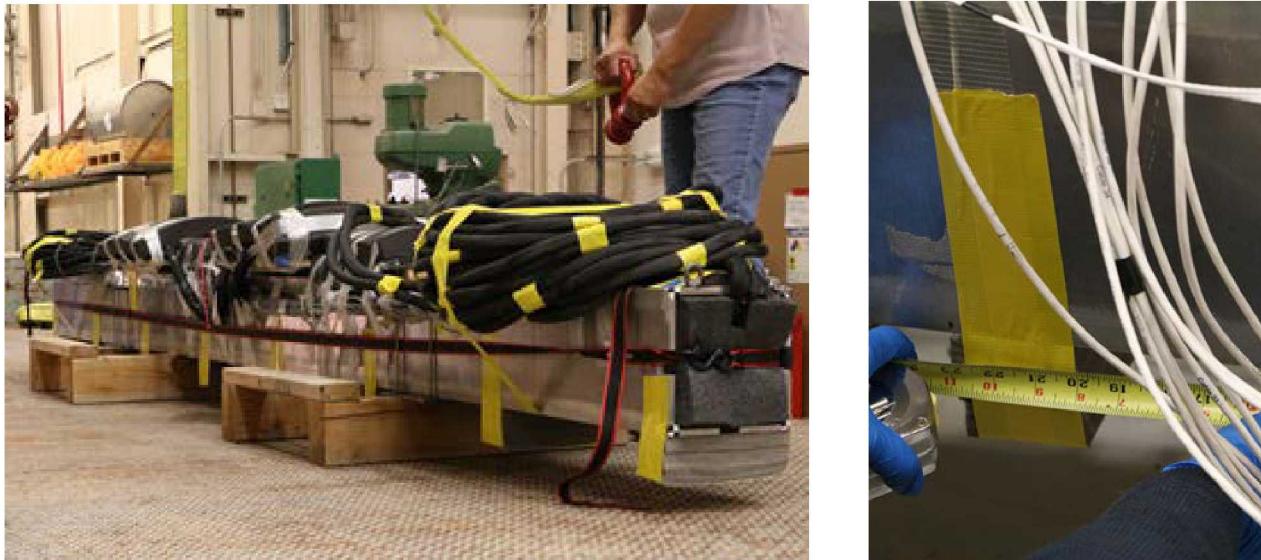
Because the basket tube experienced slight deformation at the bottom in the 30 cm drop test with the damaged assembly (2019 test), the decision was made to install felt pads in 8 locations to reduce the loads on the basket tube in the 30 cm drop with the new assembly (2020 test). The total length of the 8 pads ( $8 \times 3 = 24$ "') was the same as the total length of 4 pads ( $4 \times 6 = 24$  inches). The width and the thickness of 8 pads were the same as the width and the thickness of 4 pads. Figure 3-8 shows the surrogate assembly with 8 pads attached to its bottom (left) and the felt pad configuration (right). Figure 3-9 shows the felt spacing. The felt pads were attached to the basket tube at the SNL test facility before its transport to the drop tower.

**Figure 3-8. New Surrogate Assembly with 8 Felt Pads (left) and Close View of Felt Pad (right).**

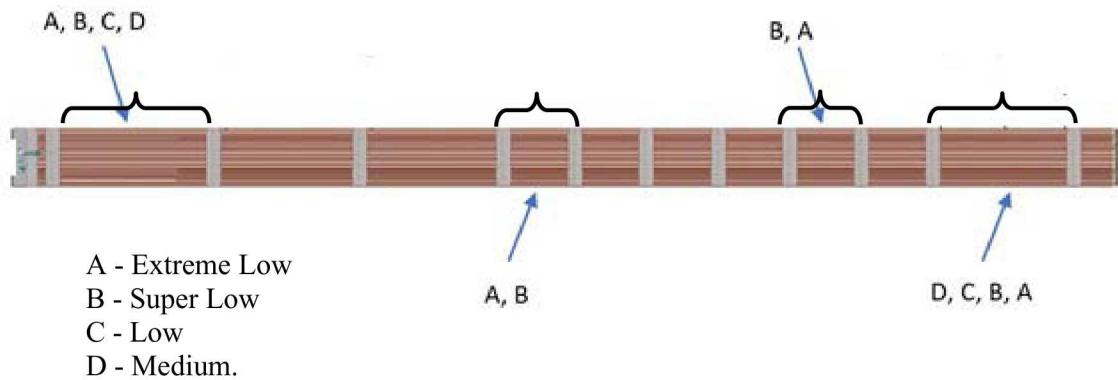
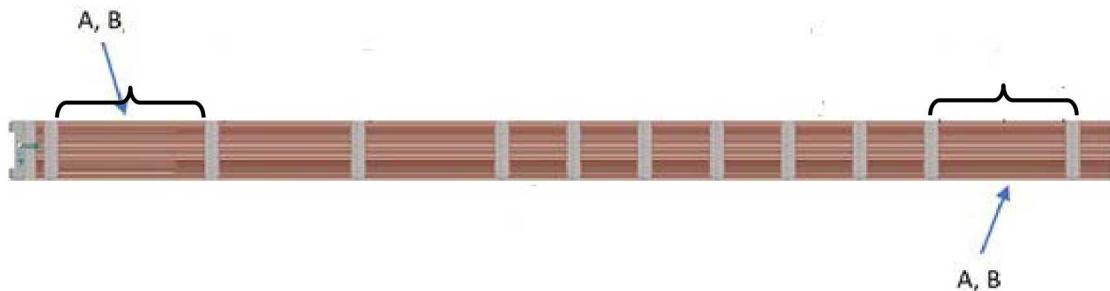
New Surrogate Assembly (2020 Test)

Old Damaged Surrogate Assembly (2019 Test)

Figure 3-10. Pressure Paper Locations and Specifications.

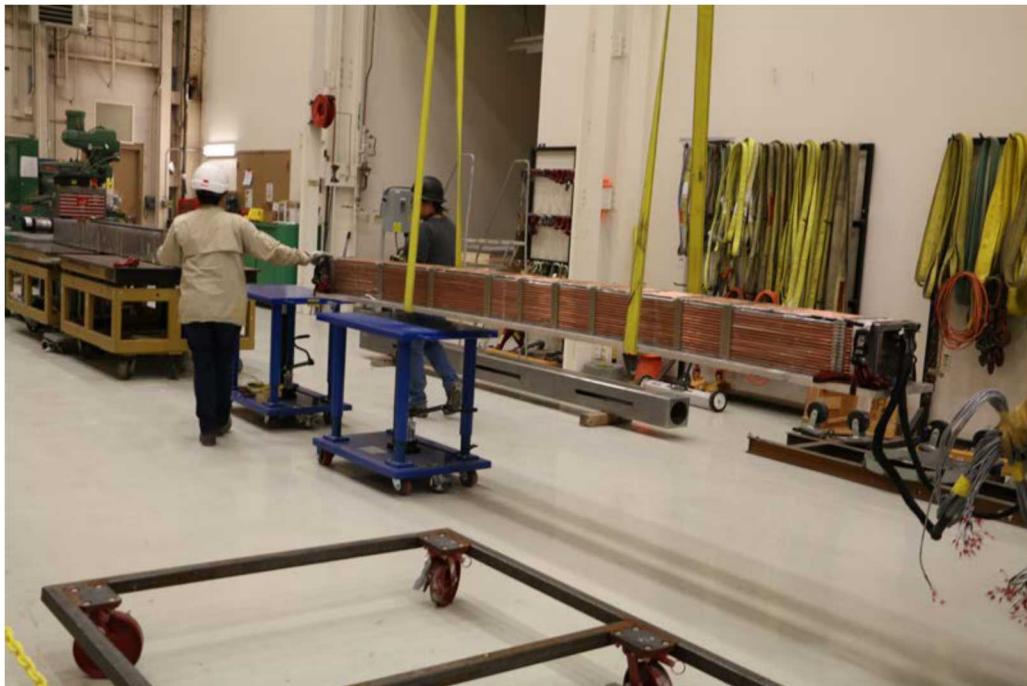
**Figure 3-12. Surrogate Assembly Placement into the Basket Tube (2020 Test).**

The instrumented surrogate assembly had to be inserted into the basket tube, transported to the SNL drop tower, and placed on the target for preparations for the tests. Figure 3-12 shows how the surrogate assembly was inserted into the basket tube.

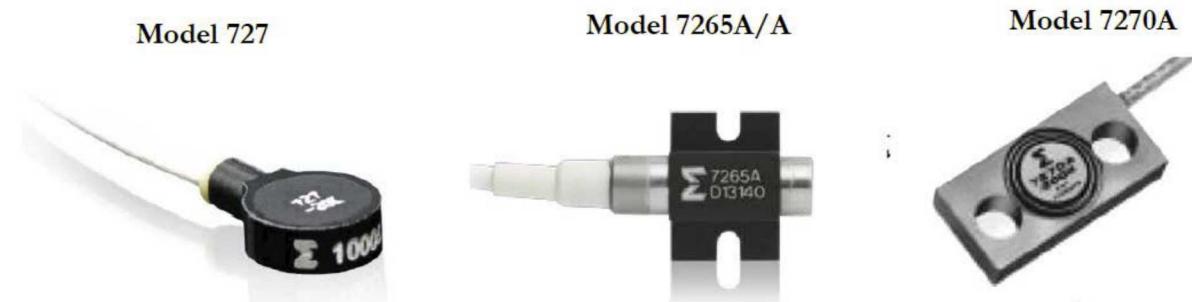
**Figure 3-26. Accelerometer Models Used in 30 cm Drop Test (2019 and 2020).**

- 7270A-20K (acceleration up to 20,000 g)
- 727-2K (acceleration up to 2,000 g)
- 7265A (acceleration up to 100 g)

The choice of the accelerometers was based on their availability, their use in the MMTT, and their size. The accelerometers are shown in Figure 3-26.

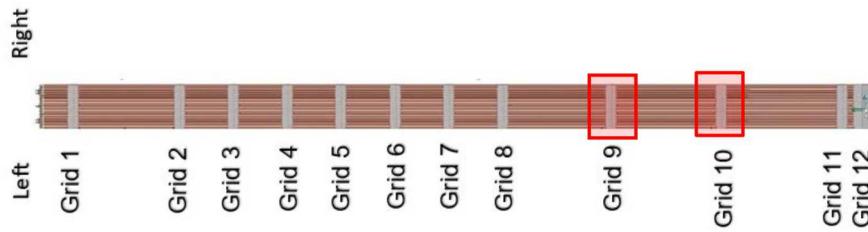
Figure 4-1 shows the spacer grid measurement nomenclature. Table 4-1 provides the post-test measurements. Figure 4-2 displays the post-test spacer grid height at each location on both sides of the assembly. The original spacer grid height was 214.2 mm. This height remained only in location 1. Some degree of deformation was observed at the other locations. The red rectangles in Figures 4-1 and 4-2 show two locations with the largest deformation. The maximum grid crushing of 6.1 mm was observed on the left side of the assembly at grid 10 (second spacer grid from the bottom nozzle end). The maximum difference between the spacer grid height on the left and right sides of the assembly (left and right sides are labeled in Figure 4-1) was 1.13 mm. The same height was measured on the left and right sides at location 5.

**Figure 4-1. Spacer Grid Measurement Nomenclature.**

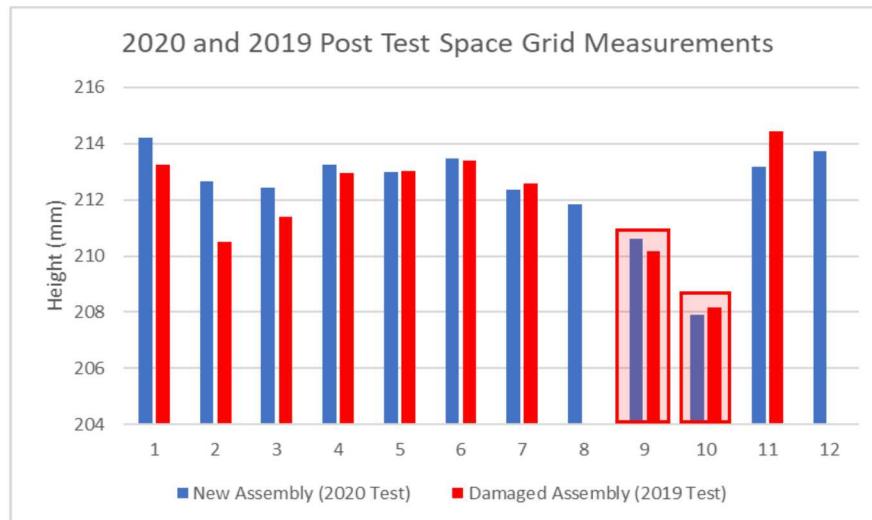
Figure 4-3 compares the spacer grid measurements performed on the old damaged surrogate assembly after the 2019 test and the new surrogate assembly after 2020 test. The damaged assembly has slightly larger spacer grid deformation, except a few locations. The spacer grid locations with the largest deformation were the same on the damaged and on the new surrogate assemblies. The maximum spacer grid crushing observed on the damaged surrogate assembly (2019 test) was 6.3 mm, which was 0.2 mm larger than the maximum spacer grid crushing on the new assembly (2020 test).

**Figure 4-3. Post-Test Spacer Grid Height in the 2020 and 2019 Tests (assembly right side).**

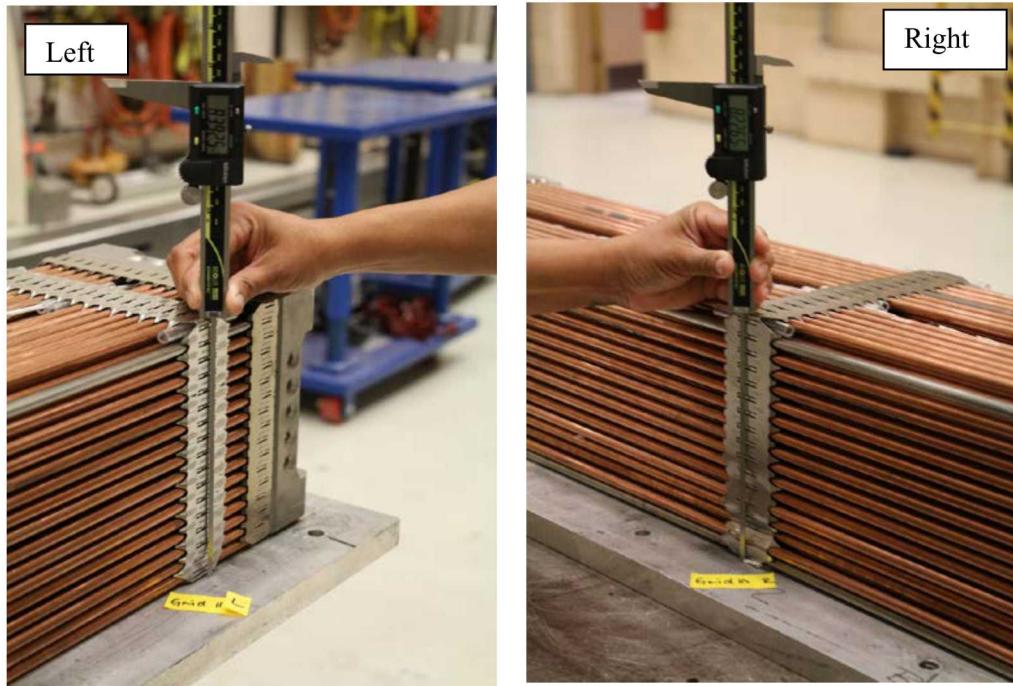
The photos of spacer grid 10 on the left and right sides of the assembly are shown in Figure 4-4 (2020 Test, new assembly) and Figure 4-5 (2019 Test, damaged assembly). In both cases, the deformation is at the bottom of the assembly.

Figure 4-4. Spacer Grid 10 with Largest Deformation in the 2020 Test.

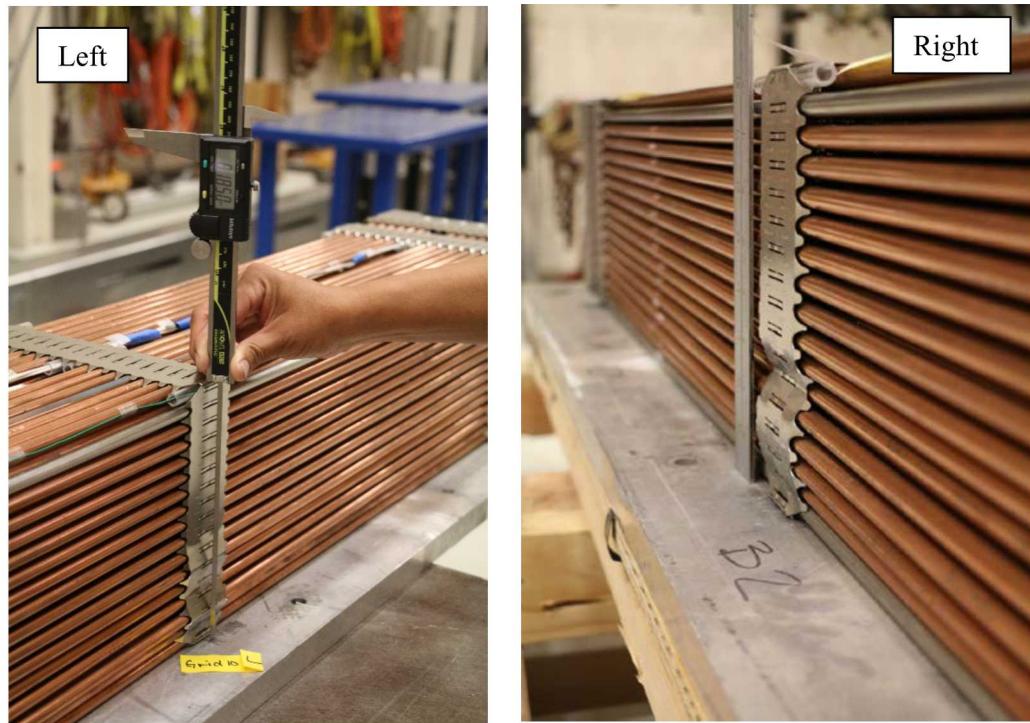
Figure 4-5. Spacer Grid 10 with Largest Deformation in the 2019 Test.

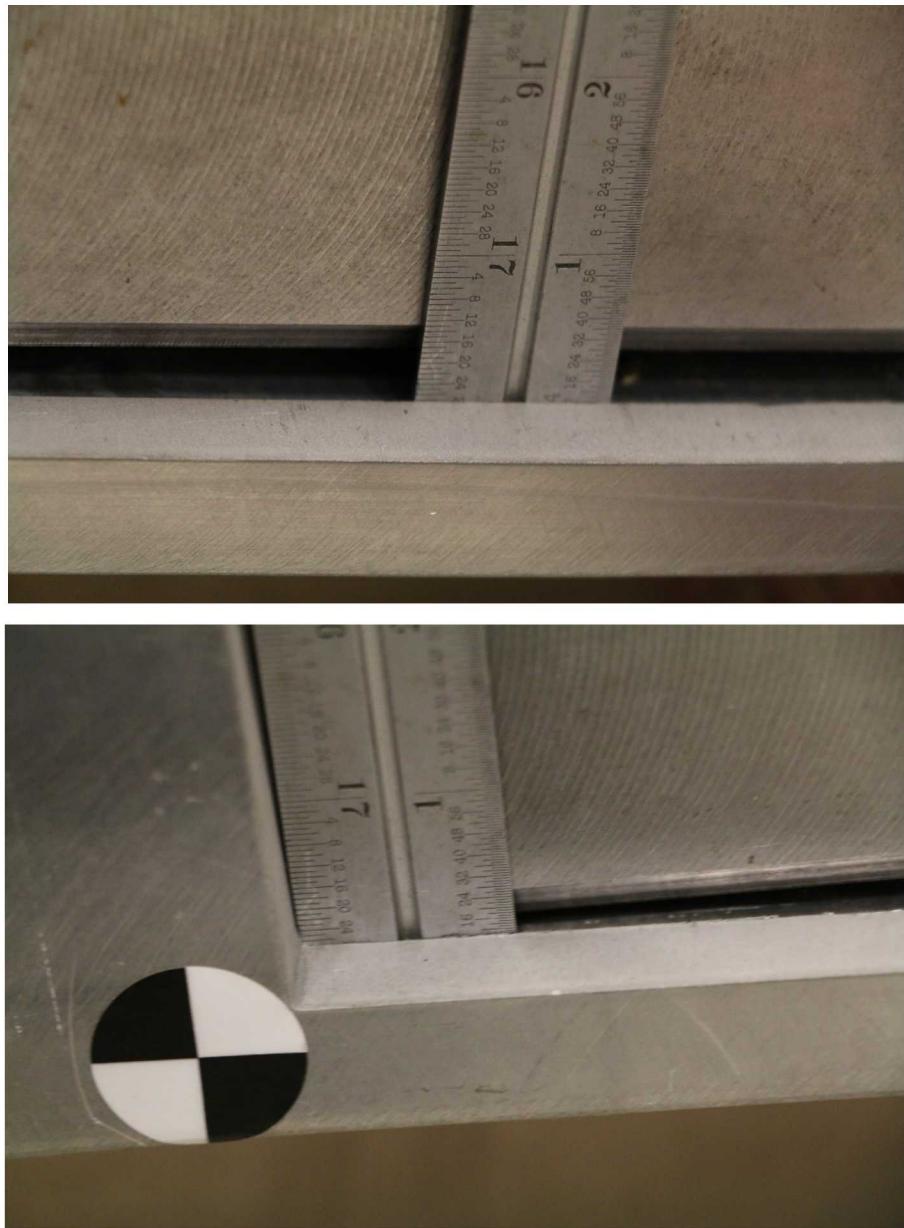
The basket tube experienced deformation beneath the windows cut on the side of the tube during the 2019 drop test. Figure 4-6 shows the deformed portion of the basket tube. The maximum deformation was about 4 mm.

**Figure 4-6. Basket Tube Deformation beneath the Observation Window (2020 Test).**

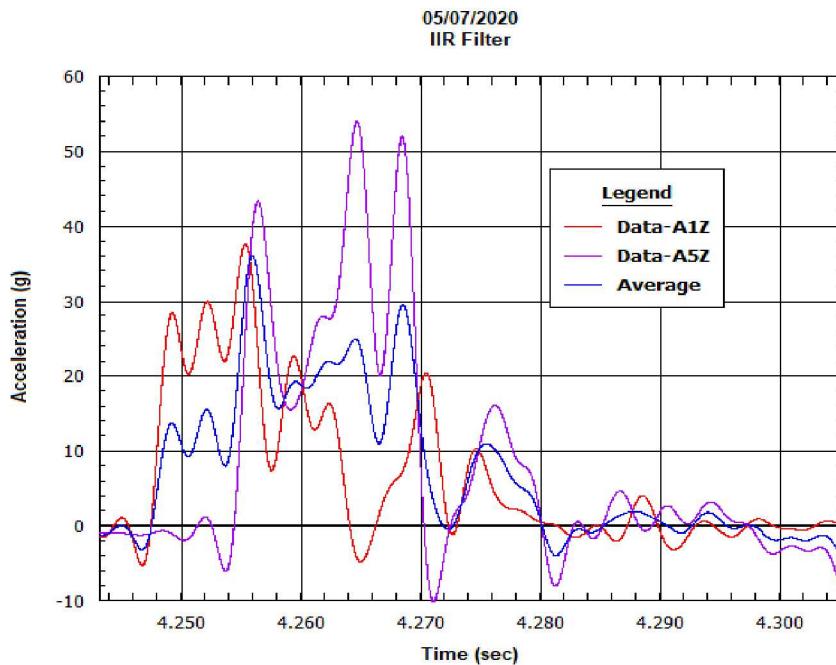
The acceleration pulses during the first impact on the top nozzle end (A1Z) and the bottom nozzle end (A5Z) of the new surrogate assembly during the 2020 test are shown in Figure 4-7. The accelerations were filtered to 300 Hz using a Butterworth low pass 6-pole filter. The peak accelerations were 38 g (top end) and 54 g (bottom end). The top end hit the target first, same as in the 1/3 scale cask 30 cm drop test. The averaged peak acceleration (Figure 4-7) was 36 g. The observed acceleration pulses are in good agreement with the expected ones. The averaged acceleration pulse is in good agreement with the observed acceleration pulse on the dummy assembly. Consequently, the effects of the impact limiters and cask were adequately represented in the 2020 test.

Note: A1Z is on the top end and A5Z is on the bottom end of the surrogate assembly.
