# ***Surrogate Assembly 30 cm Drop Test***

## **Spent Fuel and Waste Disposition**

**September 28, 2020**

**M2SF-20SN010202022**

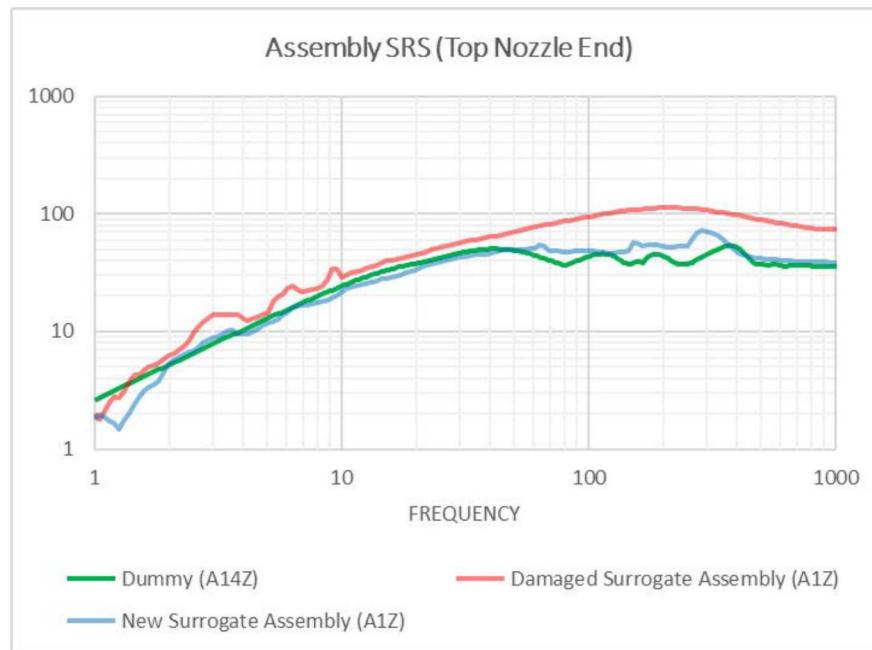
Figure 4-8 compares the acceleration shock response spectra (SRS) of the dummy assembly, damaged surrogate assembly (2019 test), and new surrogate assembly (2020 test). The new assembly SRS is very similar to the dummy one up to 50 Hz. Some small differences are present in the higher frequency domain. The new surrogate assembly has a peak around 60 Hz related to the assembly natural frequency. Similar peaks were observed during the MMTT shock events [1]. The damaged surrogate assembly SRS envelops the responses of the dummy and new surrogate assemblies. It has 3 peaks in the lower frequency (up to 10 Hz). These peaks are not present in the dummy and new surrogate assembly SRS. They reflect the structural changes in the damaged assembly.

**Figure 4-8. Acceleration SRS of Dummy and Damage Surrogate Assemblies (2019 Test) and New Surrogate Assembly (2020 Test).**

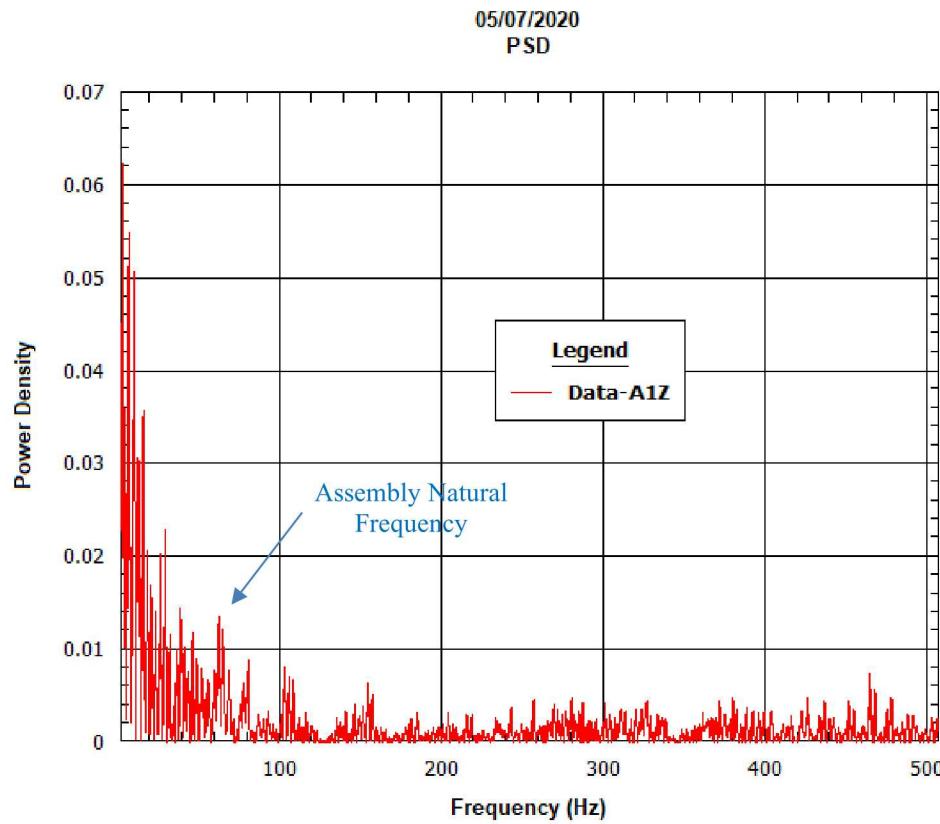
within the frequency domain up to 150 Hz. Consequently, using the 300 Hz low pass filter is appropriate. The PSD, as well as SRS, has a peak associated with the assembly natural frequency.

**Figure 4-9. Acceleration PSD on the New Surrogate Assembly Top End (2020 Test).**

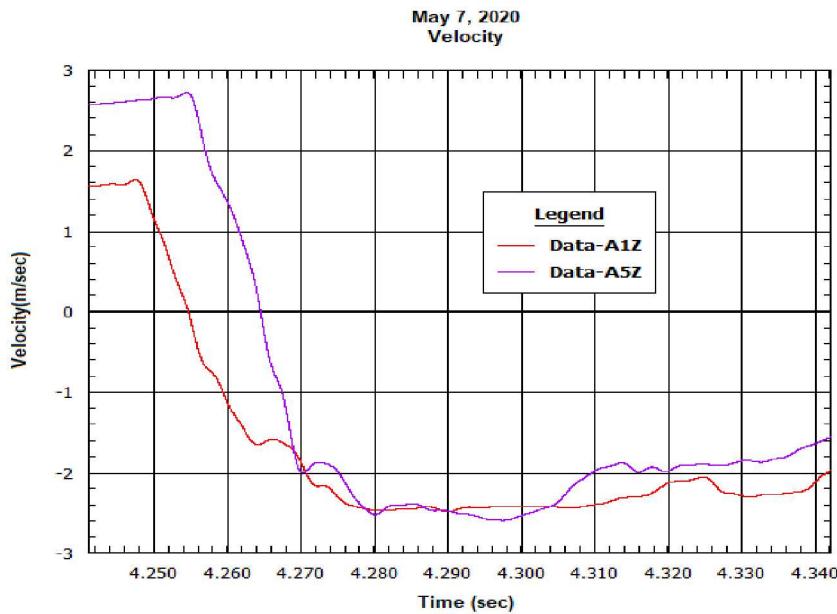
Figure 4-10 shows the first impact velocity time histories (top end and bottom end) calculated by integrating the observed accelerations on the surrogate assembly. The velocity during the first impact is  $\sim 2.5$  m/s. This is close to the video measurement (2.4 m/s).

**Figure 4-10. Surrogate Assembly Impact Velocity (2020 Test).**

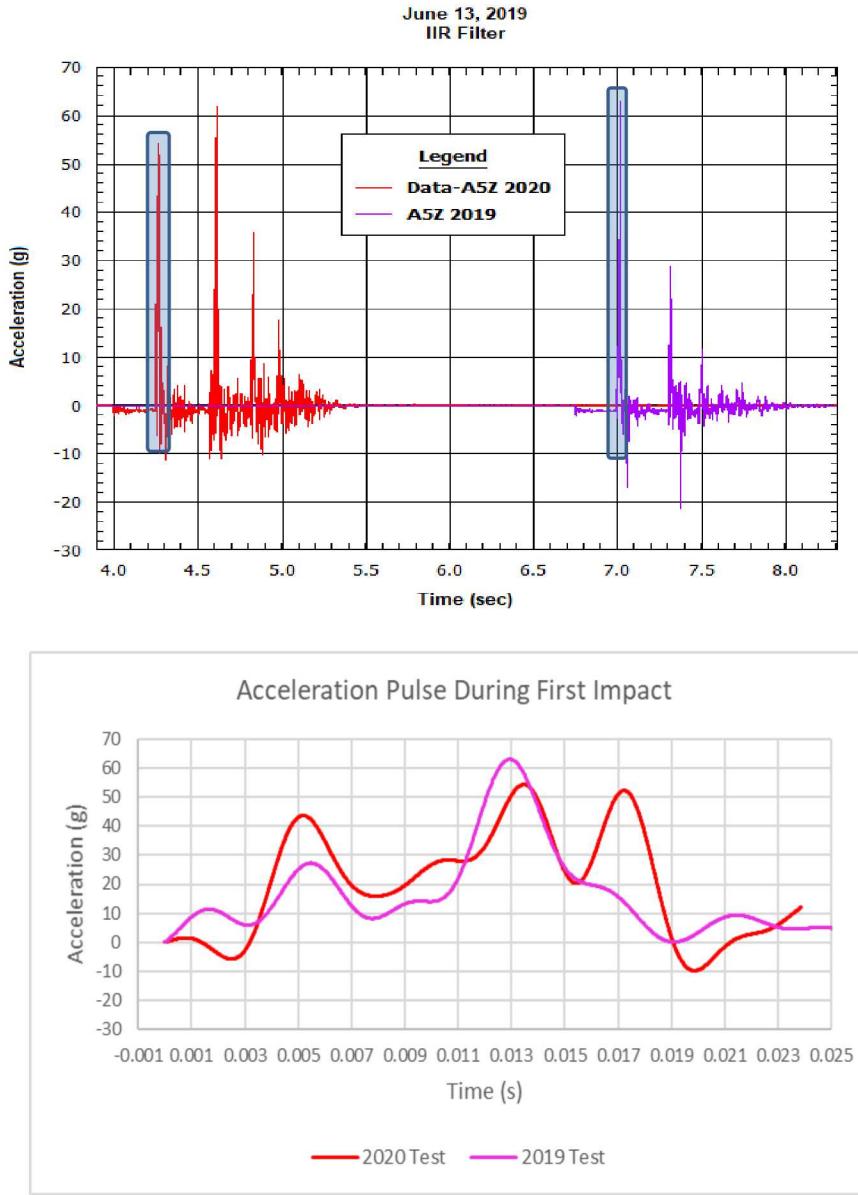
The acceleration time histories in the 2020 and 2019 tests are compared in Figure 4-12 (top figure). They are similar in their shapes and peak values. The acceleration pulses during the first impact are compared in the bottom figure (Figure 4-12). The time in this figure is counted from the moment of the first impact to provide a better comparison.

Note: Top figure shows the acceleration time histories for the duration of the test and the bottom figure shows the acceleration pulses during the first impact.

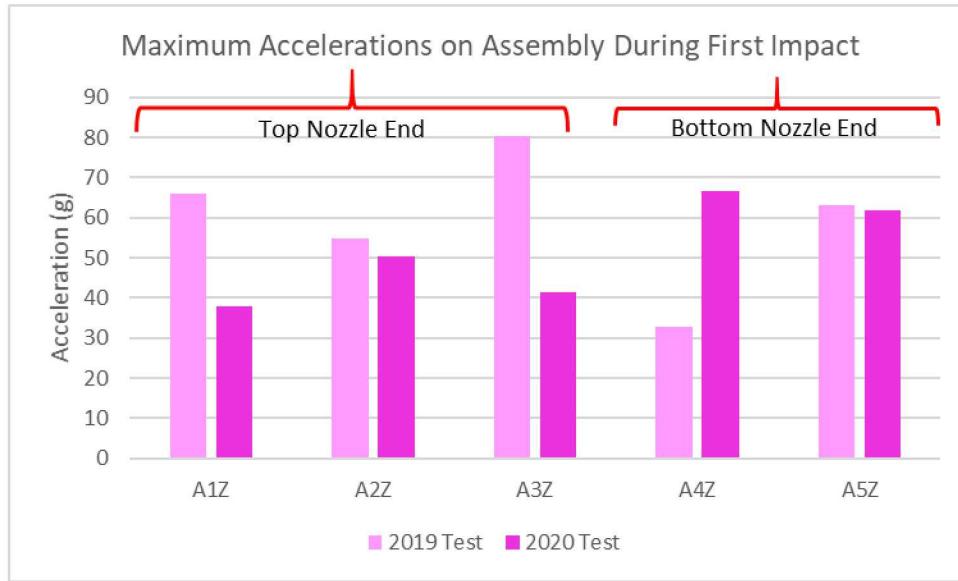
The peak accelerations on the top and bottom ends of the new (2020 test) and damaged (2019 test) surrogate assemblies during the first impact are compared in Figure 4-13. In both cases, the impact occurred first on the top end. The peak accelerations on the top end are higher in the 2019 test compared to the 2020 test. The peak accelerations on the bottom end are lower in the 2019 test compared to the 2020 test. The bottom end was a slap down end in both the 2019 and 2020 tests. It appears that the assembly damage (crushed spacer grid) resulted in a smaller slap down effect or that the impact during

the 2019 test was closer to perfectly horizontal, perhaps due to the deformation of the basket tube from the 2019 test that was present at the start of the 2020 test.

**Figure 4-13. Peak Surrogate Assembly Accelerations During the First Impact in the 2020 and 2019 Tests.**

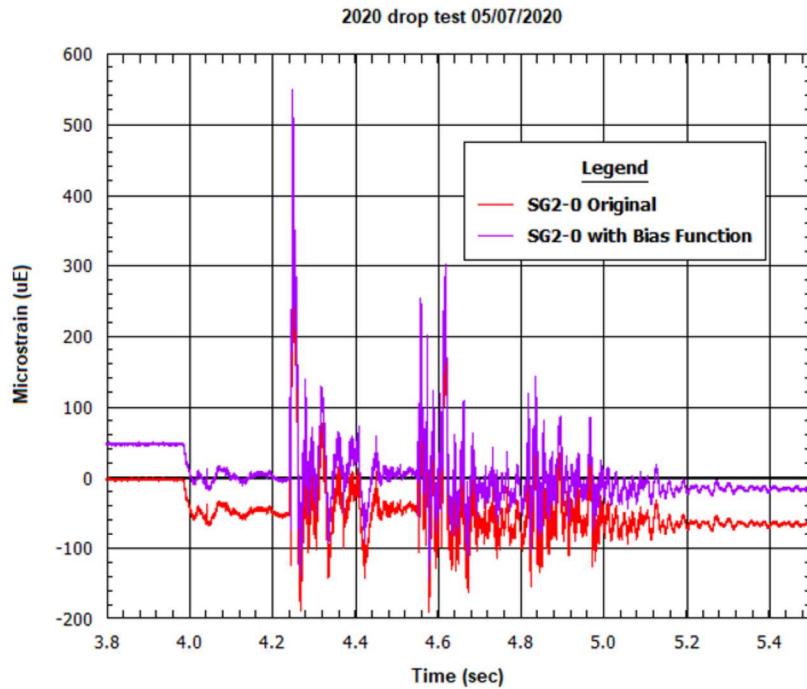
The minimum and maximum strain values were derived from the analysis of unfiltered time histories corrected for bias. The bias function available in K2 was used. The Bias function performs an offset on the Y (acceleration or strain) axis input data. This does not change the data; it corrects for any offset in the data by taking the average Y-value in the time period before the impact and subtracting this value from the entire data record. This allows for obtaining adequate (not affected by an offset) maximum and minimum values. Figure 4-14 shows an example of the original strain time history and the time history corrected for bias for the strain gauge SG2-0.

**Figure 4-14. Example of Strain Data Correction for Bias (Strain Gauge SG2-0), 2020 Test.**

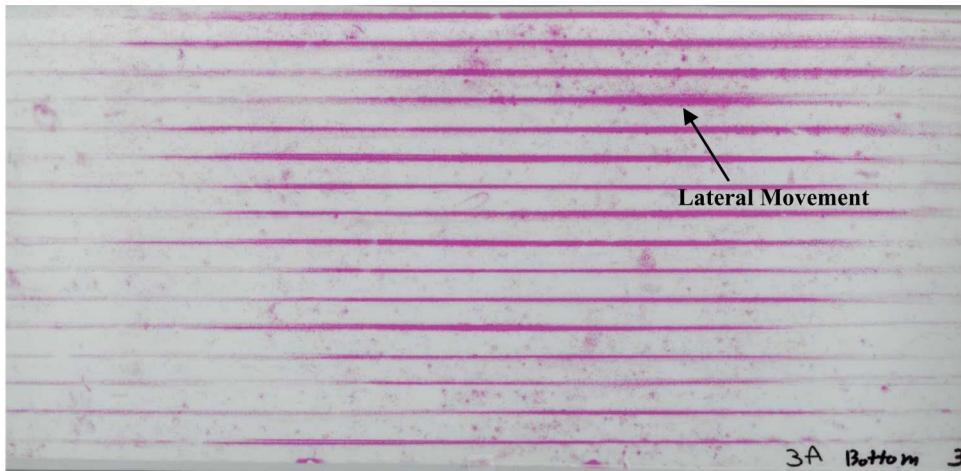
**Figure 4-19. Extreme Low Pressure Paper Between the 3<sup>rd</sup> and 4<sup>th</sup> Rods at the Bottom End of the Assembly after the 2020 Test.**

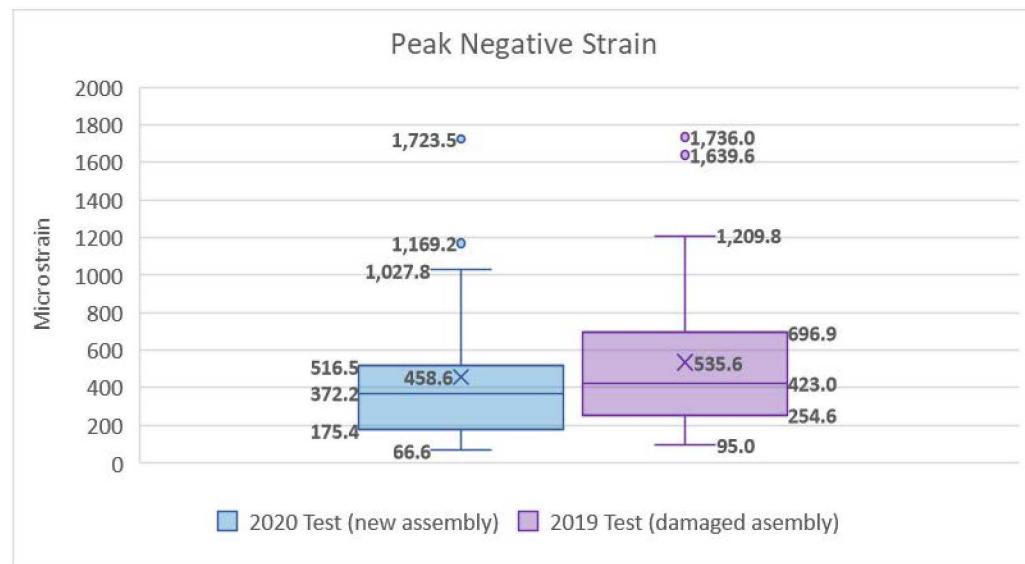
Figure 4-20. Statistics of Peak Negative Strain Values Observed in the 2020 and 2019 Tests.

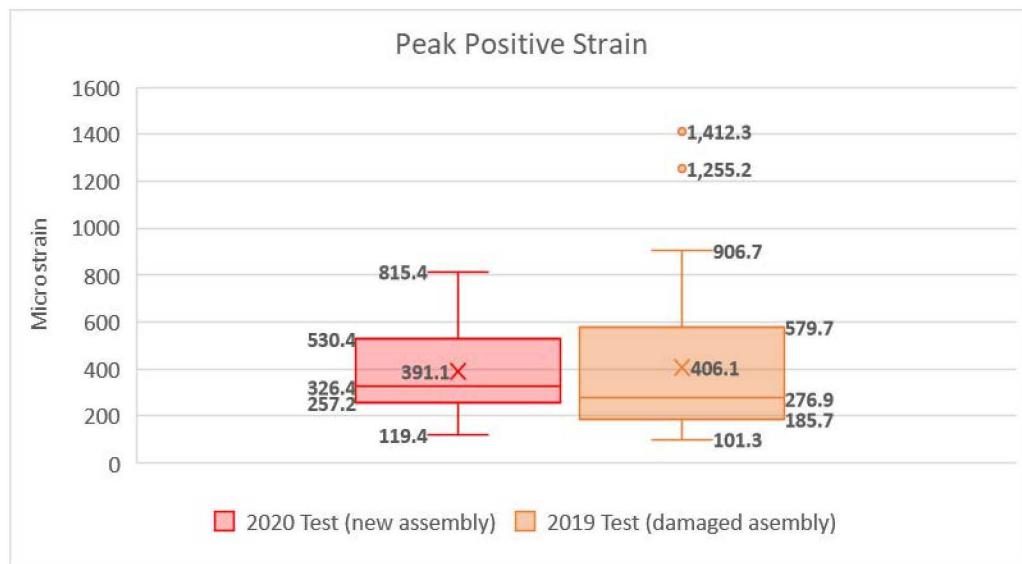
Figure 4-21. Statistics of Peak Positive Strain Values Observed in the 2020 and 2019 Tests.

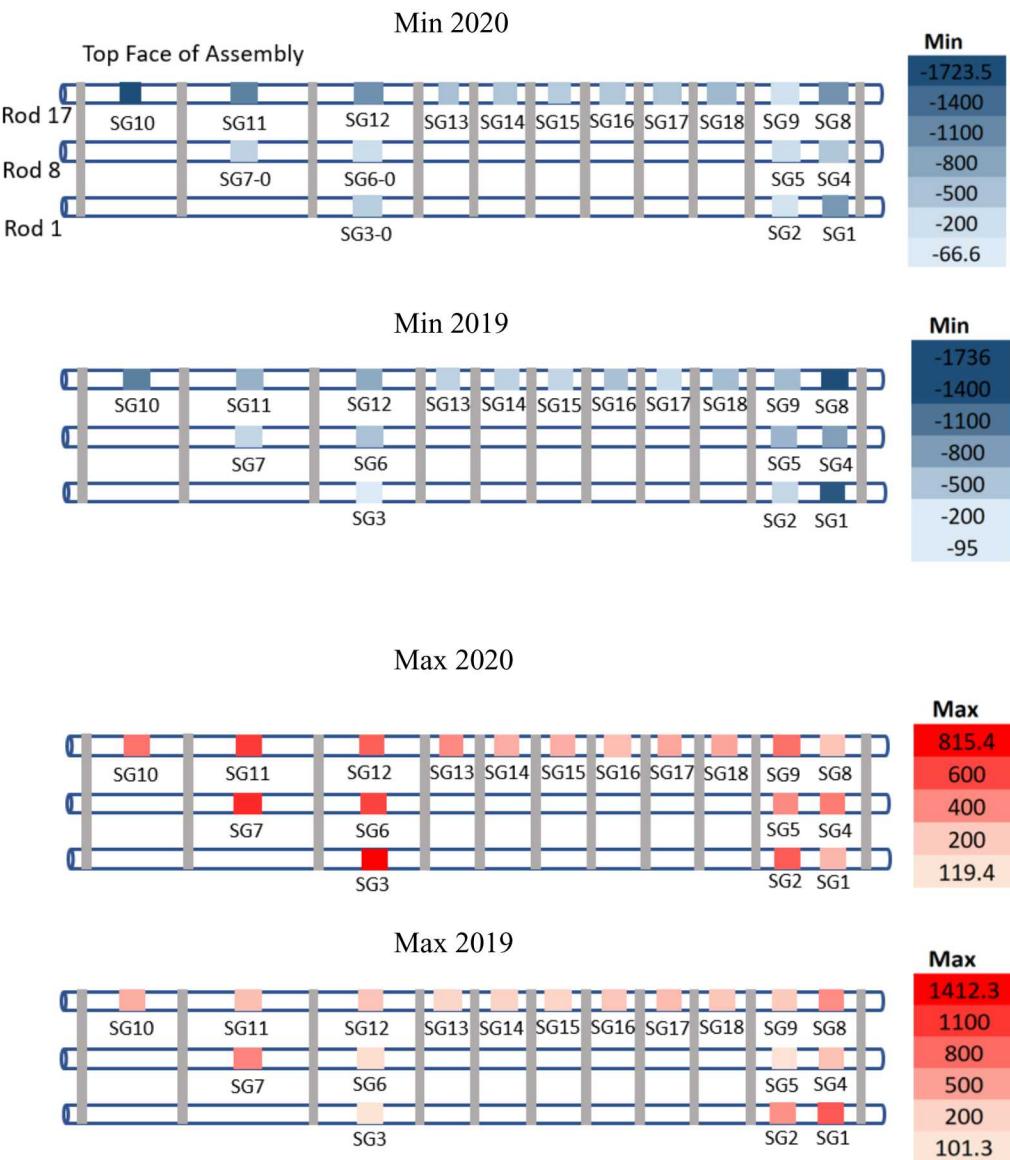
**Figure 4-28. Color Maps of the Peak Strain in the 2020 and 2019 Tests.**

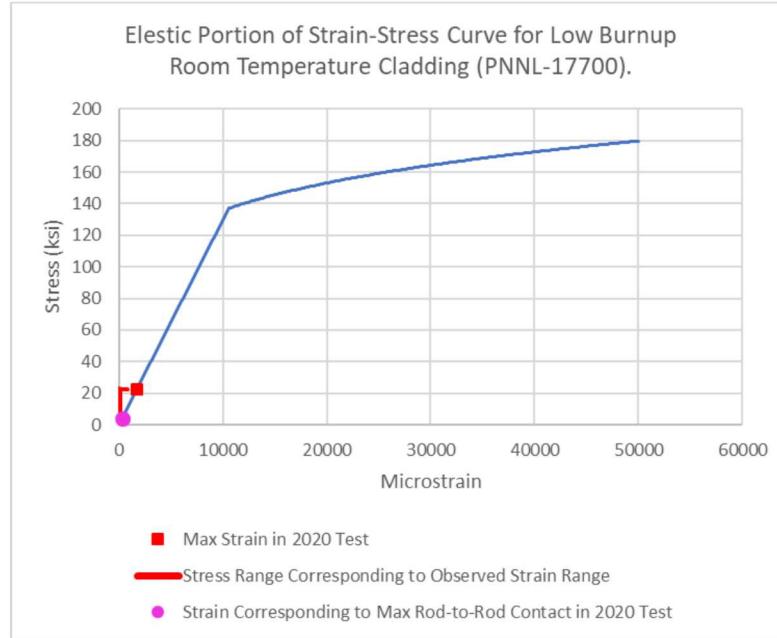
**Figure 4-38. Stress Range in the 2020 Test Based on the Strain-Stress Curve for the Low Burnup Cladding [19].**

The longitudinal bending stress corresponding to the maximum observed strain value (calculated from the strain-stress curve in [19]) was 22.3 ksi. The maximum calculated rod-to-rod contact pressure was 4.1 ksi. Both values are significantly below the yield strength of the cladding. The stress corresponding to the maximum strain value observed in the 2019 test with the damaged assembly (calculated from the strain-stress curve in [19]) was only slightly higher - 22.9 ksi.

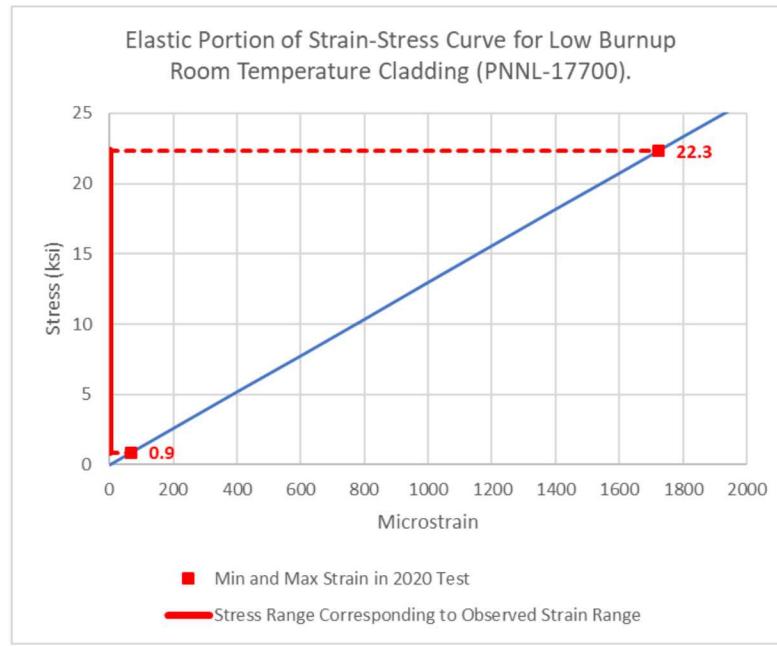
**Figure 4-39. Closeup View of the Stress Range in the 2020 Test Based on the Strain-Stress Curve for the Low Burnup Cladding [19].**

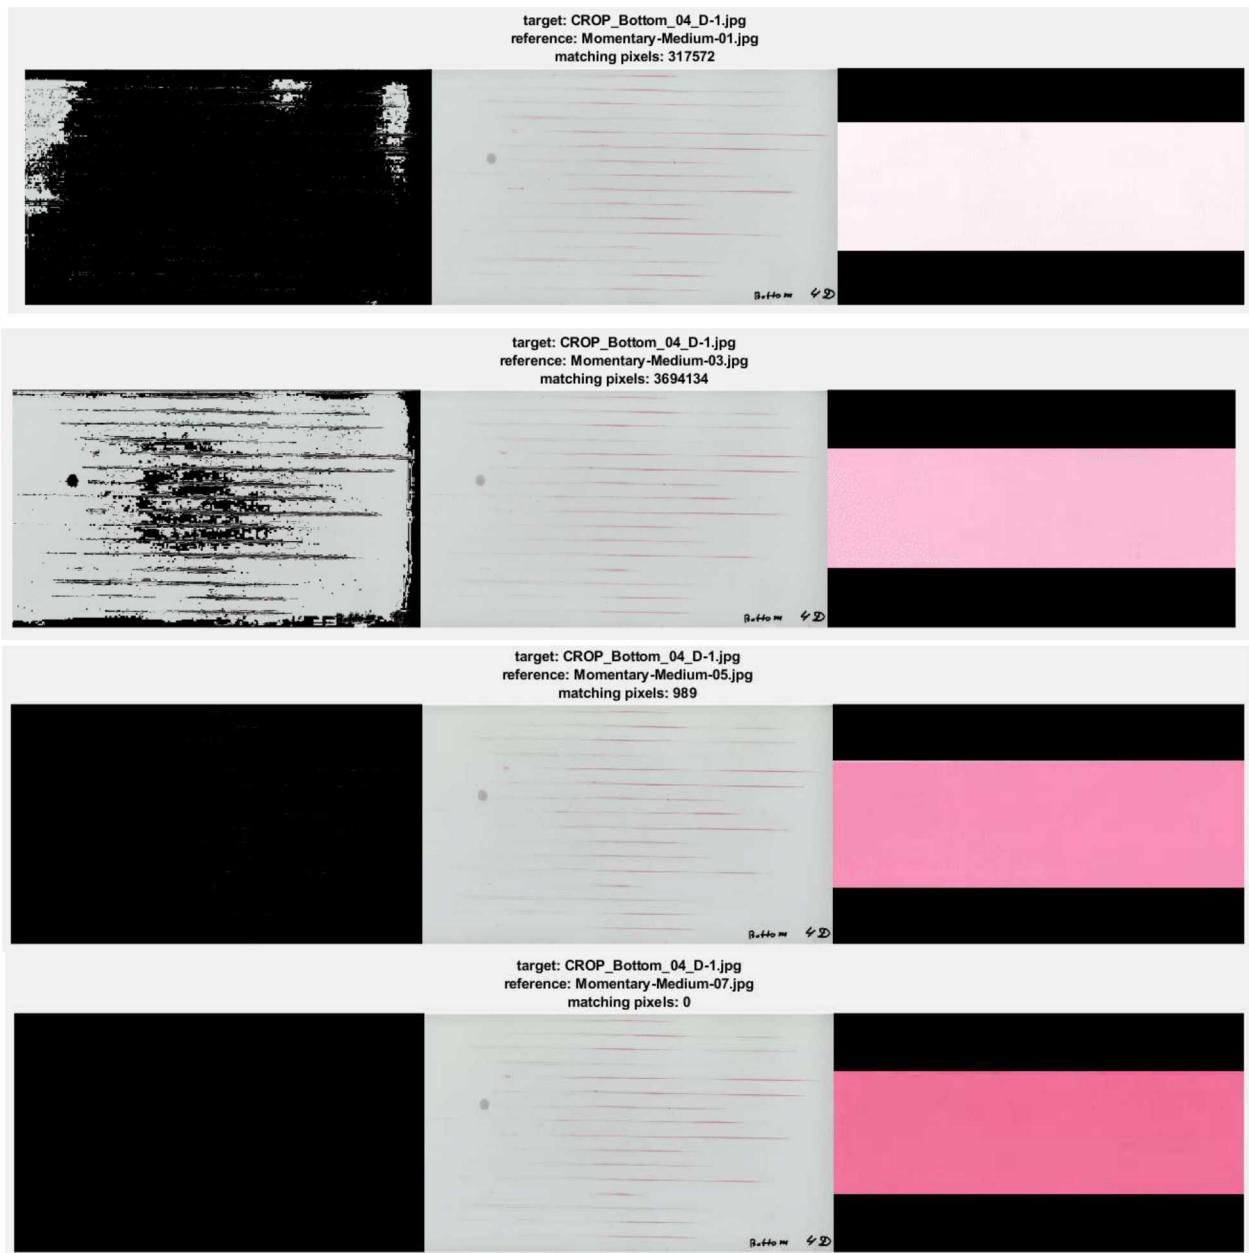
**Figure 4-44. An Example of Medium Pressure Paper Scan Processing (Long Span Next to Assembly Bottom End, Pressure Paper Sheet between Rods 4 and 5).**

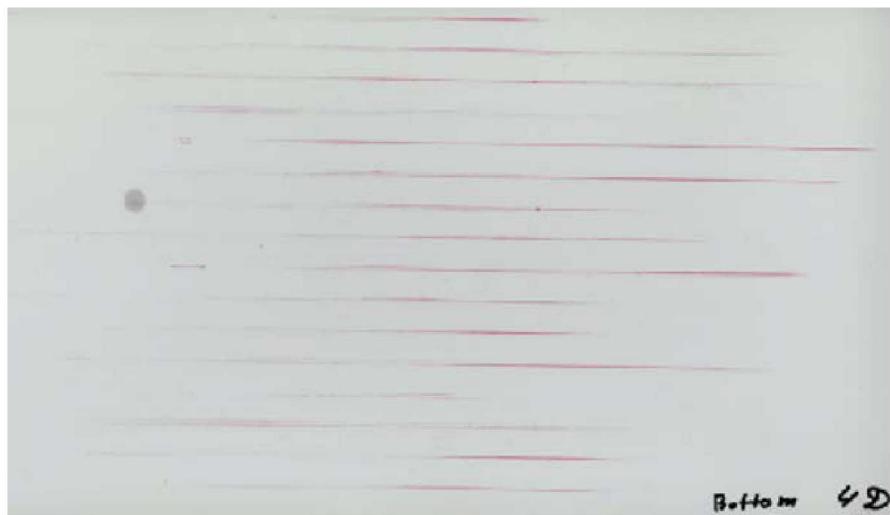
Figure 4-46. Medium Pressure Paper Sheet between the Rods 4 and 5, Assembly Bottom End, Long Span between Spacer Grids (2020 Test).

The locations of the medium pressure paper in the long span between spacer grids at the assembly bottom end in 2020 test are shown in Figure 4-45. The medium paper sheet between the rods 8 and 9 had no marks. The medium pressure paper sheet between the rods 4 and 5 had very well-defined marks indicating that rod-to-rod contact occurred between each rod in level 4 and level 5 (Figure 4-46). The medium pressure paper sheet between the rods 12 and 13 had the marks indicating that rods contacted the guide tubes (Figure 4-47).

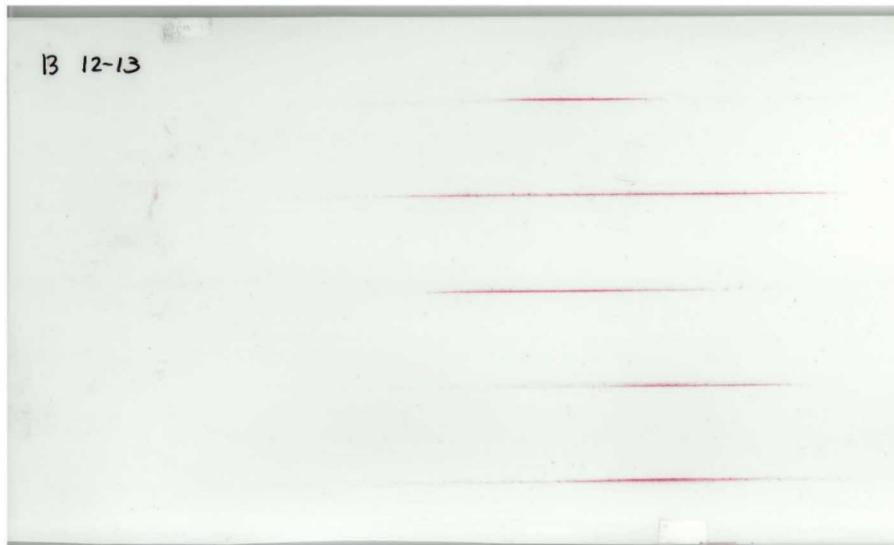
**Figure 4-49. Super Low Pressure Paper Sheet between the Rods 12 and 13, Assembly Bottom End, Long Span between Spacer Grids (2019 Test).**

During the 2019 test, the super low pressure paper was inserted between the rods 4 and 5 and between the rods 12 and 13 at the assembly bottom end. The scans of these paper sheets are shown in Figures 4-48 and 4-49. The super low pressure paper sheet between the rods 4 and 5 had very well defined marks indicating that rod-to-rod contact occurred between each rod in level 4 and level 5, similar to the 2020 test. The super low pressure paper sheet between the rods 12 and 13 had marks indicating guide tube contact, the same as in the 2020 test. The marks are more pronounced than in the 2020 test because the pressure range of the super low pressure paper was lower.

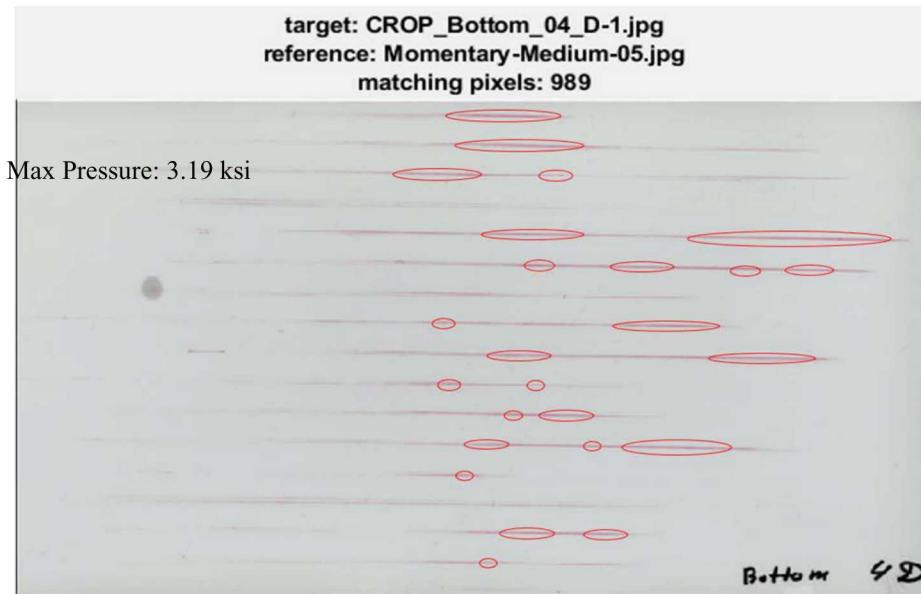
**Figure 4-55. Maximum Contact Pressure Locations, Medium Pressure Sheet between the Rods 4 and 5, 2020 Test.**

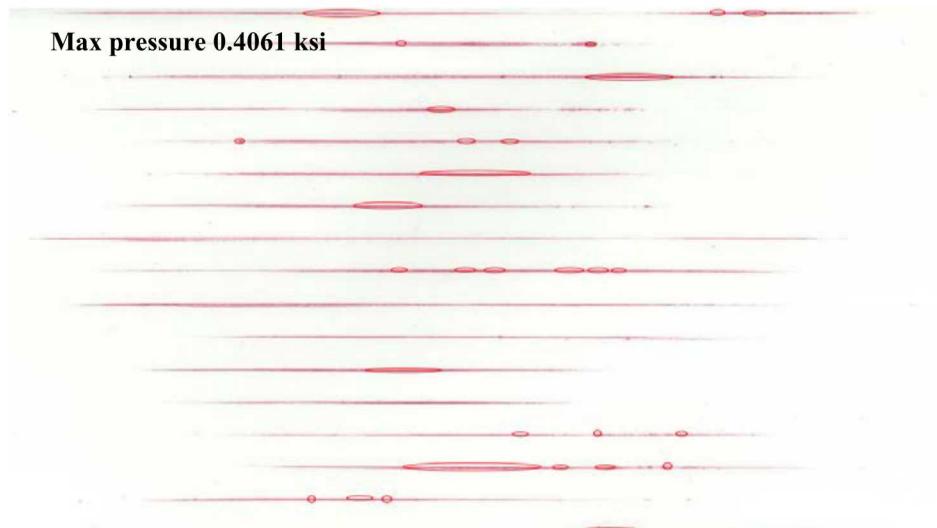
**Figure 4-63. Maximum Contact Pressure Locations, Super Low Pressure Sheet between the Rods 3 and 4, 2020 Test.**

Figure 4-63 illustrates the results of the maximum pressure processing for the super low pressure sheet between the rods 3 and 4 in the 2020 test. The maximum pressure was 0.4061 ksi. The points of the maximum pressure are located at the middle of the span where the bending is maximum. Figure 4-64 illustrate the example of this processing for the super low pressure sheet between the rods 3 and 4 in the 2019 test. The maximum pressure was the same as in the 2020 test. The locations of the maximum pressure points are similar to the 2020 test.

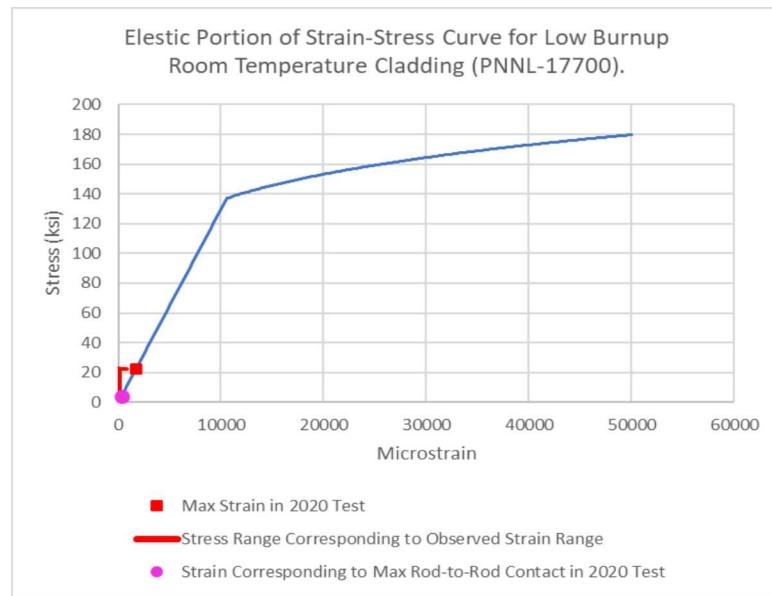
**Figure 5-1 Stress and Rod-to-Rod Contact Pressure Range in the 2020 Test Based on the Strain-Stress Curve for the Low Burnup Cladding [19].**

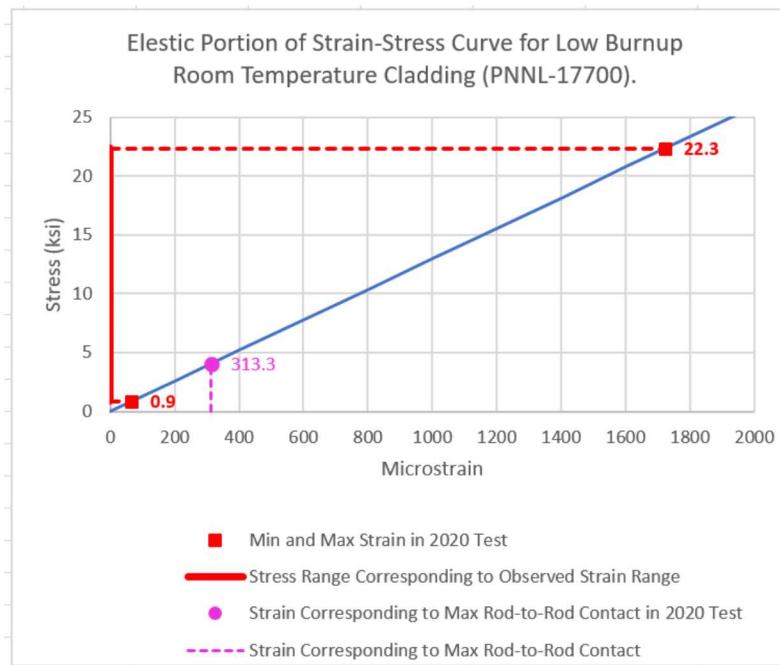
**Figure 5-2. Closeup of the Stress and Rod-to-Rod Contact Pressure Range in the 2020 Test Based on the Strain-Stress Curve for the Low Burnup Cladding [19].**

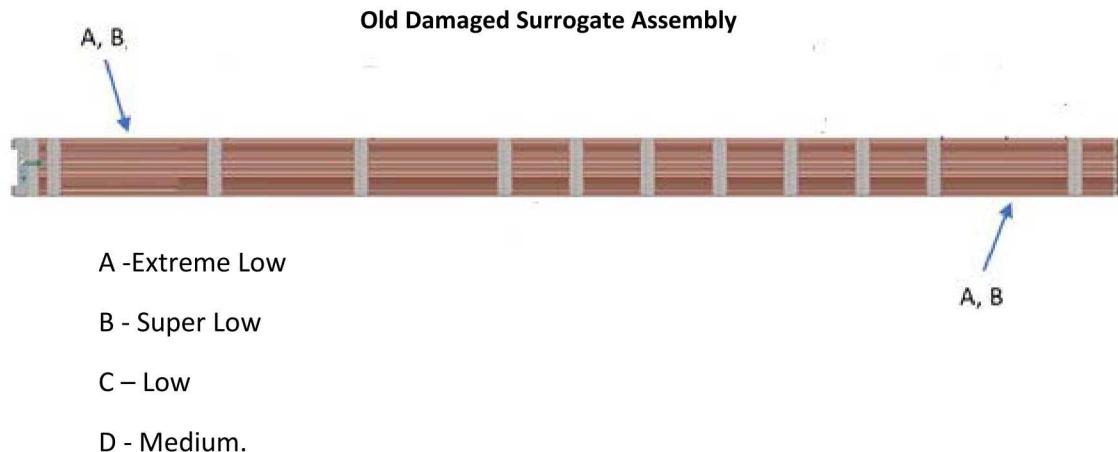
This appendix provides the original pressure paper scans from June 2019 30 cm drop test. Fifteen scans are from the long span next to the assembly bottom and fifteen scans are from the long span next to the assembly top (Figure B-31). The notation B\_01\_02 means that the pressure paper sheet is from the long span next to the assembly bottom and the pressure paper was placed between the rods 1 and 2 counting from the bottom up. Figure B-31 provides the pressure paper types used in this test.

**Figure C-1. Pressure Paper Locations and Specifications in June 2019 Test.**

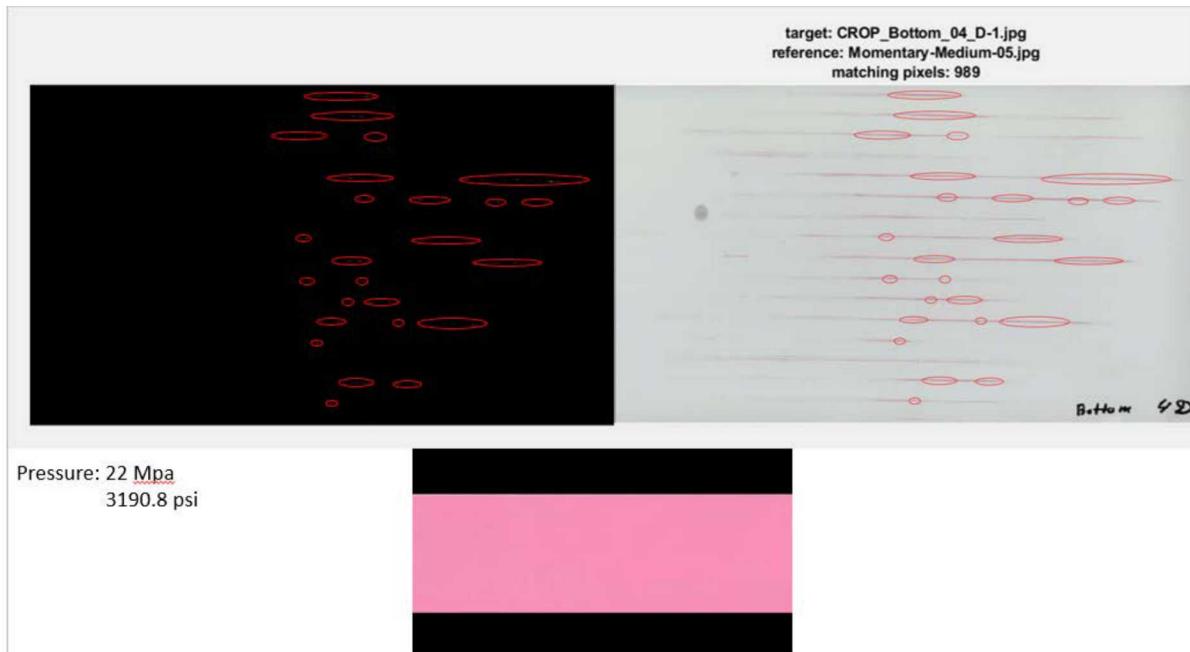
Figure D-1. Momentary-Medium-05.

The maximum rod-to-rod contact pressure was estimated for every pressure paper scan from 2020 test, except the blank ones. The results of the processing are shown in the figures below.

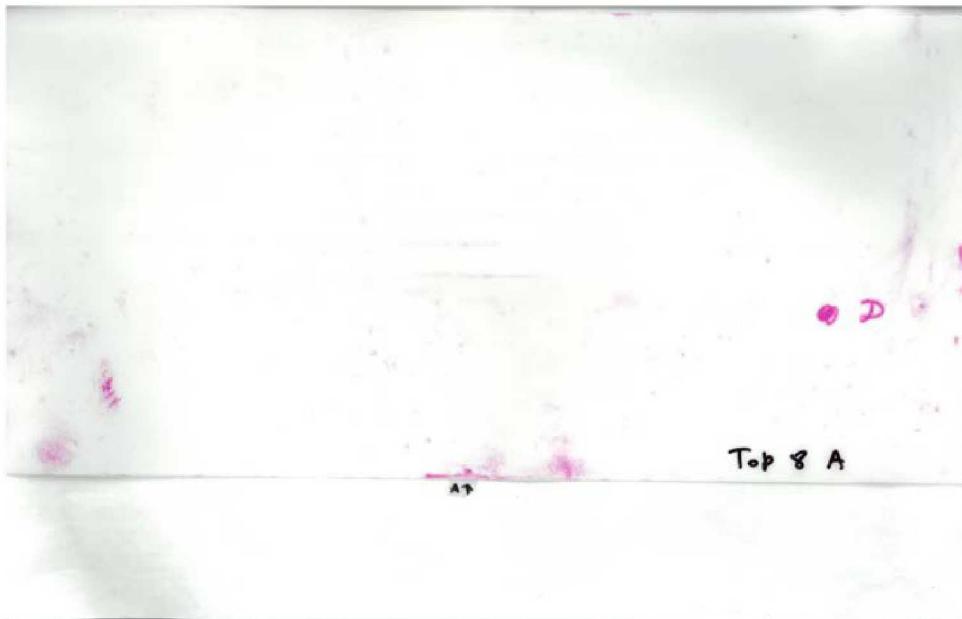
Figure D-27. Top 08\_A-1 is blank with non-drop related marks on it.
