**Sandia National Laboratories
Support of the
Iraq Nuclear Facility
Dismantlement and Disposal Project
(NDs Project)**

Calendar Year 2010

4 November 2010

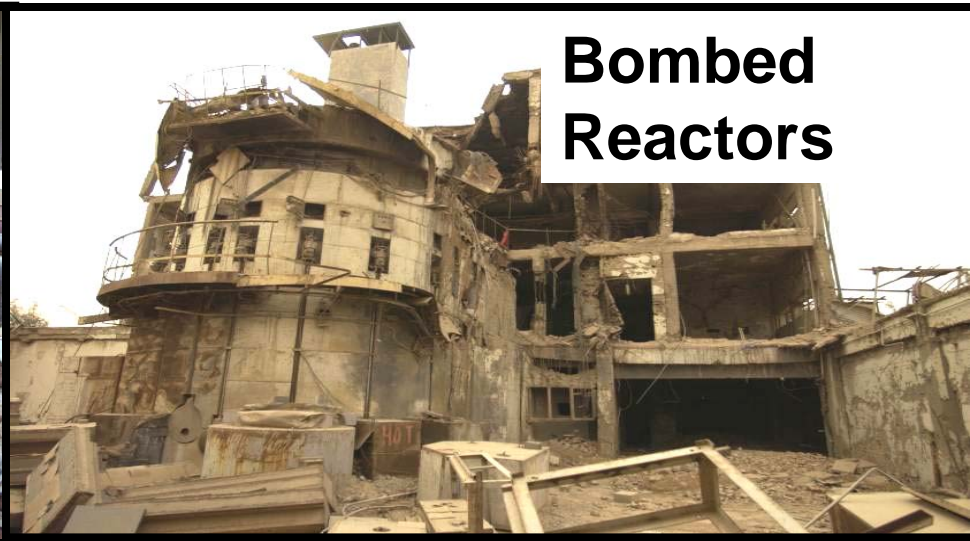
Bombed Reactors

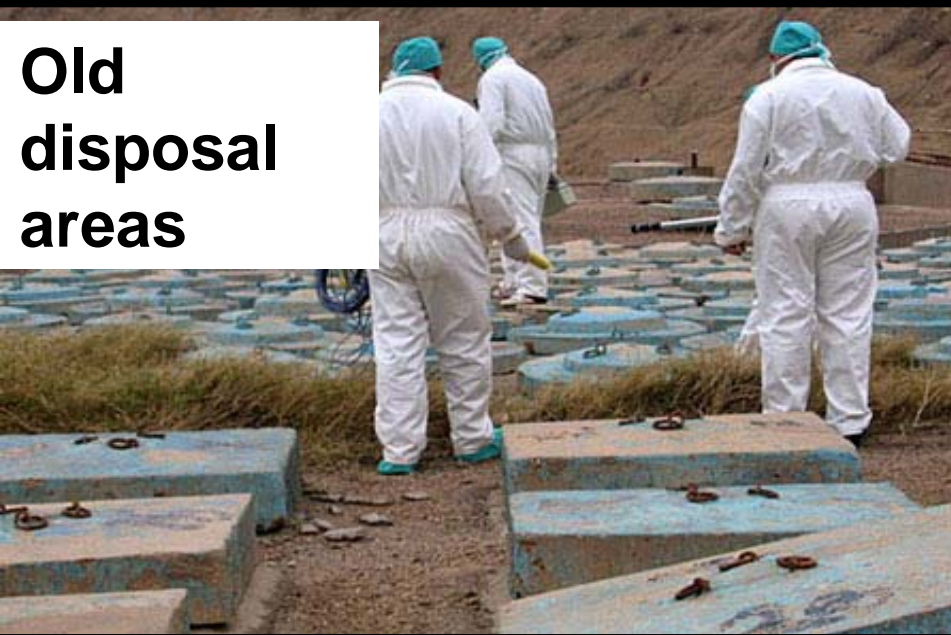
Old disposal areas

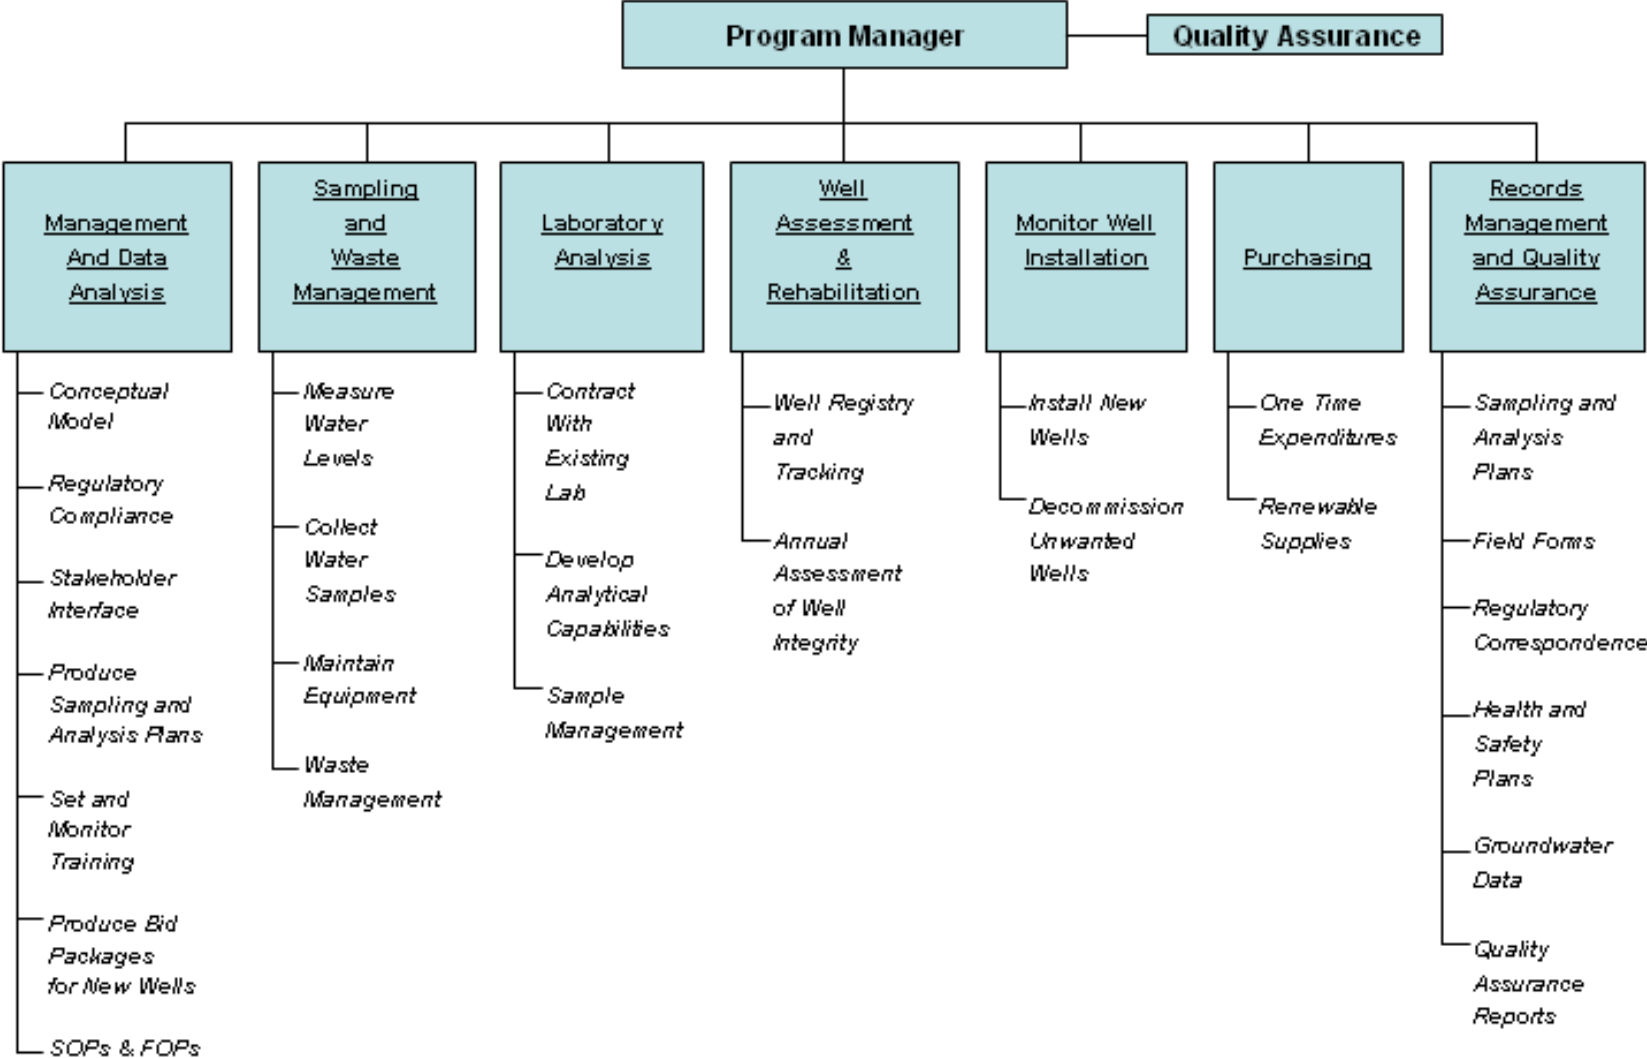
Figure 1. Groundwater Monitoring Program

- **Recommends program structure**
- **Personnel and skills for structure**
- **Equipment for structure**
- **Administrative processes for structure**
- **Draft Conceptual Site Model for AI Tuwaitha**
- **Recommended next steps**
- **Copies of SOP and FOPs**

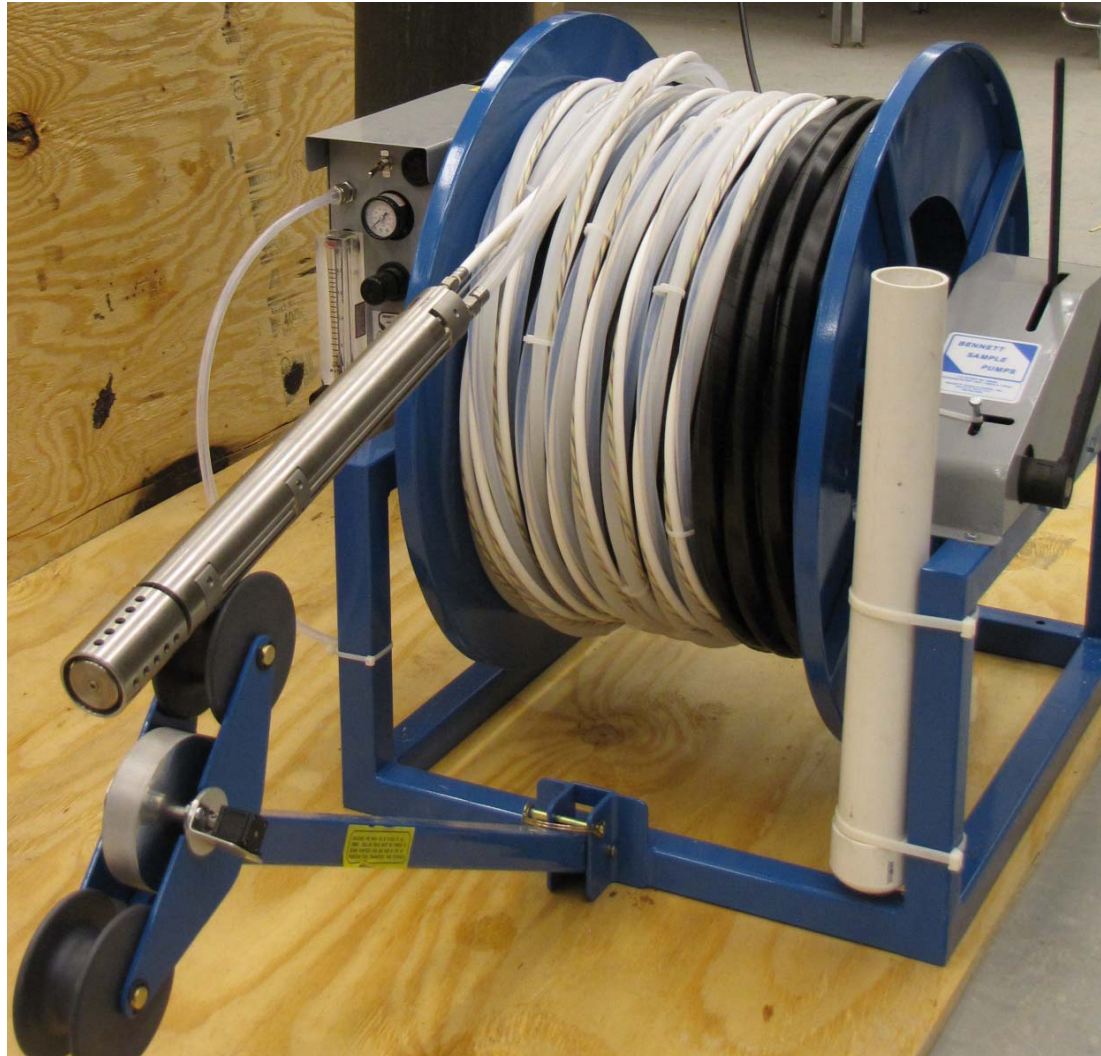
Pump, tubing and reel

- **Purchased pump, tubing bundle, water quality meters (~ \$ 25,000)**
- **Cleared U.S. export controls and shipped to Iraq**
- **Trained Dave Kenagy & Dr. Abbas on how to use – 7-9 Sept 2010 (merged training at Sandia with IAEA-funded RPC trip to U.S.)**
- **Dave and Dr. Abbas transfer equipment to RPC and trained RPC staff – 14 September**

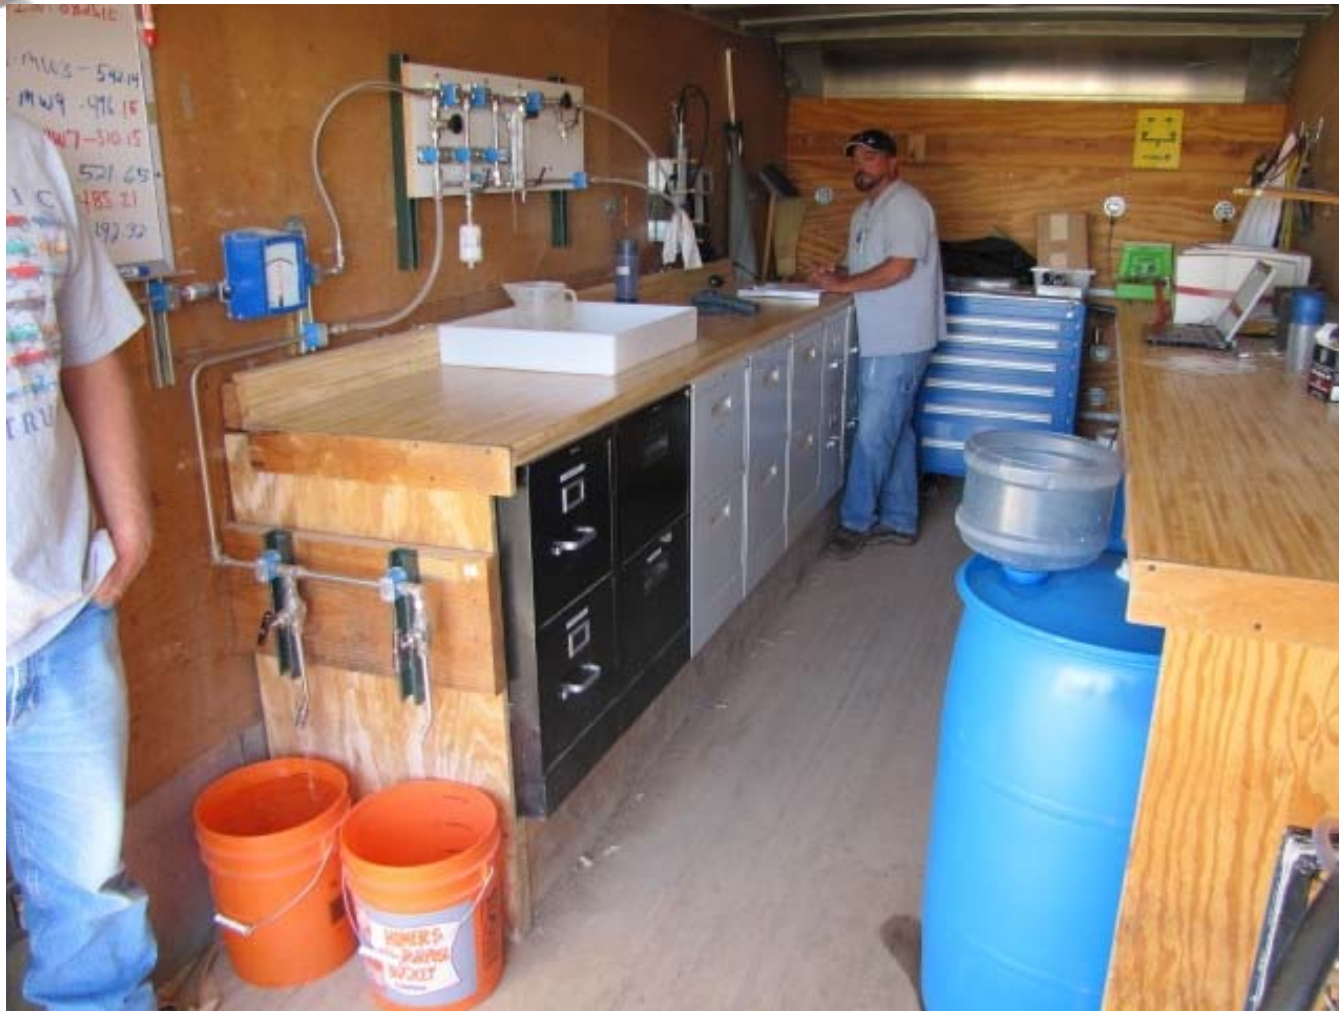
Interior Sandia sampling truck

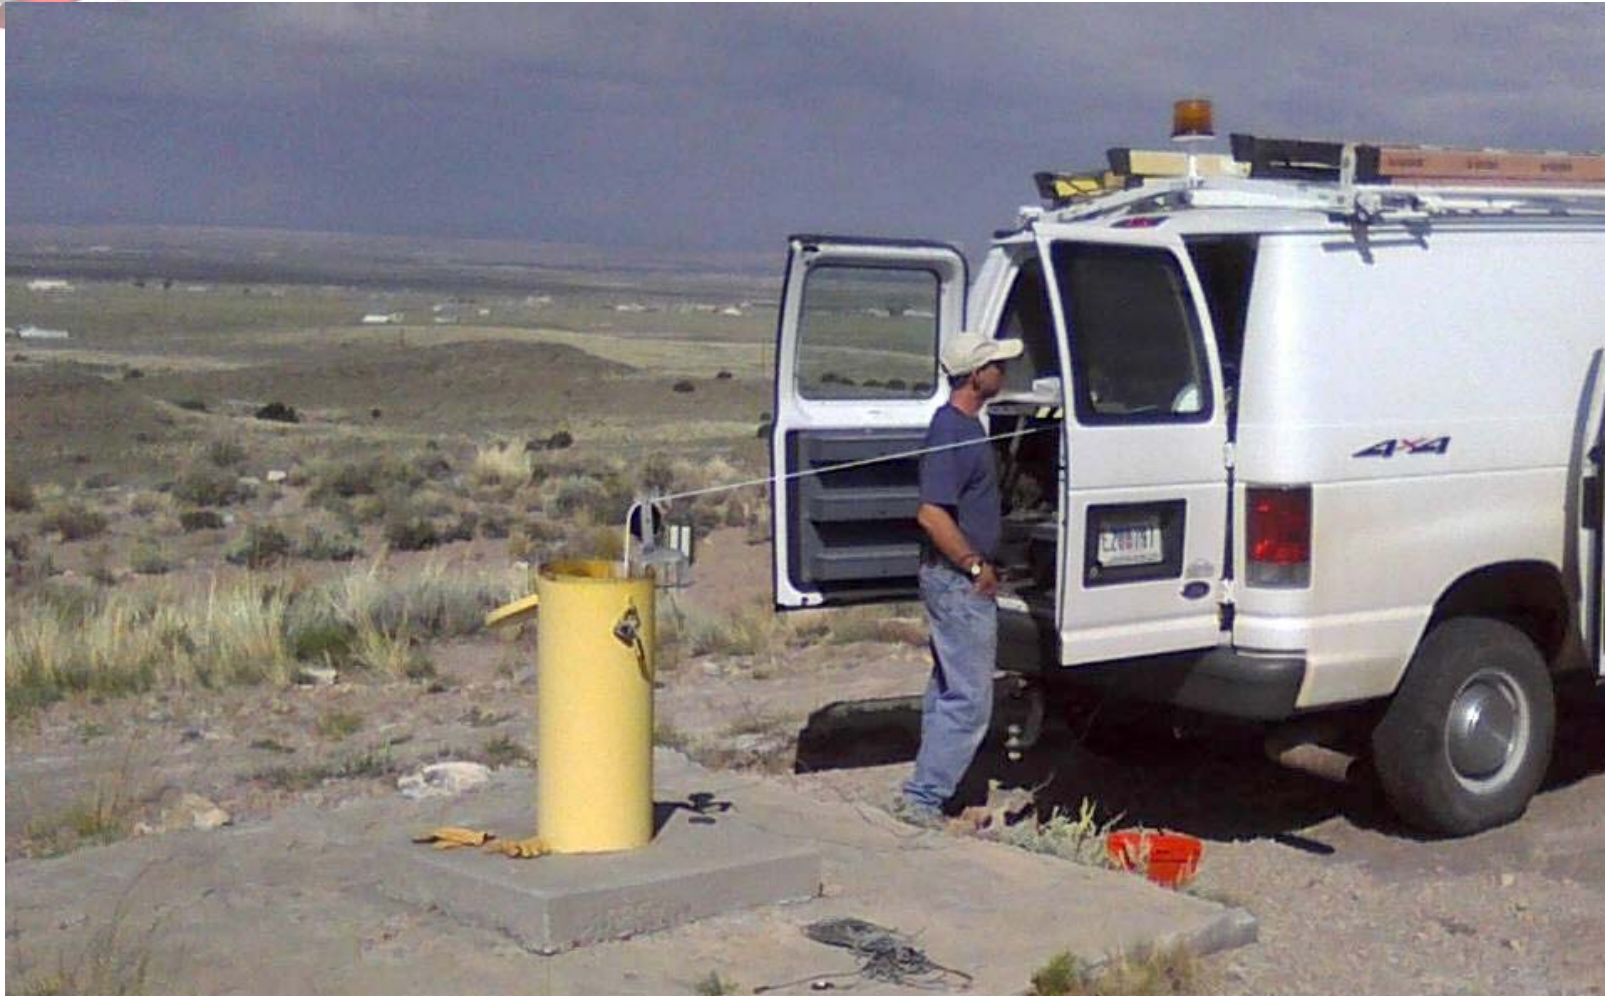
Demonstration of video-logging
monitoring well

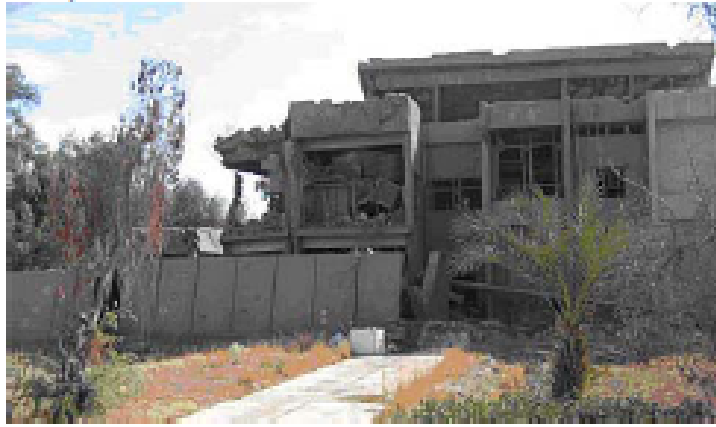
Facility Number:	Facility Name: Al-Tuwsitha Building 9 Radiochemistry Laboratory
Facility History: This building contains Italian-supplied equipment including labs, hot-cells, glove boxes, ventilation trap filters and storage tanks for liquid radioactive wastes. This lab was used for extraction of radionuclides and reprocessing the irradiated fuel to extract plutonium for research purpose.	Facility Photo:

Current Condition: This building was destroyed in the 1991 war. Some areas inside the building are heavily contaminated. The hot cell area was heavily damaged during the war but the glove box line for Pu work survived intact - concrete was poured inside all of these glove boxes by IAEA inspectors to make them unusable. Areas outside the glove boxes are contaminated, but not heavily. The storage tank contains about 3 m ³ of high level liquid waste of alpha, beta and gamma emitters resulting from the dissolution of radionuclides from the irradiated fuel. The access to the tank is very difficult. The total solid waste is estimated to be about 33 tons and the liquid waste 3 m ³ possibly 10 m ³ .

Size:	
Contaminants of Concern: The internals of the glove boxes will have some Pu contamination. Fission product and actinide

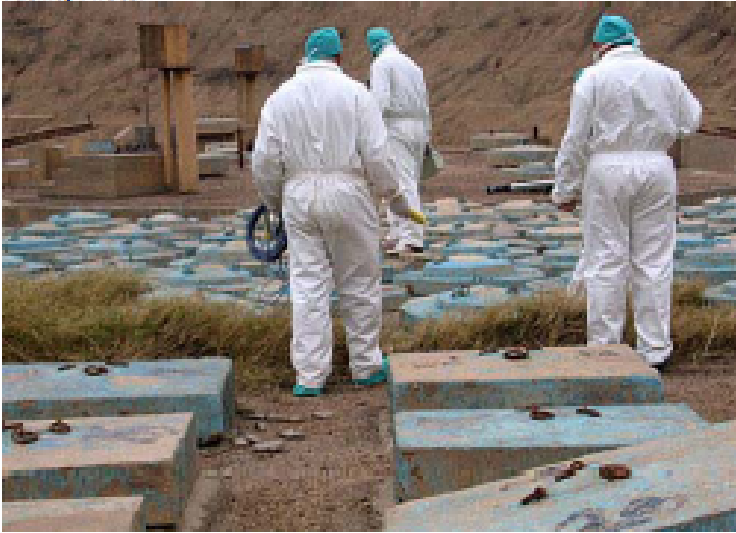
Facility Number:	Facility Name: Al-Tuwaitha Building 40 Russian Silos
Facility History: Used for both solid (98 wells/silos) and liquid waste: - liquid wastes evaporated to solid many years ago. Former liquid waste tank still shows high activity. Contents of the silos and liquid tank are unknown: some waste probably originated from the IRT upgrade but the origin of the higher activity waste is unknown. Known leakage to ground after nearby bomb explosion - further information on ground contamination would be desirable.	Facility Photo:

Current Condition: Structure still present but in decayed state. Roof structure might be unsafe. Surrounding ground areas show spotty contamination. 98 wells/silos contained about 20-30 te solid waste from IRT (including upgrade); 1967-90. 70-80 te solid waste added around 1991 from unknown origin. There were unconfirmed rumors of buried contaminated items in the surroundings.

Size:	
Contaminants of Concern: Co^{60} , Cs^{137} and others
