Data Package Supporting Application and Certification of Comparative Vacuum Monitoring Sensors For In-Situ Crack Detection

In-Situ Health Monitoring for Aircraft Using Comparative Vacuum Monitoring Sensors

Results from Laboratory and Field Evaluation Program for Modification of NDT Common Practices and Standard Practices Manuals and AMOC Applications

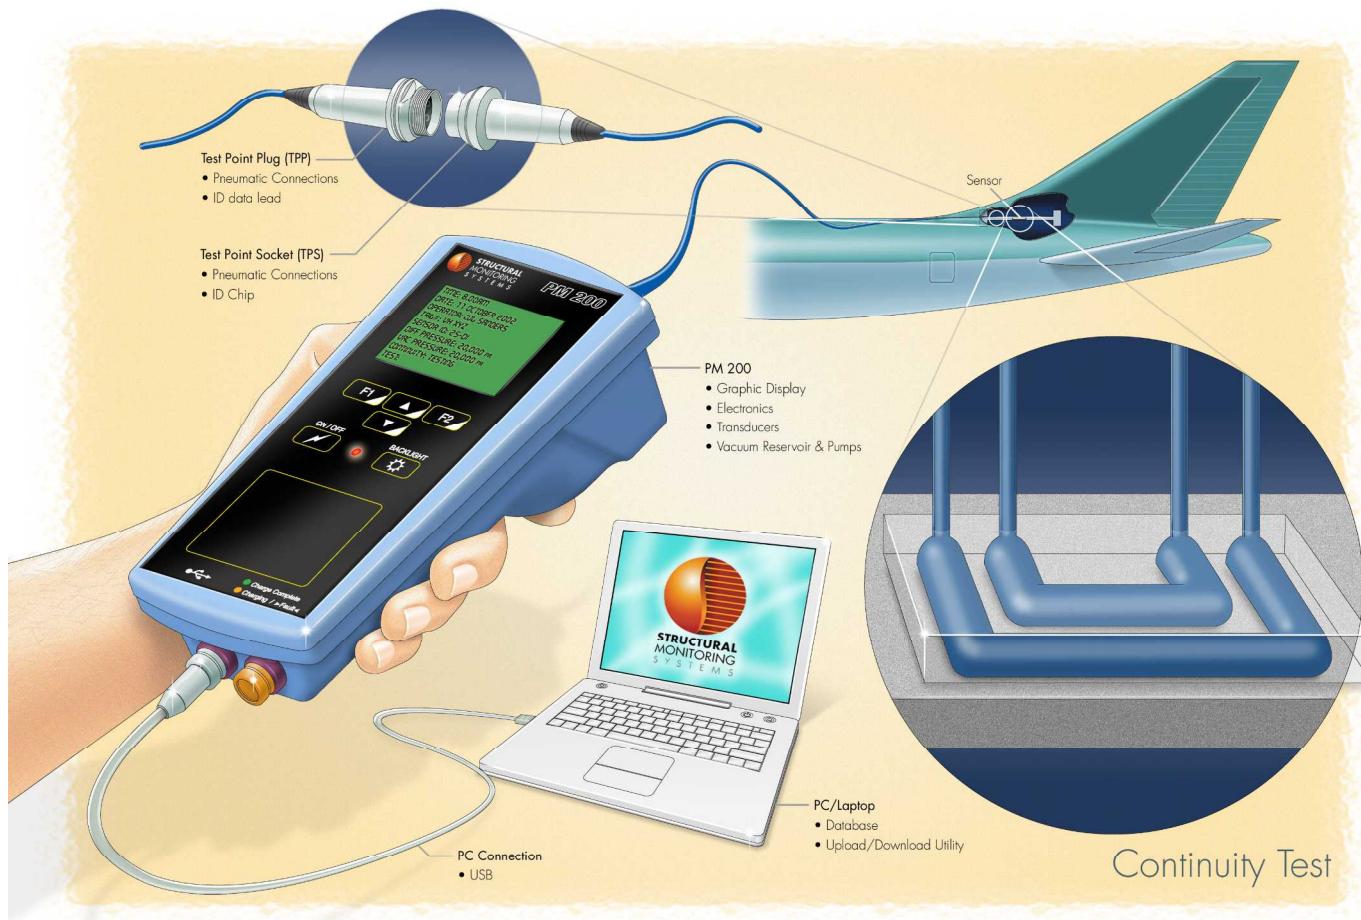
Step 1: Continuity test

- Establishes no blockage in system
- CI should read high

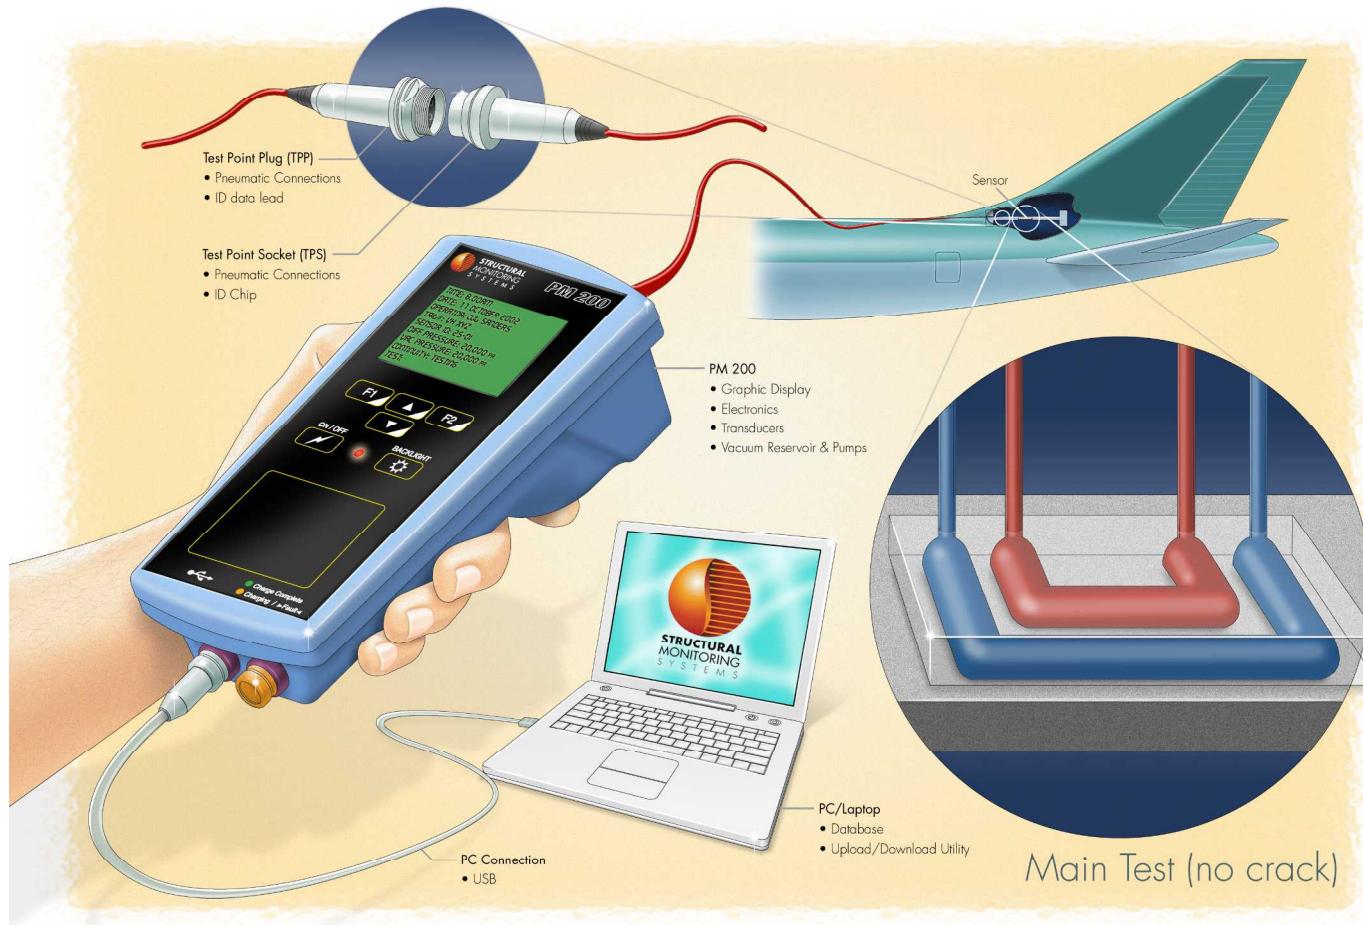
Step 2: CVM test

- Establishes no crack breaching sensor
- CI should read low (0.5 or less)

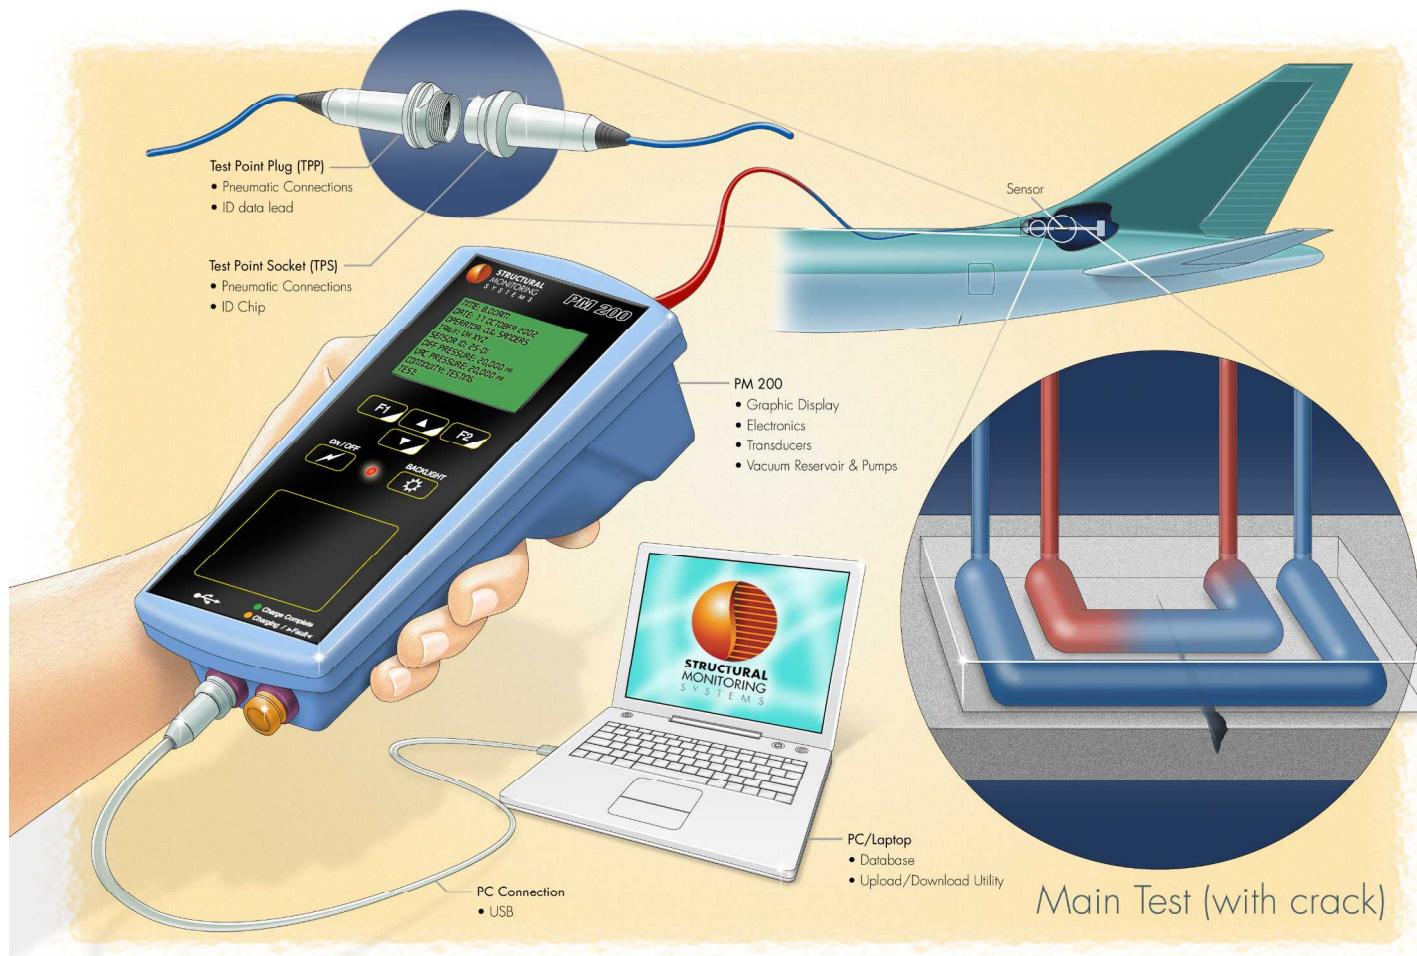
Step 2: CVM test

If crack breaches sensor.....
CI will read higher than 0.5 (usually much higher)

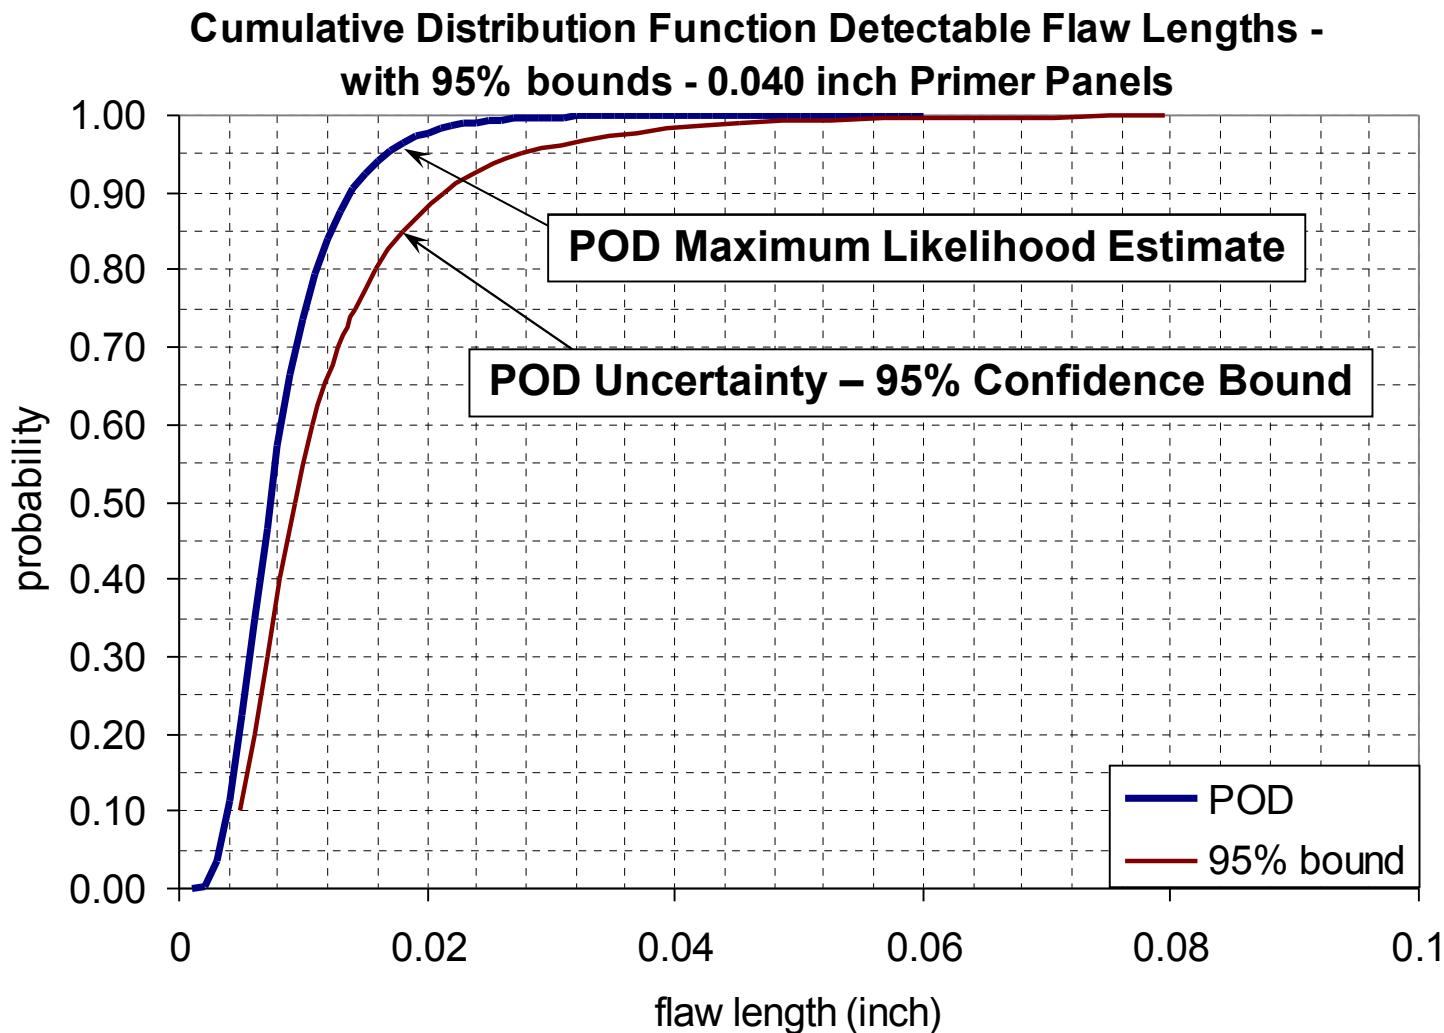
Sample Probability of Detection Curves for CVM

2024-T3 Alum.

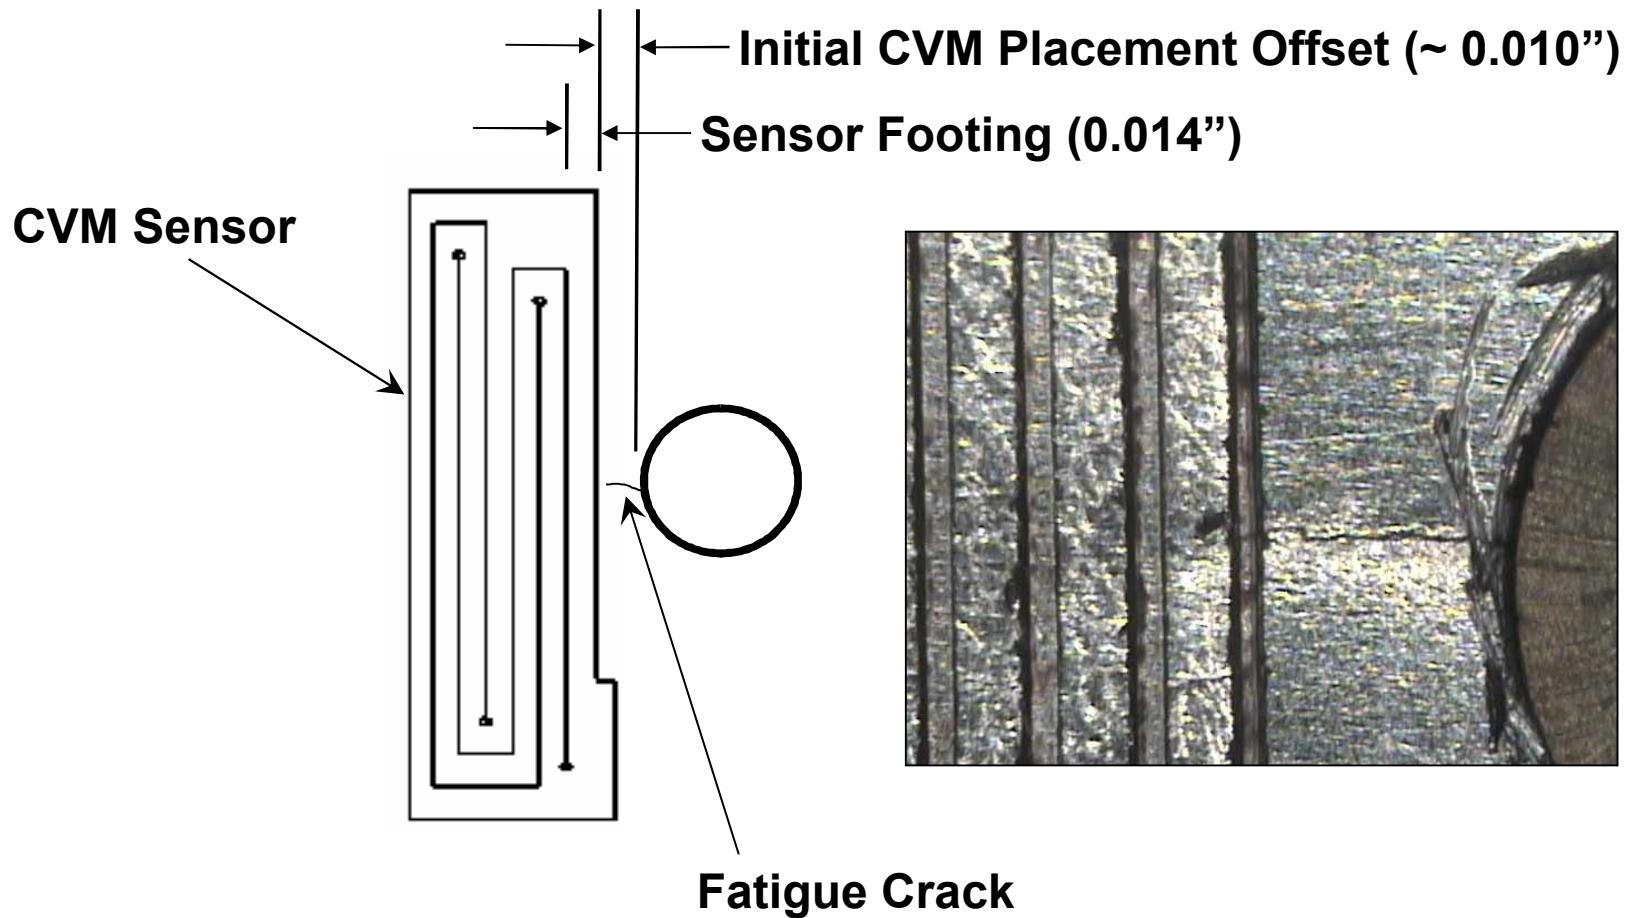
Determining Final CVM Crack Detection Level from Crack “Lag” Values

Total Crack Length at Detection = CVM Lag Detection + 0.014" + 0.010"

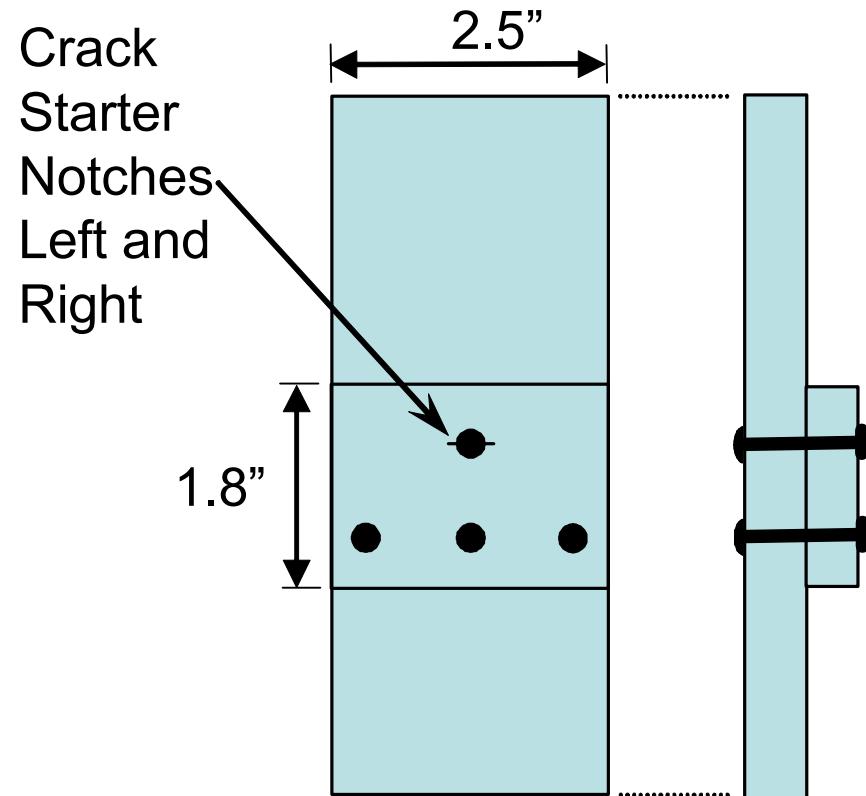
Schematic of Test Specimen to Assess CIC Affects on CVM

Test Specimen: 2.5" wide plate with a doubler plate riveted to the back (7075-T6); two rows of rivets; upper rivet row is only the single center hole in order to ensure controlled crack growth (highest center stress); single rivet also provides more space for CVM sensors as cracks grow so that more data can be acquired from each specimen

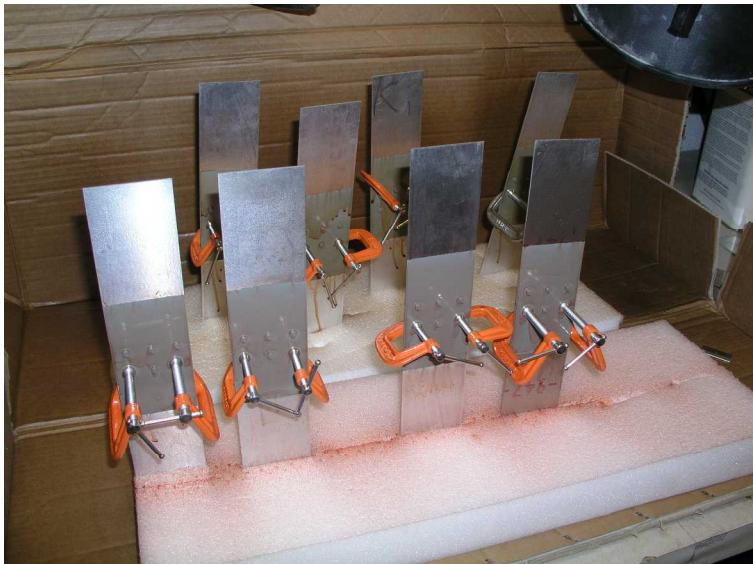
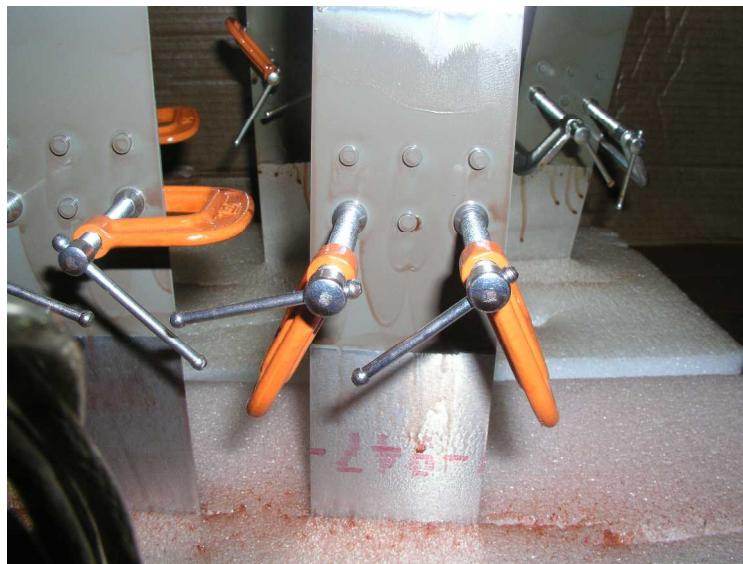
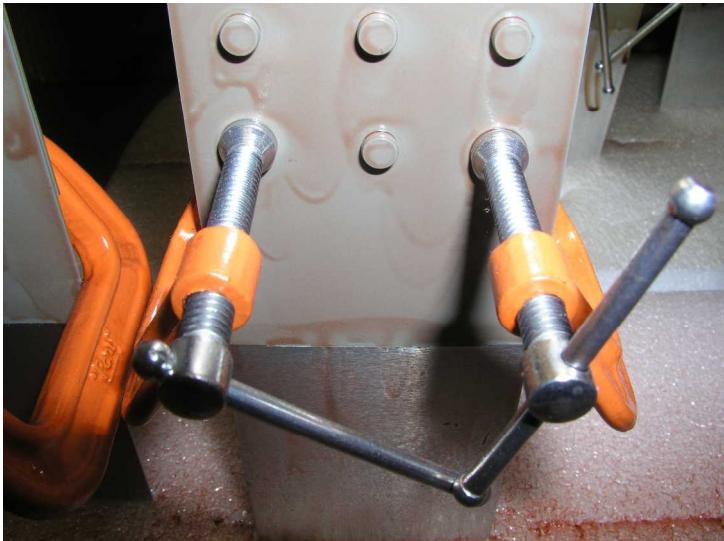
**Application of CIC
Compounds (Corban-35 and
AV-8) to Test Specimens Prior
to Fatigue Crack Growth
[starter notch in place]**

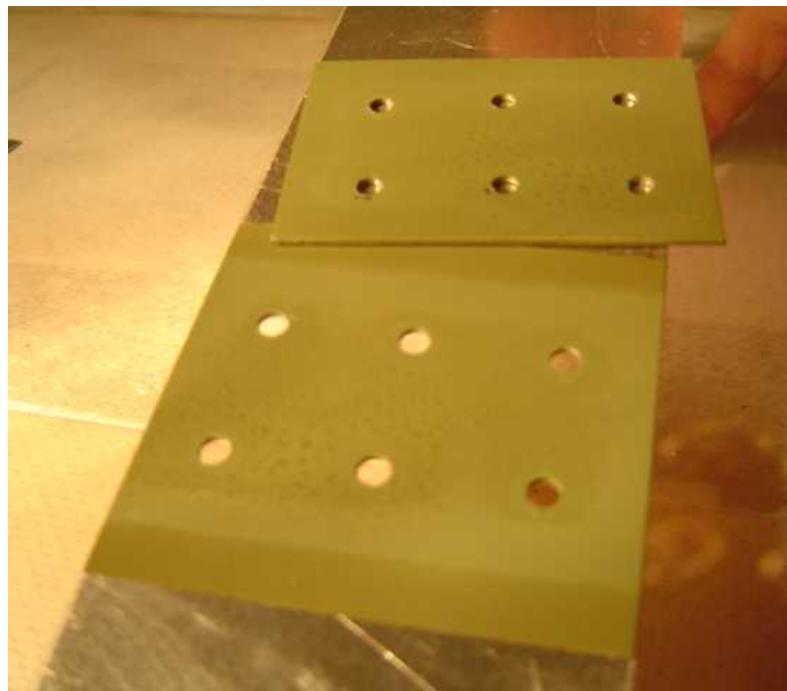
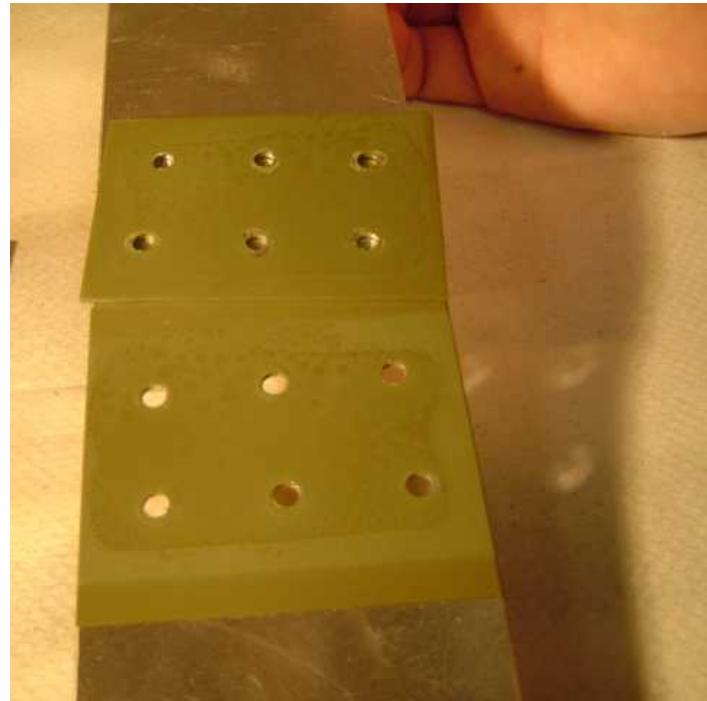
Result for Cor-35-Cure-1 thru Cor-35-Cure-3: After 24 hrs. - outside dry; inside very tacky; will not flow or wipe off; After 48 hrs. - hardened coating like nail polish

*Cor-35-Cure-1 with excessive spray;
still mostly cured in 24 hrs.*

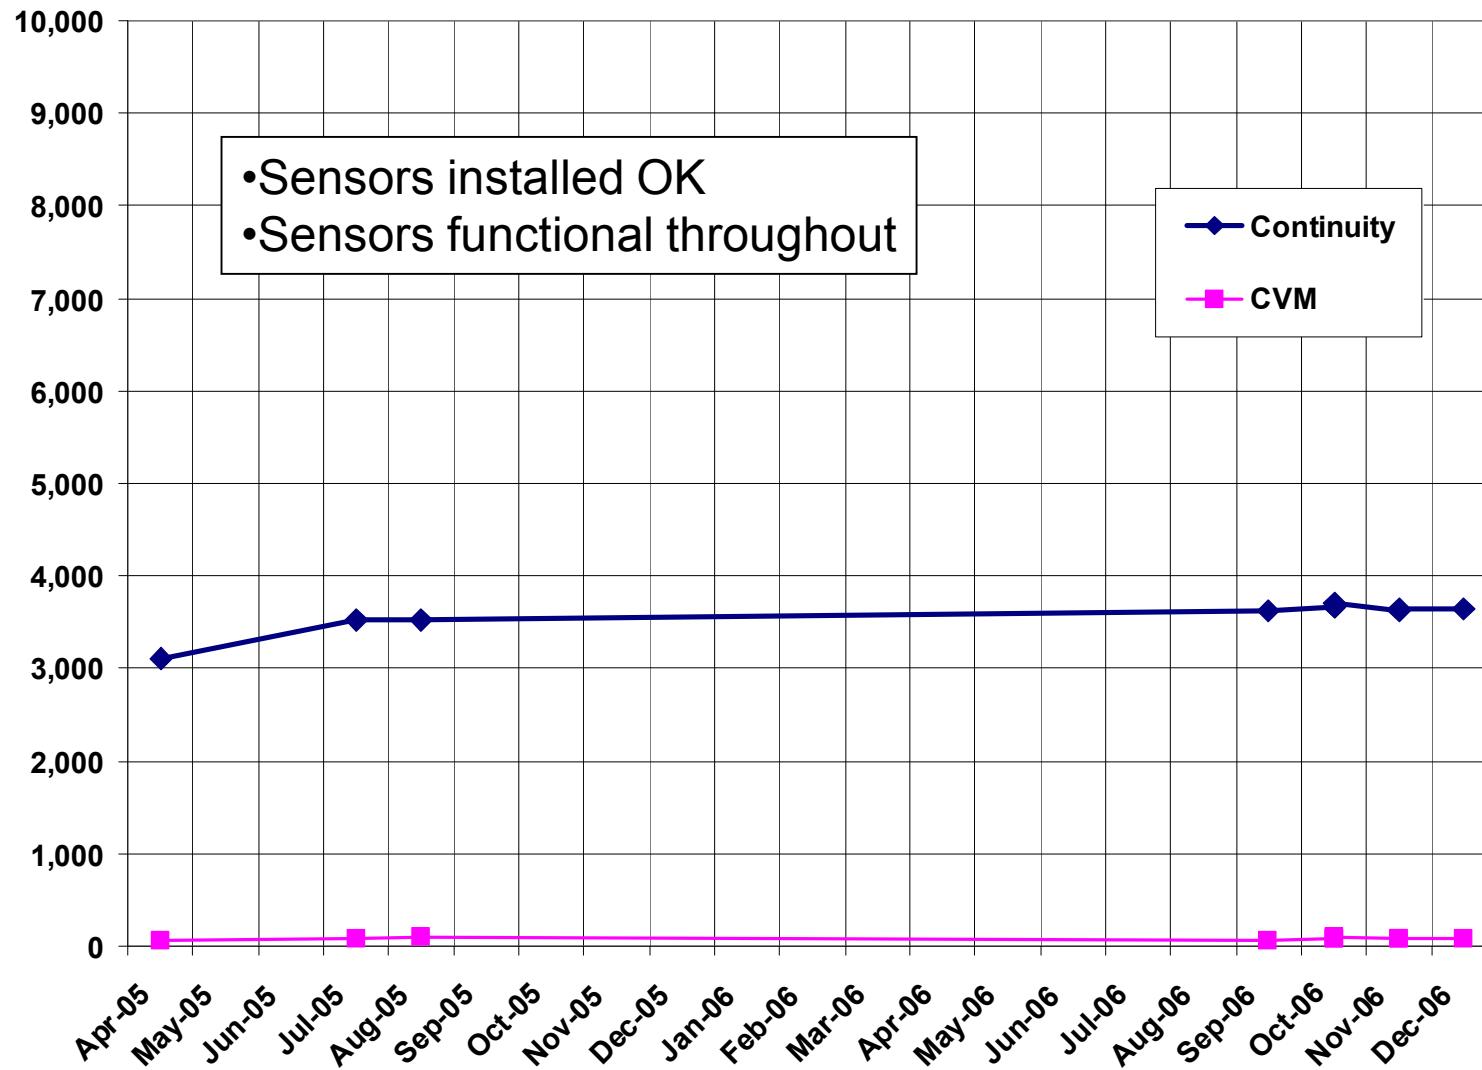
North West - DC9
AC9968 - sta 1104 Left

Sensor Type 2

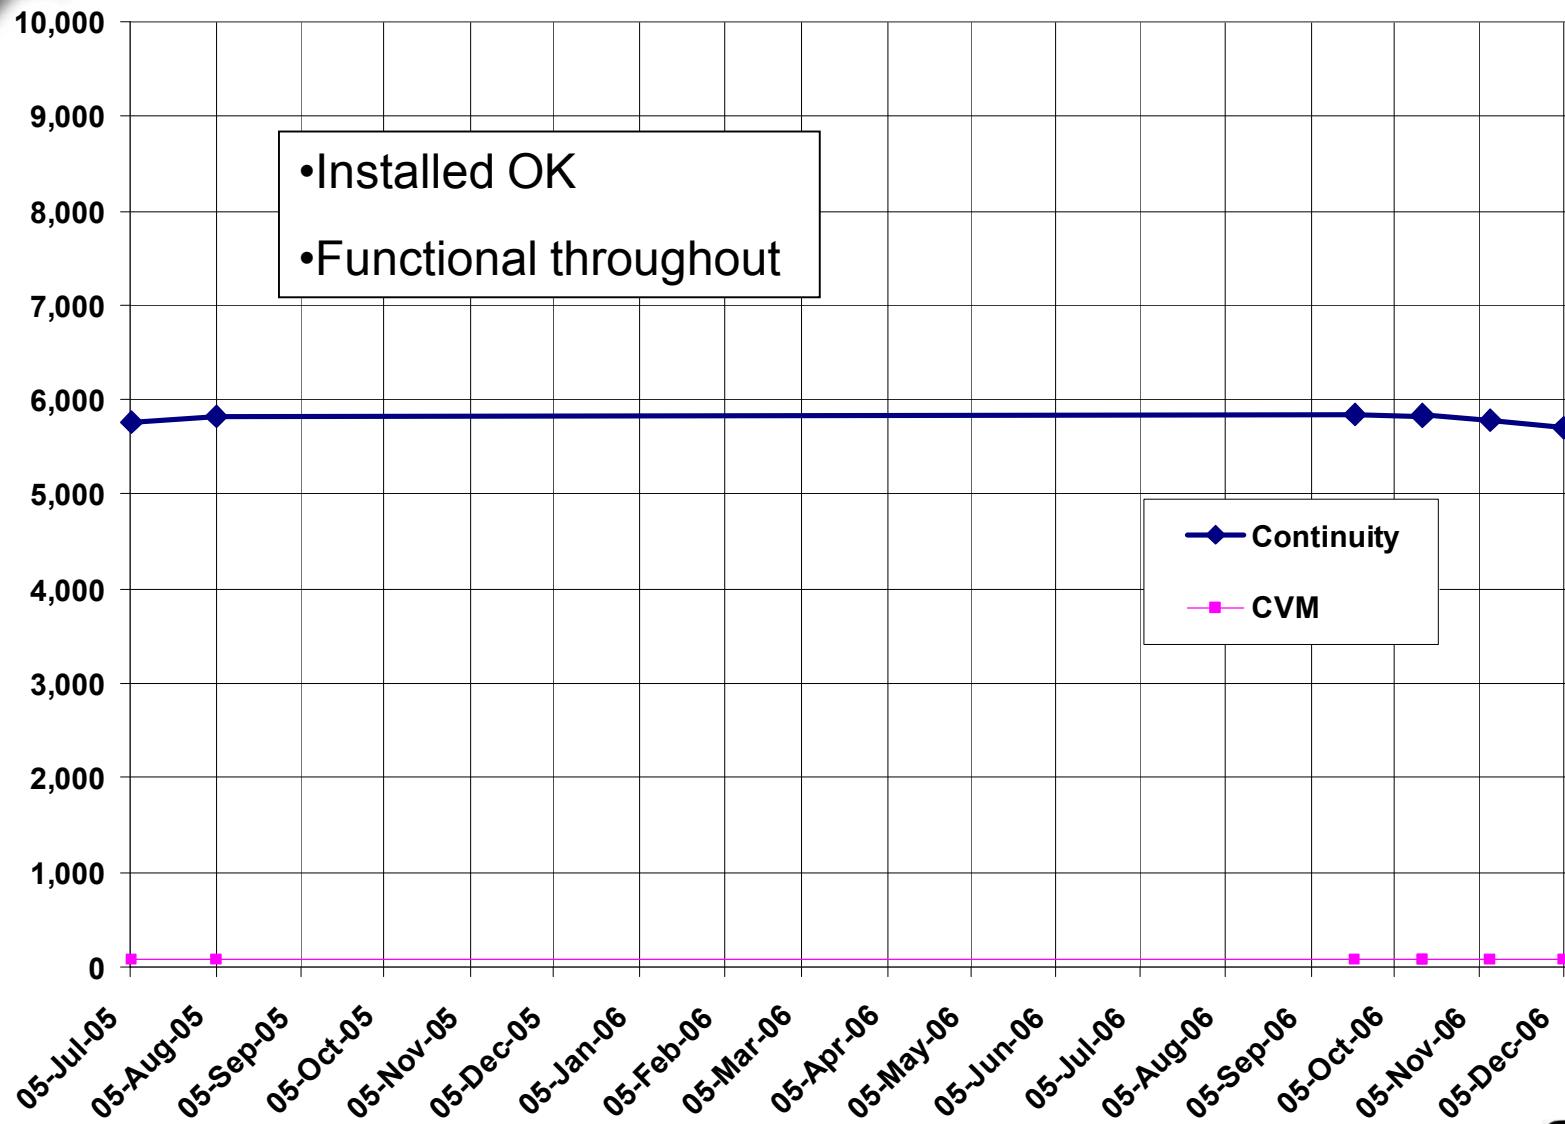
Delta - 767
Aft Pressure Bulkhead - Unpressurised
(AC1181)

Sensor Type 2

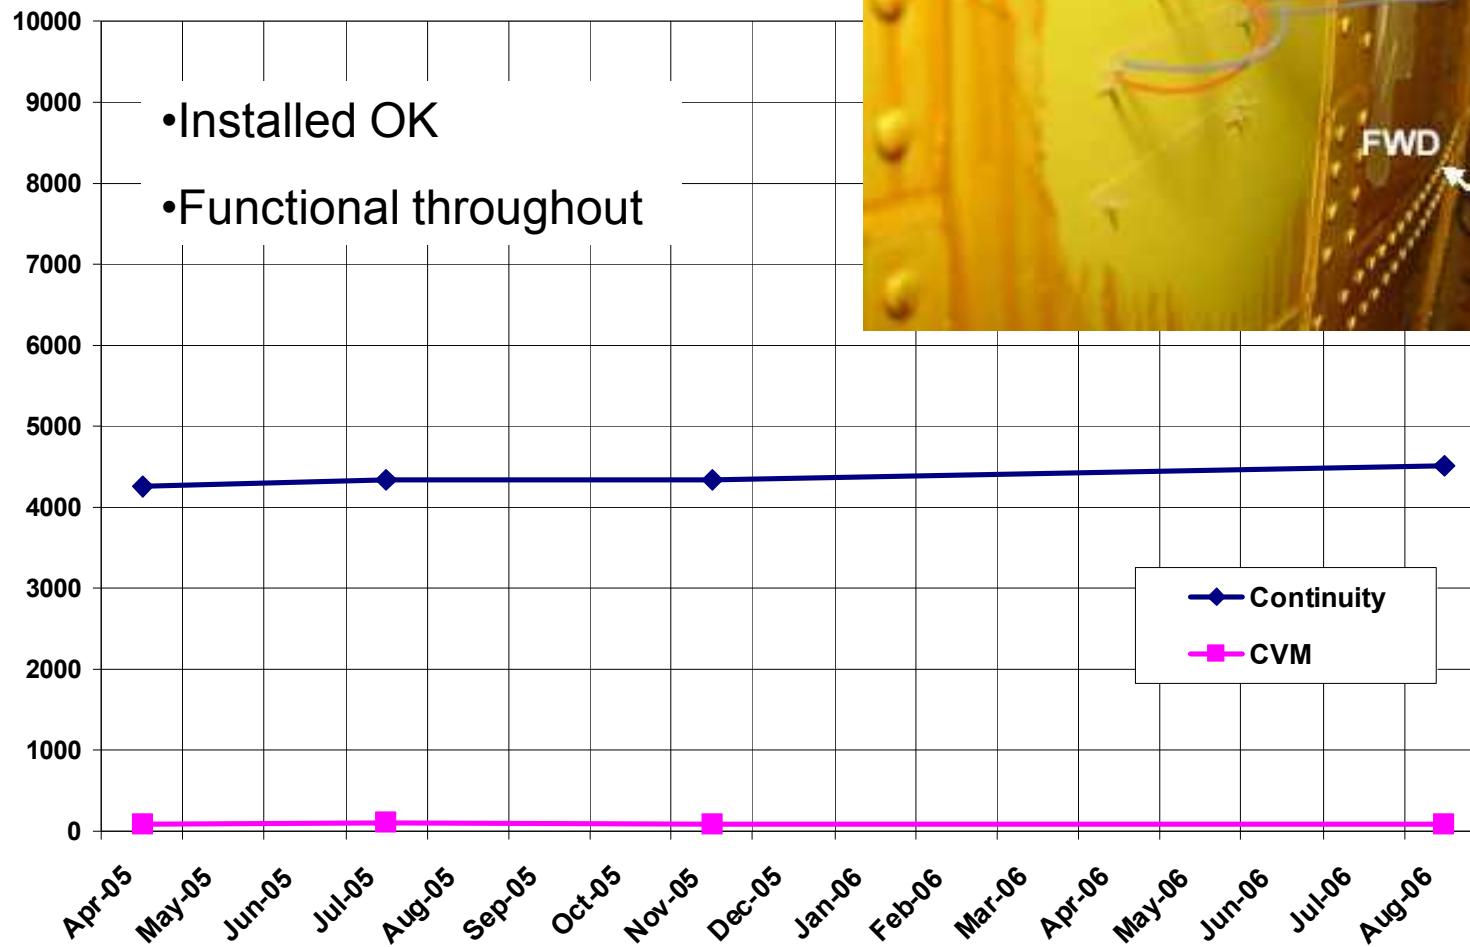
Delta - 767
Empennage - Unpressurized
(AC1181 - STA 1629)

Sensor Type 2

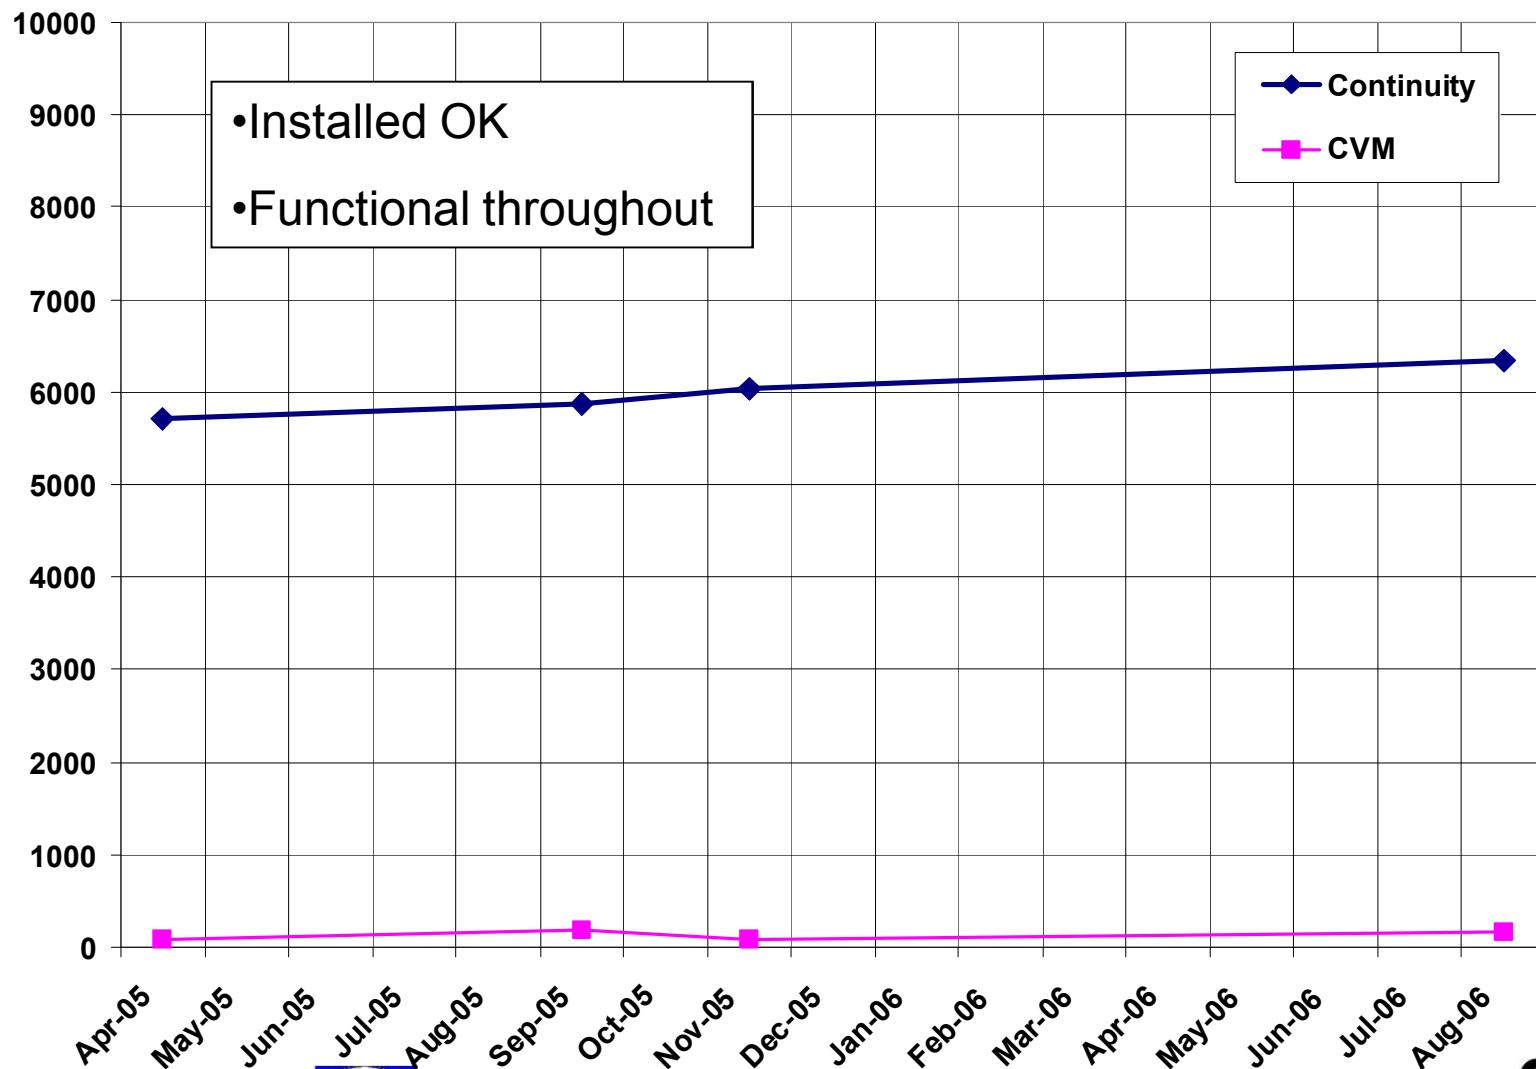
North West - DC9
AC 9961 - (rear baggage) voice recorder

Sensor Type 1
