**DESERT RESEARCH INSTITUTE  
CULTURAL RESOURCES REPORT LR040120-1  
PROJECT NO. 201323**

**Finding of Adverse Effect and Mitigation Documentation for the Stormwater Drainage and  
Street Systems, Substation Foundations, and the Bus Parking Lot in Mercury,  
Area 23, Nevada National Security Site, Nye County, Nevada**

The purpose of this letter report is to submit documentation related to the finding of effect for the undertaking and mitigation of four resources on and adjacent to the block that will be affected by planned activities to modernize parking and infrastructure in central Mercury. Two of these resources are portions of the street system and the stormwater drainage system, which are elements of the town's infrastructure. The foundations of an old electrical substation and the bus parking lot will also be replaced by new parking or landscaping. This submission is intended to comply with the stipulations in the *Programmatic Agreement between the National Nuclear Security Administration Nevada Field Office and the Nevada State Historic Preservation Officer Regarding Modernization and Operational Maintenance of the Nevada National Security Site, at Mercury in Nye County,

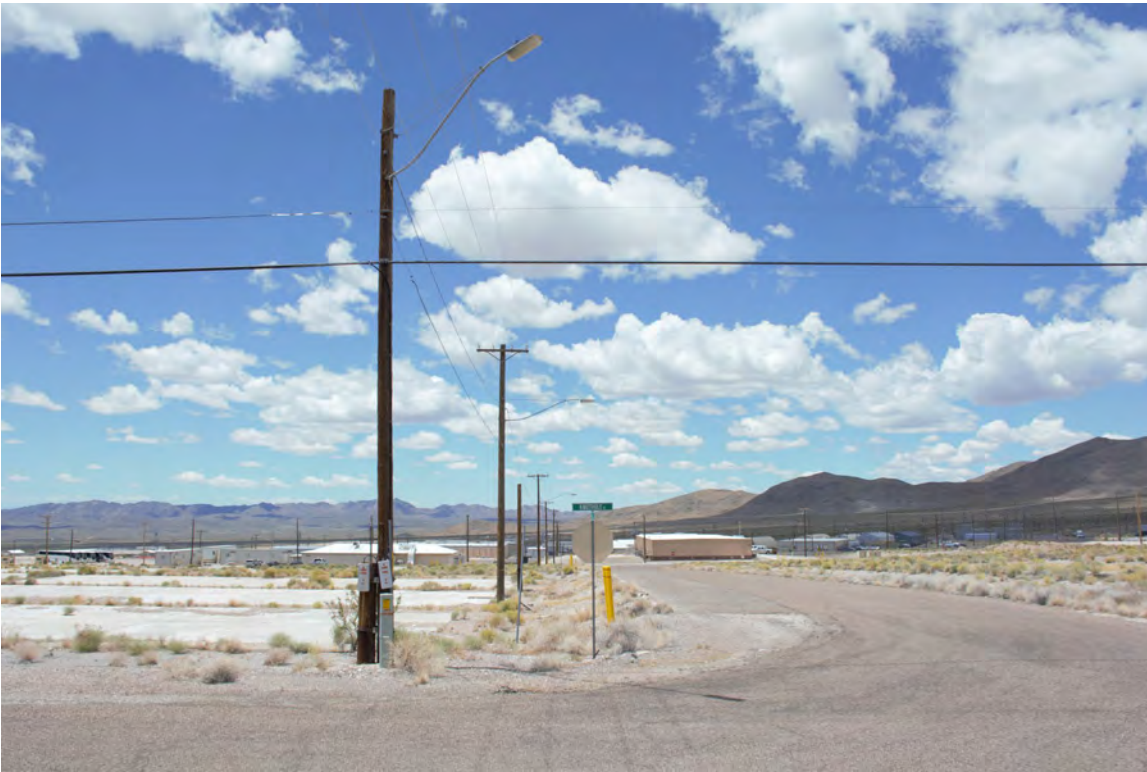
The intersection of Knothole St. and Upshot Ave.

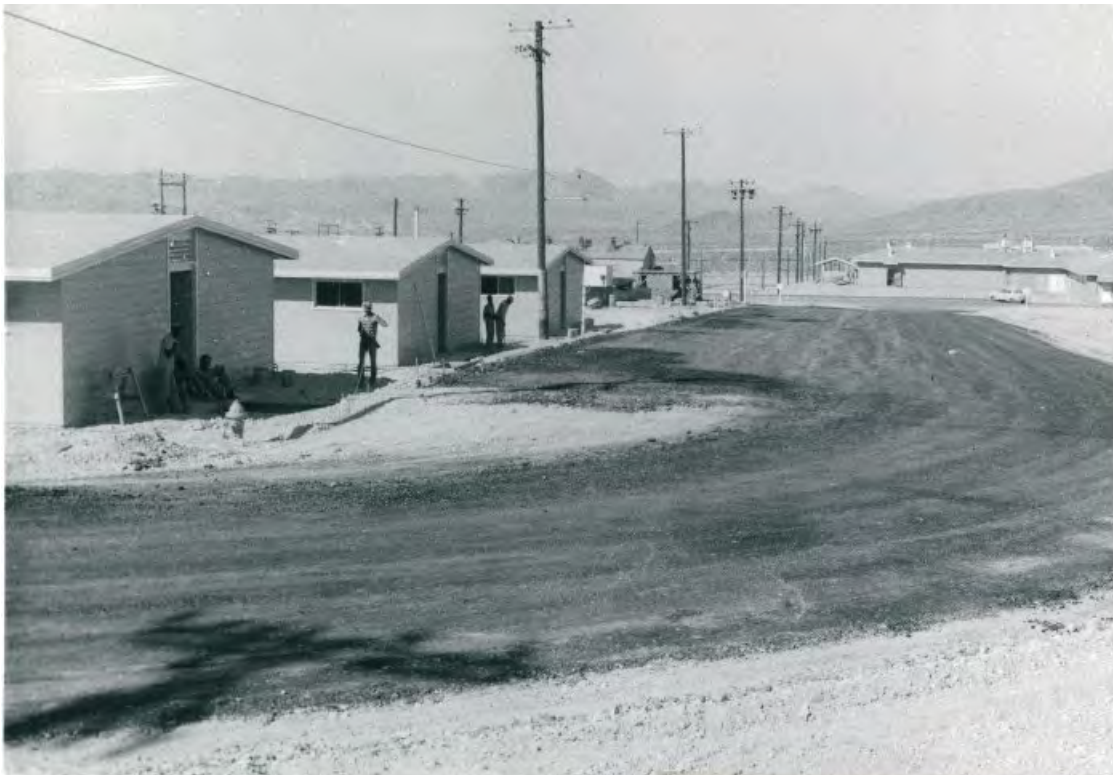
A similar view of Upshot Ave. just after its original construction, taken on September 25, 1956. (AEC 1956)

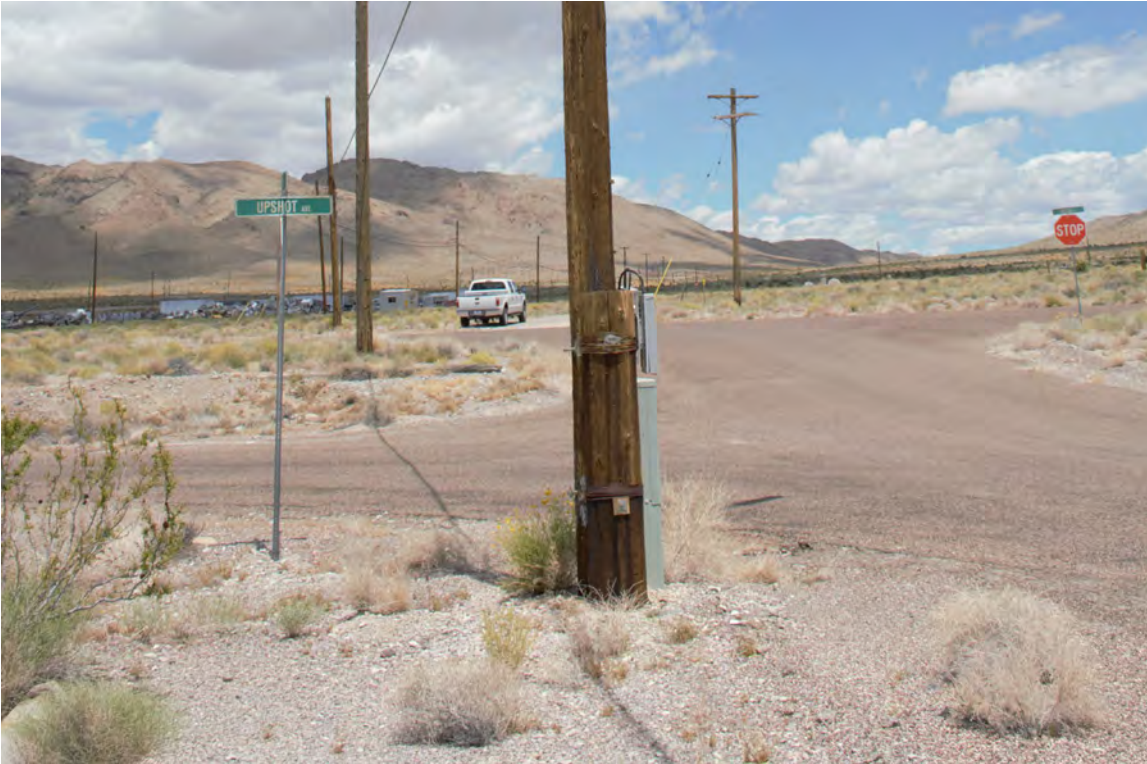
The intersection in the background is the location at which Tumbler Ave. on the left becomes Nougat Street on the right. Upshot Ave. is in the left foreground.

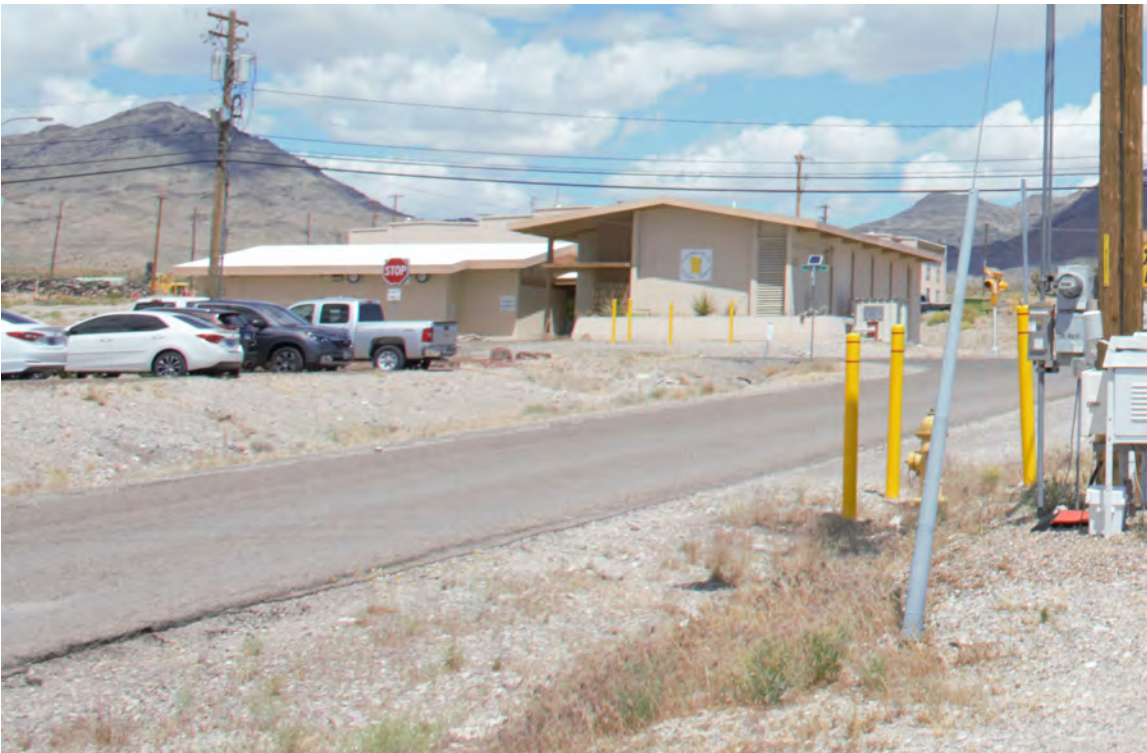
Trinity Ave., approaching Buster St. The former chapel is in the background.

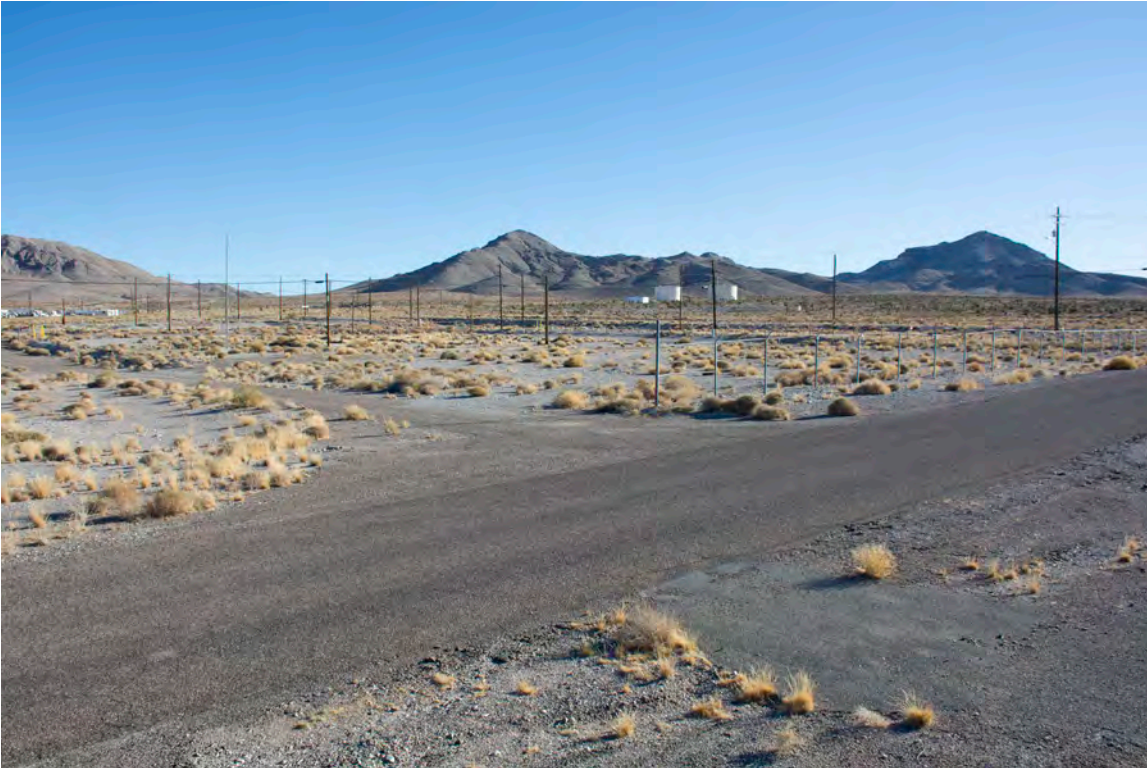
Sandstone Ave. between Jangle St. and Knothole St. The lot on the left previously contained Quonset huts.  
Direction facing: Northeast      Photographer: DRI      Date: 2019

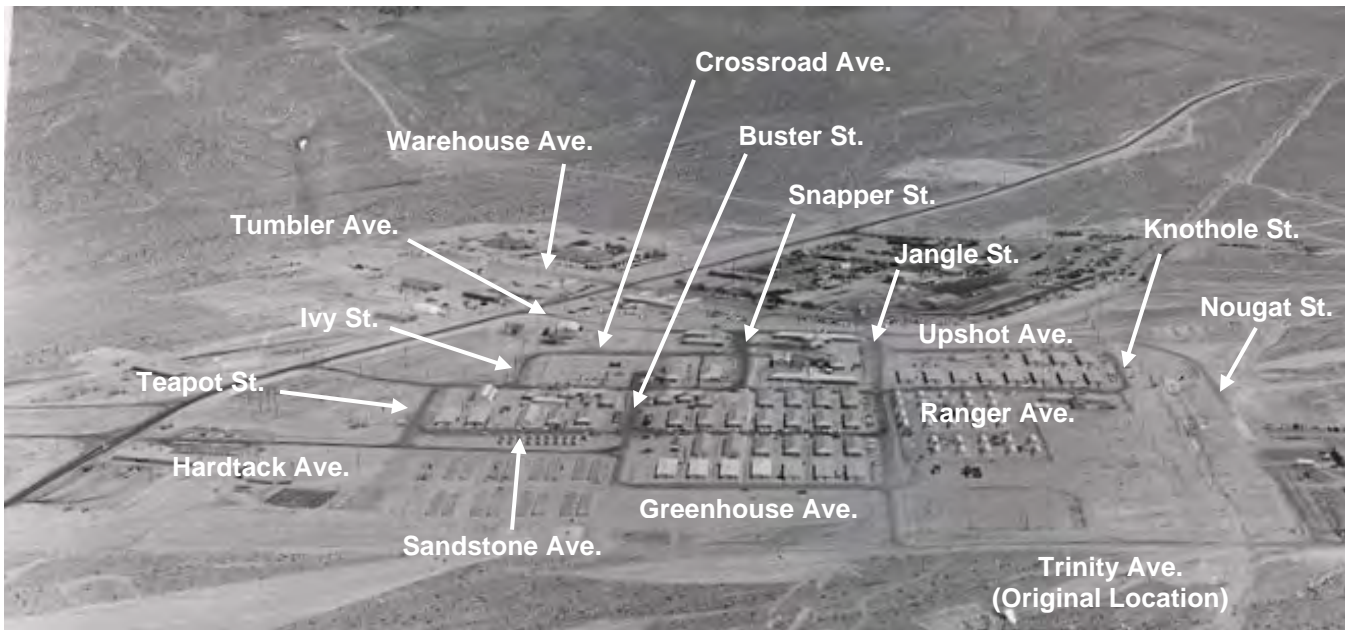
View of the street system in mid-1959. Avenues generally run east-west and streets run north-south.  
Direction facing: North      Source: REECo 1982, Photo 682-5      Date: 7/27/1959  
Road name source: REECo 1963

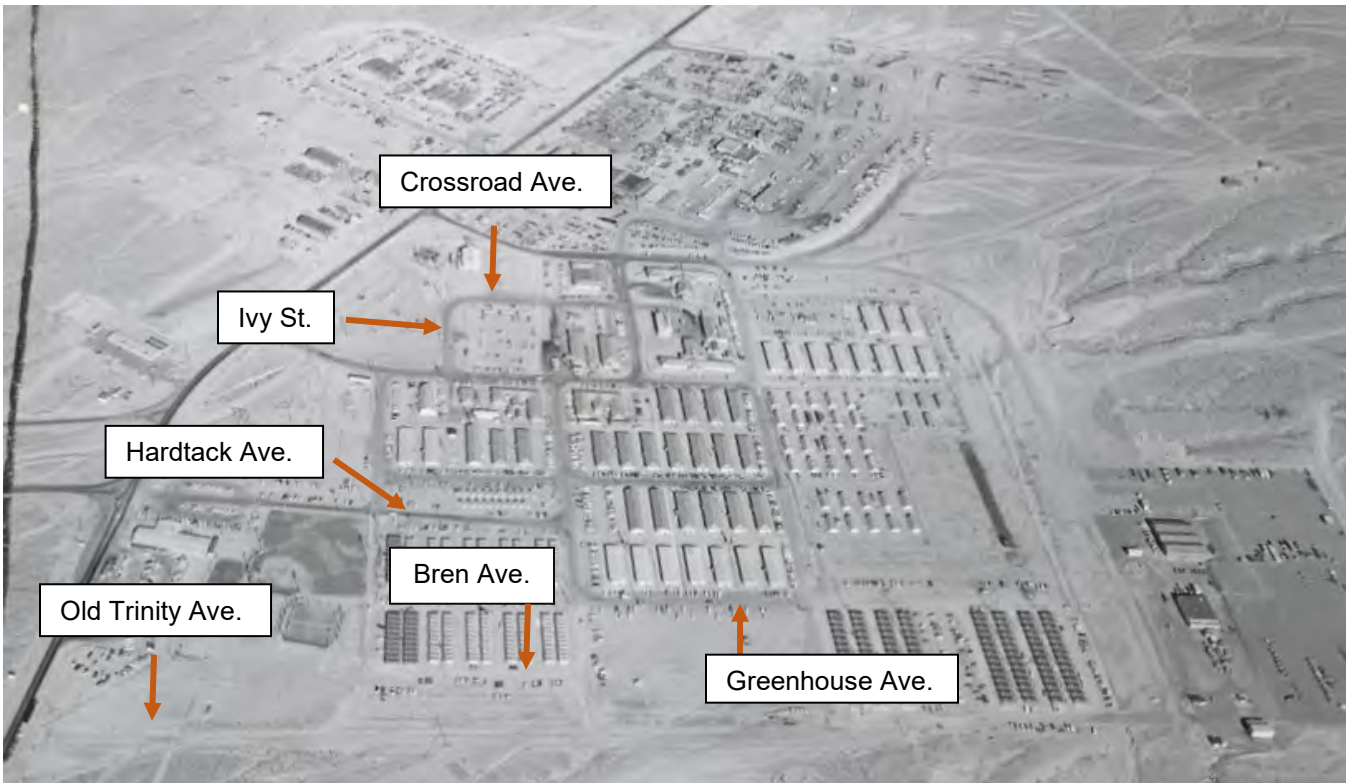
View of the street system in 1961. The street segments noted by the arrows and labels no longer exist.  
Direction facing: North      Source: REEC0 1982, Photo 1165-10      Date: 12/7/1961  
Road name sources: Koebig and Koebig 1965, REEC0 1963

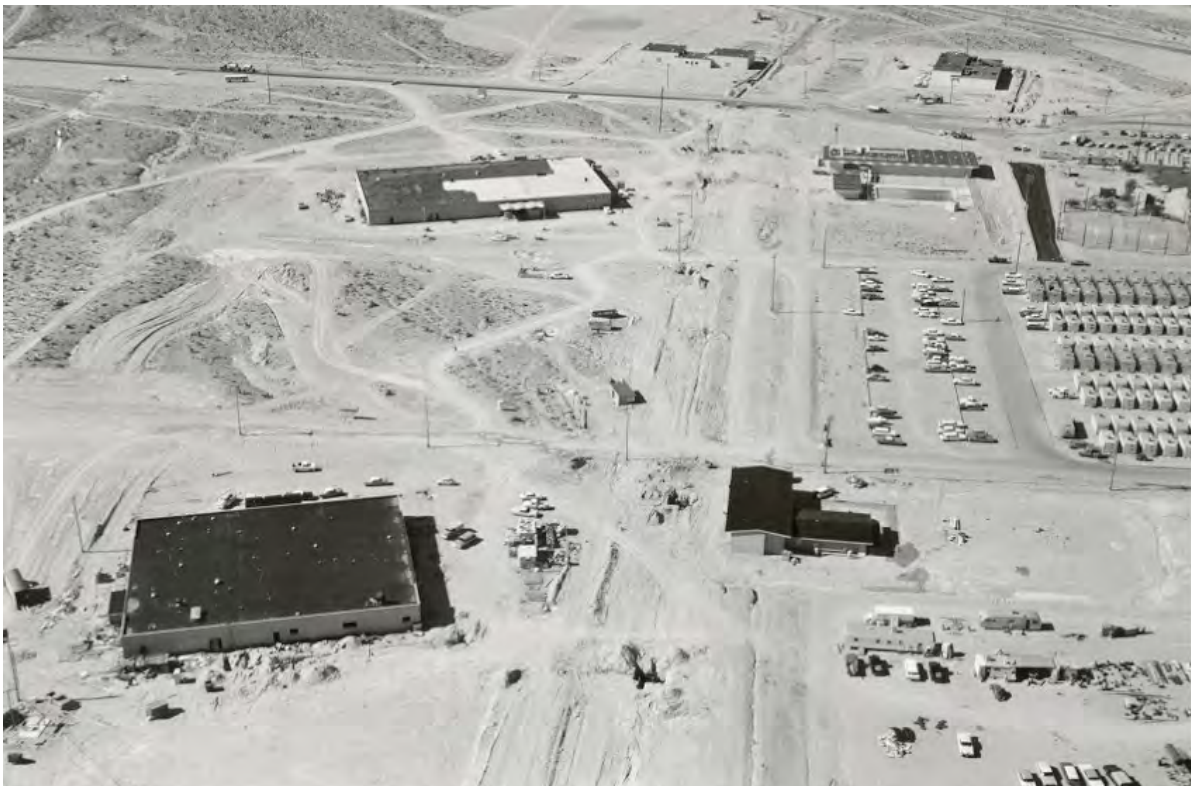
Trinity Ave. being reconstructed approximately 130 ft (40 m) to the south of its original location during a 1963 construction boom.

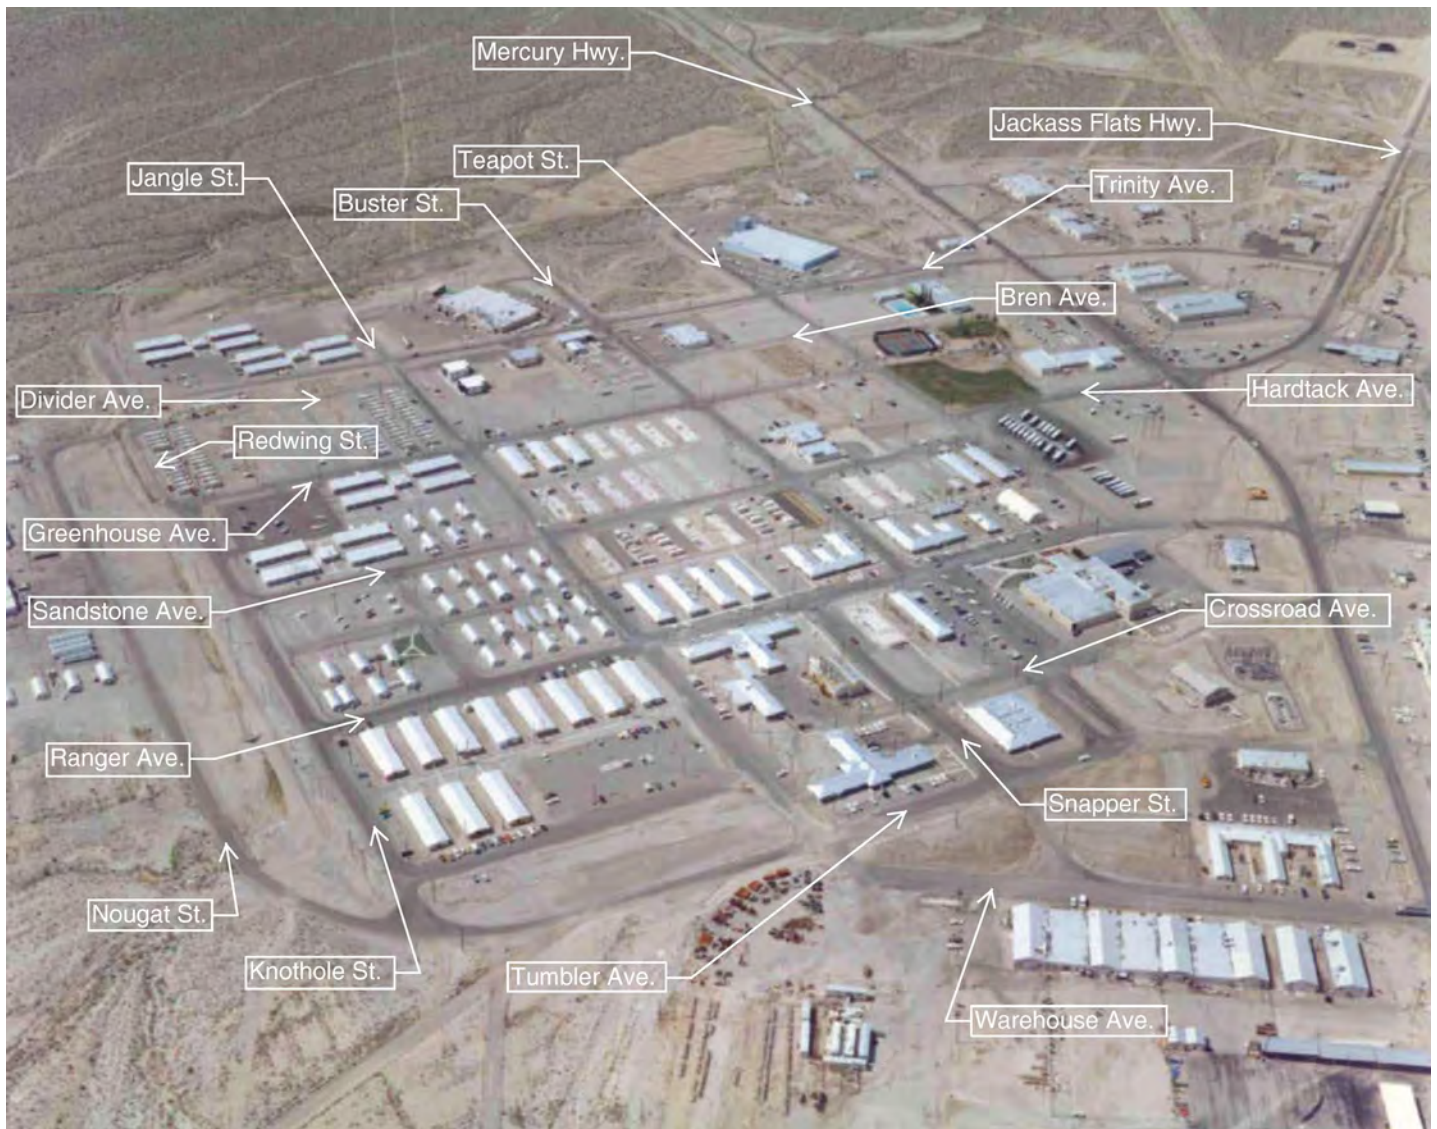
Before Knothole St. was extended south of Ranger Ave., the road east of the men's trailer park was named Redwing St. The segment of the old Trinity Ave. between Knothole St. and Jangle St. was renamed Divider Ave. Direction facing: South-southwest. Source: <https://www.flickr.com/photos/diffenderfer/15000826196/>, accessed 11/07/2019. Date: c. 1981. Road name sources: Koebig and Koebig 1965, Olsen 2017, REECo 1963.

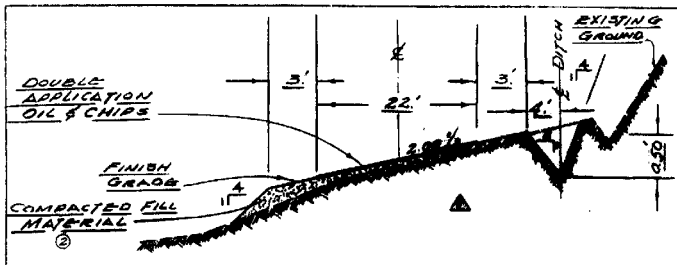
NTS  
 SHEET NO. 23-C21

- ① ALL UTILITY LINES WITHIN CONSTRUCTION AREA TO BE "GOLDAKED," & STAKED BY REECO SURVEY BEFORE CONSTRUCTION BEGINS.
- ② COMPACT FILL IN 6 INCH LIFTS TO 95% MAX. DENSITY AT OPTIMUM MOISTURE CONTENT. SCARIFY EXISTING GROUND 6" MAX. BEFORE PLACING NEW FILL. (ASTM D-1557) METHOD "D".
- ③ NO GRADING NECESSARY IN THIS AREA.
- ④ THIS AREA 6490 FT.<sup>2</sup>
- ⑤ " 19,291 FT.<sup>2</sup>
- ⑥ DOUBLE APPLICATION OIL & CHIPS.  
 PRIME WITH MC-70 @ 0.30 GAL/59. YD., CURE AS PER ASPHALT INSTITUTE RECOMMENDATIONS  
 1ST COAT OIL RC-800 @ 0.30 GAL/59. YD.  
 1ST COAT CHIPS 3/4" MINUS 20%-30%/59. YD.  
 2ND COAT OIL RC-800 @ 0.35 GAL/59. YD.  
 2ND COAT CHIPS 1/2" MINUS @ 25%-30%/59. YD.  
 COMPACT W/RUBBER TIRE ROLLER 45 PSI MIN. CONTACT PRESSURE.

BROOM OFF CHIPS BETWEEN 1ST & 2ND COAT OF OIL.  
 ROAD BED TEMP. MUST BE 40°F & RISING BEFORE ANY OIL CAN BE APPLIED.  
 MOISTURE CONTENT OF ROAD BED CANNOT EXCEED 7% AT TIME OF OIL APPLICATION.

- ALL UTILITY LINES WITHIN CONSTRUCTION AREA TO BE "GOLDKED" & STAKED BY RECO SURVEY BEFORE CONSTRUCTION BEGINS.
- COMPACT FILL IN 6 INCH LIFTS TO 95% MAX. DENSITY AT OPTIMUM MOISTURE CONTENT, SCARIFY EXISTING GROUND 6" MAX. BEFORE PLACING NEW FILL. (ASTM D-1557) METHOD "D".
- NO GRADING NECESSARY IN THIS AREA.
- THIS AREA 6450 FT<sup>2</sup>.
- 19,231 FT<sup>2</sup>.
- DOUBLE APPLICATION OIL & CHIPS. PRIMA WITH MC-70 @ 0.30 GAL/50 YD. CURB AS PER ASPHALT INSTITUTE RECOMMENDATIONS. 1ST COAT OIL RC-800 @ 0.30 GAL/50 YD. 1ST COAT CHIPS 3/4" MINUS 20"-30" / 50 YD. 2ND COAT OIL RC-800 @ 0.35 GAL/50 YD. 2ND COAT CHIPS 1/2" MINUS @ 25"30" / 50 YD. COMPACT W/ RUBBER TIRE ROLLER 45 PSI MIN. CONTACT PRESSURE.
- CRUM OF CHIPS BETWEEN 1ST & 2ND COAT OF OIL. ROAD BED TEMP. MUST BE 40°F & RISING BEFORE ANY OIL CAN BE APPLIED. MOISTURE CONTENT OF ROAD BED CANNOT EXCEED 7% AT TIME OF OIL APPLICATION.

NO.	DATE	REVISION
AS BUILT CONDITIONS		
AS BUILT (MOVED E OF 7' EAST)

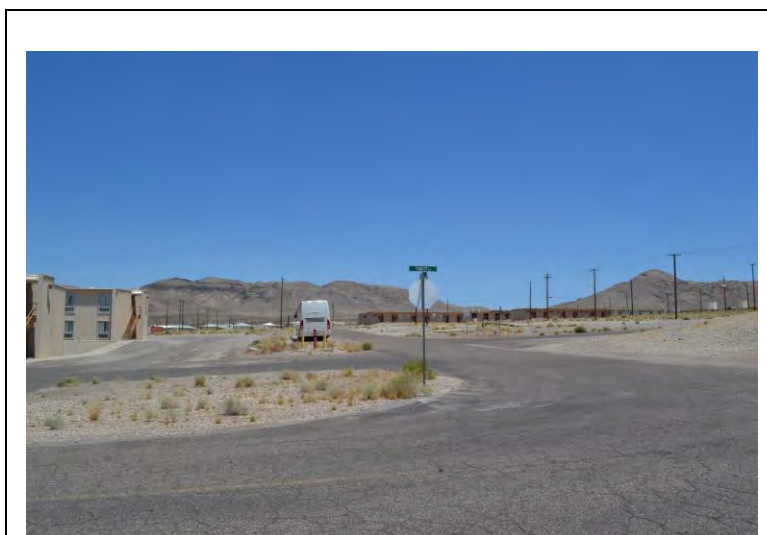
Intersection of Jangle St. and Trinity Ave., facing north (2017)

Condition of Resource(s)?		
Good <input checked="" type="checkbox"/>	Fair <input type="checkbox"/>	Poor <input type="checkbox"/>
Explanation: Maintained, in use.

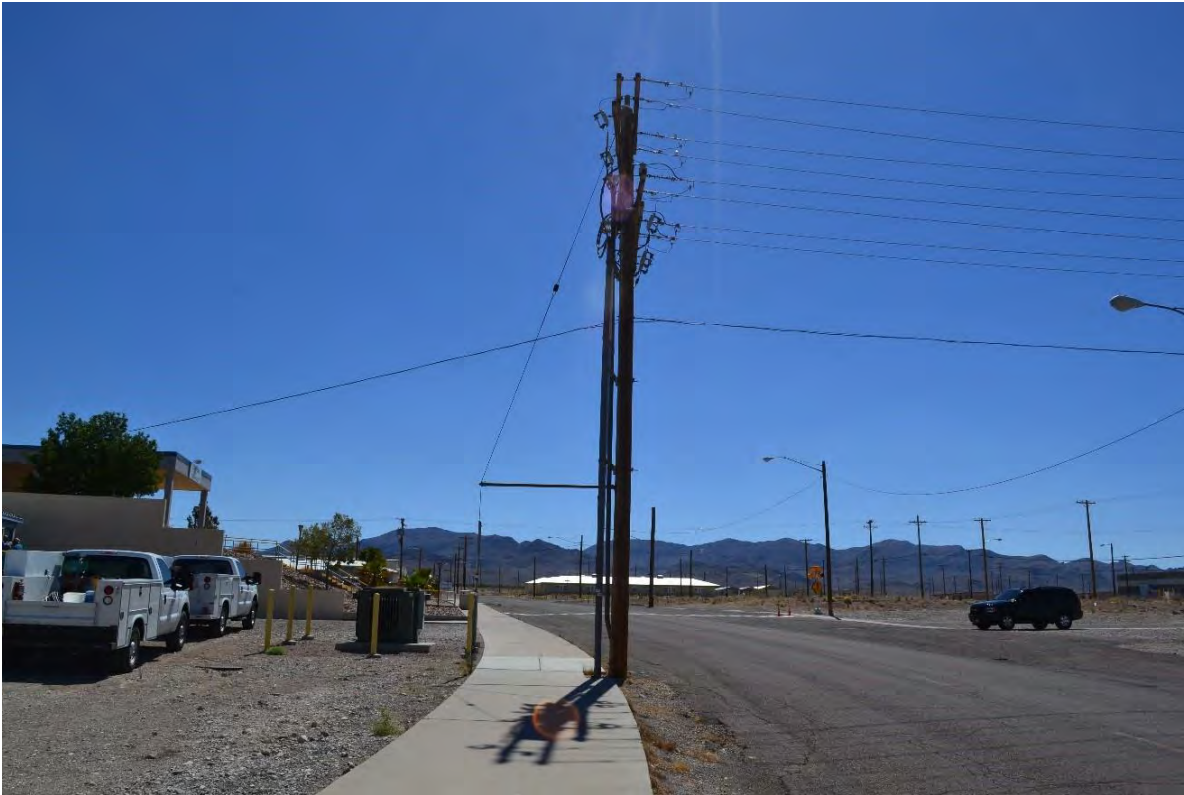
One of the few curbs found in Mercury, located on the north side of Ranger Ave. in front of the cafeteria.  
Direction facing: East      Photographer: Menocal      Date: 5/24/2017

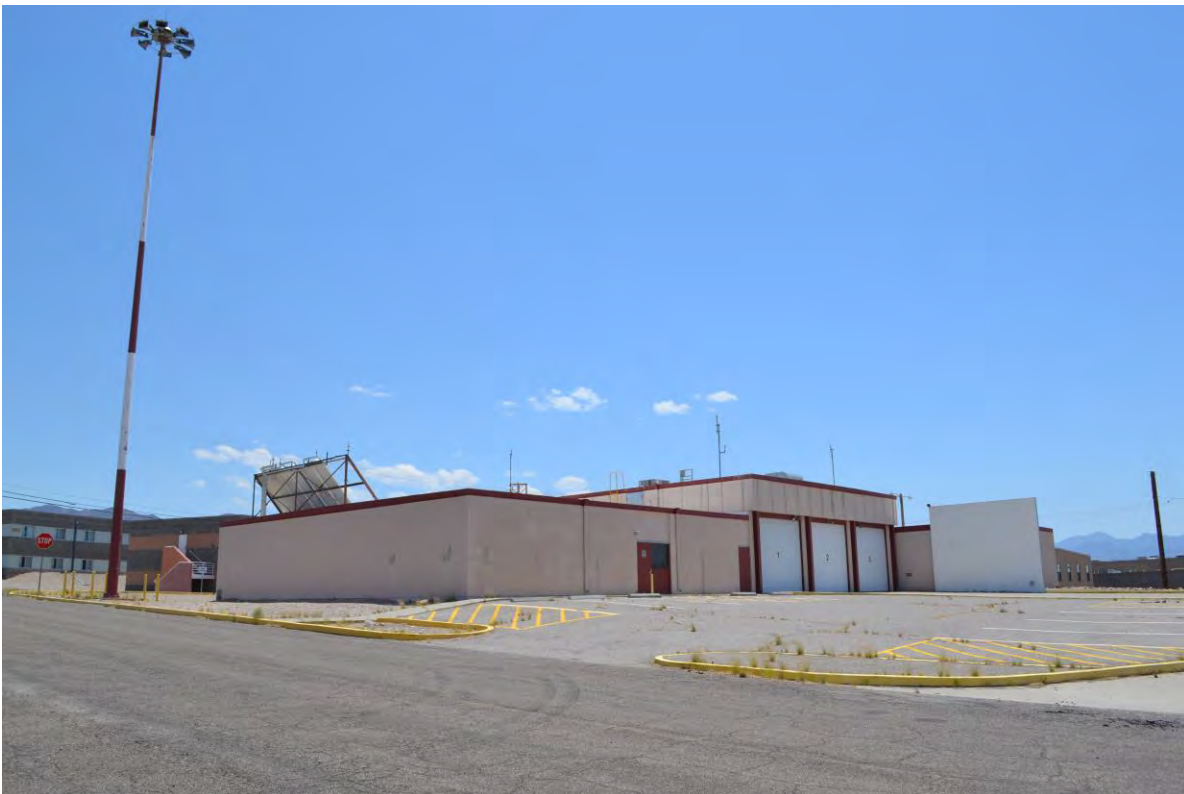
A second location where a curb can be found, on Sandstone Ave. west of Buster St.  
Direction facing: Southeast      Photographer: Menocal      Date: 6/19/2017

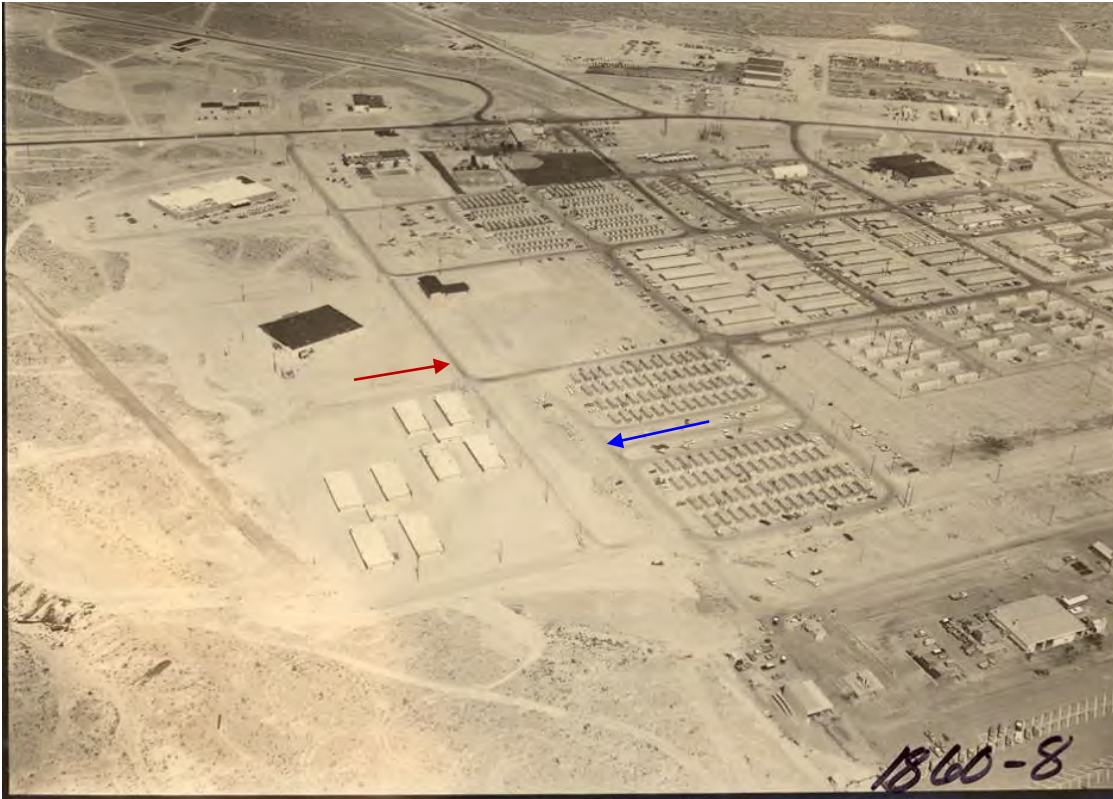
Mercury road system after the 1963-64 construction boom. The blue arrow points to the old Trinity Ave. The red arrow is at the new Trinity Ave.  
Direction facing: West-northwest      Source: REECo (1982)      Date: 1964

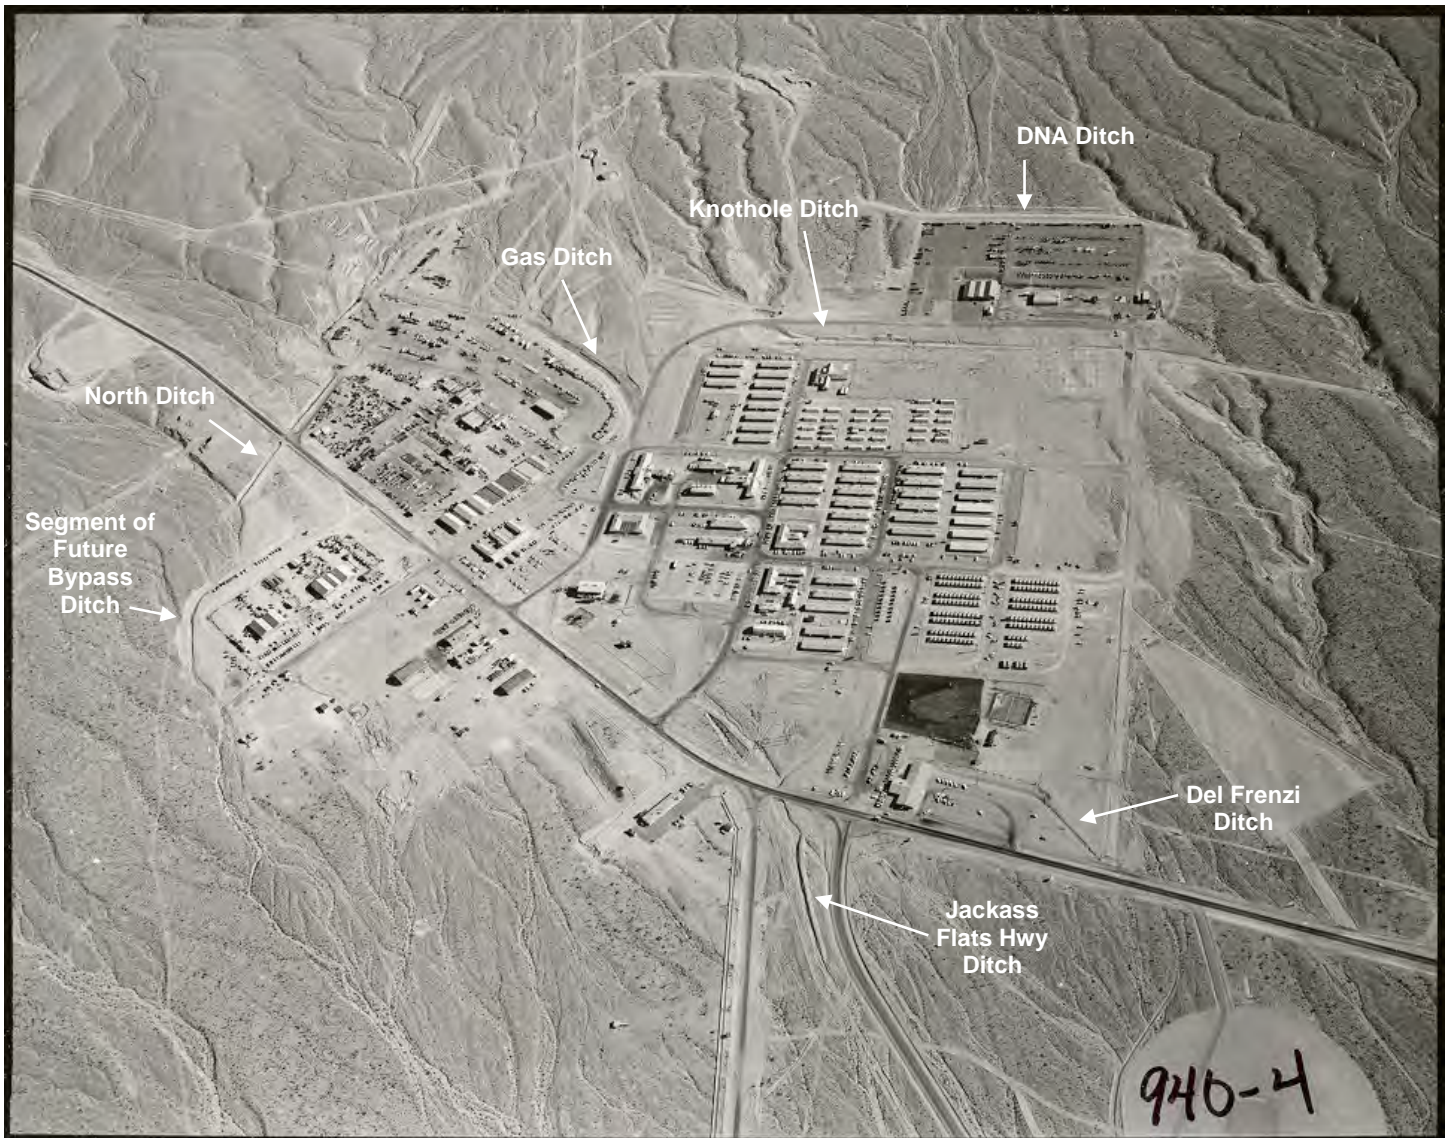
An aerial view of Mercury before the implementation of the master plan (ABA 1962) showing some of the more prominent natural and constructed drainages, facing east (REECO, January 1961).

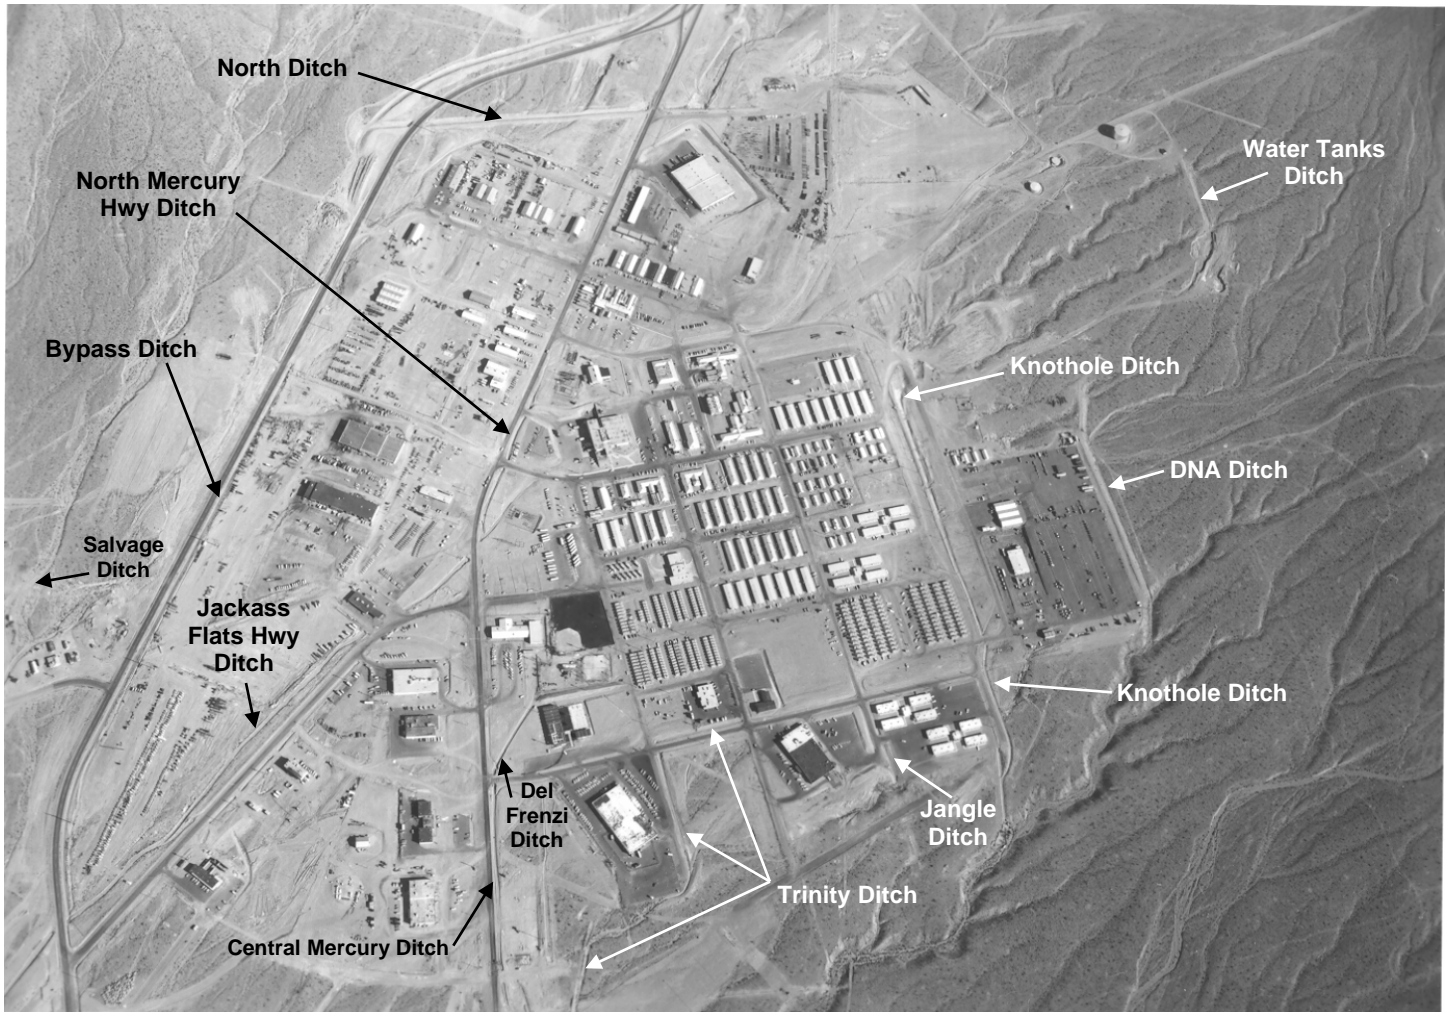
An aerial view of Mercury after the construction boom, facing north-northeast, showing some of the more prominent constructed ditches (REECo, Photo 2574-4, 10/11/1967).

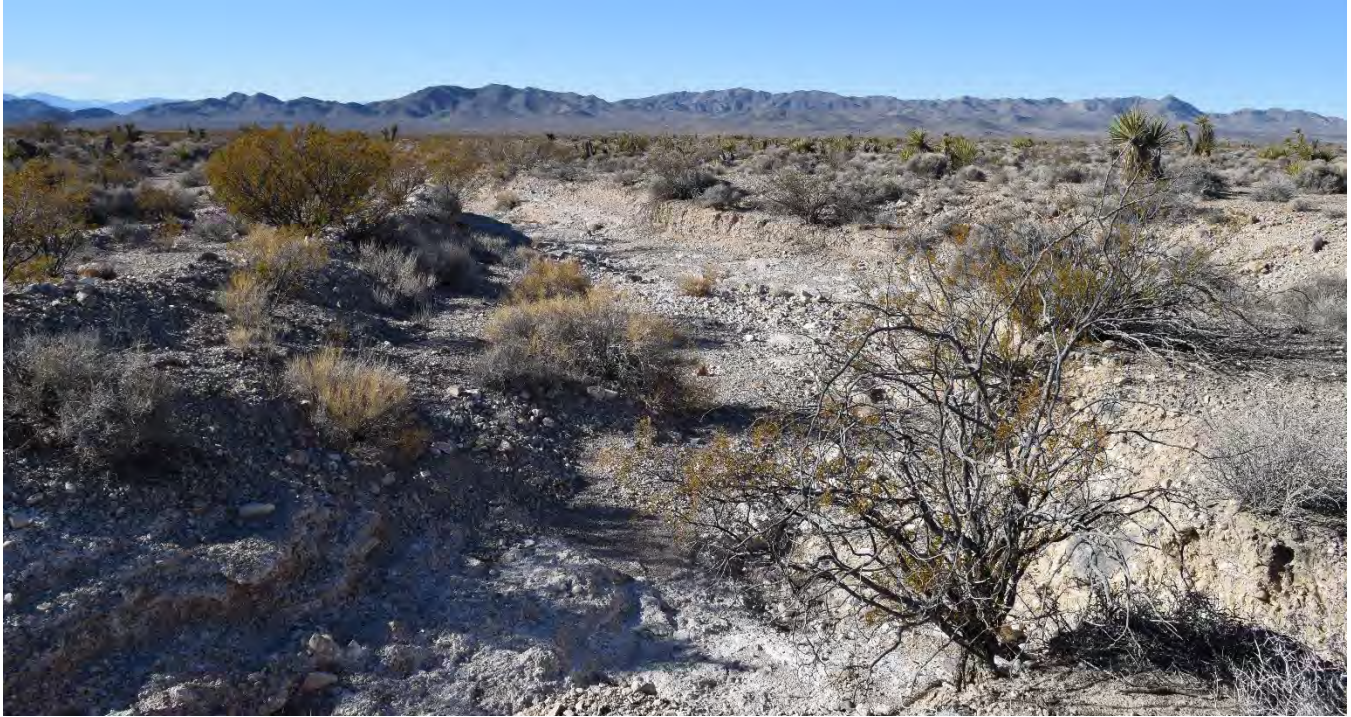
View of a drainage trench that has widened over time along a curve near the sewage lagoons and Jackass Flats Highway.

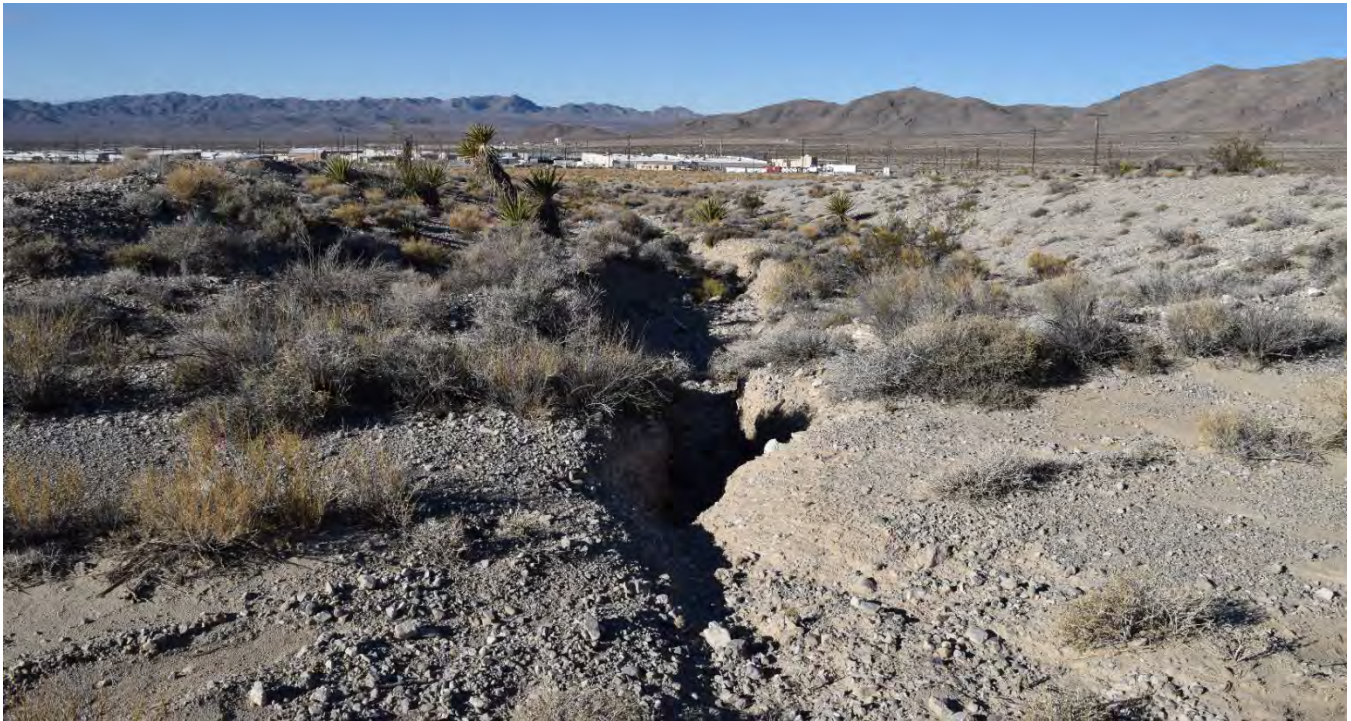
One of the natural drainages near the water tanks that feeds into the north end of the drainage along Knothole Street.

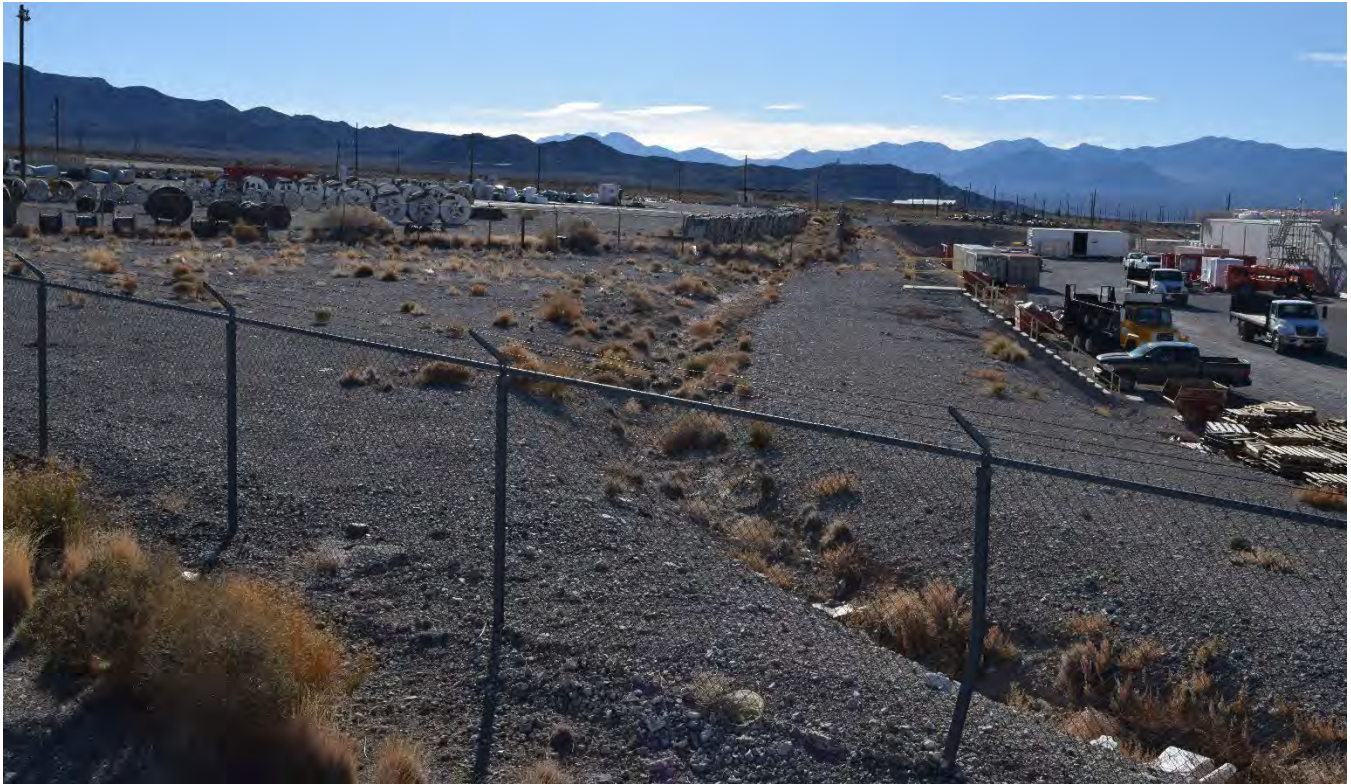
This ditch on the north side of Building 23-160 directs water around the building. The curve in the foreground feeds stormwater into the drainage along the east side of Mercury Highway.  
Elevation: N/A      Direction facing: Southeast      Photographer: DRI      Date: 2018

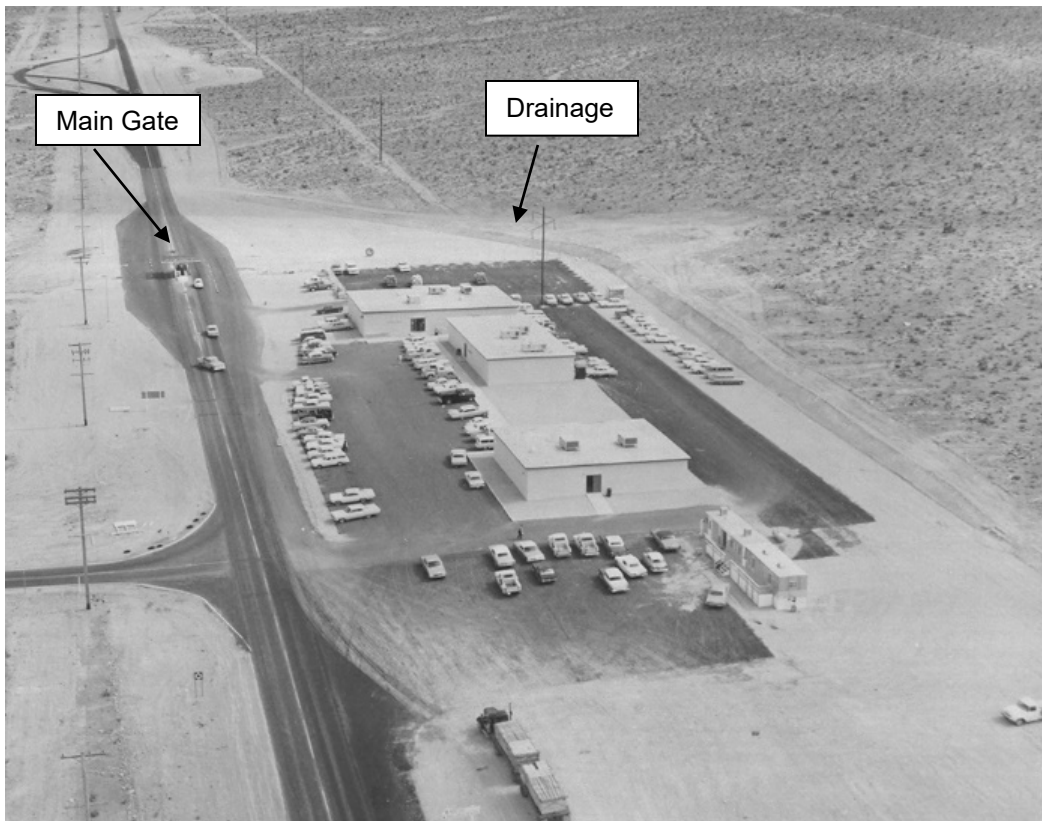
This photo, facing north-northeast, shows the drainage running along the right (east) side of Mercury Highway in the background. Upon reaching the newly constructed buildings near the main gate, a trench (at black arrow) directs stormwater east of the buildings (REECO, Photo 3028-3, 1965).

During the study conducted in preparation for expanding Mercury in the early 1960s, Koebig and Koebig (1963) stated that the drainage system on the east side of the Mercury Highway was inadequate for the calculated amount of stormwater that could accumulate on that side of the road during a peak runoff event. In addition to recommending a second culvert to safely convey this runoff under the highway, the engineers also suggested enlarging some existing culverts, diverting some drainages to avoid new construction, and constructing new culverts and ditches in several areas. New culverts were to be made of bituminous-coated corrugated metal pipe or pipe arch, and have flared metal end sections on both the upstream and downstream ends in most cases. The new culverts would be at least 15 in pipe or 18 x 11 in pipe arch.

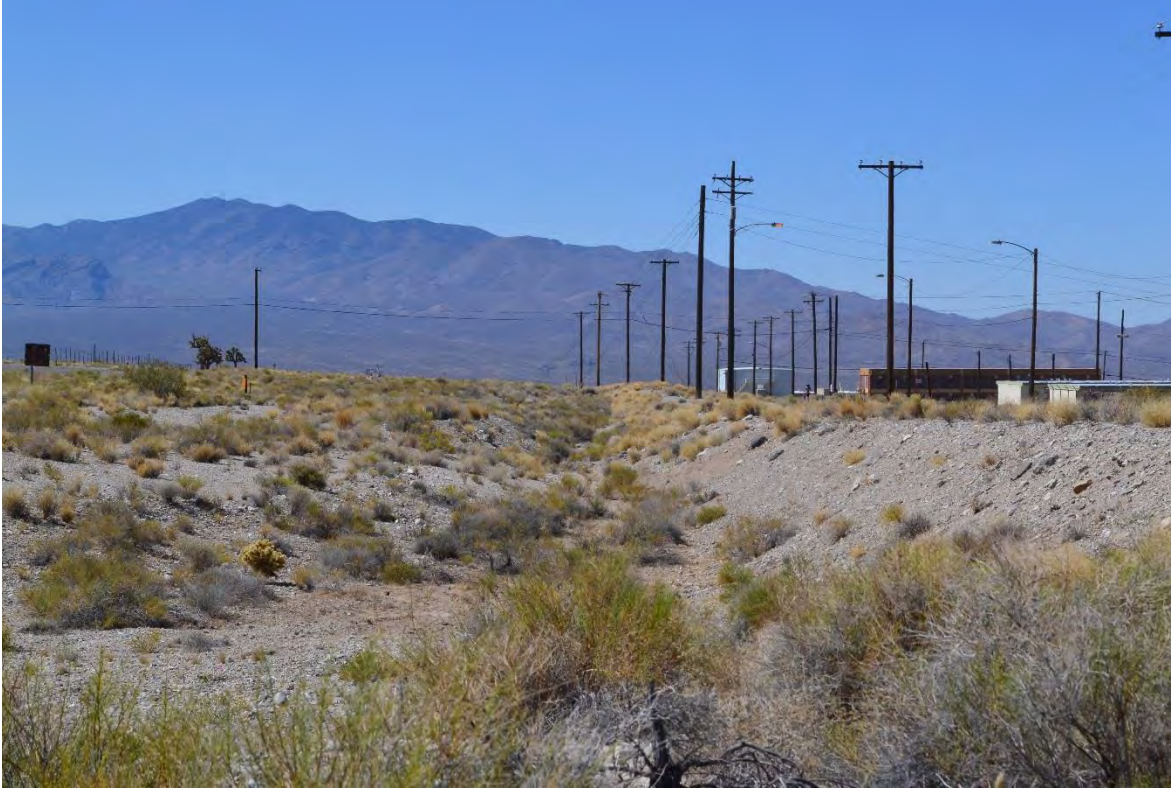
Drainage along the east side of Knothole Ave. Direction facing: South Photographer: Menocal
