**DESERT RESEARCH INSTITUTE  
CULTURAL RESOURCES REPORT LR040120-1  
PROJECT NO. 201323**

**Finding of Adverse Effect and Mitigation Documentation for the Stormwater Drainage and  
Street Systems, Substation Foundations, and the Bus Parking Lot in Mercury,  
Area 23, Nevada National Security Site, Nye County, Nevada**

The purpose of this letter report is to submit documentation related to the finding of effect for the undertaking and mitigation of four resources on and adjacent to the block that will be affected by planned activities to modernize parking and infrastructure in central Mercury. Two of these resources are portions of the street system and the stormwater drainage system, which are elements of the town's infrastructure. The foundations of an old electrical substation and the bus parking lot will also be replaced by new parking or landscaping. This submission is intended to comply with the stipulations in the *Programmatic Agreement between the National Nuclear Security Administration Nevada Field Office and the Nevada State Historic Preservation Officer Regarding Modernization and Operational Maintenance of the Nevada National Security Site, at Mercury in Nye County,

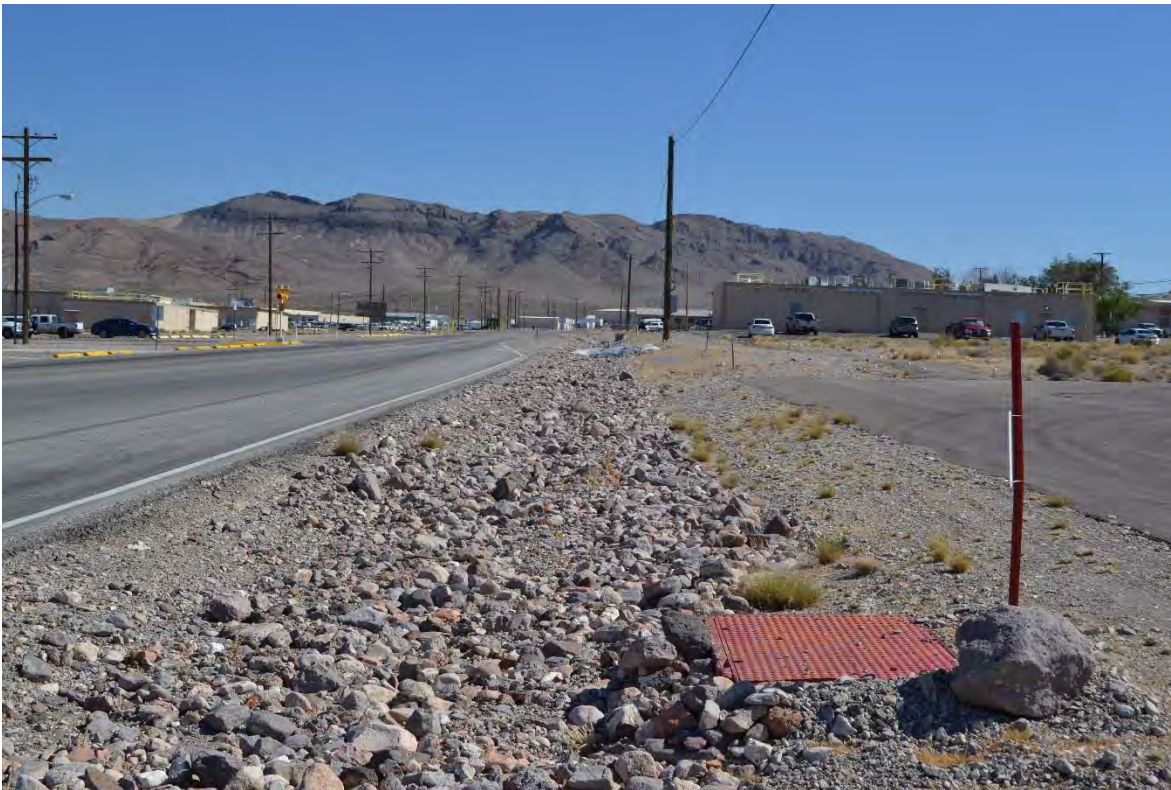
Drainage with riprap on east side Mercury Hwy. Direction facing: North Photographer: Menocal

Most culverts are corrugated galvanized steel with a protective tar coating. Some culverts are concrete. In some cases the ends of the culverts are equipped with retaining walls, wing walls, aprons, flared metal end sections, or riprap. A few ditch segments are also protected with stone or recycled concrete riprap. In the descriptions, the culverts are steel unless noted otherwise. A sample of culverts was measured and assigned numbers separately for each ditch to document the amount of flow various portions of the system were designed to handle.

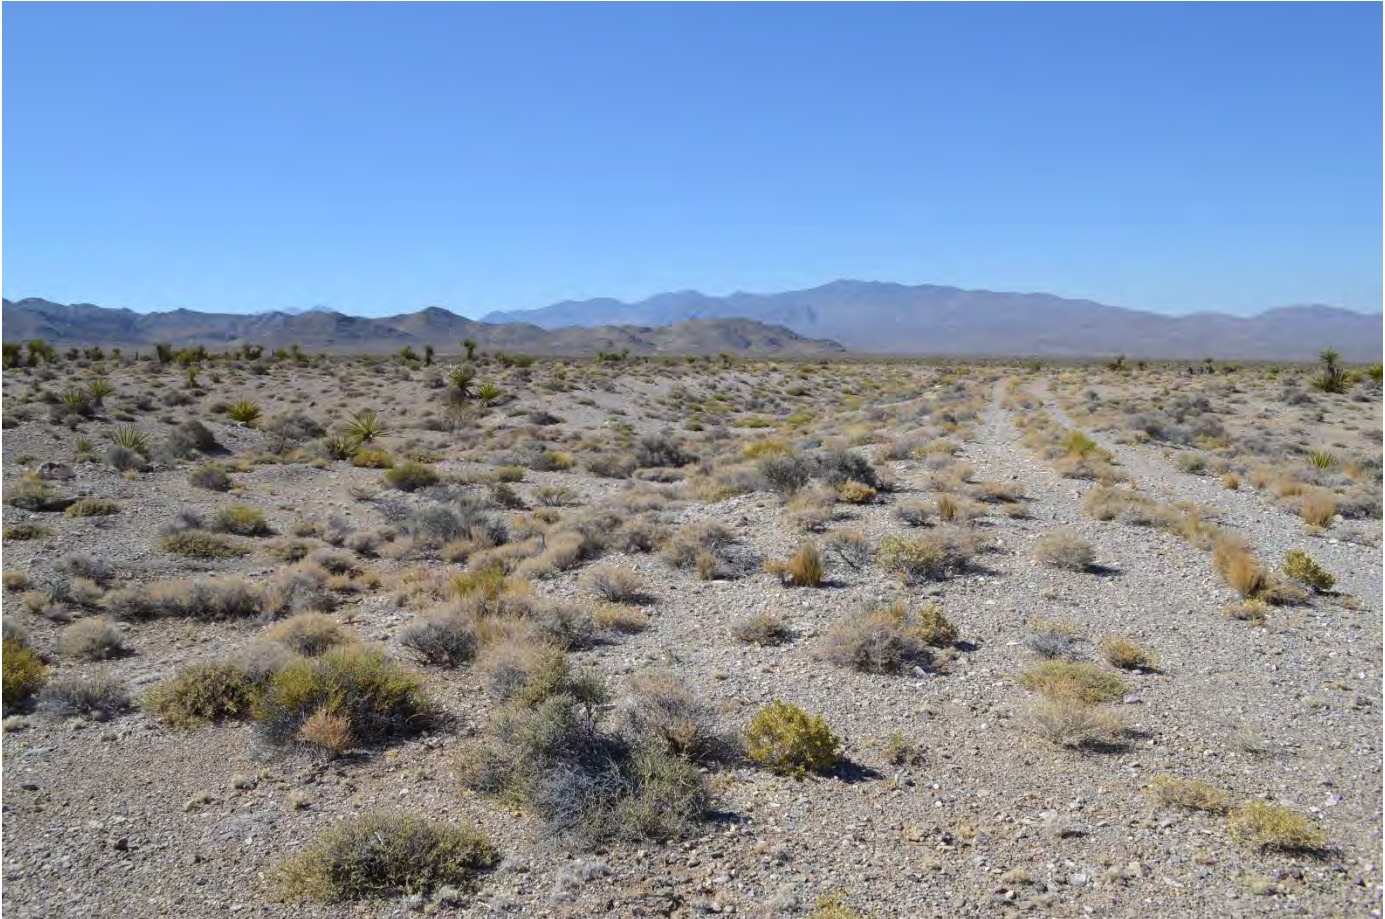
From north end of ditch, dam at center, ditch at left, blocked natural drainage at right.  
 Direction facing: South      Photographer: Menocal      Date: 2017

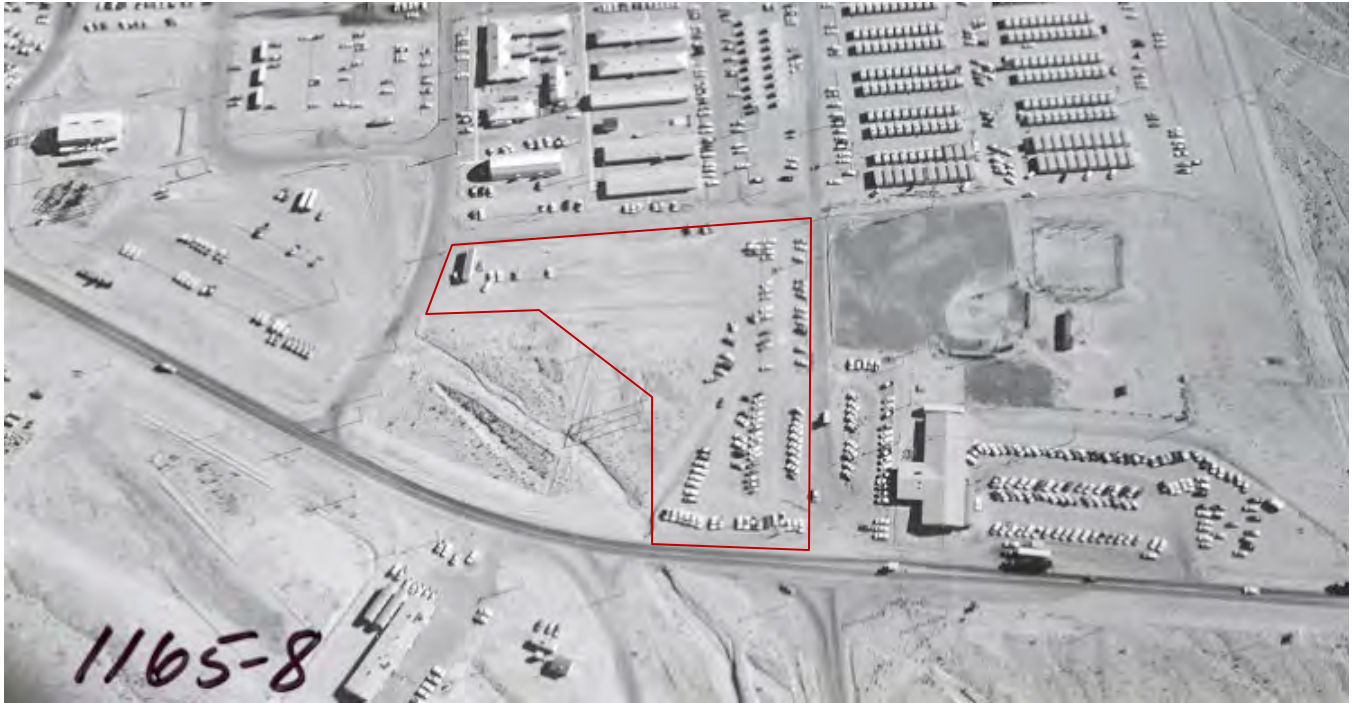
By late 1961, most of the area had been graded and partially paved (REECO Photo 1165-8, 12/7/1961, facing east).

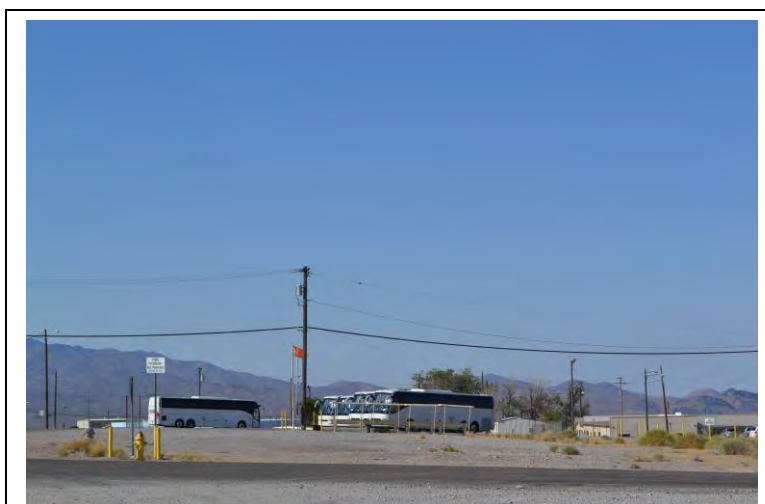
Bus Parking Area, view south, Evacuation Assembly Area in foreground (2017).

Condition of Resource(s)?		
Good <input checked="" type="checkbox"/>	Fair <input type="checkbox"/>	Poor <input type="checkbox"/>
Explanation: Area is maintained and in use.

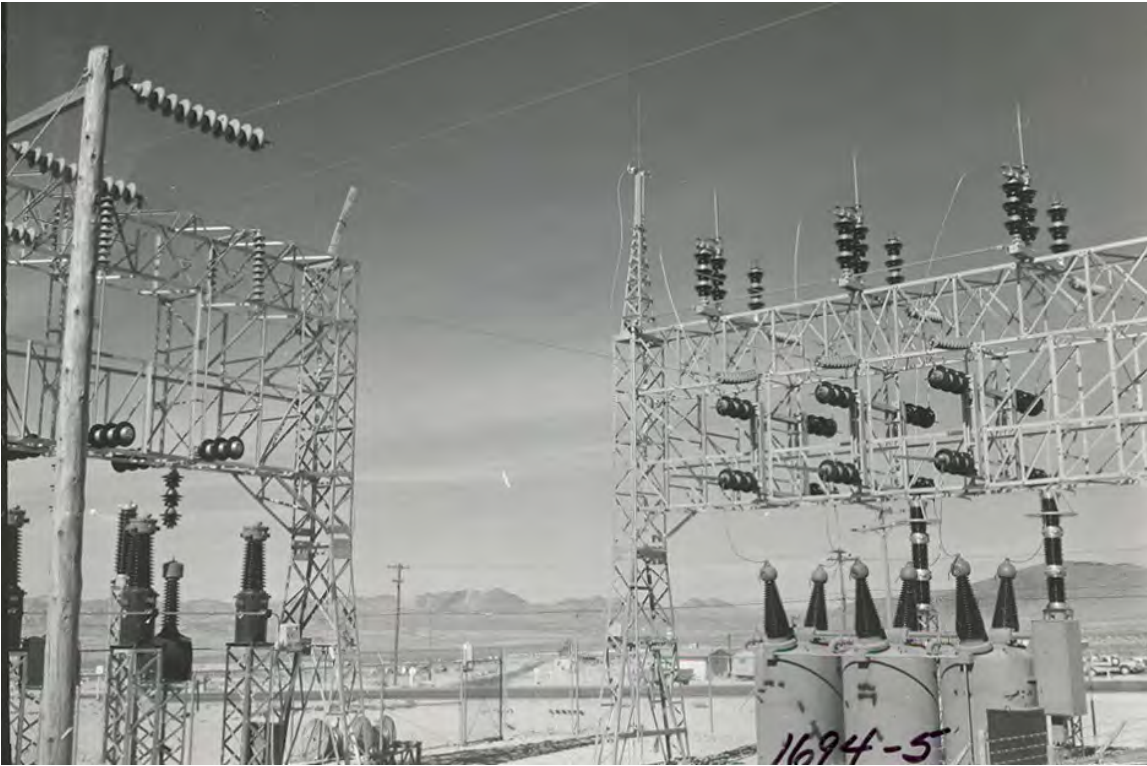
The oil circuit breakers are the equipment in the lower right side of the photo.  
Elevation: N/A    Direction facing: West    Photographer: REECO 1982, Photo # 1694-5    Date: 8/26/1963

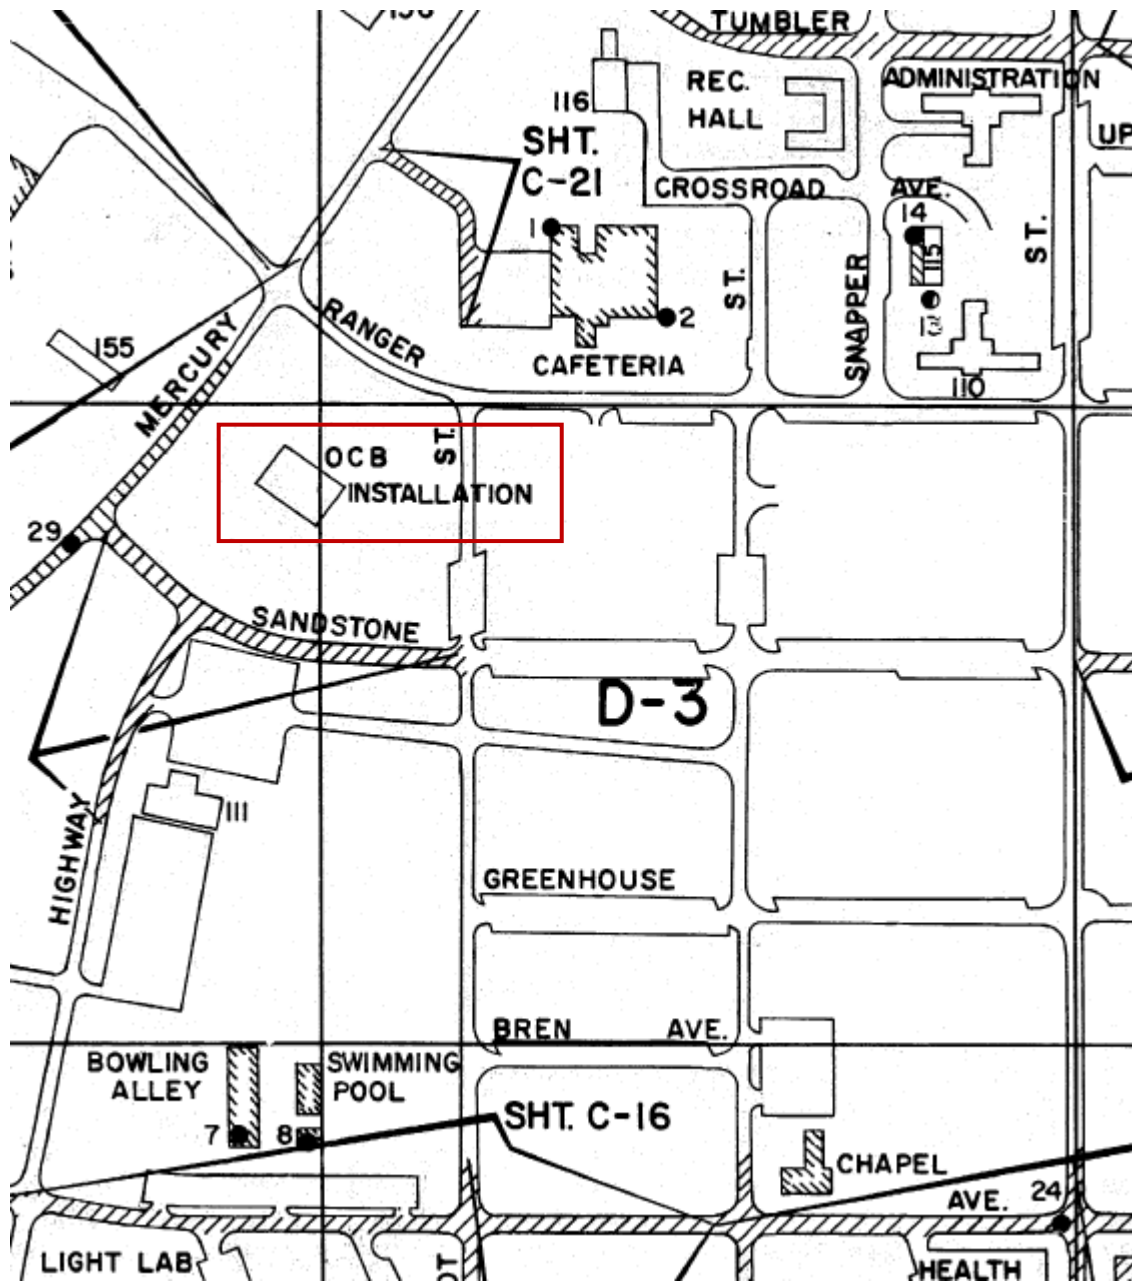
Location (red box) of the oil circuit breaker (OCB) installation (Koebig and Koebig 1963). On a 1959 map (Holmes and Narver), this block was labeled as a women's recreation area. Since the 1960s, it has primarily been used for parking.

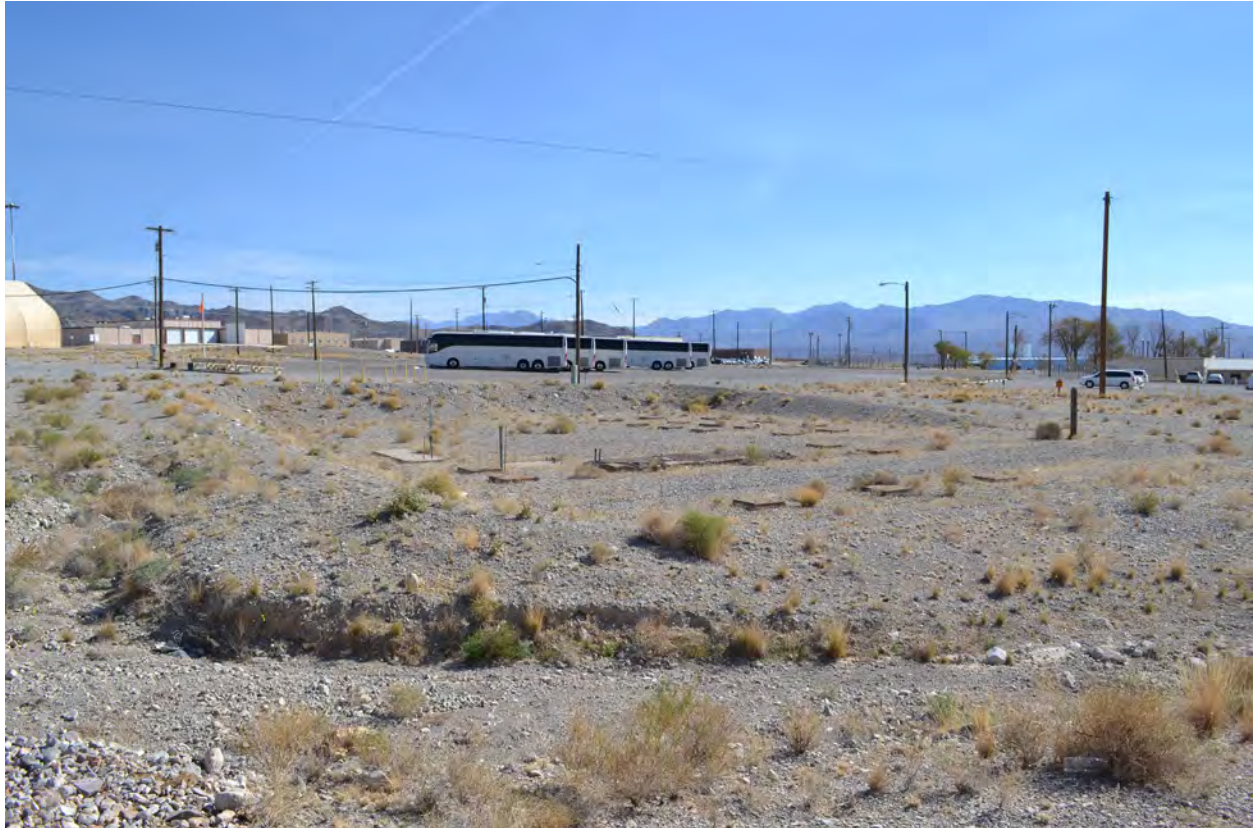
This photo, facing southeast, shows the remnants of the berm in the foreground that was built to guide stormwater around the substation (DRI 2017).

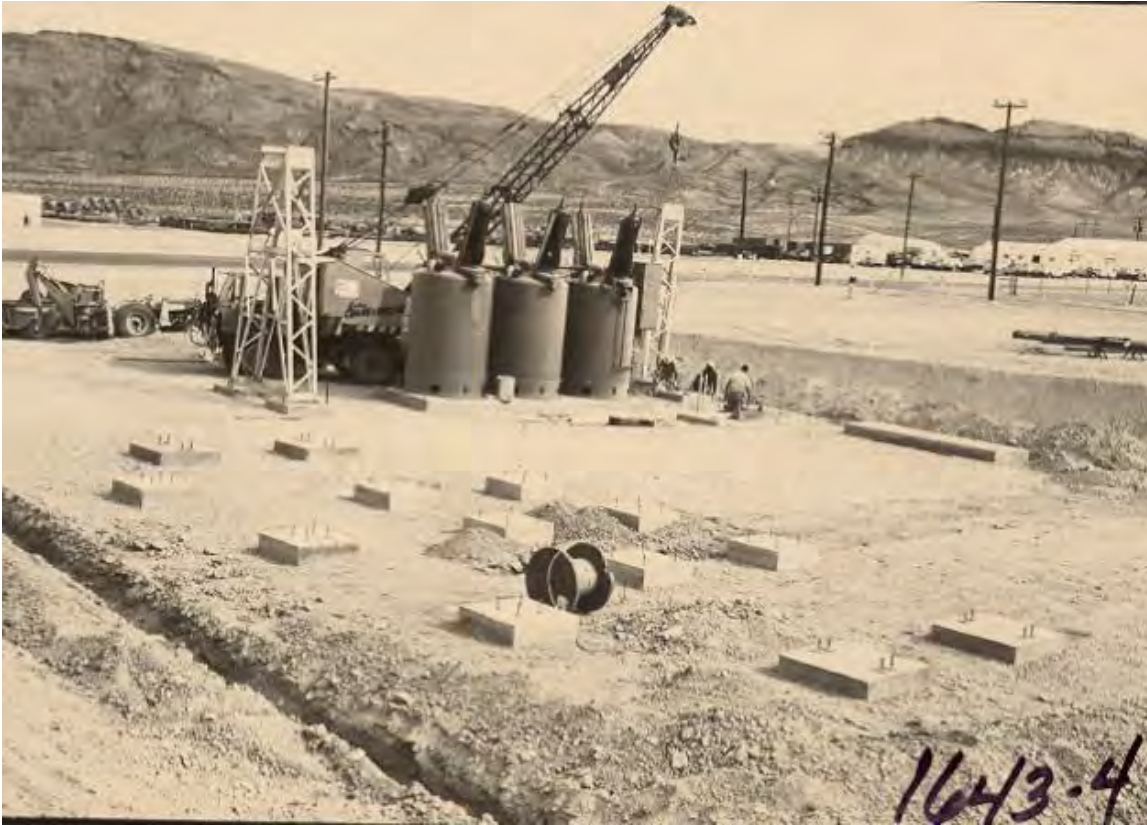
The foundations seen in this photo are still present as of 2017. (See current photo below, taken from a similar angle.)  
Elevation: N/A      Direction facing: North-northwest      Photographer: REECO 1982 (Photo # 1643-4)      Date: 1963
