Update on the Neutron Scatter Camera from the shakedown voyage

SAND2007-6719P

Project Details

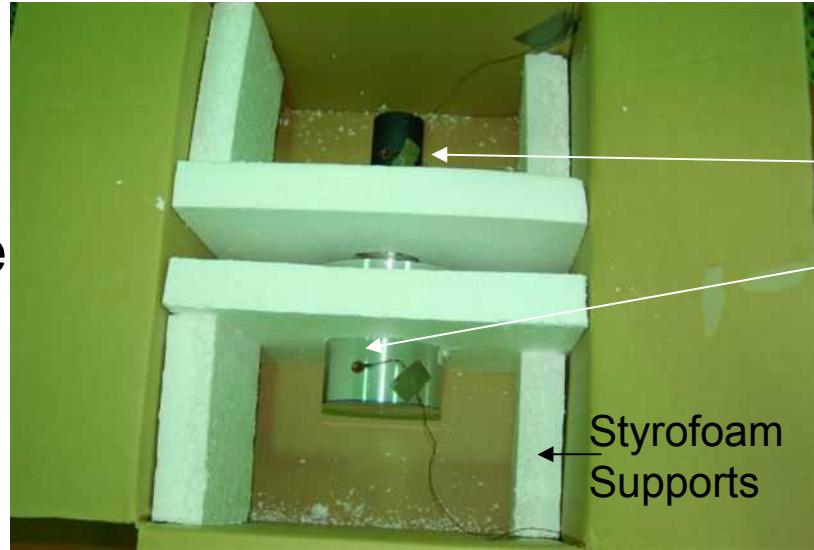
Vibration and shock test setup

Mock PMT
Detector package

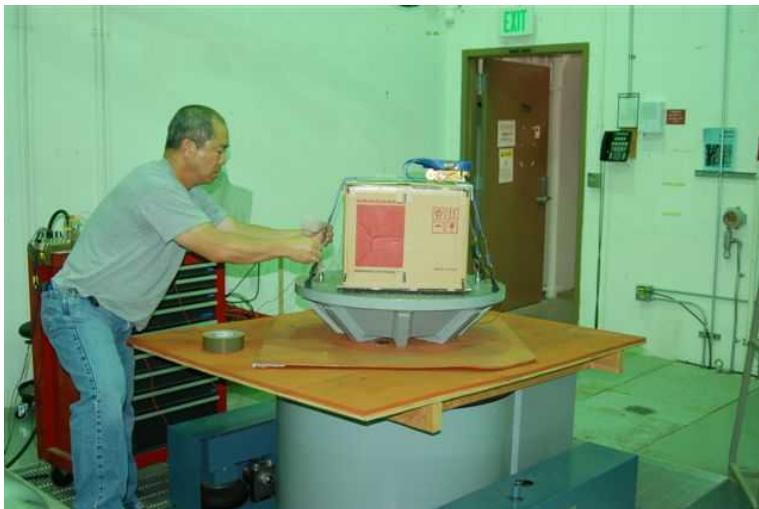
Accelerometers

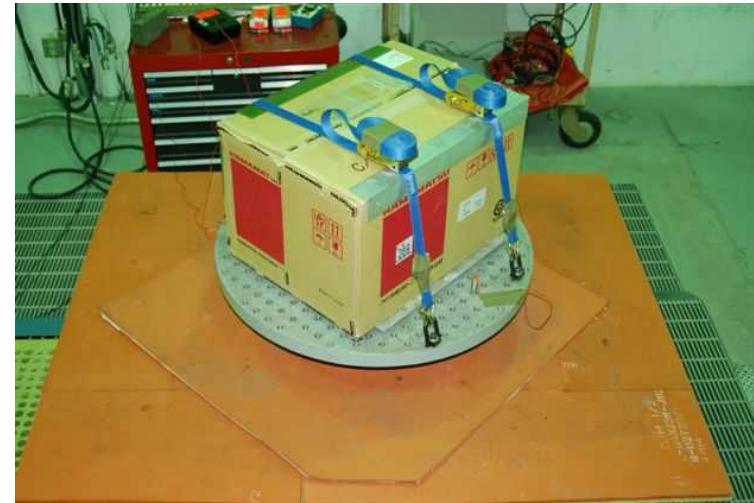
Secured to
shake table

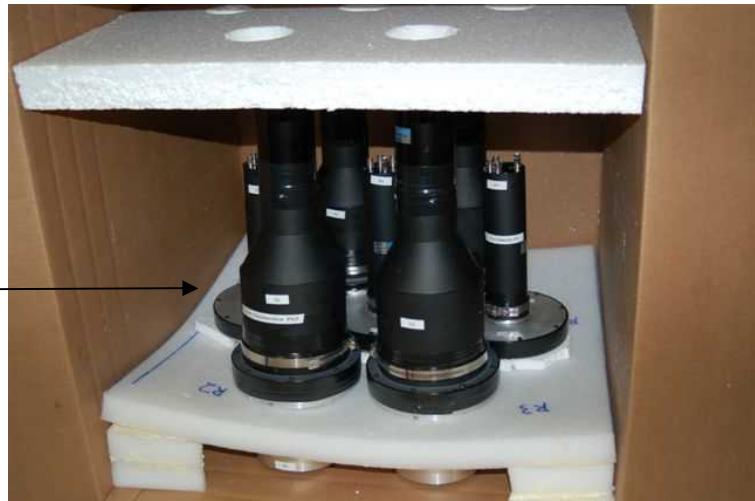
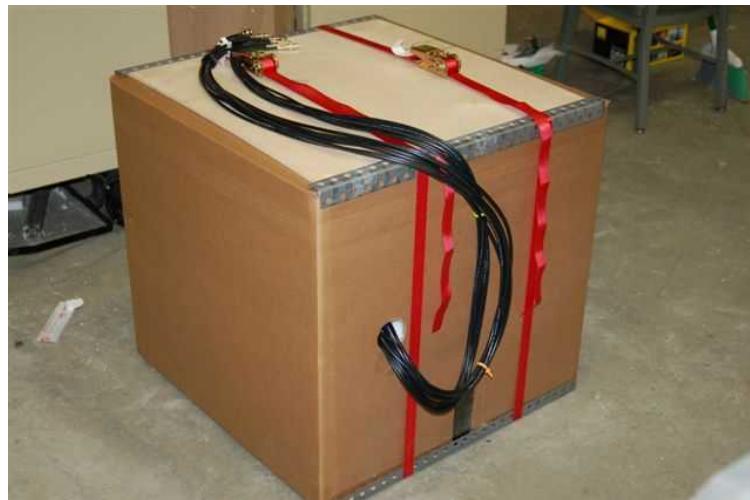
Rear Plane
PMT/Cells

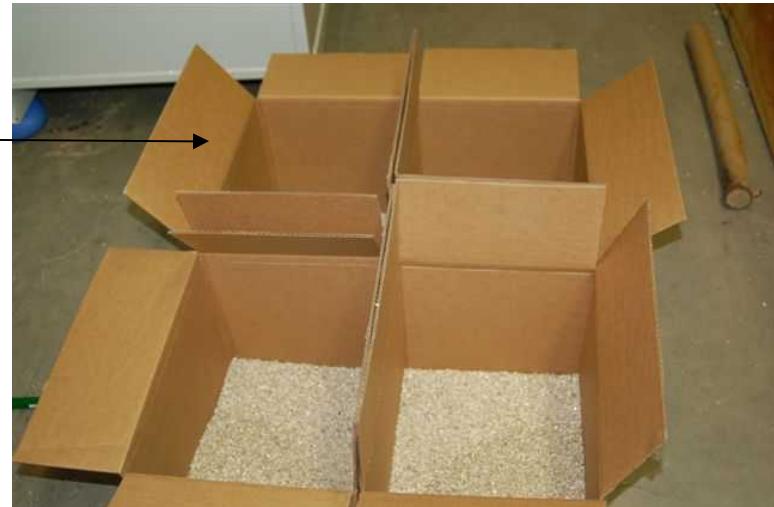
Base
boxes

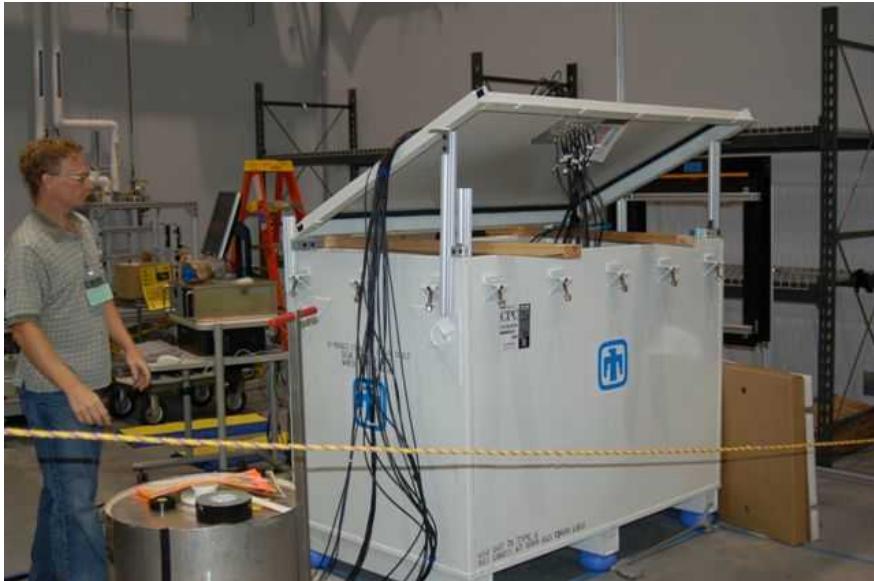
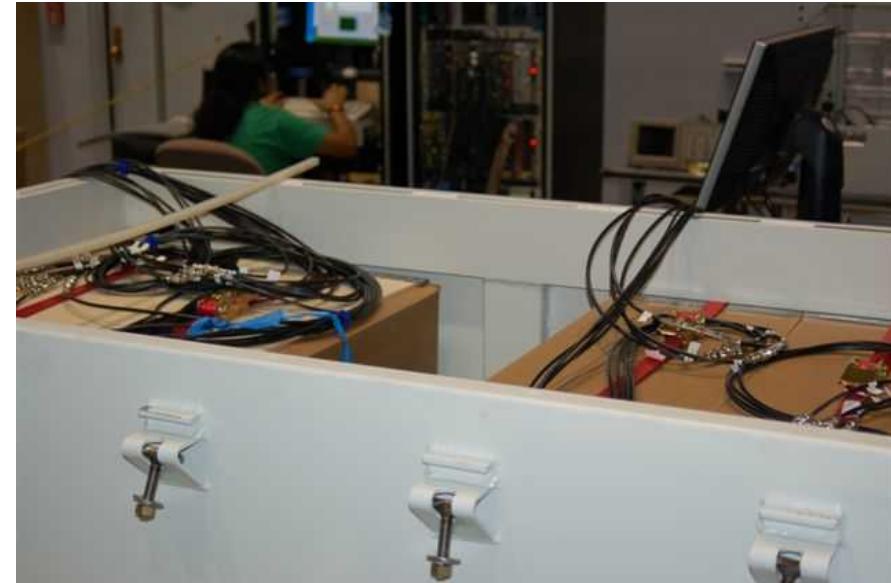
Packed into DOT-rated Type A STRONG-TIGHT container
