# FAA Airworthiness Assurance NDI Validation Center

SAND2006-6116P

## Operated by Sandia National Laboratories

# FAA Airworthiness Assurance Center

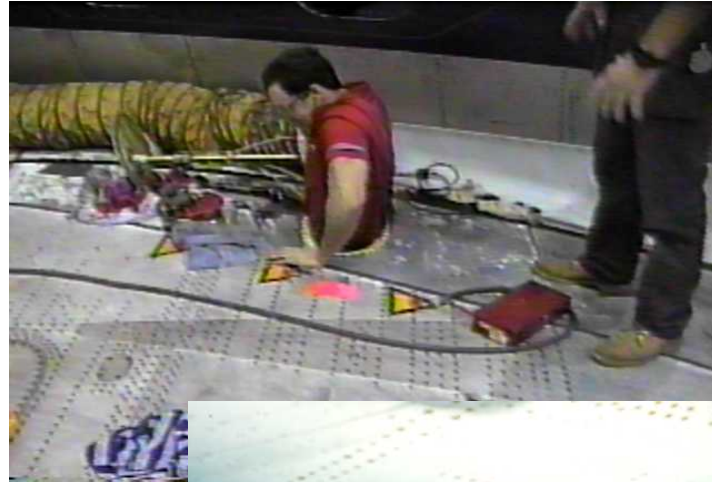
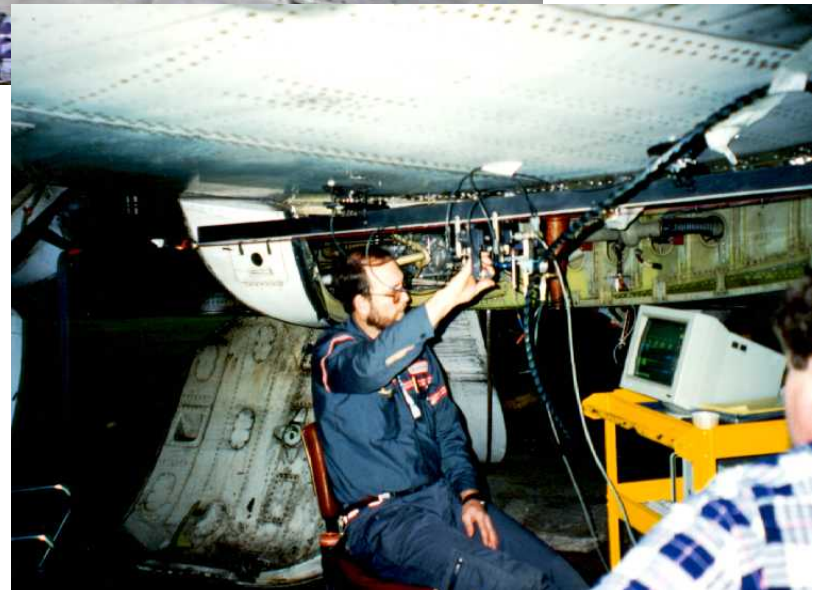
*Northwest Airlines Inspector scanning DC-9 Tee Cap with new ultrasonic technique*

**Before - 800 hours Visual Inspection**

**After - 80 hours**

- Ultrasonic technique replaces visual inspection
- Eliminates need for exposure to hazardous material in a confined space
- Doubles inspection area and increases resolution
- **Produced AMOC for Boeing AD while providing better NDI information**
- **Aging Aircraft FAR & SSID**

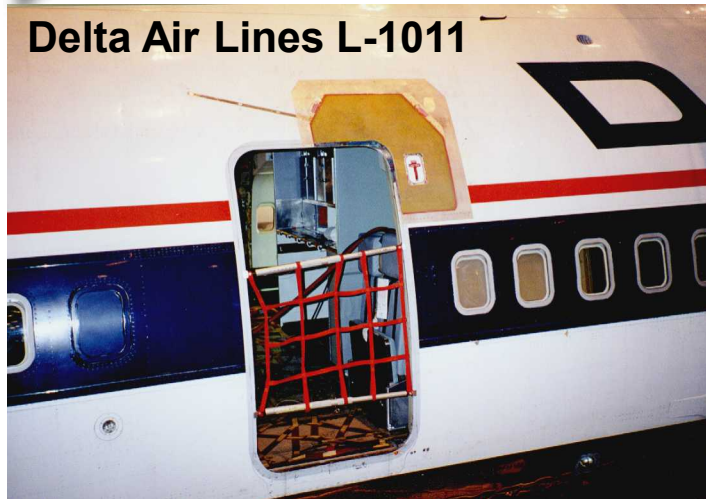
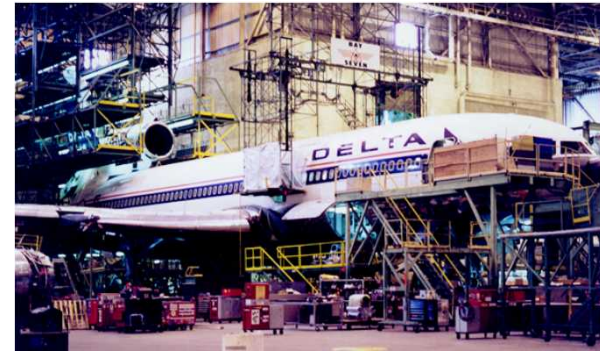
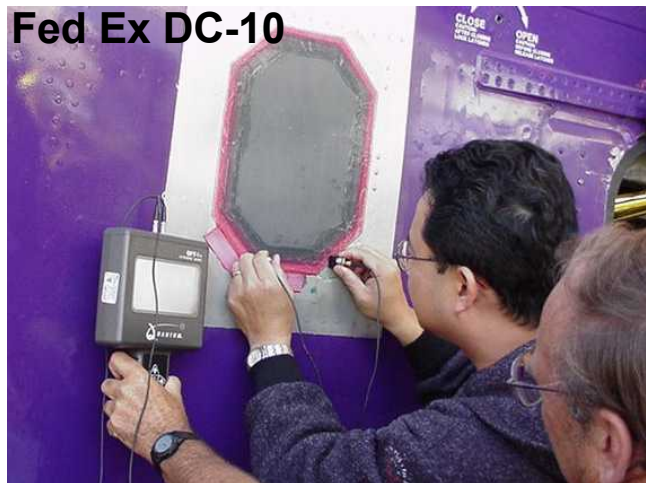
- Safely introduced new aircraft repair technology that provides both **engineering and economic benefits**
- Entire process, including advanced inspection methods, is aiding **Service Life Extension Programs**
- **Produced Boeing Structural Repair & NDT Manual revisions and FAA guidelines to assure continued airworthiness; AMOC for AD 94-05-01**
- **Aging Aircraft FAR & associated ACs**

*Technology proven to be viable for the commercial aircraft industry - Pilot Programs, Boeing NDI and SRM Manual revisions*

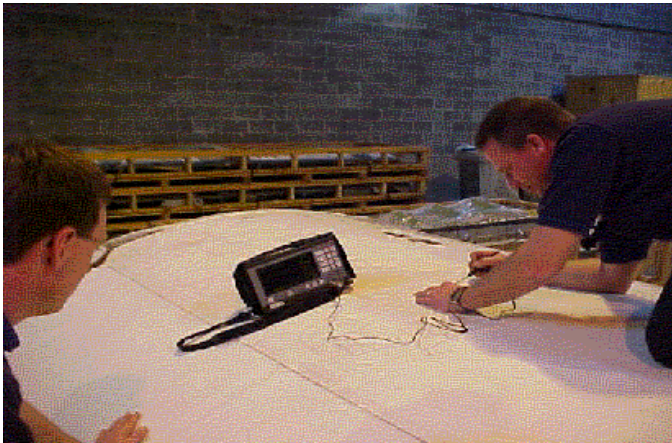
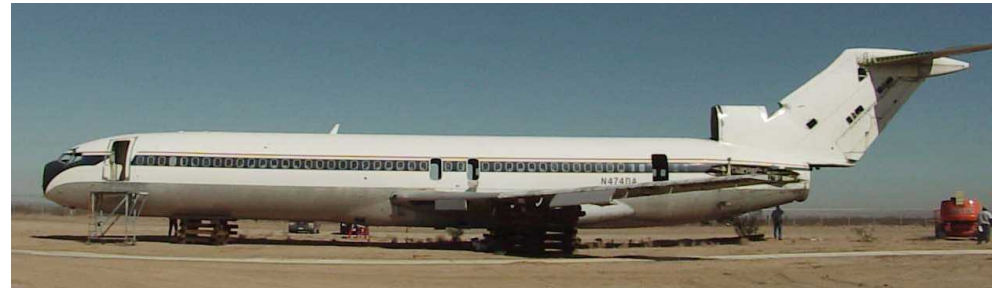
Fatigue Cracks

- **Response to AAWG and ARAC request**
- Understand WFD phenomena through lab and field studies; aging aircraft teardown inspections
- Advanced NDI has produced order of magnitude improvements to create risk management options
- Program is producing guidelines for assessing continued airworthiness
- **Effort supports NPRM regulations in Widespread Fatigue Damage (FAA-2006-24281) & Damage Tolerance Data for Repairs & Alterations (FAA-2005-21693)**

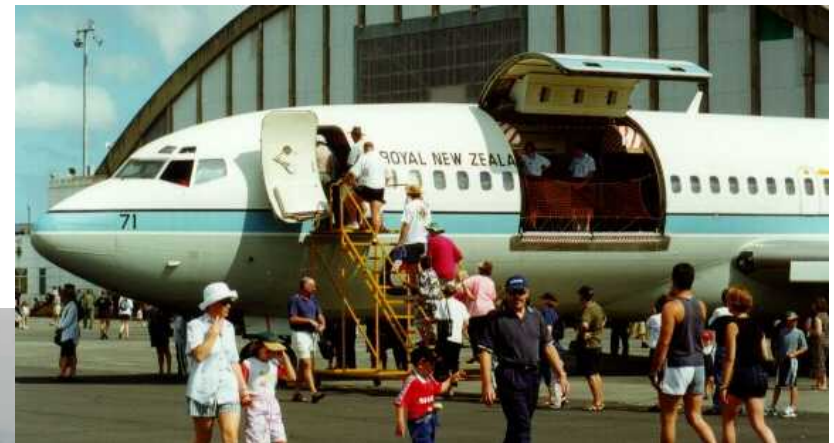
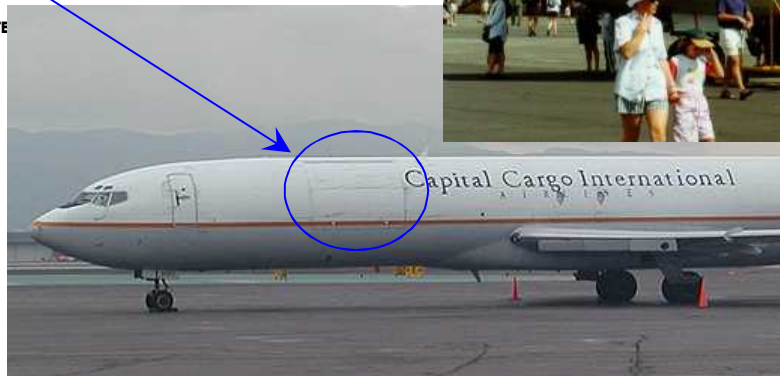
- Modification from passenger to cargo door covered lap splice joints involved in crack terminating action (AD 91-06-06 from Aloha accident)
- Program requested NDI method for immediate application to avoid grounding cargo fleet of 727 aircraft
- Bolt hole eddy current method was developed and validated
- **Inspection was incorporated into Boeing Alert Service Bulletin & approved as Alternate Means of Compliance for AD T98-23-51 and AD 99-04-22**

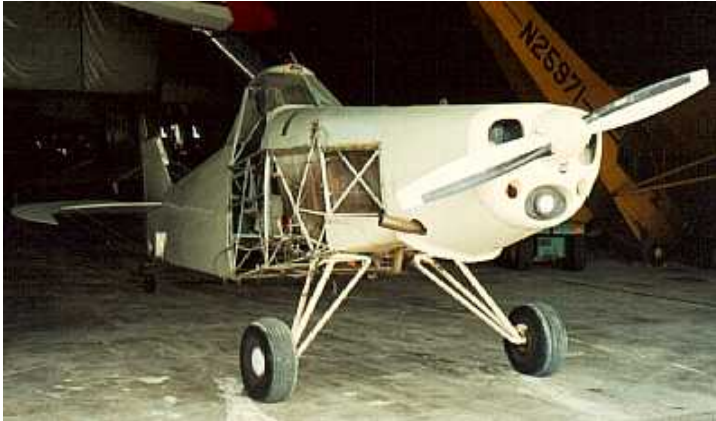
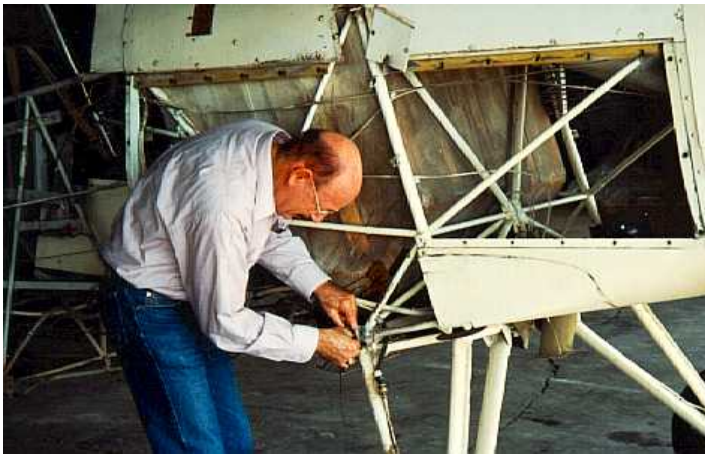
- Aircraft accident resulted in discovery of systemic corrosion problem in Piper aircraft
- Developed & validated P-E ultrasonic inspection for spar-to-fuselage attachment
- Inspection procedure was incorporated into AD 93-21-12 as means to comply with inspection requirements
- Aging Aircraft FAR and SSID

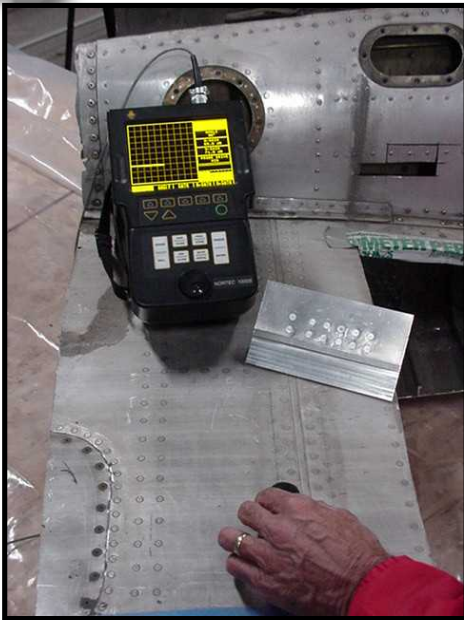
*Inspection of lower wing spar testbed (Fairchild SA226)*

Detect 0.100" cracks in 3rd, 4th, and 5th layer of spar assembly

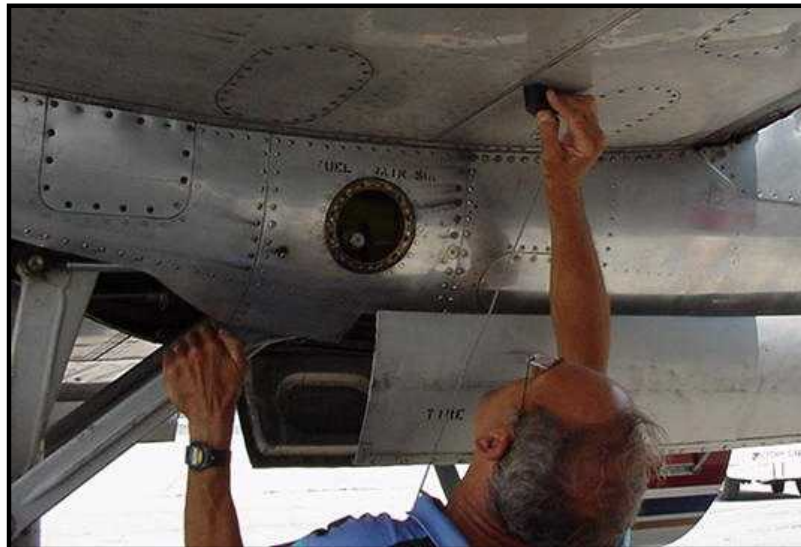
*Field testing of eddy current inspection being completed on SA226 aircraft*

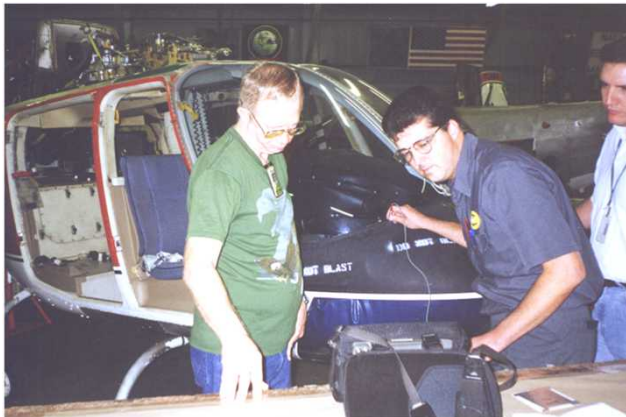
- Dual frequency EC method can detect <10% corrosion (0.002" th. loss)
- Custom probes developed to detect cracks under raised head fasteners
- Enhances safety, reduces repair costs, eliminates need to remove fasteners for inspections
- **Aging Aircraft/DT FAR; 8300.12 Flight Standard Infor. Bulletin on corrosion**

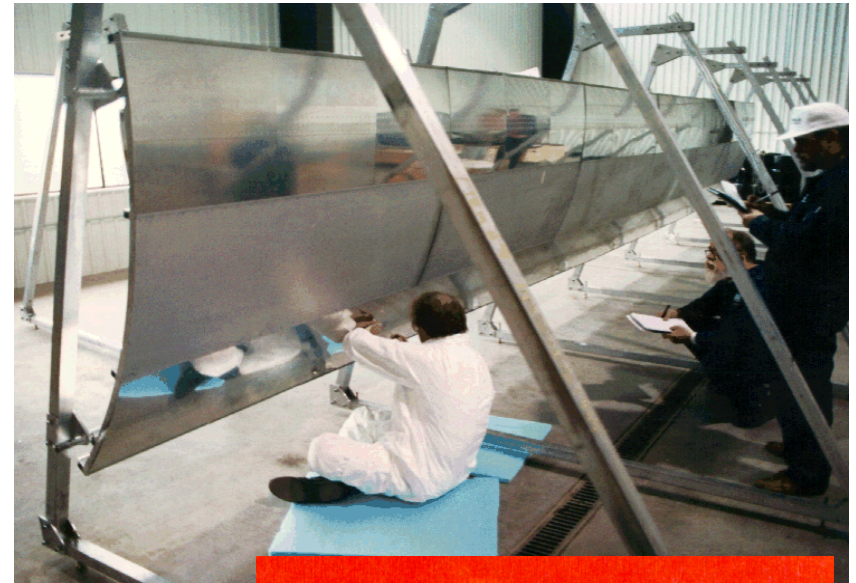
- Evaluated the performance of conventional eddy current devices at aircraft maintenance depots to detect fuselage cracks
- Demonstrated the need for better imaging capabilities to interpret eddy current measurements
- Led to development of new imaging technologies which will allow operators with less expertise to use the technology
- **Supports AD 91-06-06 (terminating action) & subsequent Boeing Alert SB 737-53A1224 (AD 99-04-22)**

Eddy current imaging technology  
for crack length measurement

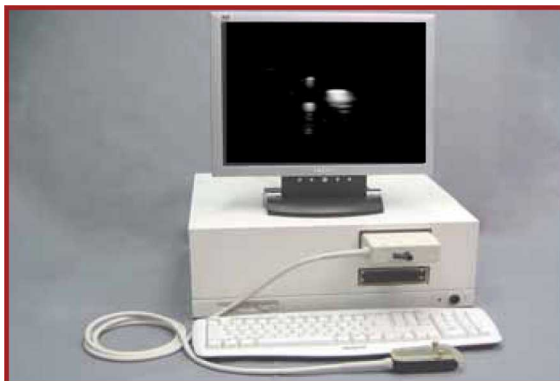
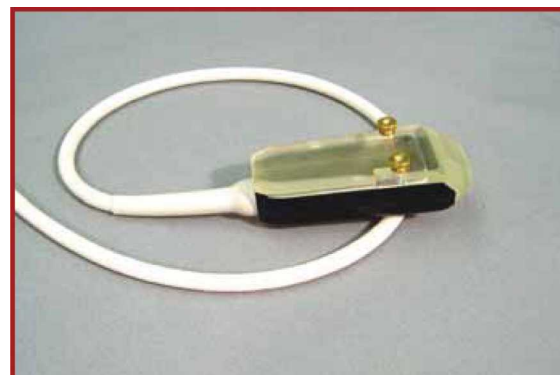
Crack

Rivet with no crack

Rivet with crack

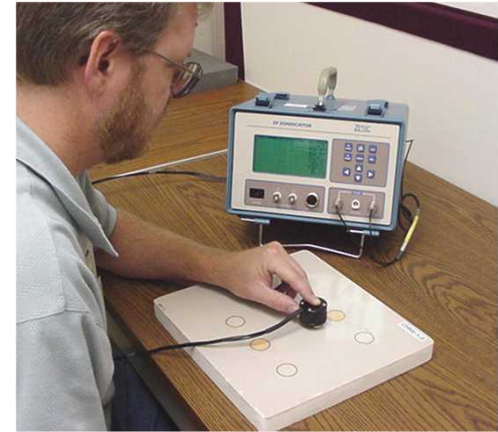
**Optimized NDT  
Reference Standards**

- Industry-wide composite reference standards developed to support damage assessment & inspection
- **SAE Aerospace Recommended Practices (ARP 5605 & 5606) - adopted into Boeing and Airbus NDT Manuals**
- Improve inspections of composite structures via introduction of advanced NDI methods
- Provides consistent approach to composite inspections - harmonized approach by OEMs worldwide

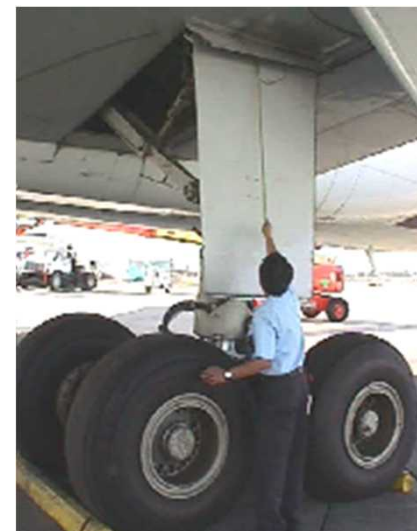
**Experiment to Assess Flaw Detection Performance**

- how well current inspection techniques are able to reliably find flaws in composite honeycomb structure
- the degree of improvements possible through the integration of more advanced NDI techniques and procedures.

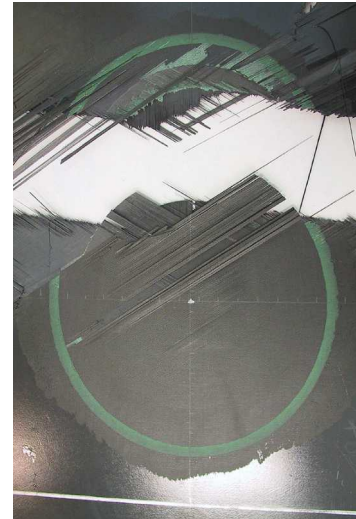
Strain field &  
repair efficiency  
assessment vs.  
NDI findings

***Comprehensive evaluation of  
composite repair and associated  
NDI technology to ensure proper  
mesh between structural  
integrity & flaw detection***

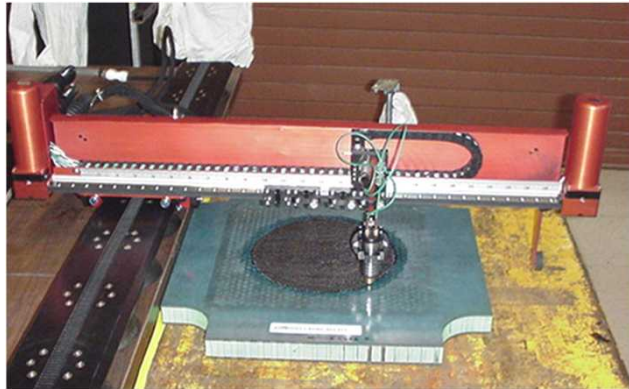
MAUS Inspections of Repaired Composite Sandwich Structures

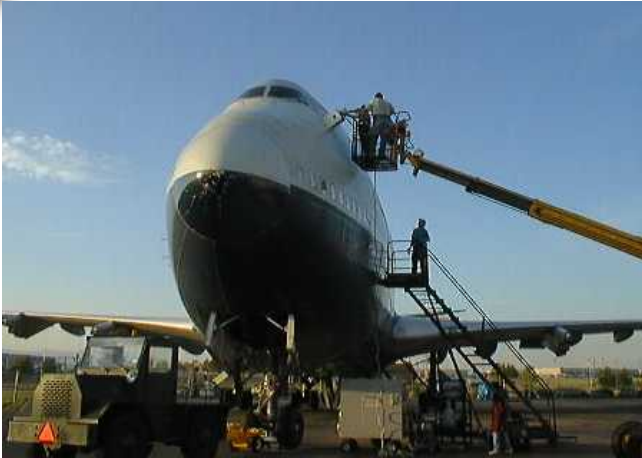
- Improved corrosion & disbond detection
- Developed in partnership with (CASR) Wayne State Univ., Boeing and Northwest Airlines
- **Boeing-approved method (NDI Manual revision) for fuselage disbond detection; addresses AD for over 2000 aircraft**

Bonded Doubler

Disbonded/Bonded  
Doubler

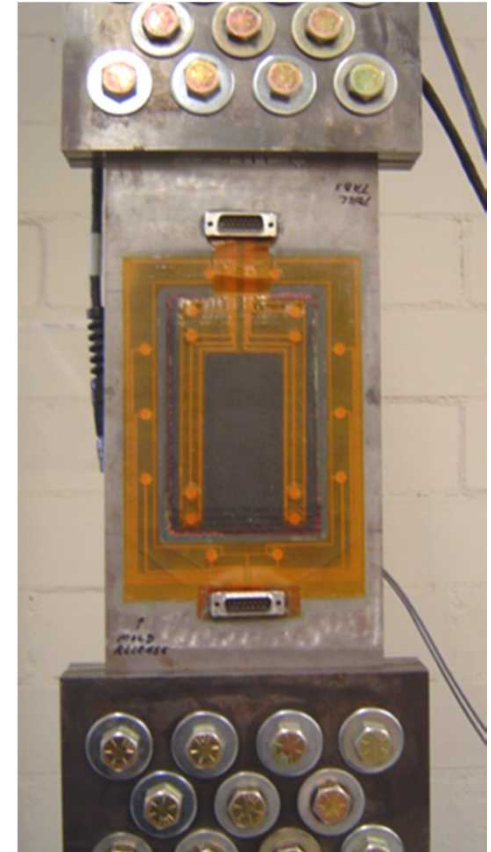
87K Cycles

***PZT crack length estimates  
within 5% of measured***

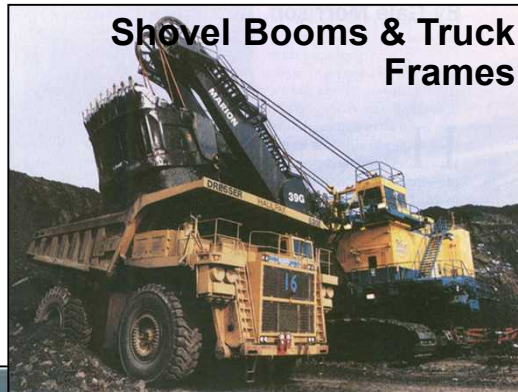
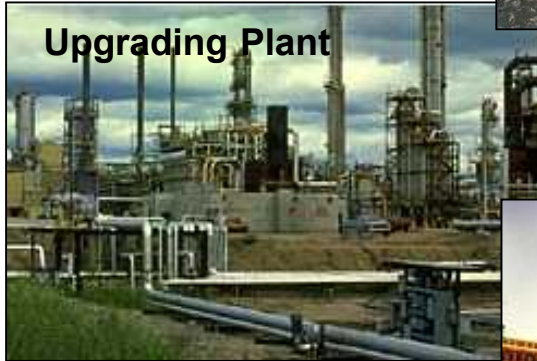
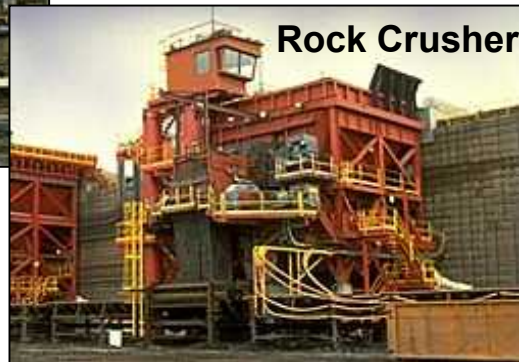
**Composite repair  
& structural health  
monitoring**
