# FAA Airworthiness Assurance NDI Validation Center Operated by Sandia National Labs

# FAA Airworthiness Assurance Center

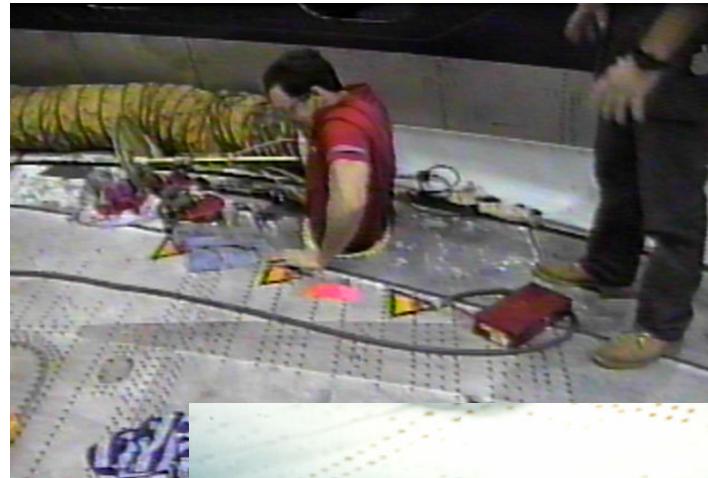
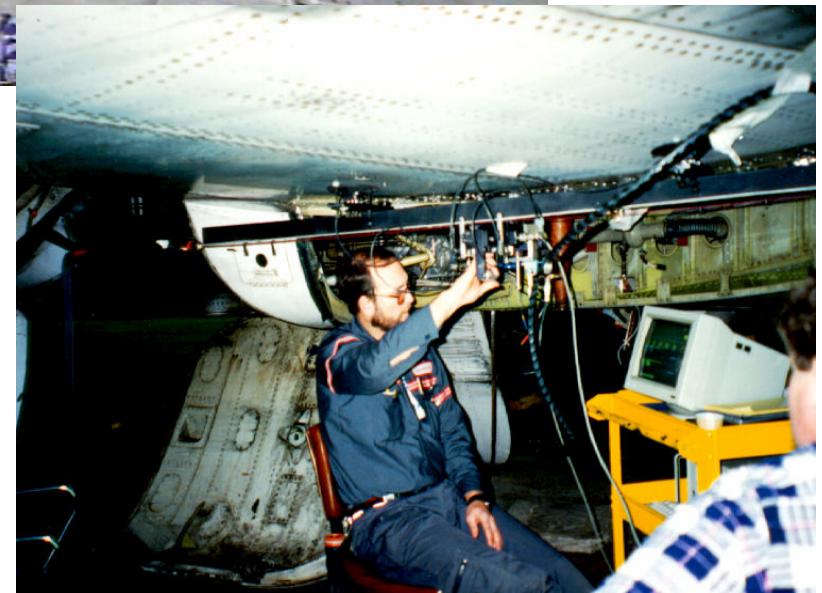
- Ultrasonic technique replaces visual inspection
- Eliminates need for exposure to hazardous material in a confined space
- Doubles inspection area and increases resolution
- Produced AMOC for Boeing AD while providing better NDI information
- Aging Aircraft FAR & SSID

*Northwest Airlines Inspector scanning DC-9 Tee Cap with new ultrasonic technique*

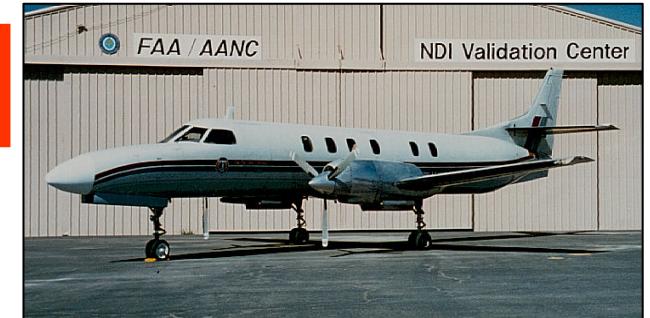
*Field testing of eddy current inspection being completed on SA226 aircraft*

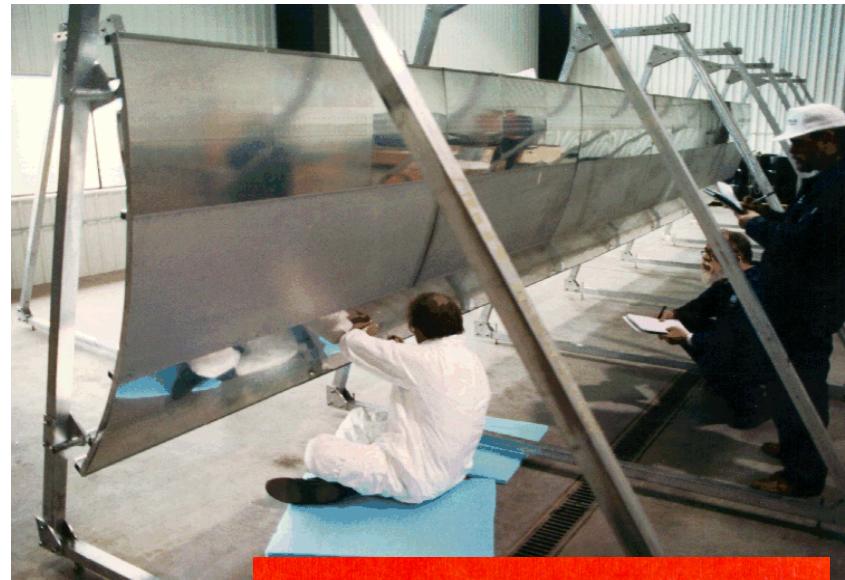
- Evaluated the performance of conventional eddy current devices at aircraft maintenance depots to detect fuselage cracks
- Demonstrated the need for better imaging capabilities to interpret eddy current measurements
- Led to development of new imaging technologies which will allow operators with less expertise to use the technology
- Supports AD 91-06-06 (terminating action) & subsequent Boeing Alert SB 737-53A1224 (AD 99-04-22)

**Eddy current imaging technology  
for crack length measurement**

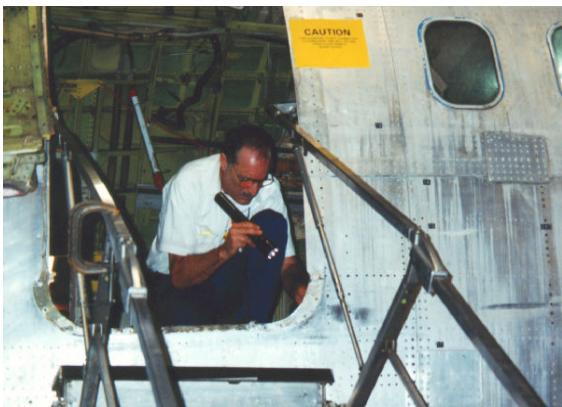
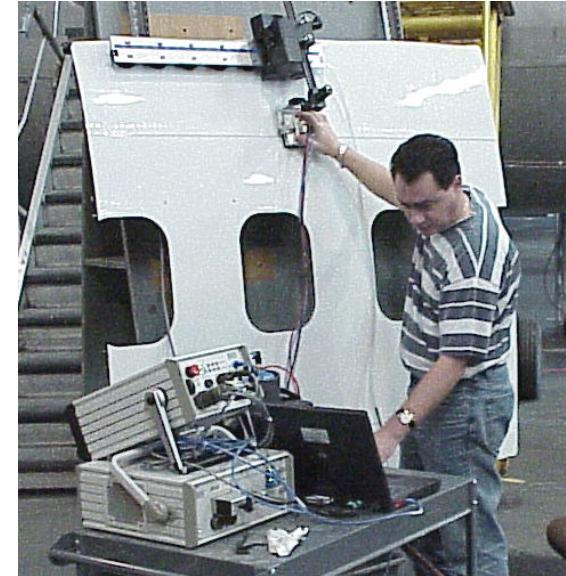
**RD Tech Performing Blind Corrosion Detection Study**

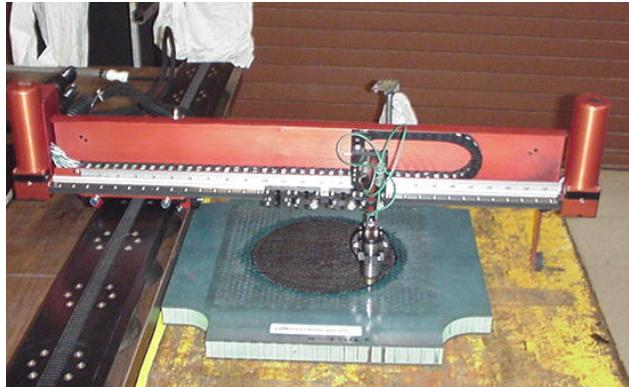
MAUS Inspections of Repaired Composite Sandwich Structures
