Nevada  
Environmental  
Restoration  
Project

DOE/NV-469  
UC-700

Closure Report for CAU No. 430:  
Buried Depleted Uranium Artillery  
Round No. 1, Tonopah Test Range

February 1997

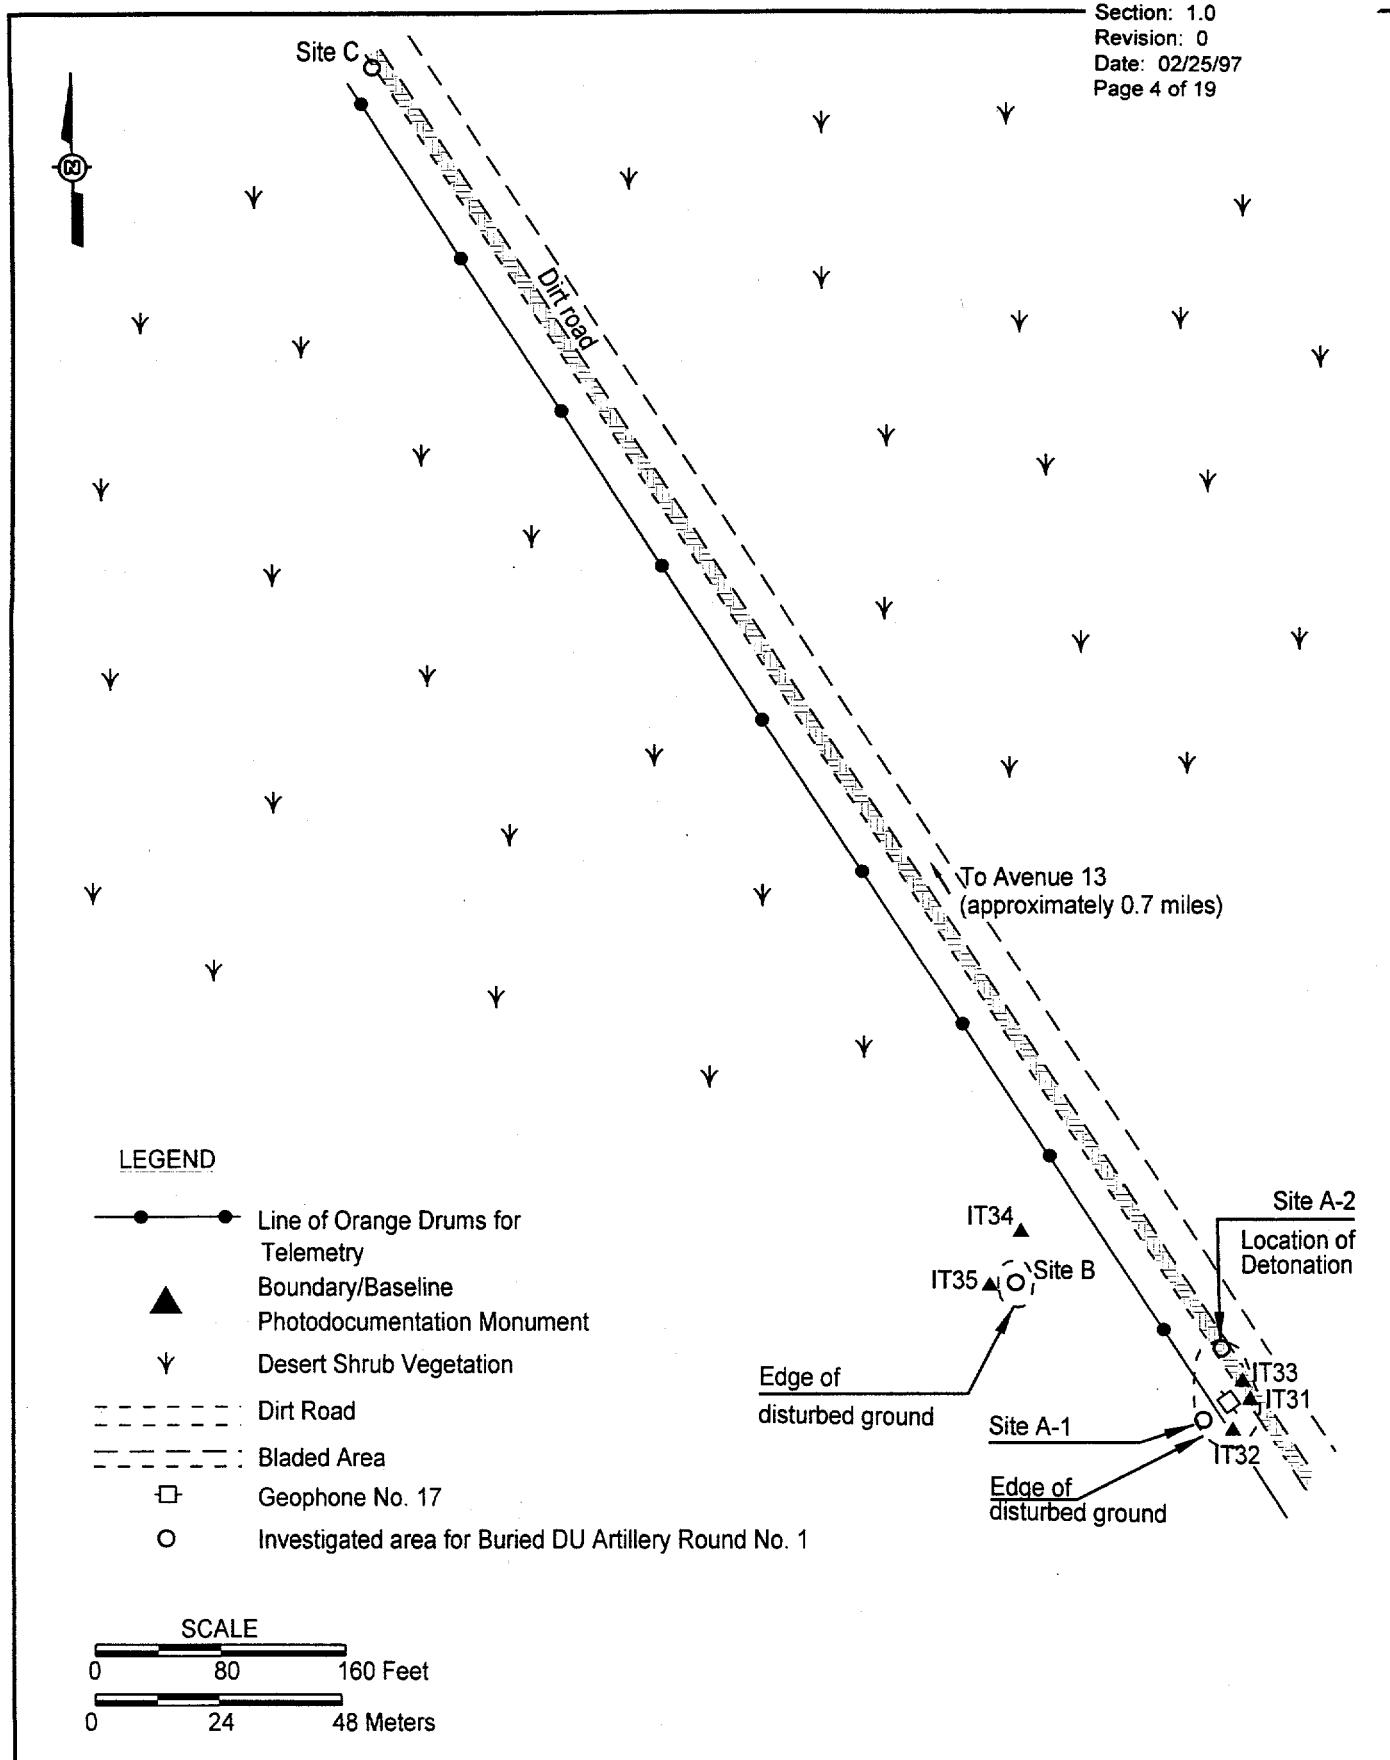
**Figure 1-3**  
**Site Location Map, Buried DU Artillery Round No.1, Sites A-1, A-2, B, and C**  
**Tonopah Test Range, Nye County, Nevada**

On October 22, 1996, a global positioning survey was performed on Sites A-2, B, and C to obtain geographic readings for the sites. A GPS was not performed at Site A-1 because it was part of the test area telemetry system and not of concern for this investigation. Figure 1-3 depicts the global positioning surveyed locations and the IT monuments. The IT monuments are photo documentation locations set up during a site visit in 1993 (IT, 1994). Based on the global positioning surveyed points, other items in the figure have been sketched in.

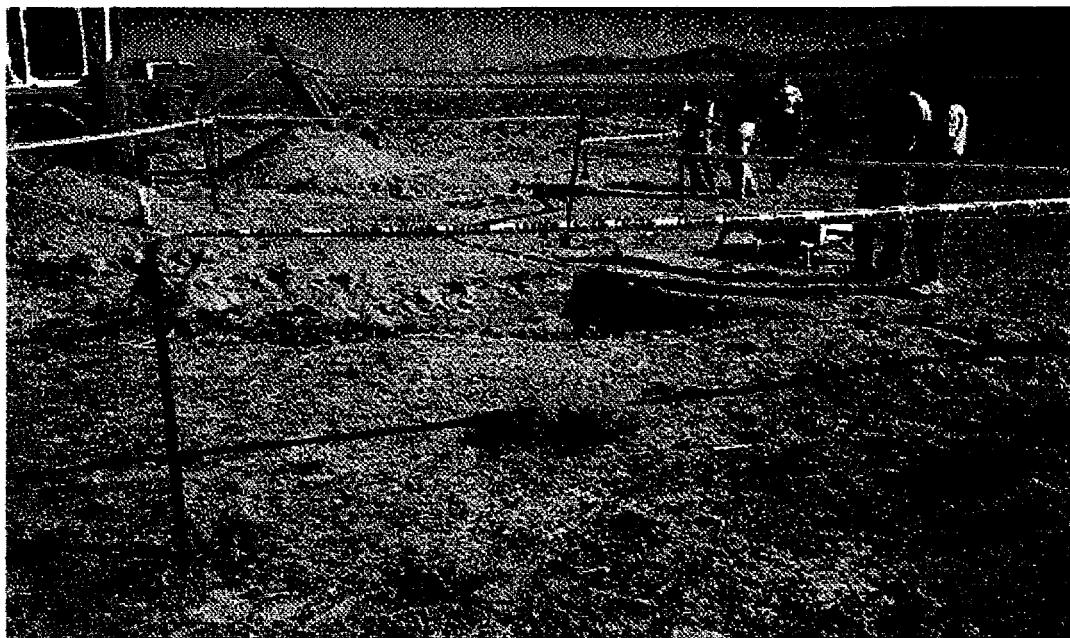
**Figure 2-1**  
**Buried DU Artillery Round No. 1, Sites A-1 and A-2, Site A-1 is in the**  
**Foreground (photo taken facing north/northeast)**

Site A is the southernmost area of concern at the CAS. It consisted of a disturbed area approximately 30 feet (ft) in diameter. Upon performing the initial magnetic survey at Site A, two areas with strong anomalous readings, referred to as Sites A-1 and A-2, were discovered (Figures 1-3 and 2-1). Site A-1 was excavated first. The anomalous reading was determined to be a geophone sensor for part of the telemetry system in the area (Figure 2-2) at an approximate depth of 4 ft. After the excavation, the hole was backfilled using the excavated spoils.

Site A-2 is located approximately 20 ft northeast of Site A-1 and consisted of a strong anomalous reading and a visual depression approximately 3 ft in diameter. These attributes suggested that this could be the location of the projectile. This area was excavated to approximately 4.5 ft using a backhoe at which time the nose of a projectile was uncovered. The remaining portion of the projectile was uncovered manually using hand excavation techniques, and radiological screening of the projectile and the excavated soil was performed. No readings above background were

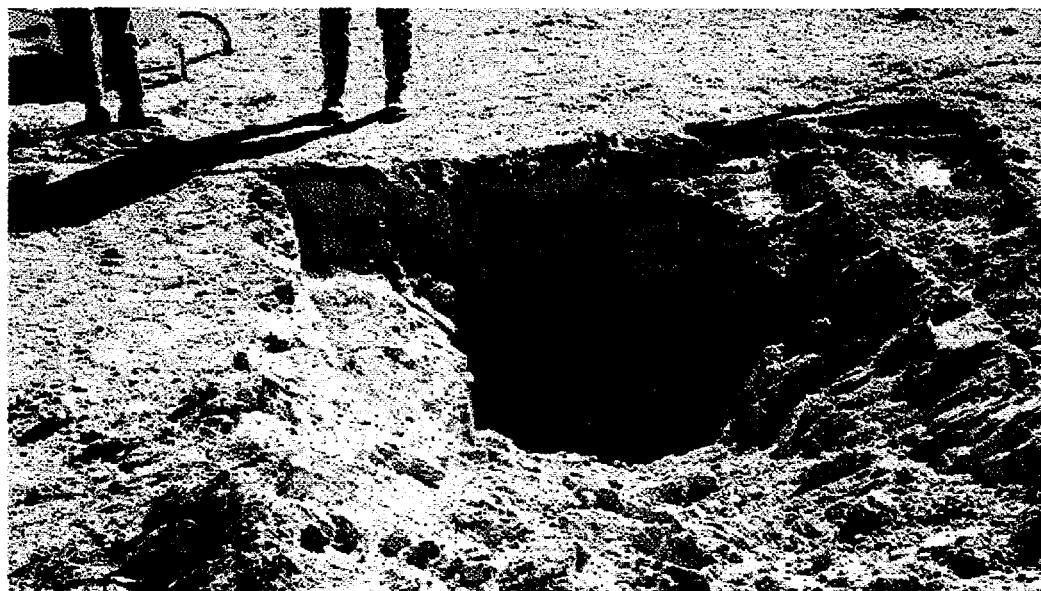
**Figure 2-2**  
**Buried DU Artillery Round No. 1, Site A-1,**  
**Geophone sensor is on right side of excavation**  
**(photo taken facing south)**

Sites A, B, and C were excavated during field activities at the Buried DU Artillery Round No. 1 site. The metallic anomalous readings at Sites B and C are believed to have been caused by the magnetic characteristics of the soil and rocks in the area. Site A was the only site which contained subsurface metallic items. The metallic anomaly at Site A-1 was caused by a metallic geophone sensor. Site A-2 contained an inert artillery projectile.

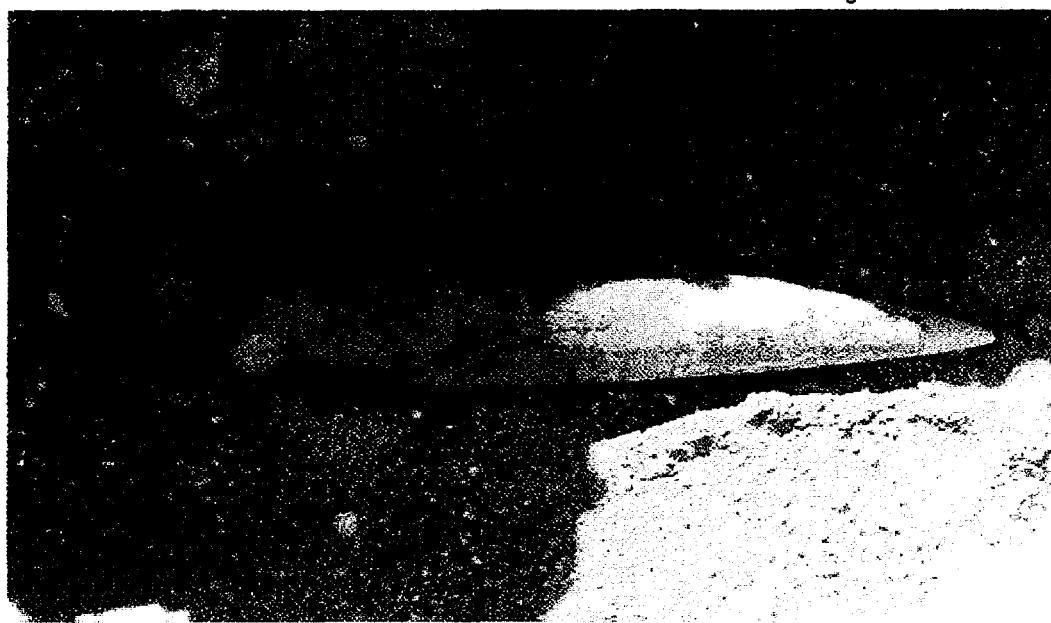
**Figure 2-3**  
**Buried DU Artillery Round No. 1, Site A-2,**  
**Excavated projectile within excavation prior to detonation**  
**(photo taken looking down into excavation)**

Radiological readings were not present; however, the projectile casing was intact (Figure 2-3). The projectile was treated as if it were the Buried DU Artillery Round No. 1 and was set up for destruction. Approximately 40 pounds (lbs) of Composition C-4 (high explosives) were placed on the projectile casing by USAF EOD personnel. The excavation was backfilled using the excavated spoils and the explosives were detonated (Figure 2-4). Upon reentry, a surface radiological screening survey of the area was performed using an Electra® alpha/beta meter. No elevated levels of radiation (readings greater than background) were detected through the screening survey. The detonation area was re-excavated to verify that the projectile and all components had been destroyed beyond recognition. Radiological screening was performed during re-excavation and, once again, no elevated levels of radiation were detected. Complete destruction of the projectile had occurred. Because of the absence of radiological contamination after the detonation, it was concluded that this was not the W-79 mockup which was the objective of the search. The detonated 8-in. projectile was one of the many hundreds of concrete-filled "warmer" rounds which were shot by weapons testing personnel just prior to W-79 tests. The purpose of the warmer rounds was to rehearse tracking and telemetry operations used during the actual test (Smith, 1996). The excavation/detonation pit was backfilled with the re-excavation spoils; thus, field activities proceeded to Site B.

An attempt was made to positively identify the projectile within Site A-2 as the Buried DU Artillery Round No. 1 prior to its destruction; however, the exterior of the projectile was corroded with rust which made locating a serial number or any other identifying marking impossible (Figure 2-3). A portion of the projectile was green in color, which suggested that it contained HE and was not just an inert round. There was also what appeared to be a parachute assembly attached to the projectile. It was later determined that the assembly at the bottom end of the projectile was not a parachute assembly, but a protective skirt. There were no radiological screening results above background (IT, 1996a). Elevated readings would have been an indication that the projectile was the DU Round; however, the casing was intact which may have inhibited a radiological leak. Based on these characteristics and the fact that positive identity of the projectile could not be made, it was treated as if it were the Buried DU Round No. 1. The projectile was destroyed using explosives. Radiological screening results of the detonation area were all at or below background radiological levels (IT, 1996a).

Based on the fact that the radiological screening results were at or below background and that the detonation was not much larger than what was to be expected for the 40 lbs of explosives used to destroy the projectile, it was determined that the projectile destroyed was not the Buried DU Artillery Round No. 1, but was in fact one of the many inert projectiles fired prior to the actual test round (Smith, 1996). After each of the sites was excavated and field screening indicated either no additional metallic debris or, in the case of Site A-2, no radiological contamination, the excavations were then backfilled.

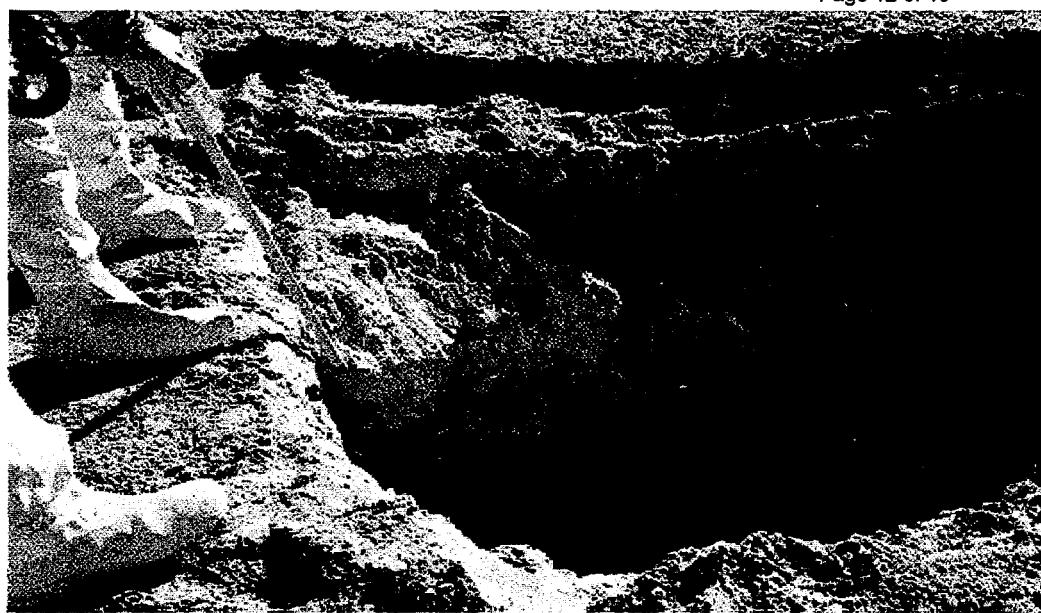
**Figure 2-5**  
**Buried DU Artillery Round No. 1, Site B,**  
**Surveying edge of excavation with a Tesoro Lobo metal detector**  
**(photo taken looking into excavation)**

made to excavate the area showing the strongest magnetic reading within Site B, which was not visually similar to Site A-2 (i.e., 3 ft diameter circular depression). Site B was excavated to a total depth of 7 ft (Figure 2-5). Each 1-ft lift of soil excavated was screened for magnetic anomalies and radiological readings; the soil within the excavation appeared to be native soil. Radiological screening results were all at or below background levels. All the magnetic anomalies were attributed to the magnetic properties of the native materials (i.e., volcanic rocks) (IT, 1996a). Based on these facts, excavation activities were stopped at 7 ft, and the hole was backfilled using the excavated spoils; thus, field activities were moved to Site C.

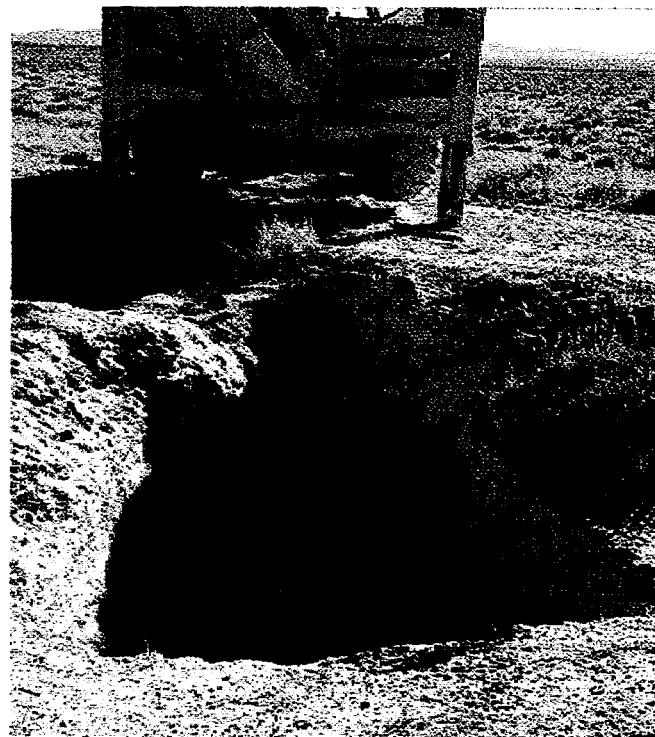
**Figure 2-6**  
**Buried DU Artillery Round No. 1, Site C**  
**(photo taken facing west/southwest)**

Site C is the northernmost area of concern and is located approximately 960 ft northwest of Site A-2. It consisted of a depression approximately 10 ft in diameter and 3 ft deep. The initial ordnance survey found weak anomalous readings in the depression. The surface radiological screening did not indicate elevated radiological readings; the pit was excavated to a total depth of 7 ft (Figure 2-6). Each 1-ft lift of soil excavated was screened for metallic anomalies and radiological readings. The soil within the excavation appeared to be native soil. Radiological screening readings were all at or below background levels, and no strong metallic readings were obtained (IT, 1996a). Magnetic readings at this site are also believed to be from magnetic geologic materials. Based on these facts, excavation activities were stopped at 7 ft, and the hole was backfilled using the spoils.
