The Critical Microstructural Conditions Leading to the Formation of Voids During Ductile Rupture

Philip J. Noell, Julian E. C. Sabisch, Douglas L. Medlin, Jay D. Carroll, Brad L. Boyce

Void nucleation during ductile rupture

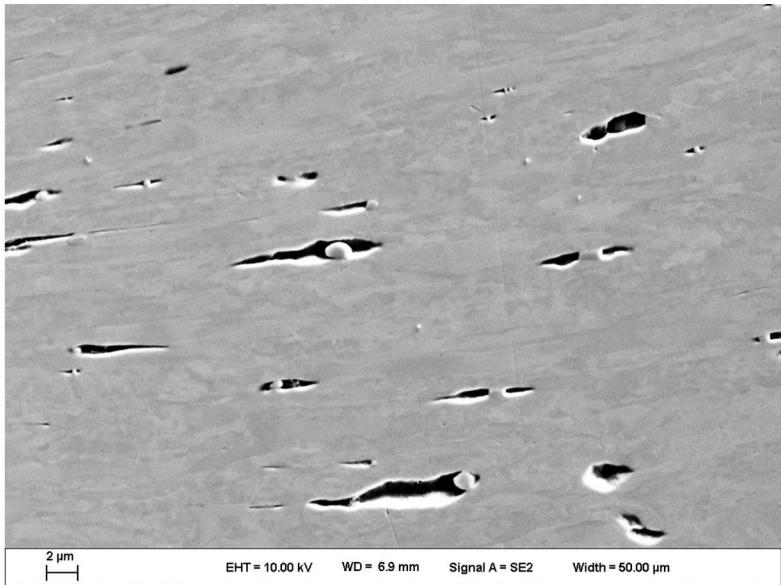
Secondary-electron image of voids in a deformed copper wire containing second-phase particles

Void nucleation in many materials is intragranular and associated with inclusions and/or second-phase particles, either by particle fracture or by particle decohesion.

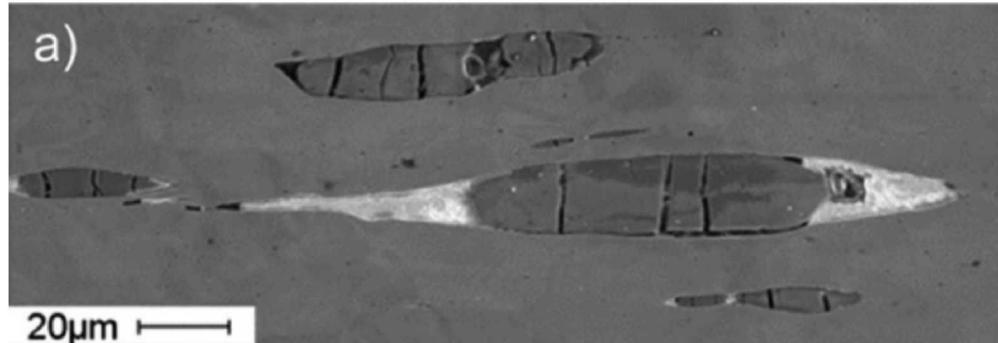
Cracked MnS inclusions in a free-cutting steel. Seo et al, ISIJ International, 2015.

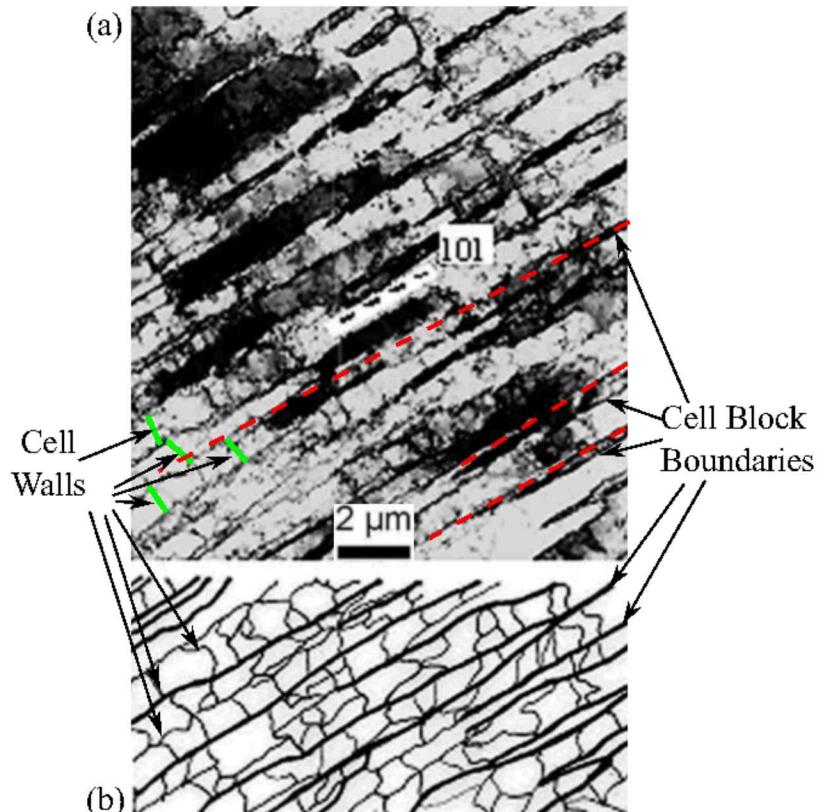
Cell blocks and cell walls in deformed iron

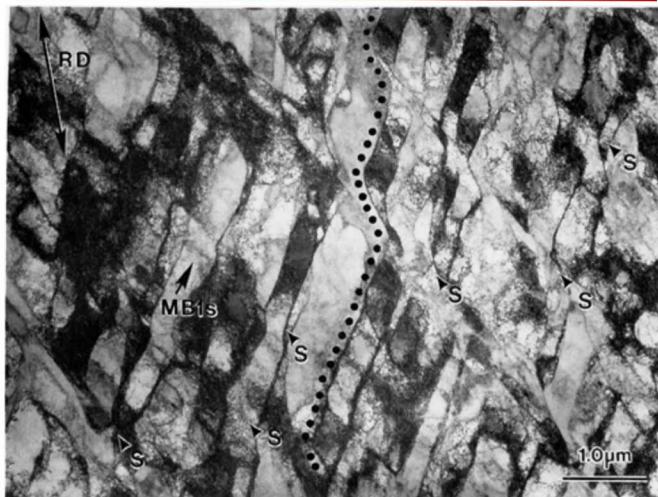
A microshear band cutting through cell blocks in Ni

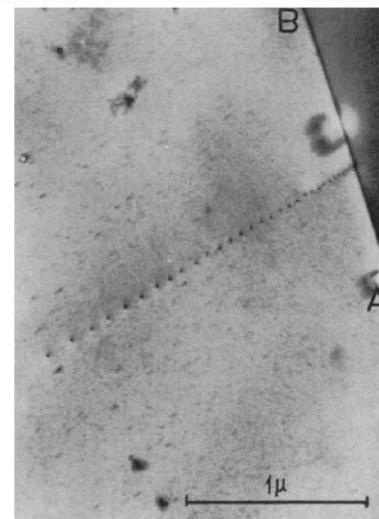
A dislocation pile-up at a grain boundary in tungsten

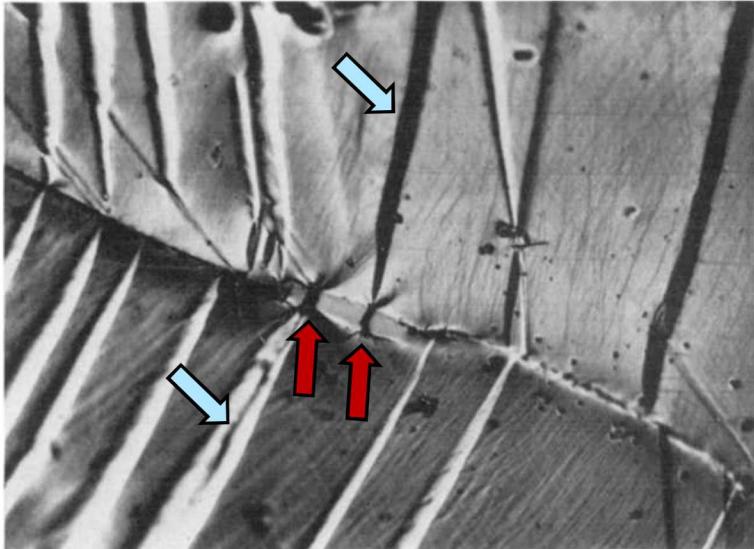
Fractured hydride platelet in Zr associated with $\{11\bar{2}1\}$ type twins; **particle fracture depended on twin type**

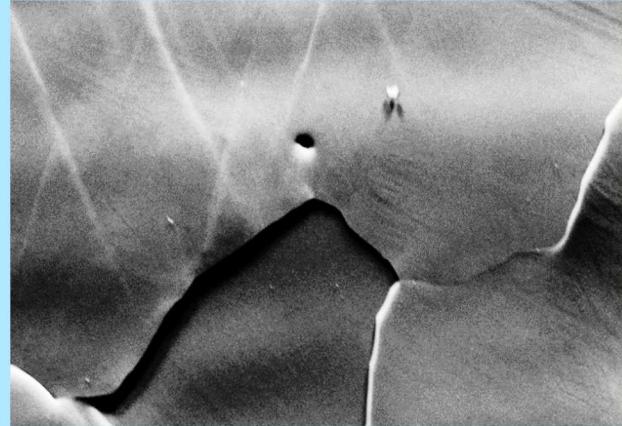
A cracked carbide associated with slip bands in an austenitic stainless steel

SE Image: only slip bands visible

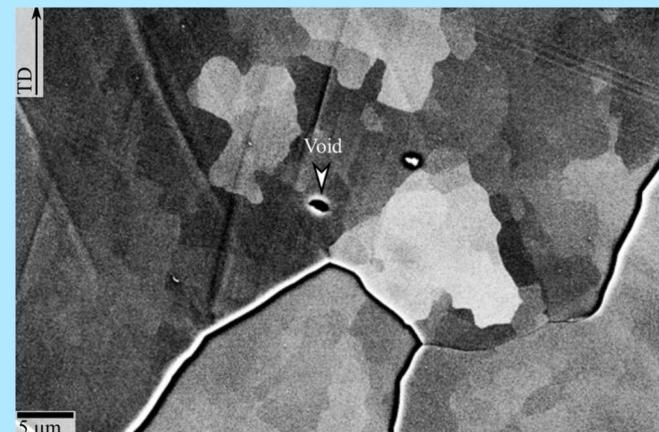
BSE Image needed to observe dislocation boundaries

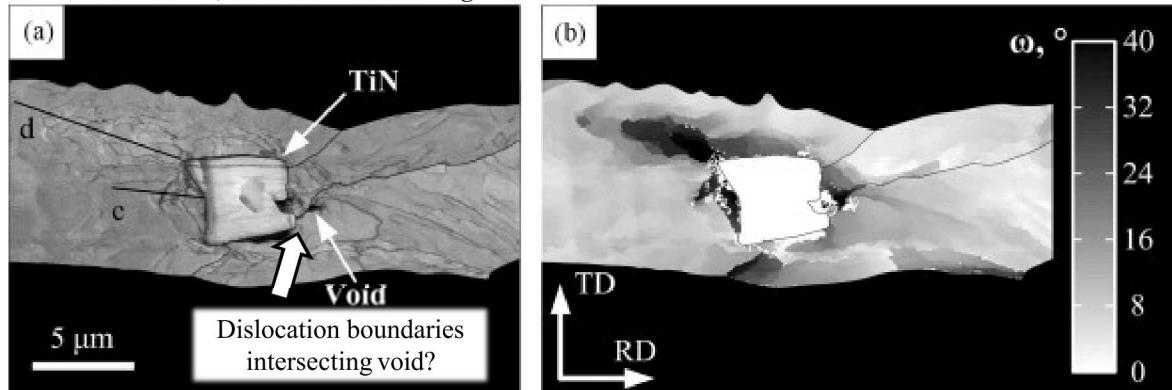
Particle debonding at a TiN precipitate in an IF steel; EBSD data suggest that debonding was associated with a dislocation boundary, but data resolution is poor

Two prior studies contain examples of particle debonding and fracture near high-angle dislocation boundaries, but *no detailed characterization of the relationship between incipient voids and deformation defects was performed*

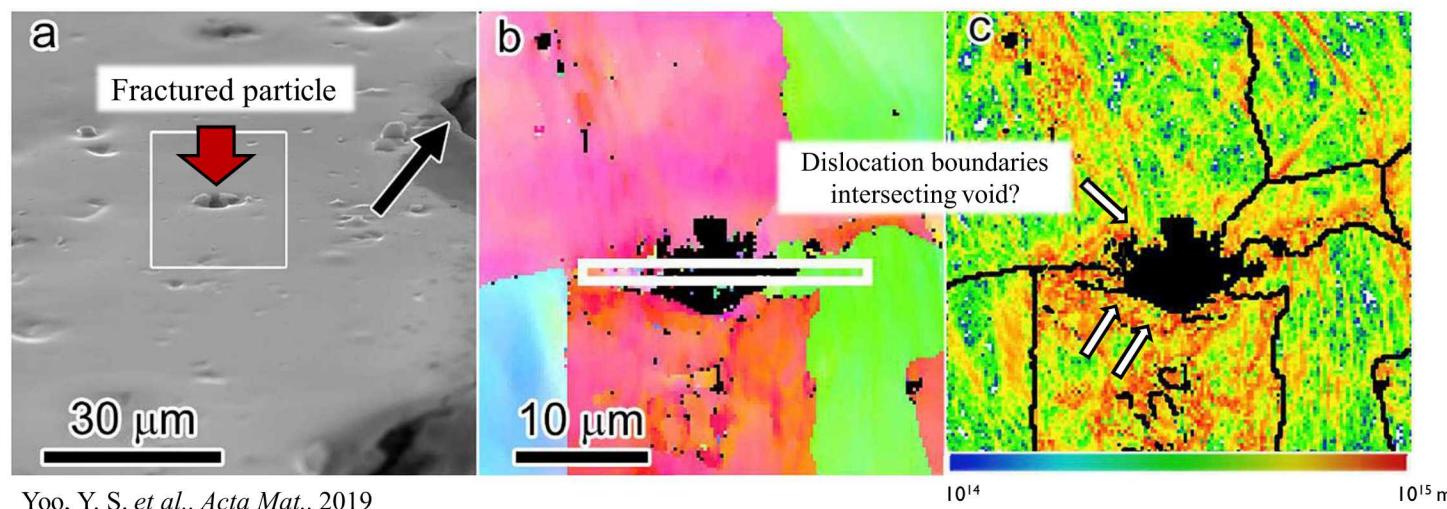
Fracture of an intermetallic particle in Al6061, EBSD data suggest high density of dislocation boundaries intersected fractured particle

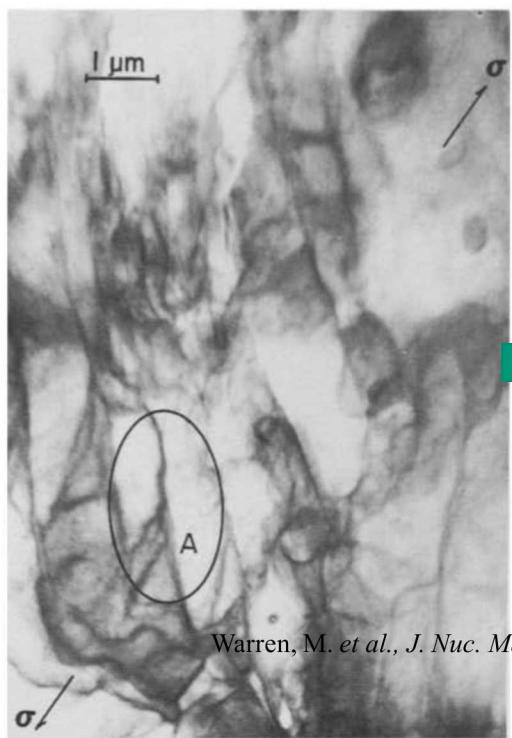
(a) The dislocation structure in a strained beryllium (HCP) single crystal

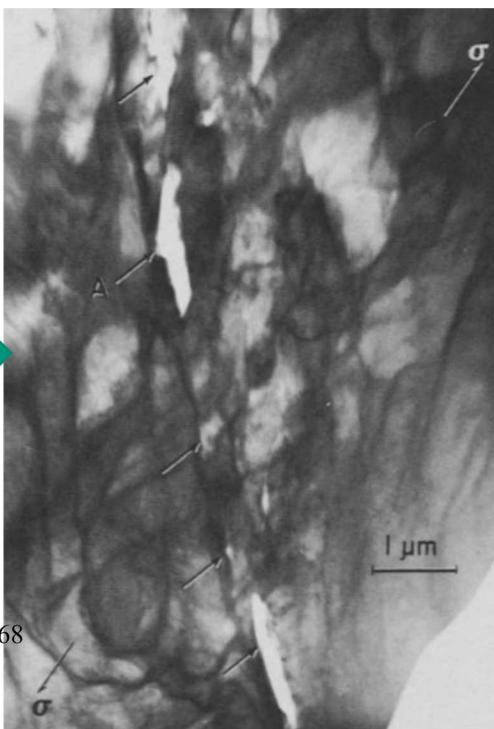
(b) The same region as in (a) after further straining. Voids along the dislocation boundary indicated with black arrows

Early studies of the ductile rupture of single crystals demonstrated that voids nucleate at deformation-induced boundaries. Vacancy clusters observed near fracture surface in some materials. **Do dislocation boundaries and, maybe even vacancy clusters, play a role in void nucleation in bulk metals?**

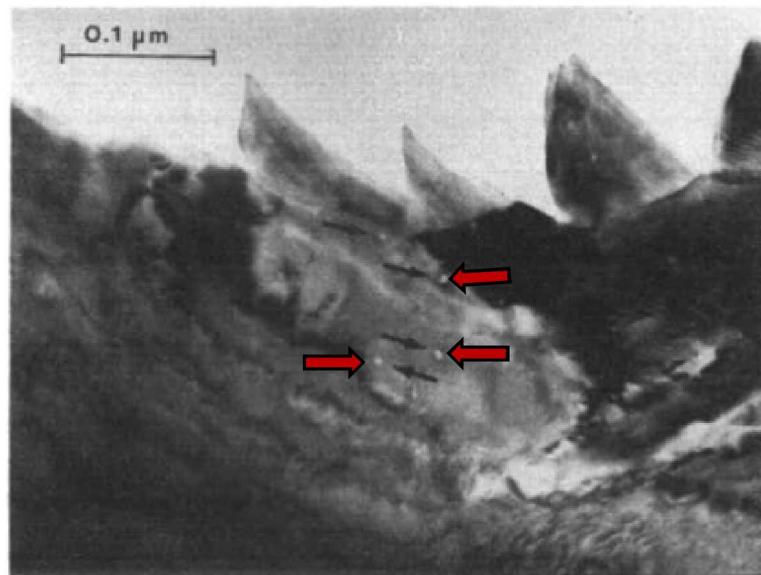
Vacancy clusters near the fracture surface of a single-crystalline, gold thin film

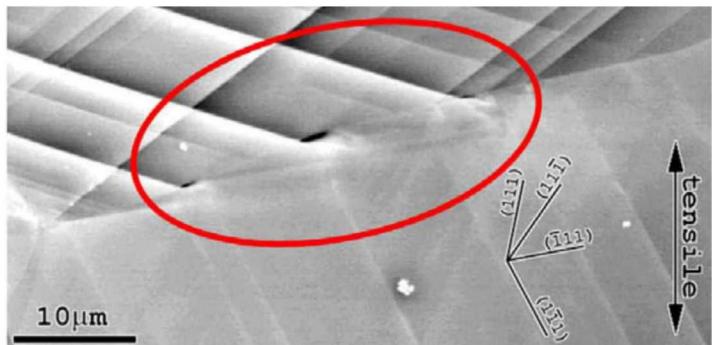
Microcracks in TiAl correlated with twin intersections.

- In pure metals that deform by twinning, voids nucleate at grain-boundary/twin intersections and twin/twin intersections
- In both pure BCC (Ta) and FCC (Al) materials that deform by slip, voids nucleated at dislocation boundaries
- In high-purity Al, void nucleation was suppressed by dynamic recrystallization, which erased dislocation boundaries

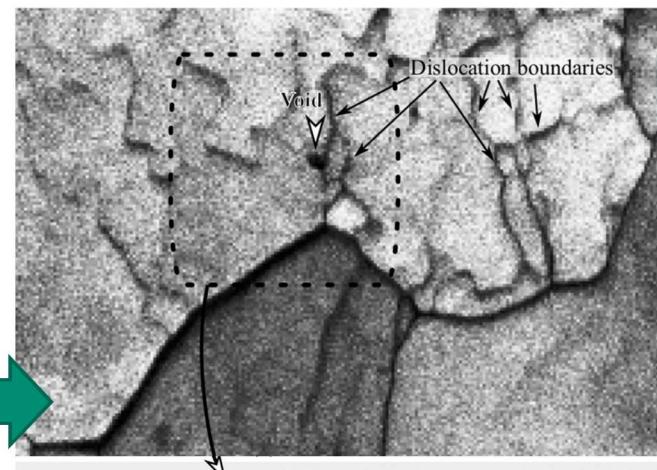
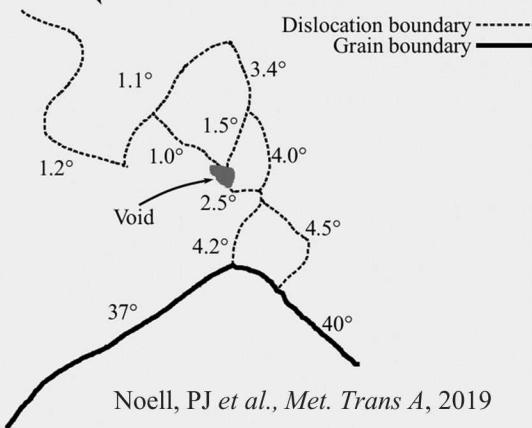
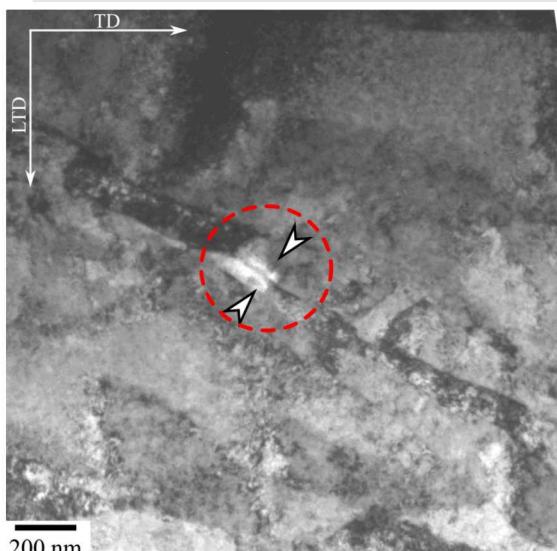
Void nucleation in Al occurred at dislocation cell walls, suppressed by DRX

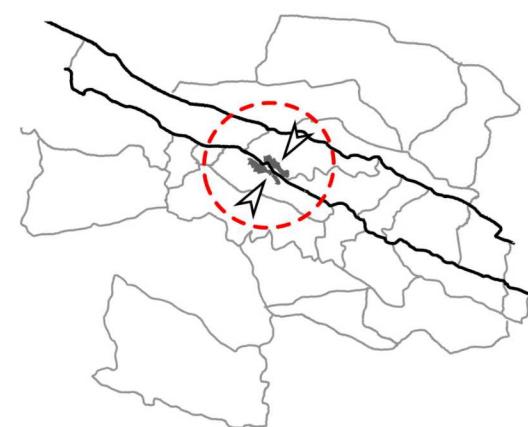
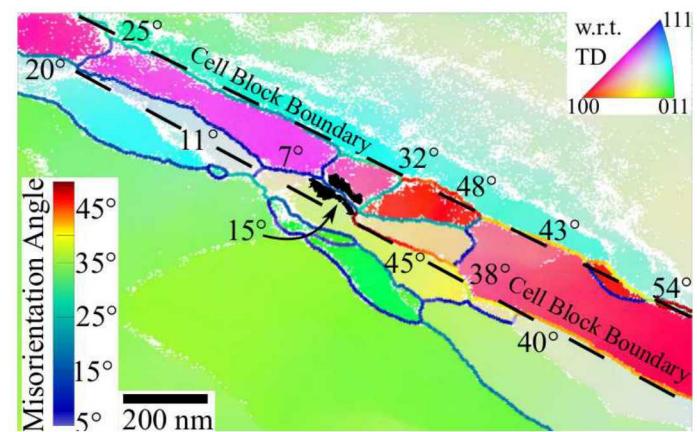
Void nucleation in Ta primarily occurred at cell block boundaries

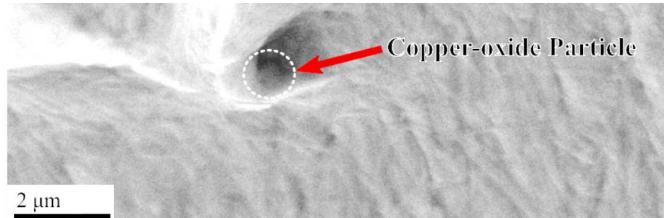
Contains \approx 200 to 500 nm copper oxide inclusions, \approx 1 inclusion per $8000 \mu\text{m}^3$ of material

Images of (above) a CuO_2 particle on the fracture surface and (below) a CuO_2 particle within a void

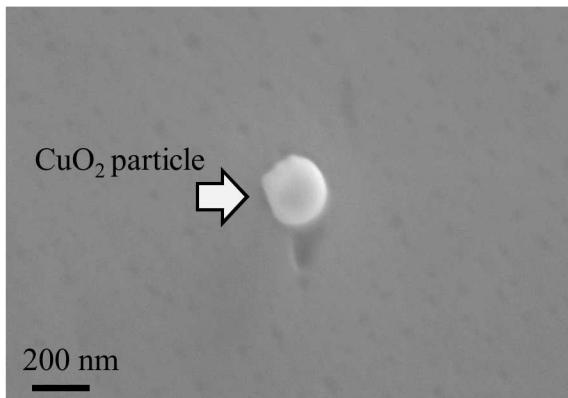
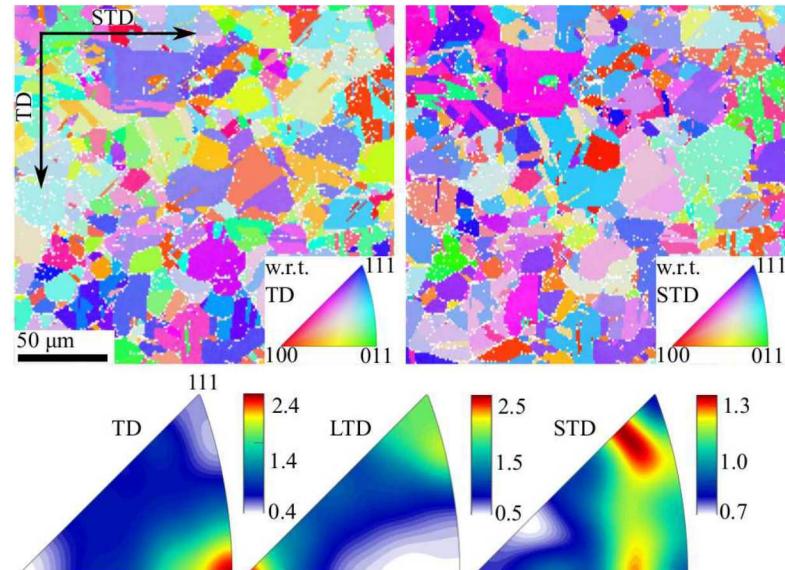
EBSD indicates that the as-received microstructure contained weakly-textured, equiaxed grains (8.7 μm diameter)

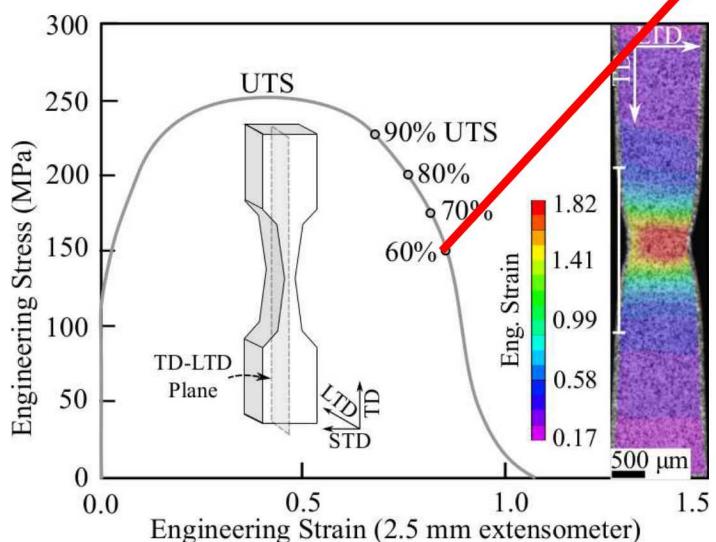
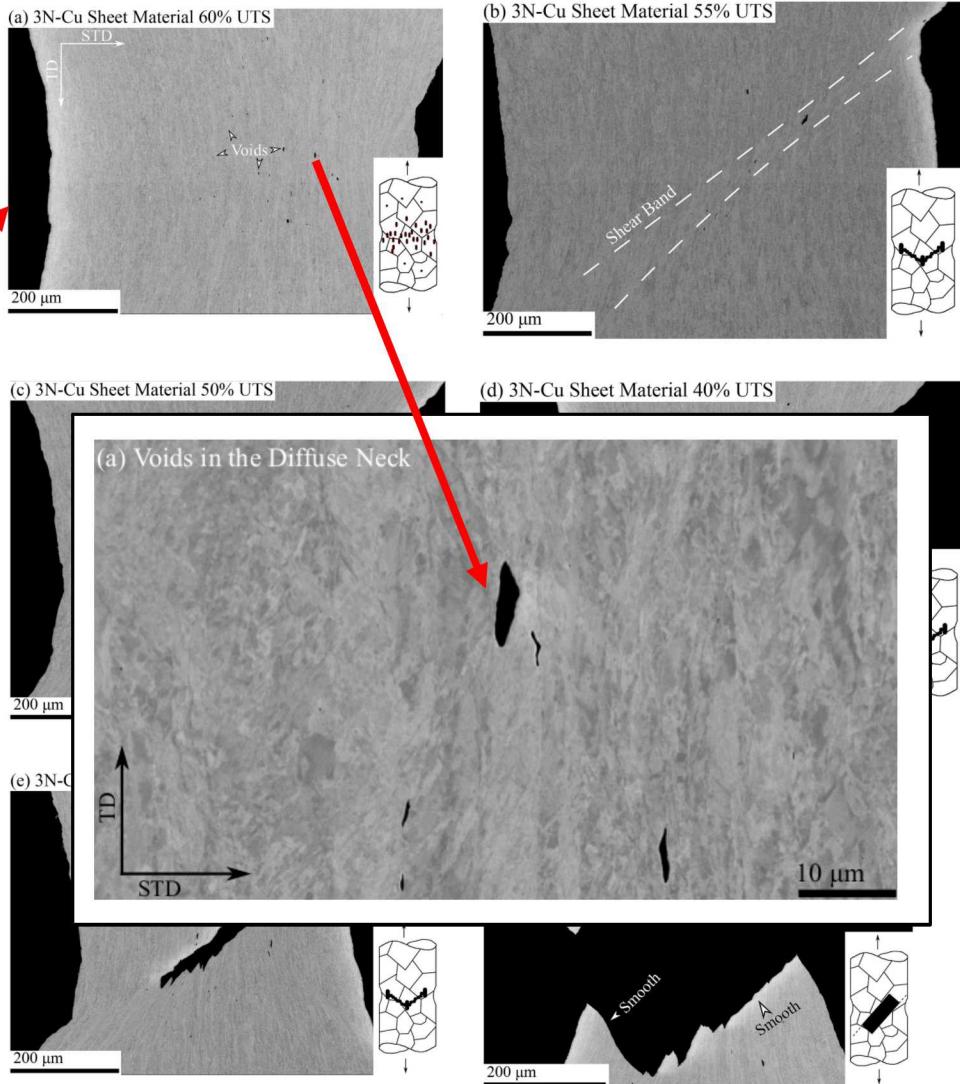
- Previous study using this material revealed that voids nucleate and grow within the diffuse neck of this material, coalesce along a shear band, and create an “Orowan void” that grows until failure
- *But where do the “failure-relevant”, microscale voids come from?*

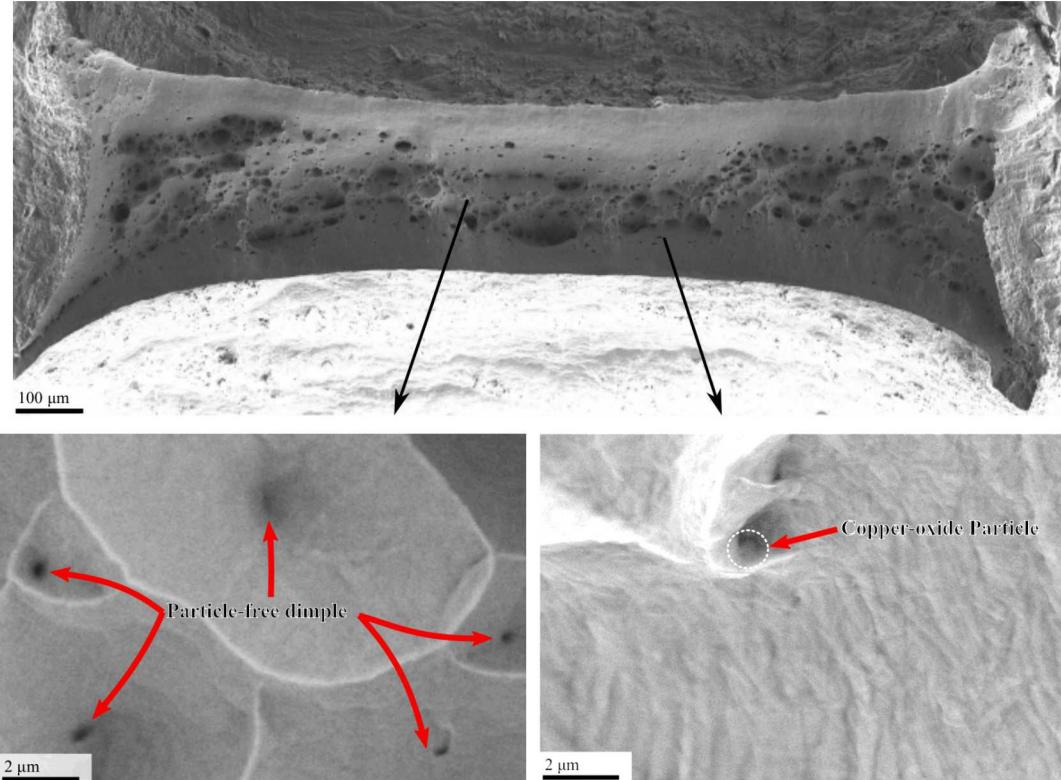
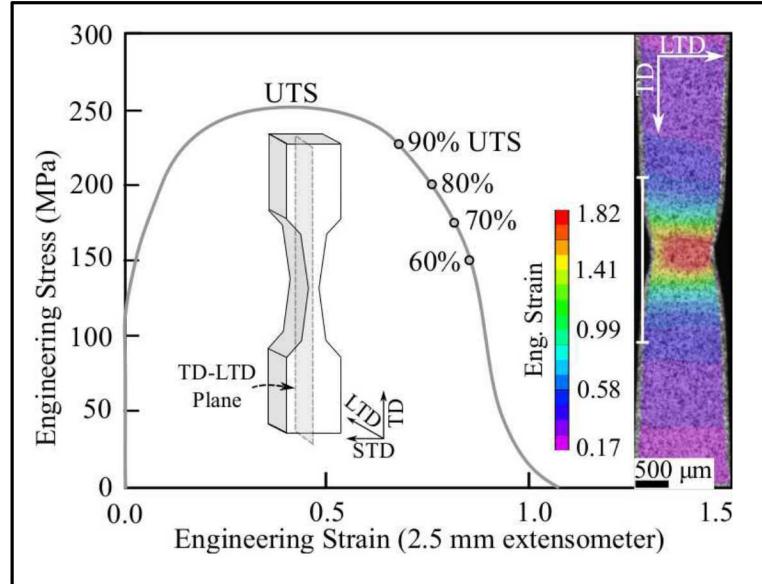
Inspection of the fracture surface suggests that most dimples were not associated with copper-oxide inclusions

To understand the origins of these voids, interrupted tensile tests used to produce specimens containing incipient voids

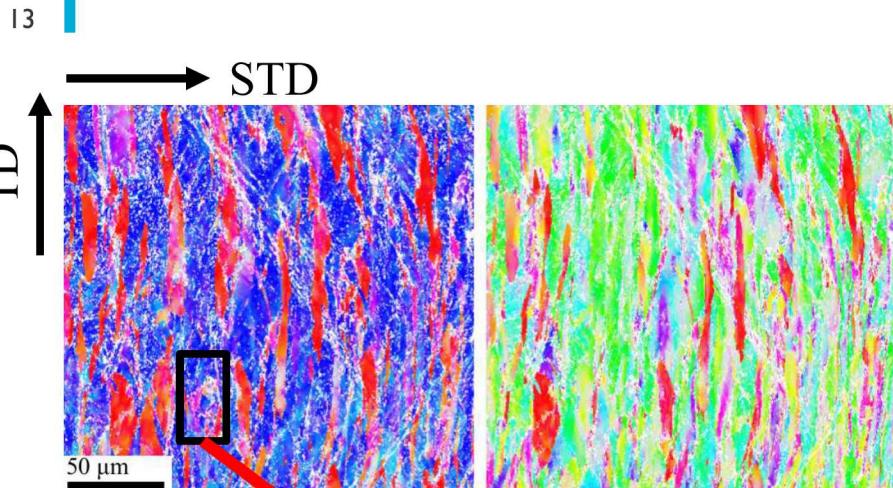
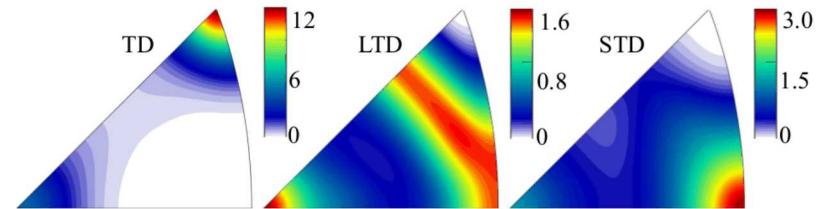
Deformation to 60% of the UTS created elongated grains (along TD), aspect ratio $\approx 4.4:1$. Approximate strain in center of neck $\approx 150\%-180\%$

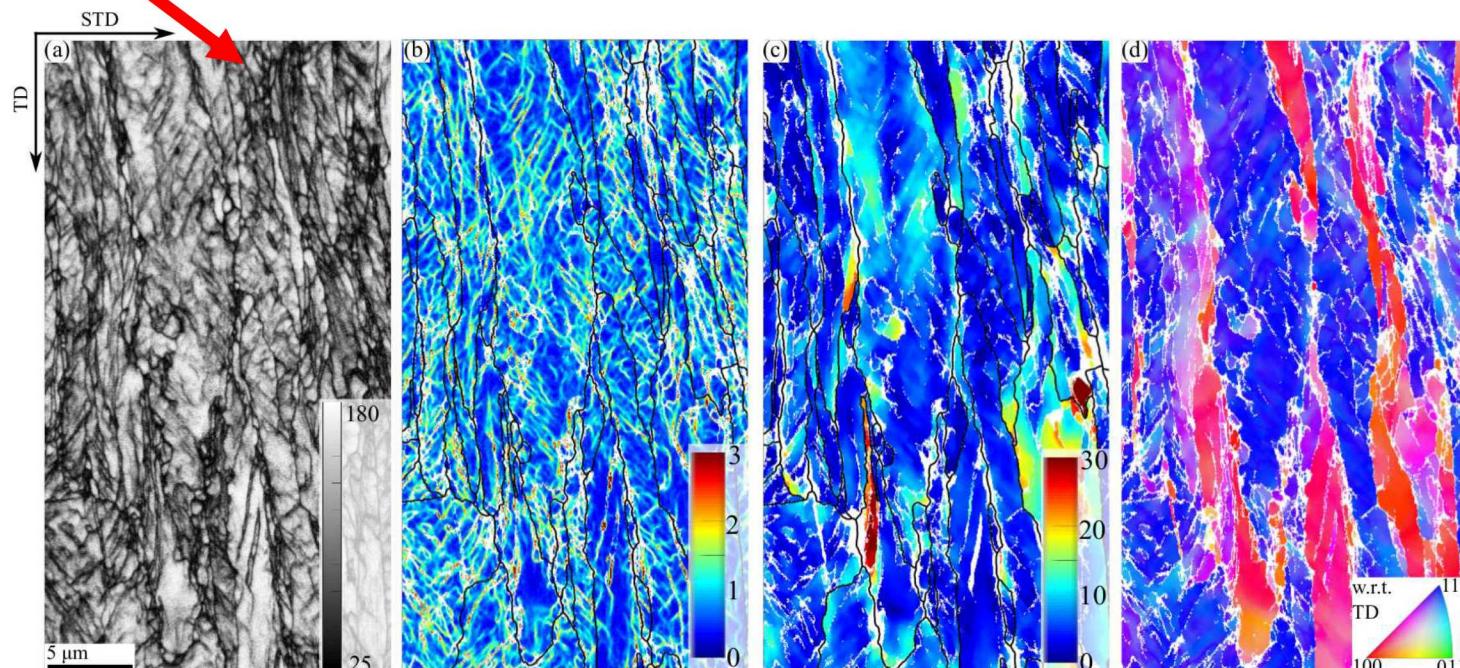
EBSD data collected with a 50 nm stepsize reveal dislocation boundaries typical of heavily deformed FCC, including both elongated, lamellar boundaries and equiaxed cell structures

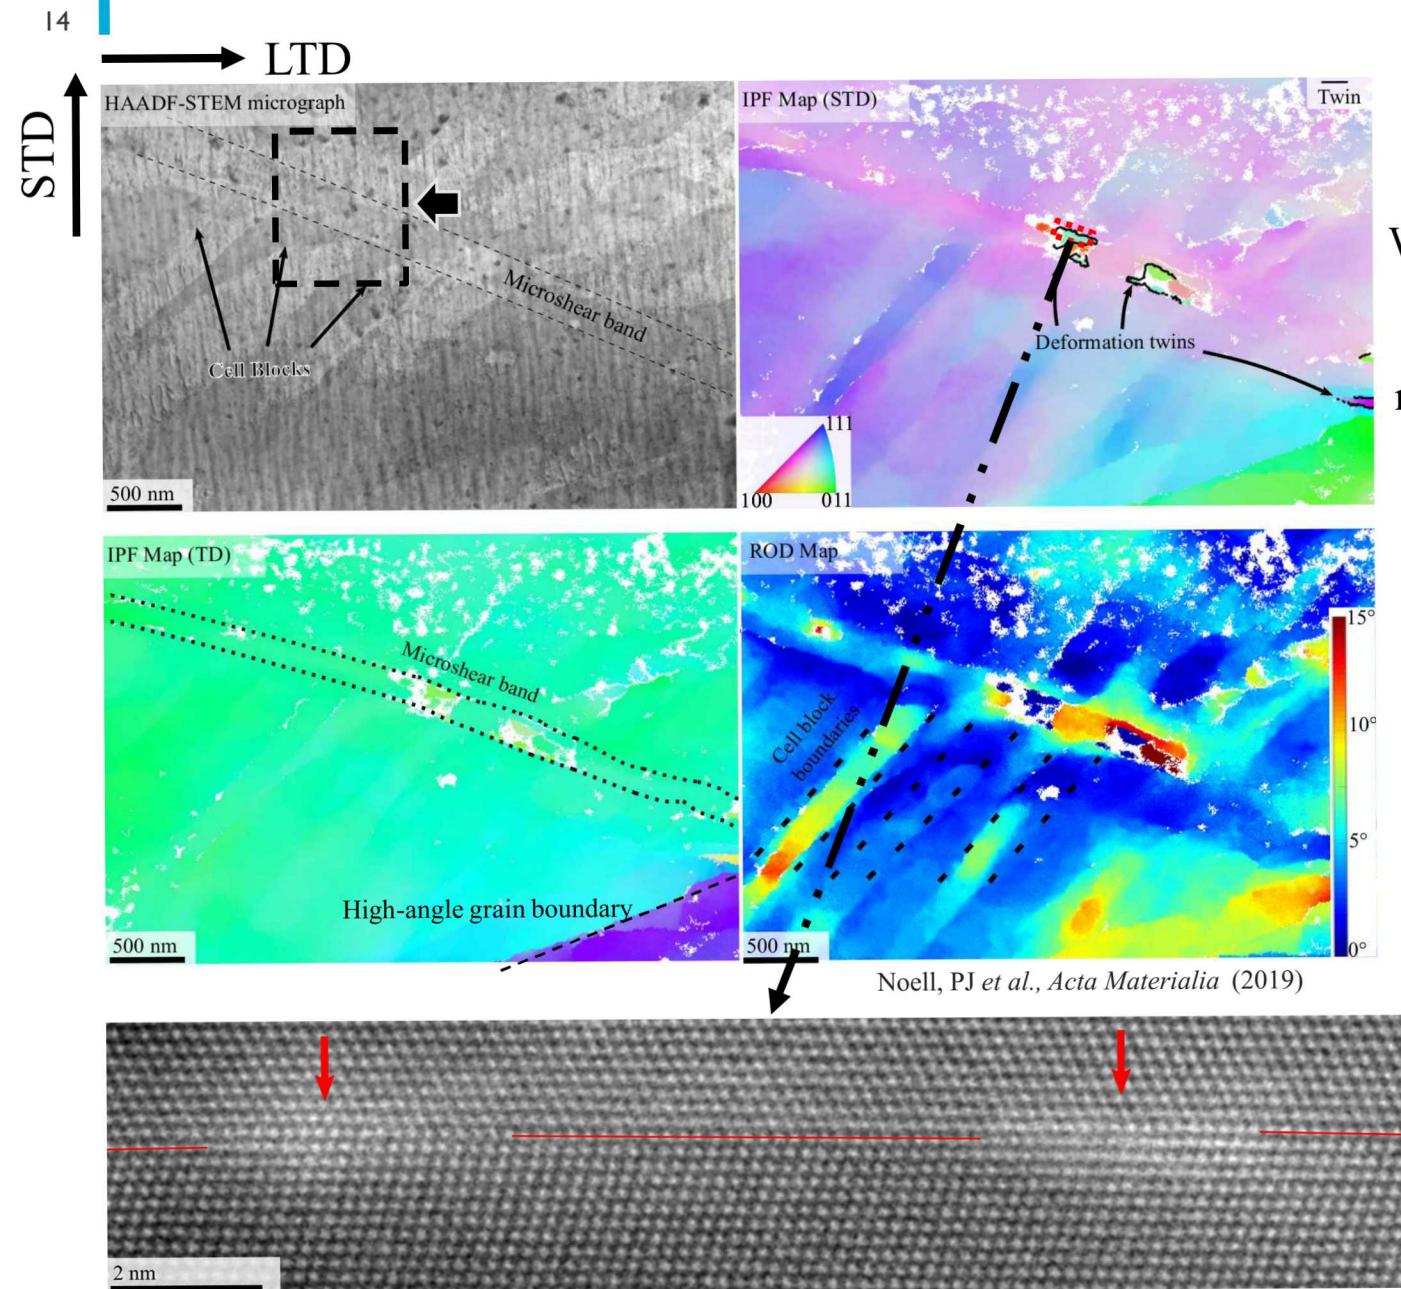
Within the diffuse neck of a 60% UTS specimen, Deformation twins and microshear bands observed at the microscale

Atomic-resolution detail from HAADF-STEM image of twin boundary shows $(a/6)<112>$ dislocations typical of deformation twins

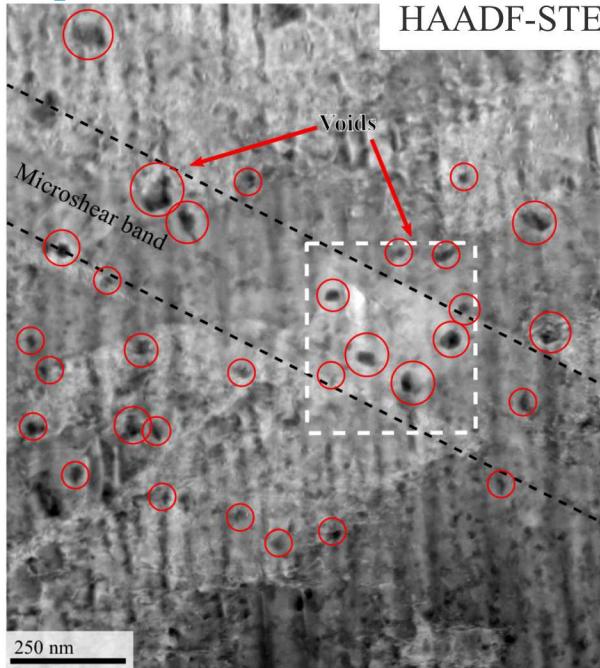
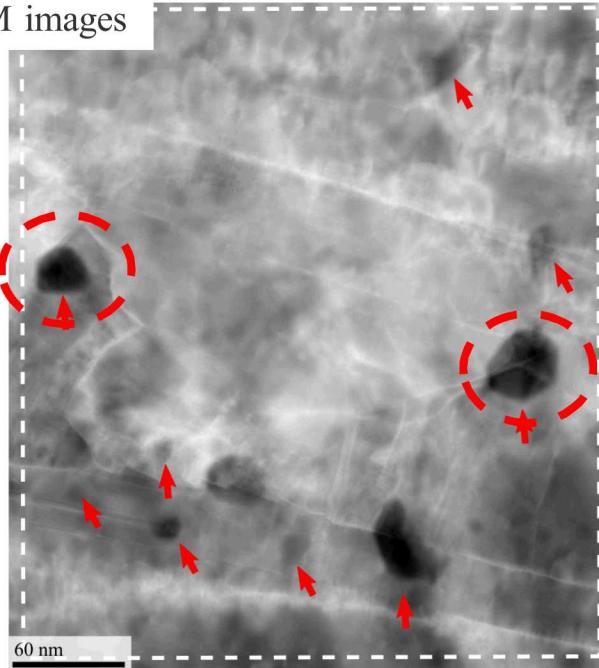
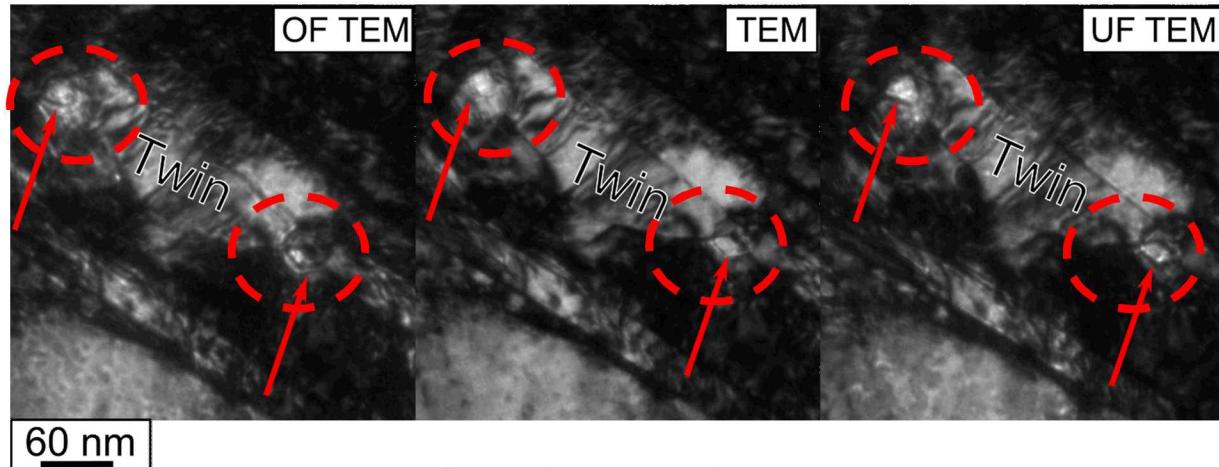
- Dozens of nanoscale (≈ 10 -100 nm) voids observed both within and outside the microshear band
- Voids are faceted, similar to those created by vacancy condensation following quenching in other materials
- ***No evidence in EDS or diffraction measurements that suggests a change in composition or secondary-phase***

A high density of nanoscale voids appear to be distributed throughout the midplane of the diffuse neck

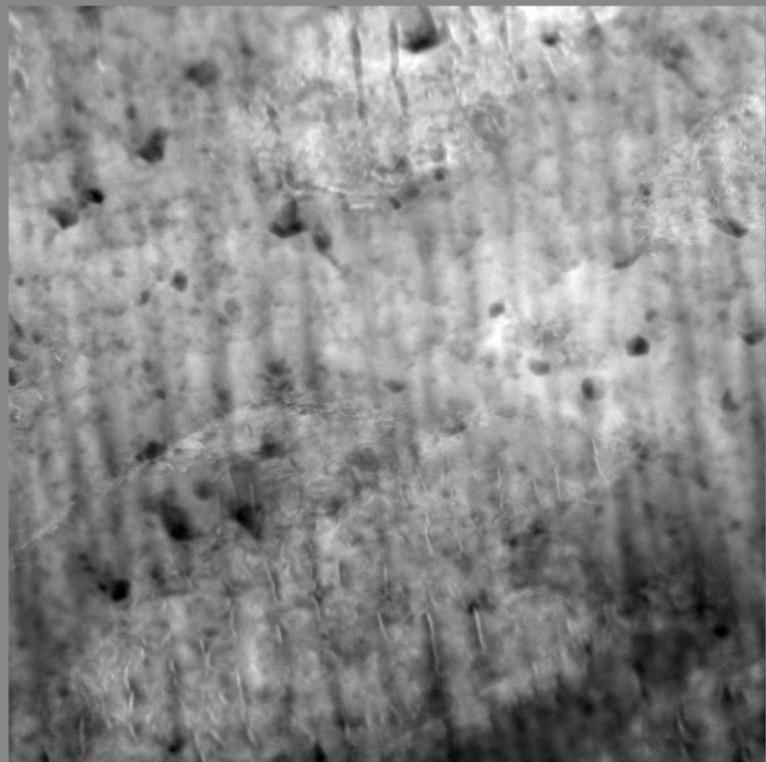
250 nm

A HAADF-STEM tomographic tilt series reveals mass-thickness contrast (indicative of voids) throughout the sample thickness.

- Estimate from these micrographs suggests a density of 10^2 per μm^2 nanoscale voids
- Observed both within microshear band and outside, suggesting they may be distributed homogenously throughout necked region

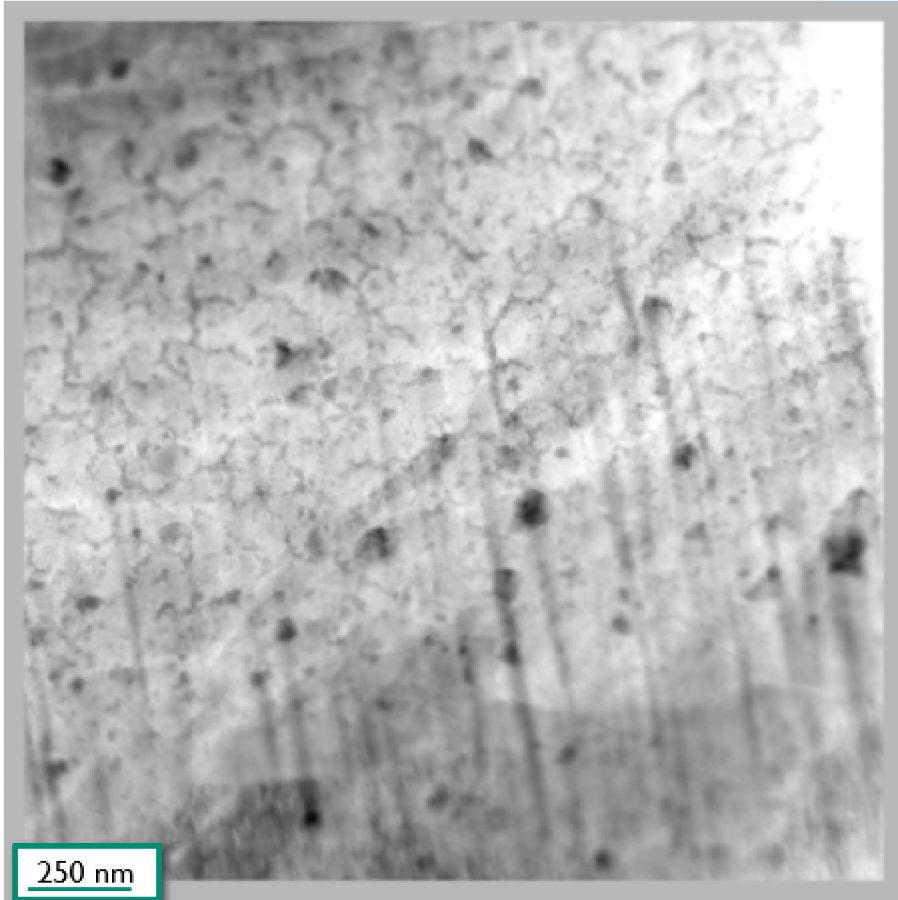
250 nm

Mass-thickness contrast, indicative of voids, also seen in HAADF-STEM of a second TEM foil (also extracted from the midplane, necked gauge region of a 60% UTS sample)

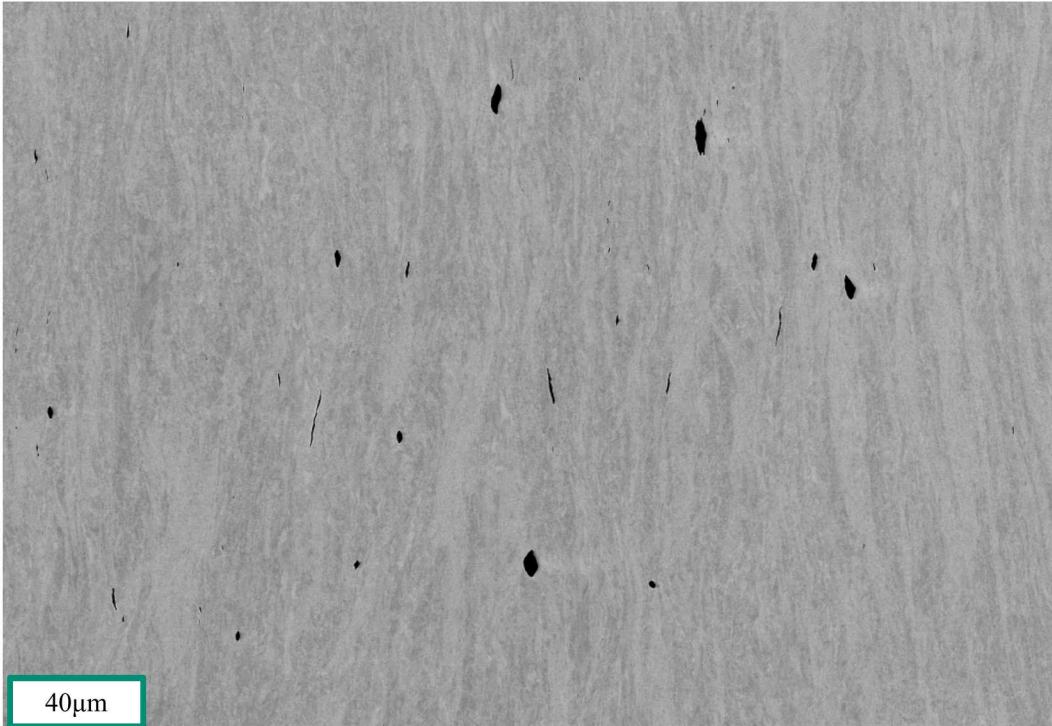
Area density of microscale voids in the center of the neck of a 60% UTS sample was ≈ 1 per $400 \mu\text{m}^2$. Conservatively, only 1 in 10,000 nanoscale voids grows to the microscale. *Void nuclei thus appear to be overseeded!*

22 incipient (< 2 μm) voids characterized using a combination of EBSD (20) and TEM (2)

- All voids associated with a deformation-induced dislocation boundary
- 13 microscale voids were particle free and emerged within a grain
- 6 microscale voids emerged at the inclusion-free intersection between a grain boundary and one or more dislocation boundaries
- 5 microscale voids emerged at an inclusion that was intersected by a dislocation boundary and, in most cases, a grain boundary

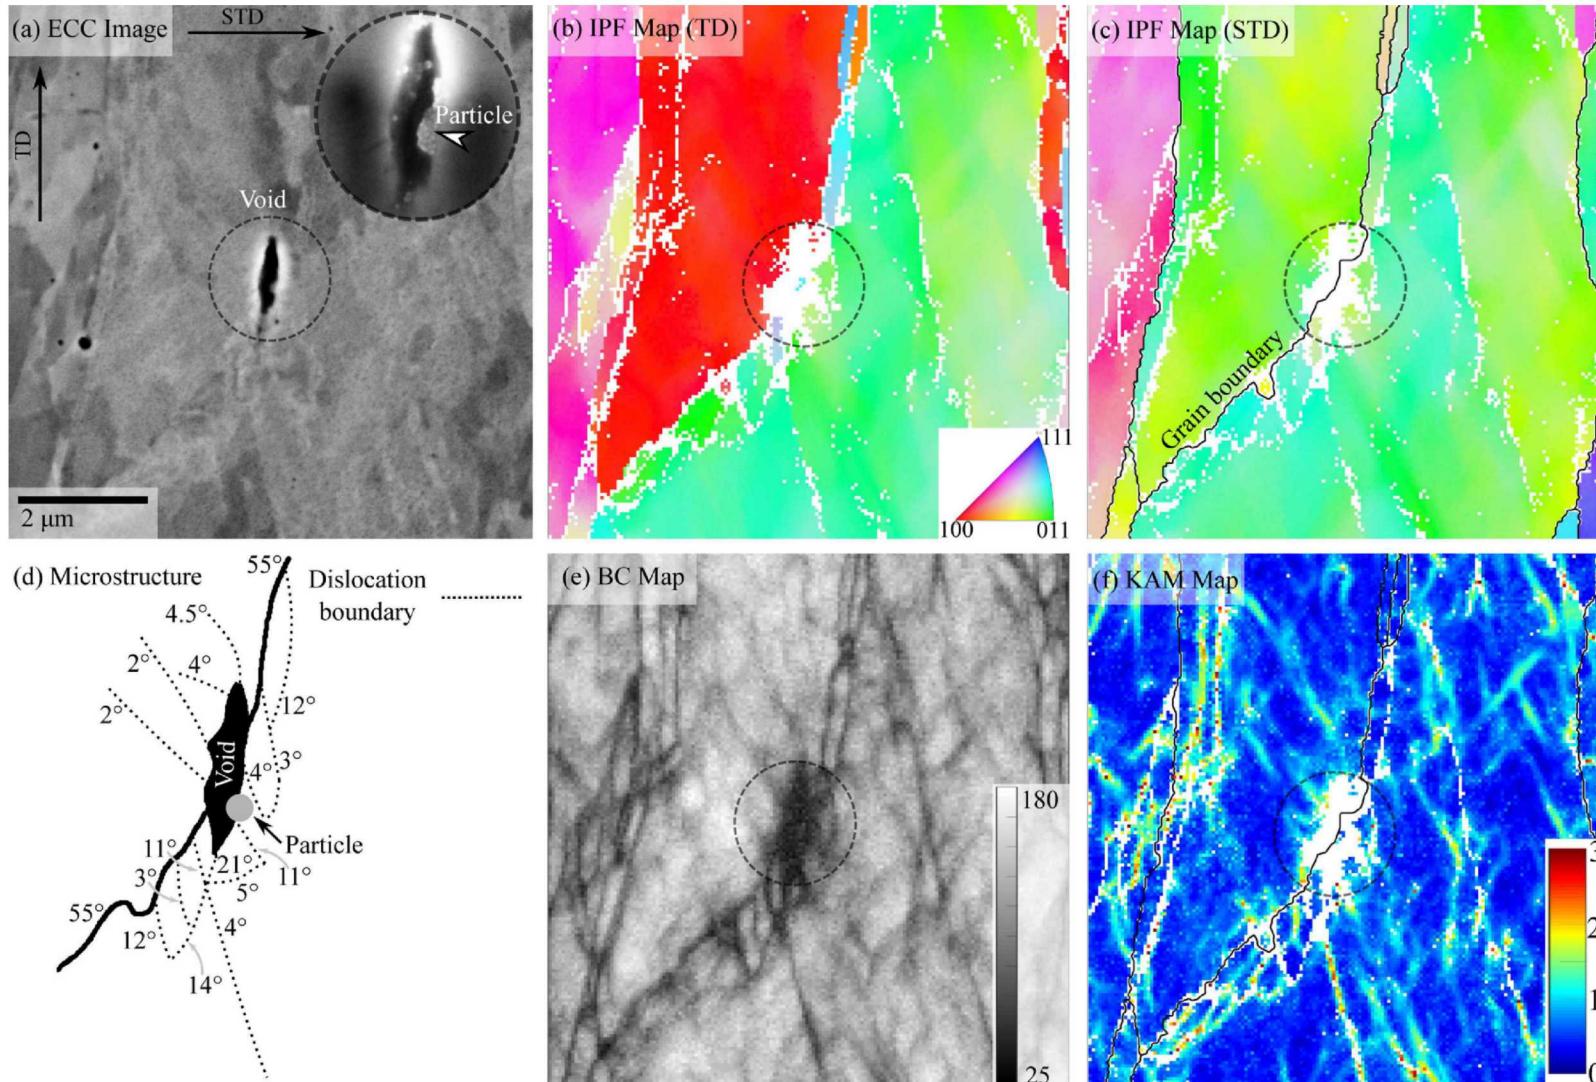
Typical void that nucleated at a particle is shown

- Intersected by multiple cell block boundaries

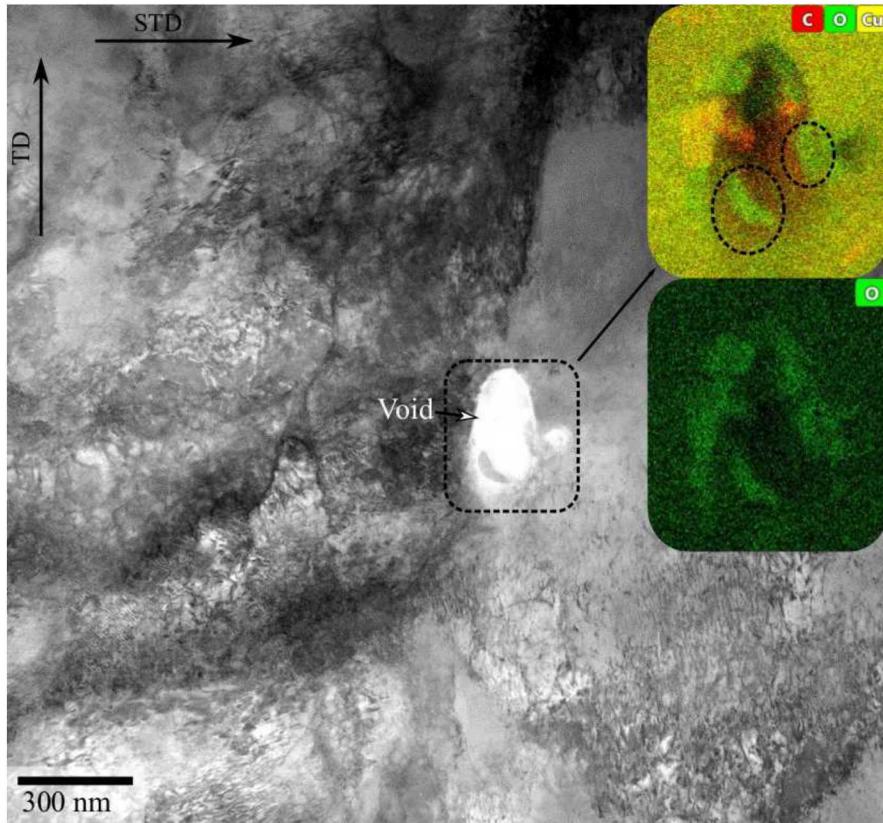
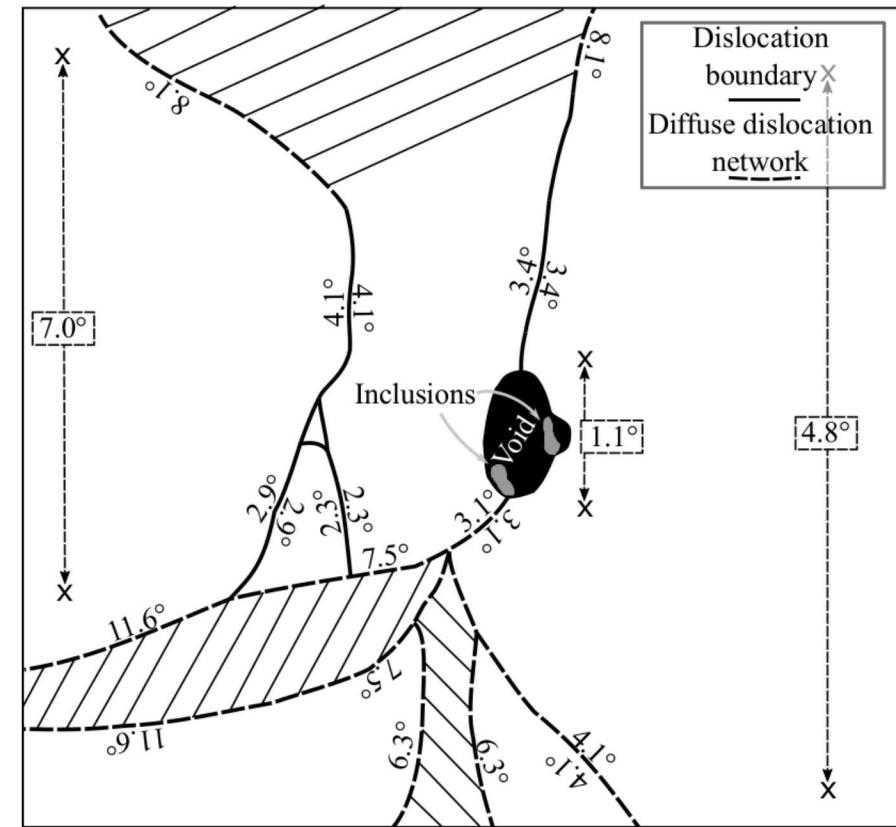
Even at the nanoscale, it is clear that dislocation boundaries are associated with the emergence of voids that are associated with particles
