The Critical Microstructural Conditions Leading to the Formation of Voids During Ductile Rupture

Philip J. Noell, Julian E. C. Sabisch, Douglas L. Medlin, Jay D. Carroll, Brad L. Boyce

Void nucleation during ductile rupture

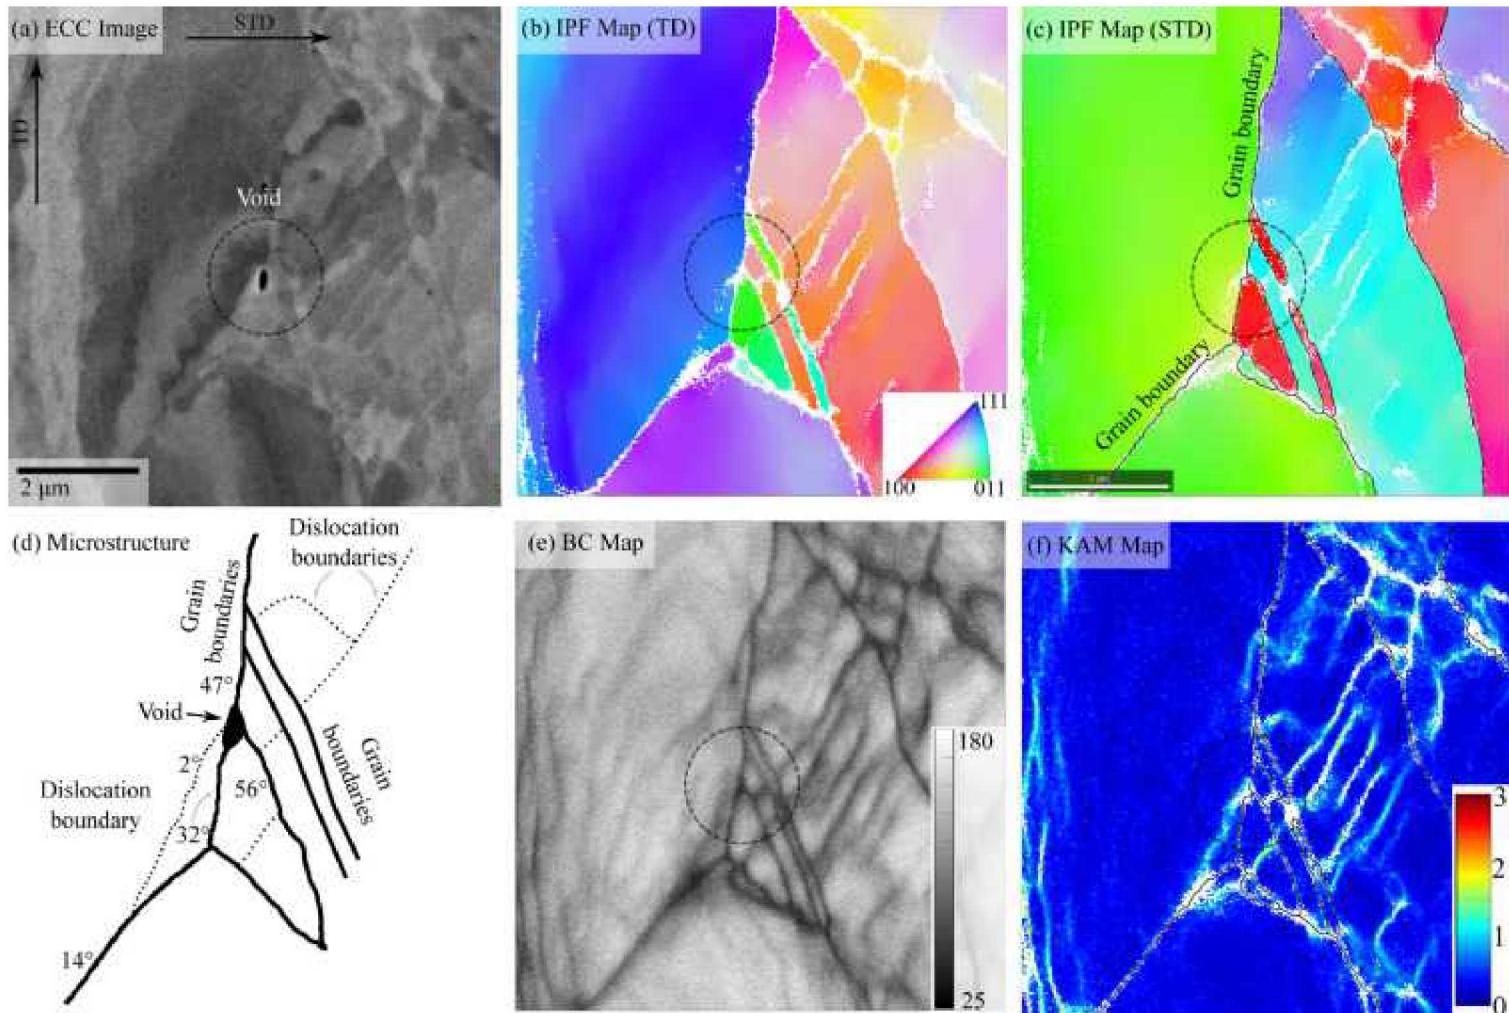
Typical void that nucleated at a grain boundary is shown

- Void emerged at the intersection between a grain boundary triple point and a cell block boundary

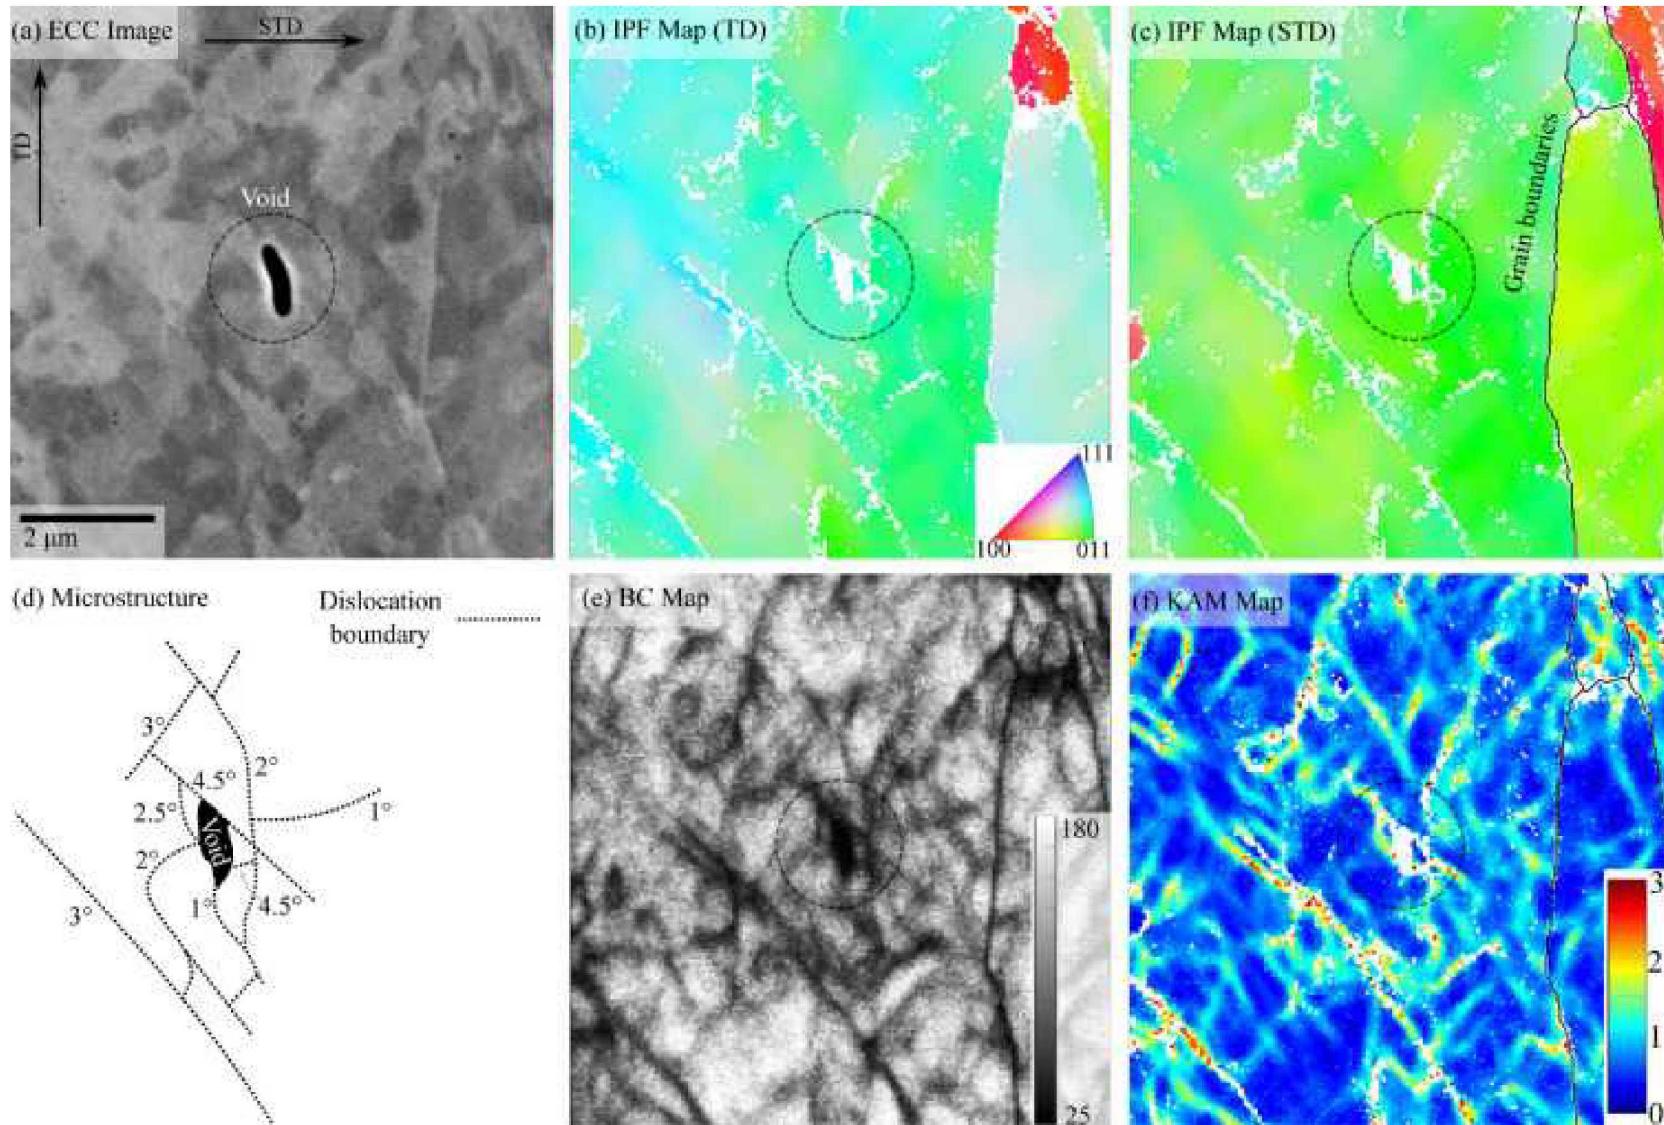
Most microscale voids emerged within grains and were not associated with inclusions or particles

These observations suggest void emergence to the microscale depends on dislocation structures

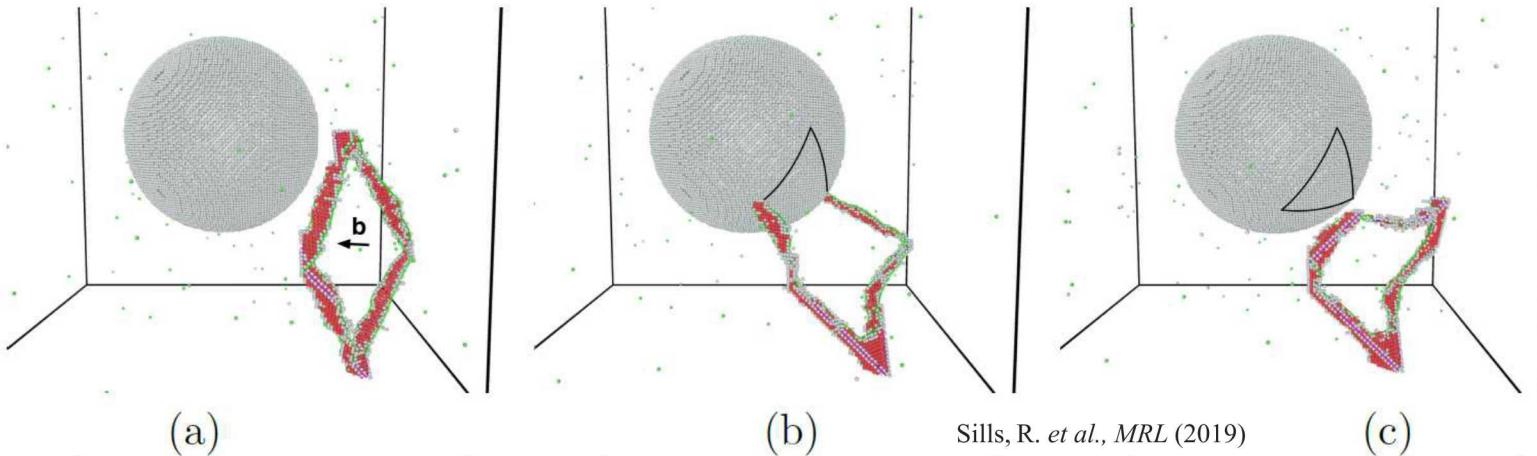
- MD simulations of void growth by dislocation absorption suggest that this is a realistic mechanism for the growth of nanoscale voids
- This mechanism is only realistic if the nanovoid is surrounded by a high-density of mobile dislocations, which is expected if the nanovoid is intersected by one or more dislocation boundaries

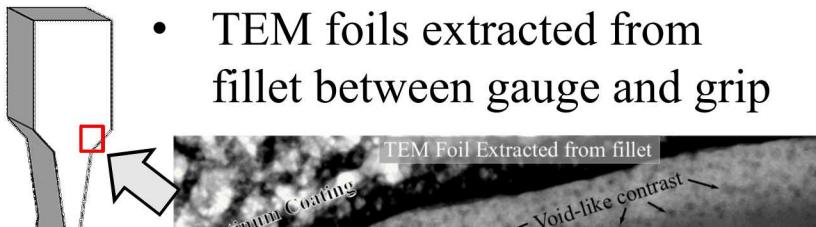
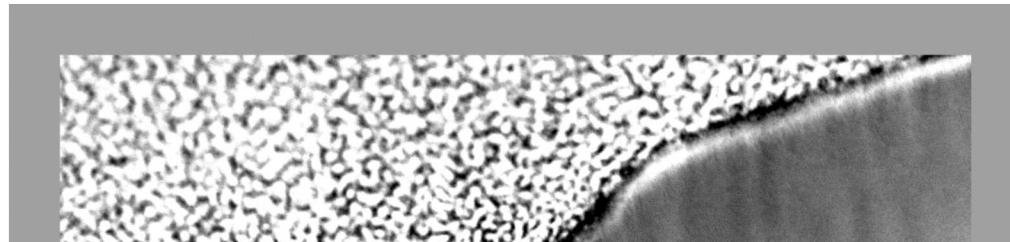
- TEM foils extracted from fillet between gauge and grip

(a)
away from the Ga melt surface layer.

This observation suggests that any nanoscale defect content smaller than ≈ 3 nm may be an artifact of specimen preparation, but that ***the >10 nm voids observed in the deformed microstructure are real, intrinsic features of the microstructure***

Extremely little mass-thickness contrast observed in tomographic series. Some surface damage is visible at the extreme tilts (central feature due to electron beam depositing material).
